## 航空器失事調查報告

ASC-AAR-02-04-002

中華民國89年10月31日  
新加坡航空公司 006班機  
BOEING 747-400 型機  
國籍登記號碼 9V-SPK  
於中正國際機場  
起飛時撞毀在部分關閉跑道上

# 摘要報告

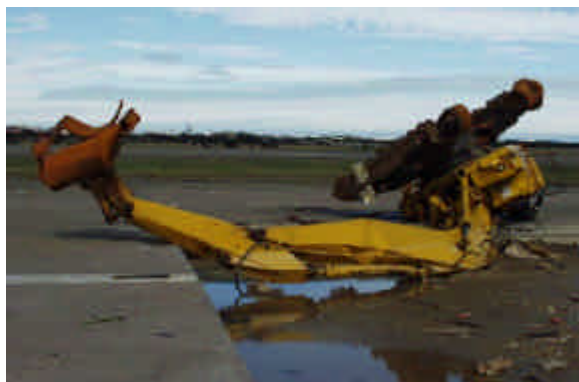
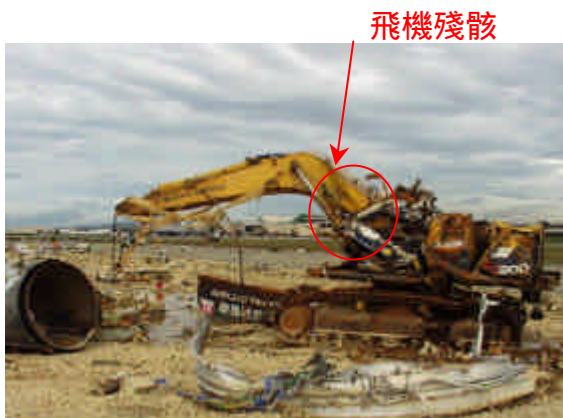
圖 1.4-1 挖土機（在 5 號坑洞內）

施工人員在 05 右跑道現場留有 11 個施工坑洞及 6 部機具，包括兩輛挖土機（圖 1.4-1）、兩輛蒸氣式壓路機（圖 1.4-2）、一輛推土機（圖 1.4-3）以及一輛空氣壓縮機。六輛機具皆因嚴重撞擊而損毀，除一輛挖土機與一輛推土機外，其餘機具都由原先位置撞落至各個施工坑洞。

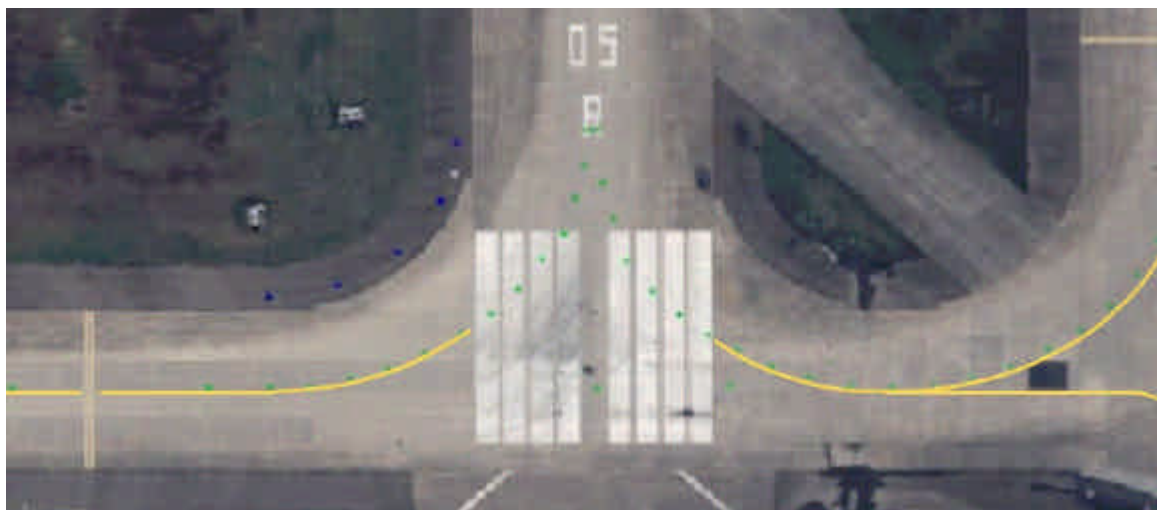
圖 1.10-6 05 右跑道頭標線區之滑行道中心線標線

N1 滑行道之單線中心線標線以一連續之弧形由 NP 滑行道連至 05 右跑道之中心線，而另一反向弧形則由 05 右跑道中心線位置切至 N1 滑行道中心線，切線繼續延伸至 05 左跑道邊線止，然 N1 滑行道經 05 右跑道頭標線區兩側之部份中心線標線則未標示，如圖 1.10-6 所示。

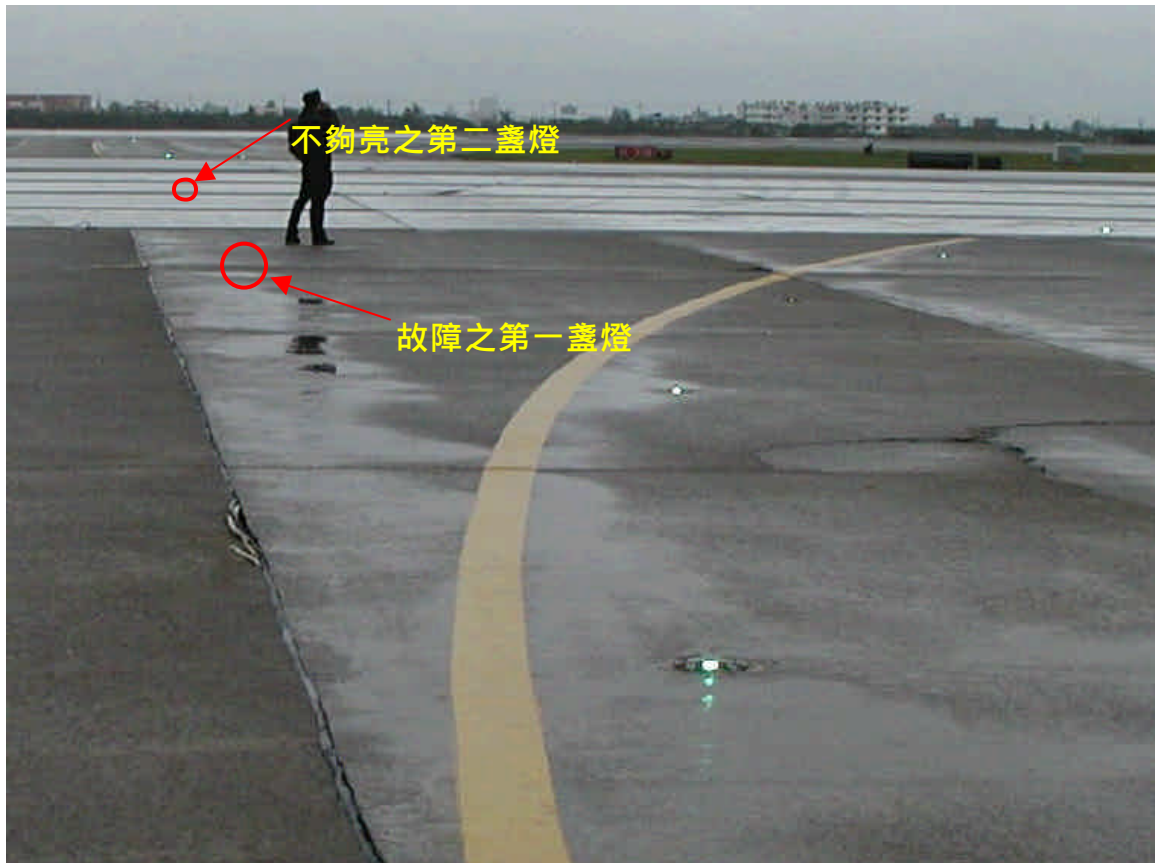
圖 1.10-10 05 右跑道頭處之 N1 滑行道中心線燈情況 (攝於八十九年十一月四日)

本會人員於現場蒐證時（民國八十九年十一月四日），發現在切點後第一盞滑行道中心線燈故障，第二盞燈則不夠亮，如圖 1.10-10。

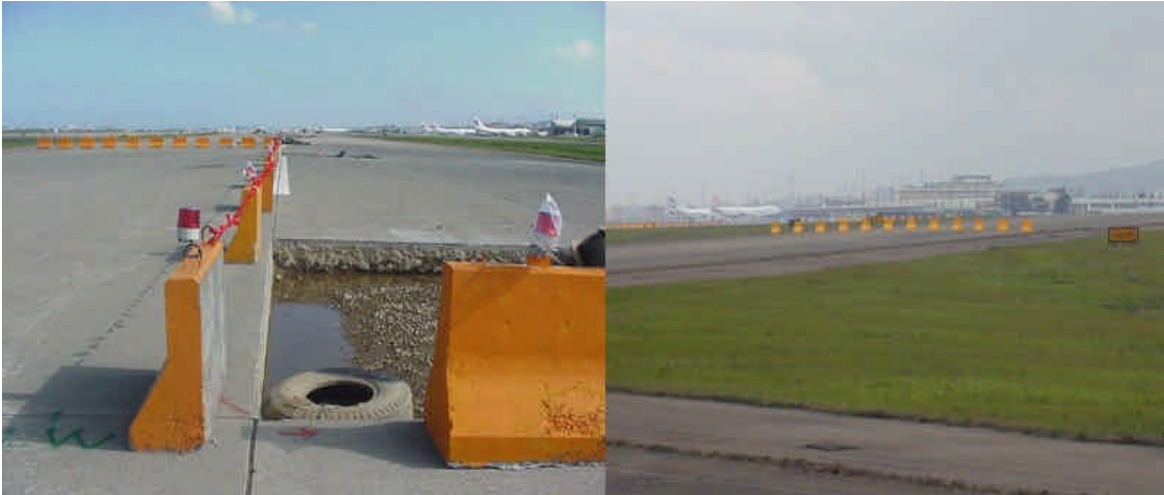
圖 1.10-11 由 05 左跑道觀察 05 右跑道關閉施工區

根據中正機場提供資訊，由於該區常有颱風帶來強風及大雨，輕質易碎之塑膠製品及紅色障礙燈很容易被吹離或沖走，形成外物損害（FOD）航空器之可能。為防止此類情況，中正機場於緊鄰施工區域，提供混凝土製高約 0.8 公尺、長 1 公尺澤西護欄以為阻攔。該護欄塗漆為黃色、橙色或黃黑混合線條。護欄上裝有夜間使用之電池式紅色警告閃光燈，燈距約 2 至 5 公尺。（見圖 1.10-11）

事故當時，澤西護欄為唯一在跑道上供辨識施工區域之目視助航設施。05 右/23 左跑道兩端部份區段仍須供滑行使用，因此保持開放而未加阻隔。

然而，本會認為 05 右跑道施工區有兩項安全缺失。首先，根據國際民航公約第十四號附約第 1 冊第 7.1.3 節（標準），緊鄰施工區應有關閉標線，但並無在 05 右跑道頭標線處漆上關閉標線之要求。其次，根據同一標準第 7.1.4 節，施工區設置之護欄必須易碎。混凝土材質護欄不合國際民航組織標準及建議措施。雖此兩項缺失並未涉及 SQ006 失事。

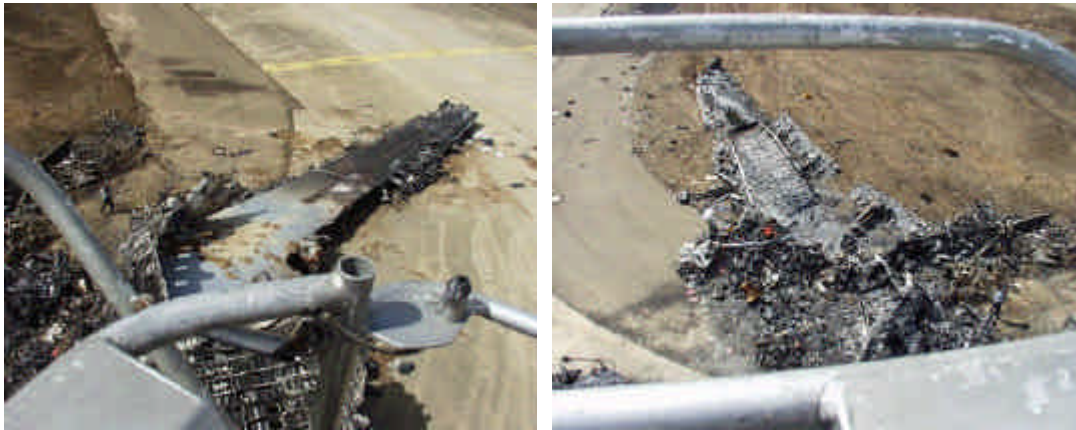
圖 1.12-7 左右兩邊機翼

左翼翼尖部分遭大火完全燒毀，但仍可識別出其輪廓，翼尖部分於機翼站位 1360 處斷裂。

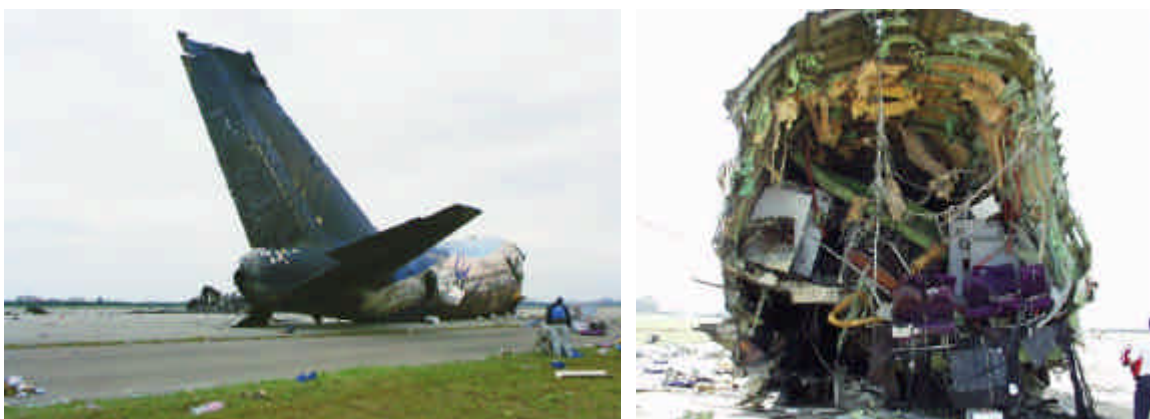
圖 1.12-8 機身後段

機身於 4 號門前方斷裂，約於機身站位 1560 處形成一斷面。

垂直尾翼遭大火薰黑，但未脫離機身，上方有部分斷裂。

機身編號 48 段下方蒙皮無縱向擦痕痕跡。

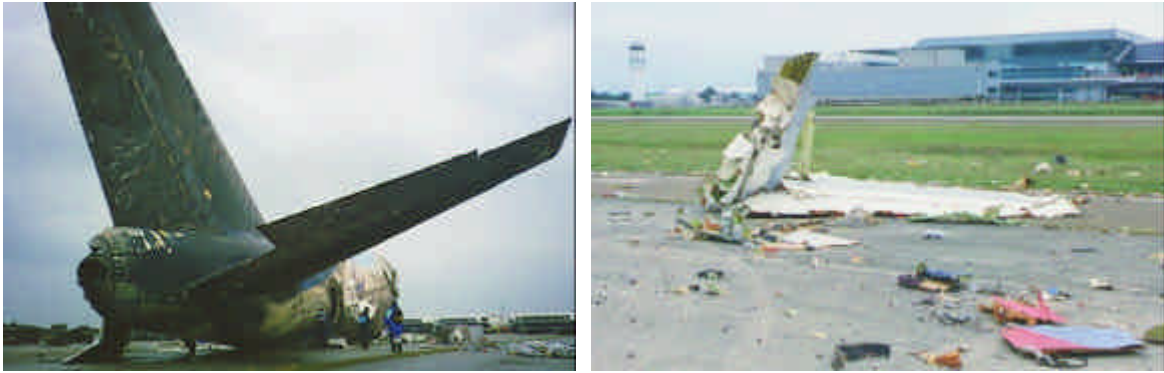
圖 1.12-9 左右水平尾翼

右側水平尾翼雖遭火燒，但大致完整，左側水平尾翼約在水平尾翼站位 270 處斷裂（圖 1.12-9）。

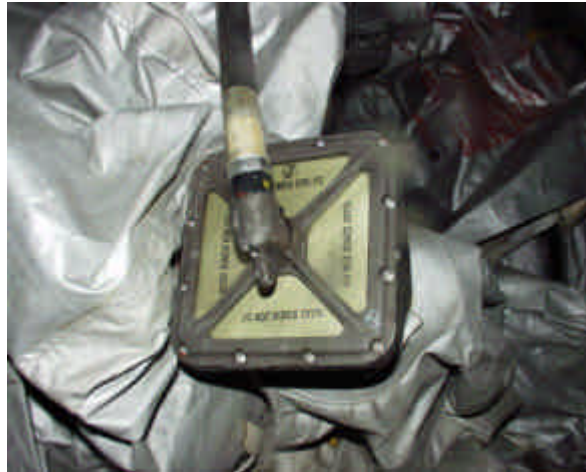
圖 1.12-10 左側 2 號門疏散滑梯充氣機

左側 2 號門完整且在全開位置，操作手柄在「自動模式」位置。疏散滑梯部分展開並伸出機外。起動拉桿旁控制疏散滑梯展開之安全插銷仍在定位，2L 疏散滑梯有多處燒痕，並已與起動拉桿分開。疏散滑梯充氣機入口處無火燒痕跡。詳見圖 1.12-10。

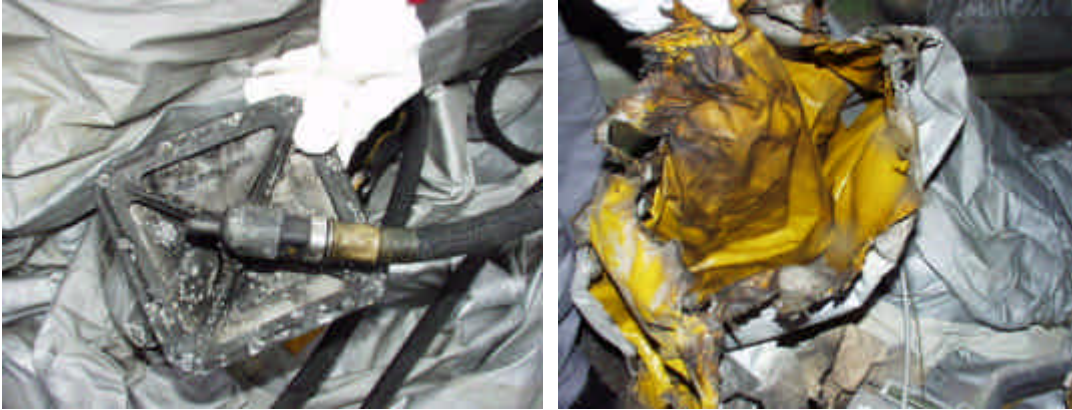
圖 1.12-11 右側 4 號門疏散滑梯充氣機（左）及其內部火燒情形（右）

右側 4 號門完整，未被開啟，操作手柄在「自動模式」。4R 疏散滑梯在艙內充氣伸展。充氣機入口處及滑梯內部有火燒破損痕跡。

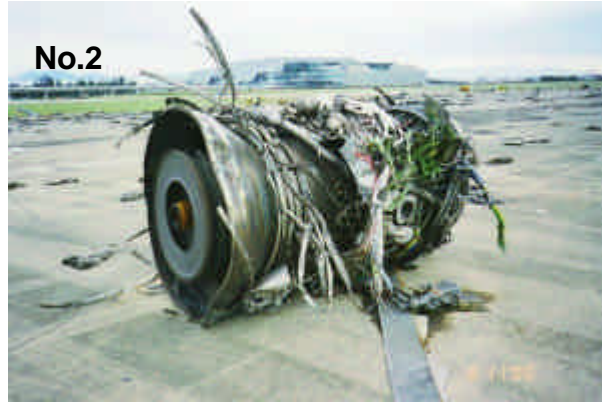
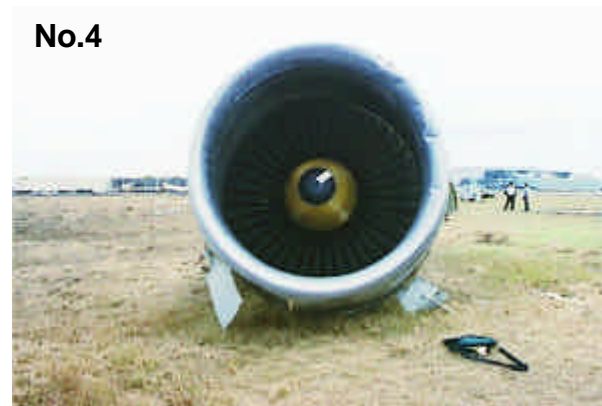
圖 1.12-12 四具發動機

現場尋獲之四具發動機皆與機身脫離，檢視發現在撞擊前，發動機並無葉片脫離或遭火燒跡象。（圖 1.12-12）

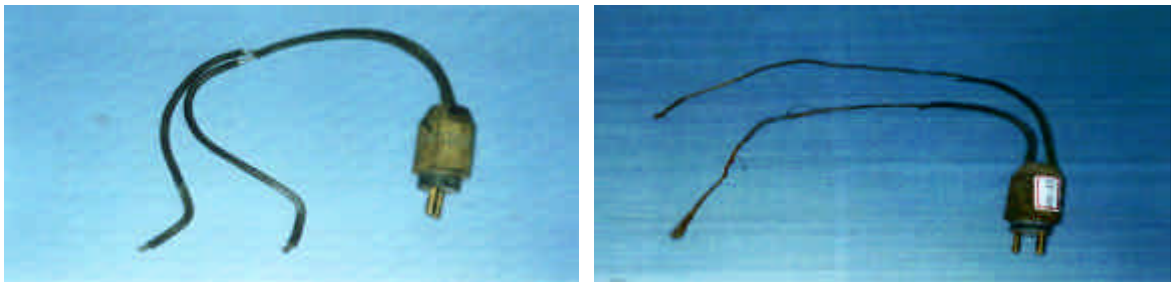
圖 1.12-15 跑道邊燈 RE239 電線（左）及 RE240 電線（右）

RE239 電線發現時未連接於任何地面之插座。雖說發現時鄰近有些破碎燈具，然無法確定該電線屬那一盞跑道邊燈。

RE240 位置之燈具在離地約 3.8 至 5 公分處切斷。切斷處沿著燈具之同一高度。燈具底部仍有螺栓與其底座結合，但上部已脫離。附近未發現金屬或玻璃碎片。兩條線束即裸露在離該燈座 5 到 15 公分處。尋獲時，發現其插頭仍連接於地下之插座。即將插頭拔出插座並於電線上做標示（圖 1.12-15）。

澳洲運輸安全局之報告指出，RE239 之兩線束係由拉扯而與燈座線夾分離。報告中敘述，線束末端皆有夾線過程中造成夾痕的特徵，且一致呈現係「剪線過程」的特性。報告中復敘述 RE239 之兩條電線絕緣層離插頭 11 公分處有相似的破裂情形，且明顯地有一段絕緣層因受拉力作用而向電線末端移動。報告中另指出，絕緣層距插頭 7.5 公分位置有 V 字型 (chevron-like) 撕裂處。RE239 電線未發現放電跡象。

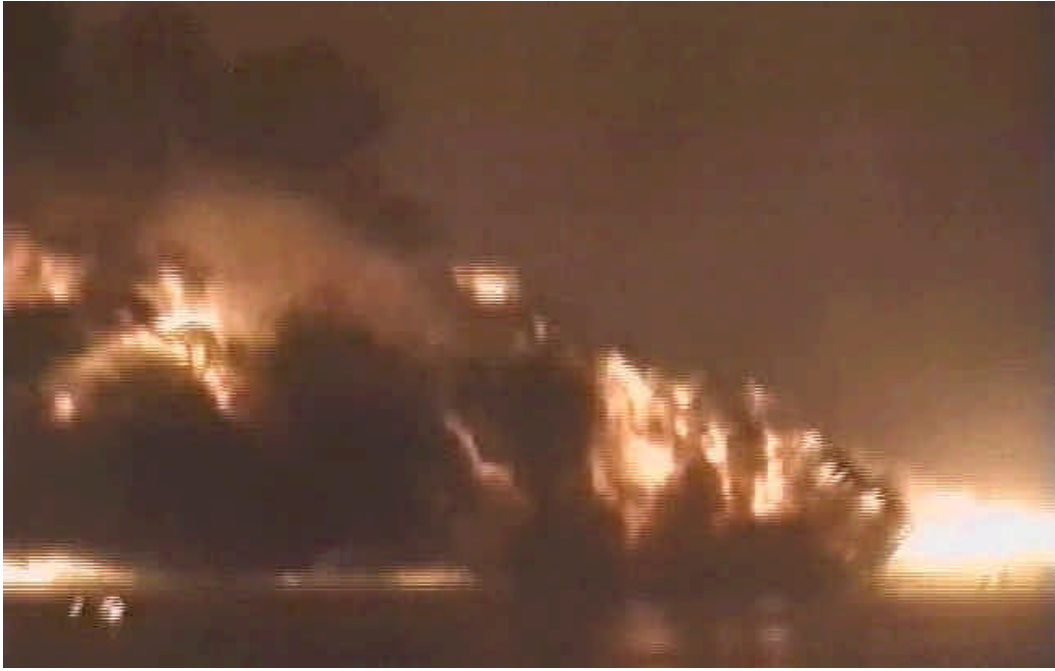
圖 1.15-1 SQ006 撞擊停止後約 30 秒飛機前段大火燃燒情形（照片由失事時滑經 A4 停機坪之班機內乘客拍攝）

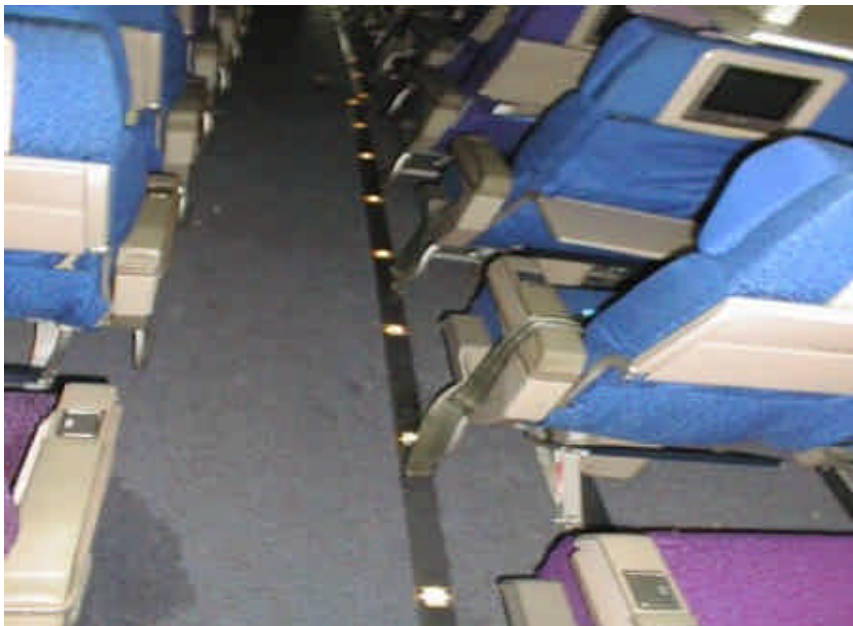
圖 1.16-3 緊急照明燈光測試結果

在本測試中，本會將乘客緊急疏散指示燈及 4、5 號門間之地板疏散指示燈（圖 1.16-3）之四組電池組（第五組無法尋獲），於 4、5 號門後取下，送往中正機場之華航維修廠進行測試，各電瓶組皆通以 7 安培電流，過電後四者之瞬間電壓為 5.2 伏特，10 秒後則降至 0.1 伏特以下，結果顯示各電瓶組皆完全放電。

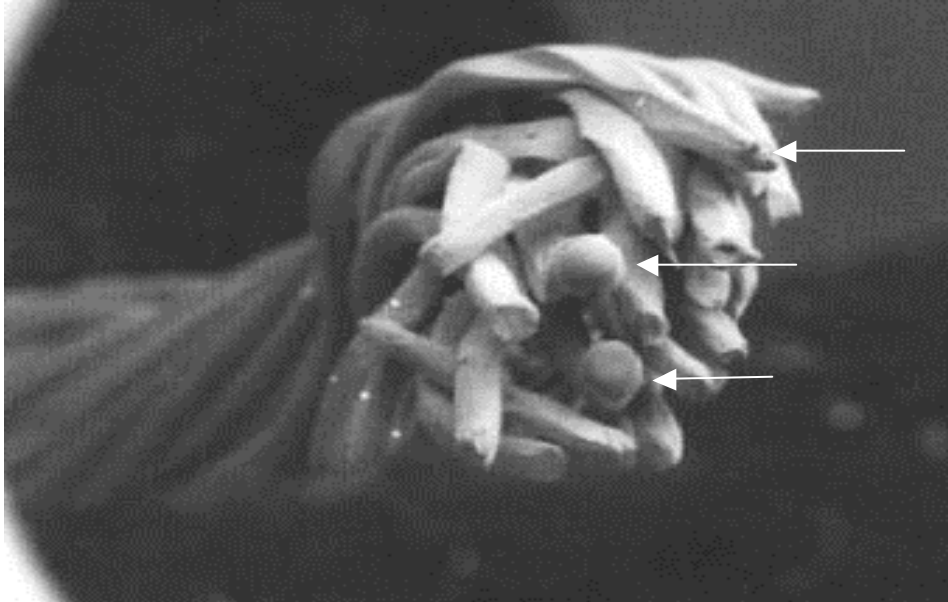
圖 1.16-4 RE240-1 電線末端之三處熔珠

RE240-1 線束末端發現三個熔珠（圖 1.16-4）。根據中科院之報告，這些熔珠像似放電而產生之局部熔融現象。報告另外提到，對其遭污染之各股電線末端進行掃描電子顯微鏡/能量散佈光譜分析後發現，三個熔珠應是在其它電線末端遭污染後才生成，其中一個熔珠表面有一缺口，比其它未產生熔融現象之電線末端乾淨（圖 1.16-5）。

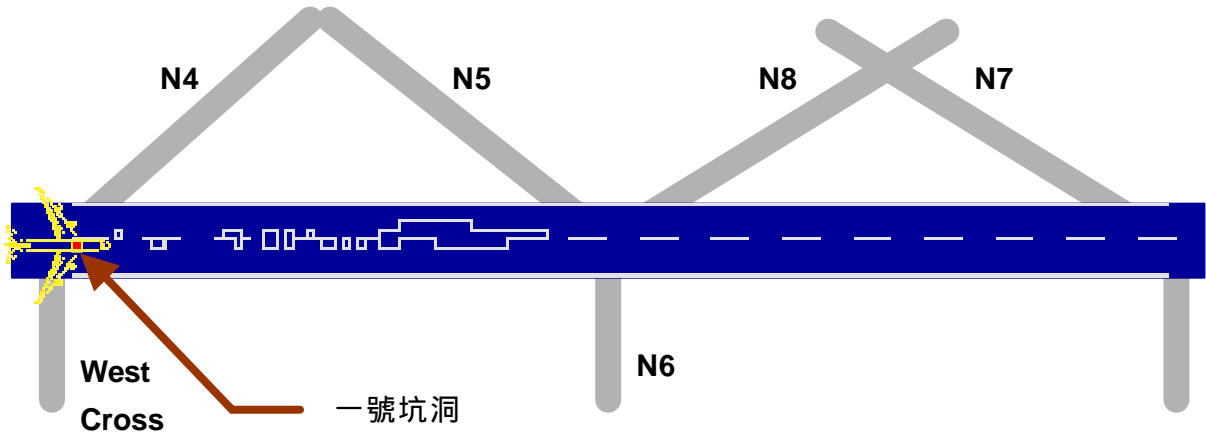
圖 2.2-1 結構失效順序說明-1

1. 右機腹起落架門（應係右側門）撞至澤西護欄，左起落架在越過 1 號坑洞時，輪胎撞擊坑洞北側邊緣，造成至少一個輪胎損壞（1 號坑洞如下圖紅色方塊所示）。

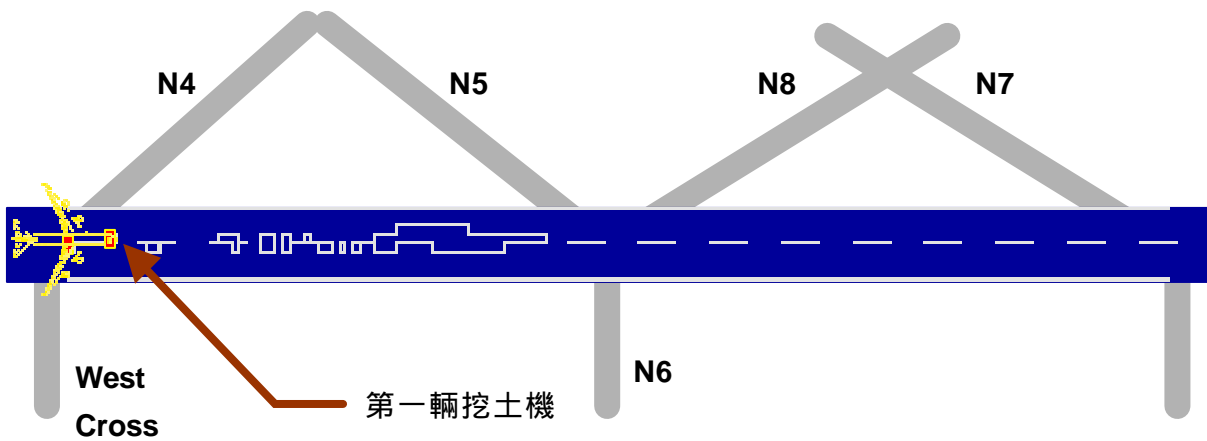
圖 2.2-2 結構失效順序說明-2

2. 左下機腹撞擊第一輛挖土機（紅色方塊所示），造成左下方機身、電子艙及貨艙損壞？。

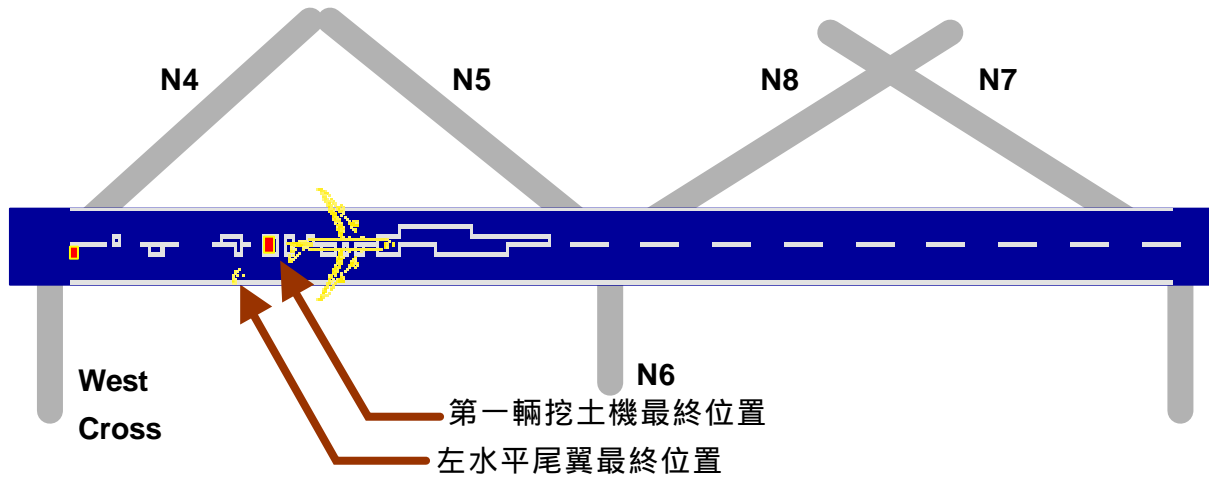
圖 2.2-3 結構失效順序說明-3

- 隨後滾行過程中，飛機水平尾翼亦遭第一輛挖土機撞及前緣及其它結構，以致斷裂掉落，翼內燃油外洩燃燒。

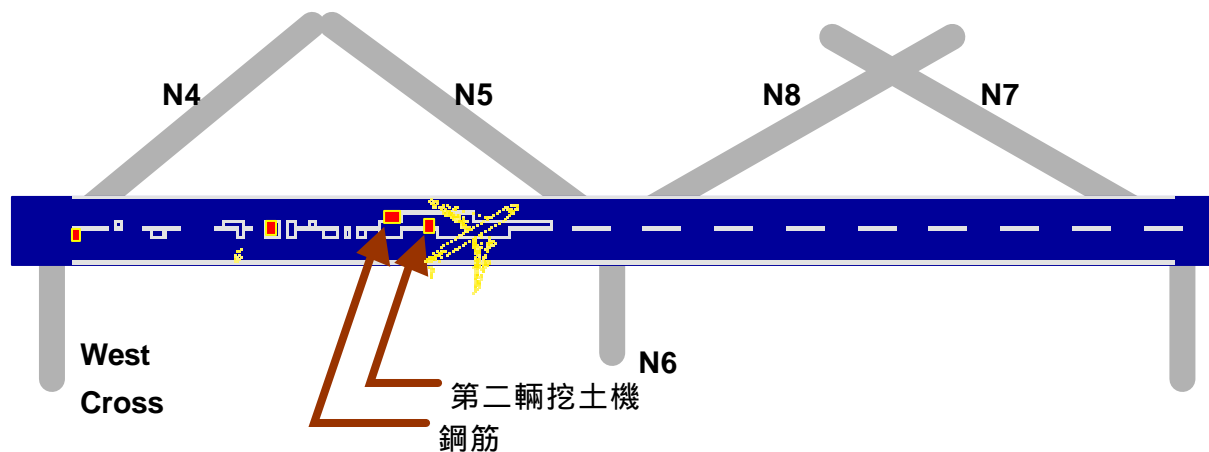
圖 2.2-4 結構失效順序說明-4

- 1 號及 2 號發動機撞擊 11 號坑洞旁之鋼筋與第二輛挖土機（紅色方塊所示）後掉落，由於機身撞擊及推力不平衡緣故，機身開始反時鐘旋轉。3 號發動機亦於 11 號坑洞附近擦撞地面與機翼飛離，掉在停機坪。

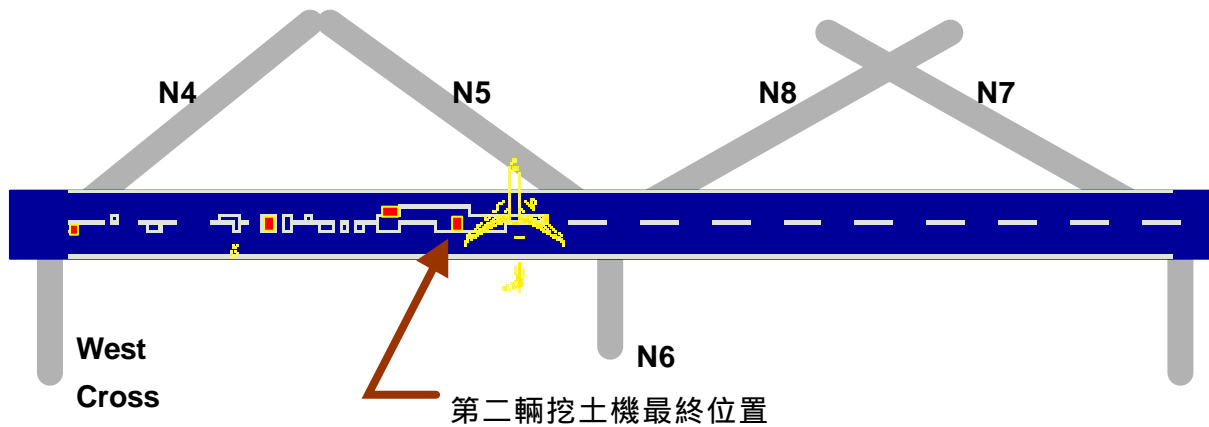
圖 2.2-5 結構失效順序說明-5

- 滾行至 N6 滑行道前，旋轉之機身與兩台壓路機（紅色方塊所示）撞擊後致使機身斷裂，後機身隨後滑至該滑行道左側。距跑道頭 1430 英尺處之草坪上開始有火燒之跡象，及散落燒? 之貨物。

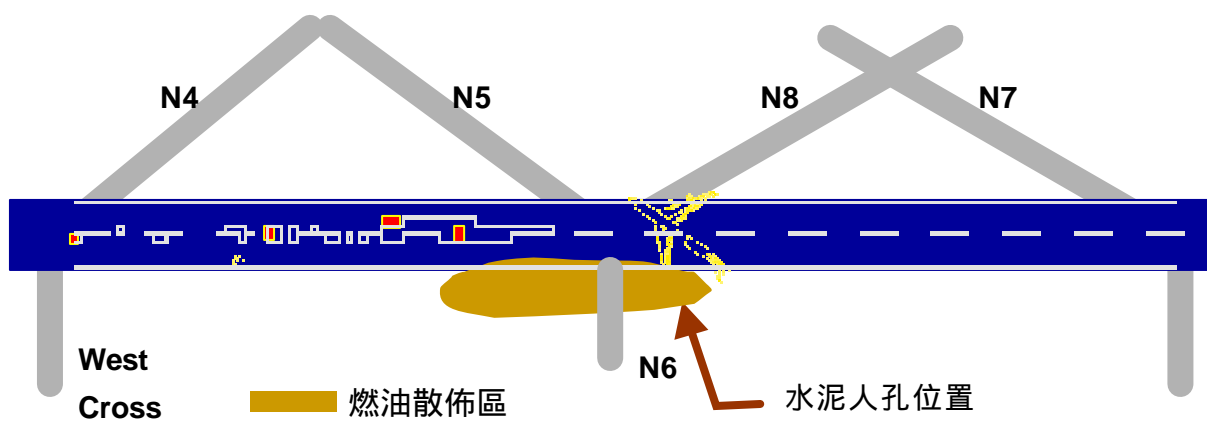
圖 2.2-6 結構失效順序說明-6

- 當前段機身繼續旋轉向前時，左翼尖撞及南方之水泥人孔（紅色方塊所示）後解體脫離，並使該機停止反時鐘旋轉，繼續向後滑行。

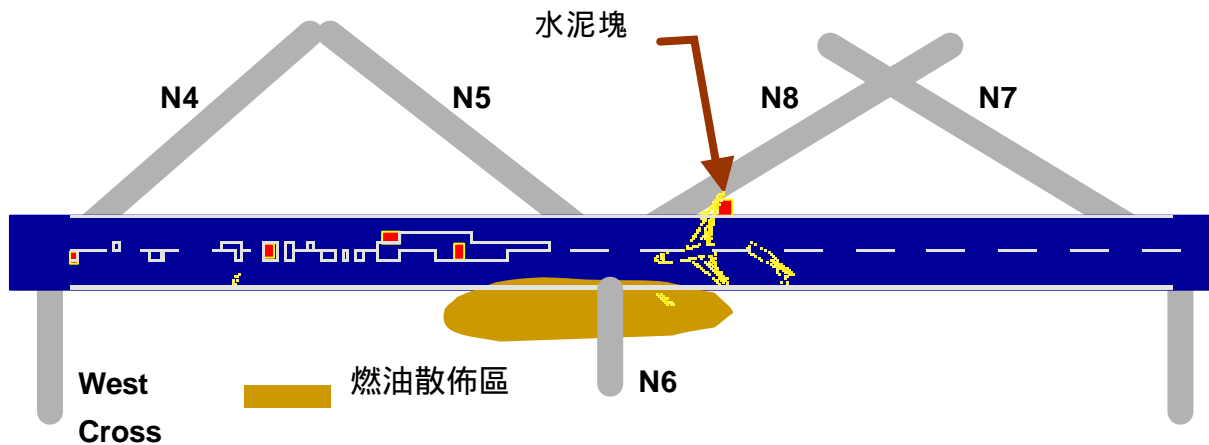
圖 2.2-7 結構失效順序說明-7

7. 4 號發動機在該機向後滑行中撞擊地面水泥塊（紅色方塊所示）後自右翼解體脫離。

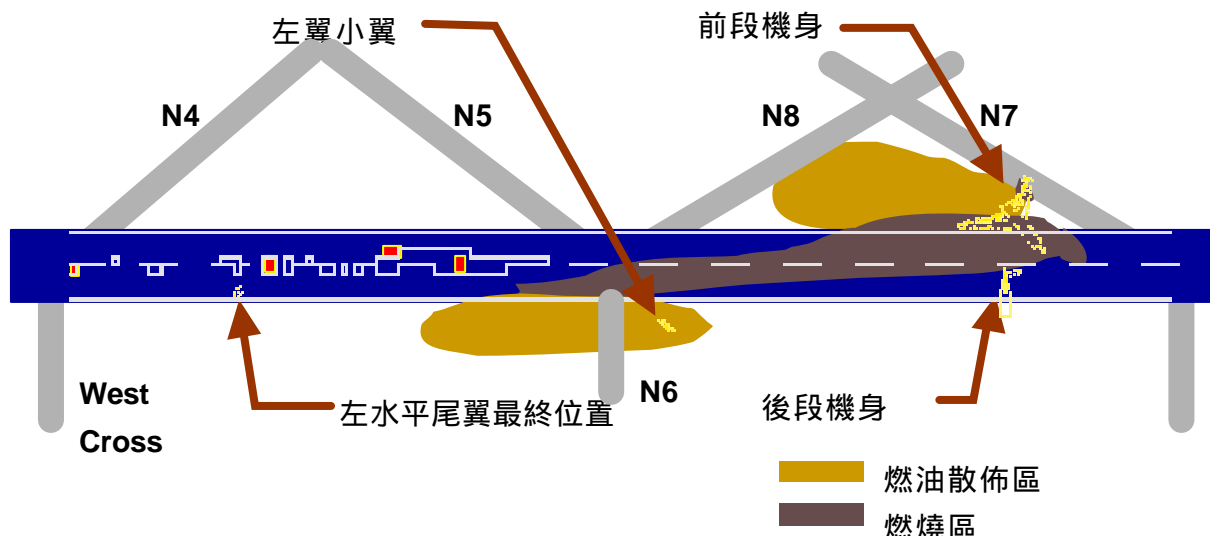
圖 2.2-8 結構失效順序說明-8

8. 當 4 號發動機脫離右機翼後，前段機身因撞擊力量再度反時鐘旋轉，直至最終停止位置。
