# 國家運輸安全調查委員會

## 重大運輸事故 調查報告

遠東航空股份有限公司 FE3060 班機

於臺中清泉崗機場落地時短暫偏出跑道

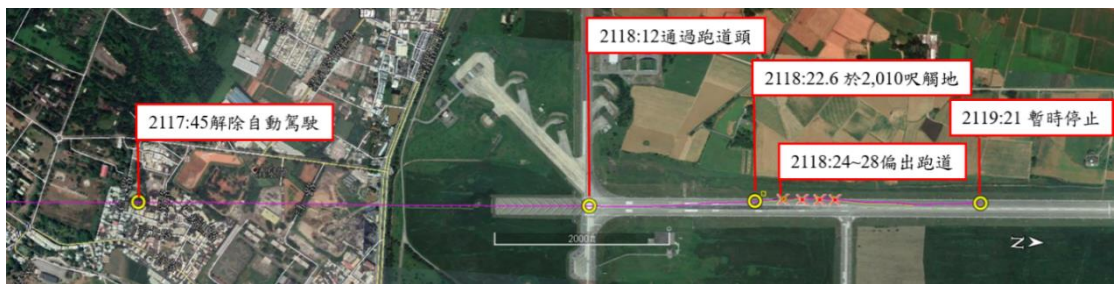
PM 於訪談時表示距跑道頭約 1 哩時，目視航機落地燈照到跑道道面有反光，且可看到水波紋，表示跑道有積水。PF 表示航機觸地剎那，瞬間向左偏，立刻放下鼻輪修正，但航機仍然向左偏出跑道，修正回跑道後，將航機停止於距跑道頭約 7,000 呎處並通知塔臺航機可能因出跑道受損，建議派員至現場檢視。經地面人員確認航機除右主輪轂有草外無其他損傷後，始將航機滑回停機位置。該機自馬公機場起飛至臺中機場全程飛航軌跡如圖 1.1-1，落地期間偏出跑道之軌跡如圖 1.1-2。

圖 1.1-2 事故機落地軌跡圖

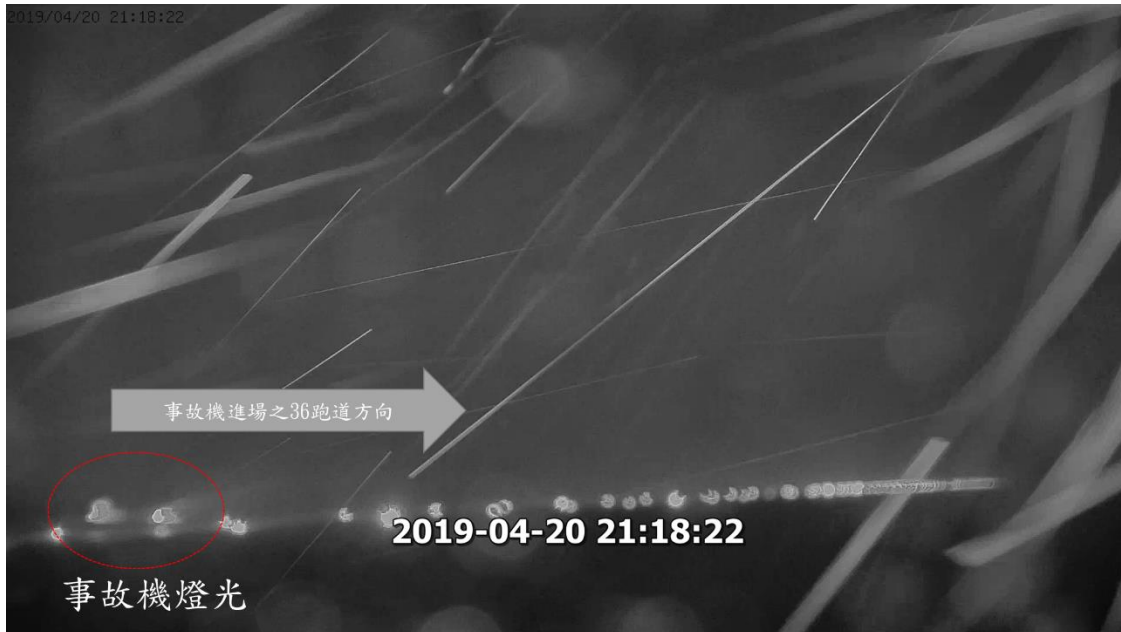
另依據事故當時 36 跑道頭安裝之監視攝影機紀錄畫面顯示，該機落地時，攝影機紀錄畫面顯示為中至小雨狀況，如圖 1.7-7。

圖 1.7-7 該機落地時 36 跑道頭監視攝影機紀錄畫面

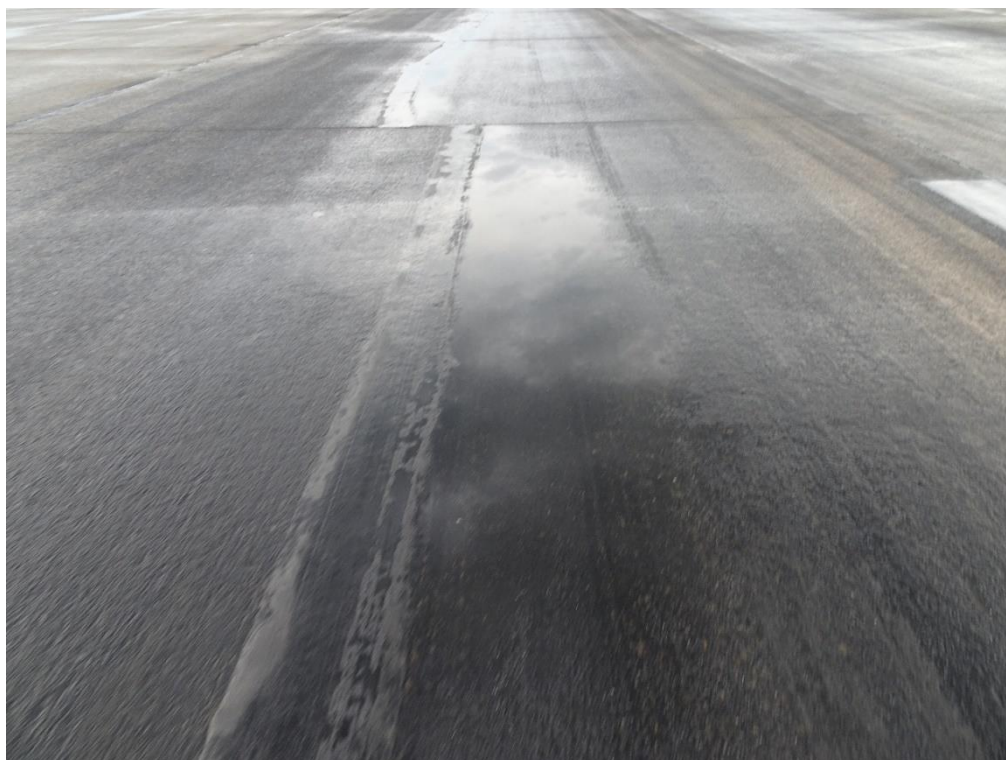
1. 臺中機場跑道道面可能因雨造成局部積水現象，但現有事實資料並無充分證據顯示事故機落地期間曾因跑道局部積水而影響航機落地後方向之操作。
2. 本次事故，除飛航組員之自述外，並無其他證據顯示本事故與飛航組員疲勞因素相關。
3. 遠東相關手冊中與濕滑/汙染跑道相關之內容，缺少詳細之操作指南，且飛航組員操作手冊及飛航手冊中，缺少機種訓練手冊需要之參考內容。
4. 事故機落地偏出跑道後，右發動機曾有短暫轉速及渦輪溫度下掉之

本會調查小組於事故後隔日，即 108 年 4 月 21 日約 0500 時於臺中機場進行事故現場量測與鋪面檢視，發現 36 跑道著陸區之鋪面存在局部之積水(如圖 1.10-3 與 1.10-4)、不規則之鋪面補塊與裂紋(如圖 1.10-5)；以及距 36 跑道頭約 2,000 呎至 4,500 呎間之兩側跑道邊緣鄰近區域存在有積水，如圖 1.10-6 與 1.10-7。

圖 1.10-3 跑道著陸區之局部水窪(一)

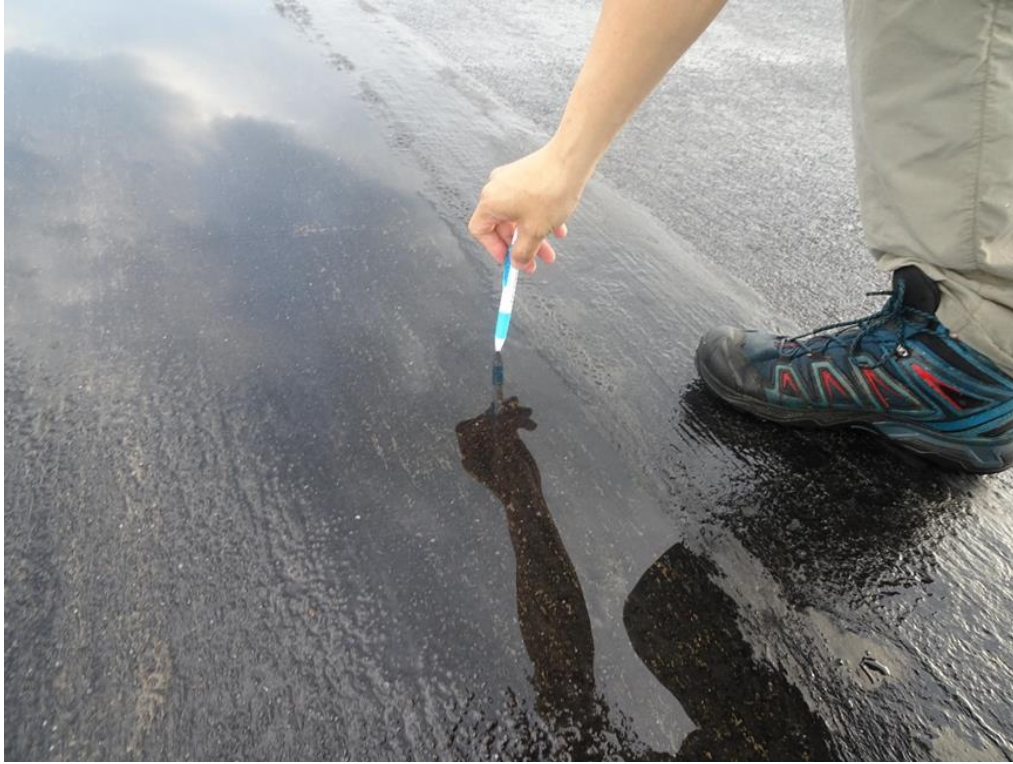
圖 1.10-4 跑道著陸區之局部水窪(二)

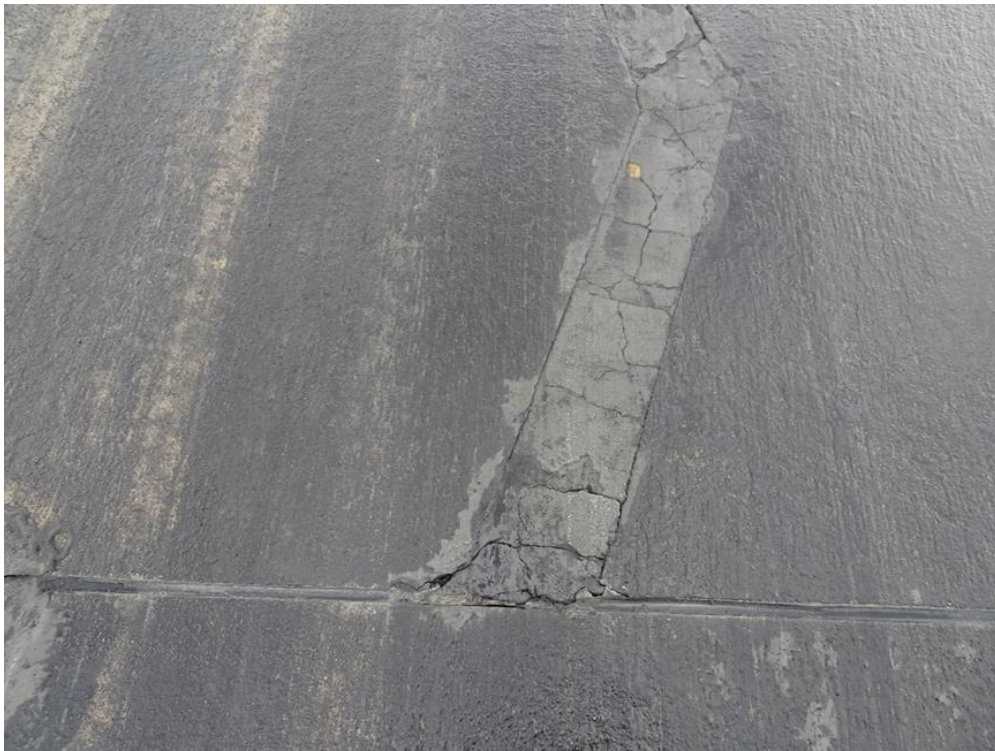
圖 1.10-5 不規則之鋪面補塊與裂紋

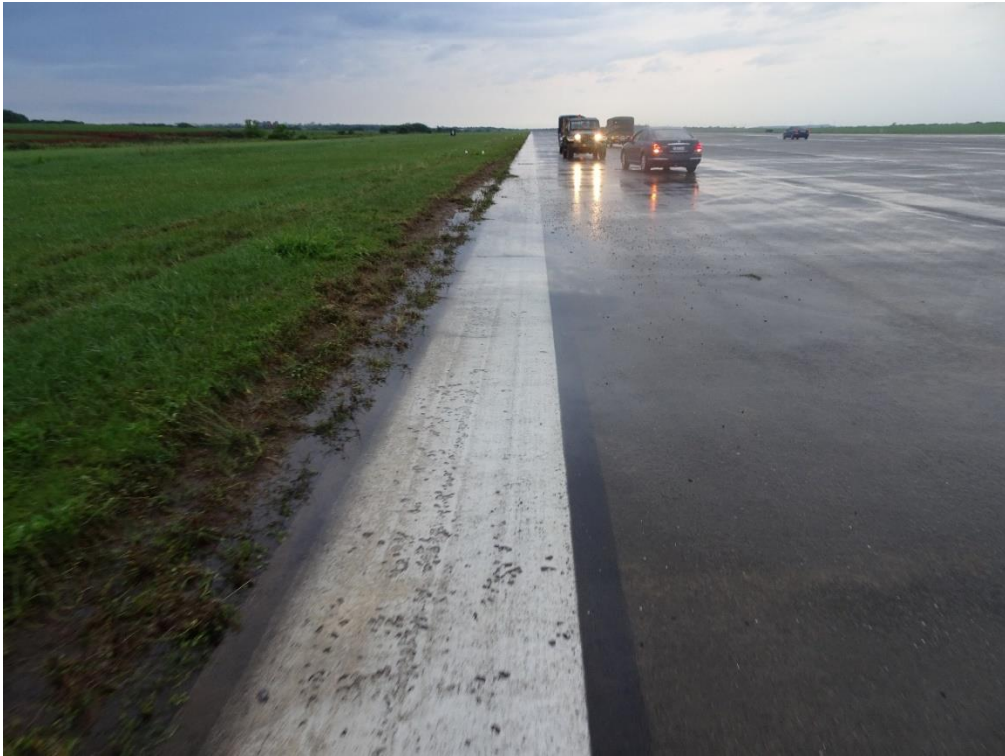
圖 1.10-6 跑道邊線鄰近區域之積水(一)

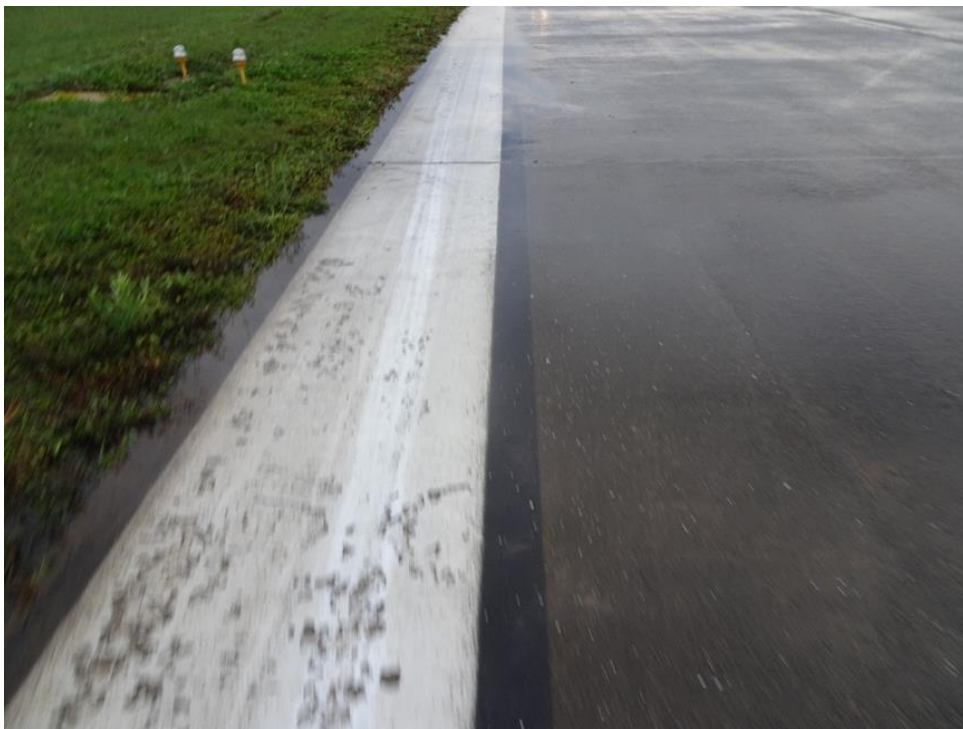
圖 1.10-7 跑道邊線鄰近區域之積水(二)

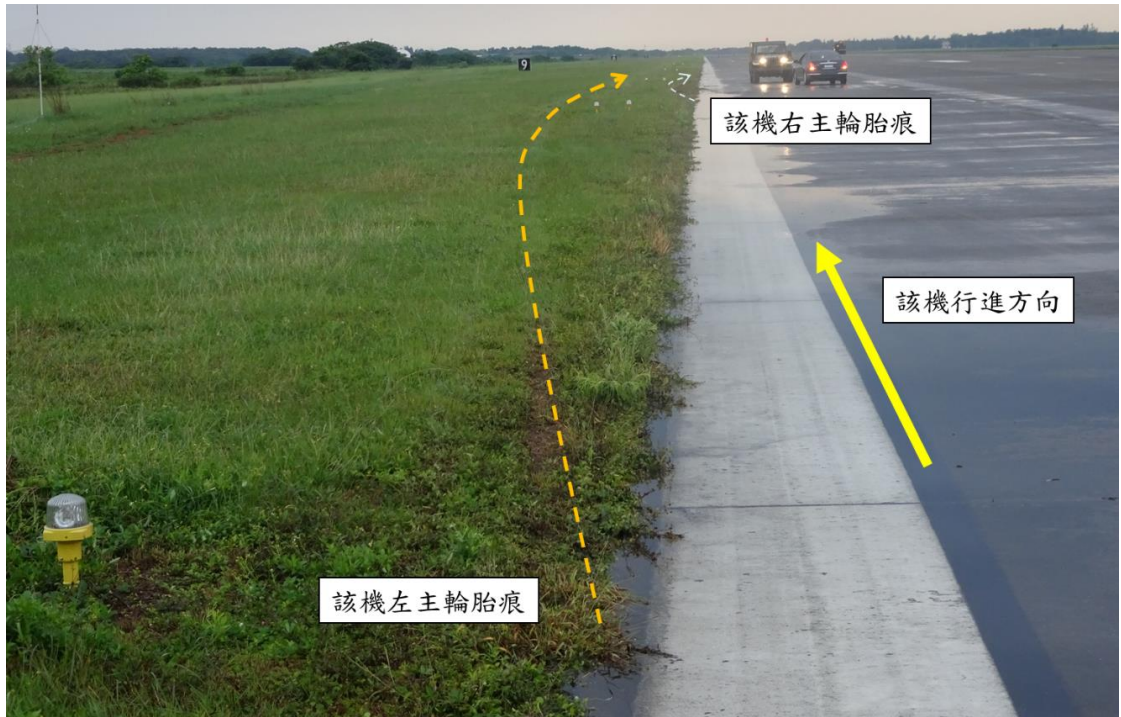
圖 1.12-1 事故機偏出跑道胎痕

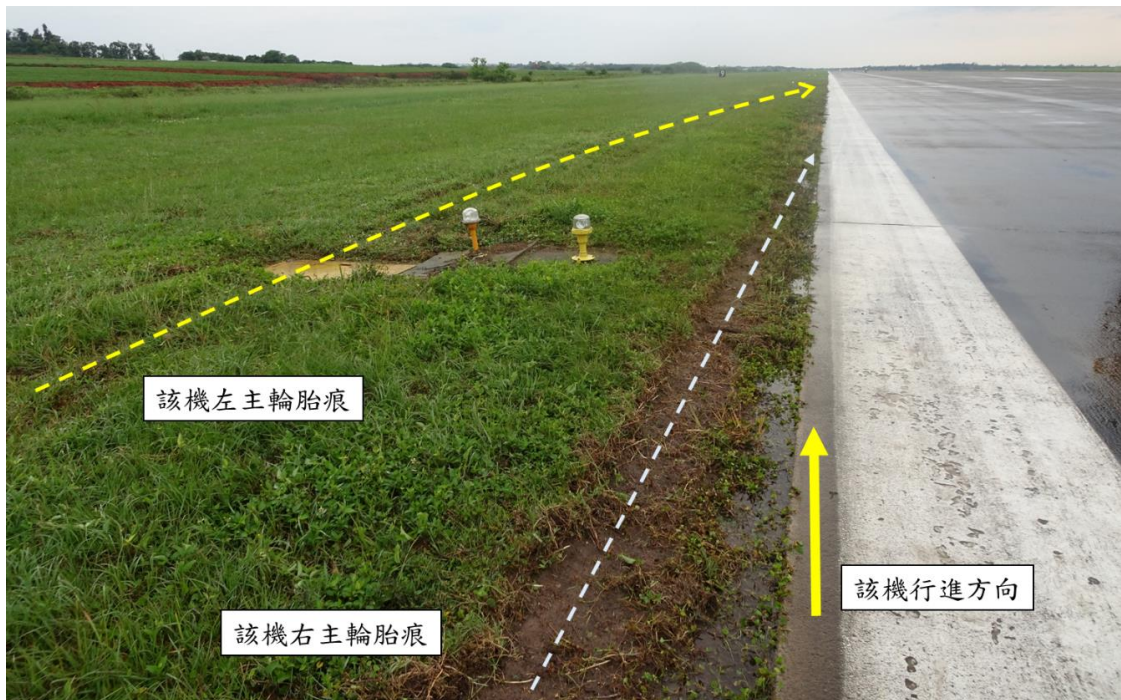
圖 1.12-2 事故機返回跑道道面胎痕

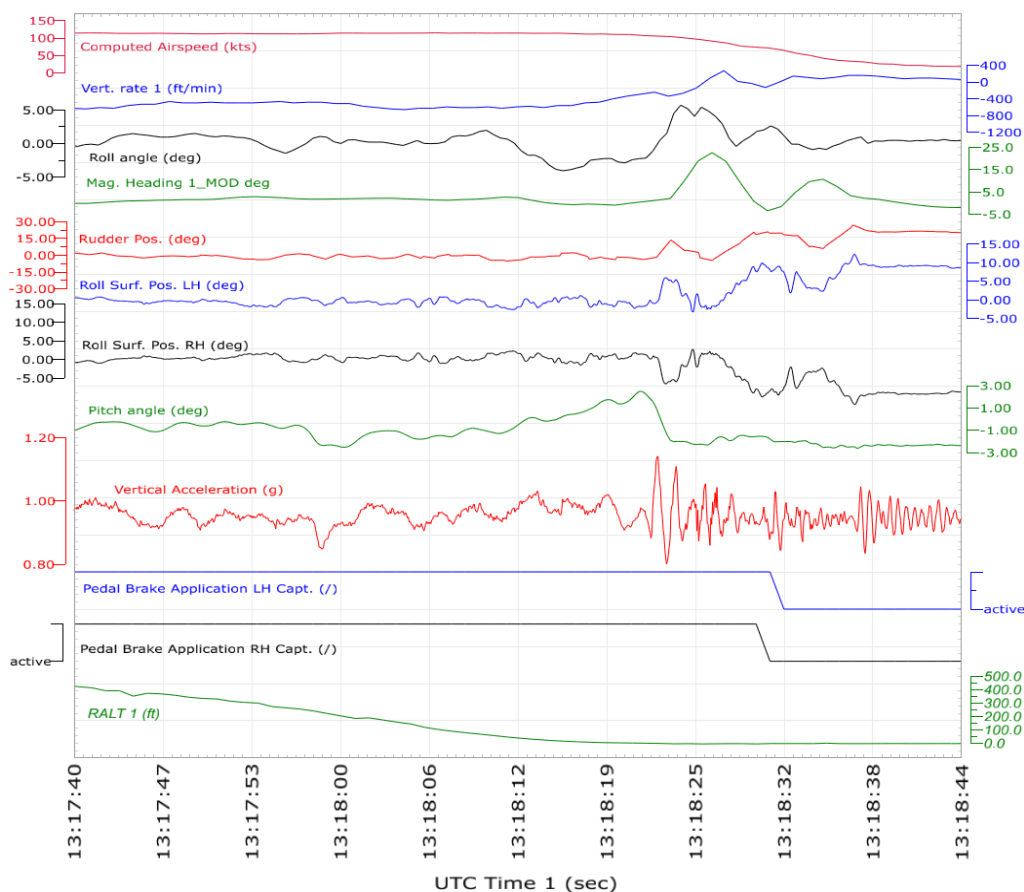
圖 2.1-1 事故機 FDR 記錄落地資料

參考圖 1.11-1、1.11-2 及圖 2.1-1：該機於觸地前約 10 秒(2118:12 時)通過跑道頭，高度 46 呎，速度為 114 哩/時，之後機翼有左偏約 4 度之坡度、下降率約為 300 呎/分，未對正跑道。經 PM 提醒後，PF 並未完全修正機翼左傾姿態，致使該機於距跑道中心線左側約 65 呎處觸地(右主輪距中心線距離)，此時該機左主輪距跑道左邊線之距離約為 20 呎。依據組員訪談紀錄，PF 表示落地仰轉時，無法目視中心線，且於偏出跑道後等待過程與 PM 談話中表示，落地前應執行重飛，顯示 PF 於落地時未能完全掌握跑道之中心線，亦未下決心立即執行重飛。
