# 雙供氣系統失效 與空中失壓

行政院飛航安全委員會

蘇水灶/ 飛安調查官

# DBL-I 事故經過

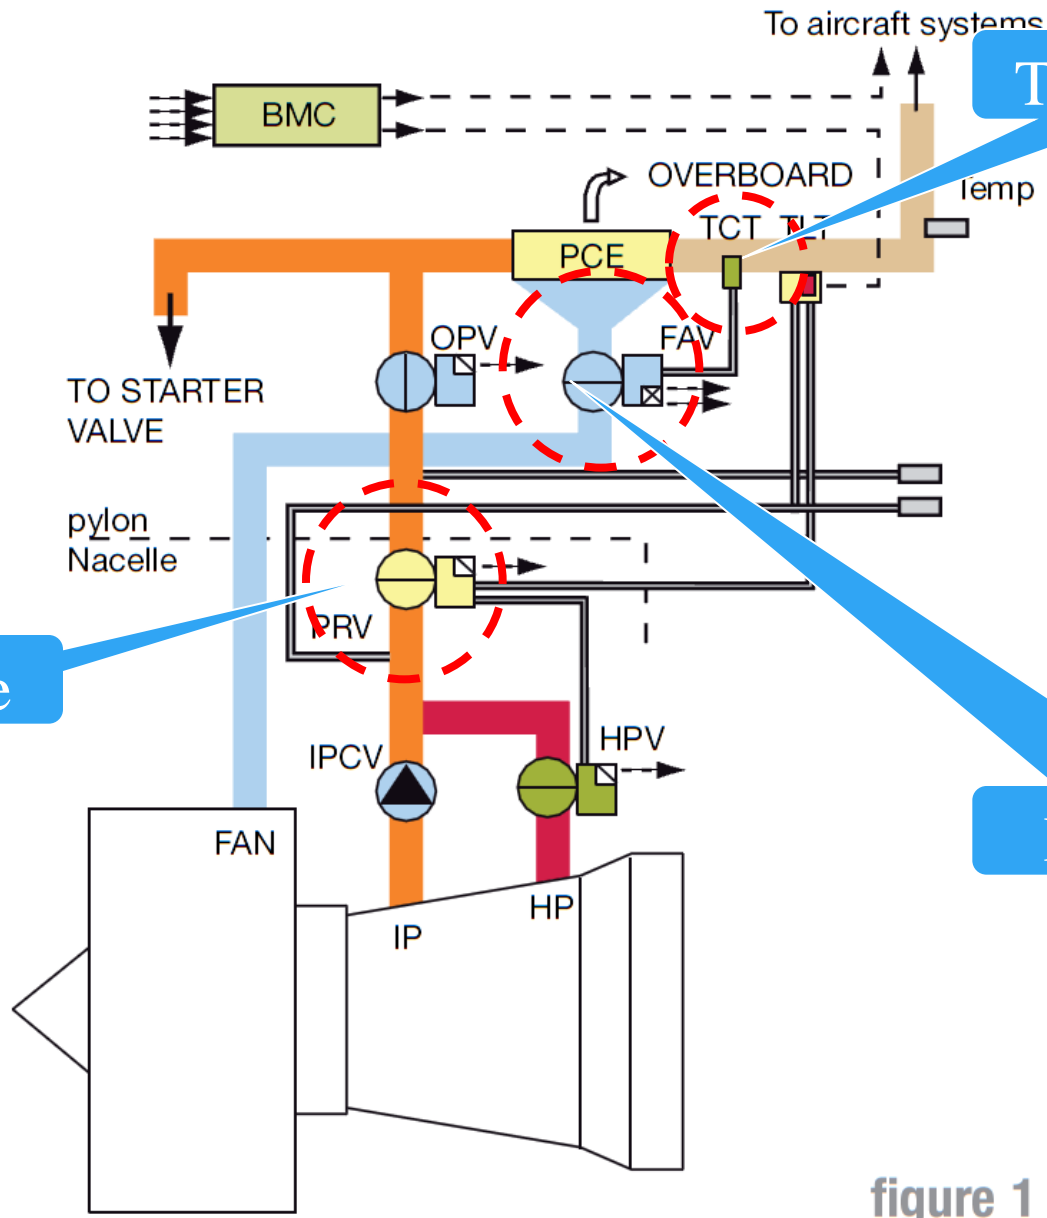
figure 1

# Replaced components

- Fan Air valve
  - P/N 6733A030000,
- Bleed valve
  - P/N 6764B040000
- Thermostat
  - P/N 398E020000

Bleed valve

Thermostat

Fan Air Valve

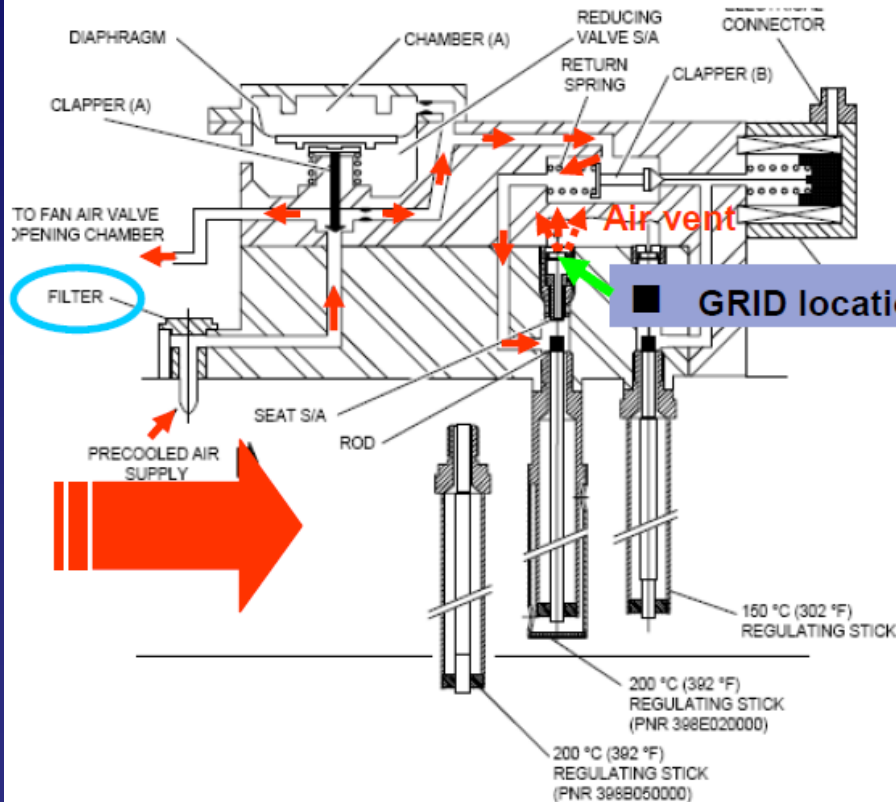
## Path of the bleed air into the THC in hot temperature condition

Grid filter item

Filter item

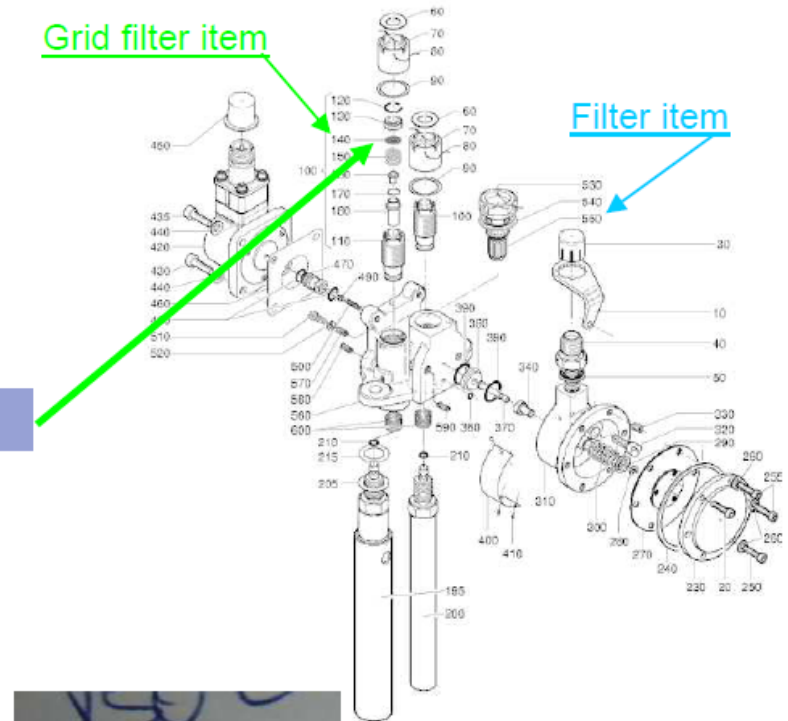
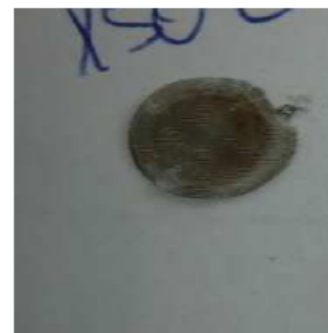
■ Contaminated grid (sample)

- **1) THC improvement:**
  - The THC filter grid has been modified. The THC modification consists in replacing mesh filter by a pollution cover. This modification is covered by VSB 398-36-04.
  - This modification will be applied in production.
  - For in-service A/C, the VSB 398-36-04 is available since week 41 2009.
  - SIL will be updated in the aim to reflect these new improvements.

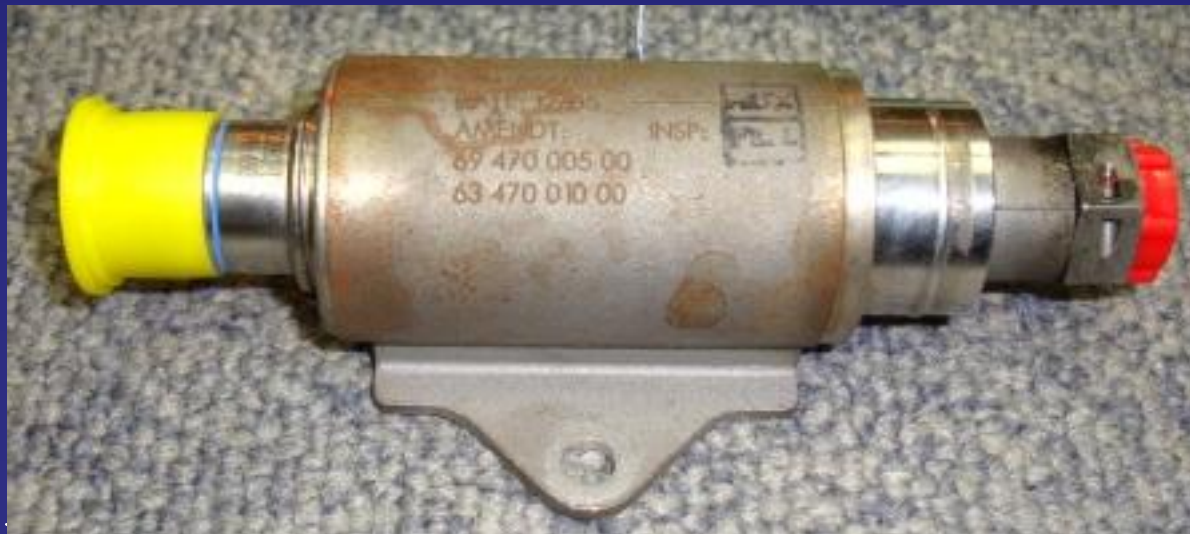
- 更換該機1、2號供氣系統Pr感測器，
  - P/N: ZRA380-00
- 發現更換下之Pr感測器其內部均有積水現象

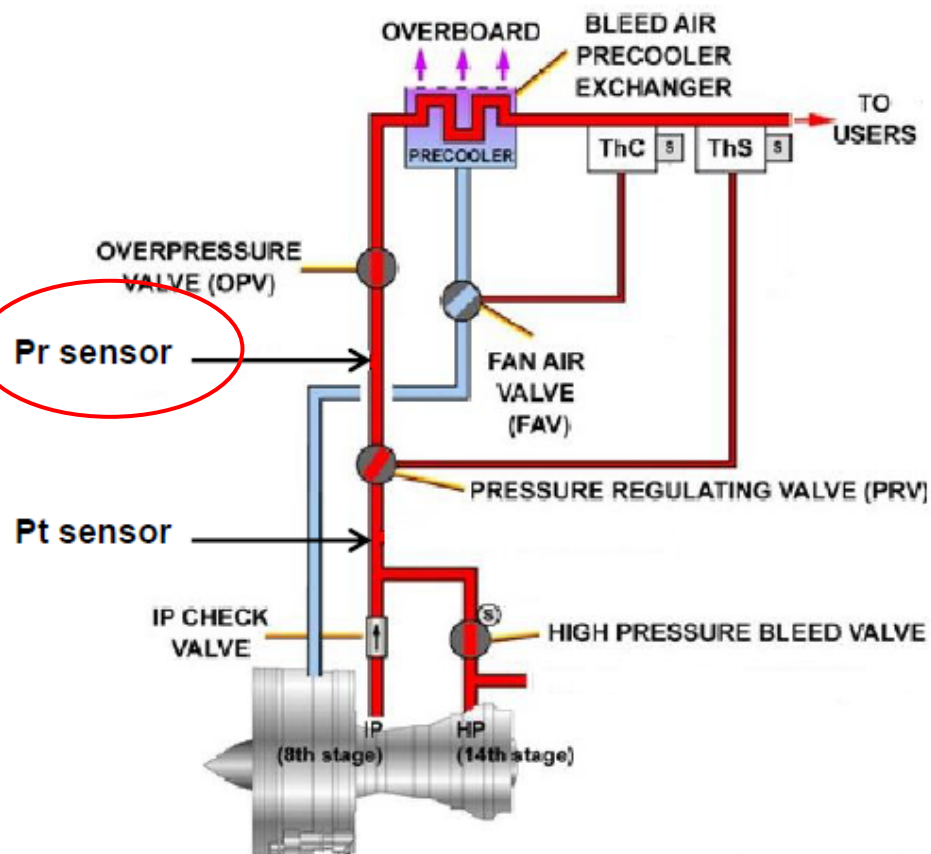
## Main components

### Pressure Regulating Valve (PRV)

Regulates upstream pressure at ~48 psig

### OverPressure Valve (OPV)

Closes if upstream pressure exceeds ~85 psig to protect downstream systems

### Pressure Regulated Sensor (Pr xducer)

Senses regulated pressure. Fault is triggered if pressure > 60 psig for 15 seconds

### Pressure Transferred Sensor (Pt xducer)

Senses transferred pressure. Main function is for T/S.

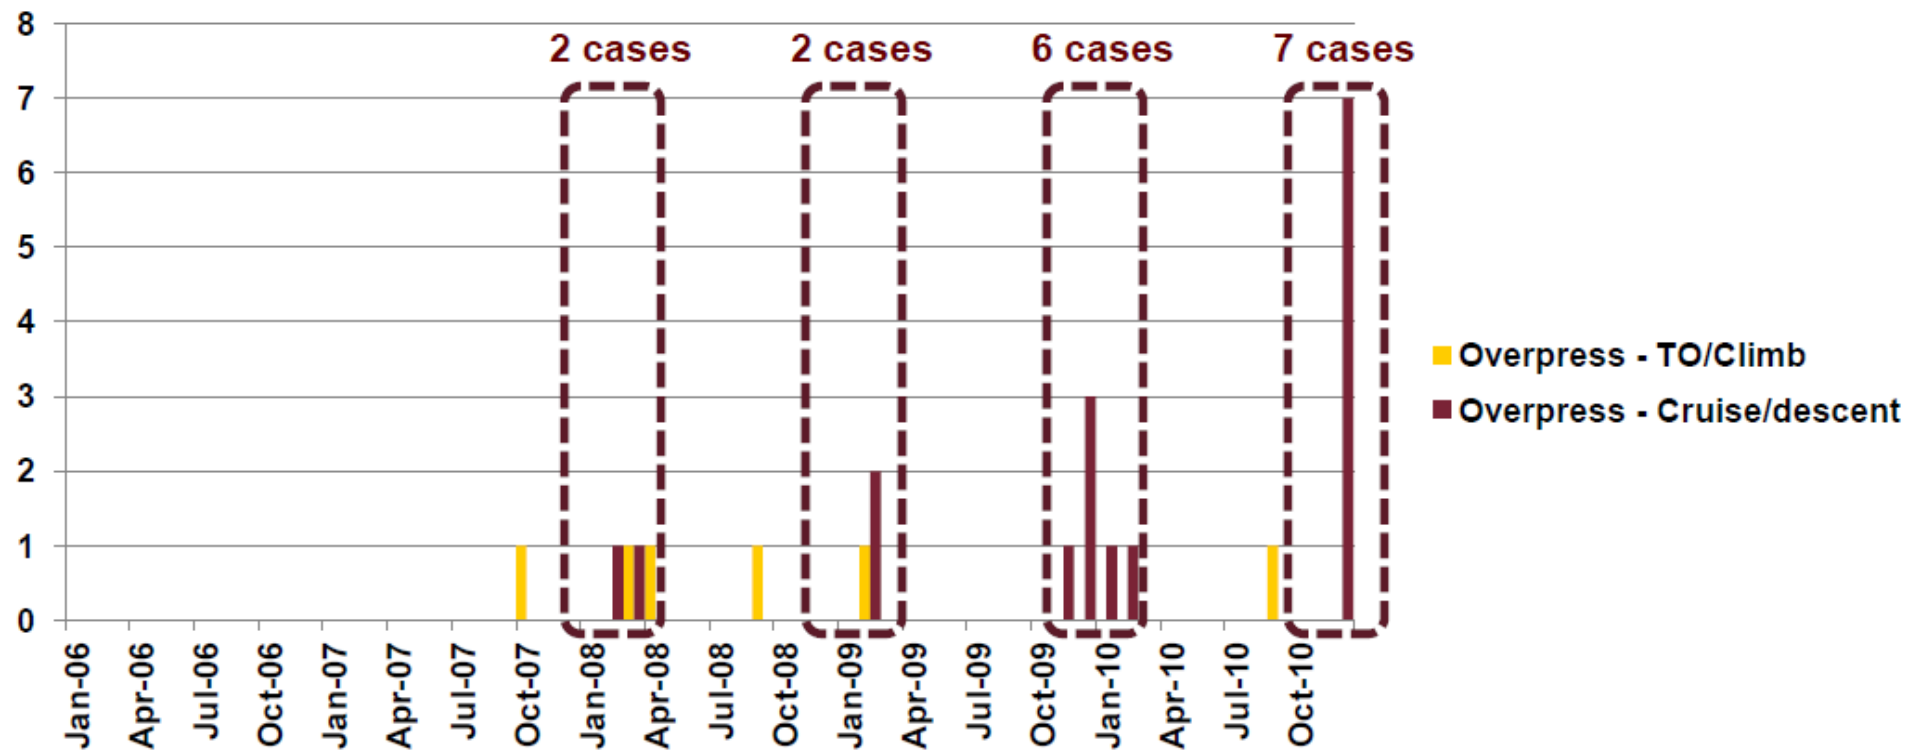
# Failure and Seasons

Case	Altitude	Flight Phase	Season	Time elapsed for failure since take off	Time between 1 <sup>st</sup> loss and 2nd loss.	SAT time in failure
1	410FL	During cruise	WINTER	8HRS	2 minutes	unknown
2	380FL	During cruise	WINTER		23 min	-65°C
3	230FL	During cruise - descending	WINTER	4,5 HRS AFTER TAKE OFF	1,5 min	unknown
4	130FL	During cruise - descending	WINTER	4,5 HRS AFTER TAKE OFF	< 1min	-25°C
5	371FL	During cruise	WINTER		12 min	unknown
6		During Cruise	WINTER	7,25 HRS AFTER TAKE OFF	unknown	unknown
7	380FL	During cruise	WINTER	10 HRS AFTER TAKE OFF	< 1min	-55°C
8	25FL	During cruise - descending	WINTER		2 min	-70°C

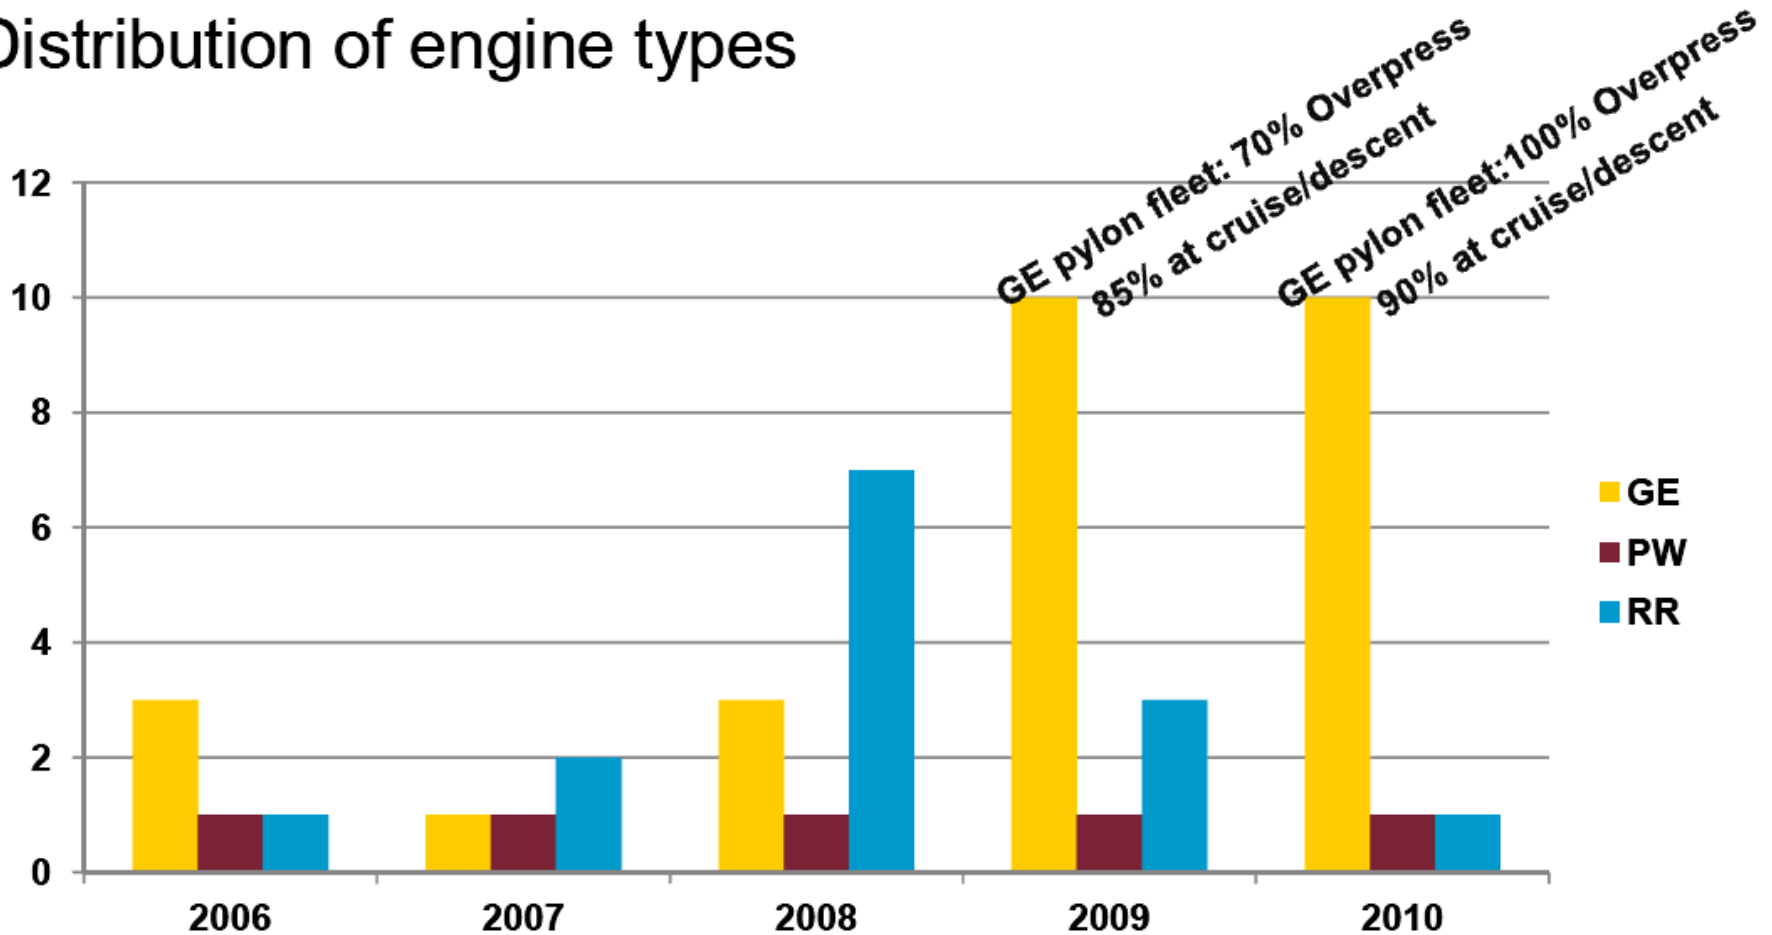
Distribution of engine types

# Overpressure VS engine type

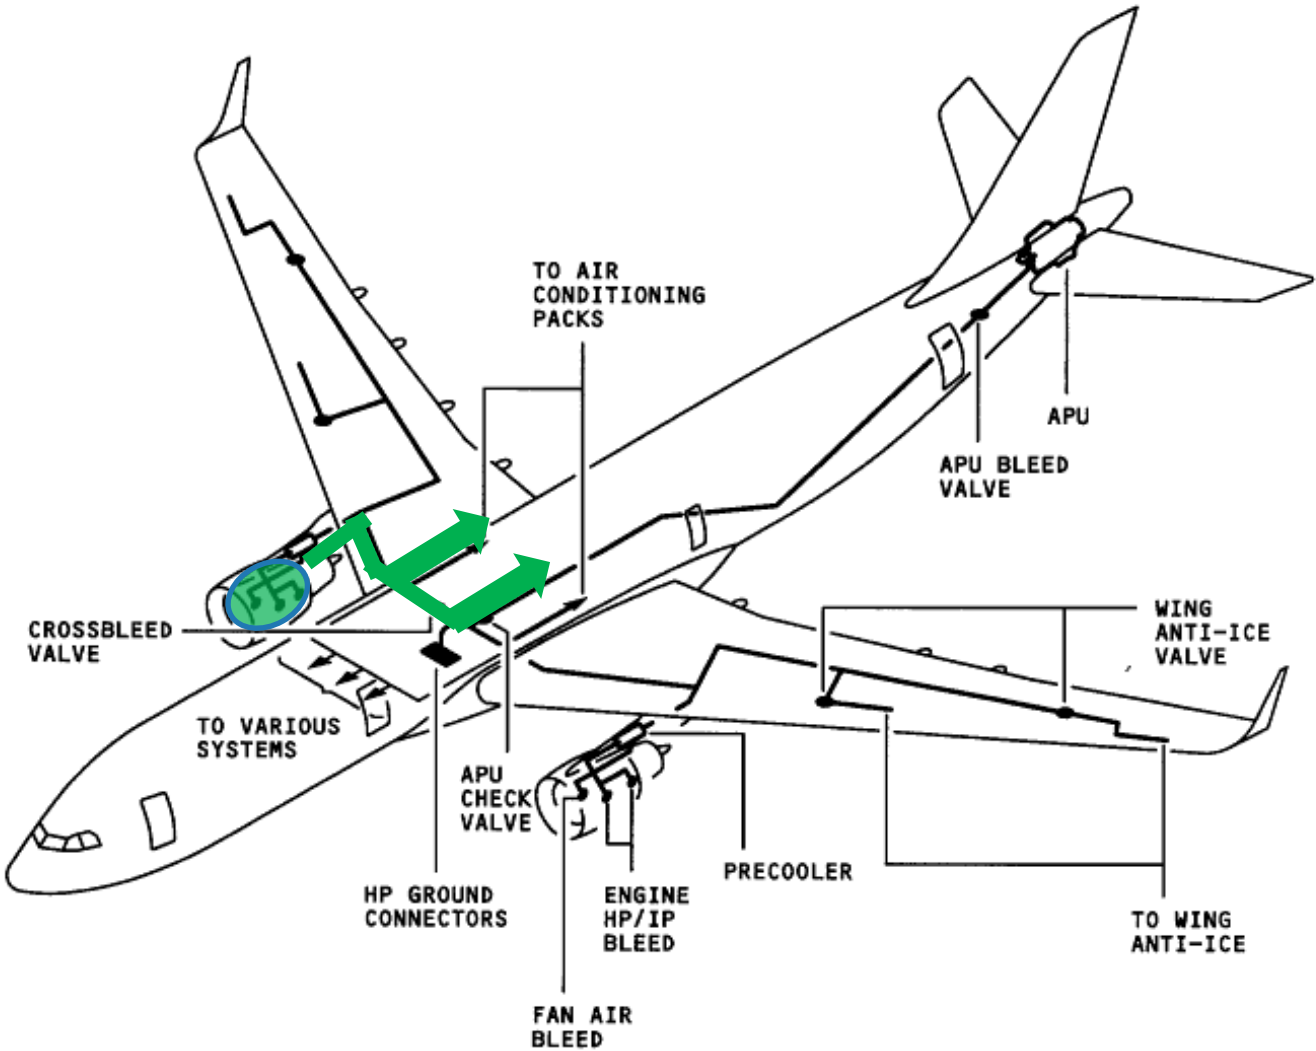
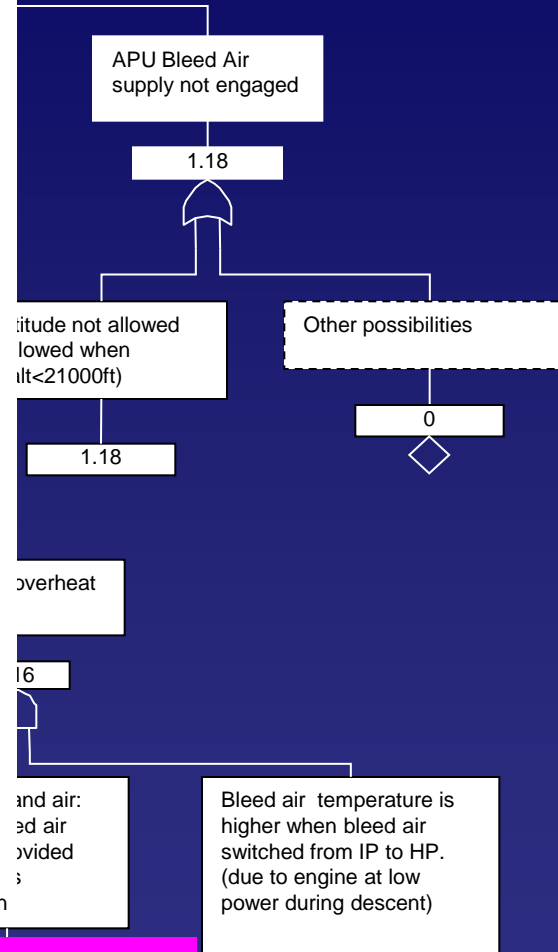
Grid filter contaminated which reduced bleed air pressure

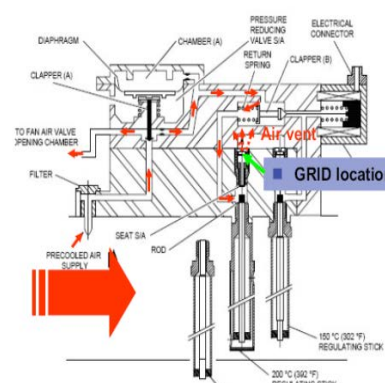
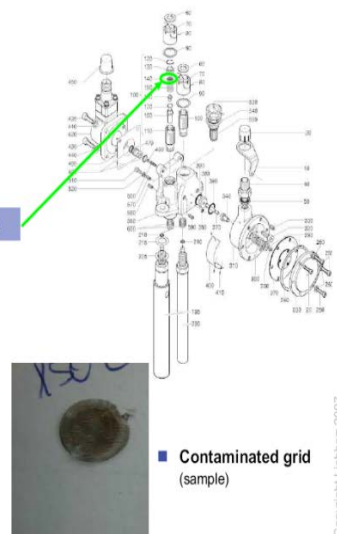
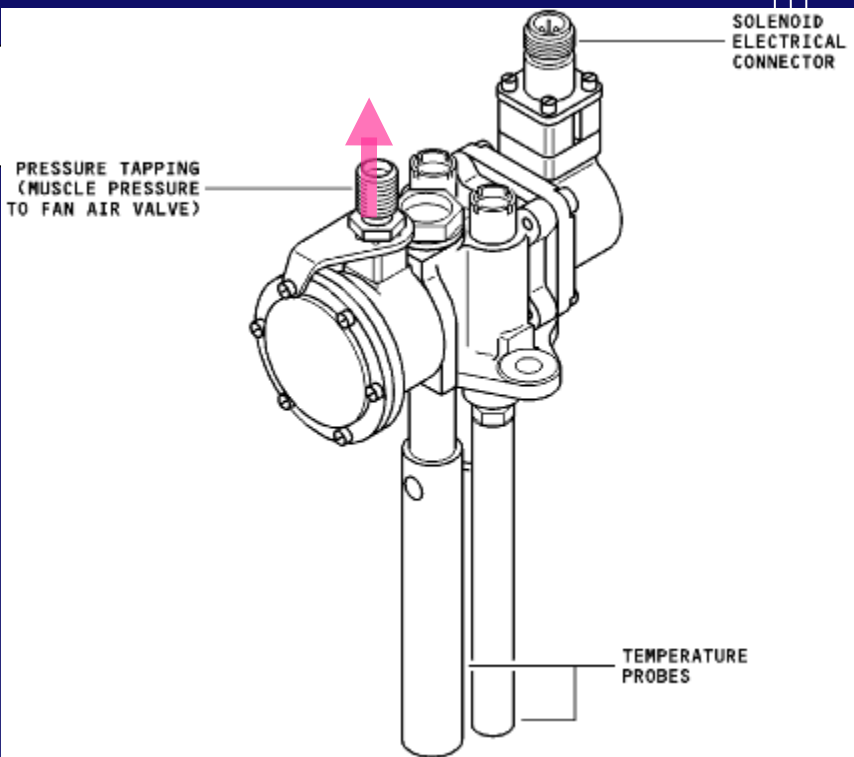
**Dual bleed lost issue : from B-HLH investigation results**

■ Engine 1 → failure mode : OVERTEMP

■ Path of the bleed air into THC
