**Aviation Safety Council
Taipei, Taiwan**

**SQ006 Accident Investigation
Factual Data Collection
Group Report**

Ground Operation Group

**February 21, 2001
ASC-FRP-01-01-002**

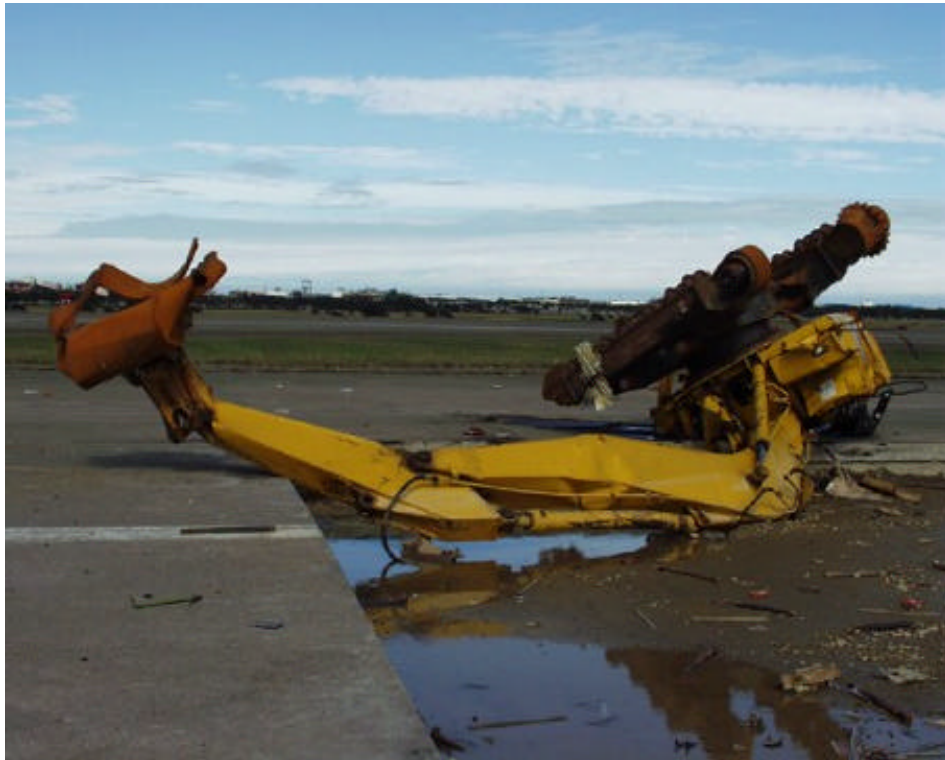
The construction crew had left 6 units of ground equipment (ref. Table 1.4-1) on site of runway 5R, namely 2 excavators (Fig. 1.4-1,2), 2 vibrating rollers (Fig. 1.4-3,4,5), 1 small bulldozer (Fig. 1.4-6) and 1 air compressor. All 6 equipment suffered serious impact damage. With the exception of one excavator and the bulldozer, the rest of the equipment had been scattered from their original positions in the various pits.

Fig. 1.4-1 Excavator (in No.5 pit)

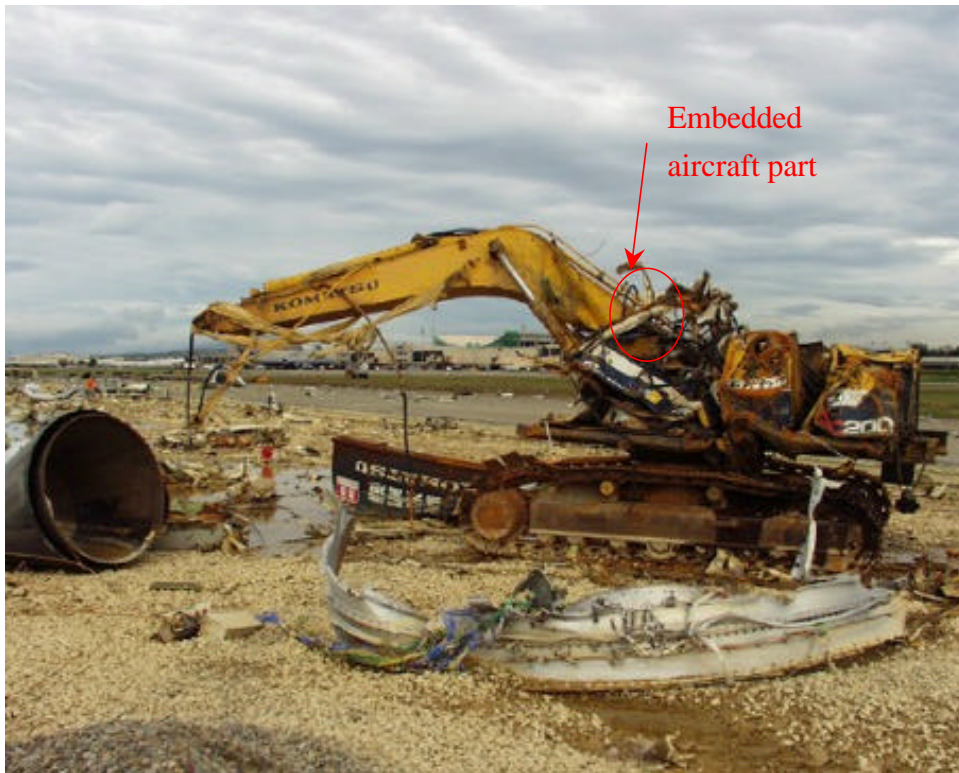
Fig. 1.4-2 Excavator (in No.11 pit)

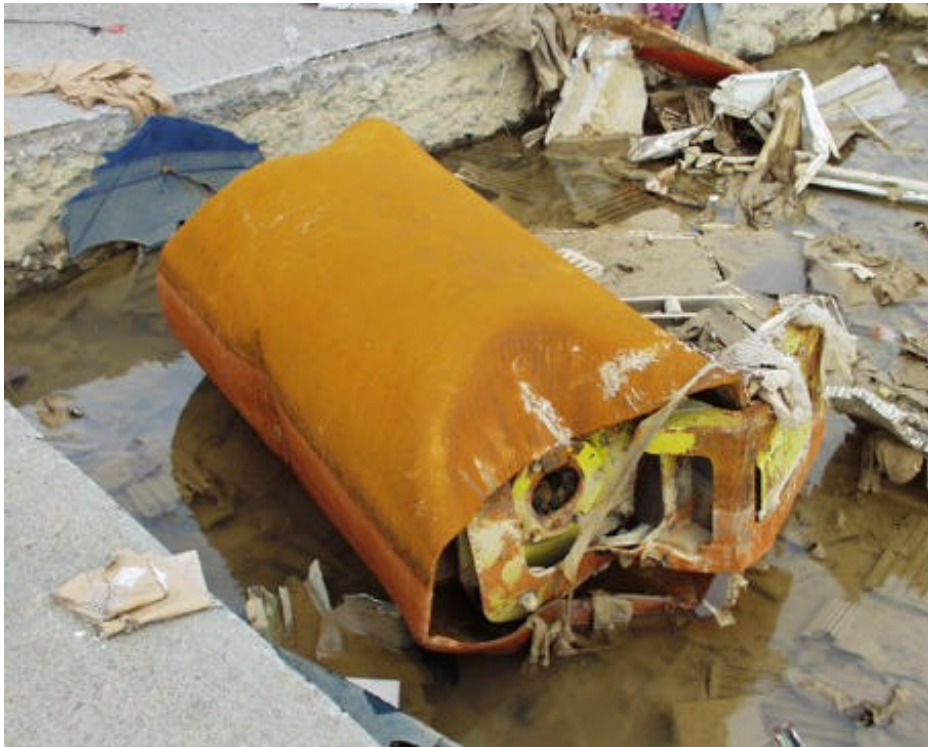
Fig. 1.4-3 Vibrating Roller (in pit No.11)

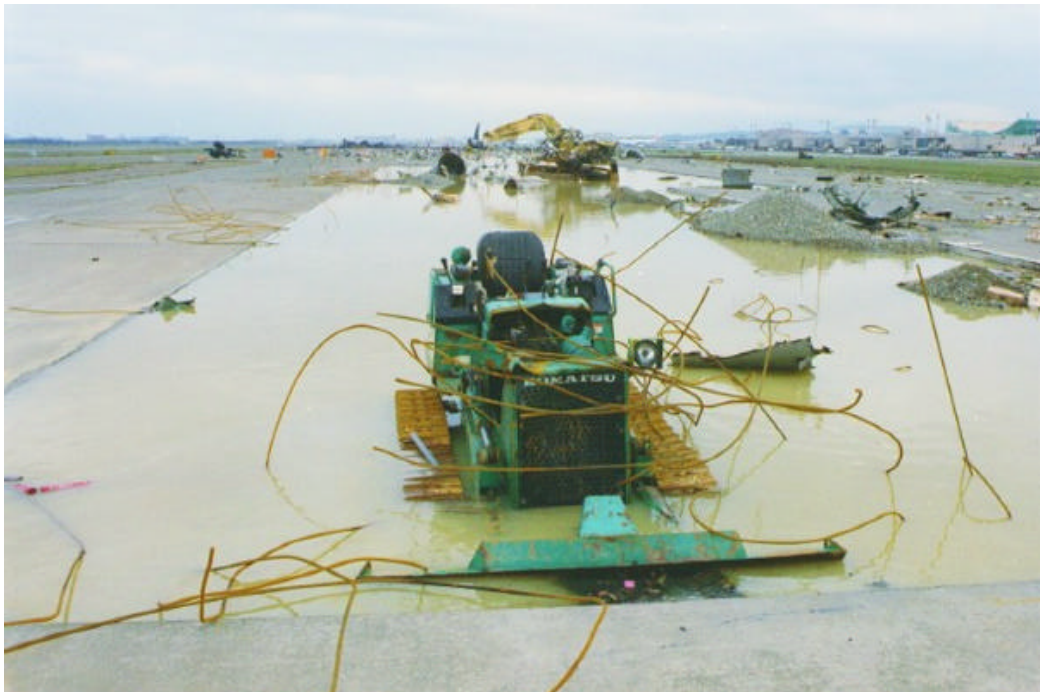
Fig. 1.4-6 Bulldozer (in pit No.11)

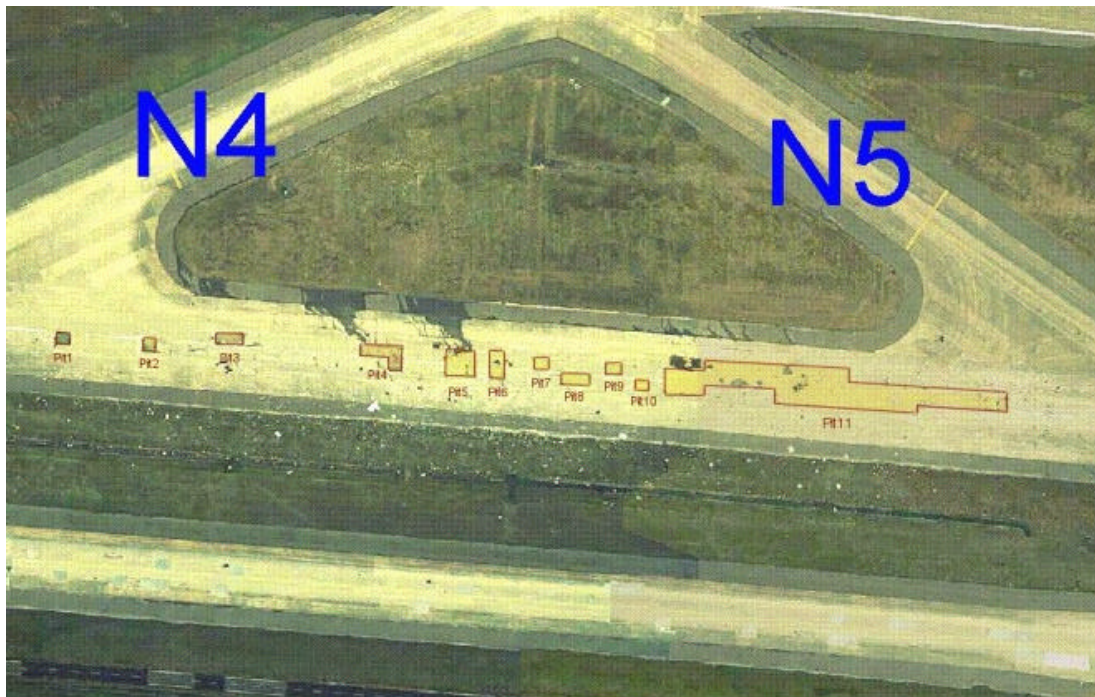
Runway 5R is a concrete non-grooved runway that had been undergoing repairs prior to the accident. The runway consists of individually poured concrete sections approximately 20 feet wide by 23 feet in length. Several of the concrete sections had been removed from the runway between N4 and N5 by the construction crew prior to the accident. The removed concrete sections formed 11 different pits that existed at the time of the accident. The group numbered each pit sequentially along the path of the airplane (Fig. 1.12.1-1).

Fig.1.12.1-1 Removed Concrete Sections formed 11 different pits.

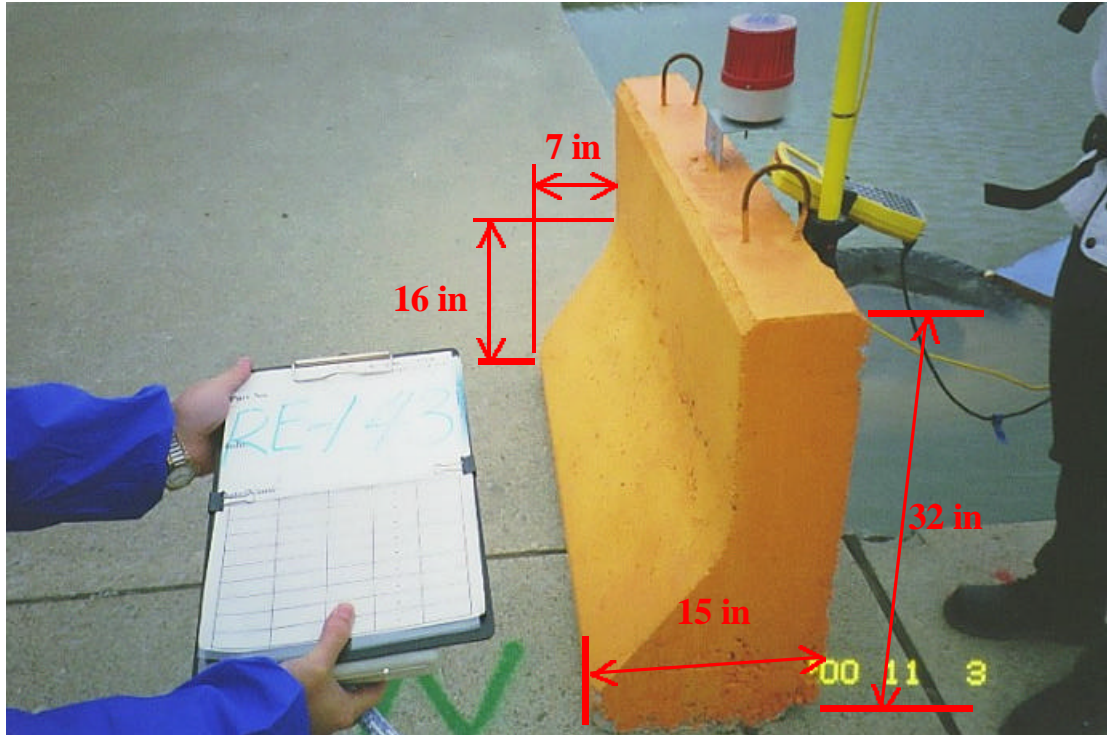
runway 5R to close that section of the runway. Each jersey barrier is 32" high by 49" long. Dimension of the barrier is shown in Fig.1.12.1-2. There was a red light on the top of each jersey barrier around the perimeter of the construction area. One of these lights was found on the ground and was still operational when ASC investigators reached the site.

Fig.1.12.1-2 Dimension of jersey barrier

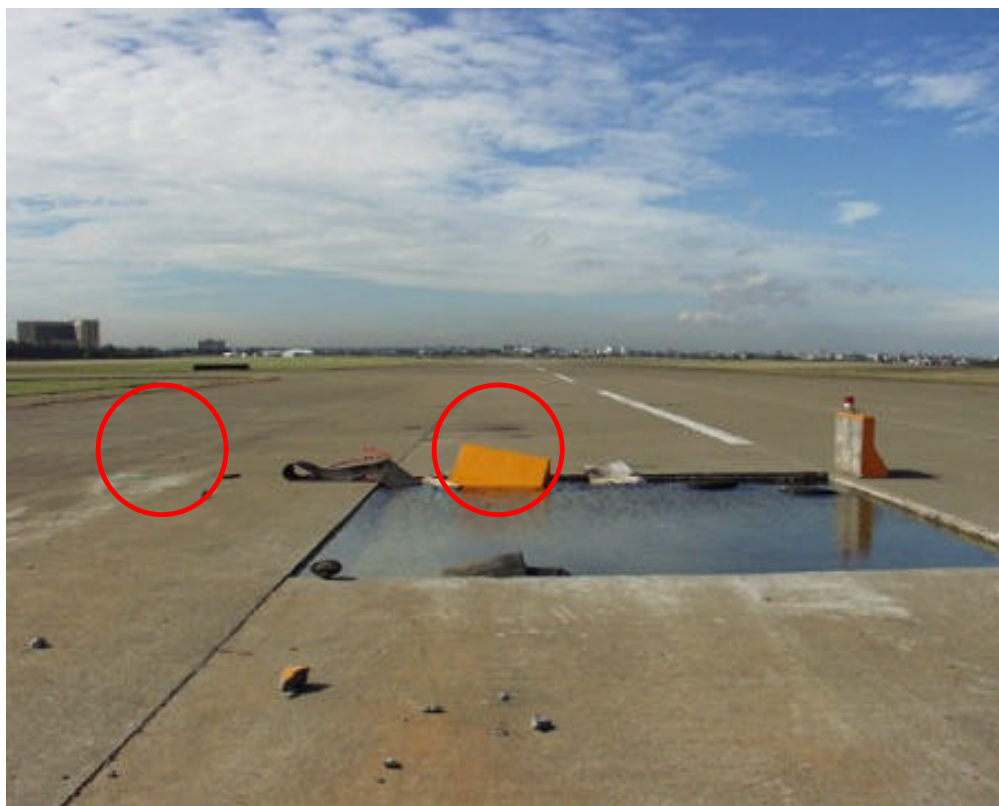
The aircraft wreckage was distributed along runway 5R (Fig. 1.12.2-1), beginning at initial impact point (Fig. 1.12.2-2) approximately 4,080 feet from the runway threshold. The airplane broke into two main sections at about fuselage Body Station 1560 and came to rest approximately 6,840 feet from the runway threshold. The left and right wings remained attached to the forward fuselage section, which came to rest on a heading of approximately 085°. The tail section (aft of Body Station 1560) was found upright on a heading of approximately 40°. It was reported that this section had been moved by the rescue personnel and high winds, and that the original orientation was on a heading of approximately 130° resting on its left side (Fig. 1.12.2-3,4,5). The rest of the major components were scattered along runway 5R (Fig. 1.12.2-1).

Fig. 1.12.2-2 Initial Impact Point (Shown circled)

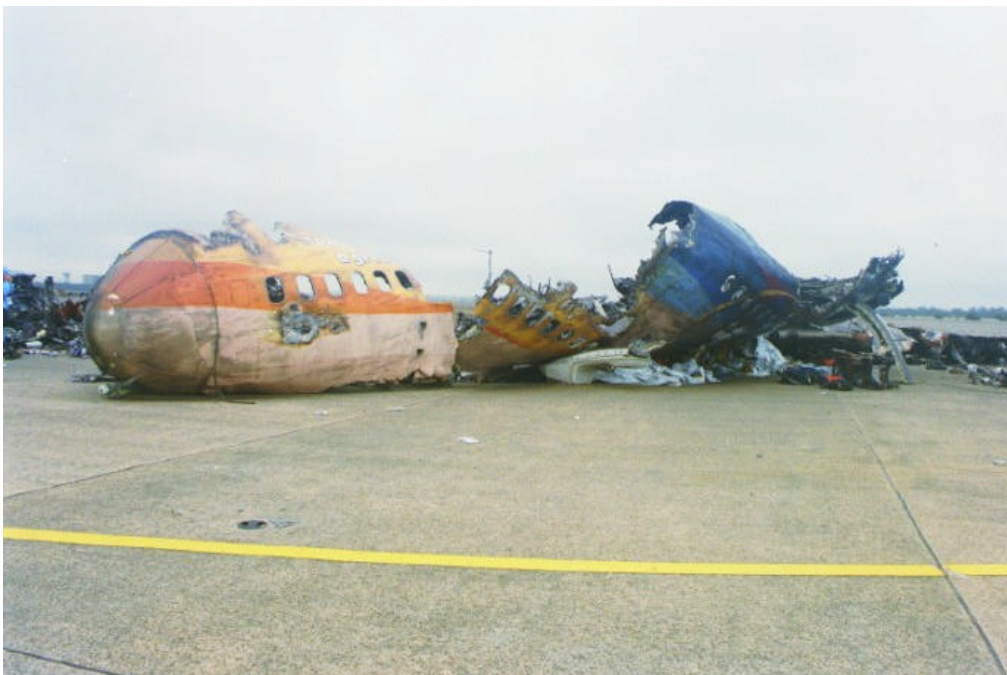
Fig. 1.12.3.1-1 Front Portion of Aircraft

- 1 The portion comprising remains of Sections 41² and 42, and part of Section 44 and the wings came to rest on the left side of runway 5R (Fig. 1.12.3.1-1).

- 2 Extensive fire damage to these sections was observed.
- 3 The RH side of the fuselage from the forward pressure bulkhead up to the RH wing root area, the main equipment center and forward cargo compartment had been completely damaged by fire.

- 4 The LH side of the fuselage above the main deck floor structure from Body Station 130³ to approximately Body Station 1284 remained intact but in a badly burnt state.

- 5 Approximately 30% of the main deck floor structure from Body Station 320 to 1000 was visible but in a badly burnt and distorted condition.
- 6 The right hand wing was extensively damaged by fire. Some portions of the front and rear spars and the winglet were still visible. (Fig. 1.12.3.1-2)

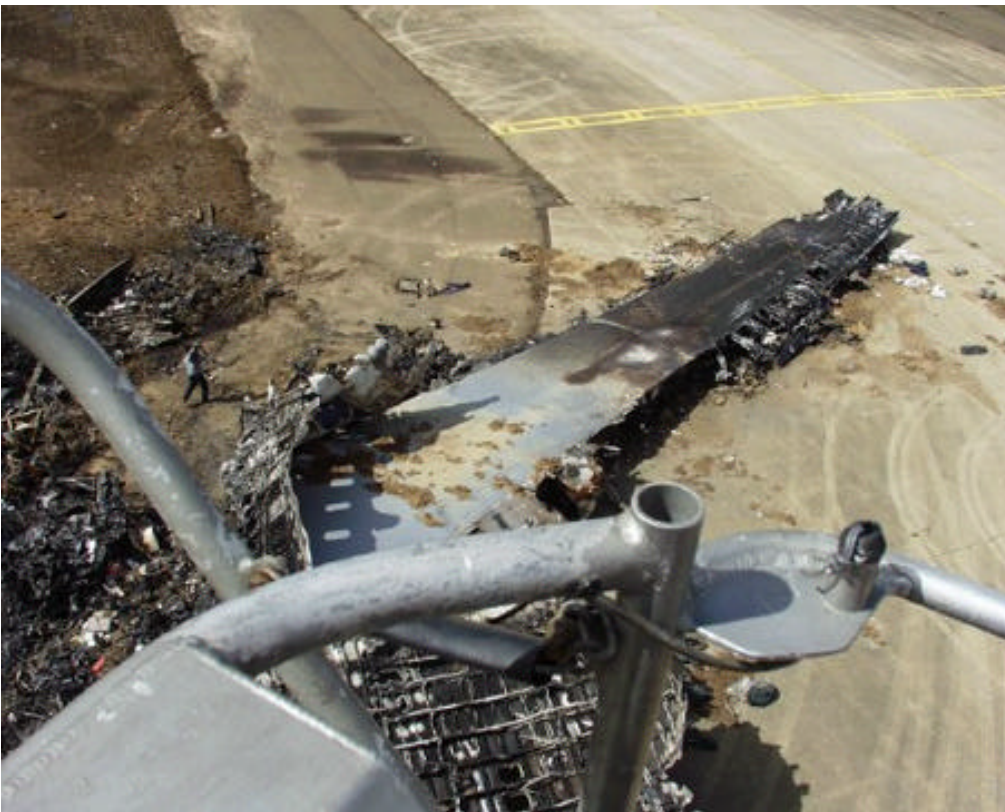
Fig. 1.12.3.1-3 Left Wing

- 7 The profile of the LH wing was still visible with most of the fire damage occurring on the outer portion. The outboard portion of the LH wing outboard of Wing Station 1360⁴ had broken off. (Fig. 1.12.3.1-3)

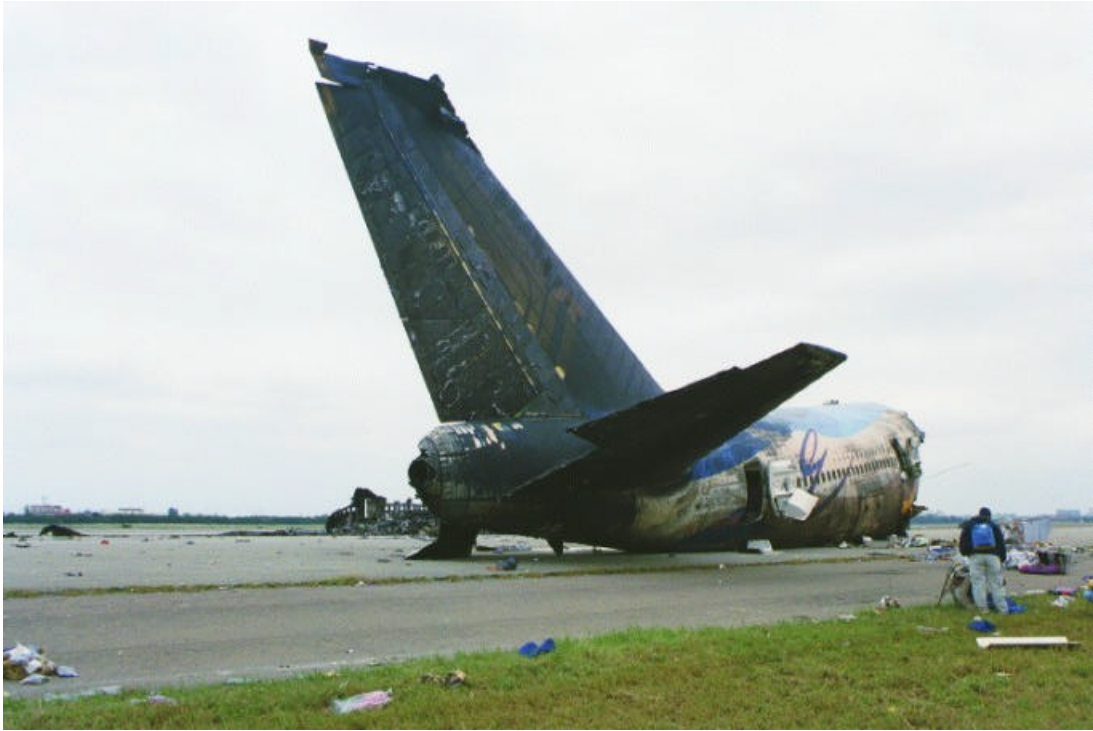
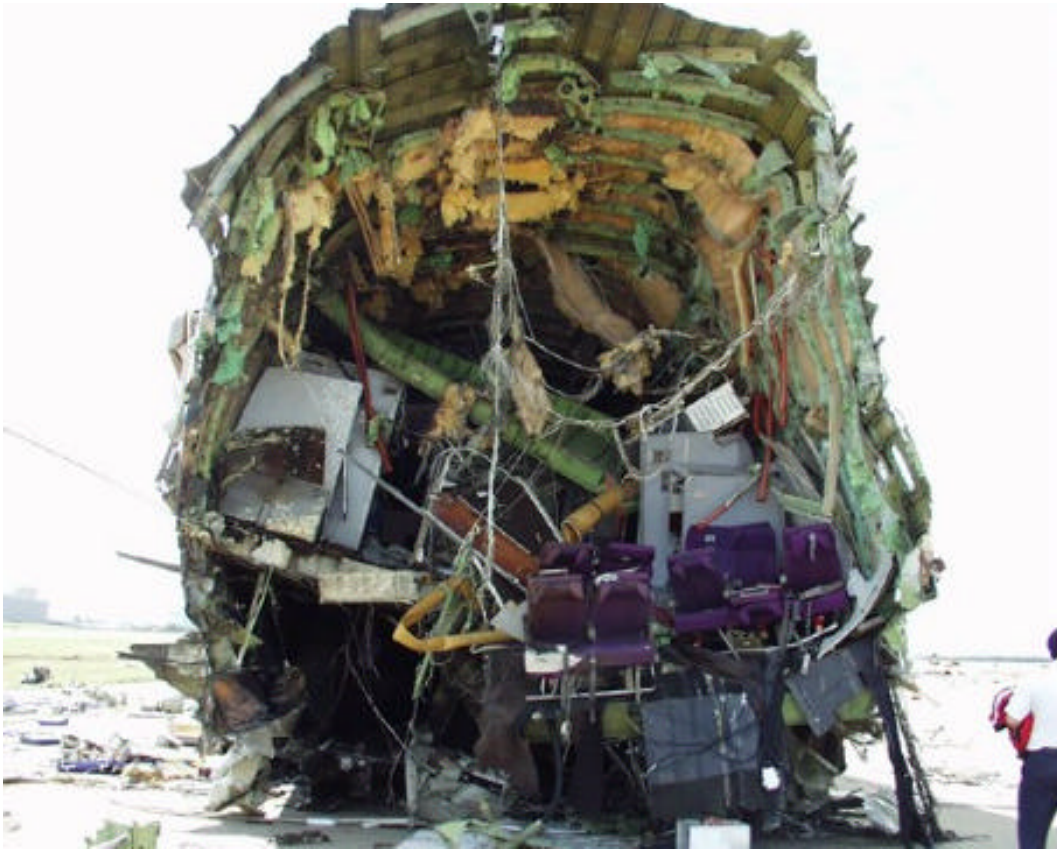
Fig. 1.12.3.2-1 Aft Portion of Aircraft

1. The aft portion comprising part of the Sections 46 and 48 of the aircraft came to rest on the right side of the centerline of runway 5R. (Fig.

2. The fuselage broke off forward of the #4 door, with a fracture running from approximately Body Station 1560 on the left side diagonally aft across the fuselage.

3. The left side of the belly skin including supporting frames and stringers had separated and the right hand belly skin was crushed, from door 4 all the way to door 5. There were severe skin abrasions and skin loss at the belly areas from Body Station 2410 to 2742. The left side of the fuselage had a large area of abrasion marks around the passenger window area and above.

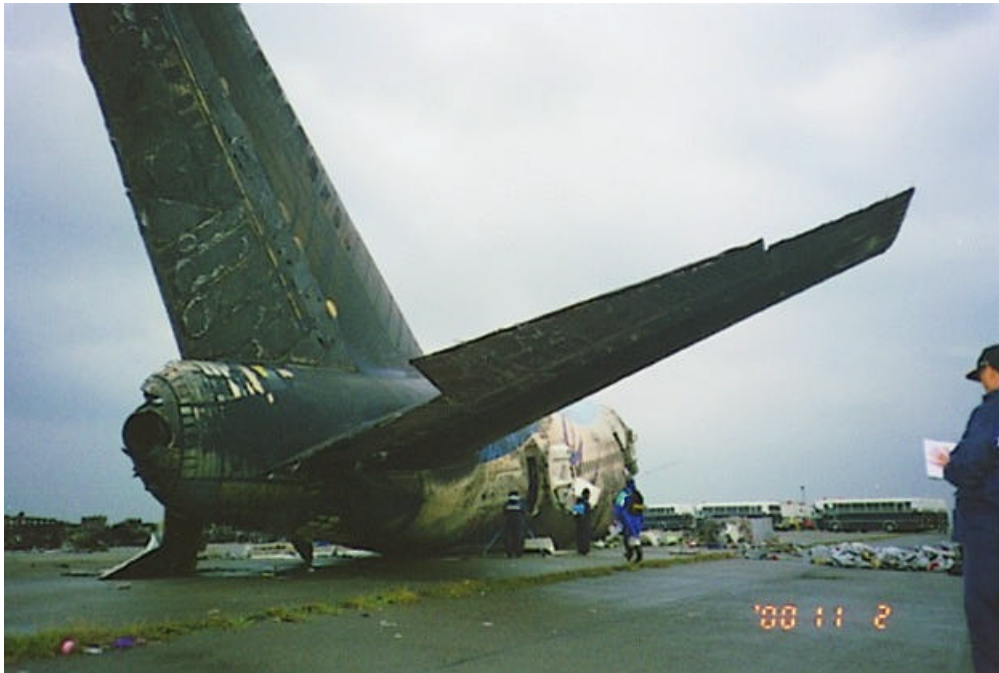
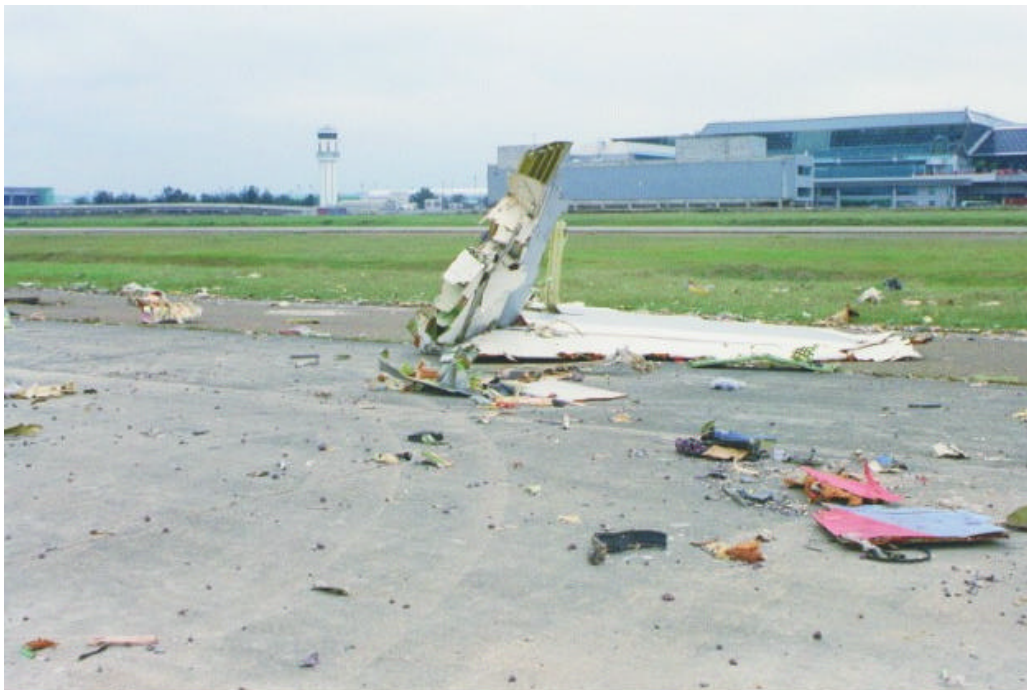
Fig. 1.12.3.2-3 RH Horizontal Stabilizer

4. Fire damage was visible at the Section 48 area and the empennage.
5. The RH horizontal stabilizer was still intact but was damaged by fire. The portion of the LH horizontal stabilizer outboard of approximately Stabilizer Station 270⁵ had broken off. (Fig. 1.12.3.2-3,4)

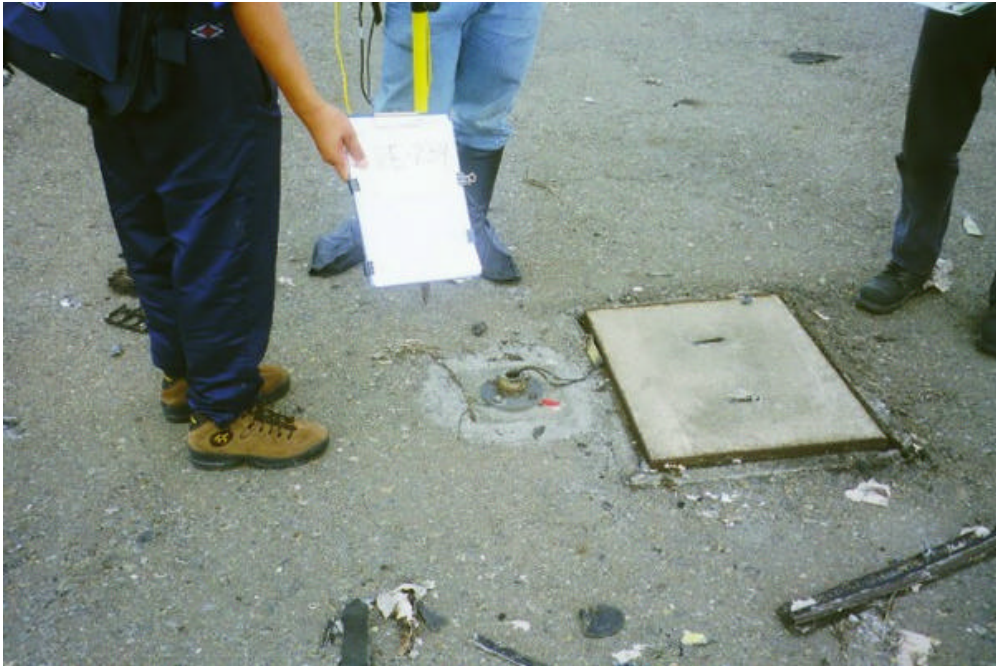
Fig. 1.12.4-1 RE239 Runway Edge Light

2 wire strands were retrieved from the right hand side and left-hand side of the runway edge lights at locations identified by the grids RE239 (Fig. 1.12.4-1) and RE 240 (Fig. 1.12.4-2) respectively. The runway edge light at grid RE240 was located in the path of the aircraft wreckage.

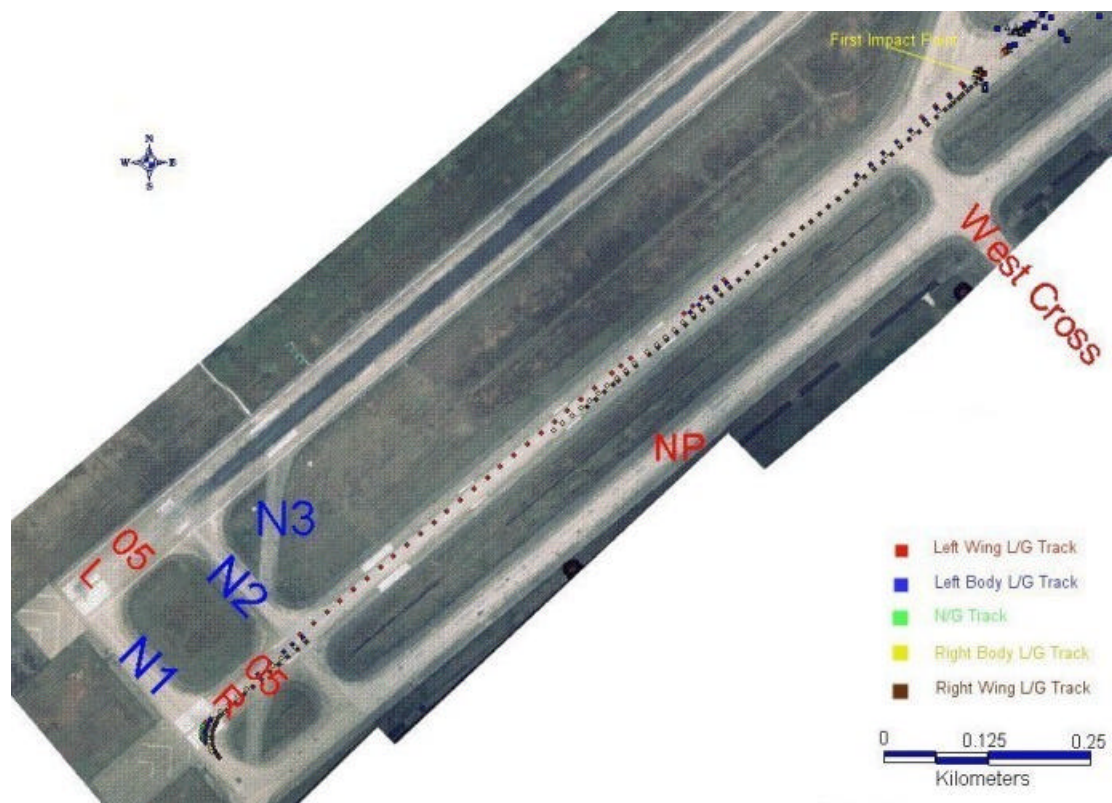
Fig. 1.12.5-1 Mapping of Tire Tracks

The group documented the marks made by the nose landing gear (NLG) and the main landing gear (MLG) tires on the runway from the beginning of taxi way N1 through runway 5R threshold to the initial impact point 4,080 feet from the runway threshold (Fig. 1.12.5-1). The tire marks were cleaner than the surrounding areas and no rubber deposits were found.
