**Aviation Safety Council
Taipei, Taiwan**

**CI611 Accident Investigation
Factual Data Collection
Group Report**

Injury Documentations Group

ASC-AFR-03-06-001

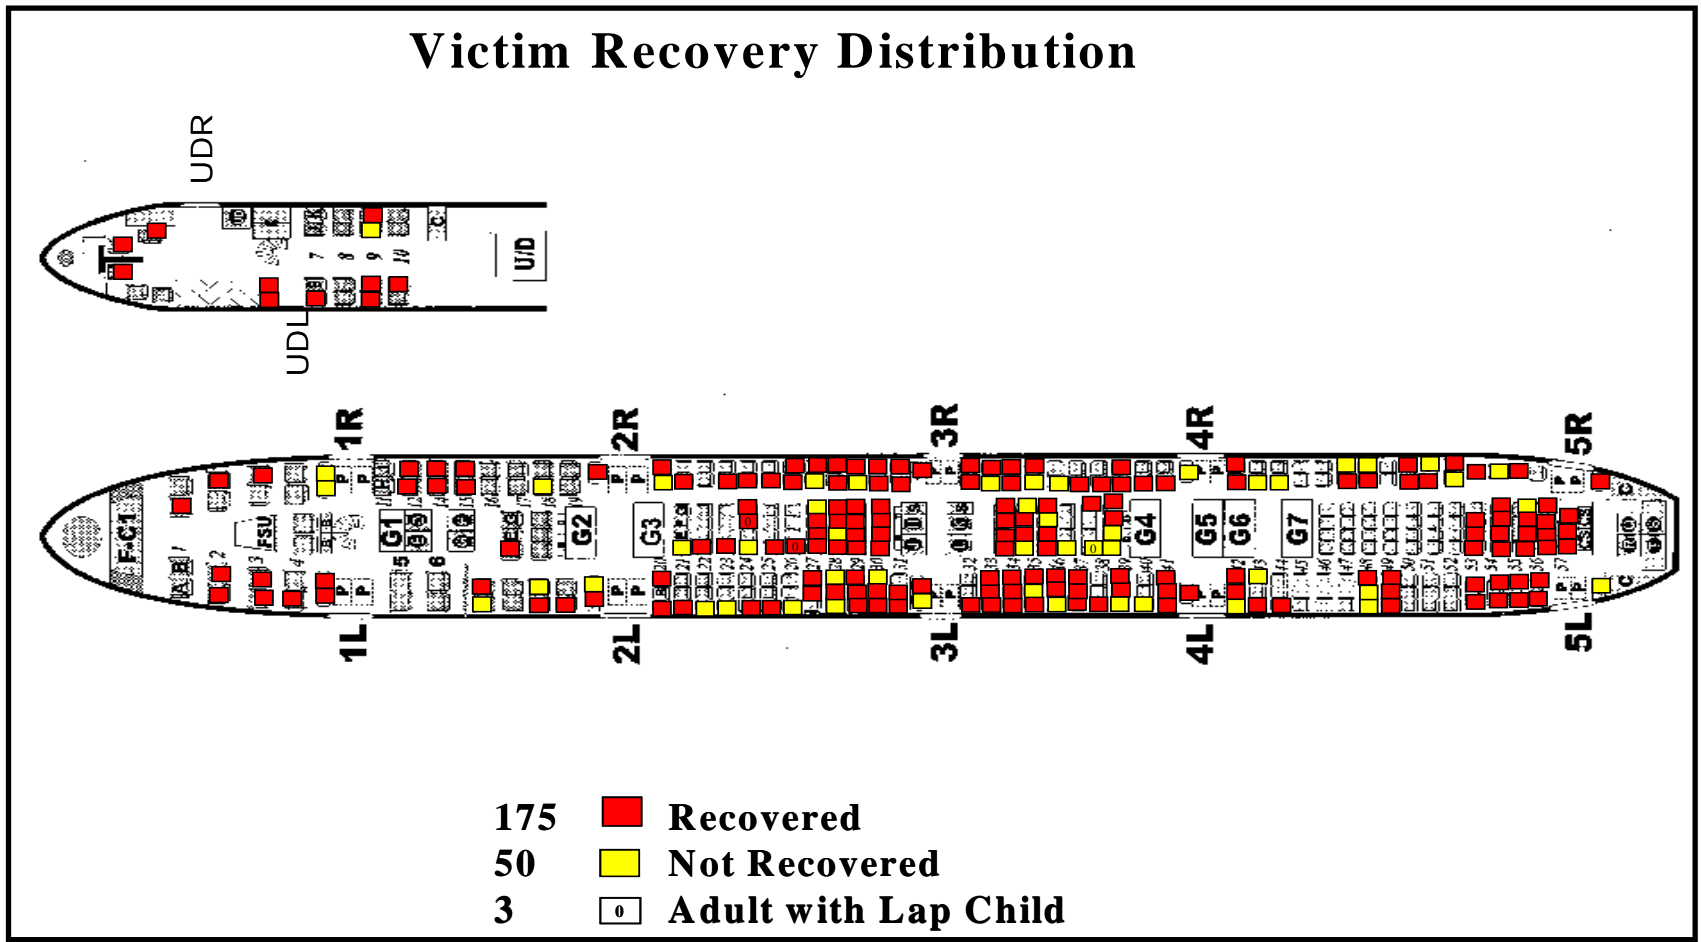
Figure 1.2-2 Victim Recovery Distributions

Figure1.2-2 shows the distribution of recovered/non-recovered victim’s assigned seats provided by China Airlines.

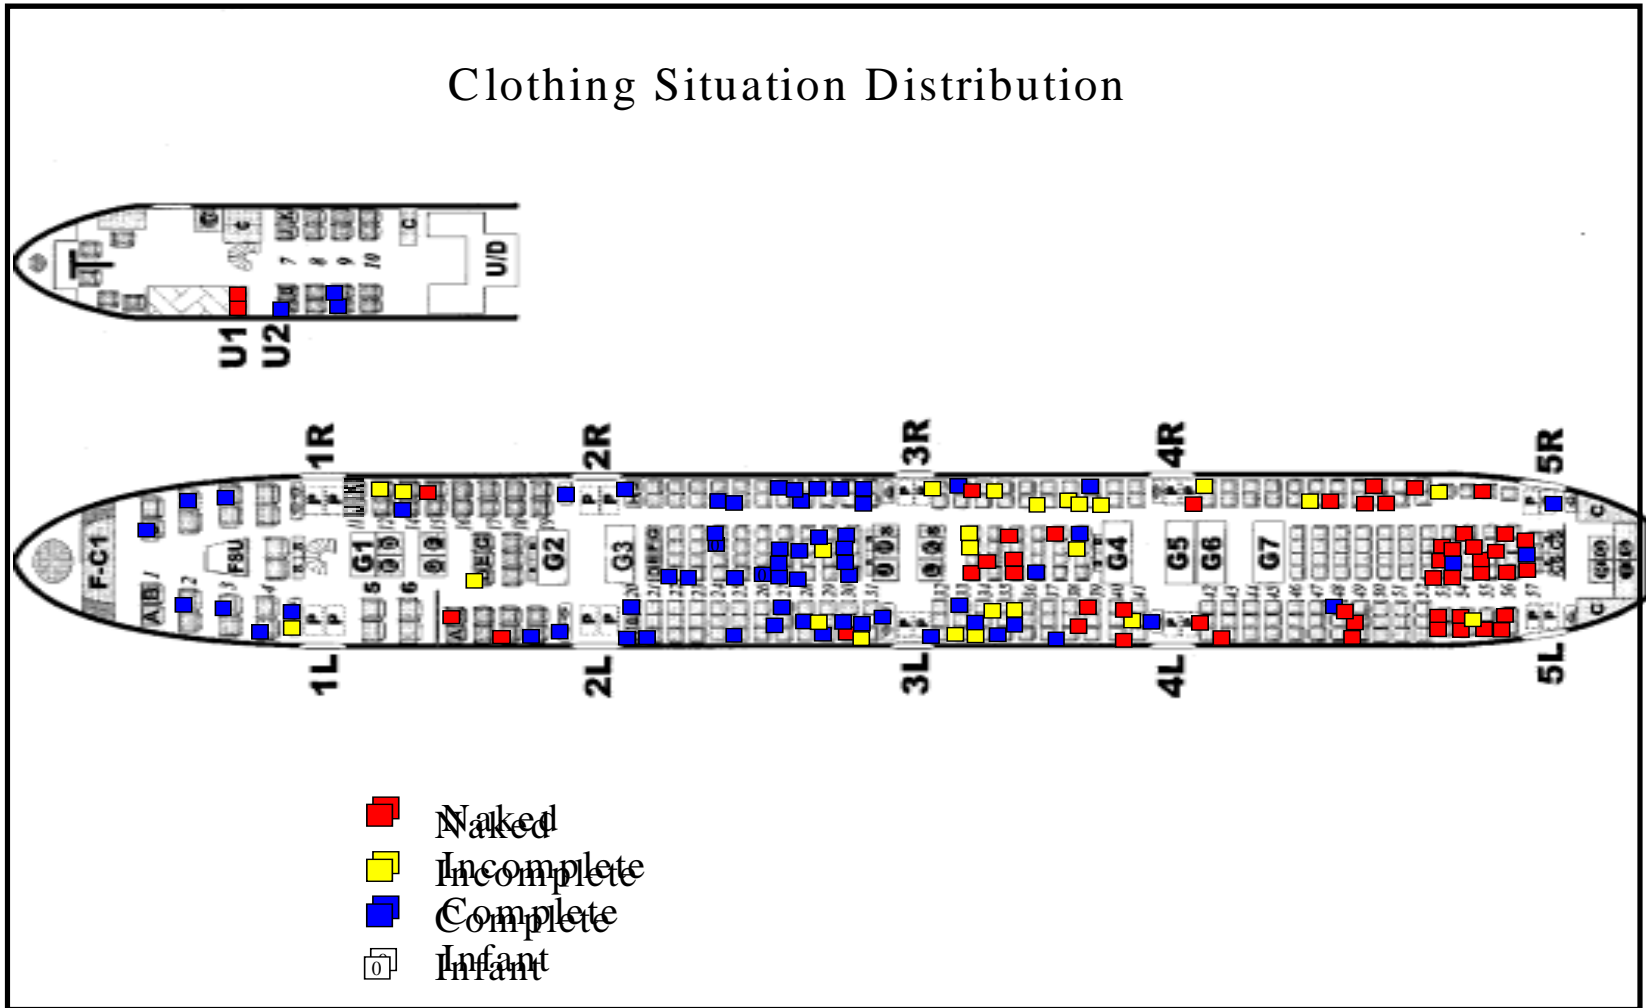
Figure 1.13-1 Clothing Situation Distributions

Figure 1.13-1 shows the clothing condition of the recovered victims. They were coded as: naked, partially clothed and fully clothed.

There were a high percentage of the naked passengers whose assigned seats were located between Zone D and E. There were also a high percentage of the fully clothed passengers that were assigned seats located between Zone A and C.

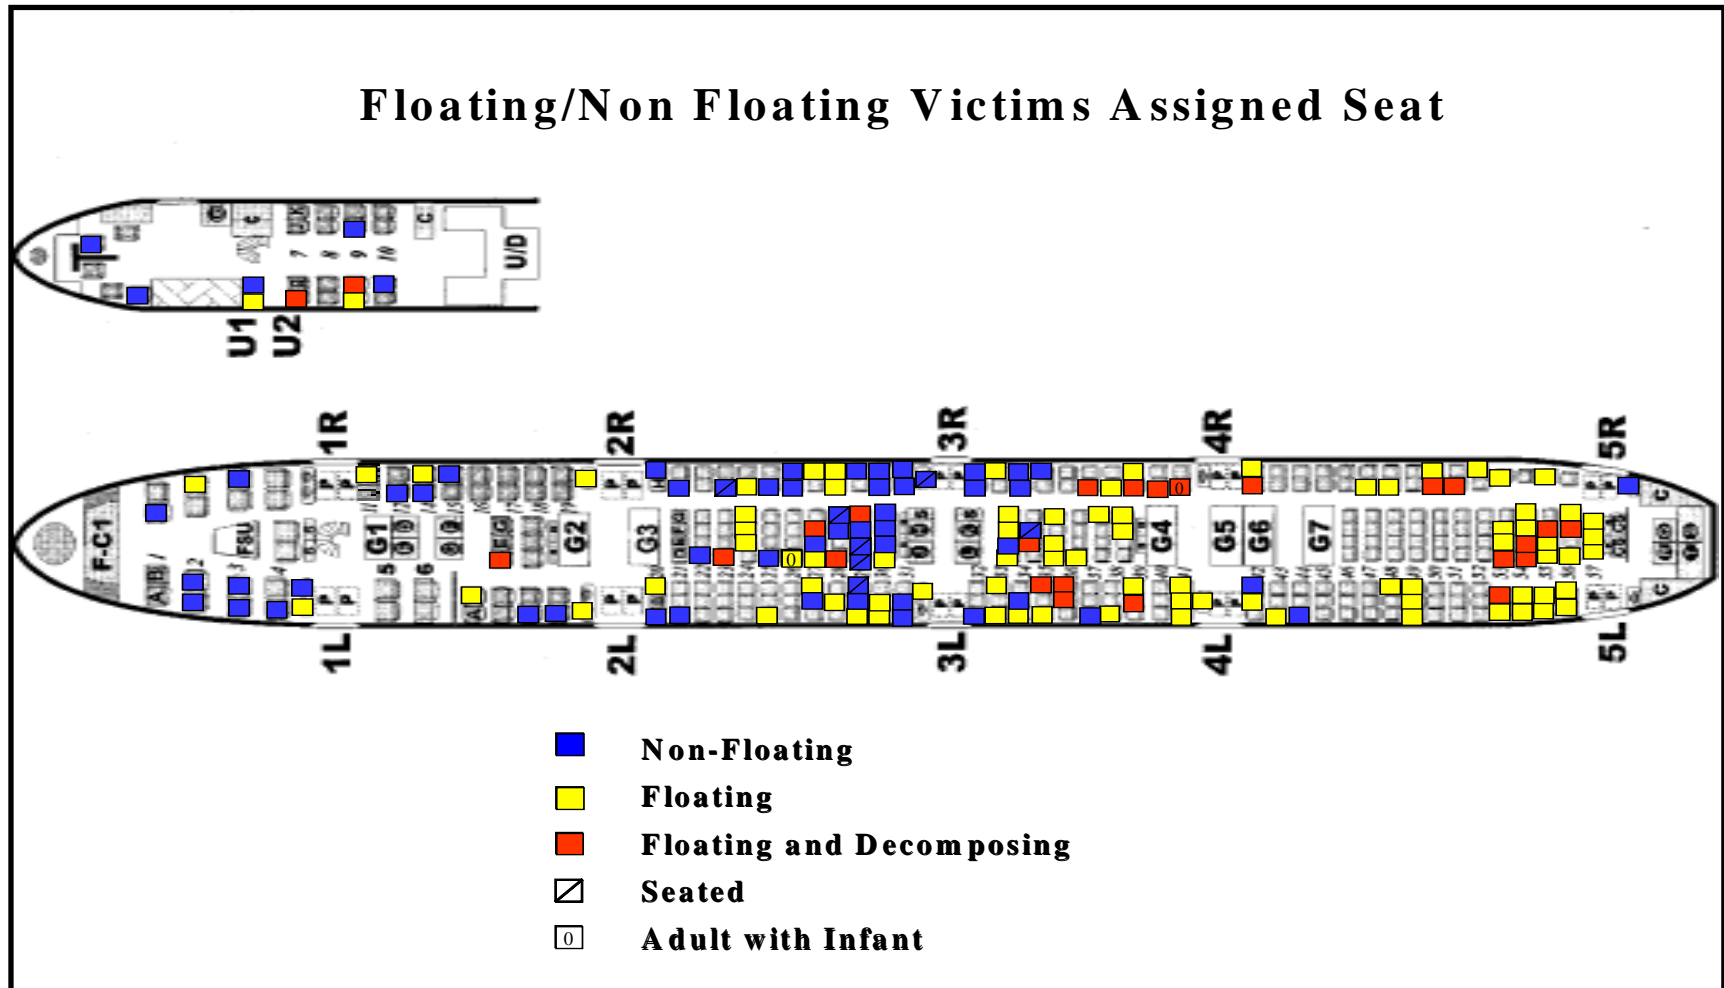
Figure 1.13-2 Floating/None Floating of Recovered Victim

Figure 1.13-2 represents the floating and non-floating victims and depicts the assigned seats of the individuals that were initially found floating on the surface of the ocean, and the victims that were later found on the bottom of the ocean floor with the wreckage. The figure also shows the victim's assigned seats whose bodies were later (after May 27, 2002) found after they had decomposed and floated to the surface of the Taiwan Straits.

Among the 82 bodies found floating on the ocean surface 76 were passengers, 6 were cabin crewmembers, and none were flight crewmembers.

There were a high (93%) percentage of passengers who were initially found floating on top of the ocean with assigned seats located between rows 42 and 57 (Zone E) in the cabin.

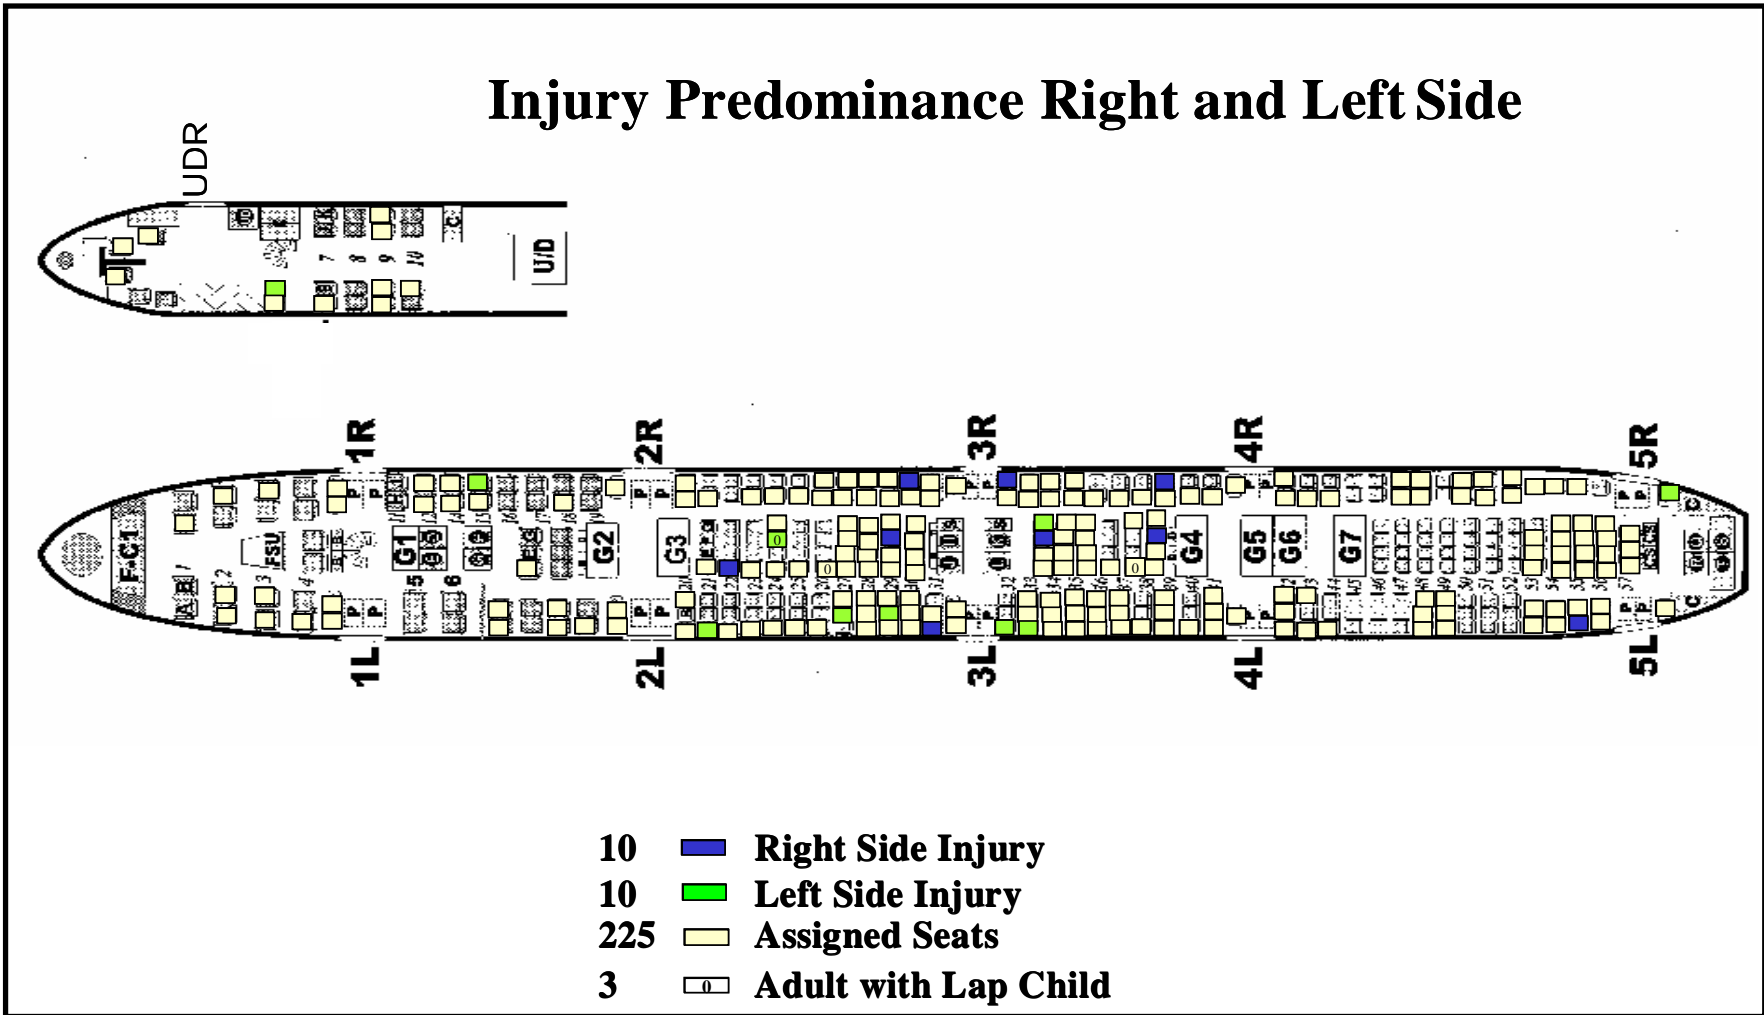
Figure 1.13-3 Injury Predominance: Right vs. Left

Occupants with injuries predominantly on the right or left side of their bodies were charted in their assigned seats. Ten occupants had predominantly right-sided injuries while 10 occupants had predominantly left sided injuries are shown in Figure 1.13-3.

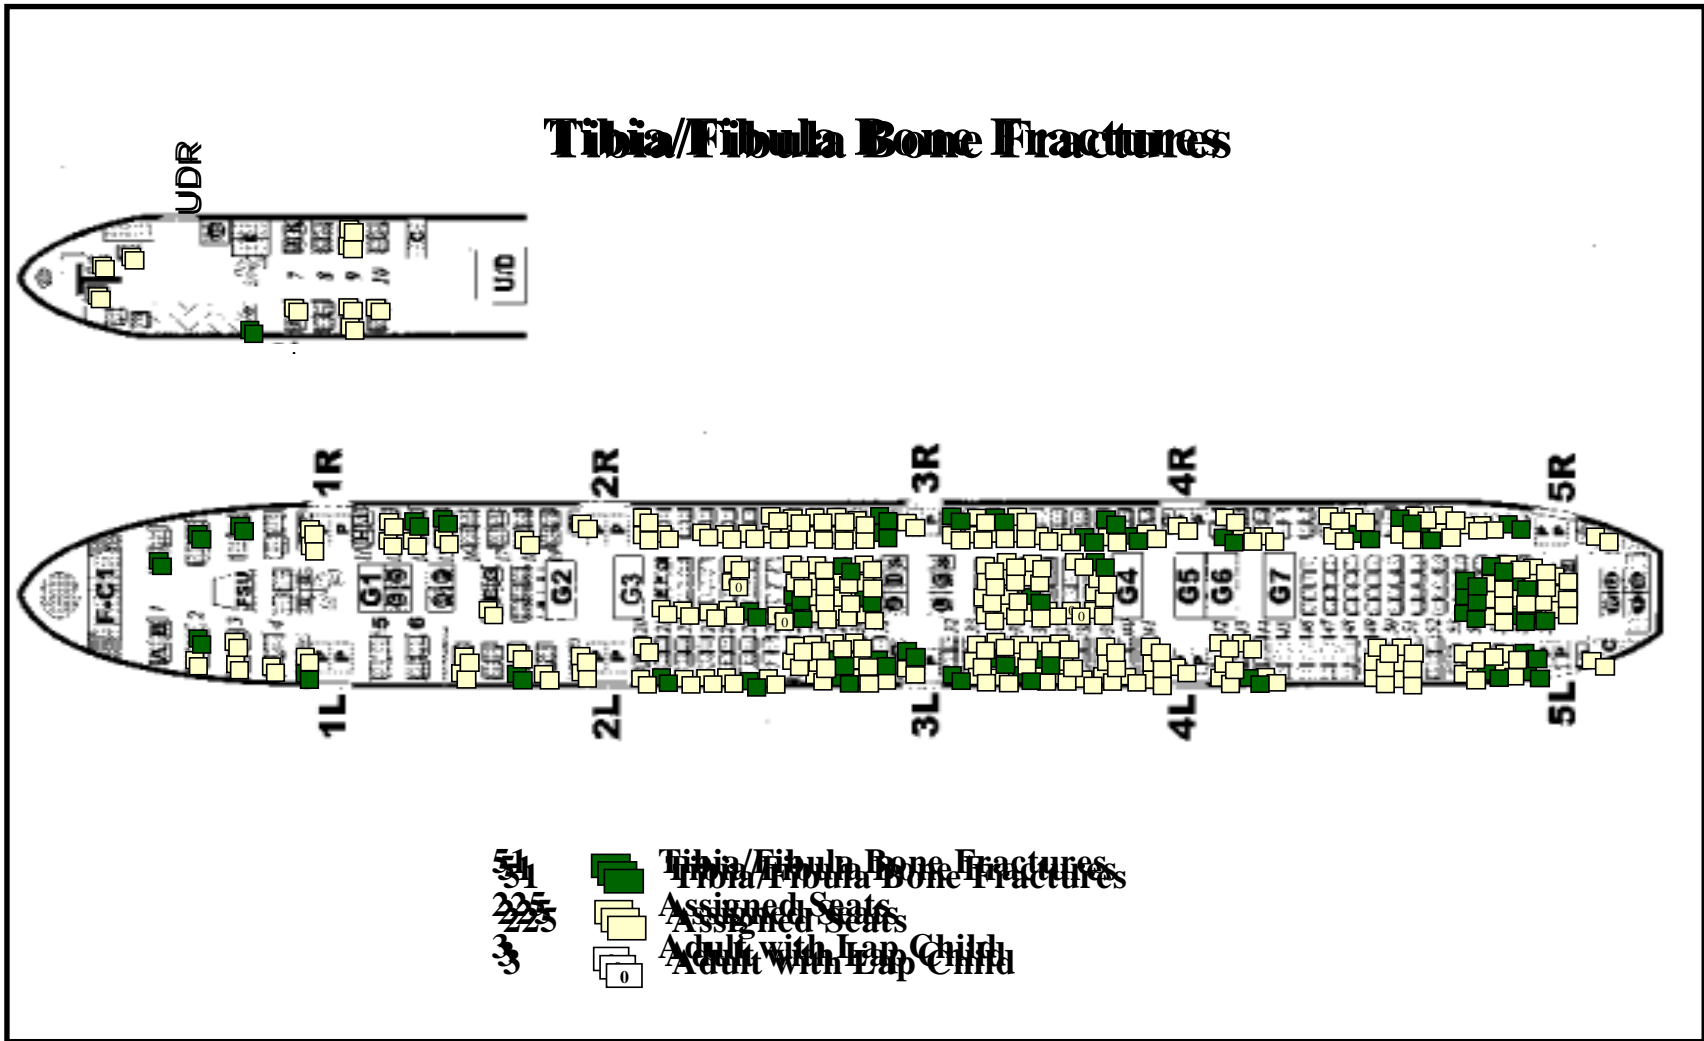
Figure 1.13-4 Tibia/Fibula Fractures

Injuries of the stronger tibia and fibula leg bones, the longer bones in the lower body, are shown in Figure 1.13-4.

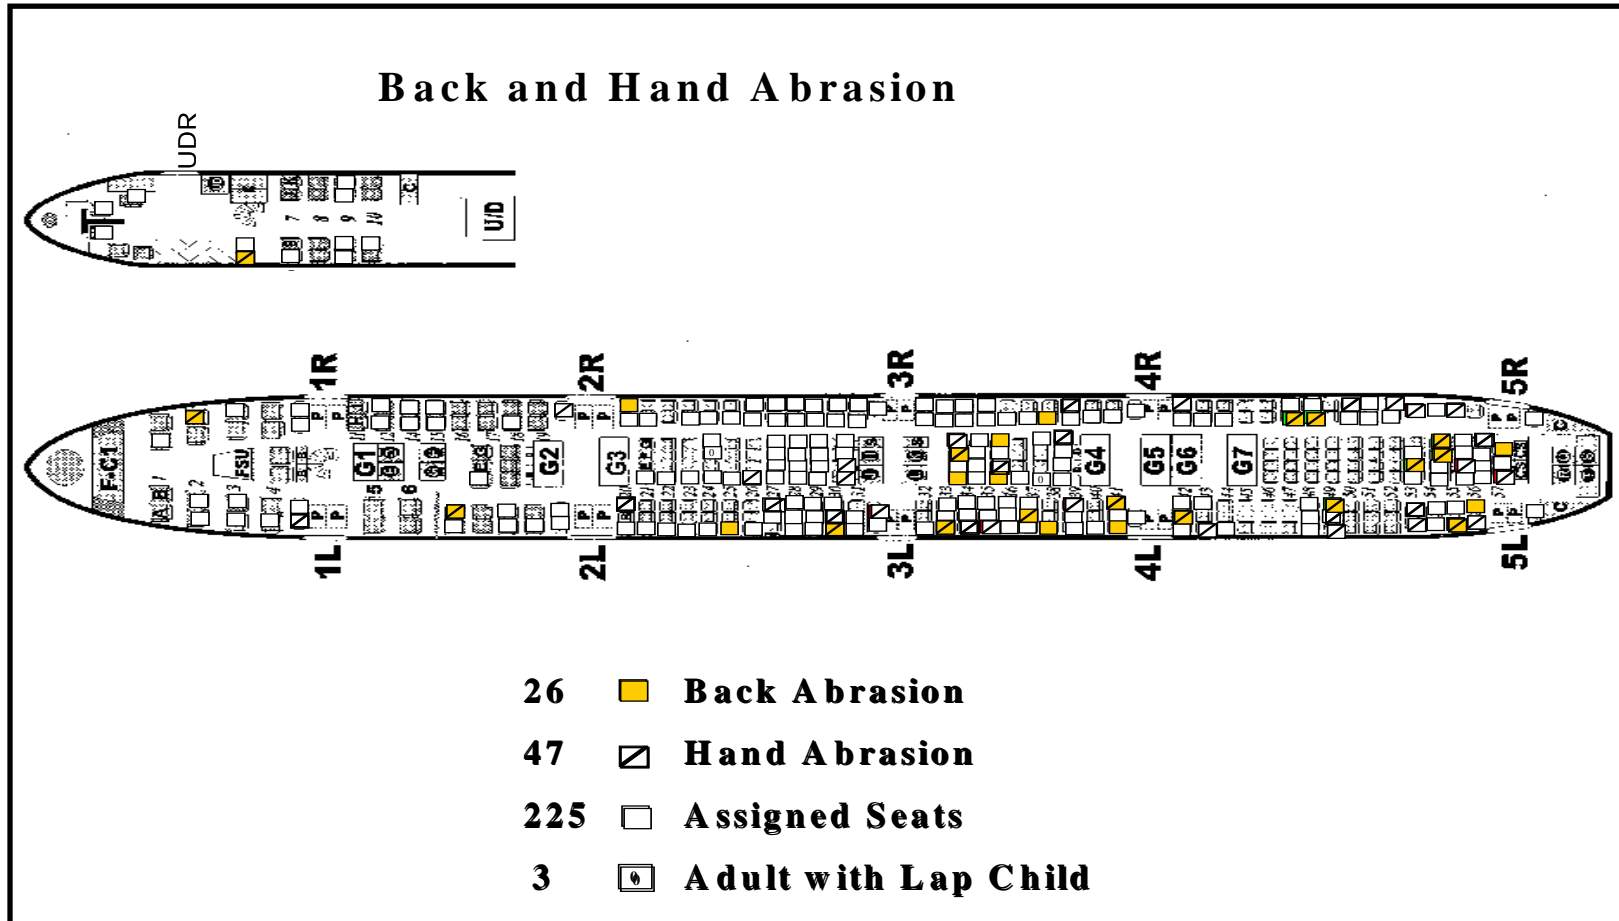
Figure 1.13-5 Back and Hand Abrasion Injuries

The abrasion of the epidermal layer of skin on the victims back was found on 26 of the recovered victims' bodies and bruises were found on 47 of the victim's hands. Neither the epidermal layer of the victims back injuries nor the hand abrasion injuries were found on any of the recovered victims whose bodies were recovered from the ocean after May 27, 2002. Those victims' bodies were too badly decomposed to observe such abrasion or dermal injuries. Figure 1.13-5 shows the distribution of victim's assigned seats with back abrasion and hand abrasion injuries.
