**Aviation Safety Council
Taipei, Taiwan**

**CI611 Accident Investigation
Factual Data Collection
Group Report**

Structure Group

ASC-AFR-03-06-001

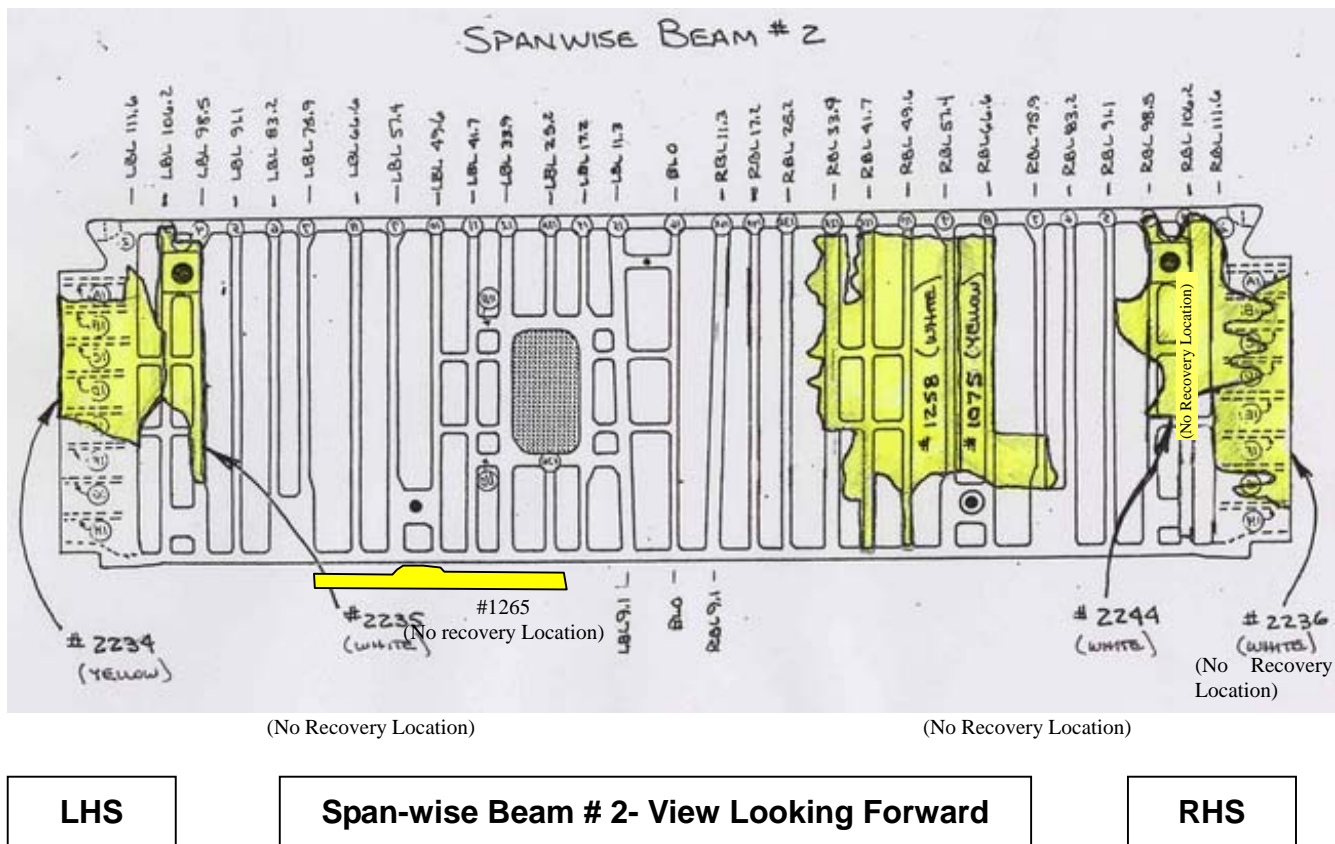
There was no evidence of any soot accumulations or fire damage on the recovered portions of SWB #2.

Figure 1.12-16 The recovered and identified portions of SWB #2

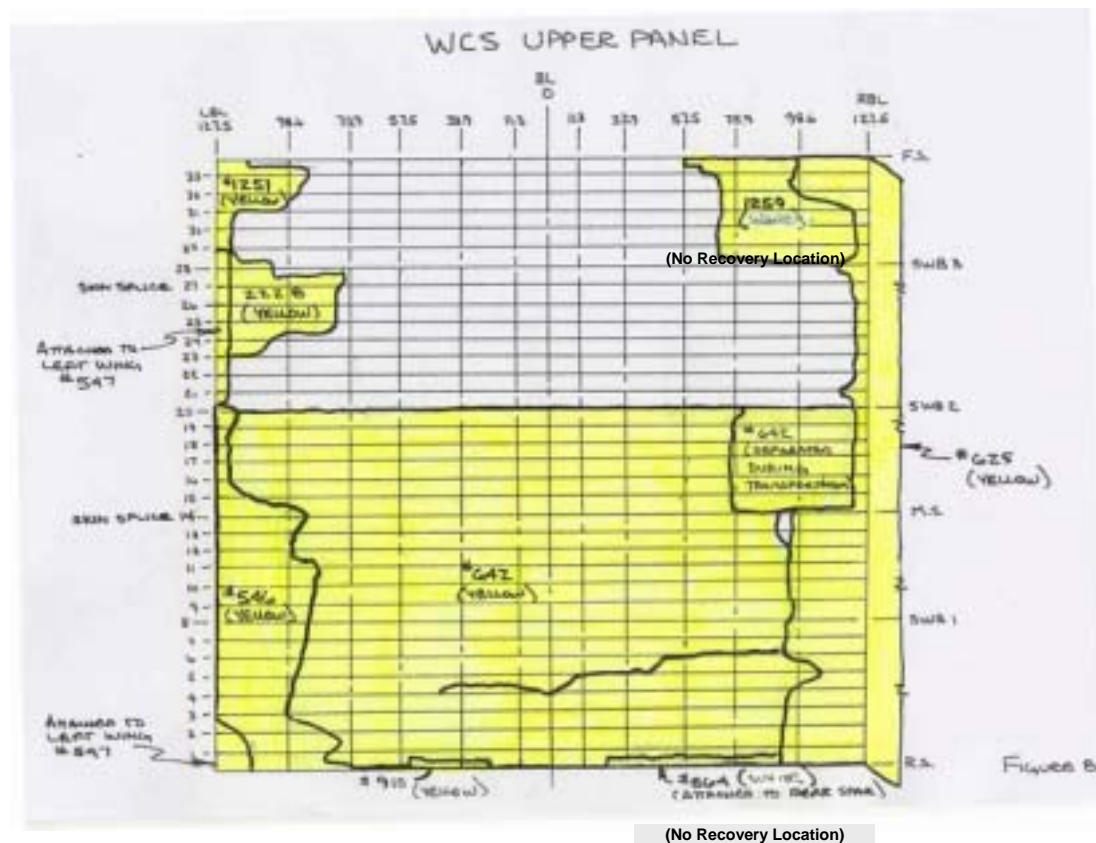
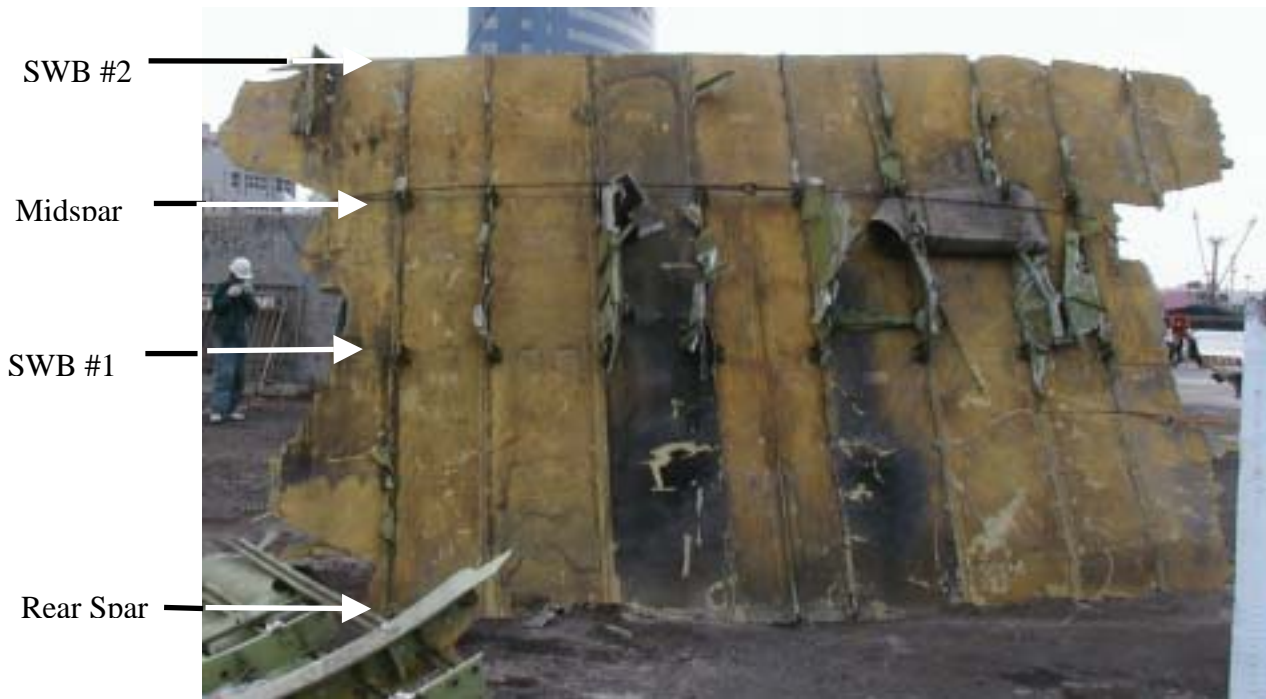
Figure 1.12-25 (a) Interior surface of Upper Panel Item #642-upper photo, (b) Exterior surface of Upper Panel Item #642-lower photo

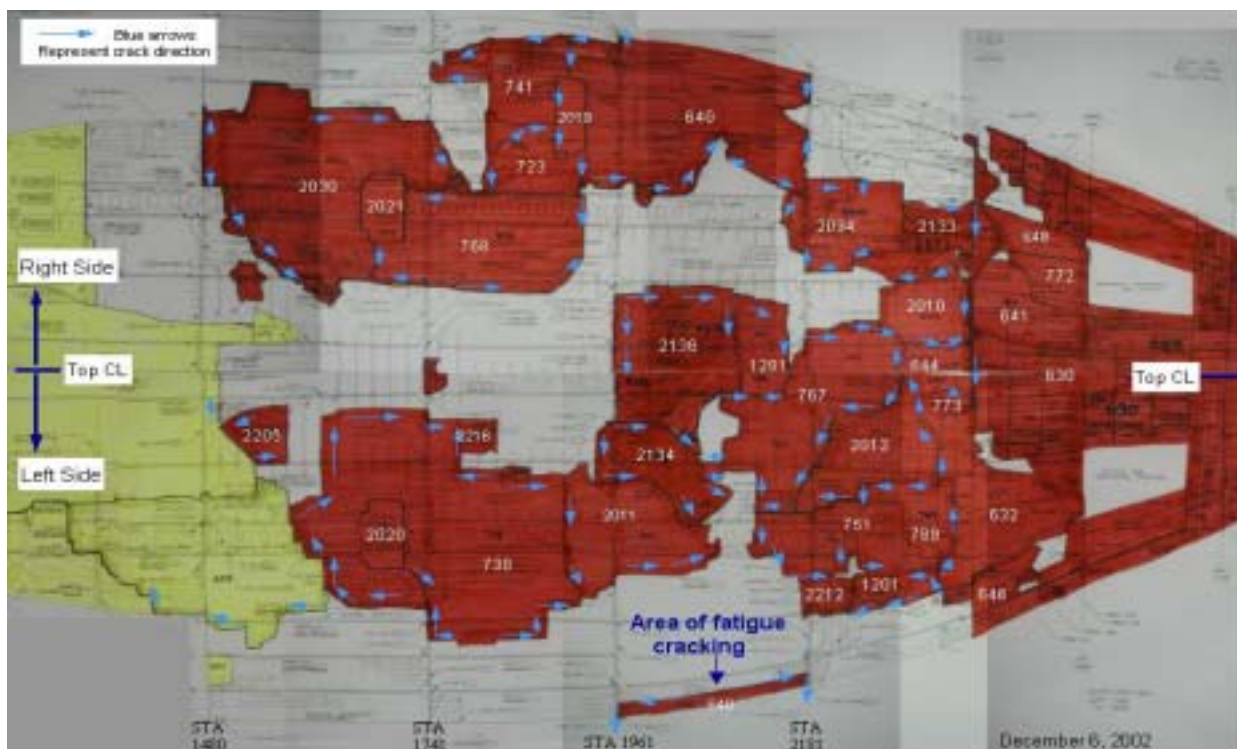
The fracture directions on item 640 show the crack progressed under the belly of the airplane and then continued forward along S-50R. The crack then progressed upward at approximately STA 1900. The direction of the fracture propagation was based on hole-to-hole cracking patterns, chevron marks, and branching cracks as shown in Figure 1.12-41.

Figure 1.12-41 Arrows show the direction of the fracture propagation

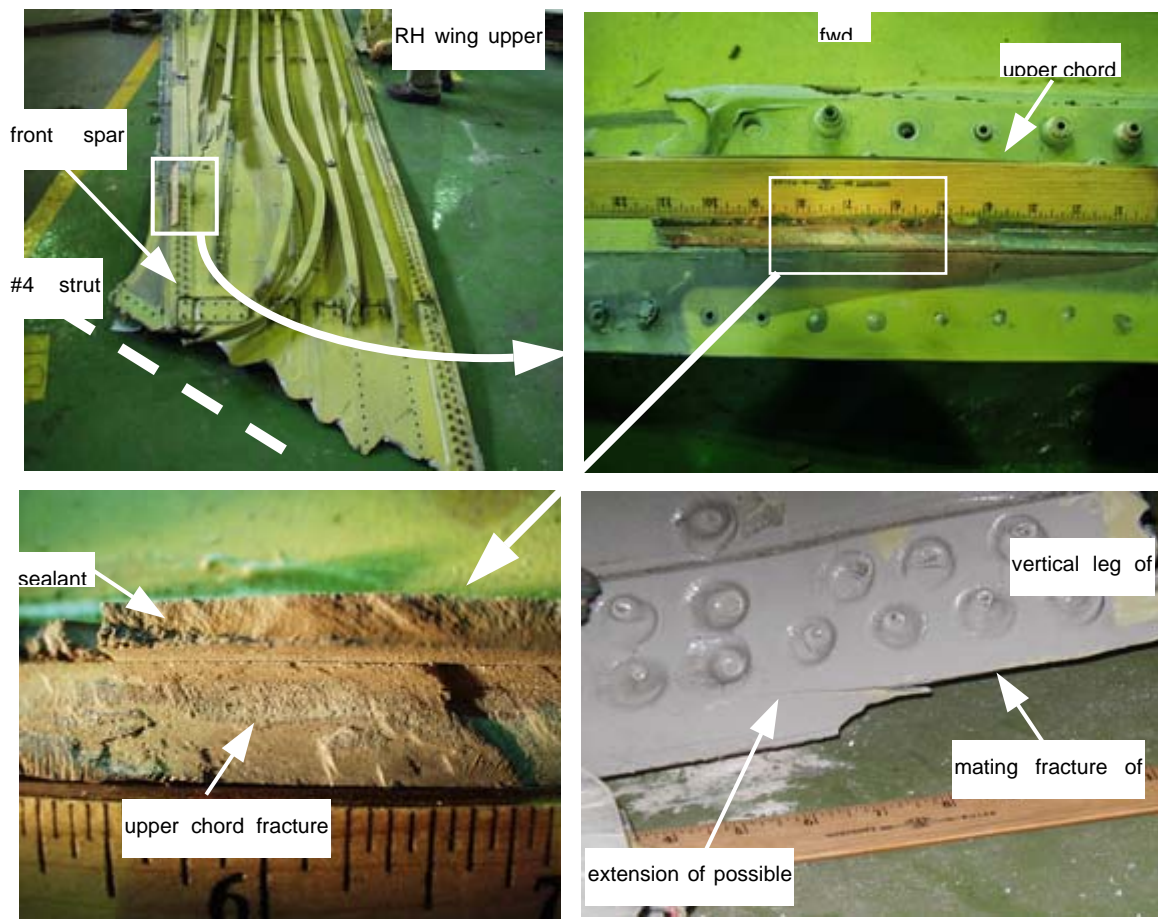
Visual examination of the fracture surface of the Right Wing Front Spar Upper Chord on item #526C3 revealed a possible pre-existing condition at approximately Wing Station 1115. The “woody” appearance of approximately an 8-inch length of the fracture surface in the vertical leg of the upper chord suggests the possibility of a stress corrosion cracking mechanism (SCC). The mating fracture on item #628 was observed to extend additionally several inches into the vertical leg such that it was not completely opened during the break up of the wing structure.

Figure 1.12-62 Right Wing Front Spar Upper Chord, Wing Station 1115 on Item #526C3

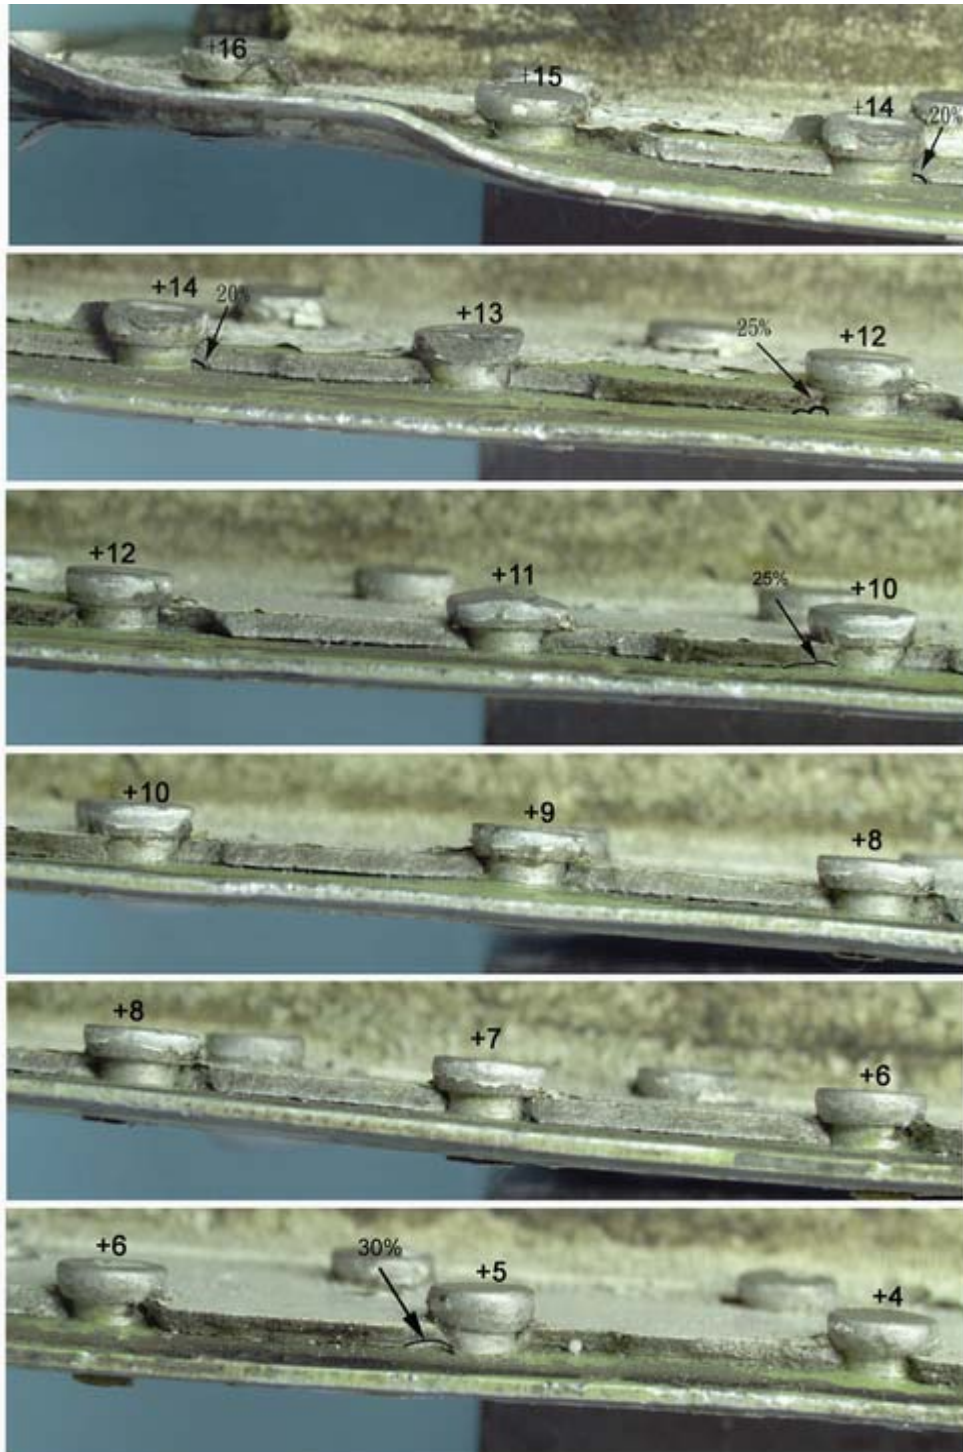
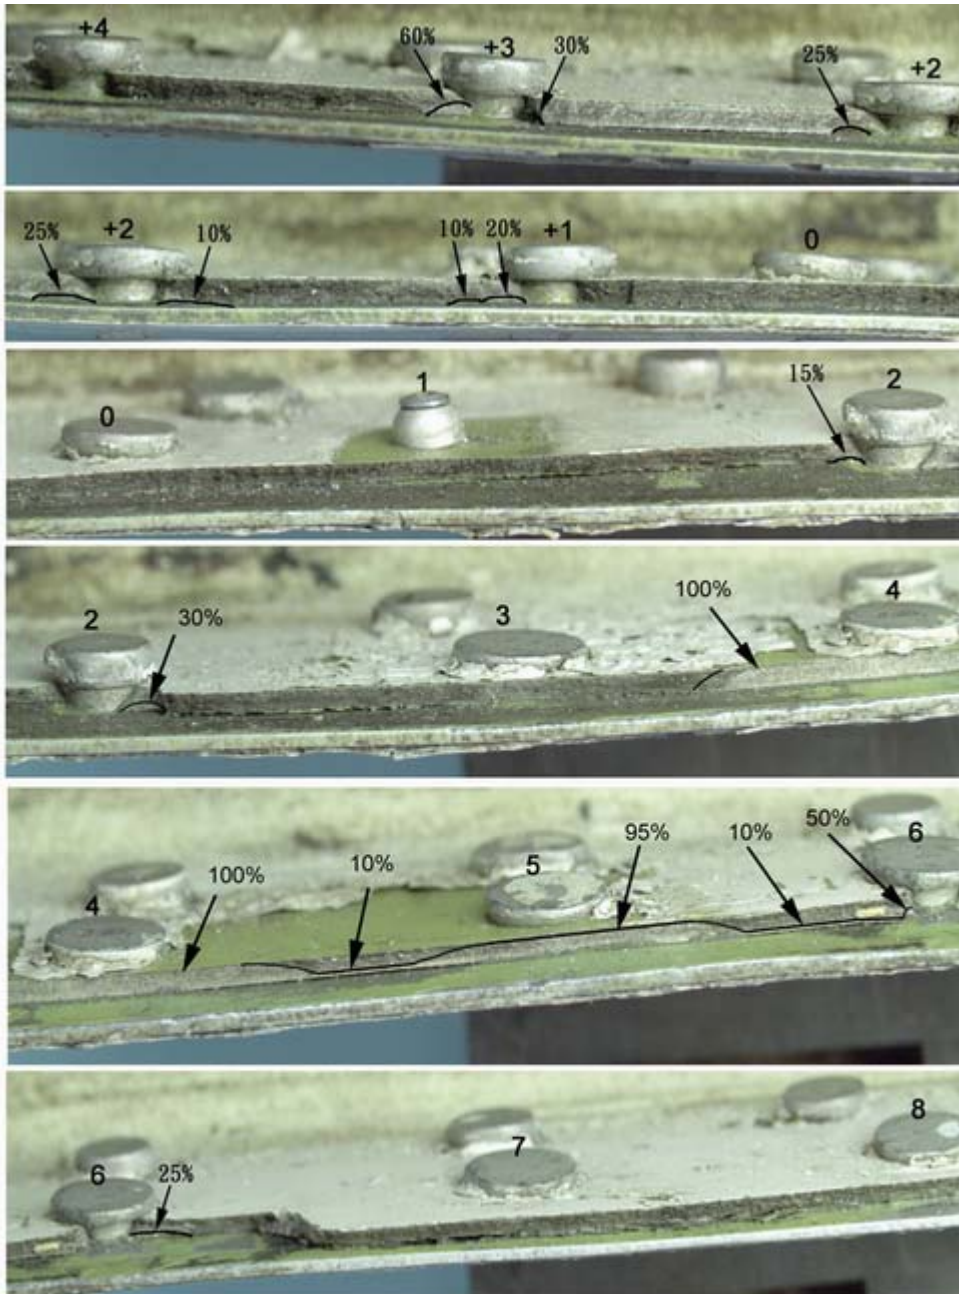
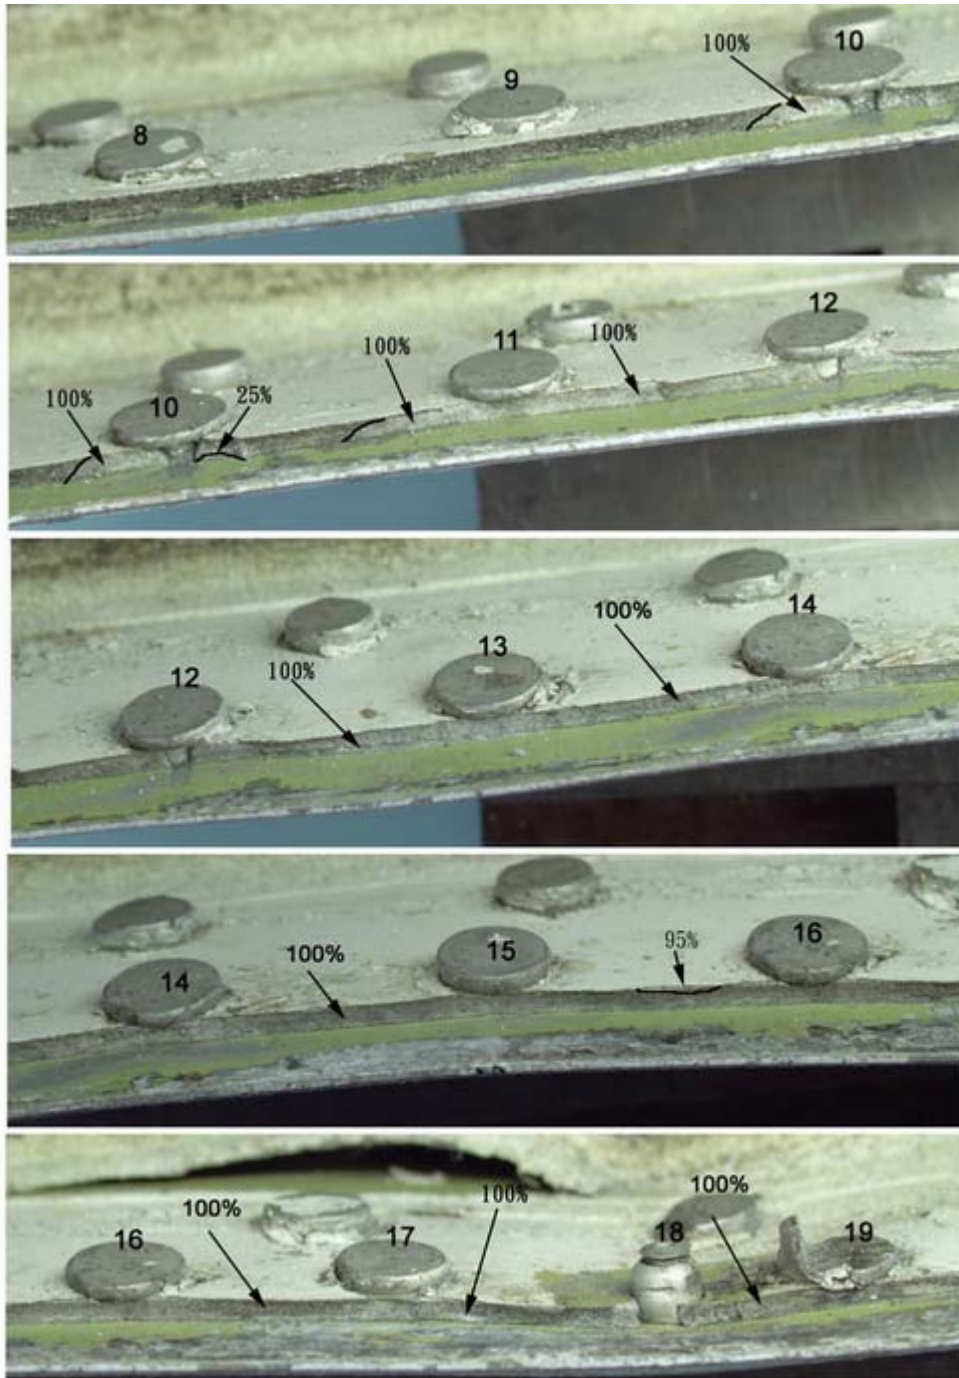
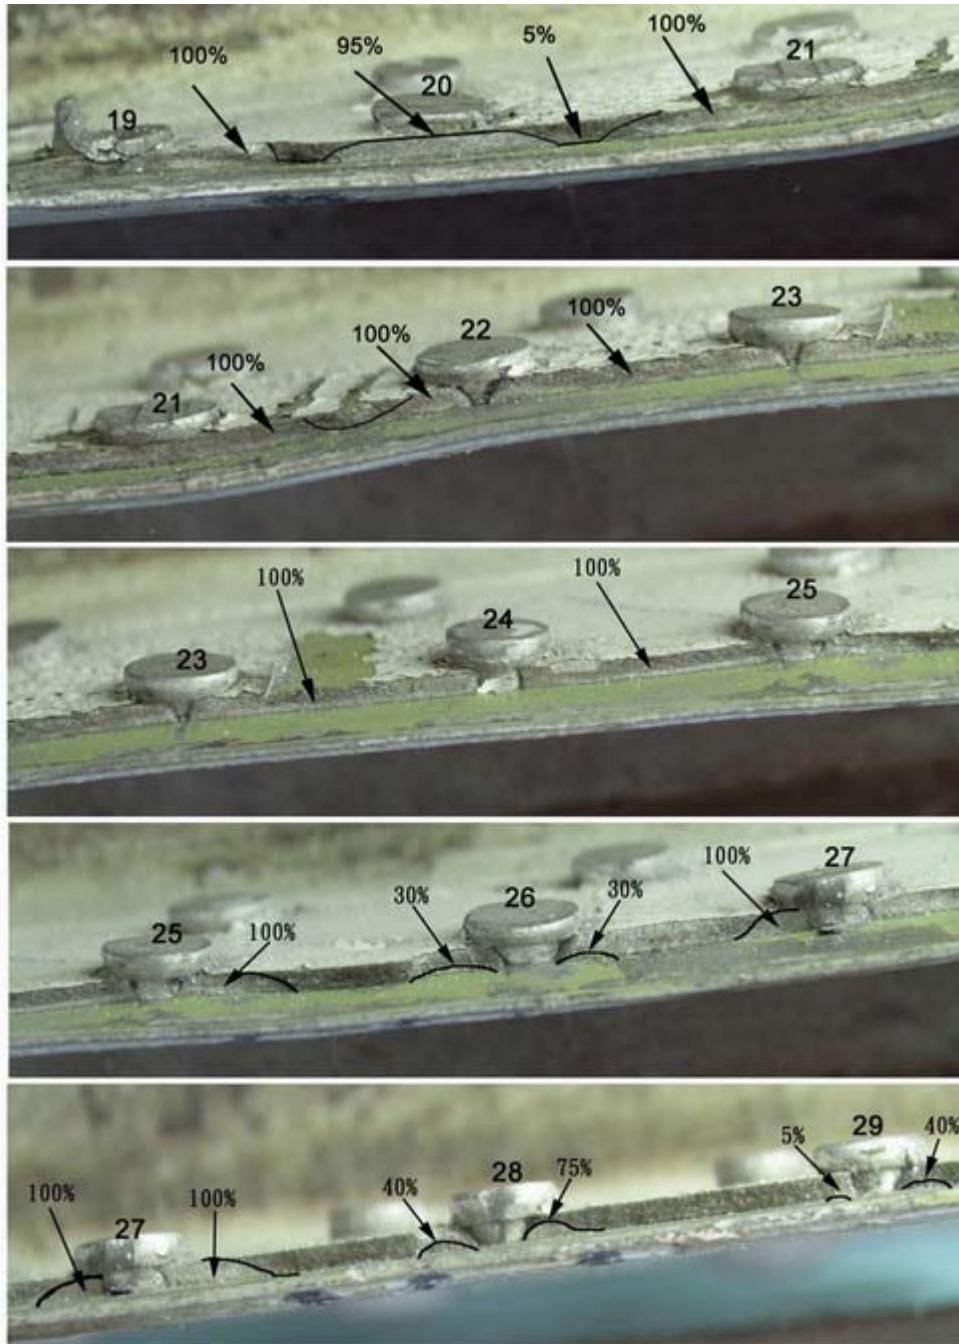
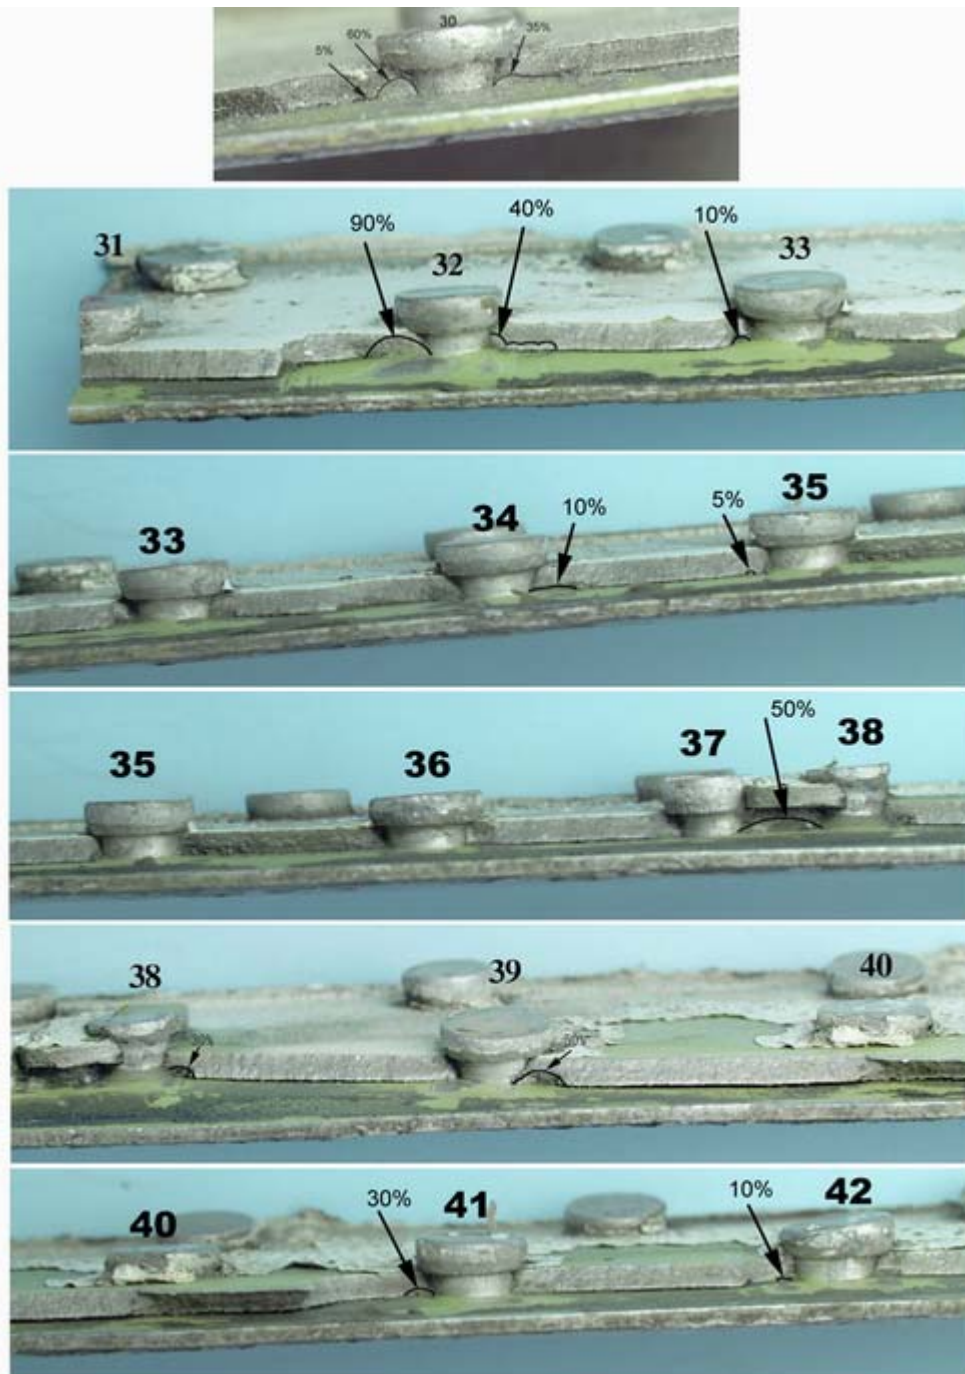
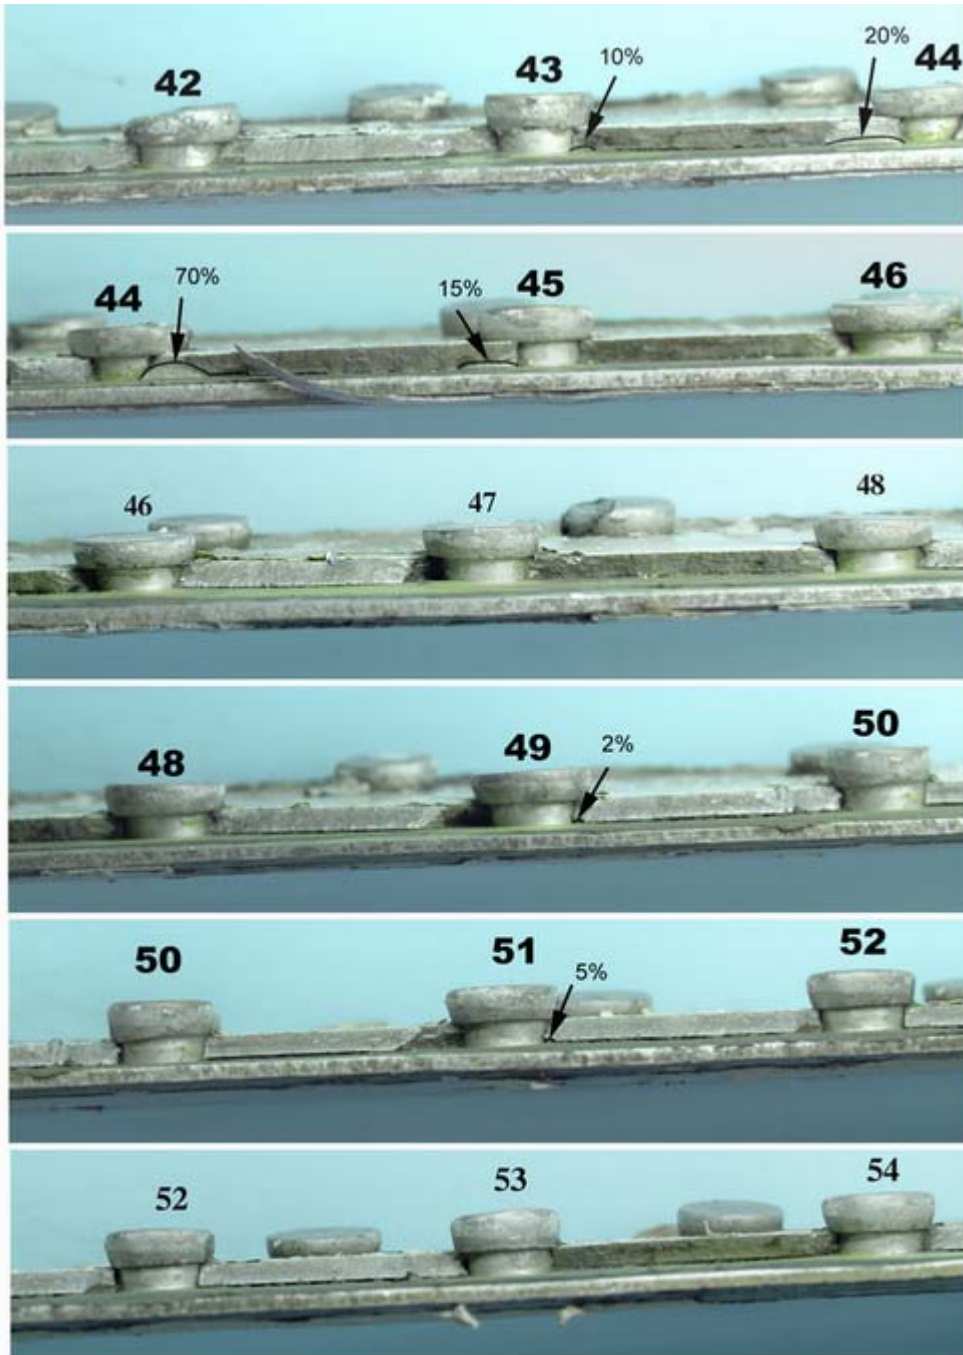
- (1) The extent of fatigue cracking was determined by SEM examination. The extent of fatigue cracking is shown in Figures 1.16-17 through 22, in which the fatigue propagated from the edge next to the doubler until it reached the black curves shown in these figures. Outside of the fatigue regions the fracture features were typical of an overstress separation. The quantities in Figures 5 through 10 denote the ratio of maximum depth of fatigue crack to the thickness of fuselage skin in the corresponding location. It should be noted that in most circumstances the fatigue initiated at the skin edge next to the doubler and progressed inboard through the direction of skin thickness.

Figures 1.16-17 Shown the extent of fatigue cracking

Figures 1.16-18 Shown the extent of fatigue cracking

Figures 1.16-19 Shown the extent of fatigue cracking

Figures 1.16-20 Shown the extent of fatigue cracking

Figures 1.16-21 Shown the extent of fatigue cracking

Figures 1.16-22 Shown the extent of fatigue cracking

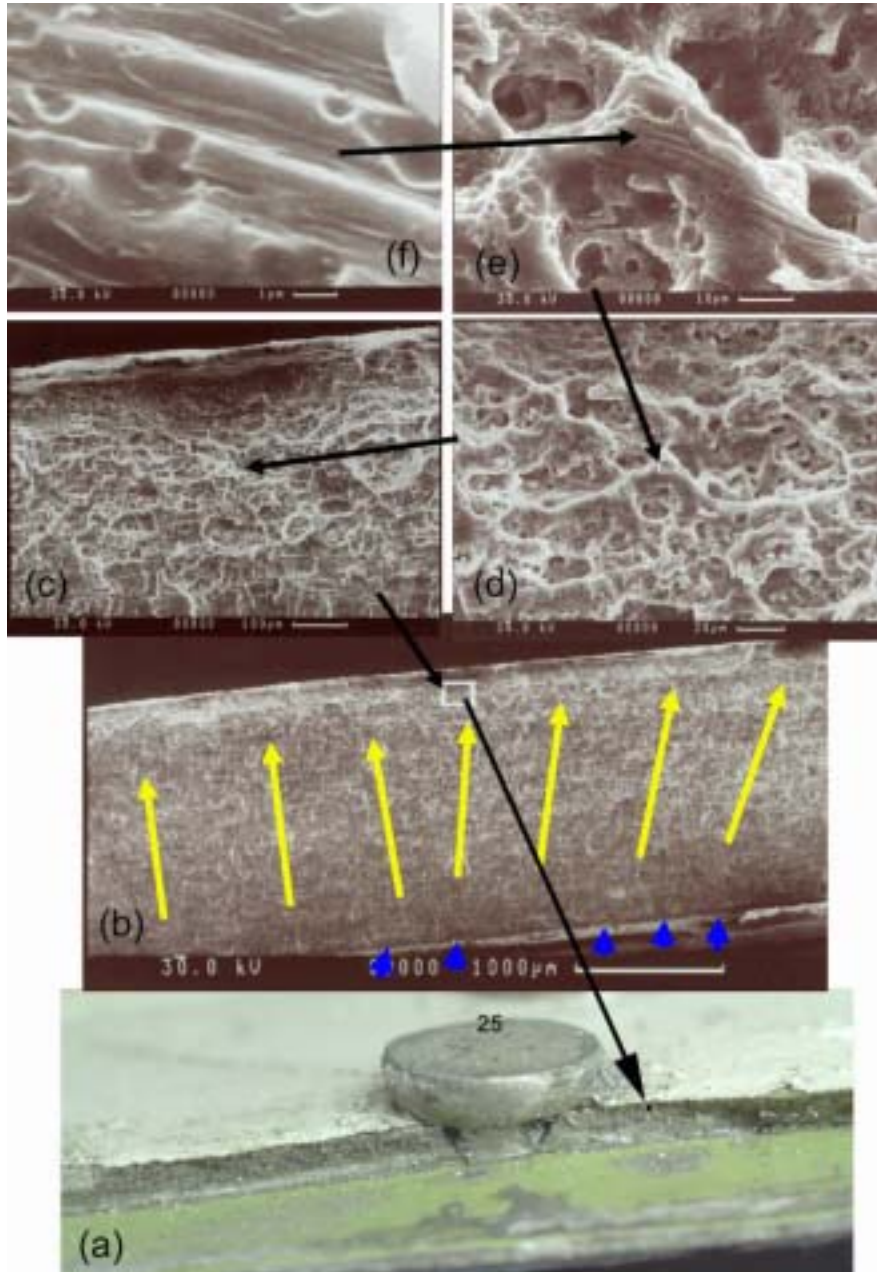
Figure 1.16-24 SEM photographs at different magnifications for the fracture surface near rivet number 25.

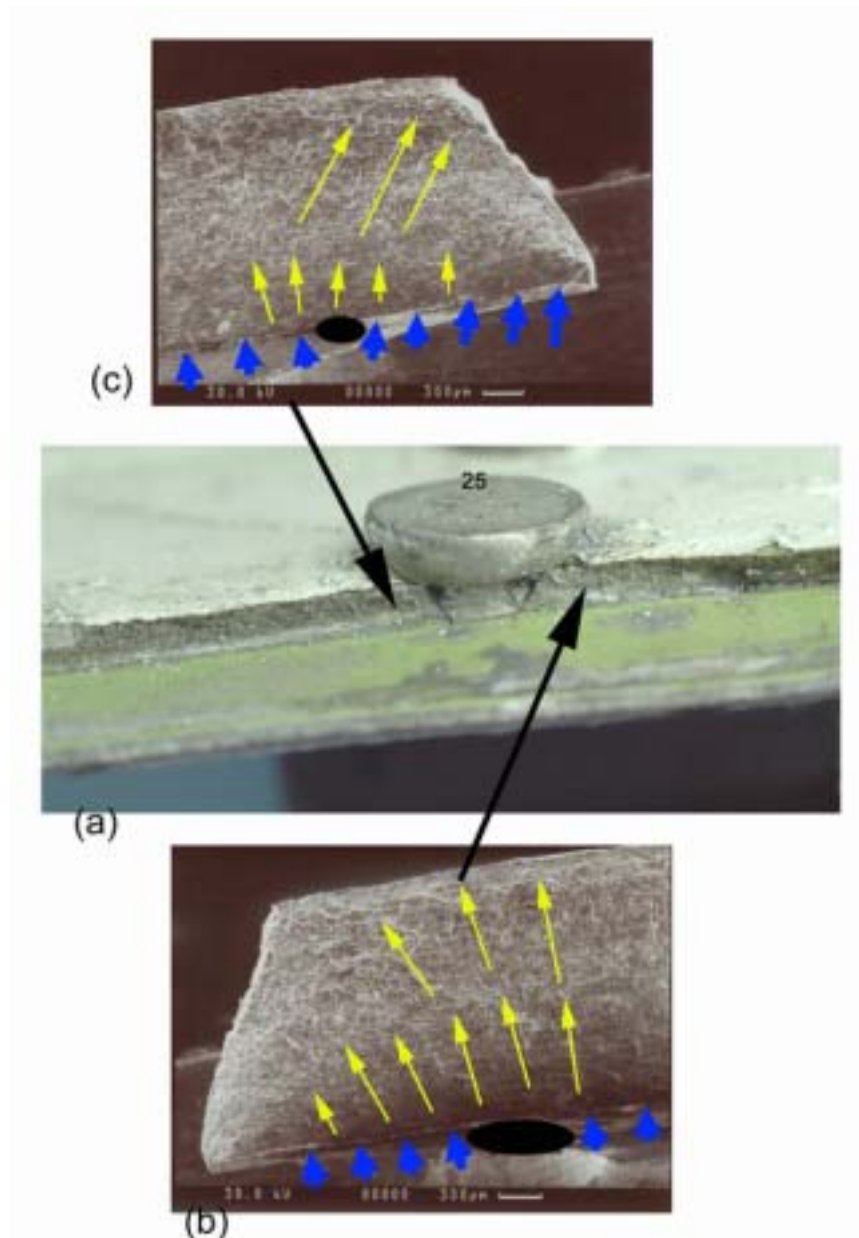
of fatigue cracks, appeared on the edge of the fuselage skin next to the doubler and fatigue propagated across and almost throughout the thickness. The directions of crack propagation indicated the earliest origins of fatigue for each side of the rivet at the approximate locations indicated by the black ellipse in Figure 1.16-25 (b) and 1.16-25 (c). The corresponding points of fatigue cracking through the thickness of the skin are near the periphery of the formed tail end of the rivet.

Figure 1.16-25 SEM photos for the two sides adjoining rivet 25

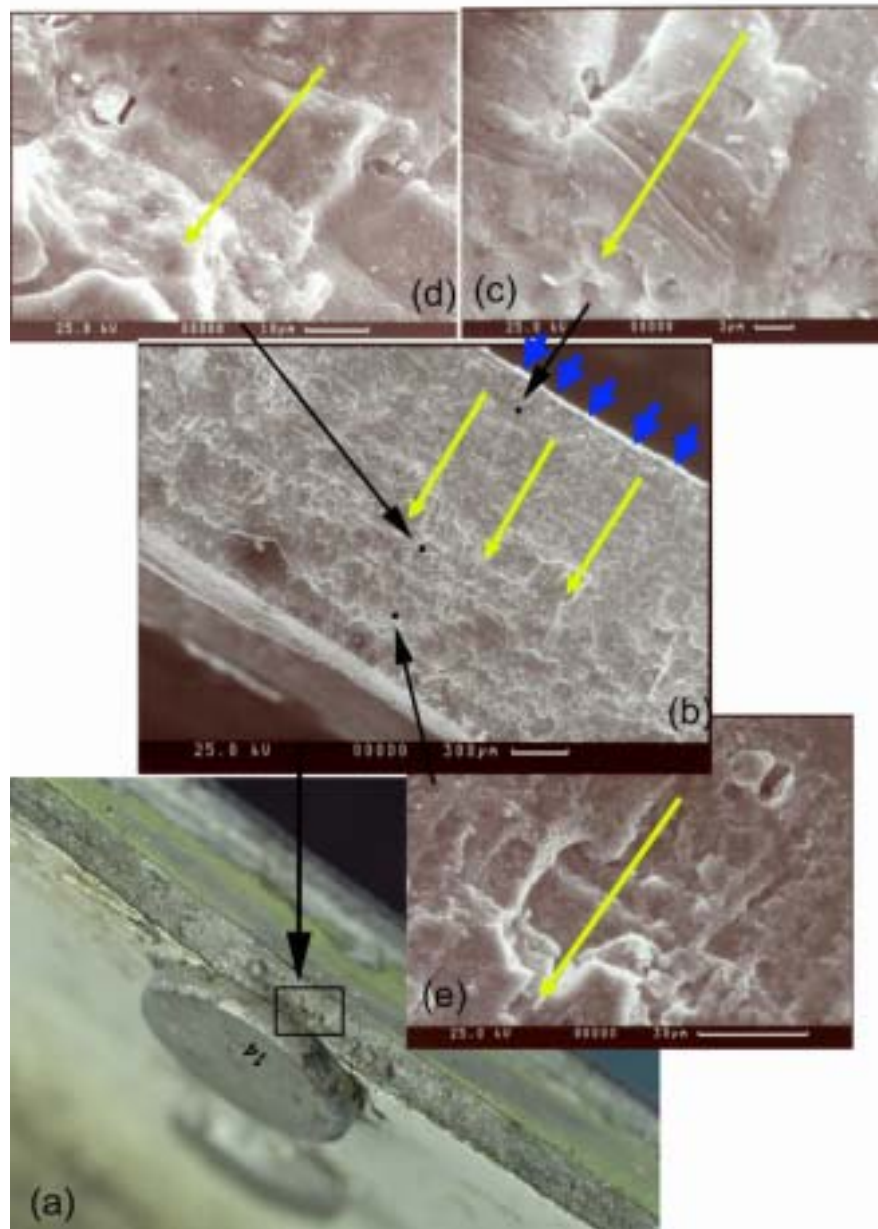
1.16-26 (d) and 1.16-26 (e), denoted by three small black squares, are high magnification photographs for various locations in Figure 1.16-26 (b), showing different spacing of fatigue striations at distances of 250 μm , 1020 μm , and 1480 μm , respectively, away from the skin edge next to doubler. These photographs can be used to measure the striation density at various locations along the crack front. Further, the cycles of loading can be estimated using fracture mechanics.

Figure 1.16-26 The fracture morphology of fatigue for the area near rivet 14

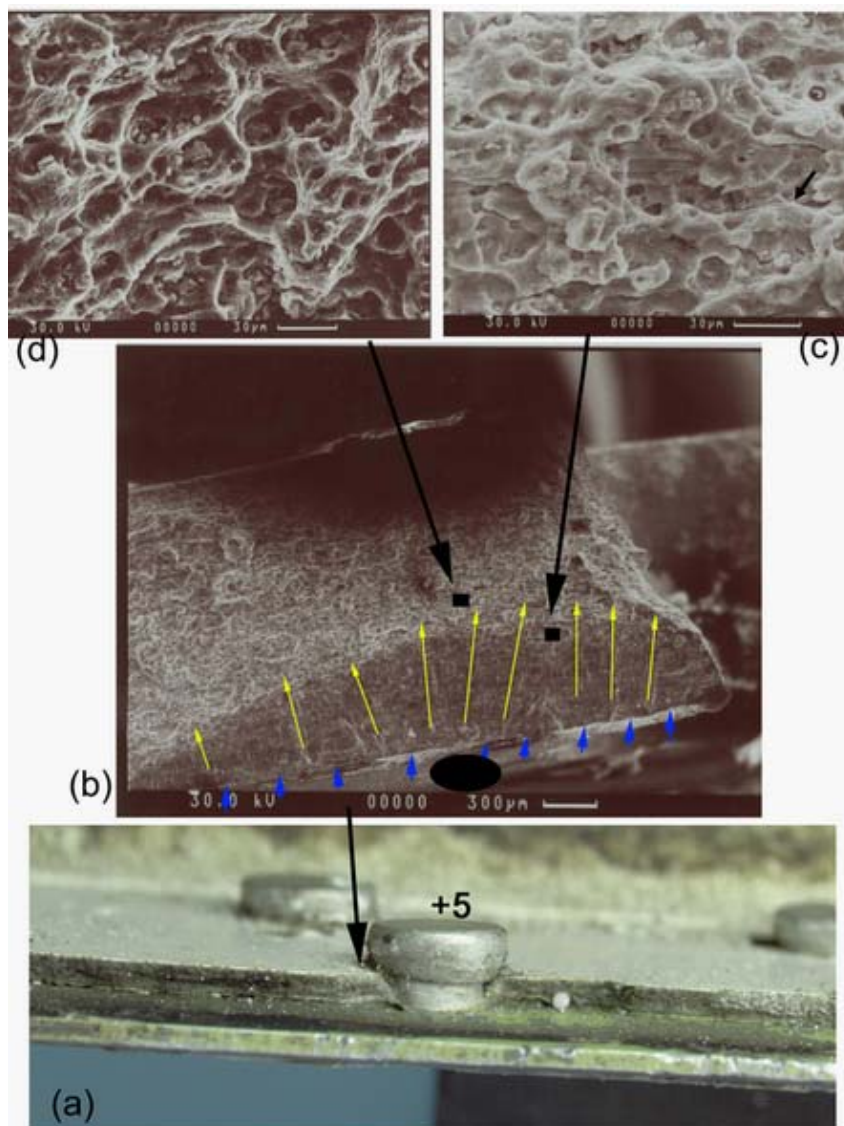
(5) SEM photographs shown in Figure 1.16-27 (c) and 1.16-27 (d) are close-up views of the fracture located in the area indicated by the two black squares in Figure 1.16-27 (b). Figure 1.16-27 (c) illustrates visible striations, a typical characteristic of fatigue cracking. In addition, Figure 1.16-27 (d) illustrates dimples, a typical characteristic of overstress. By comparing the proportion of fatigue crack area to overstress area, it is smaller in the area near rivet +5 than those near rivet 25 and 14, in which most areas of fracture surfaces have been identified as fatigue cracking. However, the morphology of fatigue near +5 is similar to those near rivets 25 and 14, such as the direction of crack propagation and the origins of fatigue cracking.

Figure 1.16-27 Illustrates visible striations, a typical characteristic of fatigue cracking and dimples, a typical characteristic of overstress

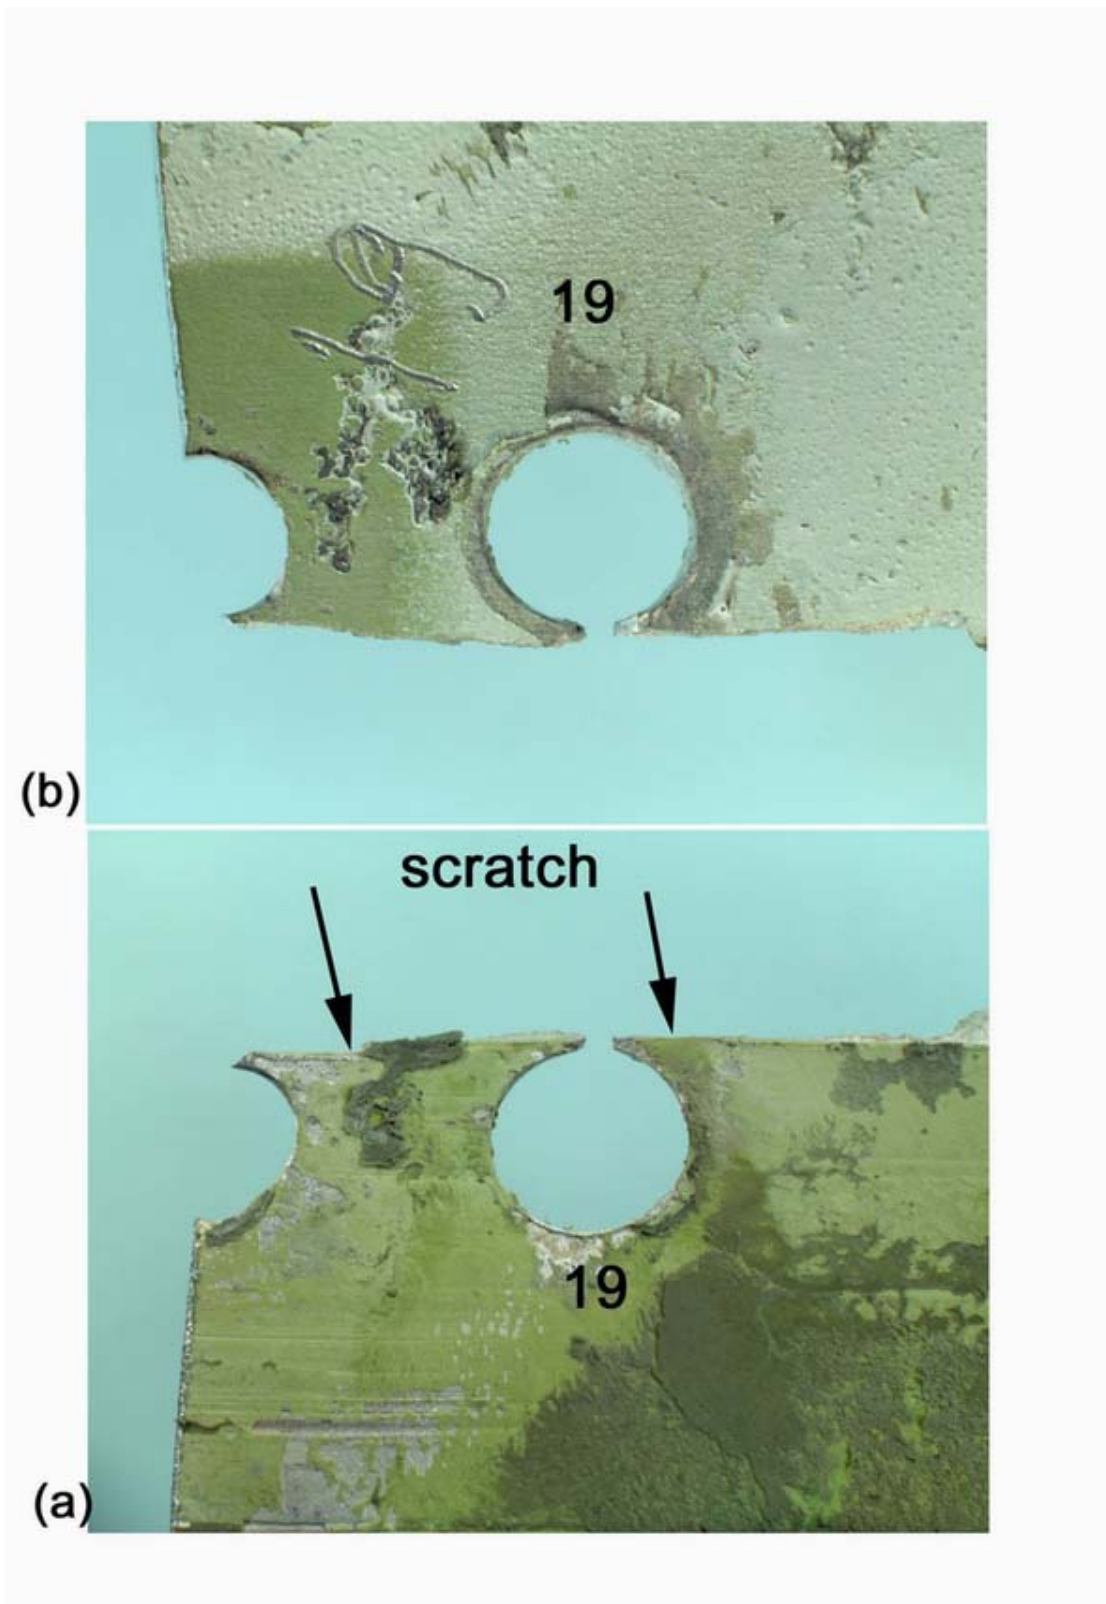
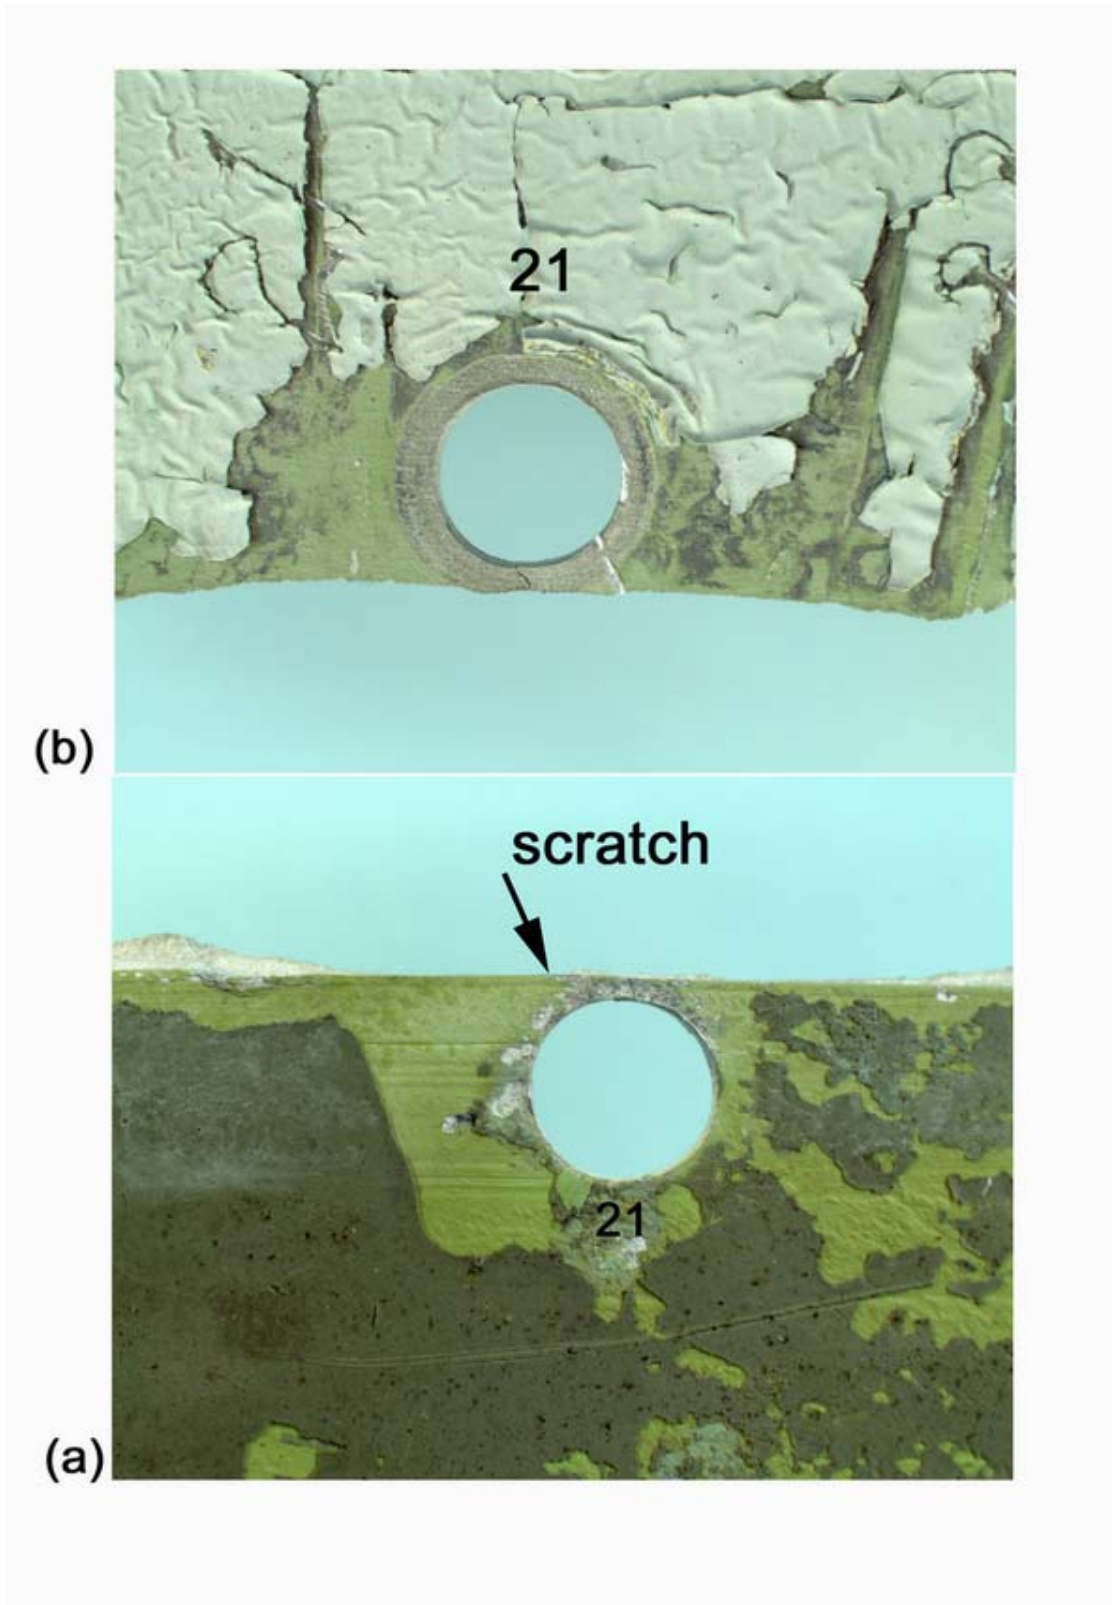
- (7) Figures 1.16-28~30, showing macroscopic photographs on both sides of the skin surface around the rivets numbered 19~21, respectively, indicated that many scratches existed on the faying surface of fuselage skin. The scratches were covered with paint. Figure 1.16-28~30 also illustrate that the fatigue cracks at nearby rivets were approximately located around the periphery of the formed tail end of the rivet, in which residual tensile stresses could be induced by the process of riveting. As indicated by black arrows in Figures 1.16-28 and 29, the paths of the fatigue cracks were very straight and always followed the track of scratches along the direction parallel to stringer S-49L.

Figure 1.16-28 The skin surface around the rivets 19

Figure 1.16-29 The skin surface around the rivets 20

Figure 1.16-30 The skin surface around the rivets 21

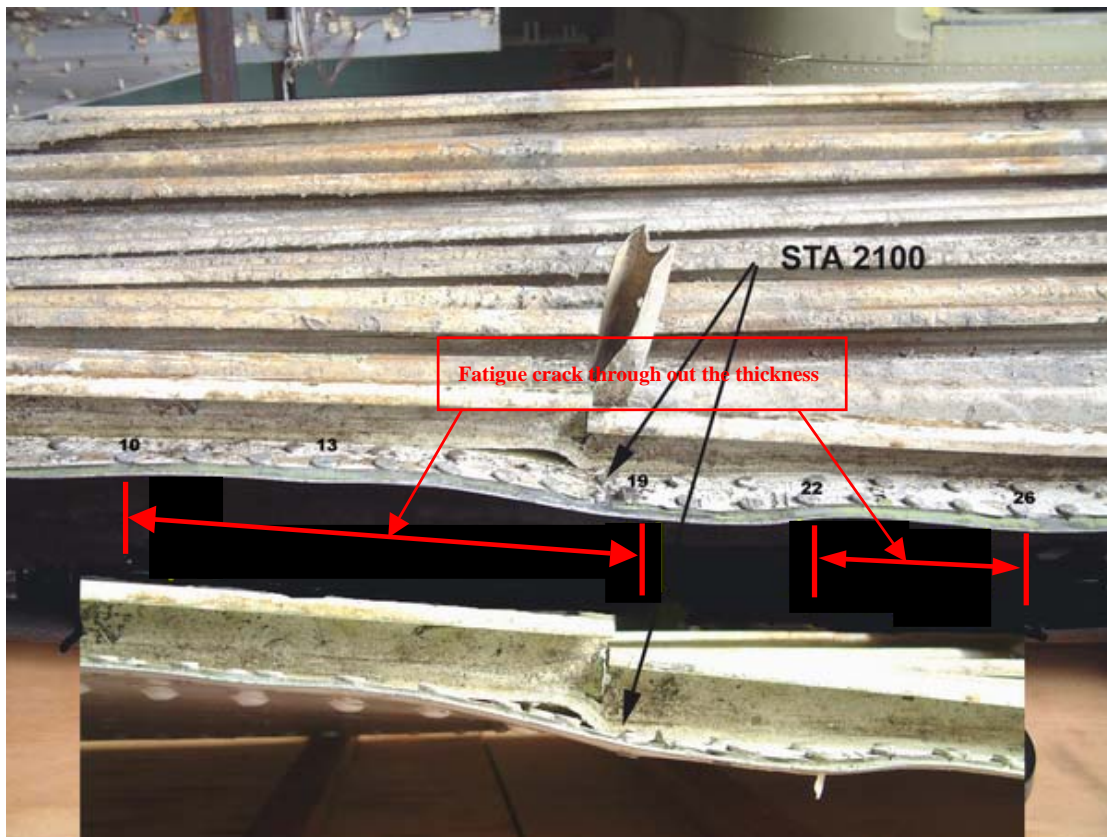
- There was no evidence of contact damage with an object in the area that could account for the local deformation to the skin and doubler.

Figure 1.16-31 Show apparent evidences of local deformation near frame of STA 2100
