**Aviation Safety Council
Taipei, Taiwan**

**CI611 Accident Investigation
Factual Data Collection
Group Report**

Structure Group

ASC-AFR-03-06-001

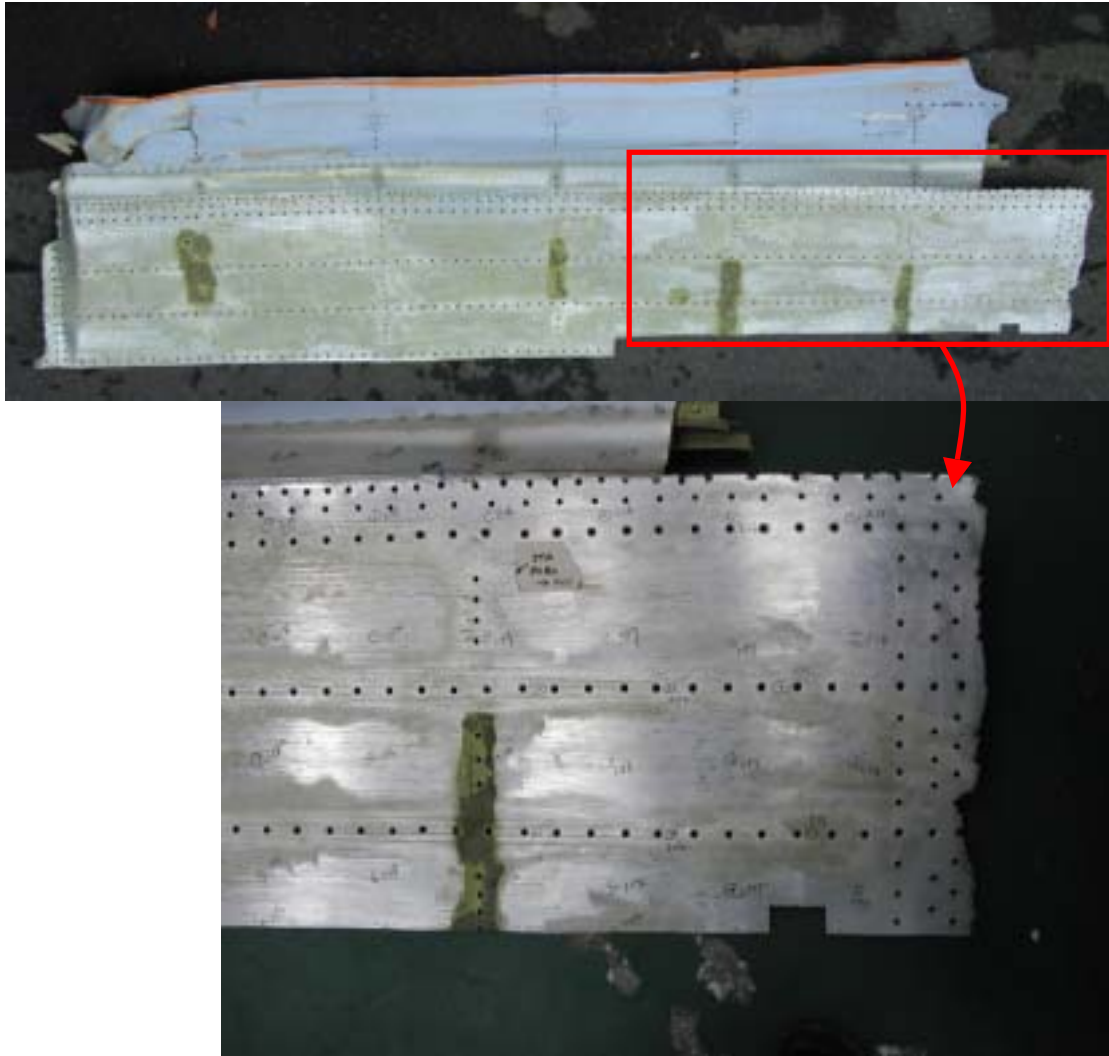
- (11) After removing all rivets and then separating skin from the doubler, many scratches were visible on the faying surface of the skin. Figure 1.16-33 shows this feature after removal of the paint and sealant. Scratches existed almost everywhere. The most severe scratches on the skin surface were located just under the stringers or frames.

Figure 1.16-33 Show this feature after removal of the paint and sealant

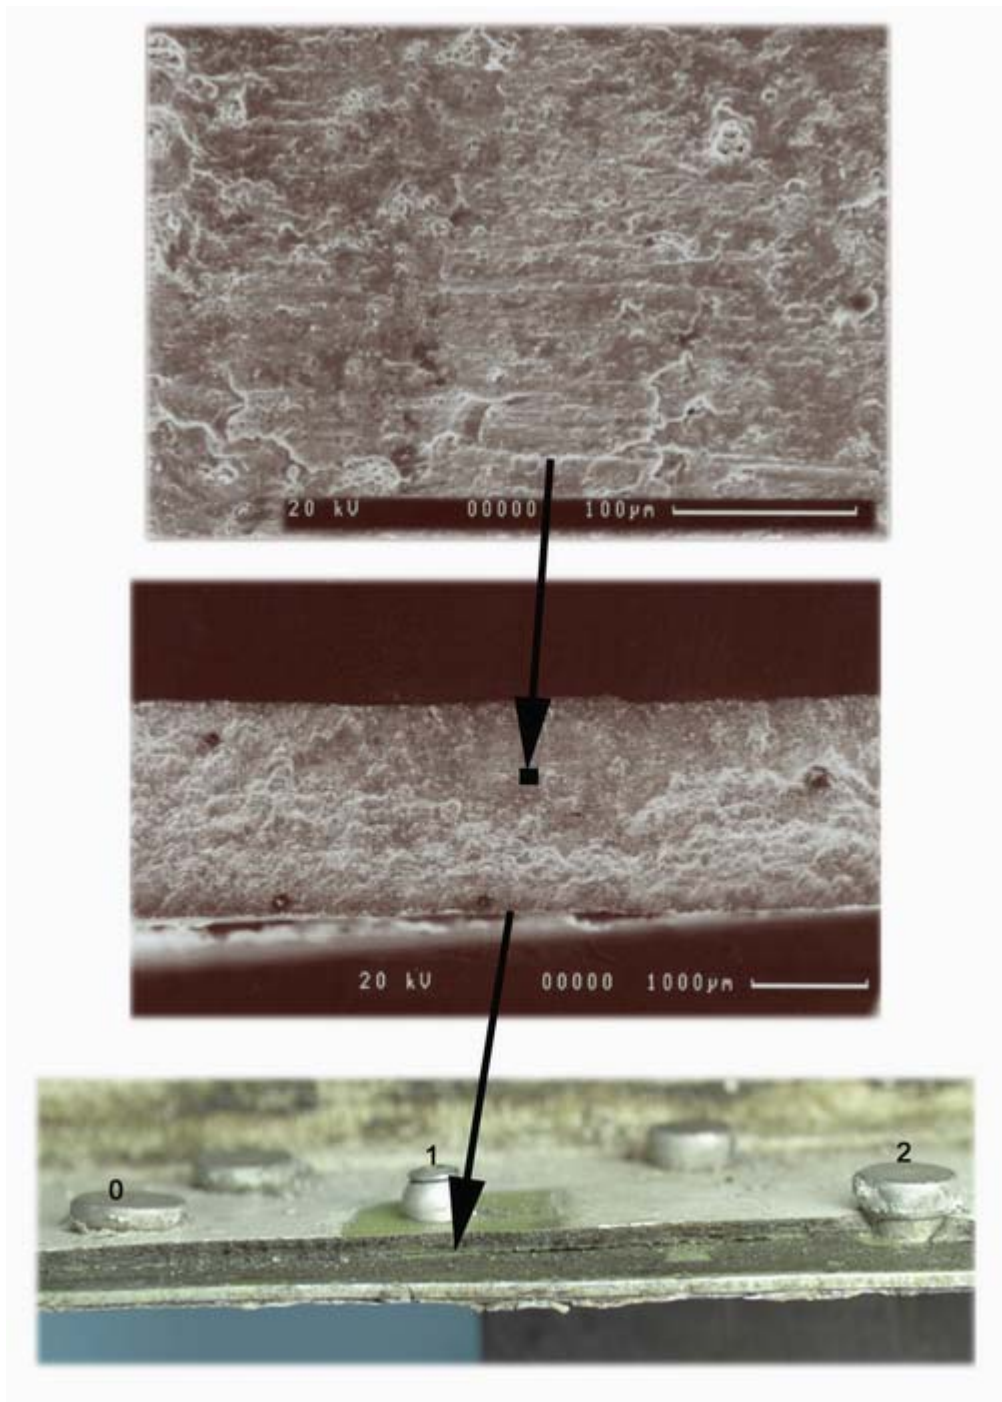
- (12) Rub marks produced by abrasion prevailed over the fracture surface near rivet number 1 (Figure 1.16-34). However, in contrast, the fracture surface near rivet +13 contained less evidence of rubbing and so dimples were visible, as shown in Figure 1.16-35.

Figure 1.16-34 Rub marks produced by abrasion prevailed over the fracture surface near rivet number 1

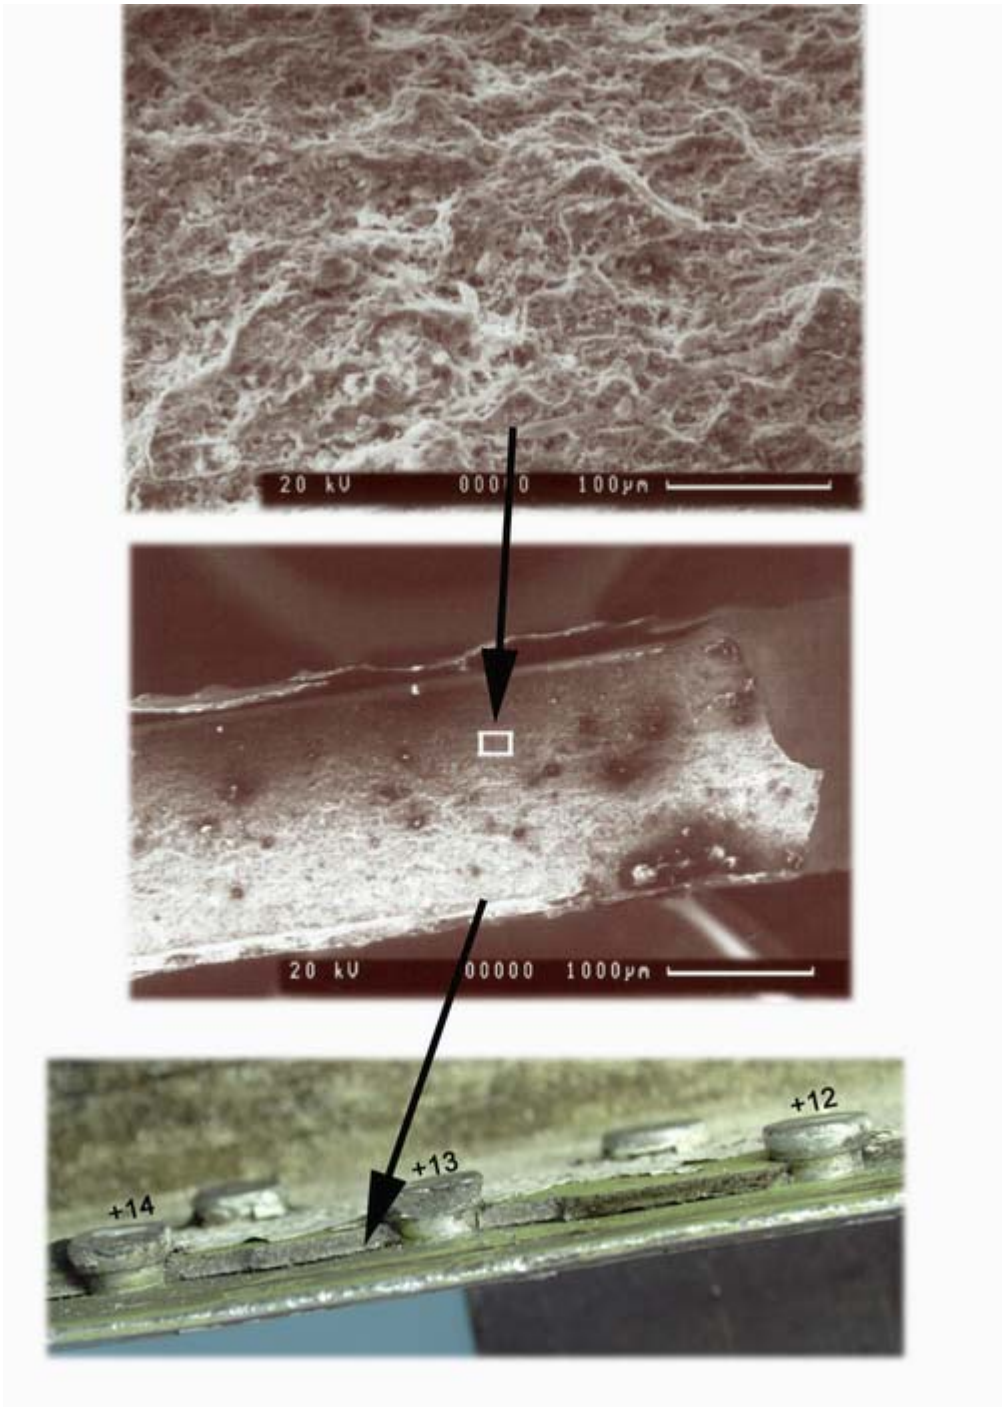
Figure 1.16-35 The fracture surface near rivet +13 contained less evidence of rubbing

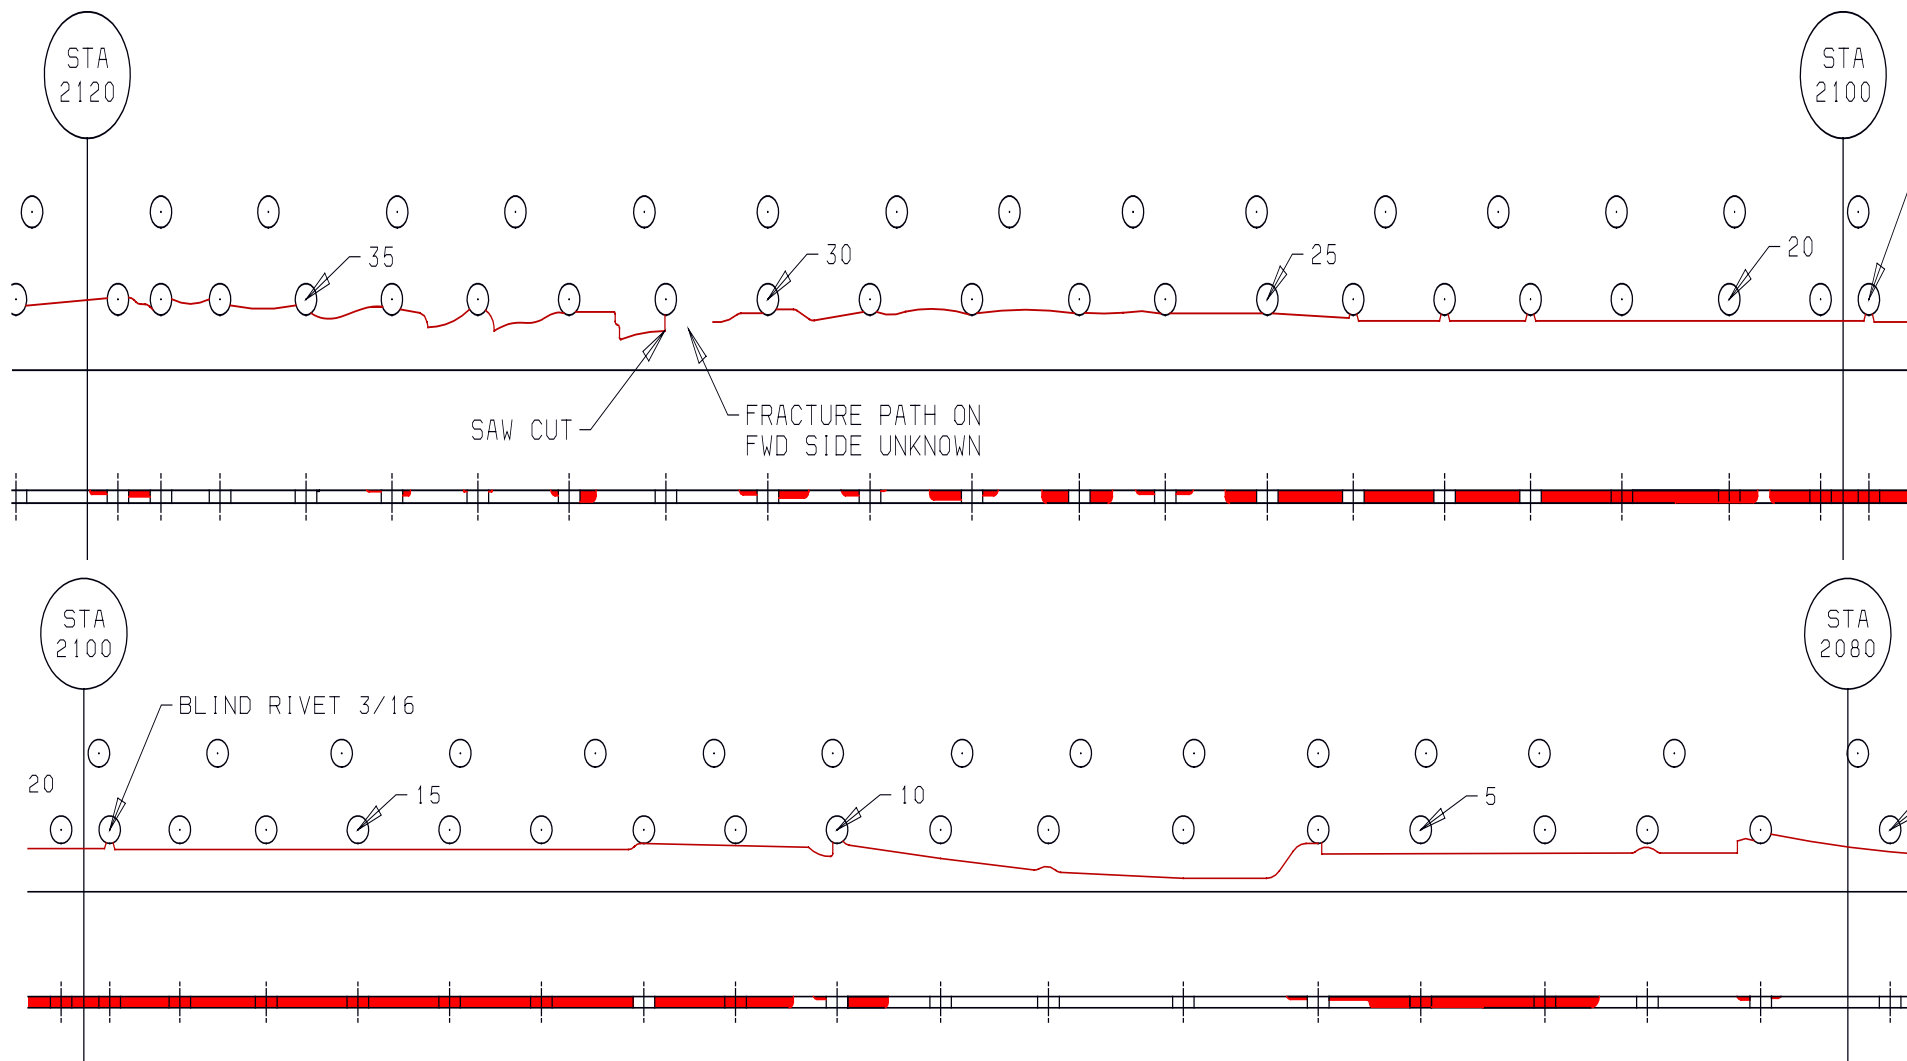
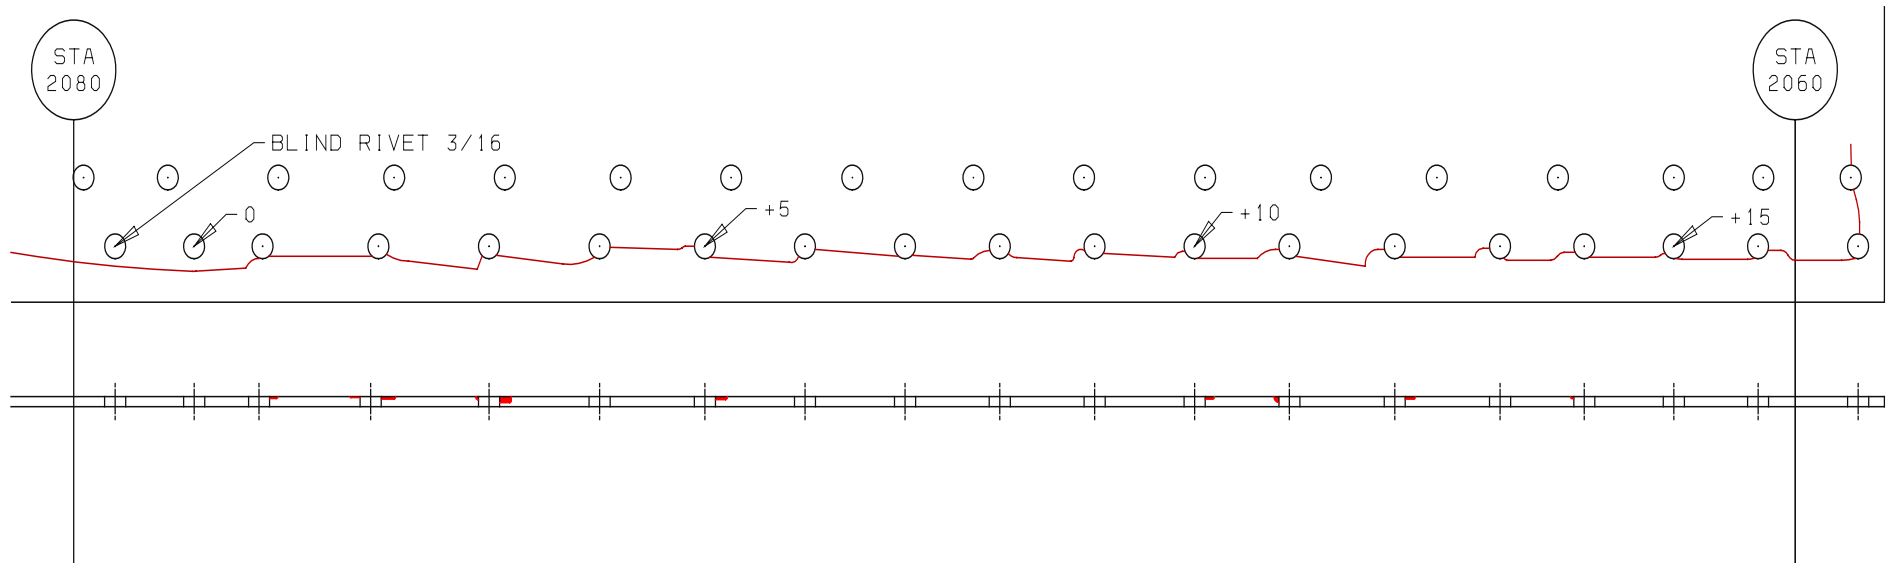
Figure 1.16-39 A detailed map of all fatigue cracks confirmed during examination at Boeing- STA 2060~2120

Figure 1.16-39 (Cont) A detailed map of all fatigue cracks confirmed during examination at Boeing- STA 2060~2120

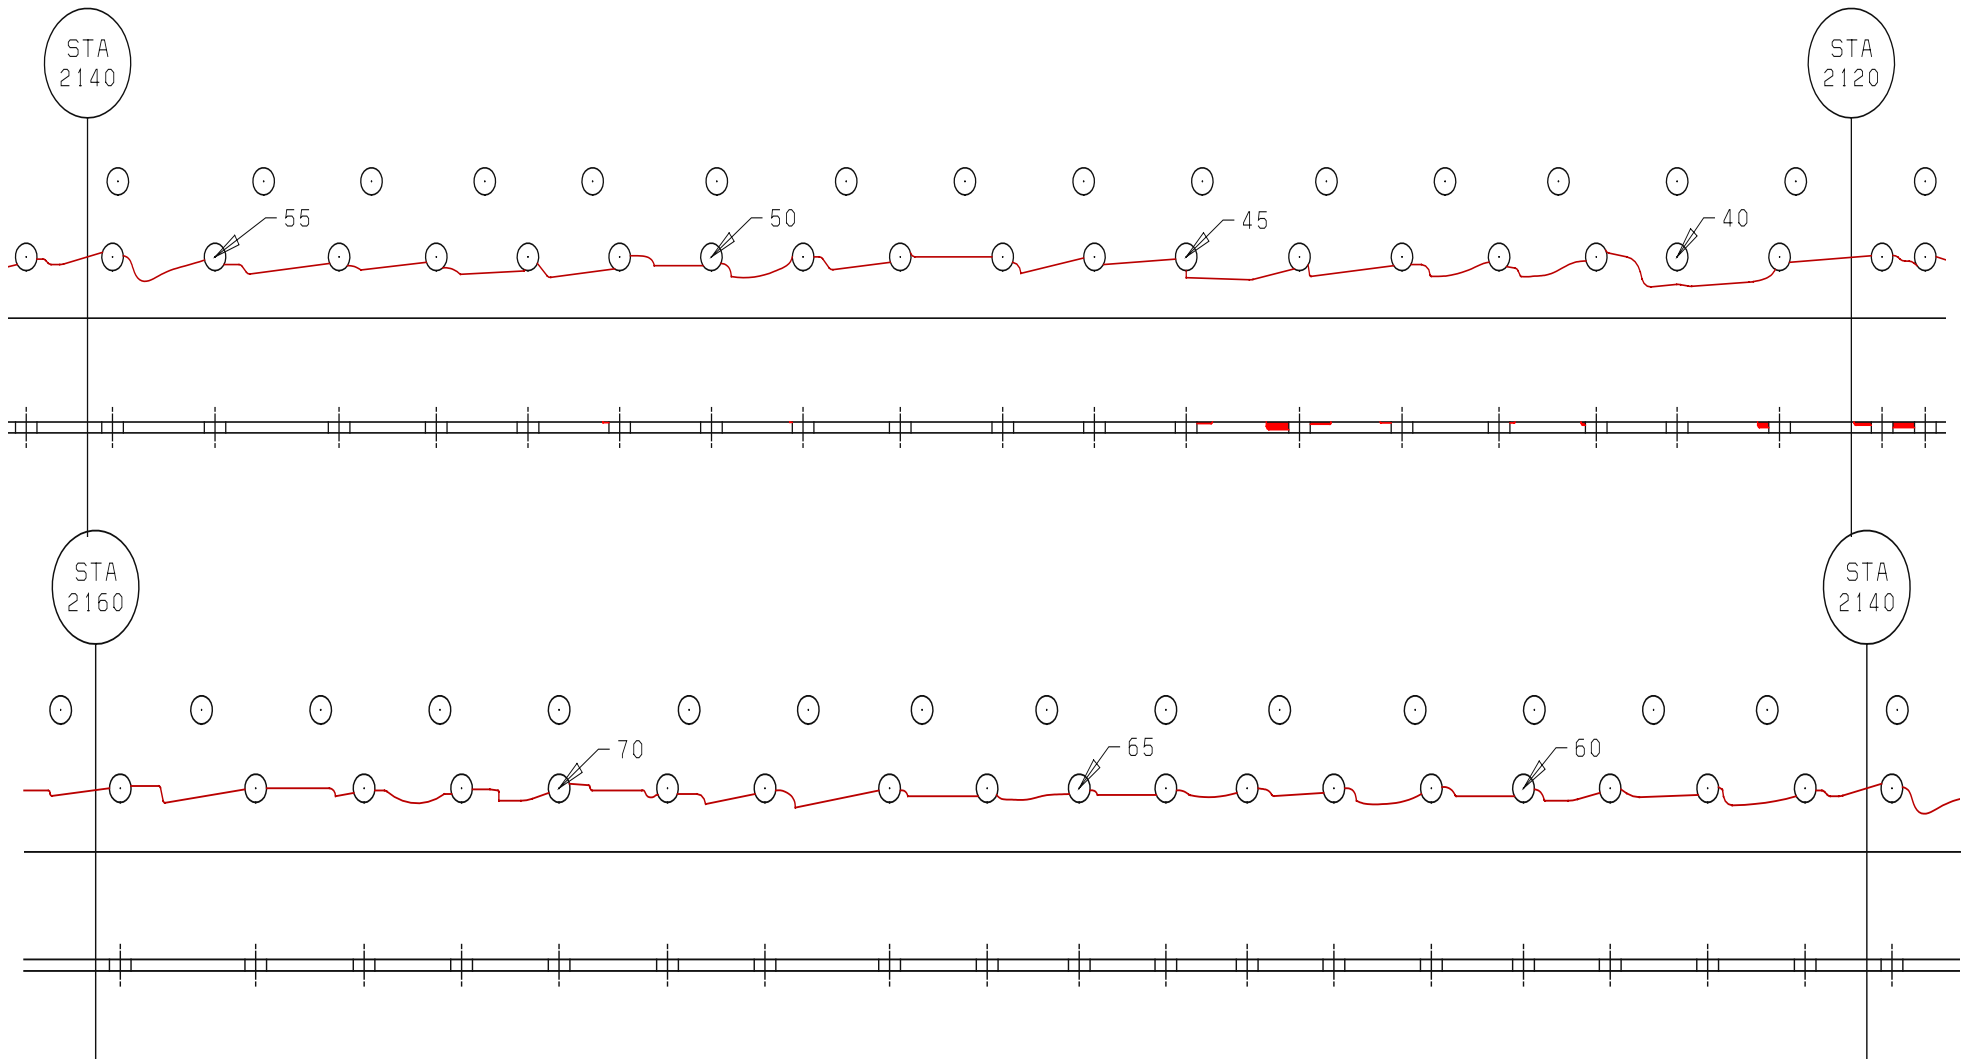
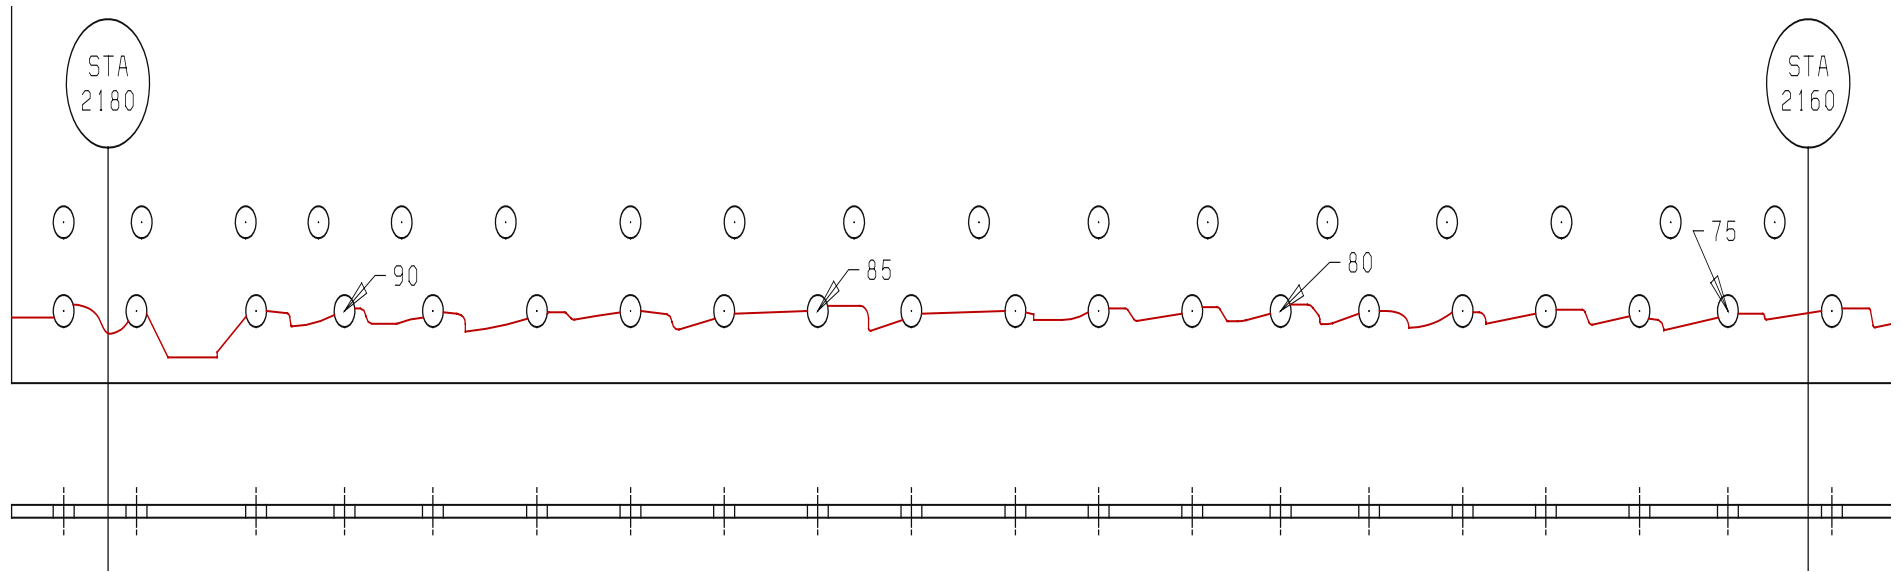
Figure 1.16-40 A detailed map of all fatigue cracks confirmed during examination at Boeing- STA 2120~2180

Figure 1.16-40 (Cont) A detailed map of all fatigue cracks confirmed during examination at Boeing- STA 2120~2180

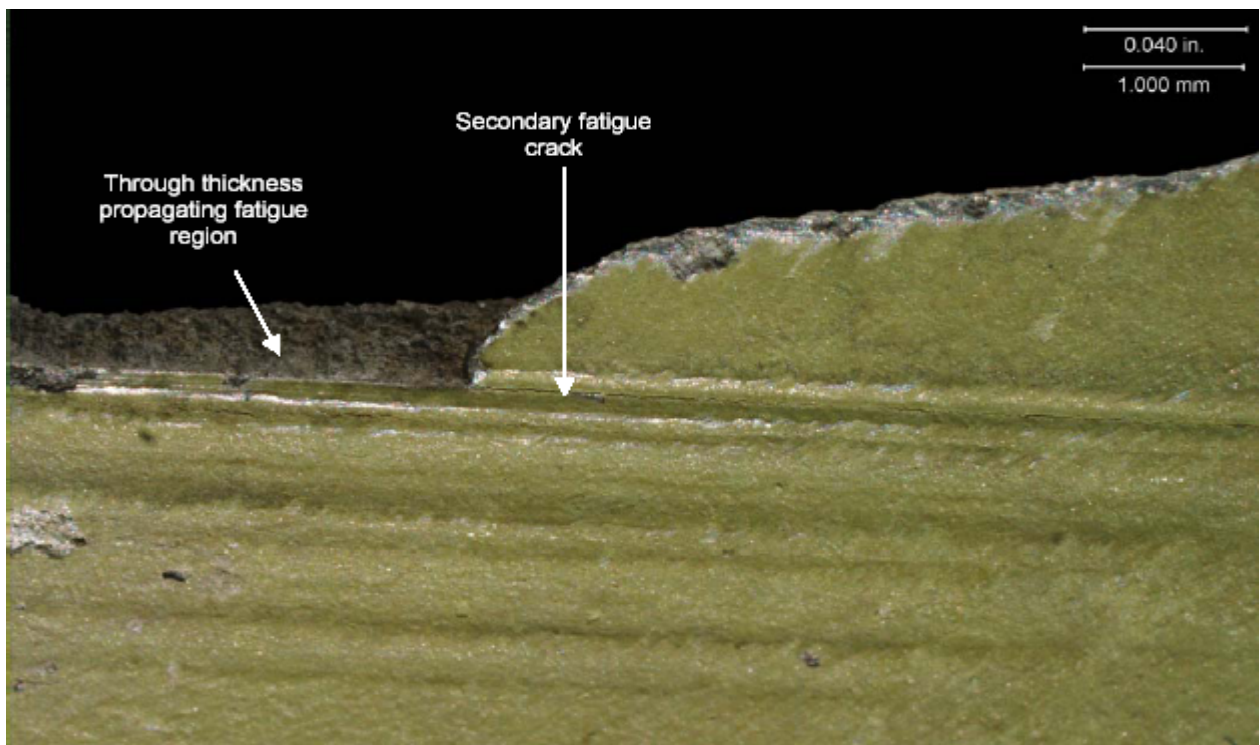
Figure 1.16-42 Surface of skin faying with repair doubler between hole 29 and hole 30 showing the longitudinal scratches in relationship to this fatigue crack. Note the secondary crack extending out of this common scratch.

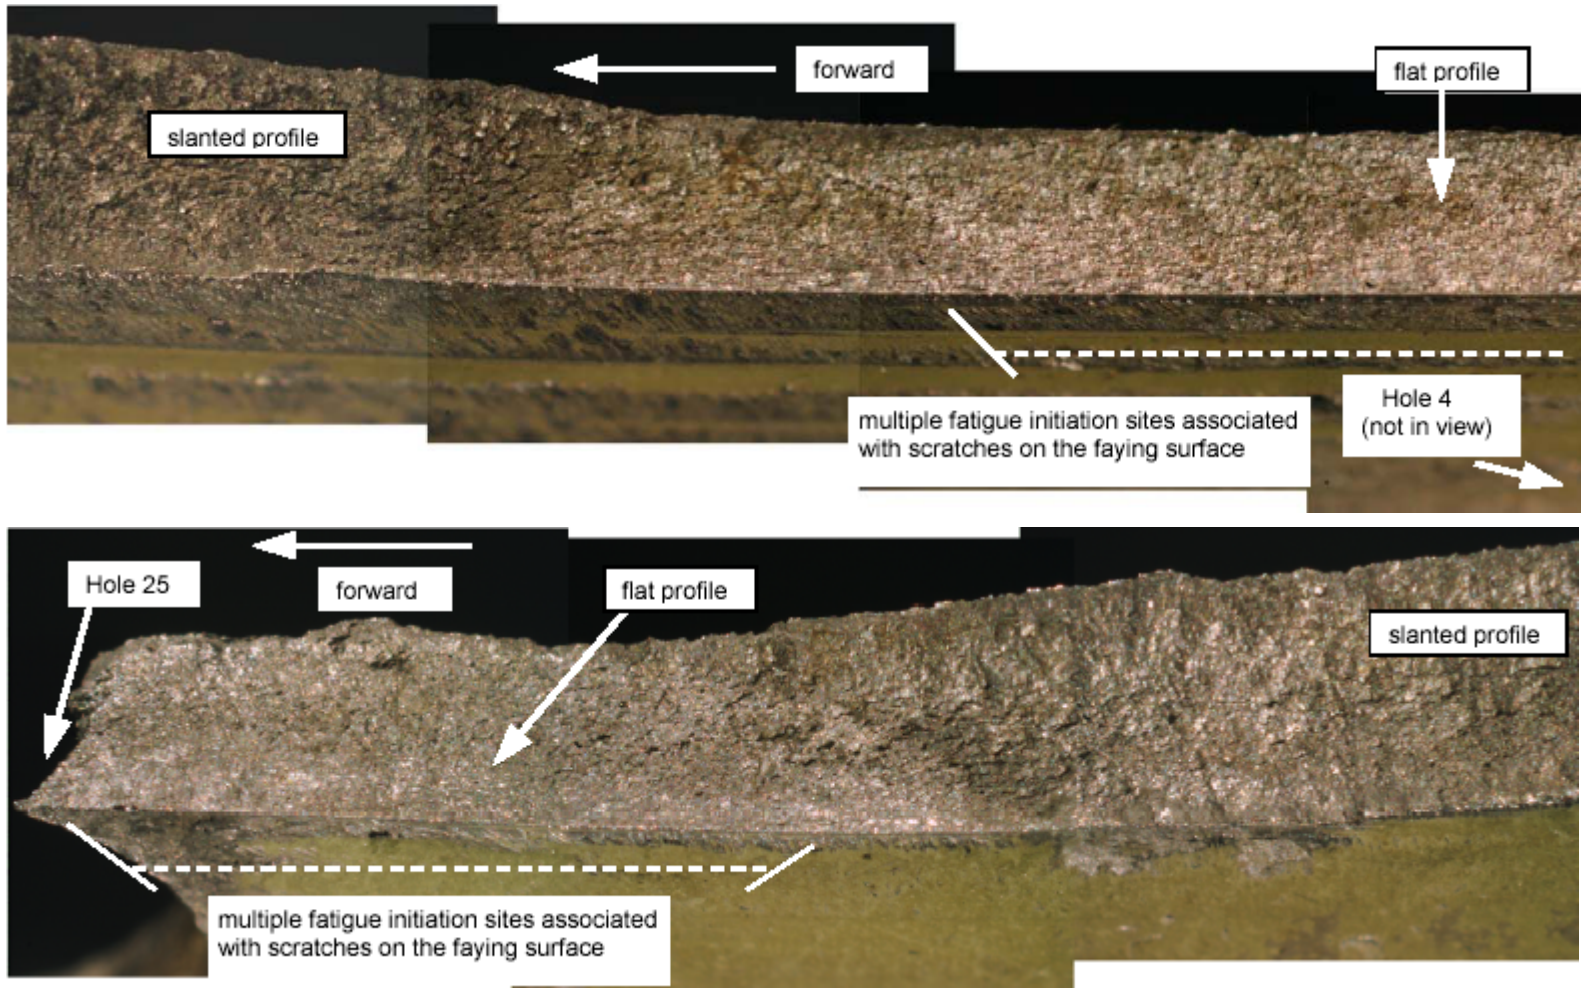
Figure 1.16-43 Photographs showing the transition regions from flat fracture profiles to slanted profiles just forward of fastener Hole 4 (top) and Hole 25 (bottom).

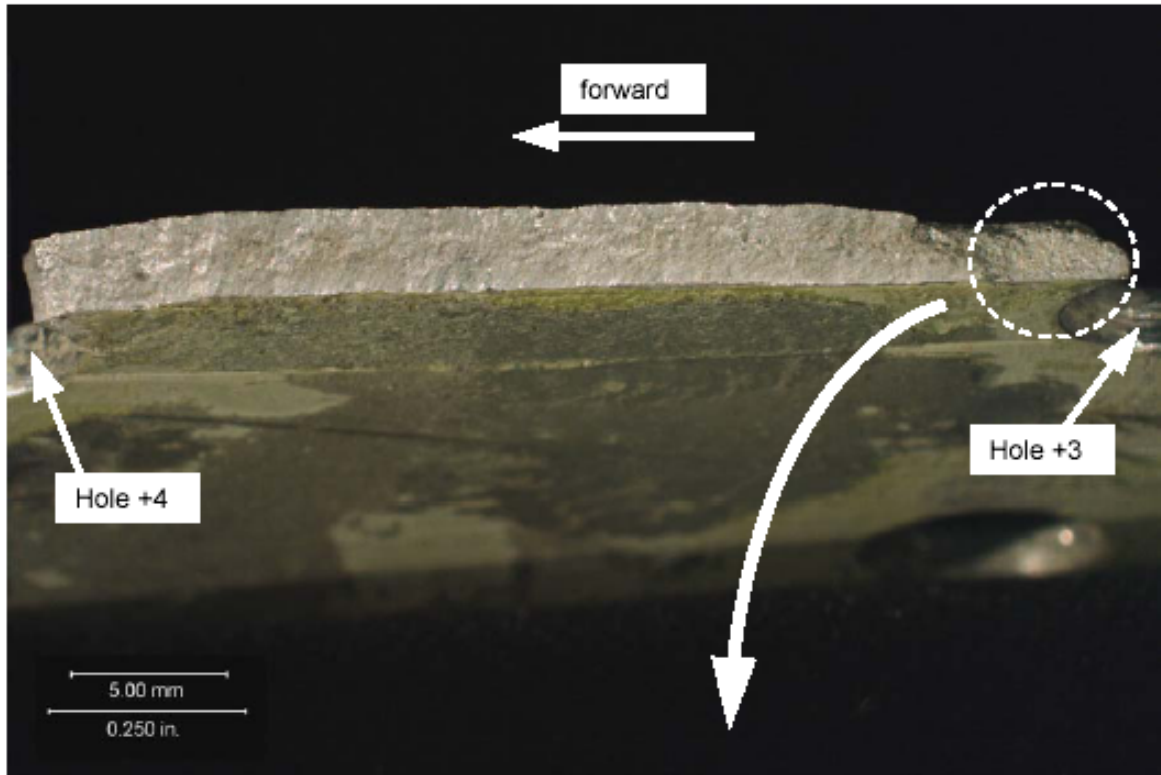
Figure 1.16-46 Photographs of the fracture segment extending from Hole +3 to +4 (top), and closer view of the flat profile fatigue region on the forward side of Hole +3 (bottom).

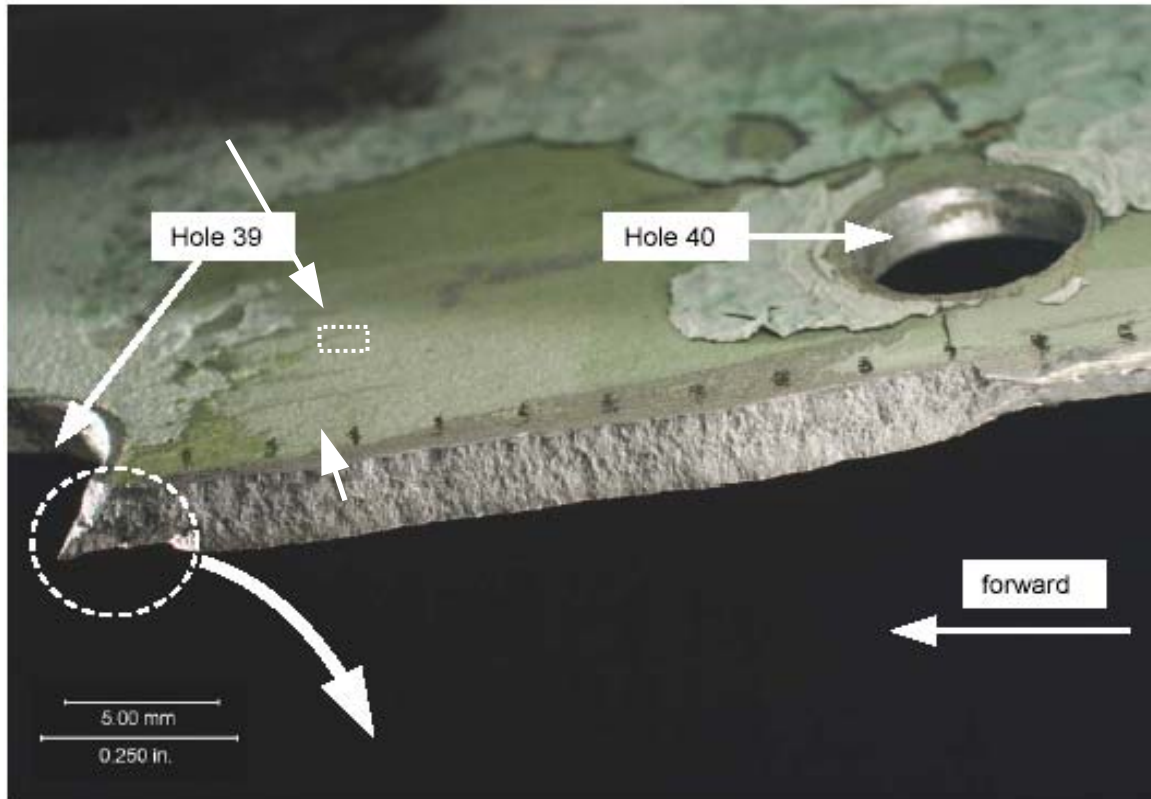
Figure 1.16-47 Photographs of the fracture segment extending from Hole 39 to 40 (top), and closer view of the flat profile fatigue region and short transition zone on the aft side of Hole 39 (bottom). SEM photographs showing an increase in striation spacing near the extent of the flat fracture thumbnail (indicated area) are shown below in Figure 1.16-48.

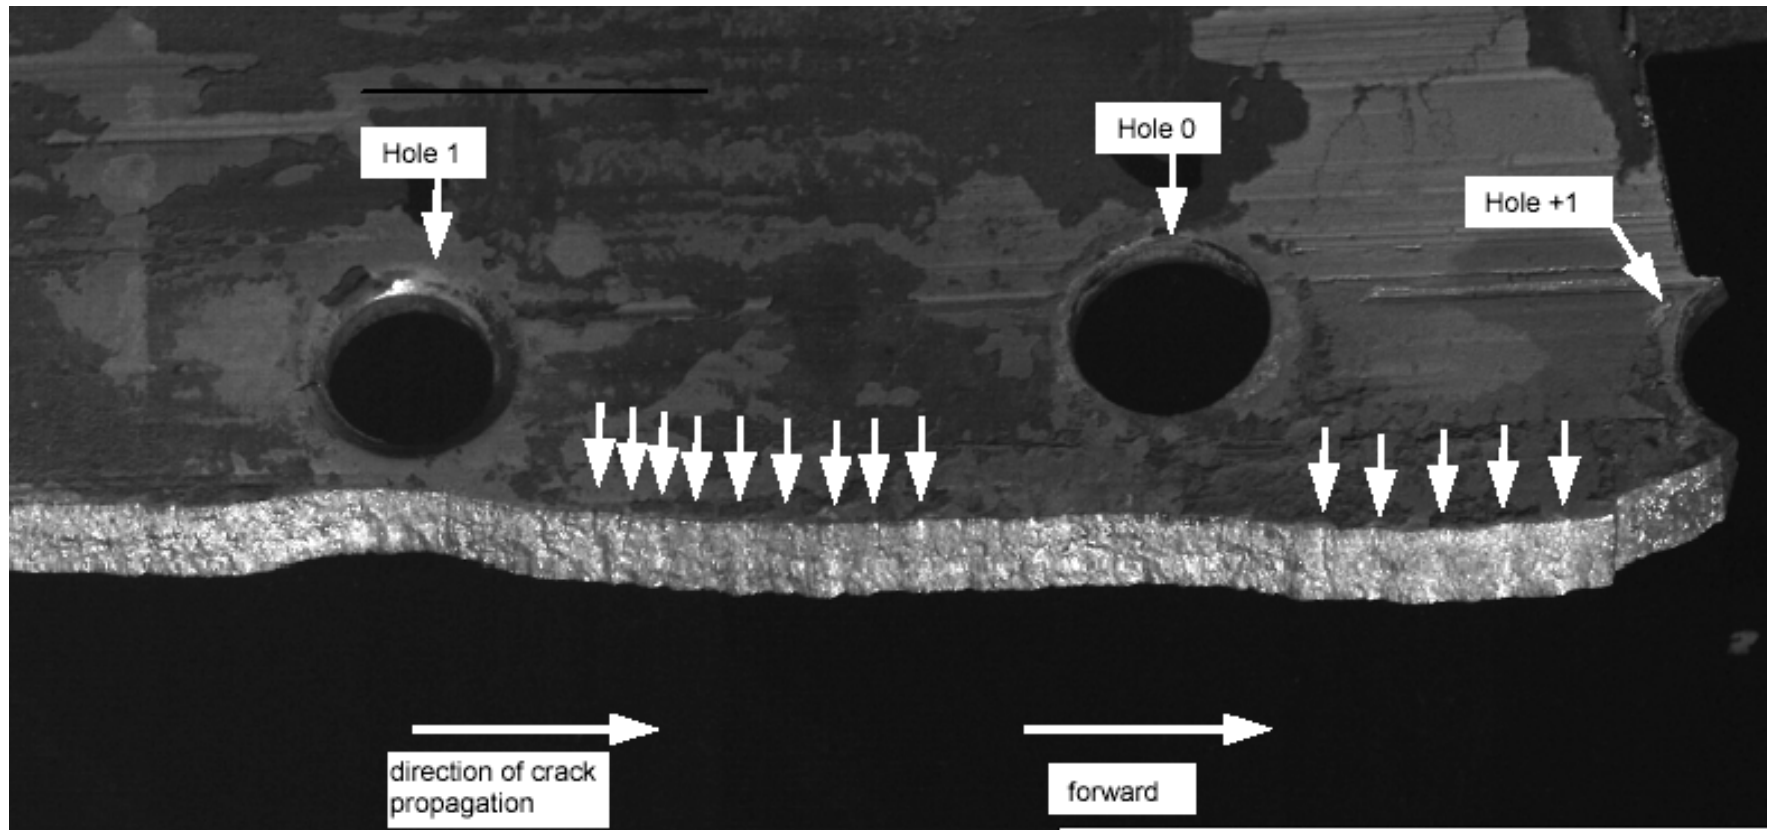
Figure 1.16-49 Photograph showing the incremental crack growth indications on the fracture segment from Hole 1 to Hole +1 with two groups of them identified with arrows. This area is just a few inches forward of the flat profile fatigue and transition areas of Hole 4 shown in Figure 1.16-21. Note that the regular spacing generally increases as the distance increases from the main cracking system at Holes 4 through 26

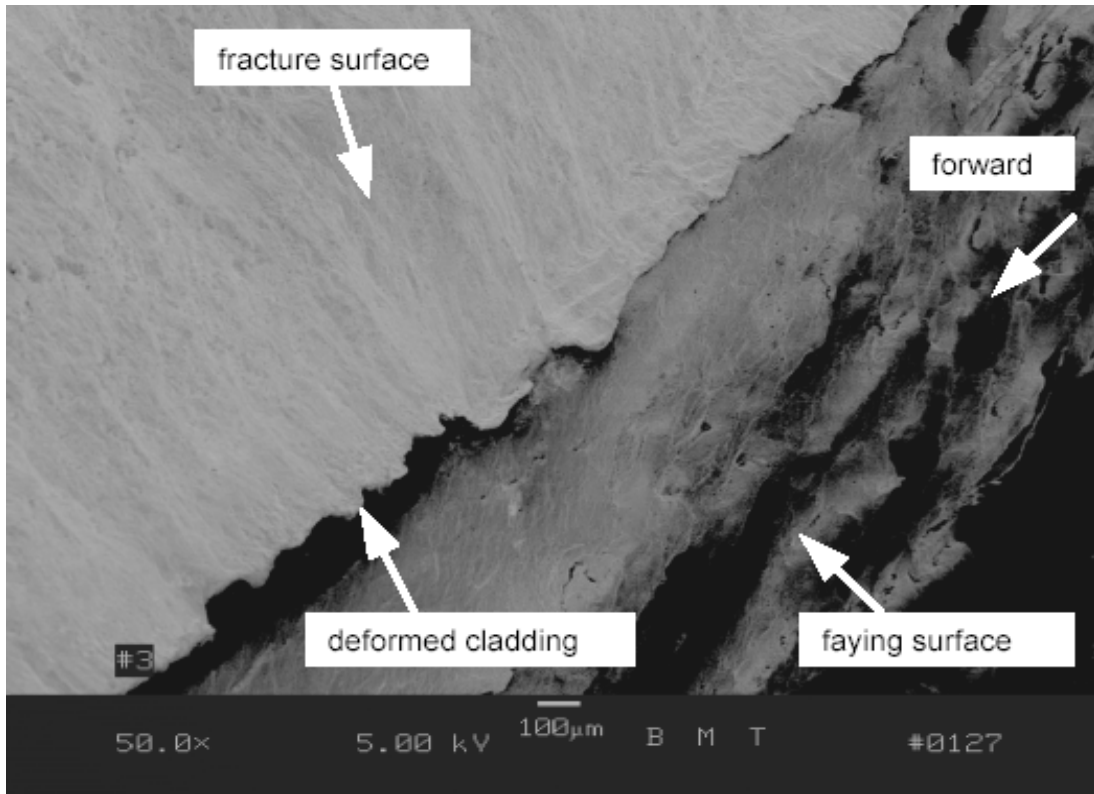
Figure 1.16-53 Scanning electron microscope photograph along the edge of the fracture common to the faying surface where the aluminum cladding remained near Hole 3. The fracture surface profile was slanted here.

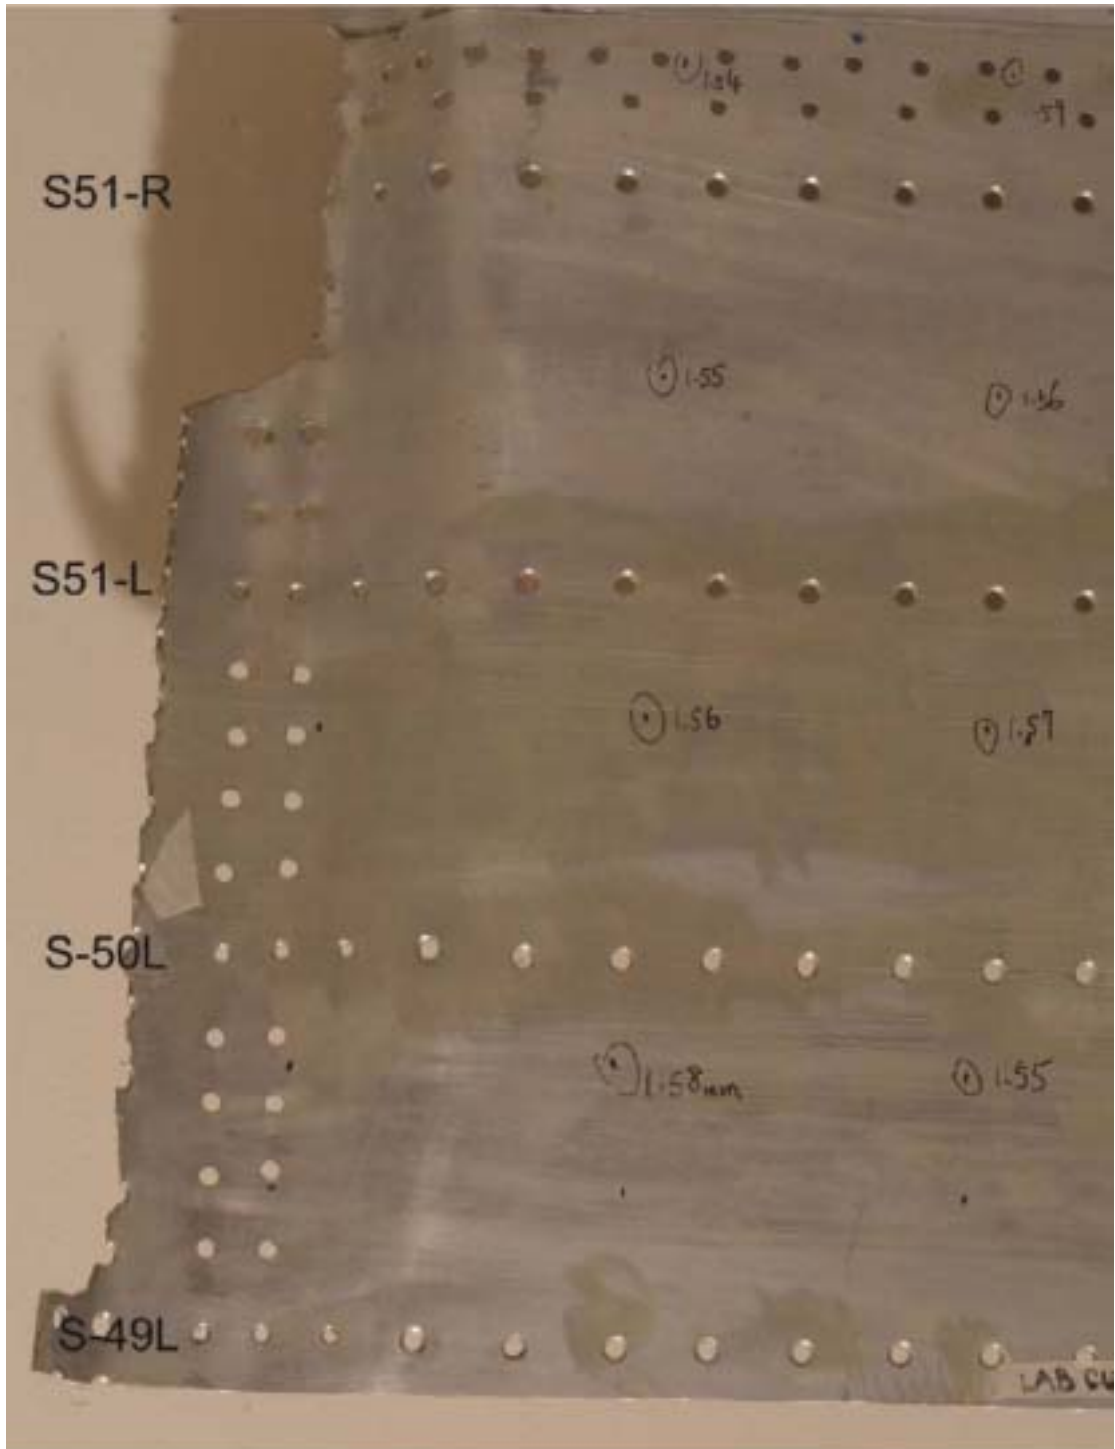
Figure 1.16-62 Extent of damage consistent with a tail strike– Scratches may be noted at S-50L and S-51L. Numerical information on skin are results of thickness measurements at the CSIST. Scratch severity increases as you move forward on the panel as shown in the following photographs.

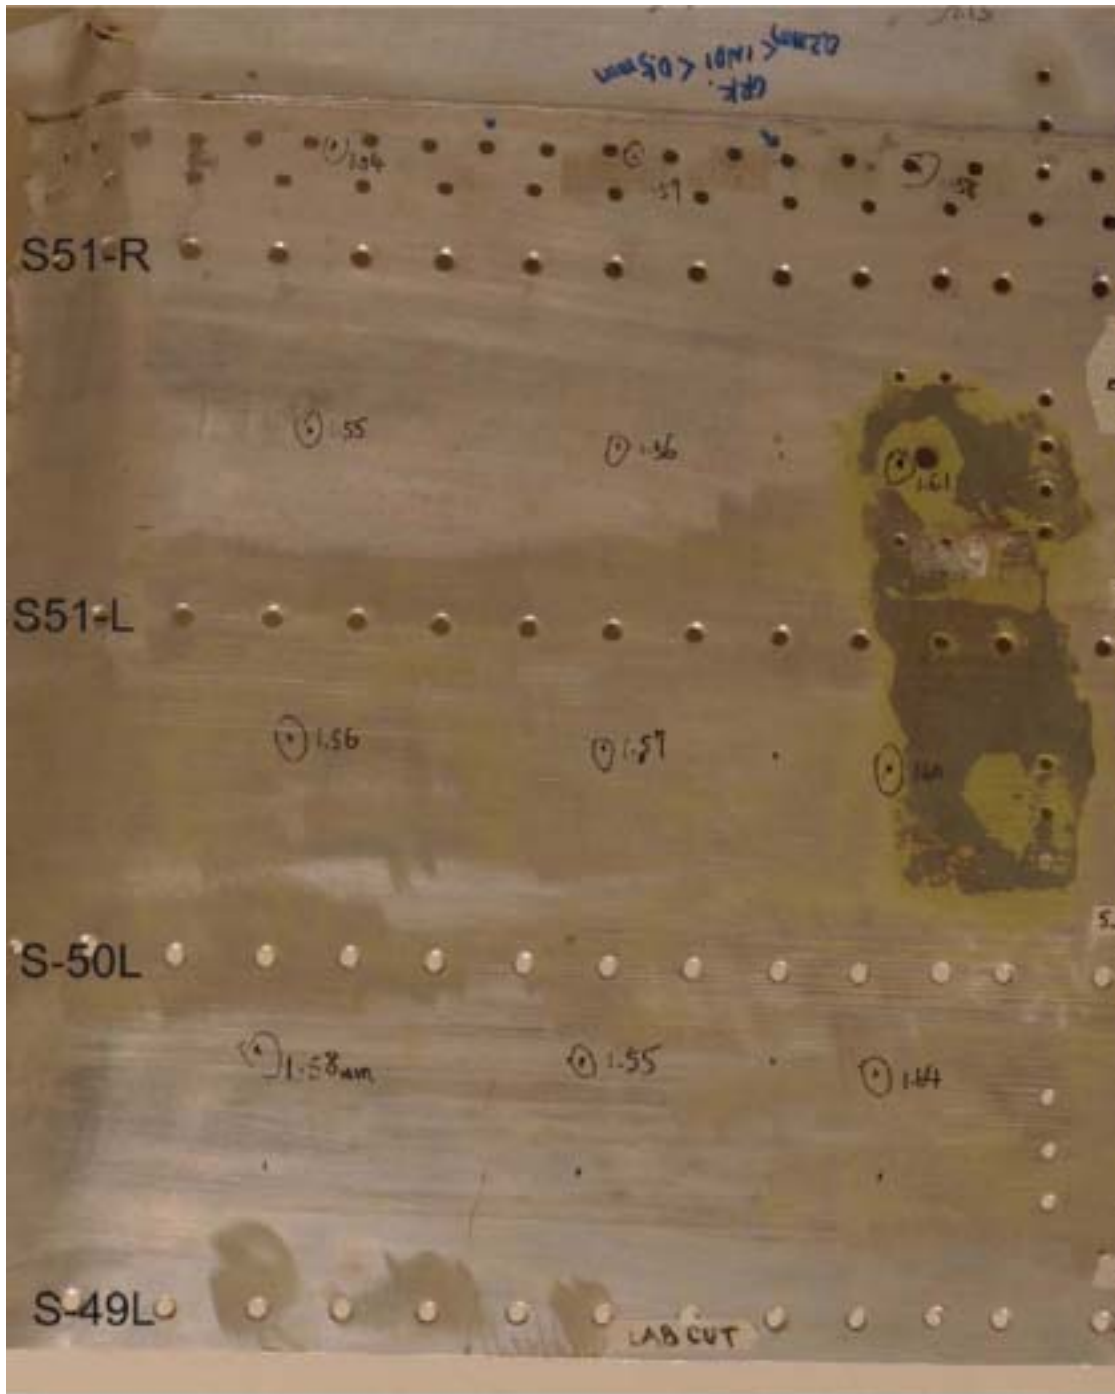
Figure 1.16-63 Extent of damage consistent with a tail strike– Scratches may be noted at S-50L and S-51L. Scratches may also be noted at the shear tie between S-49L and S-50L.

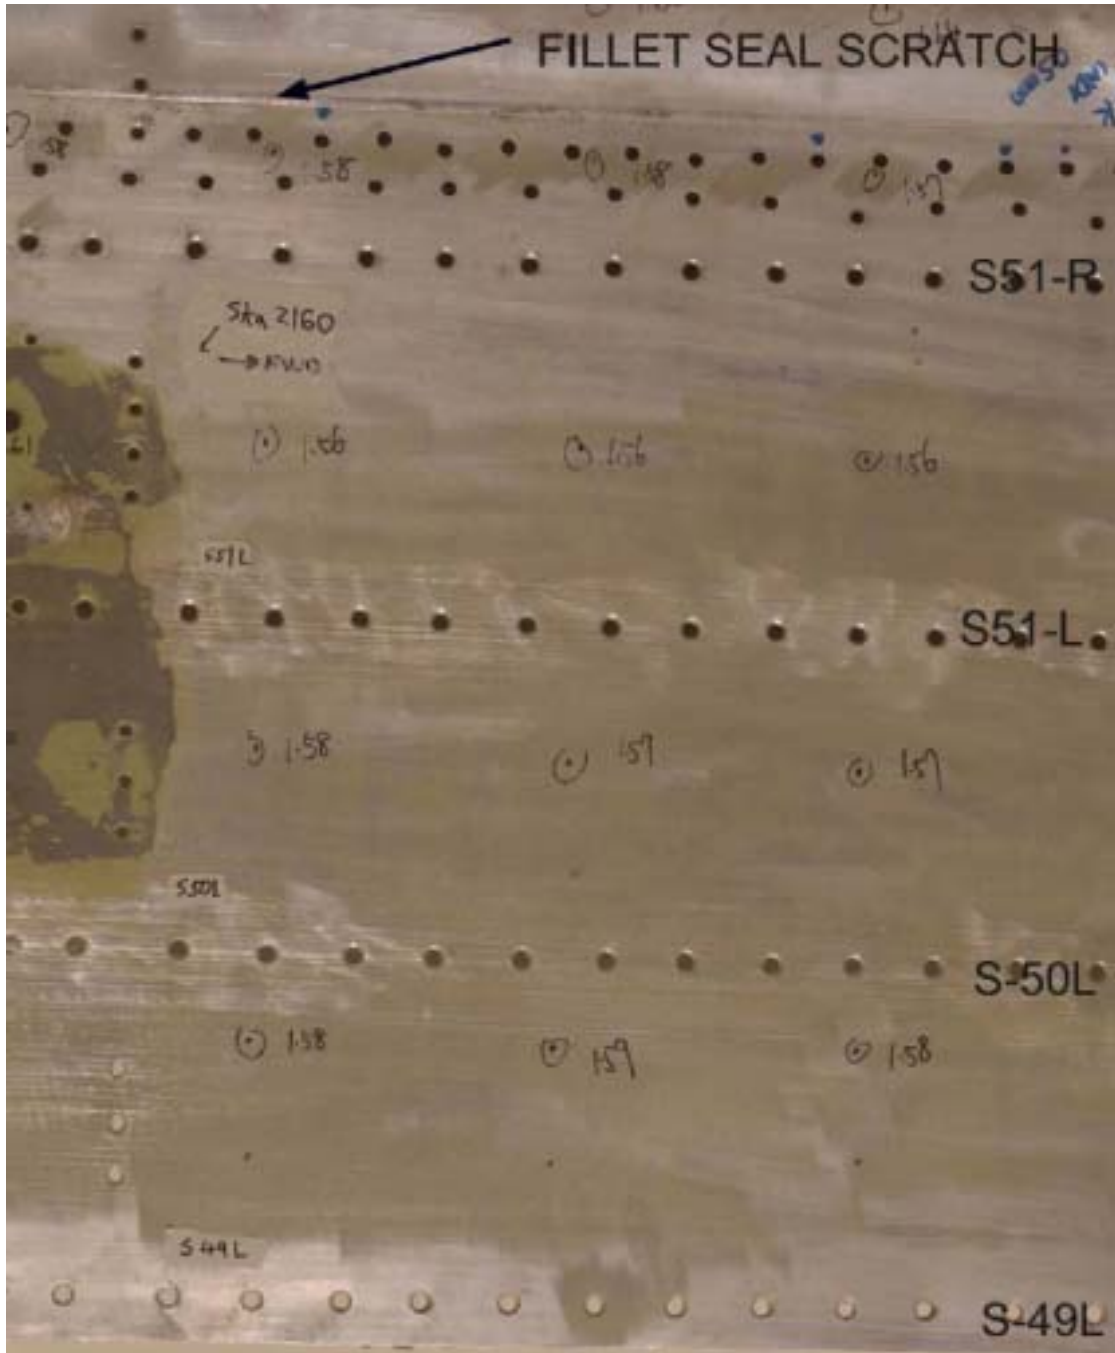
Figure 1.16-64 Extent of damage consistent with a tail strike- Note that minimal damage occurs on the right hand side of the repair area. Scratching in the doubler fillet seal area may also be seen in this photo.
