**Aviation Safety Council
Taipei, Taiwan**

**CI611 Accident Investigation
Factual Data Collection
Group Report**

Structure Group

ASC-AFR-03-06-001

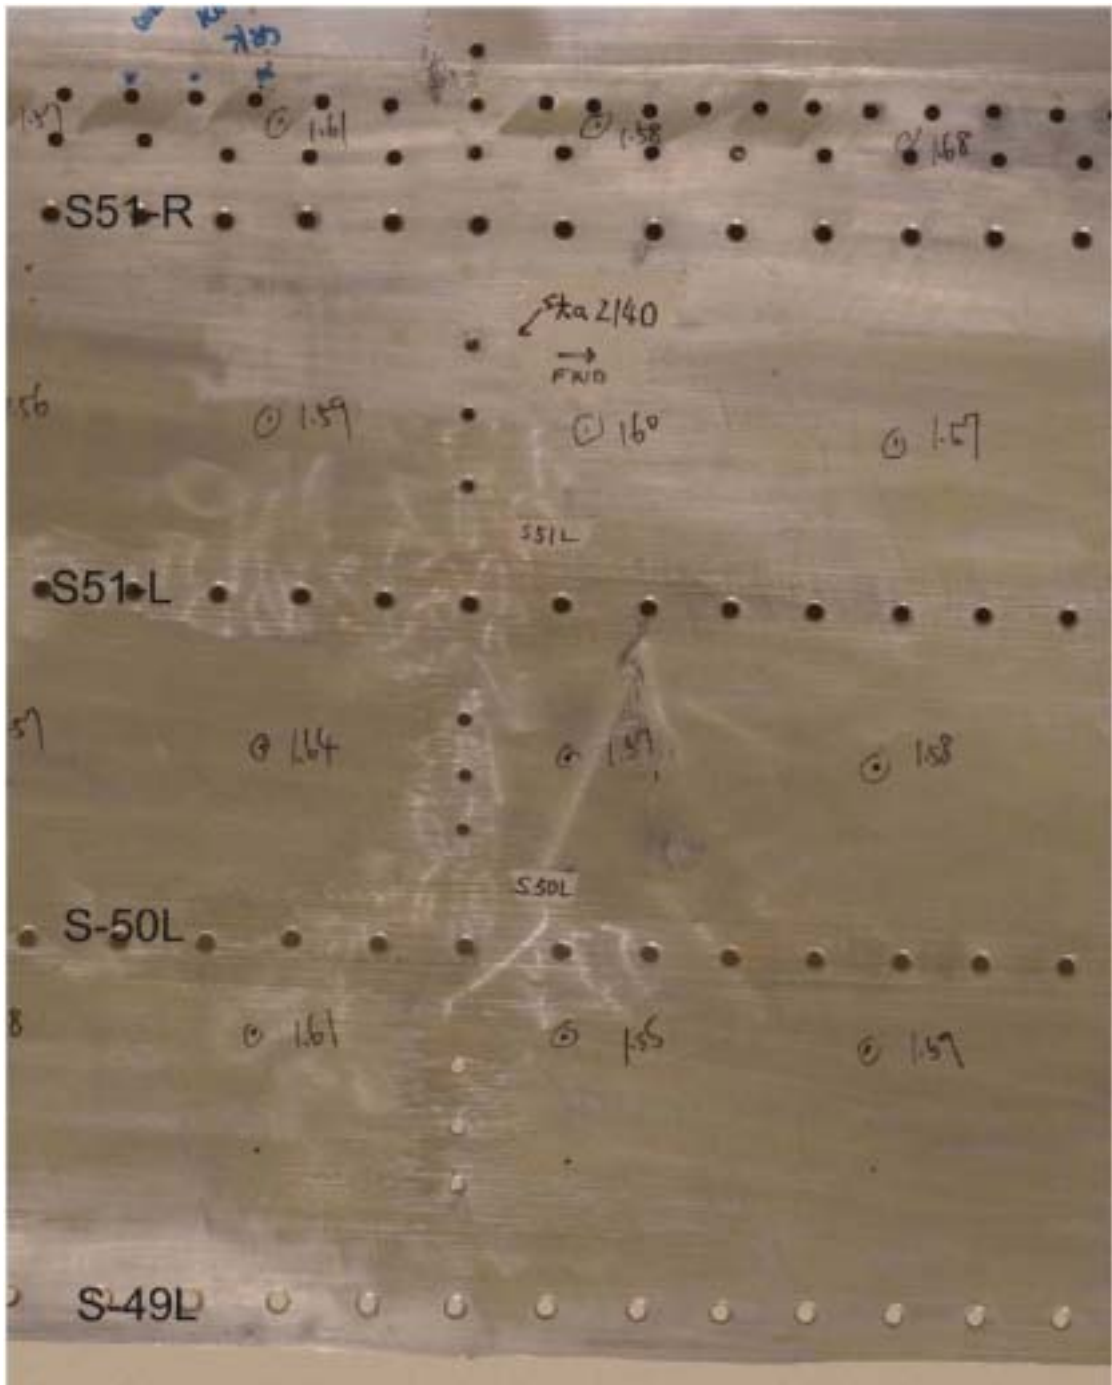
Figure 1.16-65 Extent of damage consistent with a tail strike

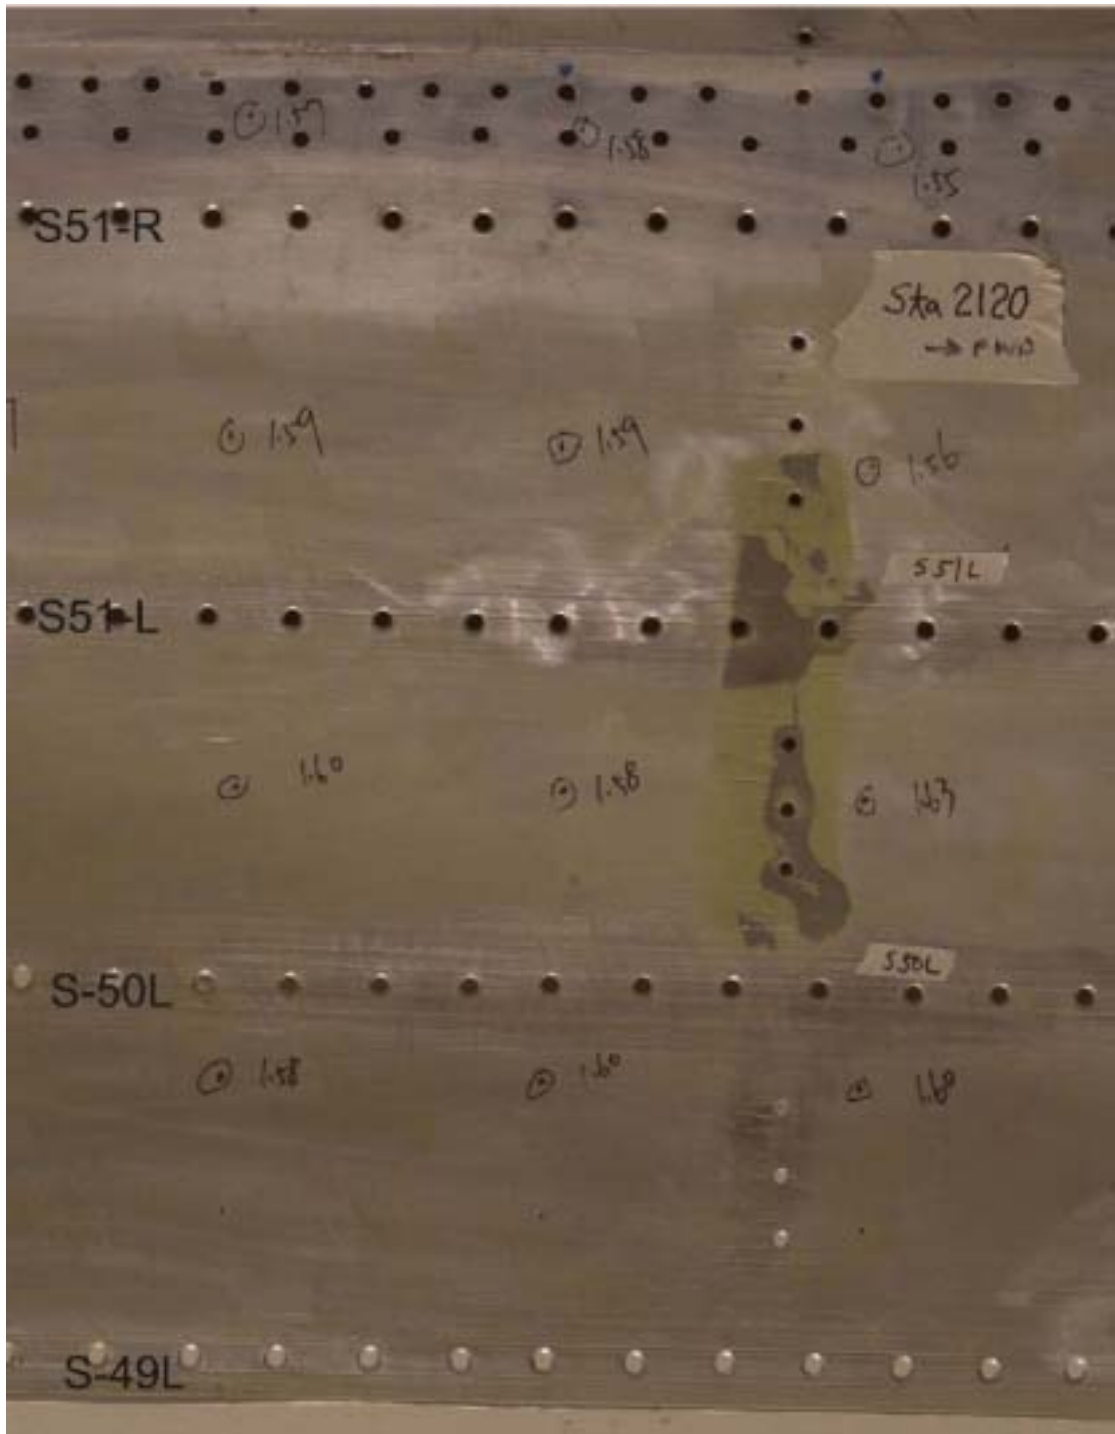
Figure 1.16-66 Extent of damage consistent with a tail strike- Deep scratches can be noted at S-49L, S-50L, AND S-51L.

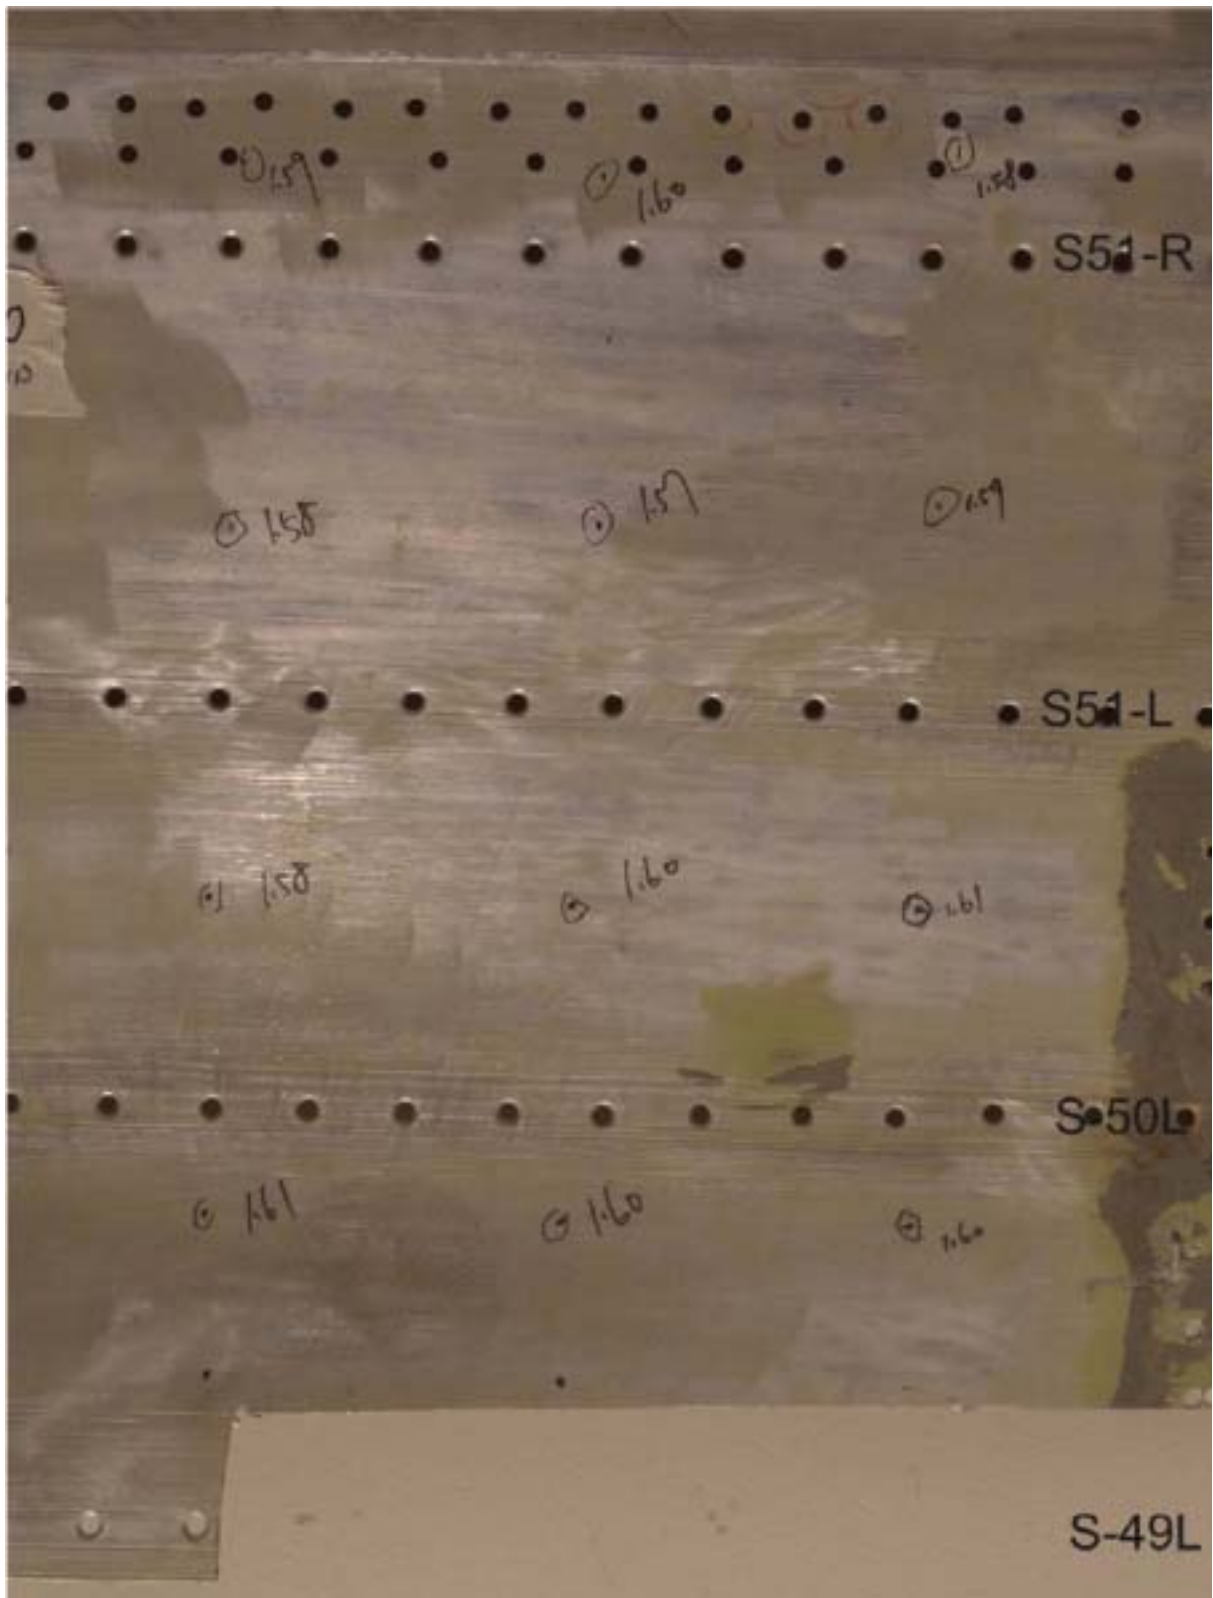
Figure 1.16-67 Extent of damage consistent with a tail strike

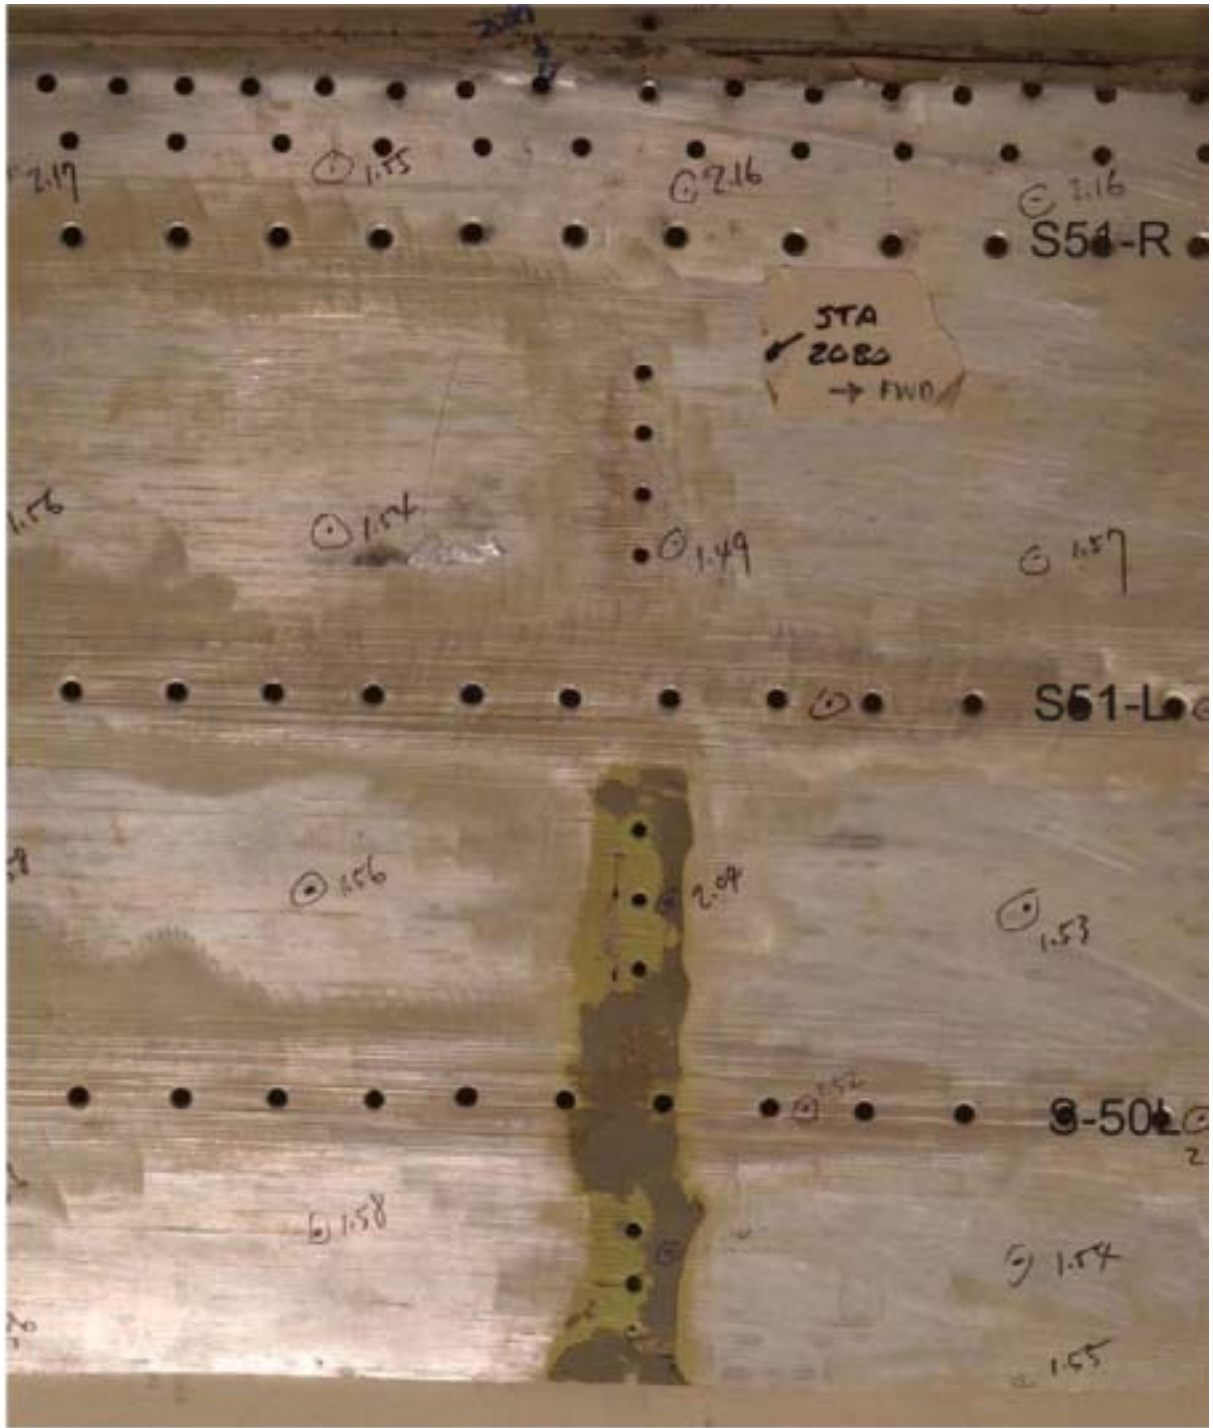
Figure 1.16-69 Extent of damage consistent with a tail strike- Note the severity of damage in this photo

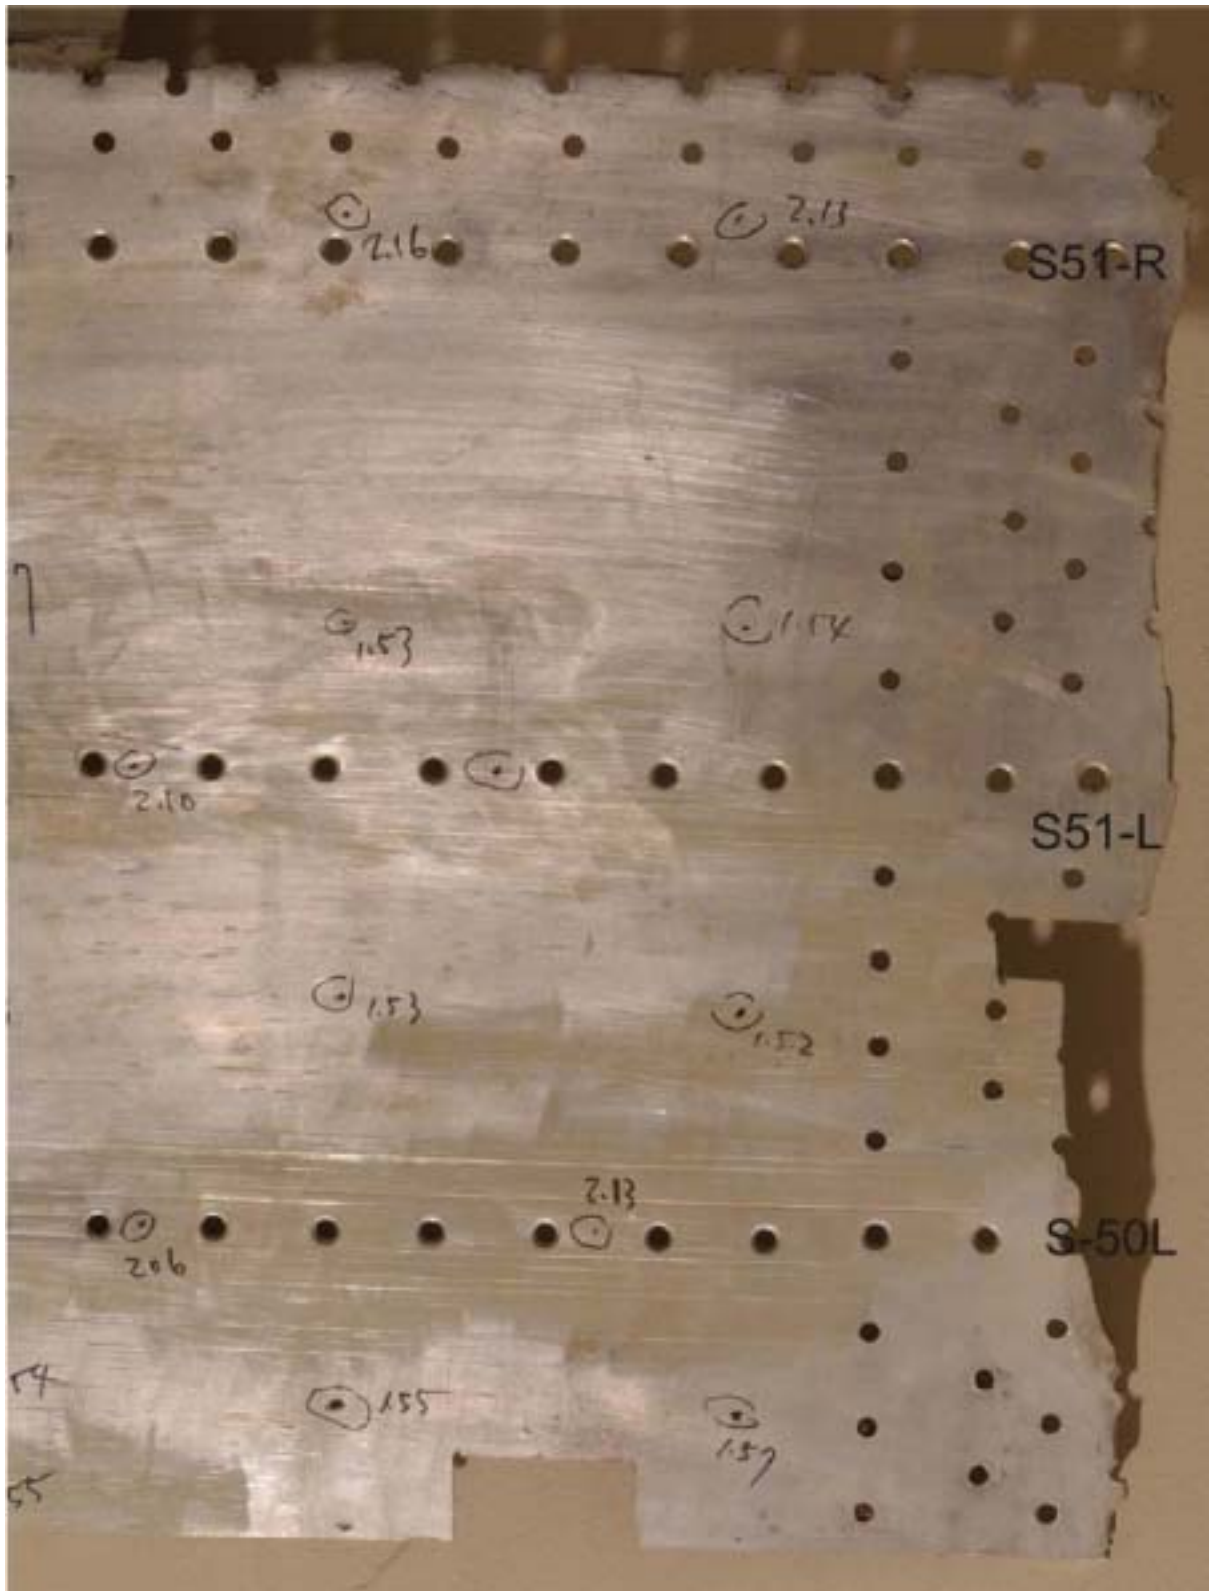
Figure 1.16-70 Extent of damage consistent with a tail strike

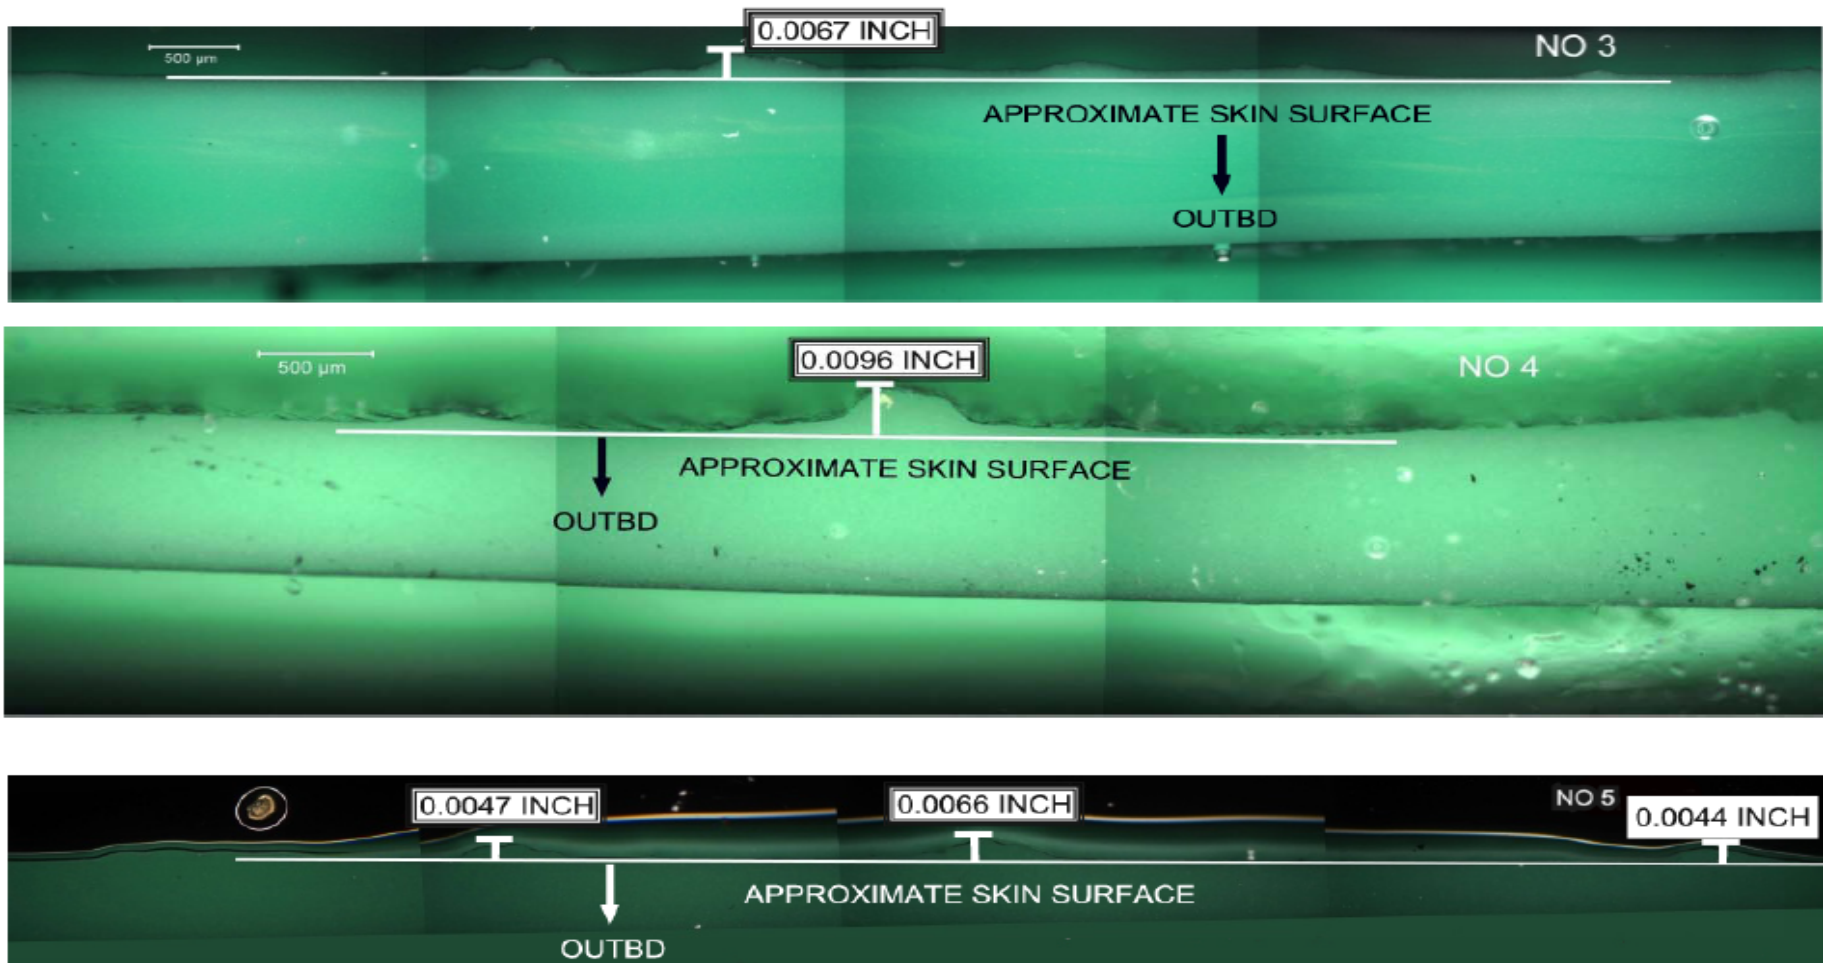
Figure 1.16-74 Scratch profile composite photographs– Shown above are replicas from locations 3,4, and 5. Location 4 presented the deepest scratch found using this technique

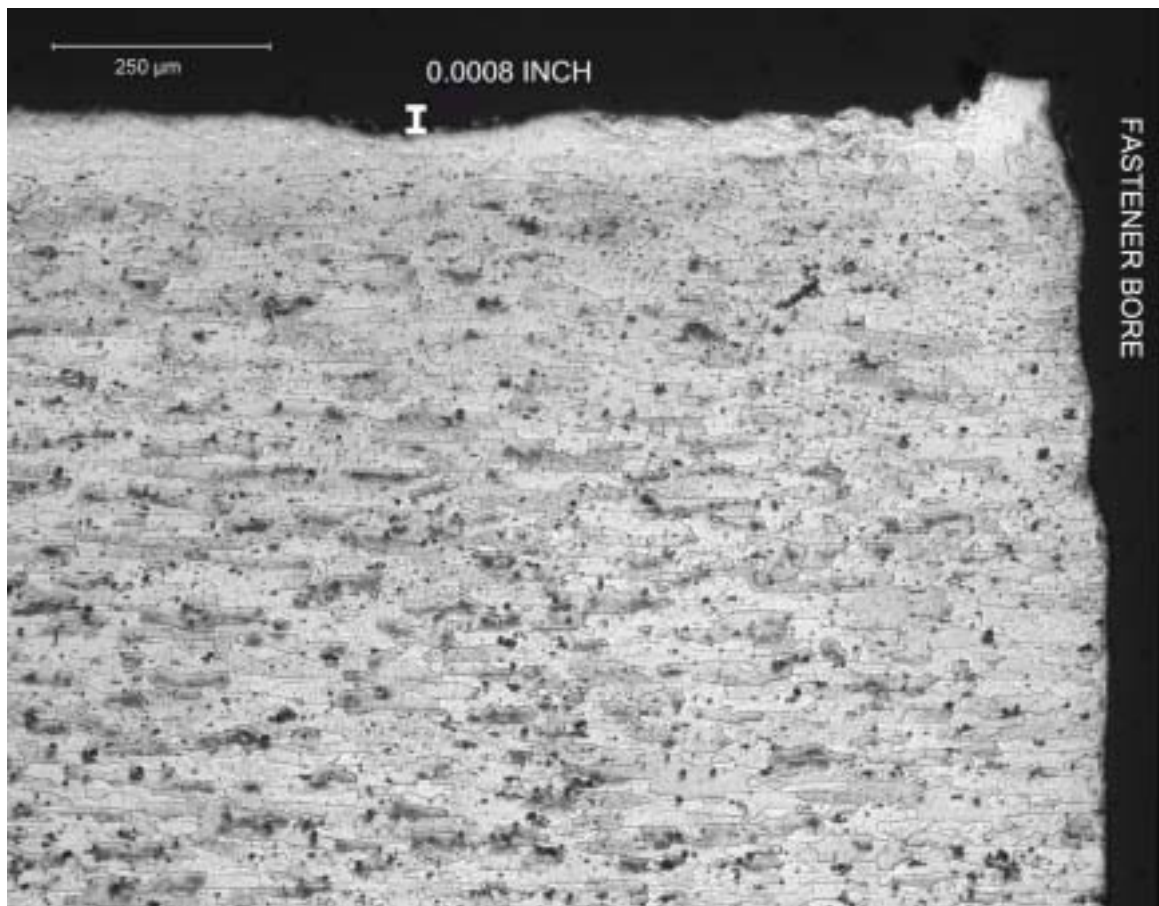
Figure 1.16-93 OUTER FASTENER ROW SCRATCH FEATURES AT PLANE A-A – Skin damage at this location was much less severe than on the left hand side of repair doubler. Skin cladding was not compromised by surface damage in this view.

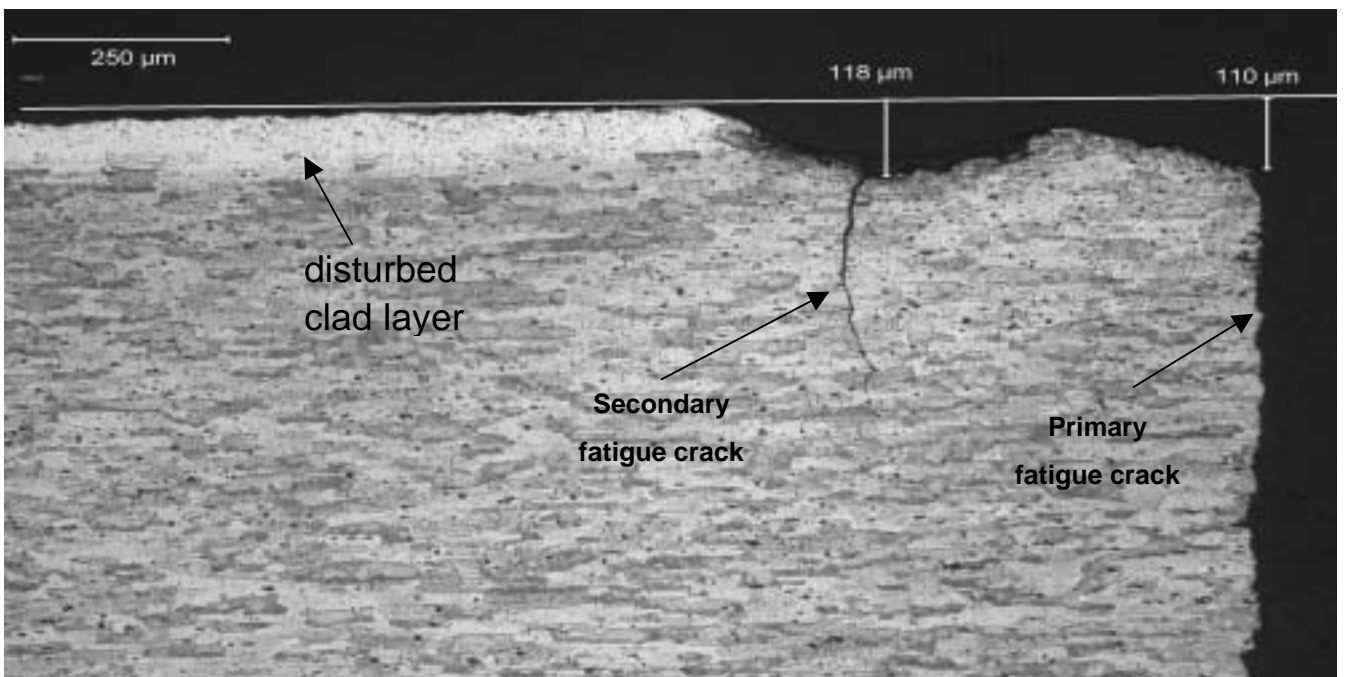
Figure 1.16-96 Metallographic specimen through the area indicated in Figure 1.16-73 above. The line shown was projected back to an area of undisturbed clad material to determine the depth of the scratches at the primary and secondary fatigue cracks present in this area.

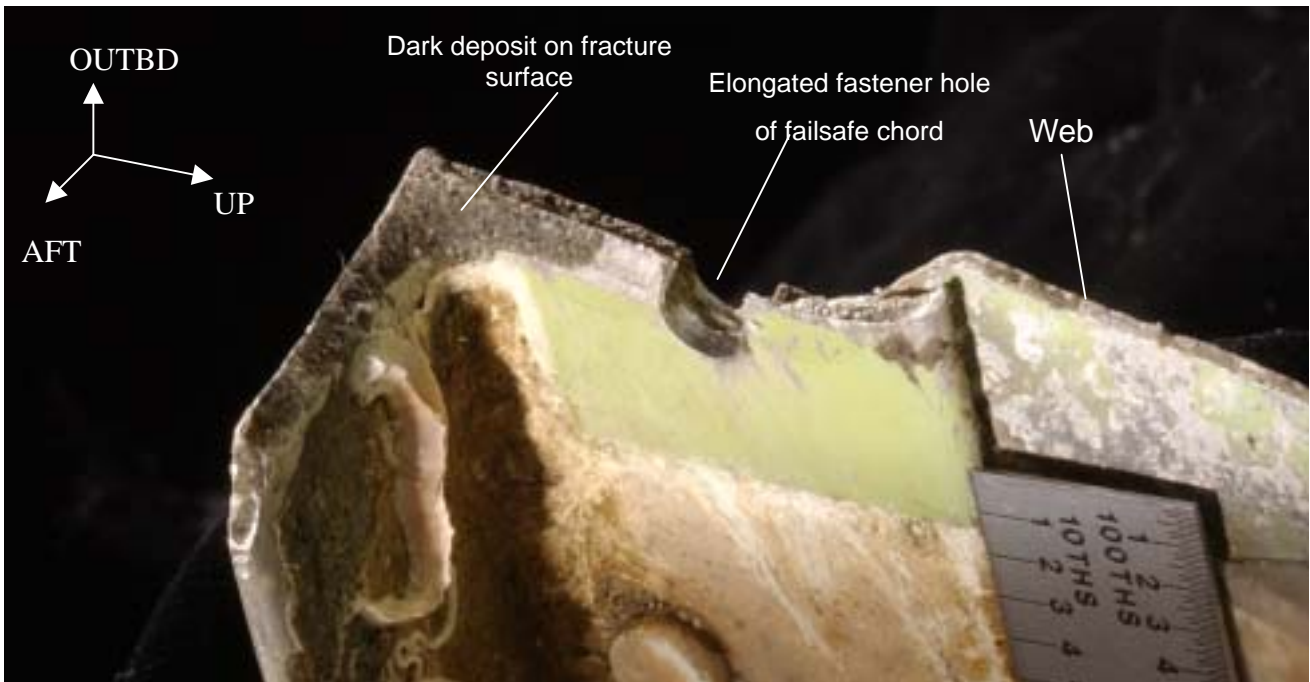
Figure 1.16-116 Fracture surface of failsafe chord and web common to S-49L of the STA 2060 frame segment.

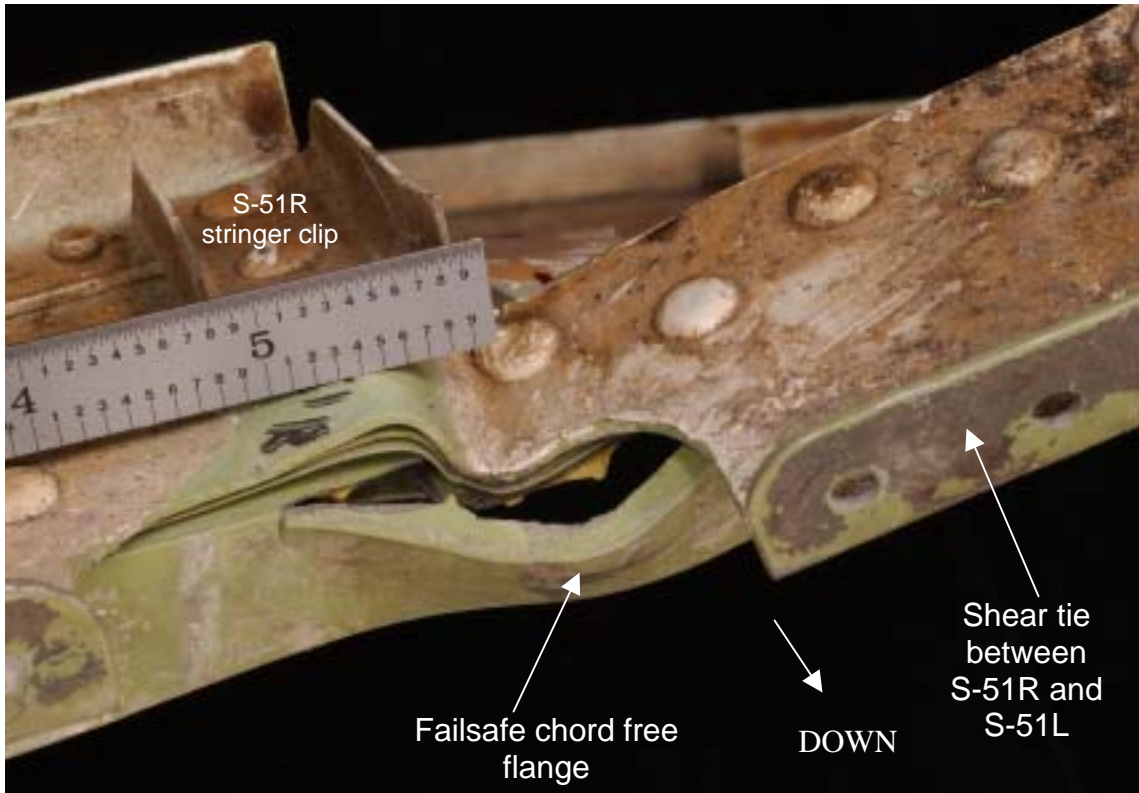
Figure 1.16-120 Fracture in failsafe chord free flange radius at S-51R of the STA 2040 frame segment.

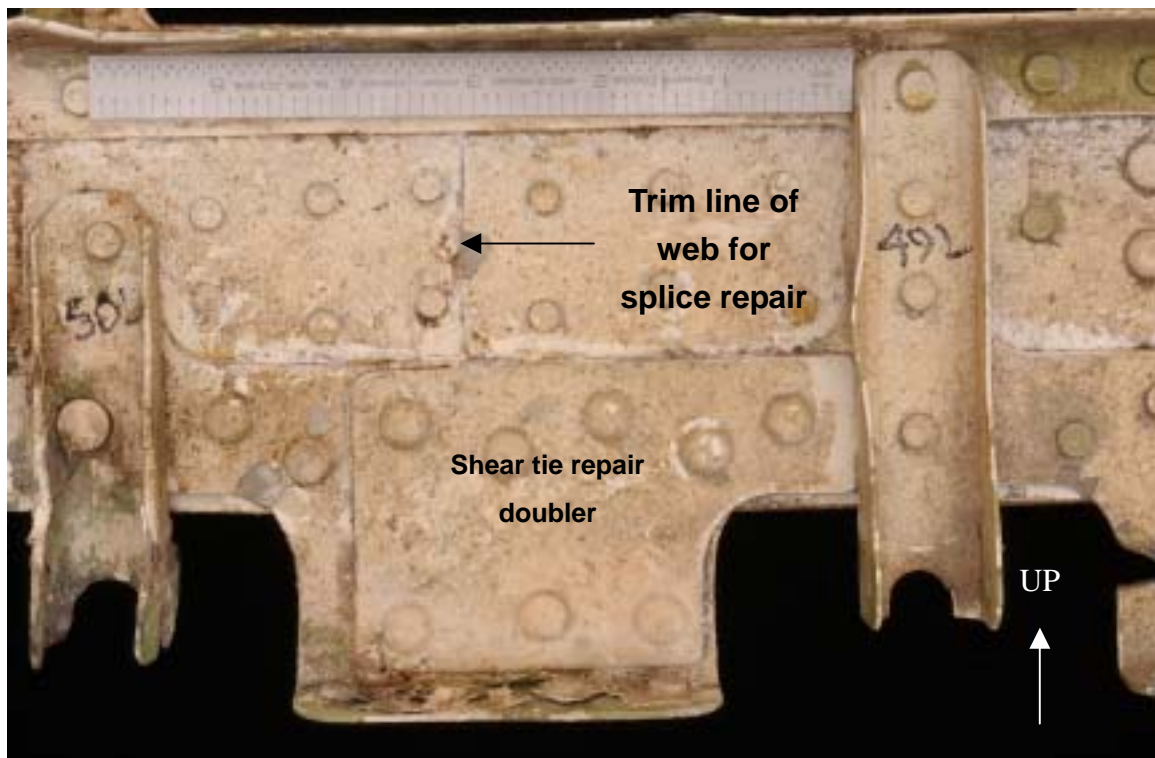
Figure 1.16-125 STA 1940 frame segment showing the shear tie repair doubler and web splice repair at the location between S-50L and S-49L.

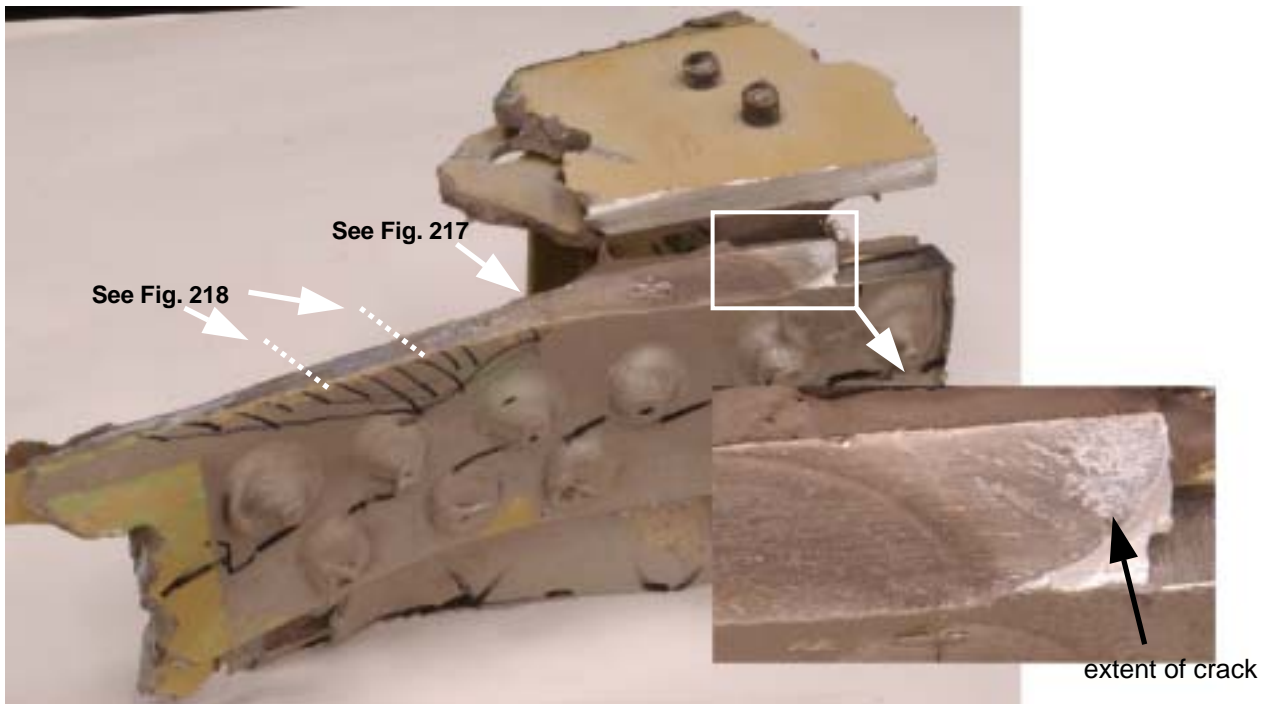
Figure 1.16-216 Photograph showing the discolored fracture of the upper chord after opening the extension of the crack and the locations shown in Figures 5 and 6, where the fracture was characterized on the mating portion by SEM and metallography.
