**Aviation Safety Council
Taipei, Taiwan**

**GE791 Accident Investigation
Factual Data Collection
Group Report**

Recorders Group

ASC-GRP-03-10-001

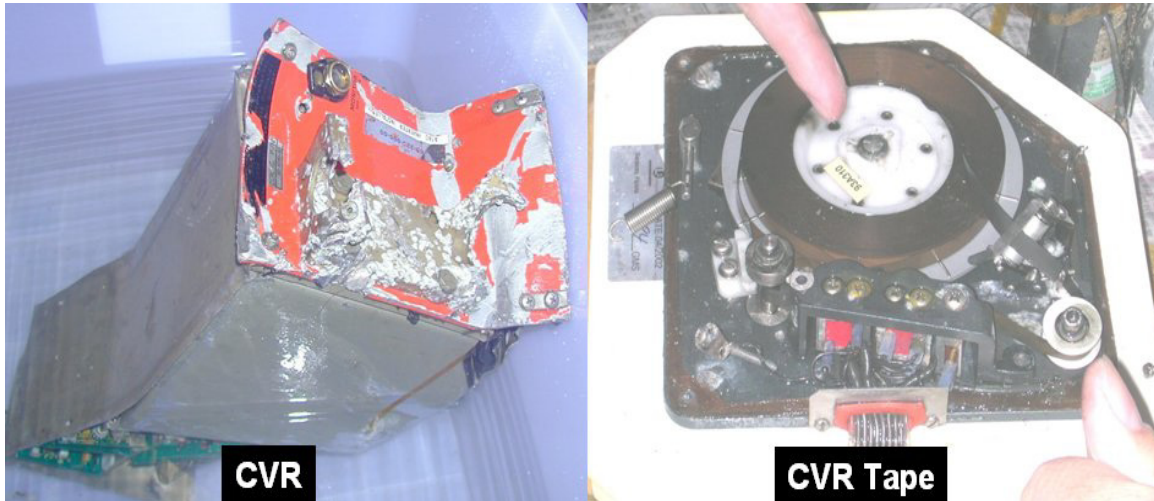
The exterior of the CVR unit was seriously damaged when it was found. The protective dust cover was separated from the unit. The front panel, without the underwater locator beacon (ULB) and nameplate, was seriously distorted but still attached to the chassis. It arrived ASC lab in a container filled with fresh water. There were several dents and scratches on the interior crash enclosure. The recording assembly appeared to be in good condition except several damages on the plastic reel. The magnetic tape was wet and remained in its original positions without damage. Discoloration and dirt were found on the tape.

Figure1.11-1 Damage of the CVR and the tape

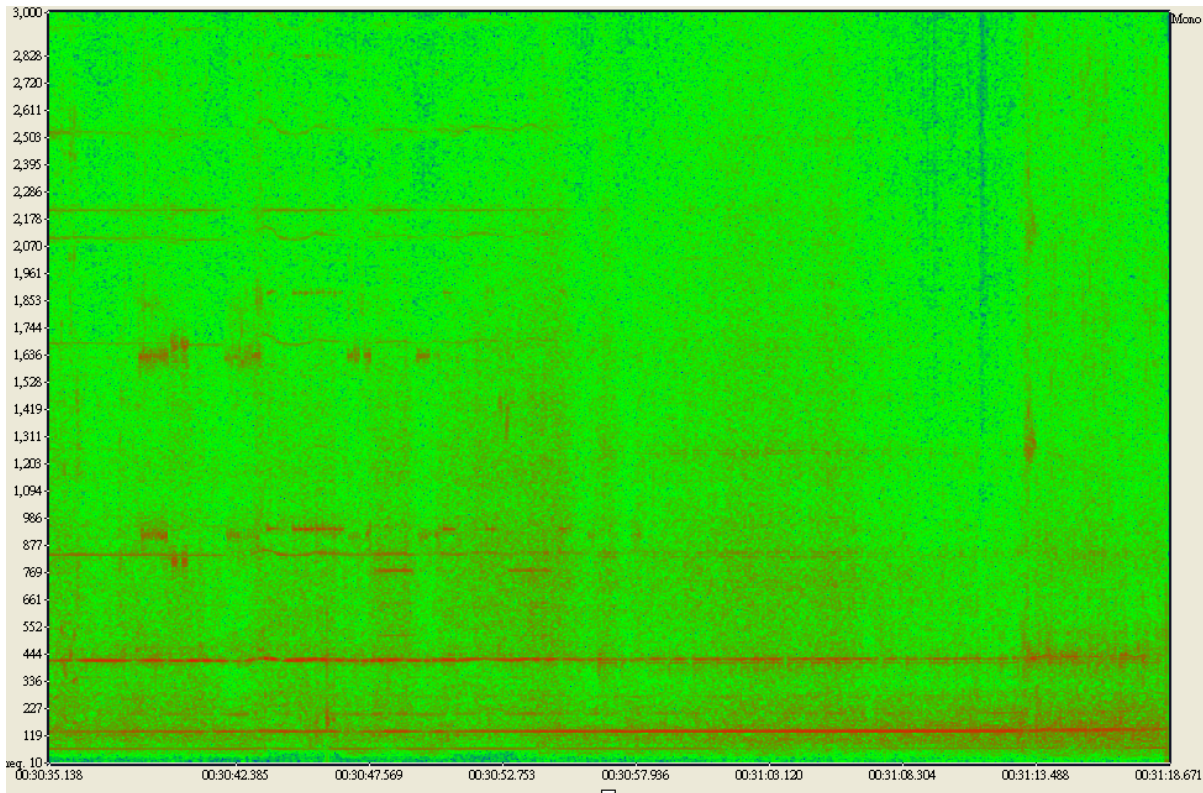
The spectrum of the last 39.76 seconds recording from 30:38.67 to 31:18.43 was shown as Figure 1.11-2.

Figure1.11-2 Spectrum of CVR recording from CVR time 30:38.67 to 31:18.43

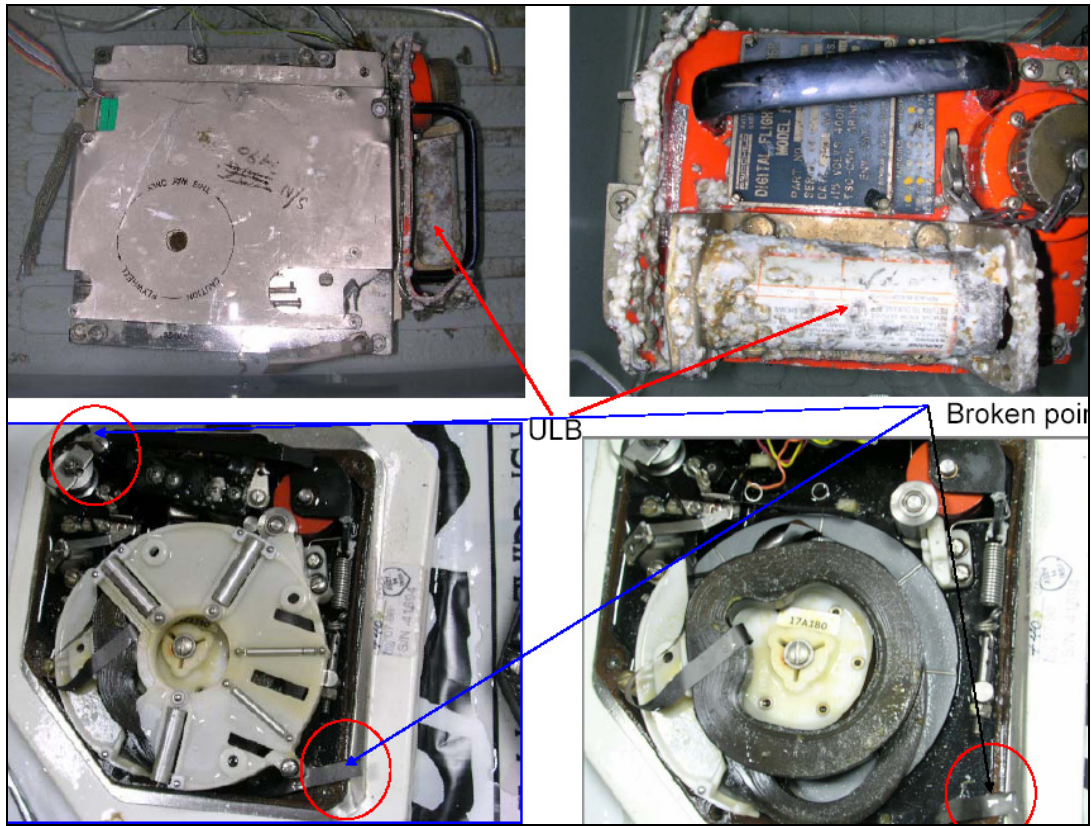
The damaged Loral model F800 FDR, part number 17M800-261, serial number 3490, was brought to the lab in a container filled with water. The protective dust cover and circuit board assemblies were lost while the front panel with the ULB and nameplate was still attached to the unit. The magnetic tape was stained and wet with the inside half squeezed out of the reel. There was a cutting break on the tape between the corner guide roller and the write heads. After it was cleaned and re-reeled, a detail examination showed some discoloration and wrinkle on it, especially the portions exposed to the outside or contacting with the mechanism. Several serious wrinkles were found near the cutting end.

Figure1.11-3 Damage of the DFDR

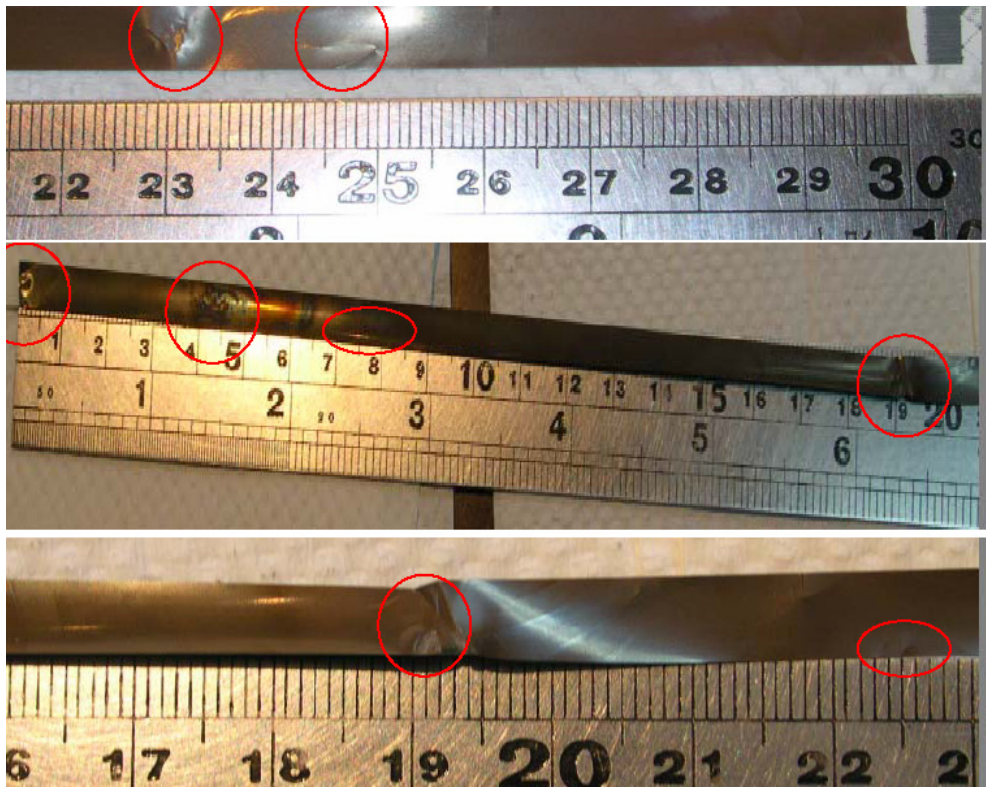
Figure1.11-4 Damage of the DFDR tape

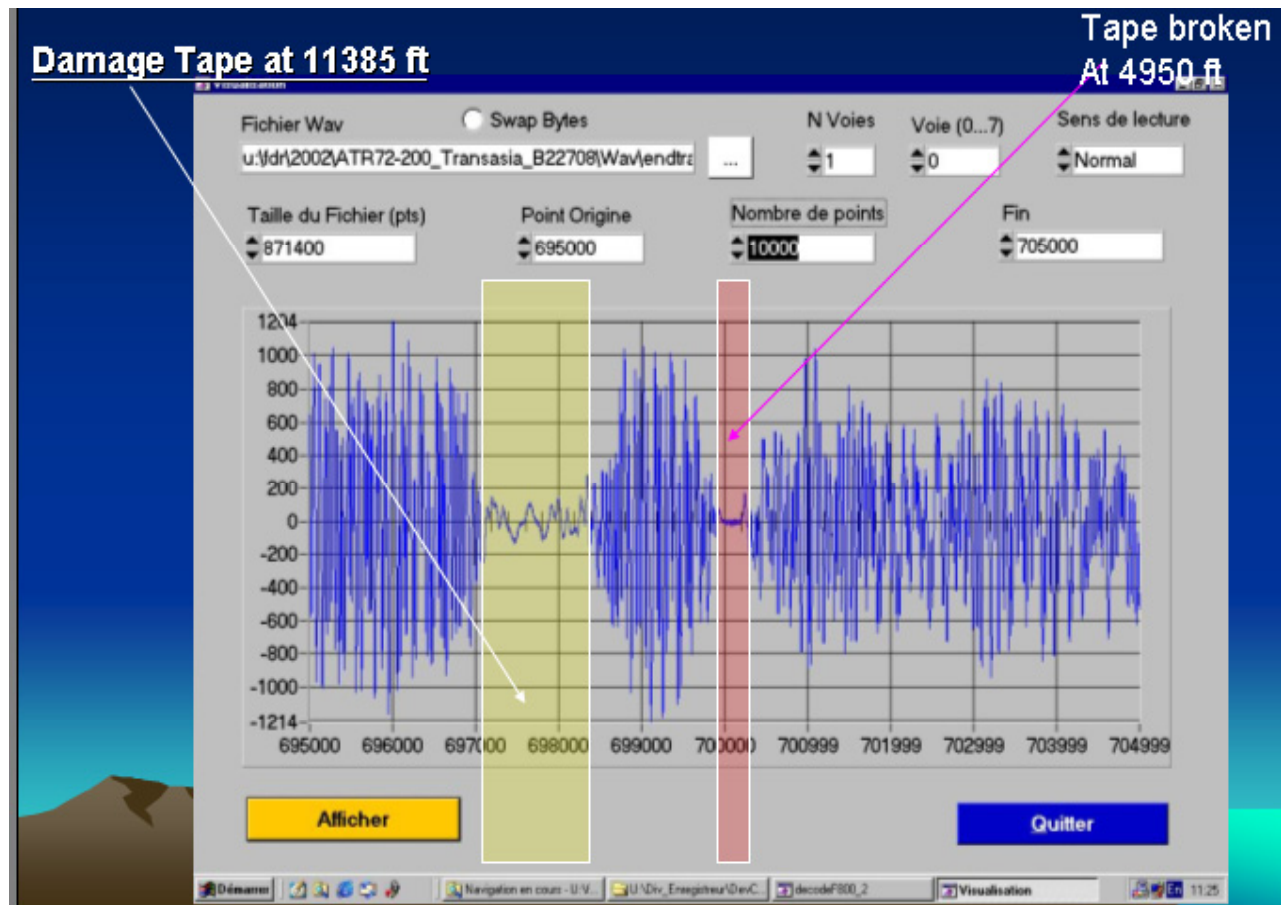
There was 99% of the flight data was readout by the GCR decoding module within RAPS. But the last 7 seconds of data was missed because of the weak signals of the tape. In March 2003, the ASC utilized the GCR readout system developed by BEA and the last 7 seconds data was successfully decoded.

Figure 1.11-10 The weak signals of the DFDR tape nearby the tape break-up (frame 70000)

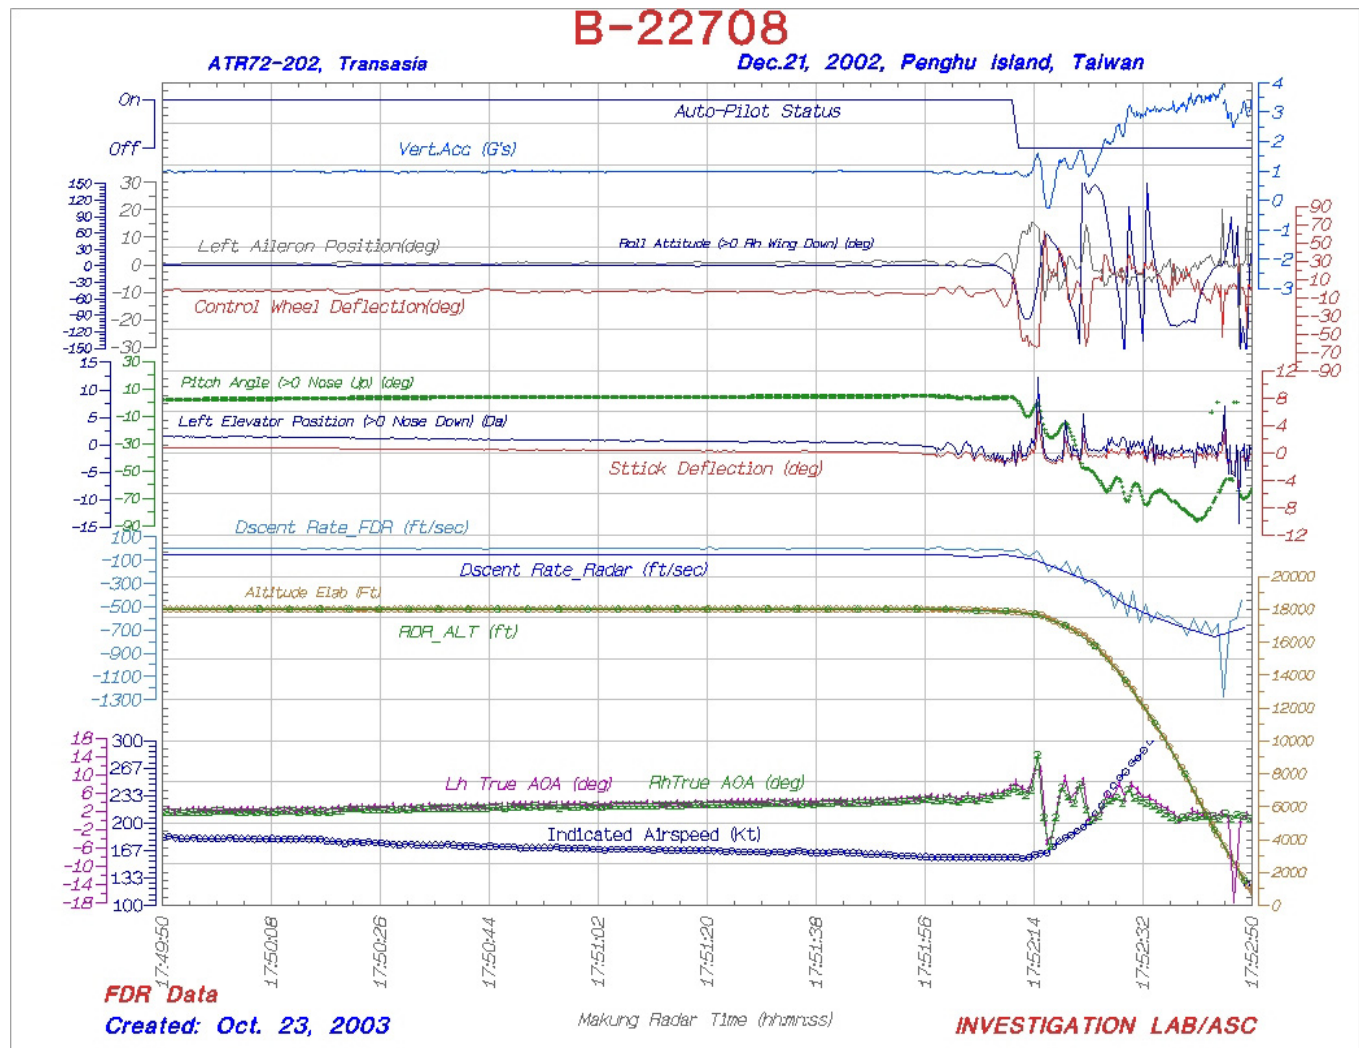
ATR's charts are a linear model which does not take into account the elasticity of the control cable and the aerodynamic force effects. The results after the calculating were shown in Figure 1.11-13 and 1.11-14. After the calculation and calibration, we found:

1. Maximum true AOA were 10.8 of the left and 15.0 of the right at 1752:14 with 3 seconds after AP disengaged, altitude 17,703 feet, IAS 161.2 knots, pitch attitude 3.5 degrees, left bank 68.6 degrees and descent rate 42 feet per second (ft/s);
2. Minimum true AOA were -4.6 of the left and -5.2 of the right at 1752:16 with altitude 17,428 feet, IAS 164.2 knots, pitch attitude 22.9 degrees, right bank 58.7 degrees, descent rate 204 ft/s;
3. Between 1752:33 and 1752:52 the descent rate was over 500 ft/s and the vertical acceleration fluctuated from +3.08G to +4.02G; and
4. Between 1752:43 and 1752:45.5, the descent rate was from 729 ft/s to 1,273 ft/s when the vertical acceleration increased from +3.36G to +4.02G.

Figure 1.11-13 The calibrated flight data of the last 3 minutes of GE791 (17:49:50~17:52:50)

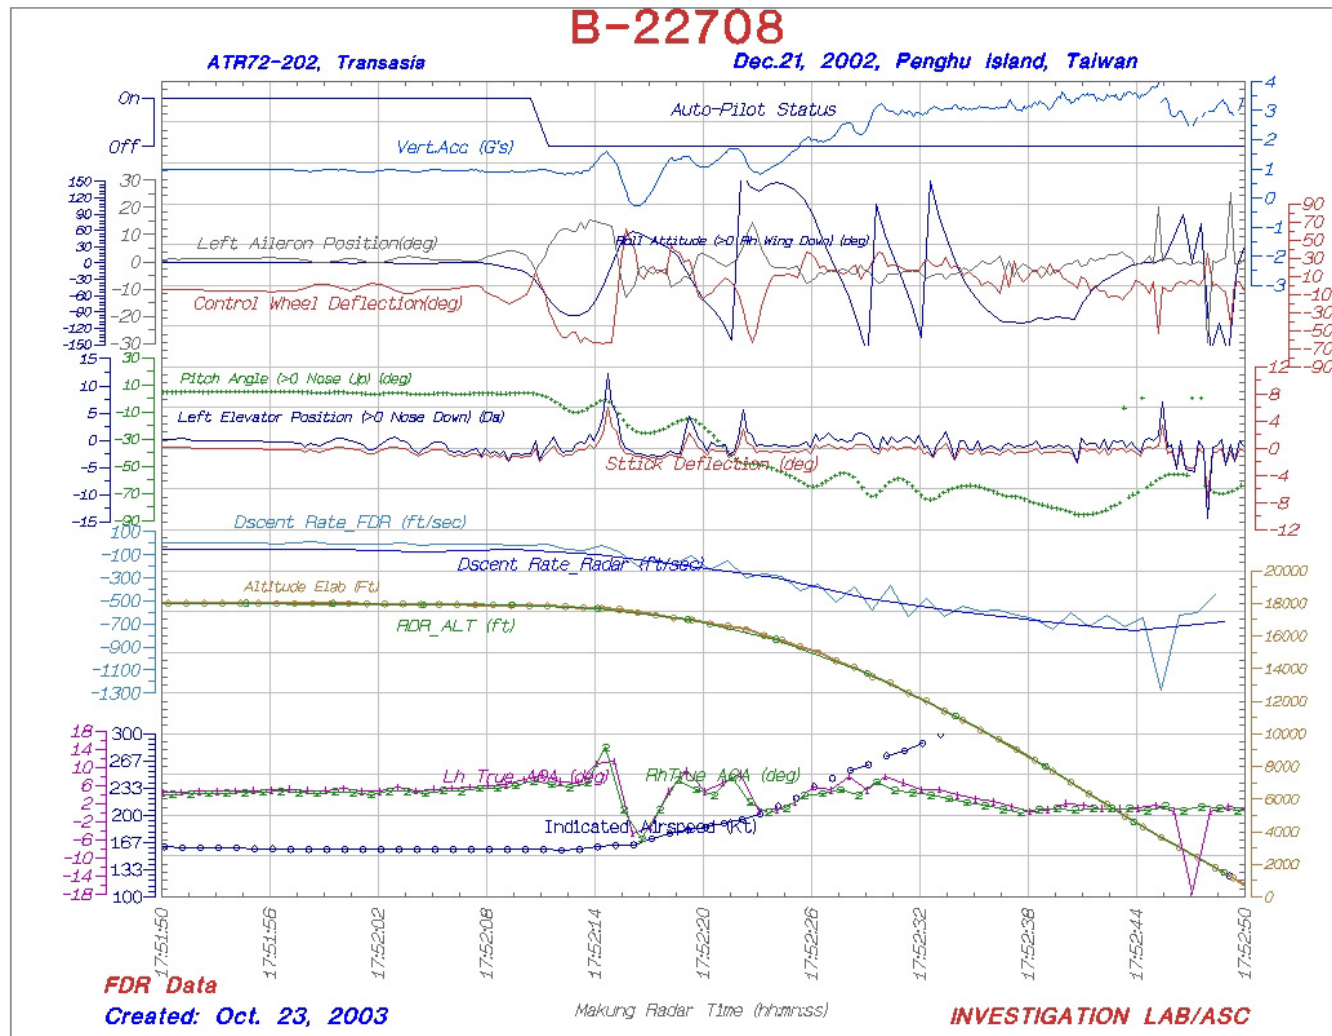
Figure1.11-14 The calibrated flight data of last one minutes of GE791 (17:50:50~17:52:50)
