**Aviation Safety Council  
Taipei, Taiwan**

# **GE 791 Occurrence Investigation Report**

**IN-FLIGHT ICING ENCOUNTER AND CRASH INTO THE SEA  
TRANSASIA AIRWAYS FLIGHT 791  
ATR72-200, B-22708  
17 KILOMETERS SOUTHWEST OF MAKUNG CITY,  
PENGHU ISLANDS, TAIWAN  
DECEMBER 21, 2002**

**ASC-AOR-05-04-001**

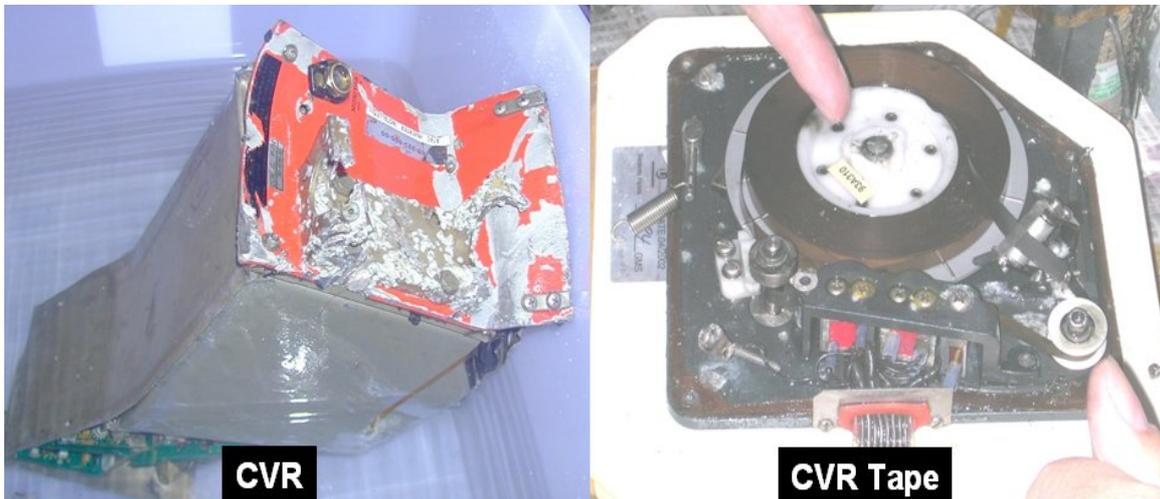
Figure 1.11-1 CVR physical damage and the CVR tape

The exterior of the CVR unit was seriously damaged when it was found. The protective dust cover was separated from the unit. The front panel, without the underwater locator beacon (ULB) and nameplate, was seriously distorted but still attached to the chassis. It arrived ASC lab in a container filled with fresh water. There were several dents and scratches on the interior crash enclosure. The recording assembly appeared to be in good condition except several damages on the plastic reel. The magnetic tape was wet and remained in its original positions without damage. Discoloration and dirt were found on the tape.(refer to figure 1.11-1)

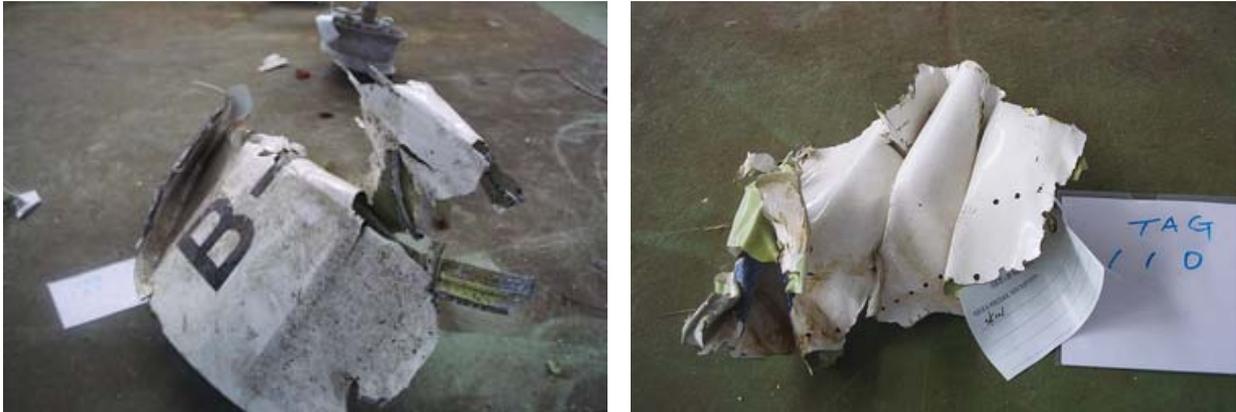
Figure 1.12-1 Fuselage skin

- Fuselage skin: They were seriously wrinkled. The fracture edges were irregular. The painting surface has no any fire phenomenon. The fracture surfaces have no fatigue and corrosion phenomenon(refer to figure1.12-1).

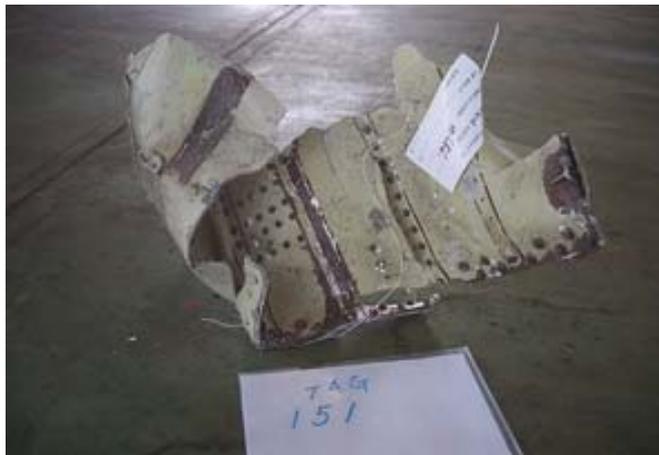
- Front spar: It's seriously broken and bended. The fracture edge was irregular. Wing root were bent downward and perpendicular to the longitudinal axis. Wing tip bent downward and 45 degree perpendicular to the longitudinal axis. Trailing edge structure broken and bent afterward. (Figure 1.12-6~8) ◦

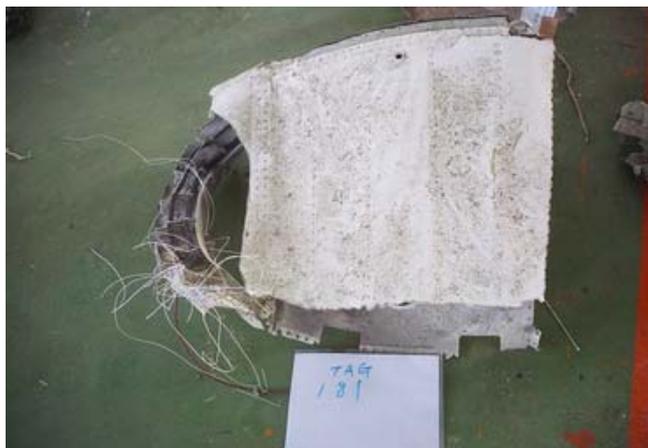
- Flap structure : Driven mechanism was broken. Honeycomb structure was seriously broken. The surface layer was separated from core structure. There was no impact marks found on surface. The leading edge was broken. The skin at front part was broken. The fracture surface was perpendicular to longitudinal (refer to figure 1.12-9~11).

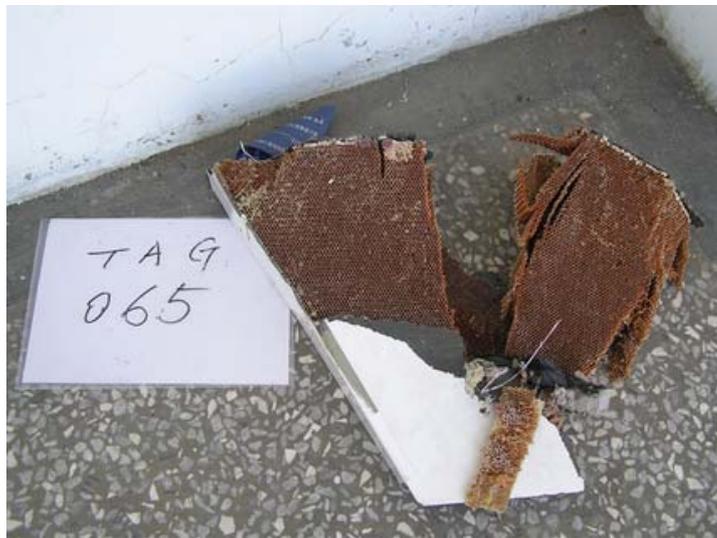
- Tail structure : The honeycomb structure of vertical stabilizer , rudder and elevator was seriously broken and delaminated. Fracture surface was irregular. The paint was peel off. Some dents and scratch found on surface. Separated window frame protruded into the honeycomb structure of rudder (refer to figure 1.12-12~16)

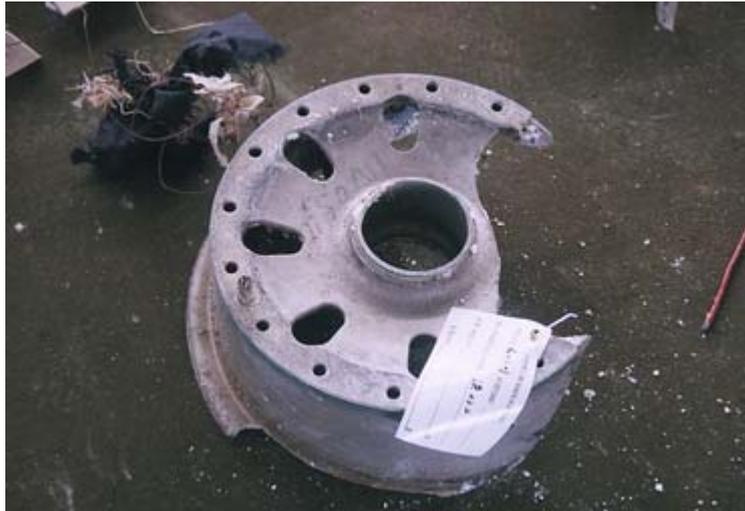
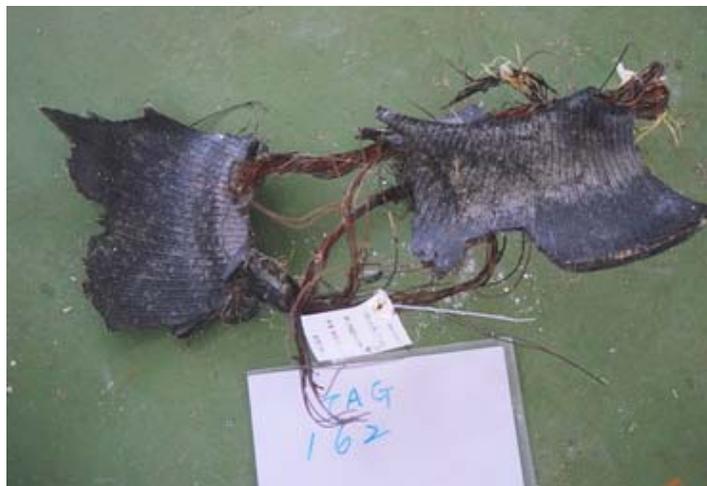
3. Body landing gear: The damage around the body landing gear including supporting structure broken, vicinity skin wrinkled, landing gear strut bended, wheel separated and broken, and tire broken (figure 1.12-17~21).

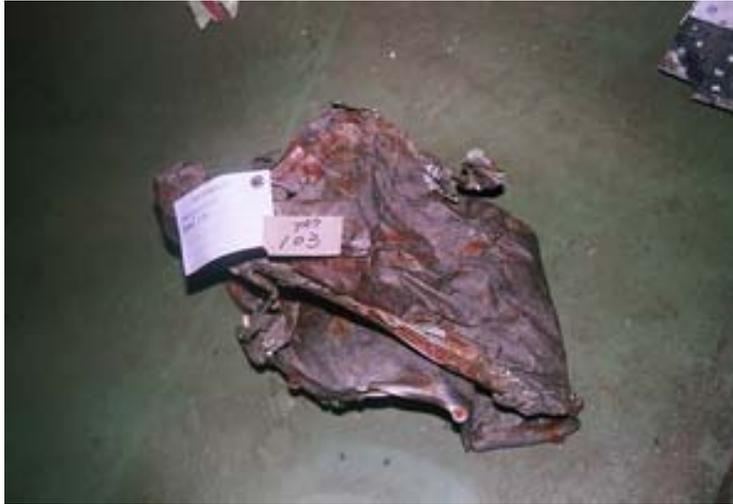
Figure 1.12-22 Exhaust pipe

- Power plant: The damage found on recovered power plant included exhaust pipe squeezed, tail cone separated but not broken, propellers broken, bended and separated (refer to figure 1.12-22~24)

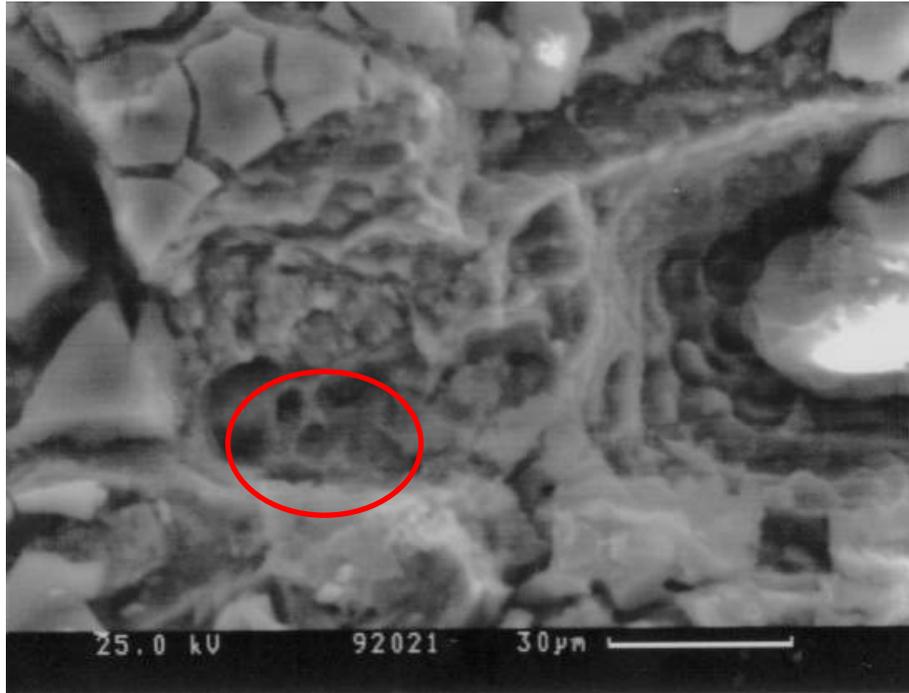
Figure 1.16-5 SEM examination showing the dimple structure (790X) ◦

14. There is no structure fatigue damage was found. All the structure failure was cause by over load damage and occurred during water impact. (2.6)
15. Before August 1997, TNA's procedures to SB evaluation, to EO production and to maintenance record keeping system in General Maintenance Manual were not established very well. (1.6.9.2、1.6.10、1.6.11、2.7.1、2.7.2)

The surface of this sample was covered a layer of oxide which is adverse for SEM examination. This examination found dimple structure on fracture surface which due to overload damage (refer to figure 1.16-5).

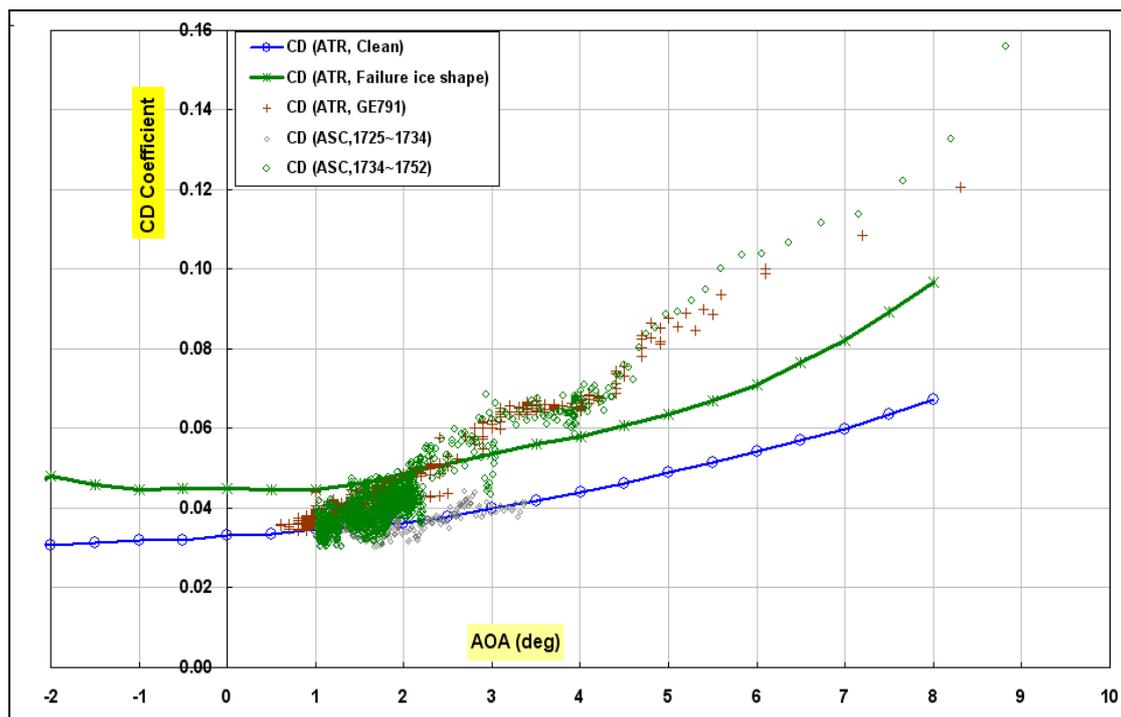
Figure 2.4-2 The extra drag of GE791 due to ice versus time (blue: clean configuration; green: de-icing boots inoperative; red: GE791 ice accretion)

11. Four minutes prior to autopilot disengaged, the extra drag increased about 500 counts, and airspeed decayed to 158 knots, and lift-drag ratio loss about 64% rapidly. (2.4.2)

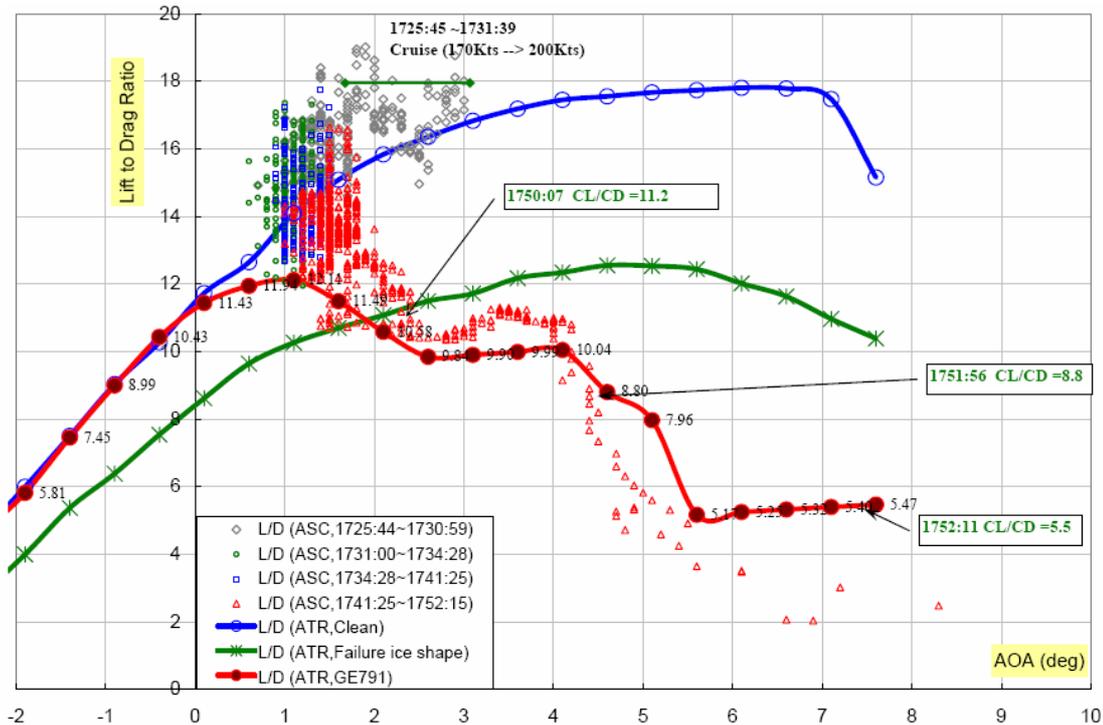
Figure 2.4-4 The lift-drag ratio of the GE791 due to ice accretion versus true AOA

12. During the 10s before the roll upset, the longitudinal and lateral stability has been modified by the severe ice accumulated on the wings producing the flow separation. Before autopilot disengaged, the aerodynamic of the aircraft (lift/drag) was degraded of about 40%. (2.4.4)
