Aviation Safety Council

**GE235 Occurrence Investigation
Factual Data Collection
Group Report**

Survival Factors Group

ASC-FRP-15-07-006

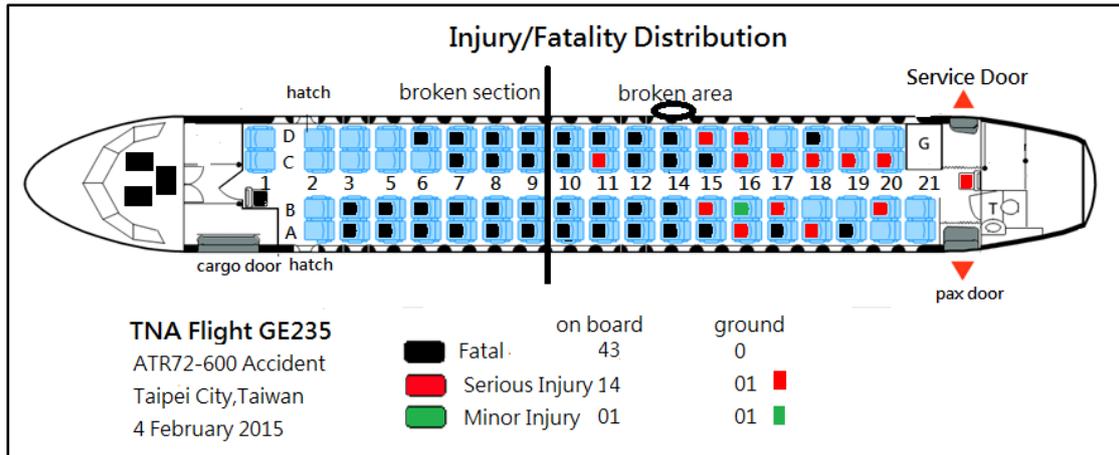
Figure 1.2-1 shows the cabin configuration with passenger injury and fatality distribution. The passenger seating positions were based on the airline seating plan and interviews with the surviving passengers.

Figure 1.2-1 Injury and fatality distribution

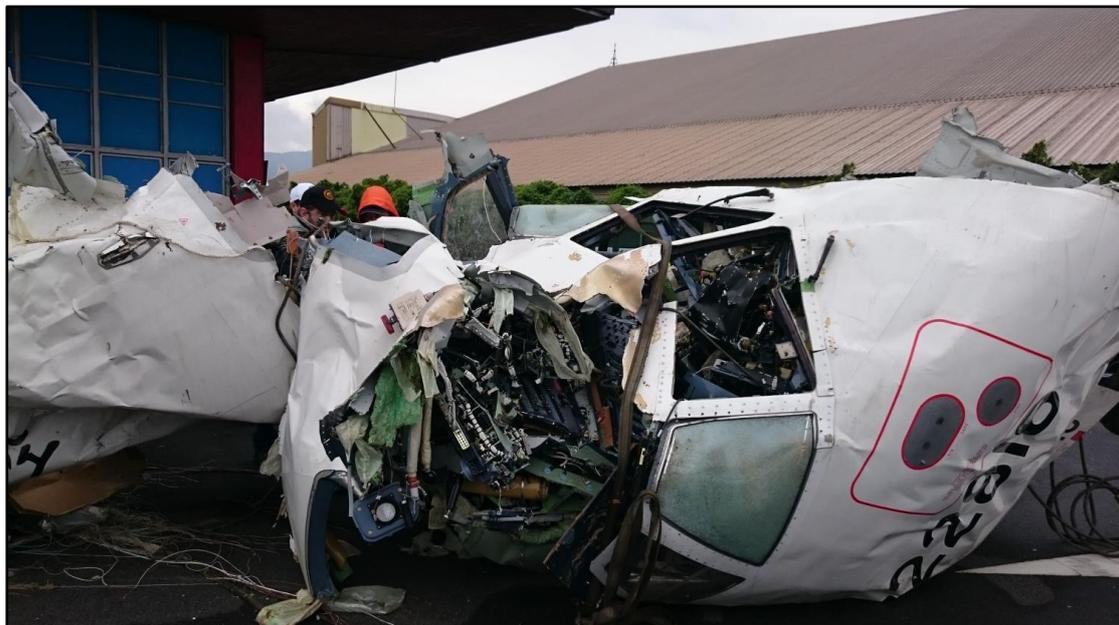
Forward fuselage area including cockpit suffered severe compression and damages due to the impact, as shown in Figure 1.3-1.

Figure 1.3-1 Wreckage on Cockpit

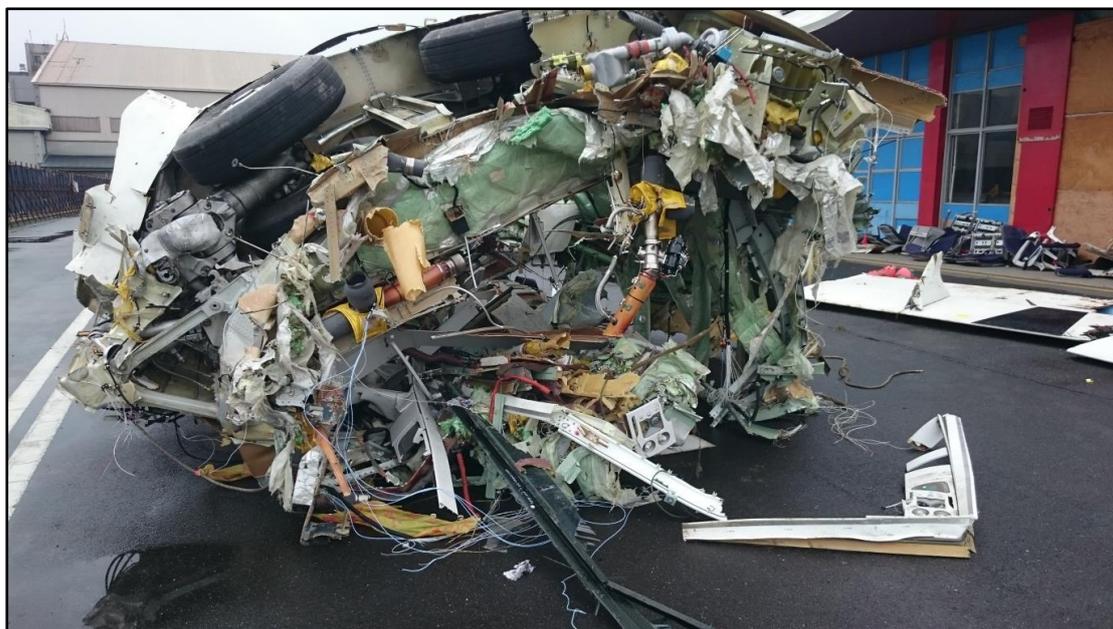
Forward and middle-aft fuselage was separated from frame 24-25 (around seat row 9-10), as shown in Figure 1.3-2. There was also a break/hole on the right hand side fuselage located at frame 28-28A area

Figure 1.3-2 The FWD and Mid-Aft fuselage separation from frame 24-25

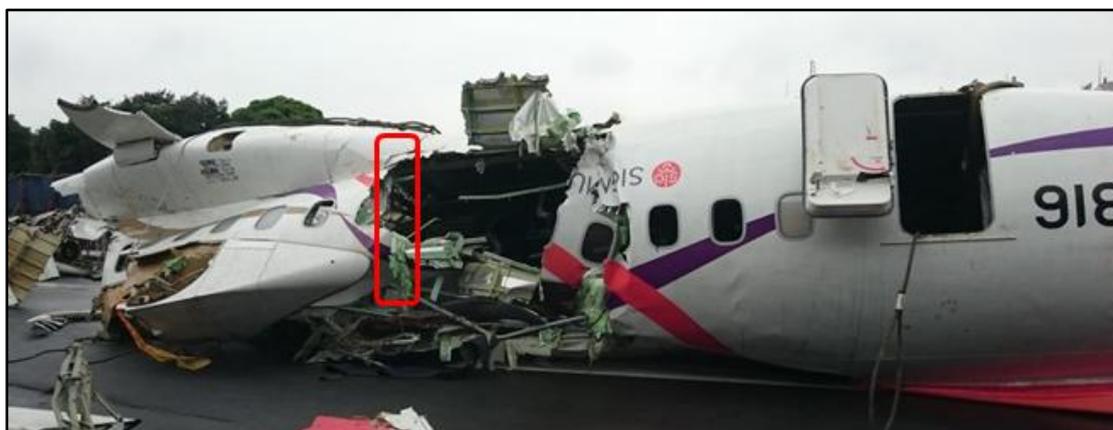
(around seat row 14-15). This break was then sawed to a larger hole for rescue purpose. The fuselage from frame 24 to tail cone was almost kept in its original shape, as shown in Figure 1.3-3.

Figure 1.3-3 A broken area on the right hand side fuselage located at frame 28-28A area

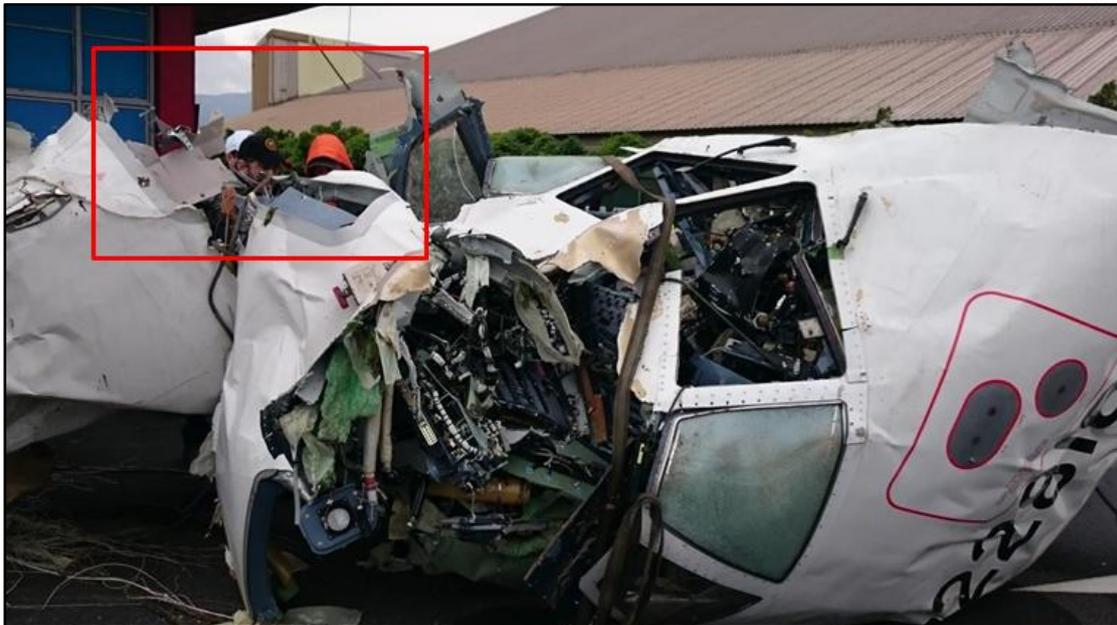
The frame that contains cockpit hatch door was severely damaged with the door missing, as shown in Figure 1.3-4. The actuator of cargo door was retracted. The cargo door was not opened before the impact; however afterward only door fitting remained connected to the actuator, as shown in Figure 1.3-5. Right hand side emergency door was dislocated from the door frame. The emergency door, with mounting hinges broken,

Figure 1.3-4 Cockpit and hatch door

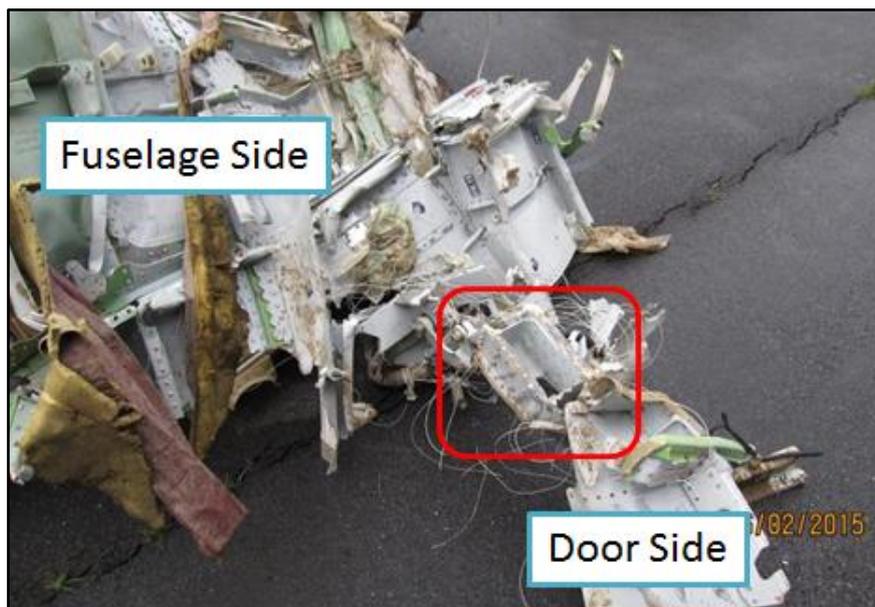
Figure 1.3-5 Cargo door

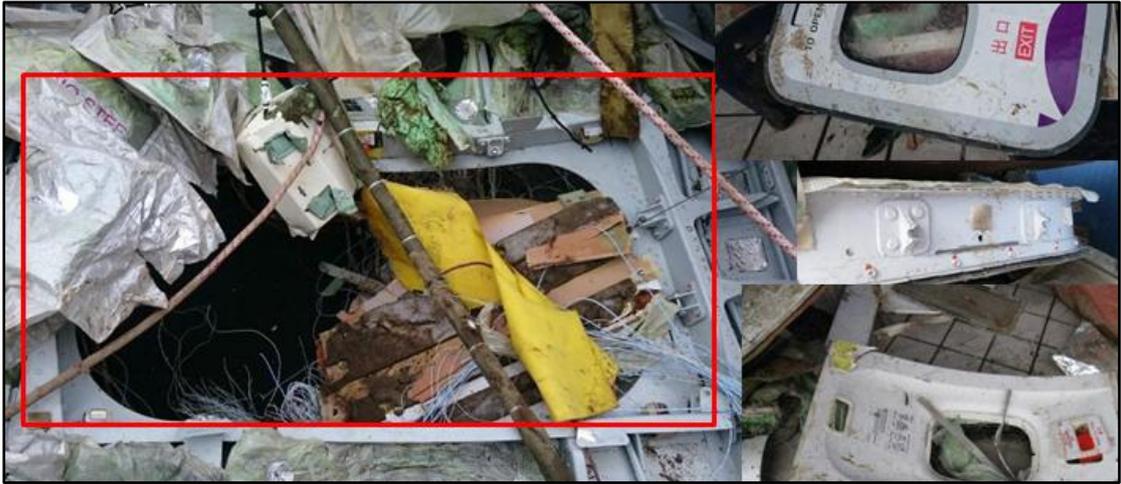
was considered being pushed into cabin during the impact, as shown in Figure 1.3-6. Left hand side emergency door broke into halves due to the impact. The fuselage side door frame could not be located due to severity of damages to the FWD airframe. According to broken hinge location, this door was pushed into cabin during the impact, as shown in Figure 1.3-7. Left hand side passenger door was closed and intact at the time of the accident. Both internal handle and external flap handle were pulled down to un-lock position, as shown in Figure 1.3-8. Right hand side service door was still functioning, and was opened during rescue operation, as shown in Figure 1.3-9.

Figure 1.3-6 RHS Emergency escape door

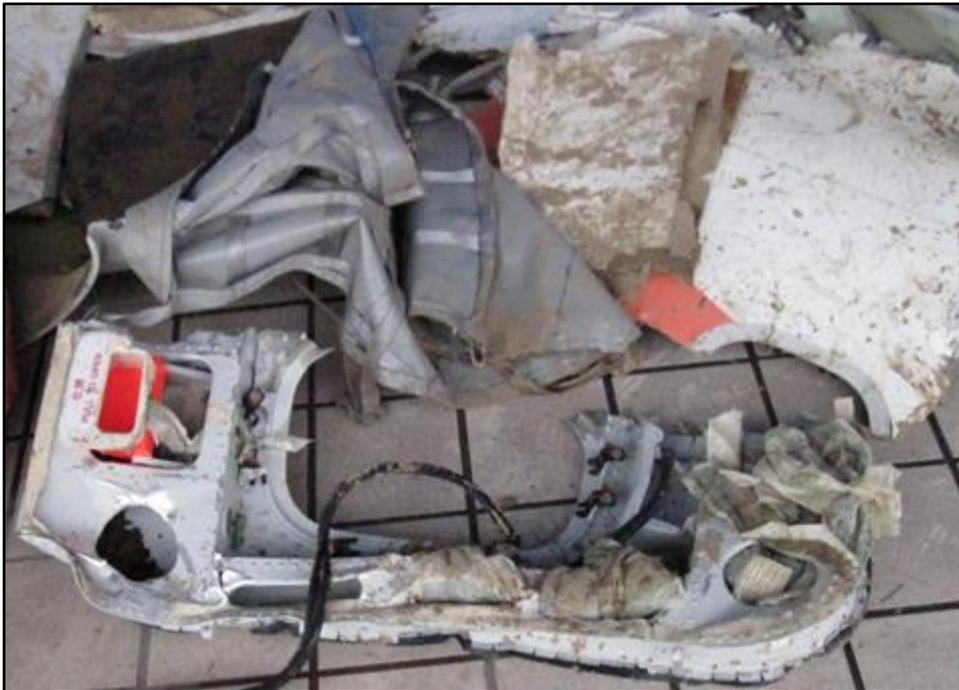
Figure 1.3-7 LHS Emergency escape door

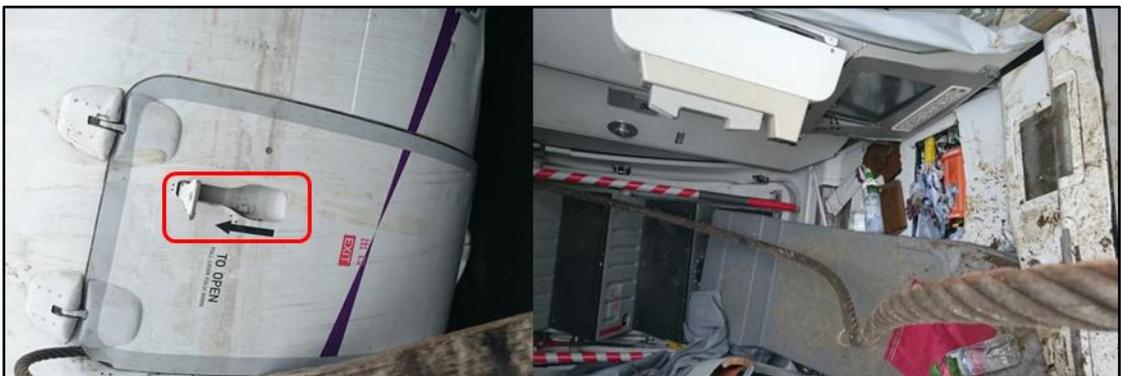
Figure 1.3-8 LHS Passenger door

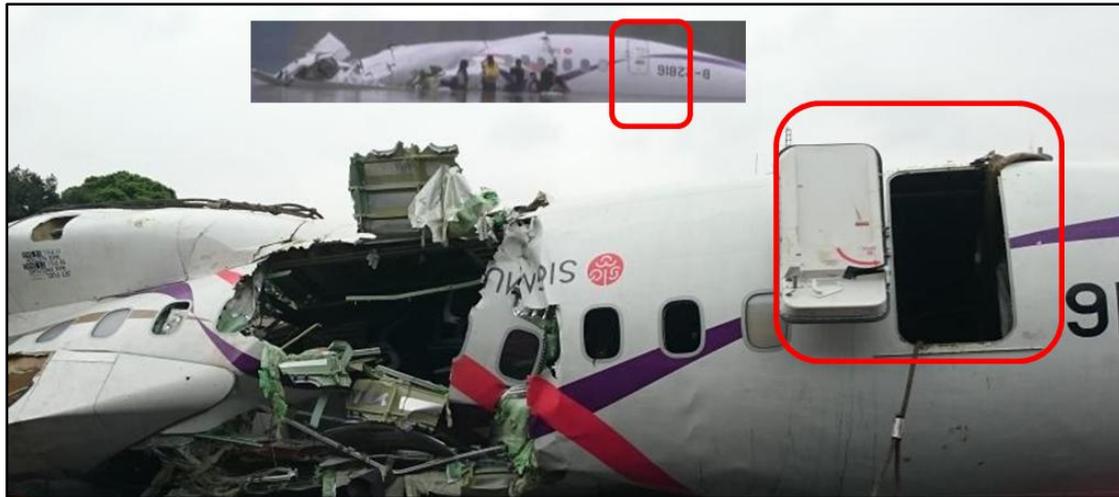
Figure 1.3-9 RHS Service door

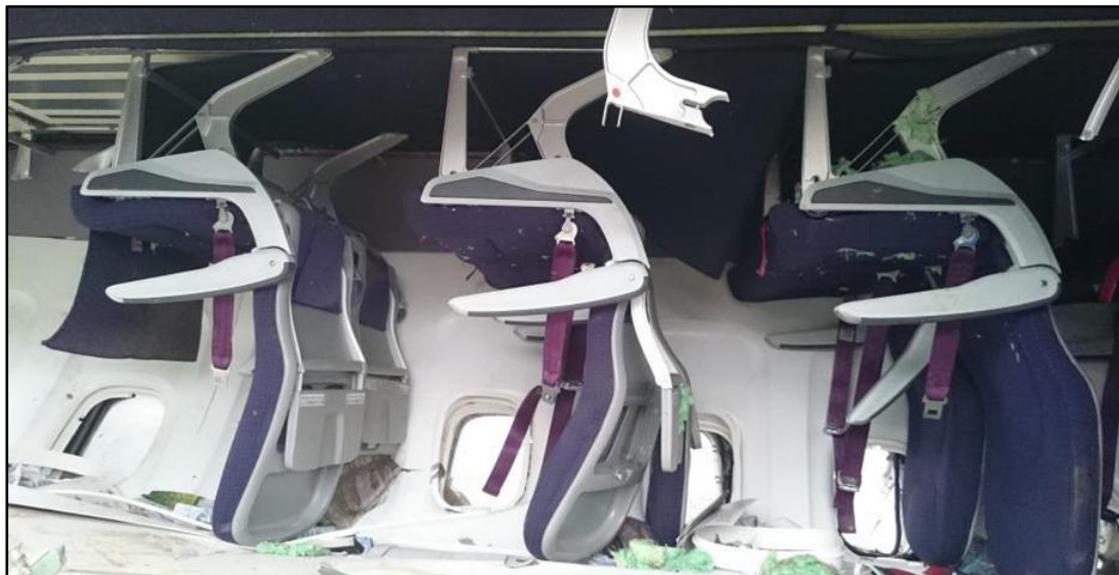
There were 8 sets (2 seats for 1 set) of passenger seats kept intact on seat tracks located in the aft fuselage, as shown in Figure 1.3-10. 28 sets of passenger seats were dislocated from their positions due to the impact (about 5 sets) or rescue effort (about 23 sets), as shown in Figure 1.3-11. Their original positions could not be identified.

Figure 1.3-10 Passenger seats intact on seat track

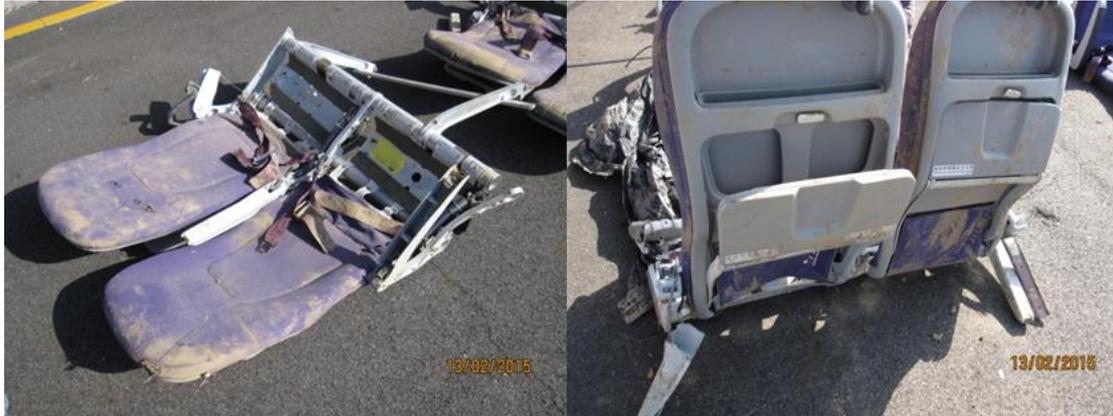
Figure 1.3-11 Passenger seats dislocated from its position
