# 國家運輸安全調查委員會

### 調查報告

遠東航空股份有限公司 FE8026 班機

於進場階段距松山機場約 10 哩處左發動機失效

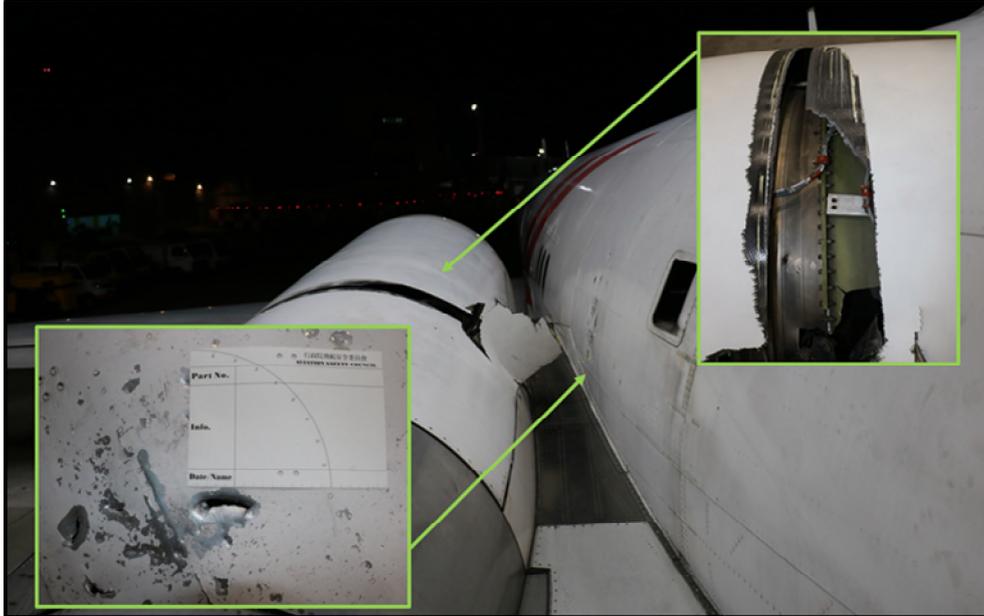
圖 1.12-1 左發動機外罩及機身損壞狀況

事故發動機因第 4 級低壓渦輪轉子葉片斷裂，自渦輪轉盤脫離，向外擊破渦輪扇旁通機匣後方 K-flange 機匣（位置如圖 1.6-1）約 1 點鐘至 3 點鐘位置，後續擊穿相對應位置之發動機上罩蓋，再擊穿事故機機身尾段左機身蒙皮，發動機上蓋約有長 100 吋寬 10 吋不等之長形破口，機身蒙皮擊傷範圍約 24 平方吋，其中有 3 處擊穿蒙皮處，詳如圖 1.12-1。

該機機身蒙皮遭擊穿處為非加壓區，從機尾艙門進入該區檢查，並未發現任何電器線路或油氣管路受損，該區機身內亦無發現葉片殘件，惟於事故機落地後檢查時，在左發動機下罩蓋內尋獲少許疑似葉片材質之細小破片。

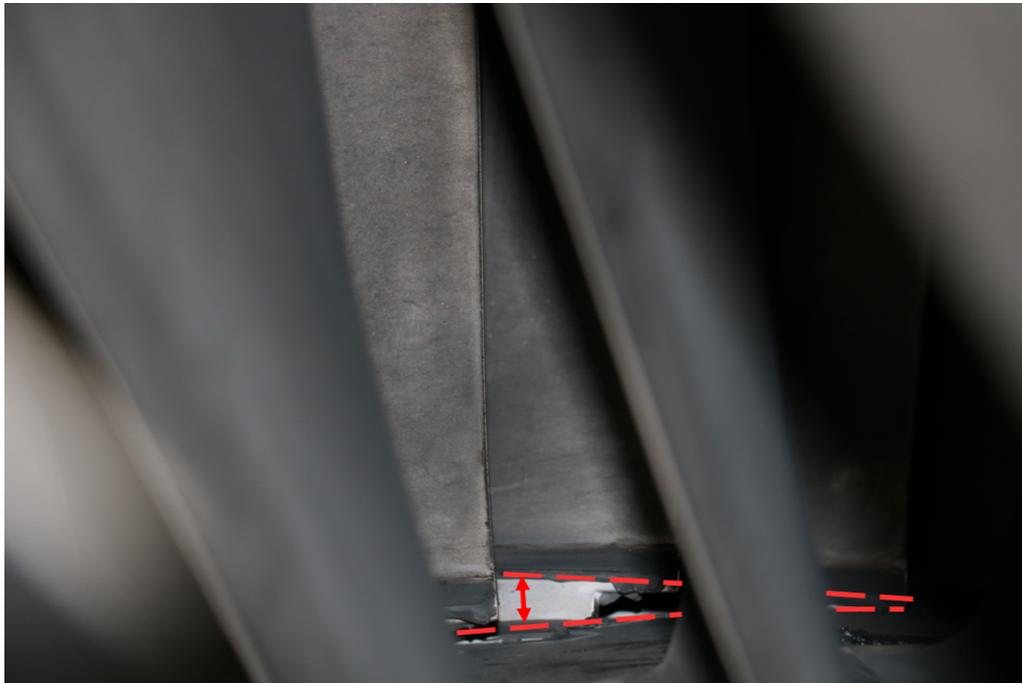
圖 1.16-1 進氣導片脫離位移

第 1 級壓縮器位於 9 點鐘至 12 點鐘之定子進氣導片自其內機匣上往順時鐘方向脫離位移，詳圖 1.16-1。

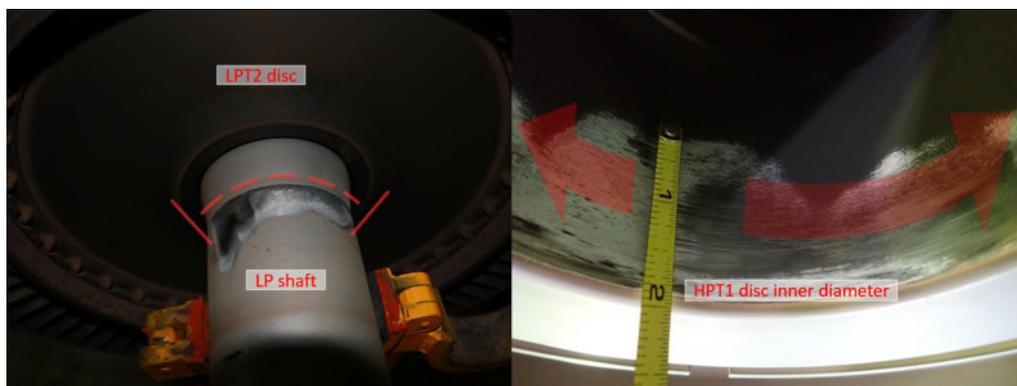
圖 1.16-2 低壓渦輪軸表面環狀磨損痕跡

使用扳手驅動液壓泵或以手扳動第 1 級高壓渦輪轉子葉片，N2 軸（高壓軸）可自由被轉動，第 1 級高壓轉子葉片後緣無損傷。N1 軸（低壓軸）第 2 級低壓渦輪前方軸表面有一約長 2 吋之環狀磨損痕跡，詳圖 1.16-2 左圖，與其相對應之第 1 級高壓渦輪盤表面有一約 1 至 2 吋之環狀磨損痕跡，詳圖 1.16-2 右圖。

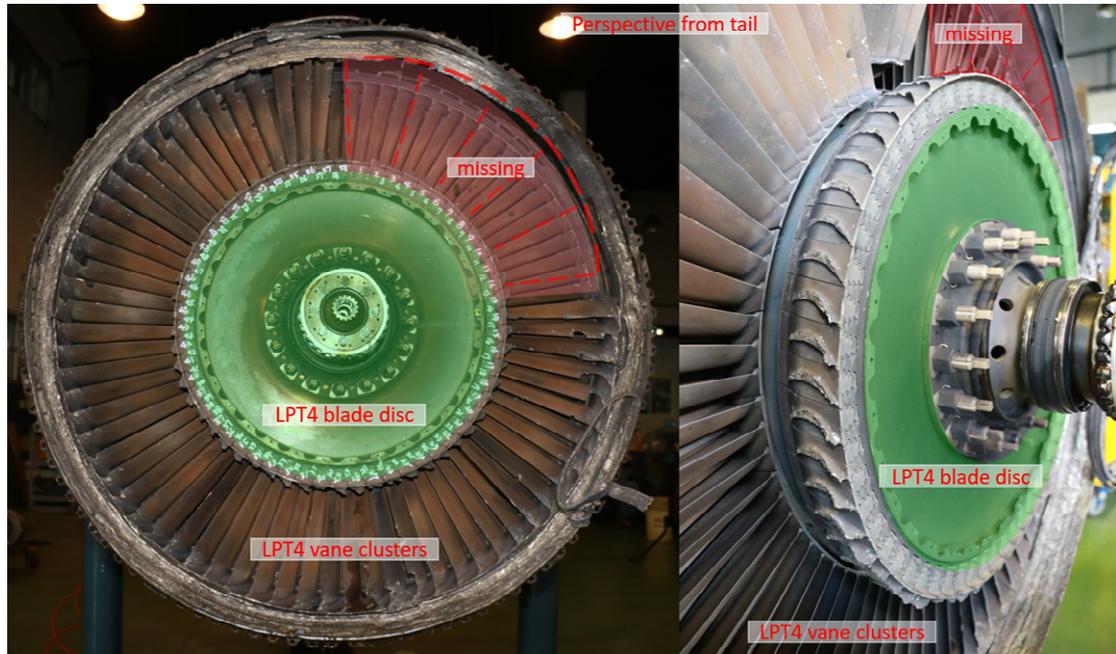
圖 1.16-3 第 4 級低壓渦輪定子葉片扇形段脫離

第 4 級低壓渦輪定子葉片扇形段 (turbine stator vane cluster) 其中 5 組自渦輪脫離，詳圖 1.16-3，其餘未脫離定子葉片無斷裂型態之破壞，但於葉片後緣有撞擊痕跡，詳圖 1.16-4。

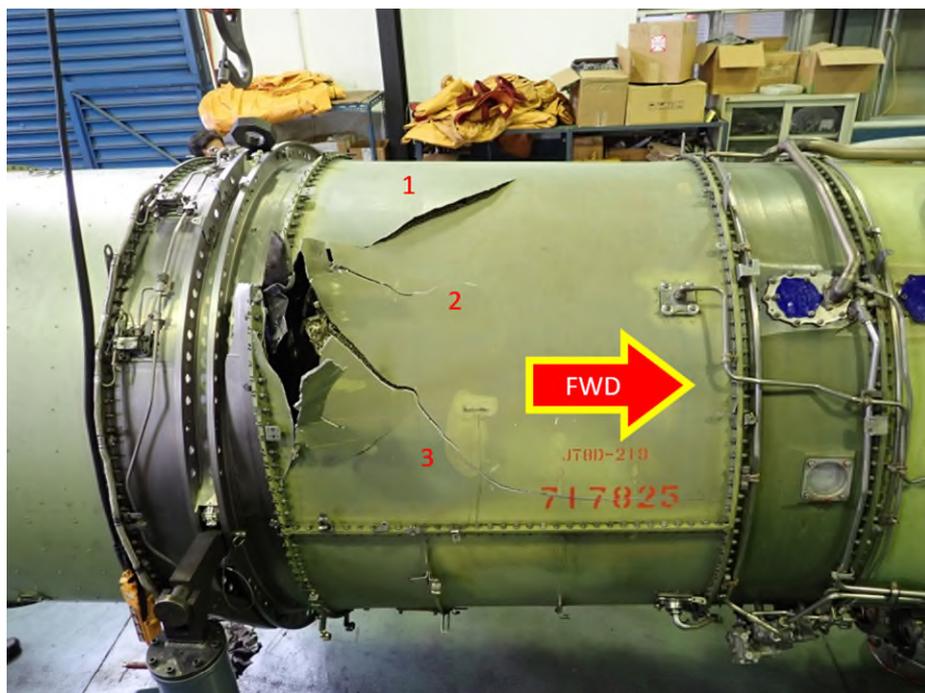
圖 1.16-5 發動機機匣上之扇狀輻向撕裂口

位於渦輪扇旁通機匣後方 K-flange 螺桿與安裝孔依序自 12 點鐘以順時針方向編號 1 至 132，編號 14 至 18 區段螺桿與螺桿孔損毀，渦輪扇旁通上機匣右側約 1 點鐘至 3 點鐘位置，有一約 10 吋長的內部結構件穿刺，造成葉片外氣封環展延變形、渦輪扇旁通上機匣上有一約長 20 吋寬約 6 吋，自發動機軸心方向向外破出的裂口，該處主要有三道以破裂處為中心的扇狀輻向撕裂口，朝發動機前端延伸，由上至下編號 1 至 3，破裂長度分別約為 20 吋、17 吋及 38 吋，詳圖 1.16-5。

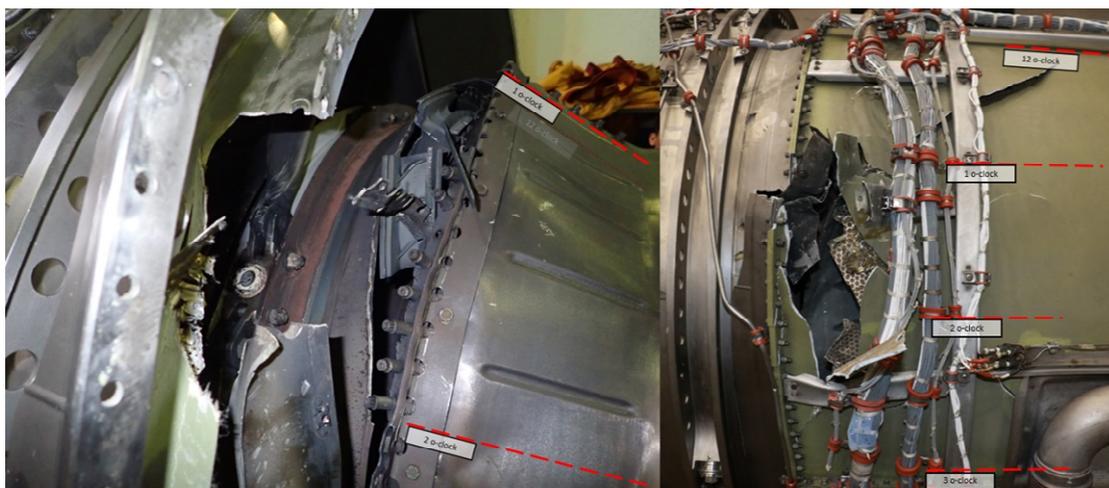
圖 1.16-6 渦輪扇旁通機匣與發動機渦輪排氣機匣損壞位置

位於 K-flange 附近之渦輪扇旁通機匣與發動機渦輪排氣機匣（圖 1.16-6），其相接處破裂約位於 1 點鐘至 3 點鐘位置，該破裂區域最大寬度約 4 吋，破裂處有數根螺桿彎折變形；靠近底部有 20 根螺桿斷裂，其餘 80 根螺桿仍位於其安裝之位置。

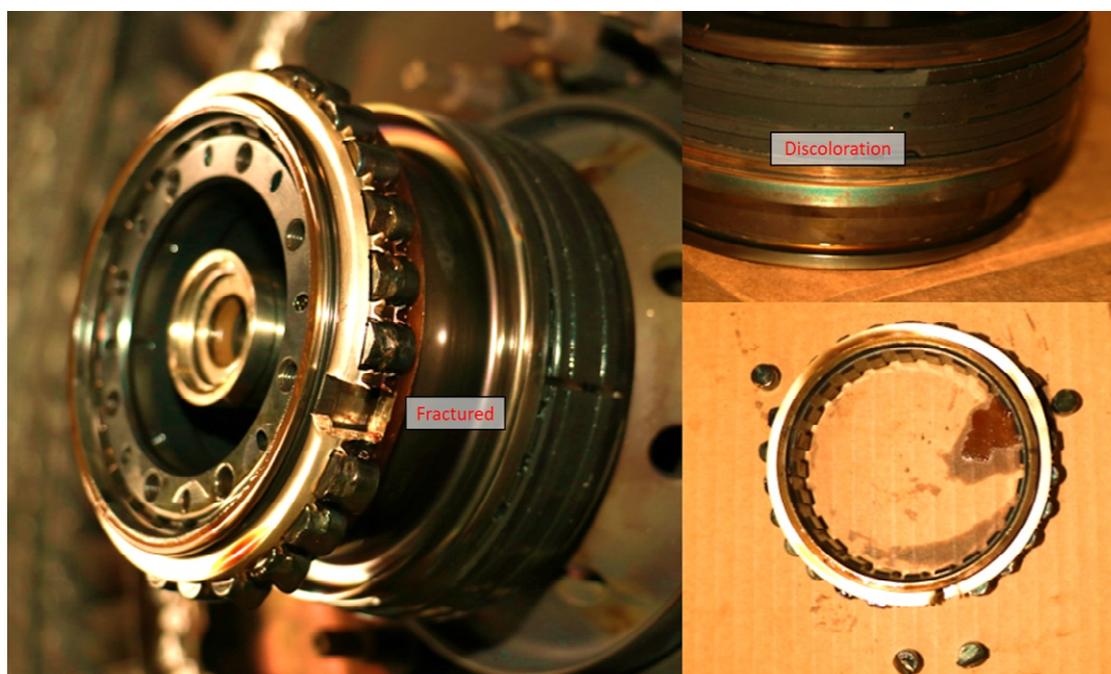
圖 1.16-7 受損之 6 號軸承

5 號軸承目視狀況良好無顯著損傷，6 號軸承拆除後發現軸承滾柱與軸承室皆有顯著損傷，並發現一滾柱支架碎片。軸承碳封有輕微金屬磨損，外觀大致完整，但於碳封外徑凸緣上發現有部分受熱變色的跡象，詳圖 1.16-7。

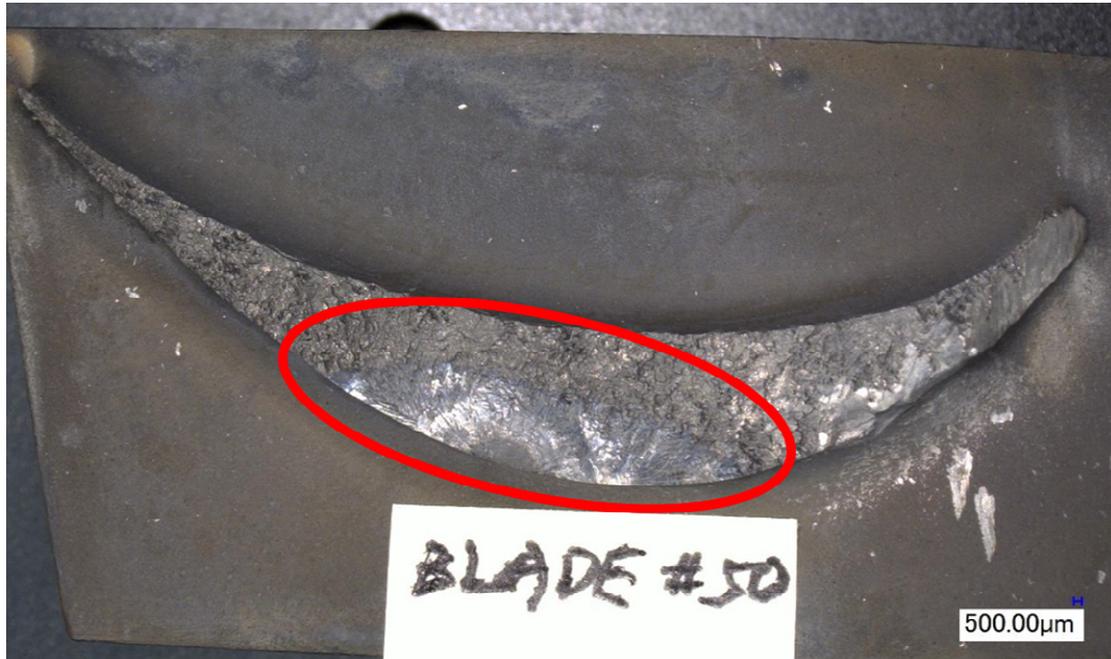
圖 1.16-8 疑似疲勞裂紋之葉片根部斷面

渦輪轉子葉片共計 58 片，全數自葉根處斷裂，僅殘存少部分葉片根部於轉子盤鳩尾榫槽（dovetails）上，事故機落地後檢查均未尋獲斷裂脫落之葉片。檢視葉片斷面，編號第 50 號葉片根部發現有疑似金屬疲勞斷面的特徵紋路，詳圖 1.16-8。

1. *All 4th stage LPT<sup>8</sup> blades were fractured transversely through the airfoil adjacent to the root platform. A singular 4th stage LPT blade was observed to have a thumbnail-shaped fatigue progression. Appearance of the fracture surface under high magnification was indicative of HCF.*

中譯：第 4 級 LPT 轉子葉片全數自葉片剖面鄰近根部處橫向斷裂，其中 1 片發現有拇指紋路形狀之疲勞紋生成，斷面外觀以高倍數影像放大後顯示為高周疲勞（high cycle fatigue, HCF）的跡象。

拆檢左發動機發現第 4 級 LPT 編號第 50 號葉片根部斷裂面疑似存在金屬疲勞特徵紋路，之後調查小組將左發動機損壞零件共 8 項送 P&W 公司檢測，確認高周疲勞為導致第 4 級 LPT 編號第 50 號葉片斷裂原因。

綜上所述，事故機於降落松山機場過程中遭遇左發動機故障，排除因外物損傷所致；左發動機第 4 級 LPT 編號第 50 號轉子葉片因高周疲勞導致斷裂，葉片斷裂後造成 5 組第 4 級定子葉片脫落、6 號軸承移位及其餘 57 片第 4 級 LPT 轉子葉片斷裂，斷裂葉片撞擊造成渦輪扇旁通機匣裂損，斷裂葉片及零件擊穿左發動機外罩，導致發動機非包容性失效。

1. 依據適航指令 CAAAD 2011-03-13 及事故後 Pratt & Whitney 公司正式發布更新版 ASB A6224 R7 版修訂發動機渦輪葉片扭矩檢查時距，並依民航局要求執行低壓渦輪轉子葉片檢查。

依前述 2.2.2 分析結果，第 4 級 LPT 轉子葉片於未達規定之檢測時間即已斷裂，並造成發動機飛包容性失效，顯示適航指令 FAA AD 2011-07-02 設定之葉片檢測規範及時距仍有修訂空間；經調查小組洽詢 NTSB 授權代表，P&W 公司針對本次事故，預於 2019 年第 3 季發布更新版 ASB A6224，修訂內容（詳如 4.2.2 所列 P&W 公司進行之改善措施）包含：葉片葉冠槽初始檢查將降為 2,000 小時、扭矩大於 15 lb-in 的重複檢查時距將由 1,000 小時降至 500 小時、扭矩小於 15 lb-in 的重複檢查時距將改為於 20 小時內拆除發動機以及只採用最低扭矩值做為重複檢查之指引。

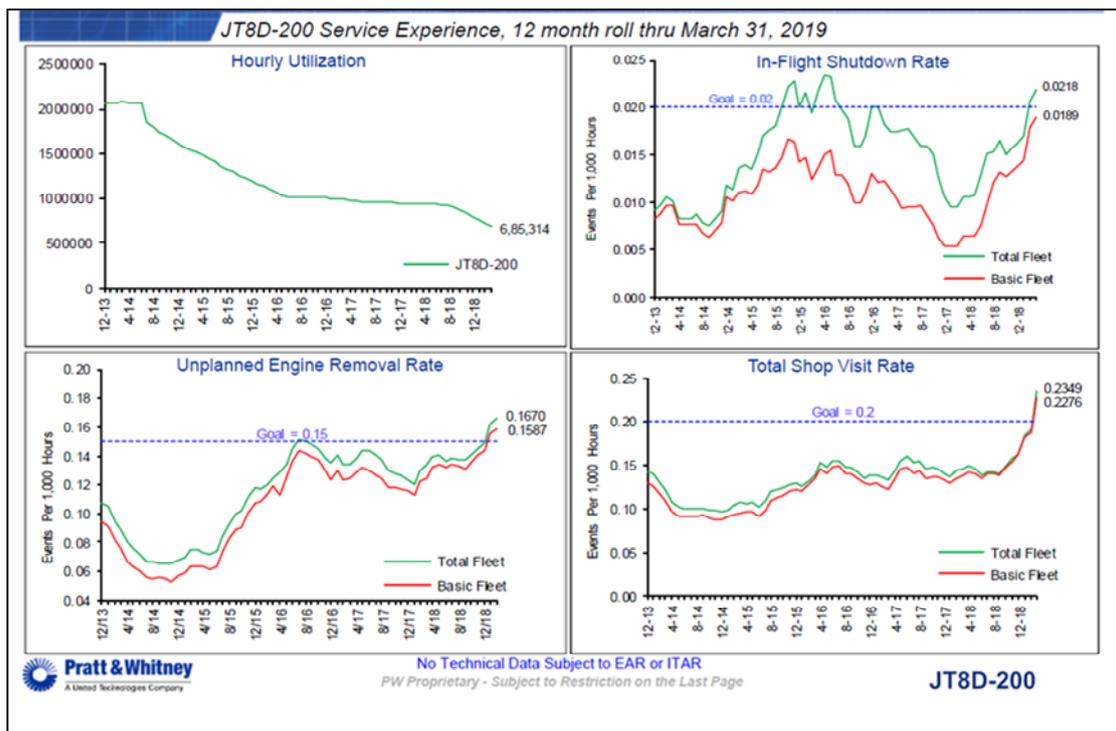
圖 1.18-3 JT8D-200 型發動機可靠度相關資料

依據 P&W 公司統計資料，事故型發動機計至民國 108 年 3 月 31 日止，12 個月內，全球使用時數紀錄 685,314 飛行小時，發動機空中關車 (in-flight shutdown) 事件共 13 起，其中 3 起事件因 LPT 第 4 級葉片失效造成，平均每千小時失效率為 0.0189，低於發動機製造廠設定之可接受平均每千小時失效率 0.02 目標值，詳圖 1.18-3。
