飛航事故調查報告 第二冊

ASC-AOR-05-02-001

中華航空公司 CI611 班機

行政院飛航安全委員會
AVIATION SAFETY COUNCIL
中華民國九十四年六月

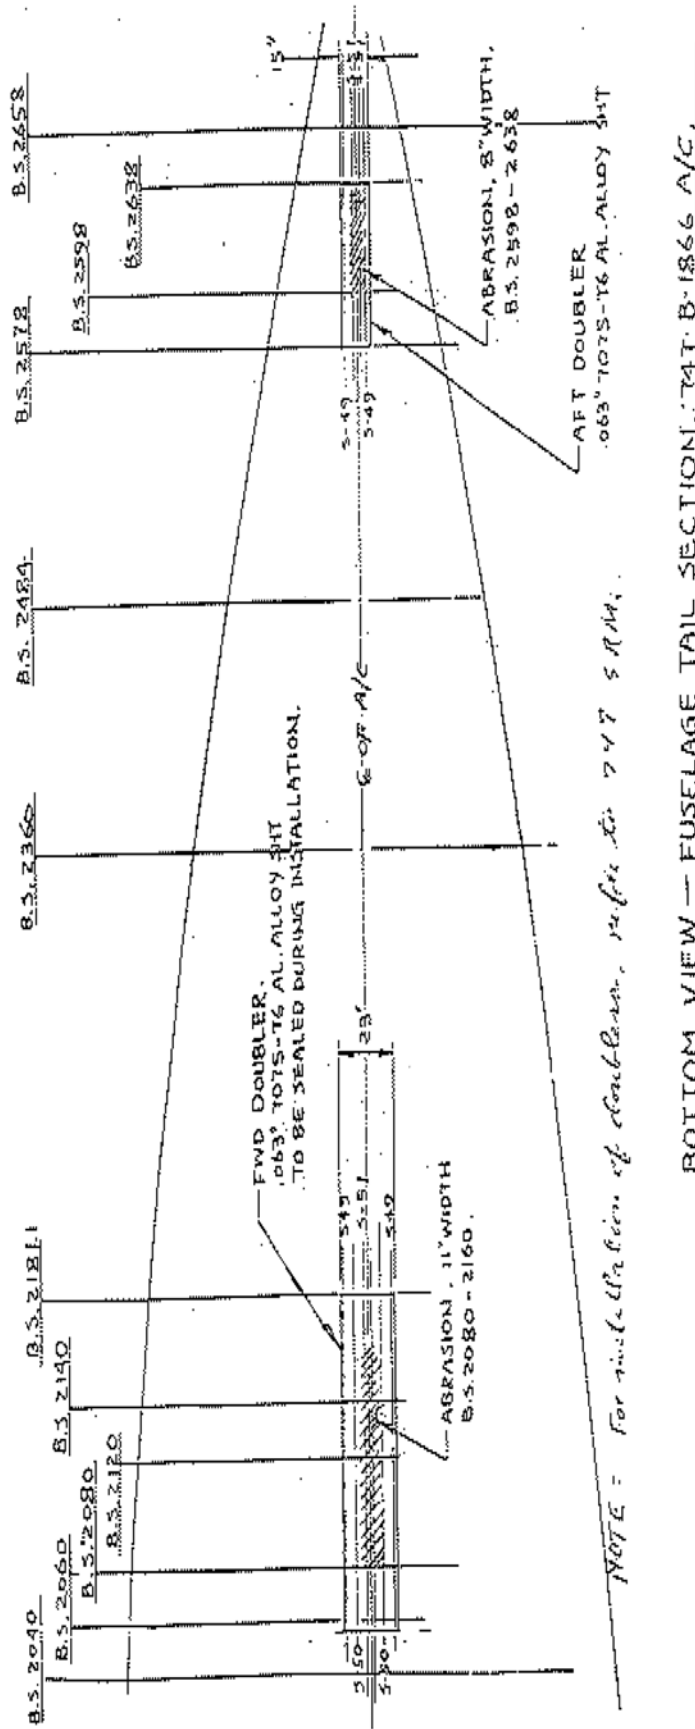
Preliminary inspection found the serious abrasion damages on fuselage tail portion bottom skin between F.S. 2080 and 2160 and between F.S. 2578 and 2638. The aft drain mast was missing. LH outflow valve door inb'd corner partially cut.

1. Close visual inspect internal structure for any defects inside the abraded skin.
2. Install two reinforcing doublers, made of .063" 7075-T6 Alum. Alloy plates at two places of the abraded area, forward 23"x125" (to be sealed during installation on this pressurized area) and aft 15"x54". See attach Figure.
3. Aft water drain mast reinstalled and functional test.
4. LH outflow valve door cut area temporarily repaired with 6061-T6 Alum. Alloy and functional test.
5. Conduct permanent repair IAW 747 SEM within four months.
6. The said temporary repair was concurred by Boeing Rep.

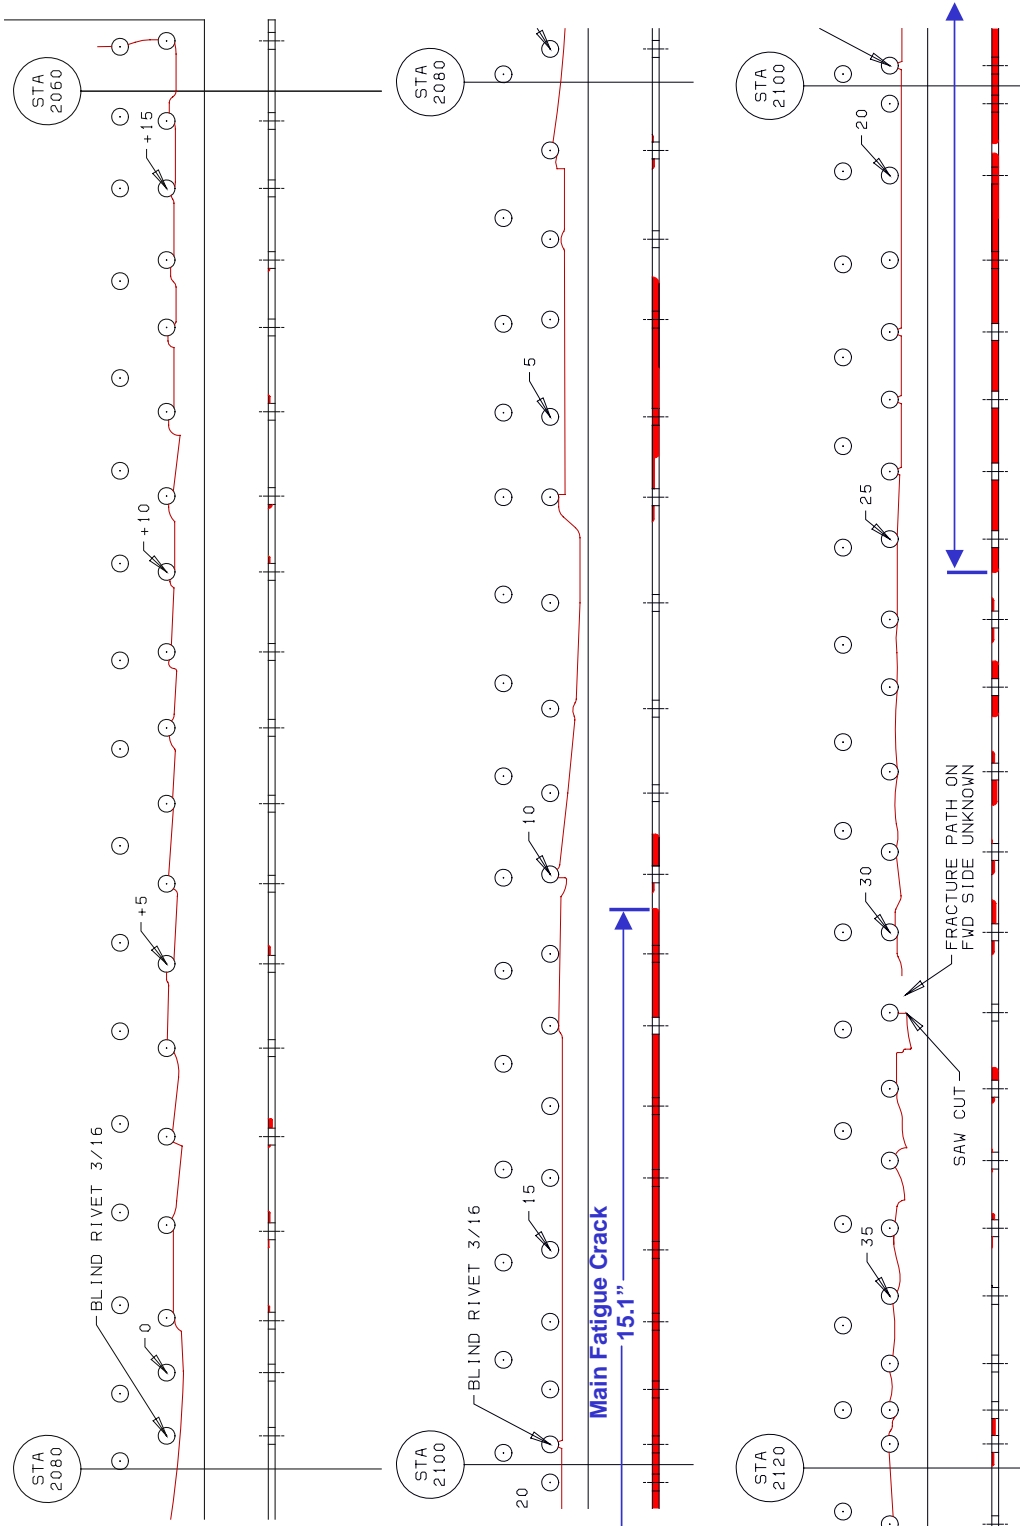
Figure 5. Map of fatigue cracking (red areas) observed on fracture above S-49L from STA 2060 to STA 2120. The length of the main fatigue crack centered about STA 2100 is shown. Refer to Table JVI for a complete list of fatigue crack lengths and depths.

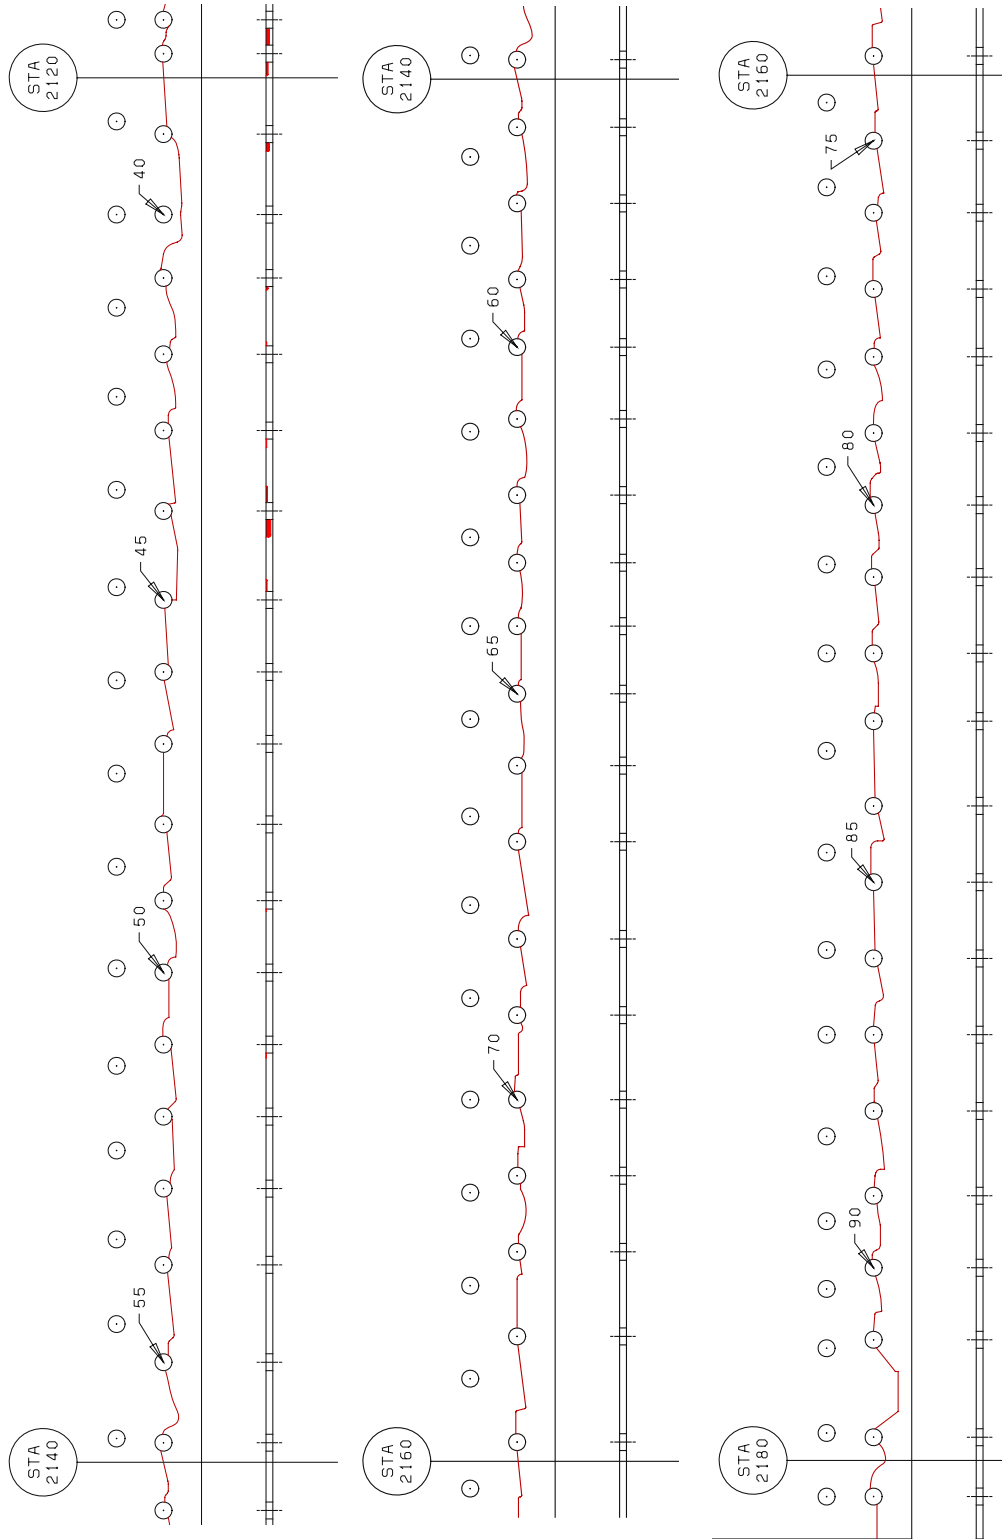
Figure 6.
Map of fatigue cracking (red areas) observed on fracture above S-49L from STA 2120 to STA 2180. Refer to Table JVI for lengths and depths of the fatigue cracks provided in this figure.

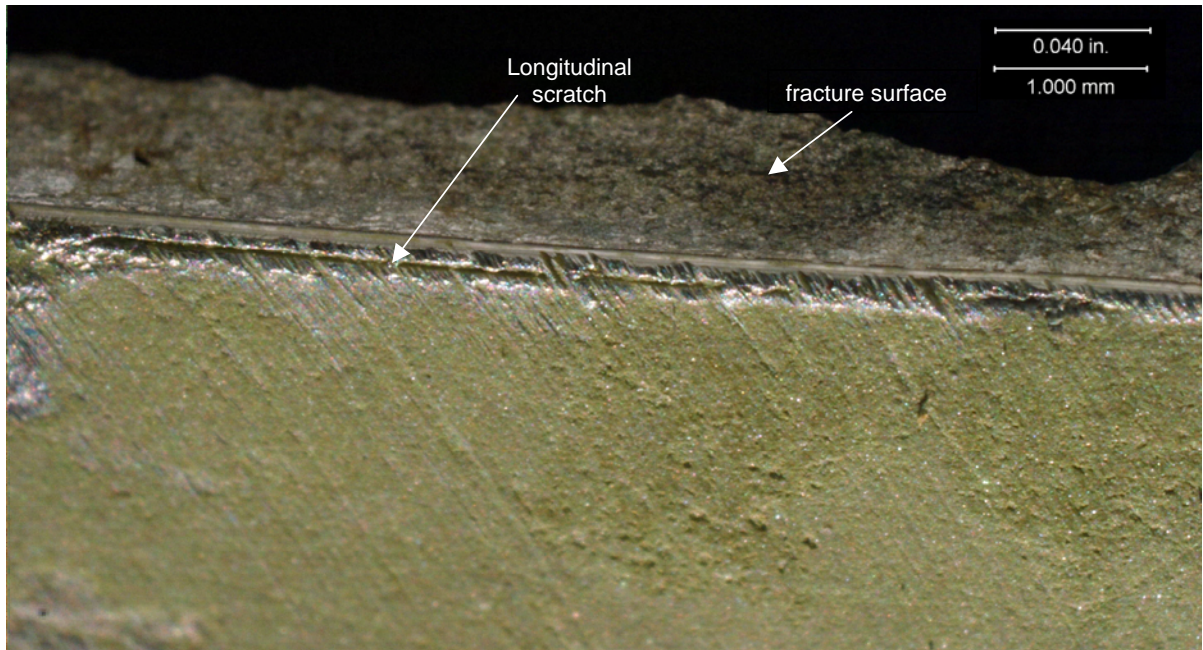
Figure 7.
Surface of skin faying with repair doubler near hole 20 showing the longitudinal scratch where fatigue crack initiation occurred from multiple origins. Also note the sanding marks induced during rework of the skin.

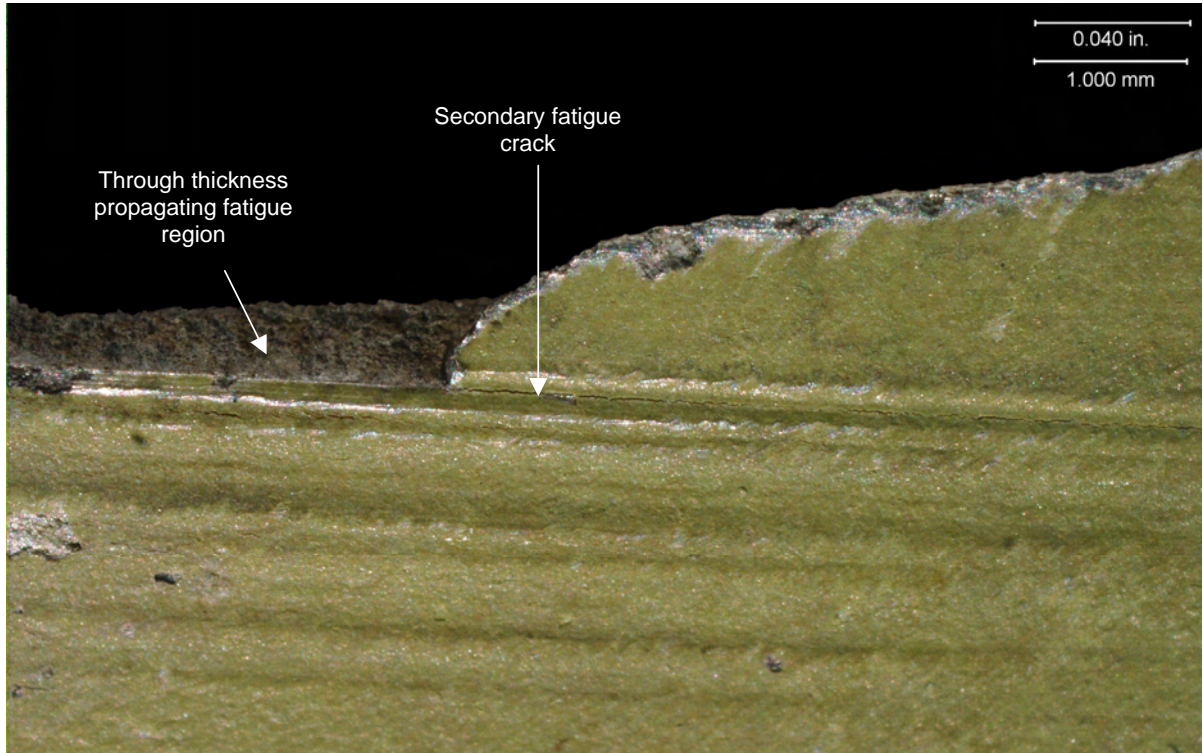
Figure 8.
Surface of skin faying with repair doubler between hole 29 and hole 30 showing the longitudinal scratches in relationship to this fatigue crack. Note the secondary crack extending out of this common scratch.

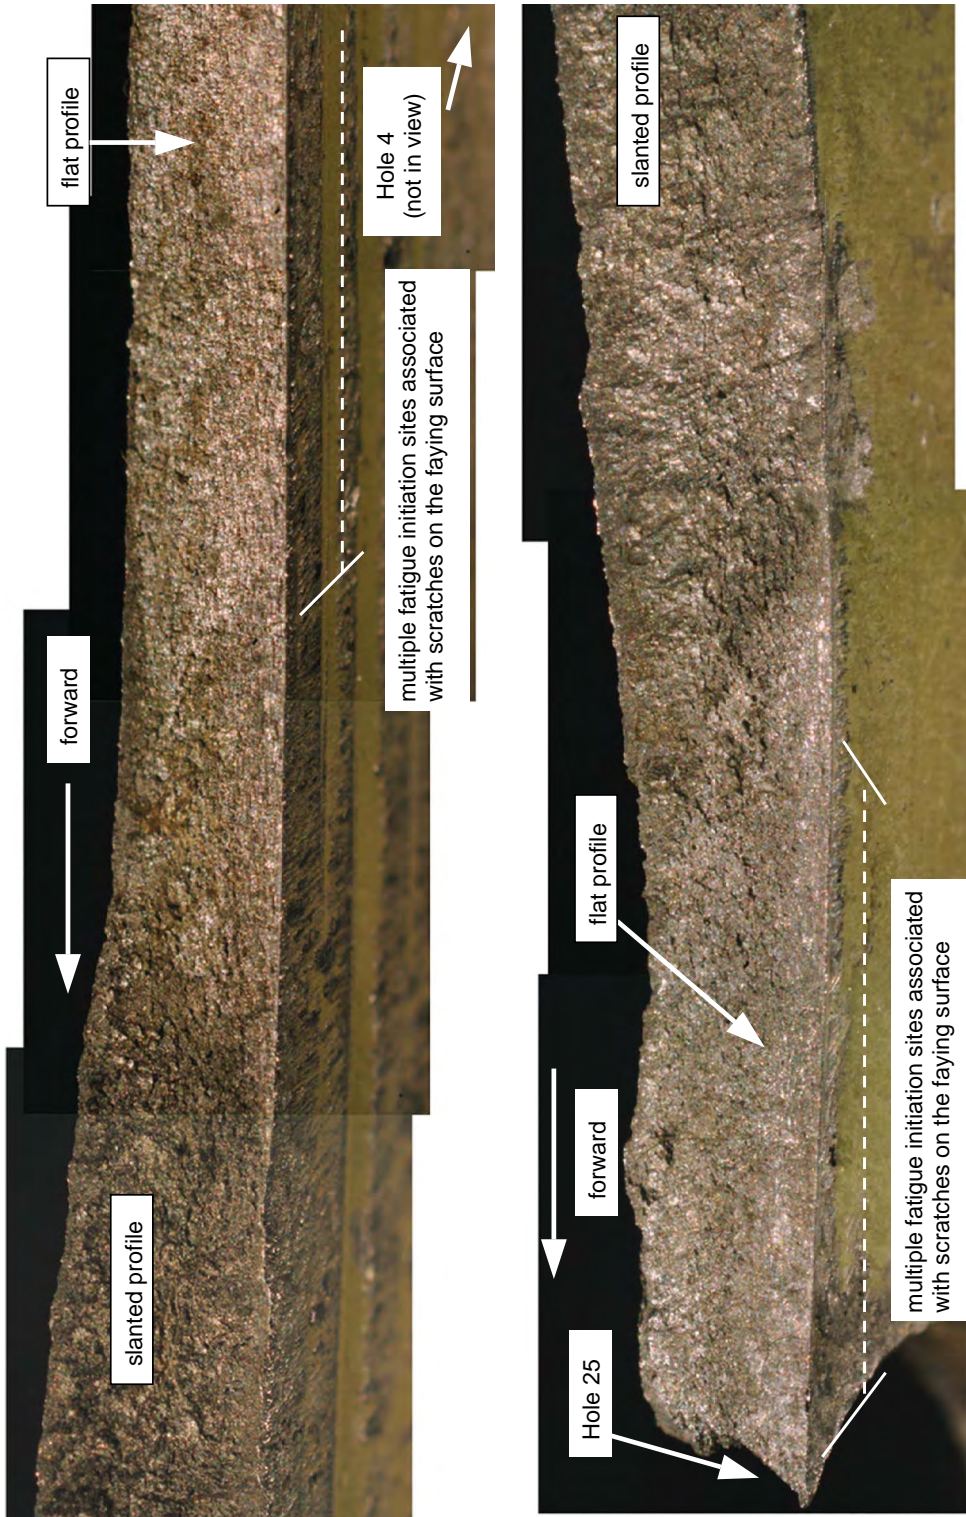
Figure 9, Photographs showing the transition regions from flat fracture profiles to slanted profiles just forward of fastener Hole 4 (top) and Hole 25 (bottom).

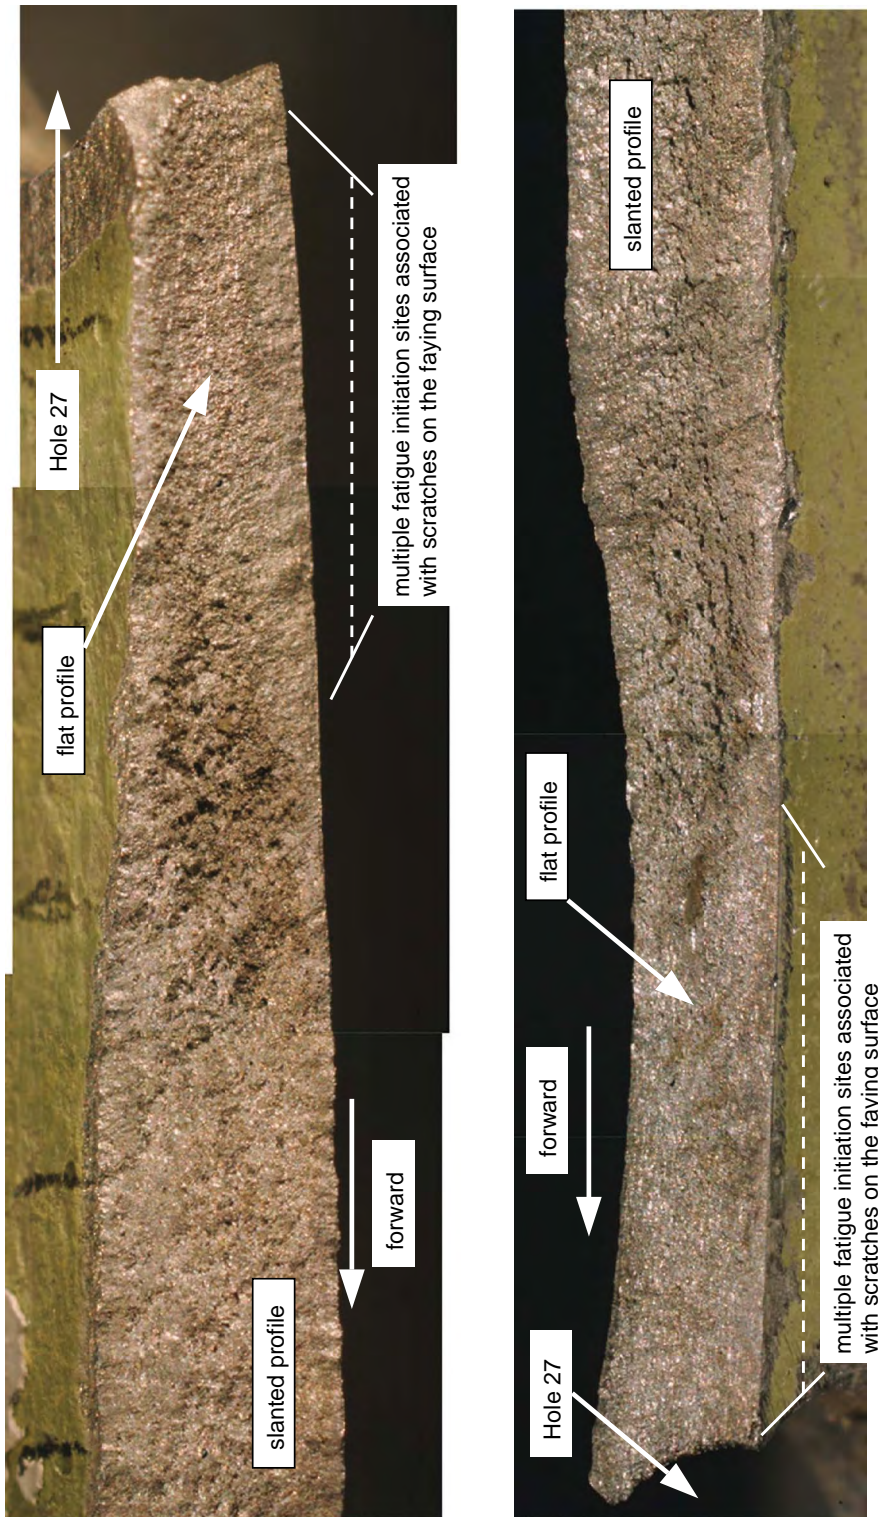
Figure 10, Photographs showing the transition regions from flat fracture profiles to slanted profiles at fastener Hole 27 in the forward direction (top) and the aft direction (bottom).

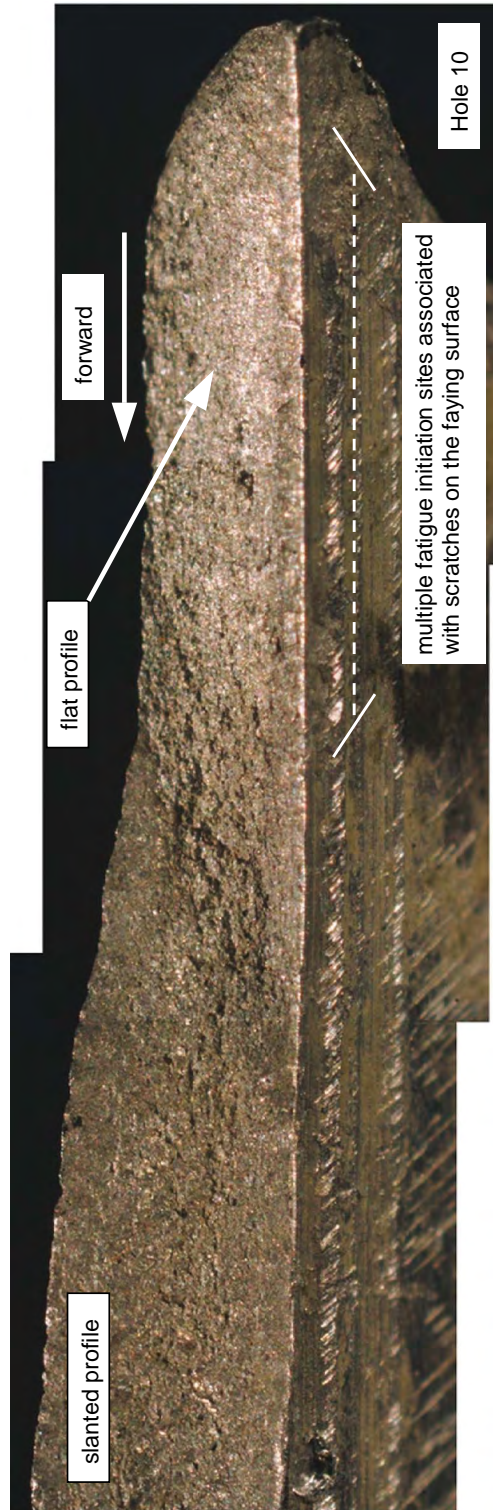
Figure 11, Photograph showing the transition region from a flat fracture profile to a slanted profile at fastener Hole 10 in the forward direction.

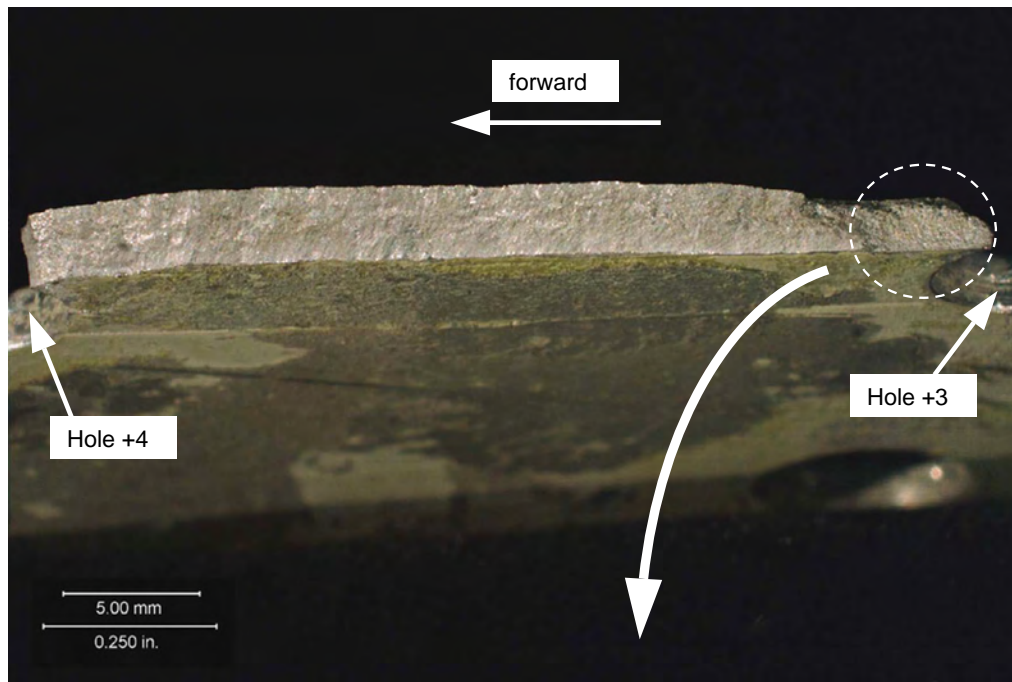
Figure 12, Photographs of the fracture segment extending from Hole +3 to +4 (top), and closer view of the flat profile fatigue region on the forward side of Hole +3 (bottom).

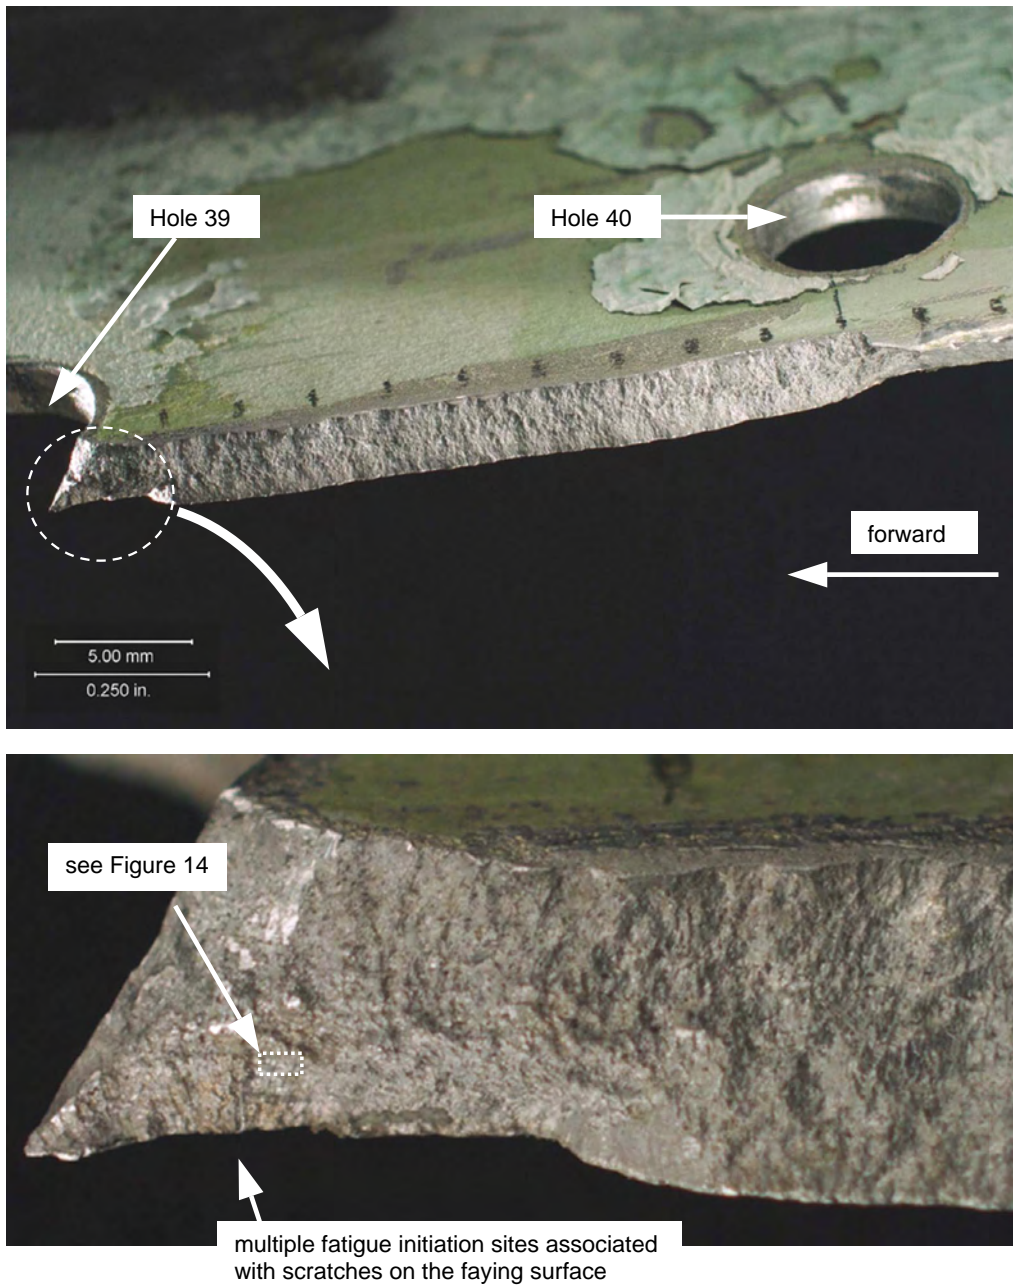
Figure 13, Photographs of the fracture segment extending from Hole 39 to 40 (top), and closer view of the flat profile fatigue region and short transition zone on the aft side of Hole 39 (bottom). SEM photographs showing a dramatic increase in striation spacing near the extent of the flat fracture thumbnail (indicated area) are shown below in Figure 14.

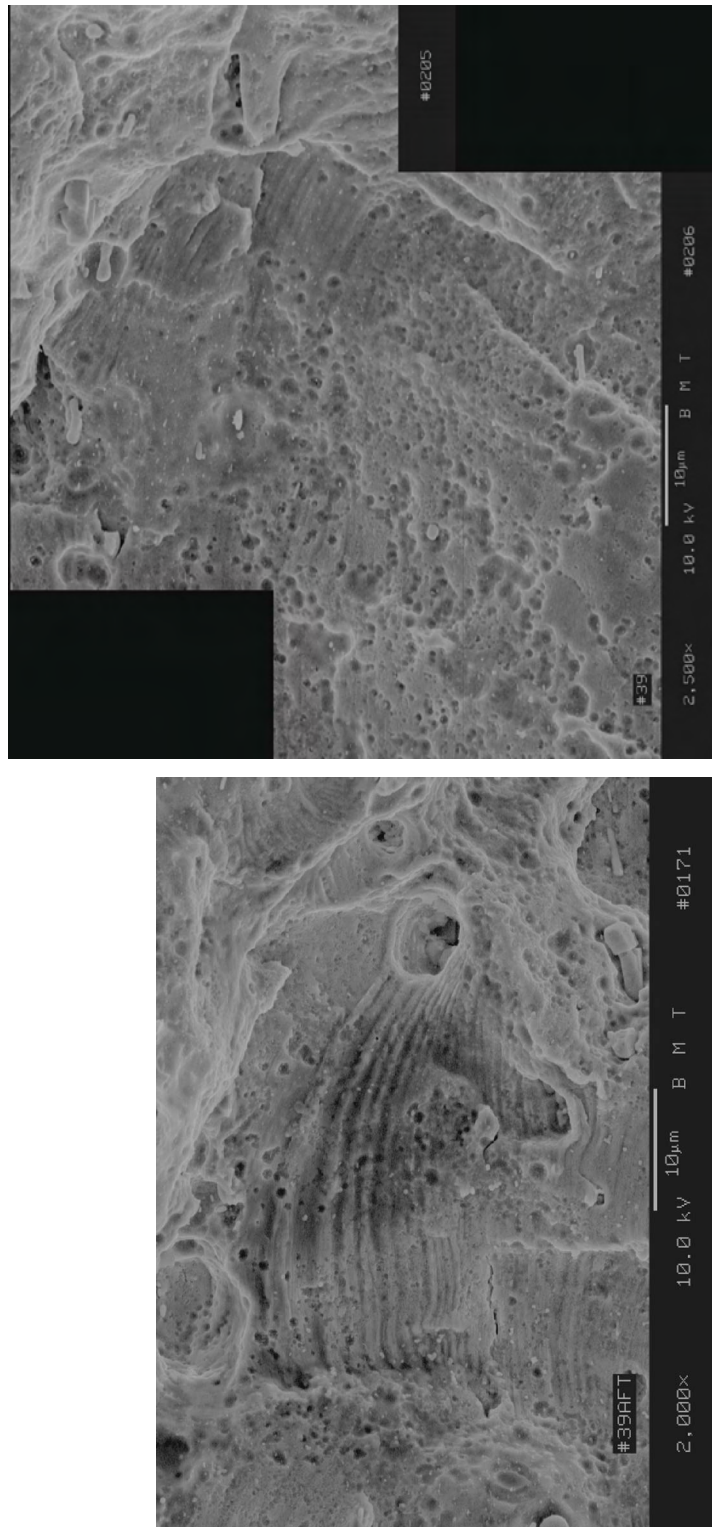
Figure 14, scanning electron microscope photographs showing fatigue striations near the end of the flat profile fracture surface aft of Hole 39. Just beyond these regions, the fracture surface was dominated by a dimpled morphology, indicative of the fracture mechanism of micro-void coalescence, or ductile separation. Severe pitting due to corrosion can also be seen.

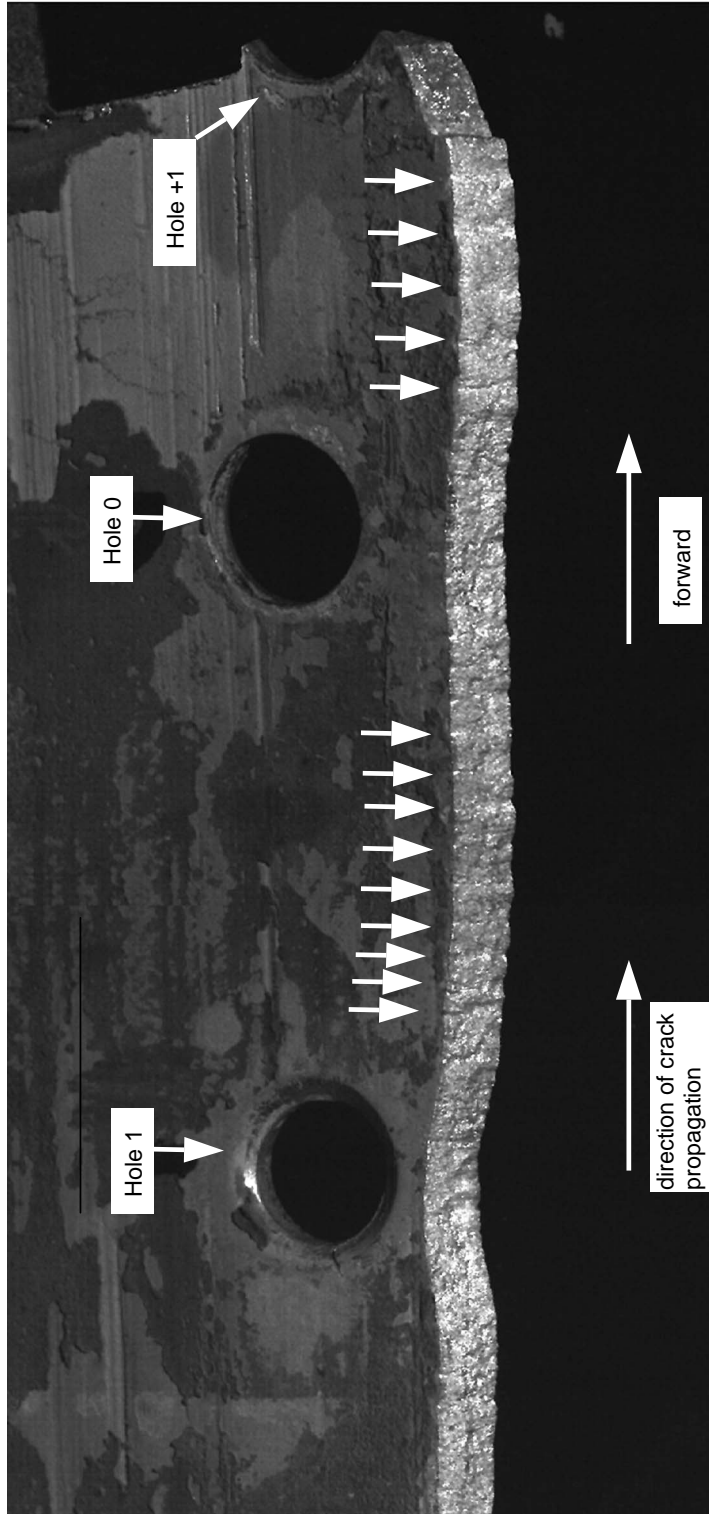
Figure 15, Photograph showing the incremental crack growth indications on the fracture segment from Hole 1 to Hole +1 with two groups of them identified with arrows. This area is just a few inches forward of the flat profile fatigue and transition areas of Hole 4 shown in Figure 9. Note that the regular spacing generally increases as the distance increases from the main cracking system at Holes 4 through 26. These features indicate that the dominant crack was growing at macroscopic rates in a forward direction here when these features were formed, rather than in a through-thickness direction as was the earlier fatigue initiation and propagation mechanism. This point is further exemplified in the following Figure 16.

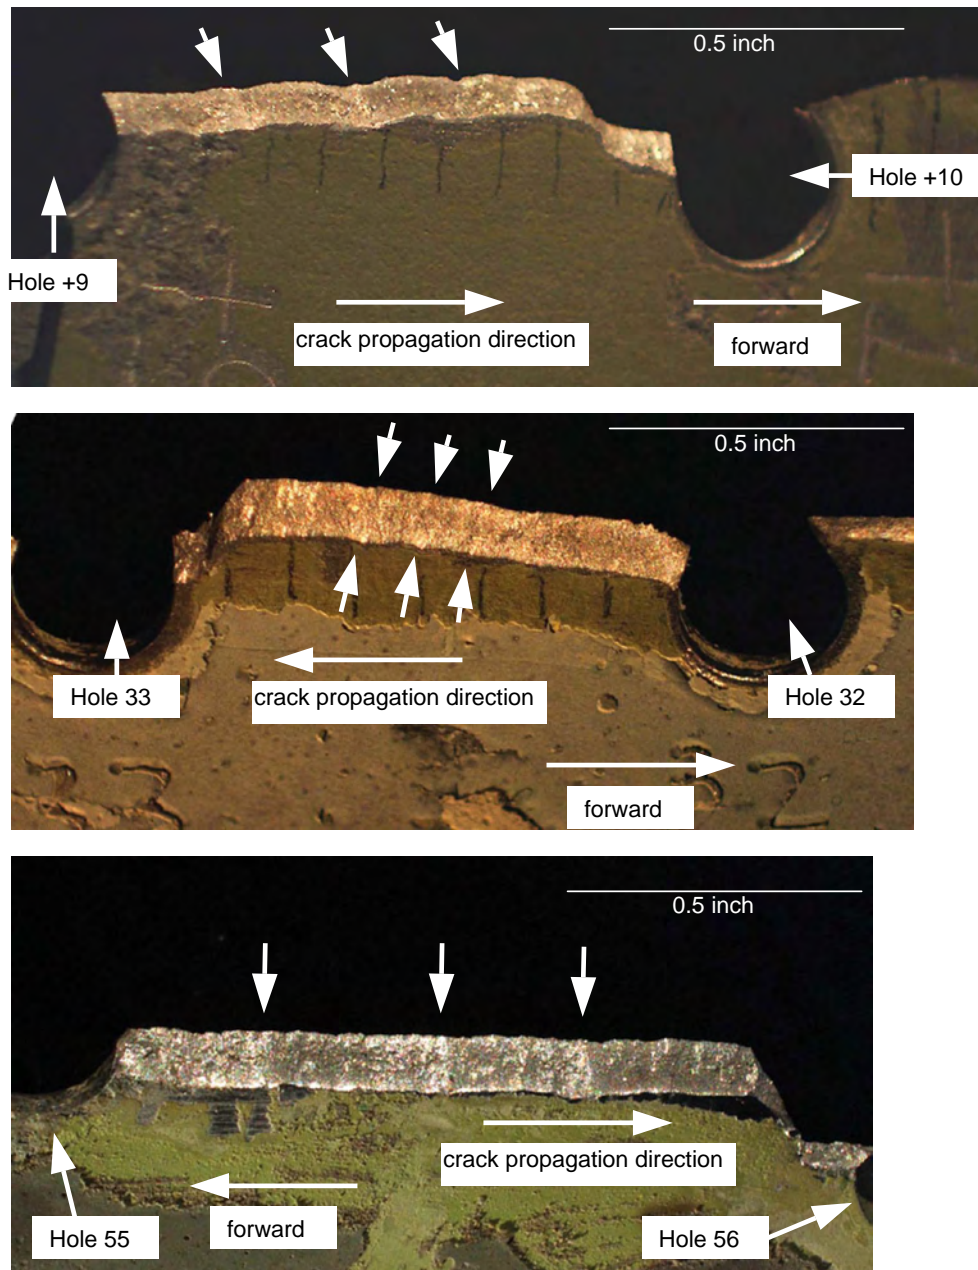
Figure 16, Photographs showing the incremental crack growth indications on the fracture segments between Holes +9 and +10 (top), Holes 32 and 33 (center), and Holes 55 and 56 (bottom).

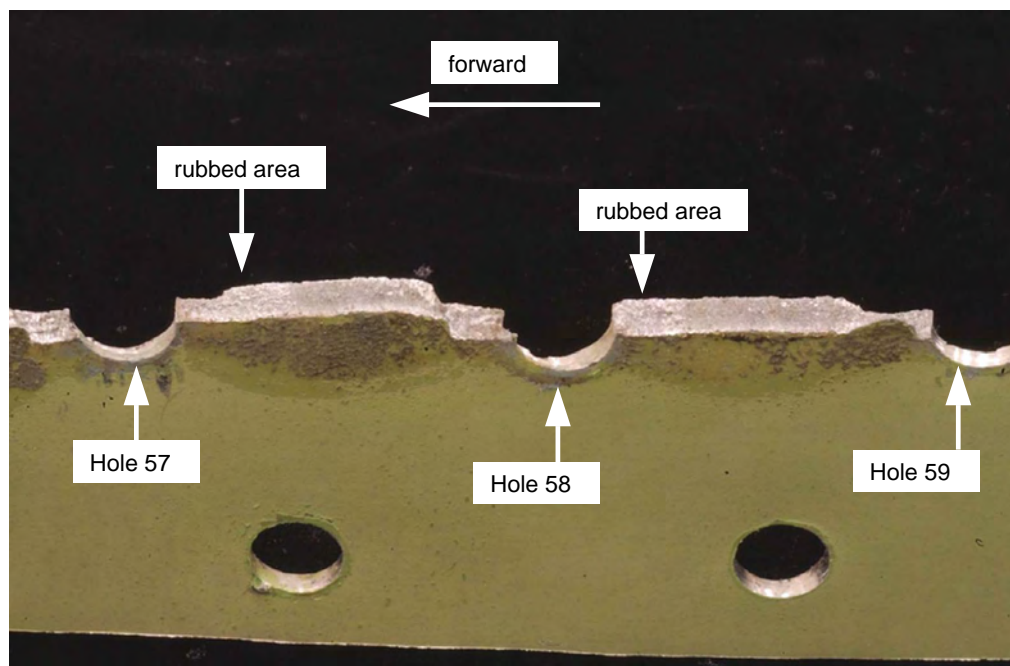
Figure 18, Photograph of the fracture surface at Holes 57, 58, and 59. The shiny areas are indicative of rubbing with the mating fracture surface and appeared consistently forward of this area, but were not present aftward beyond Hole 62.

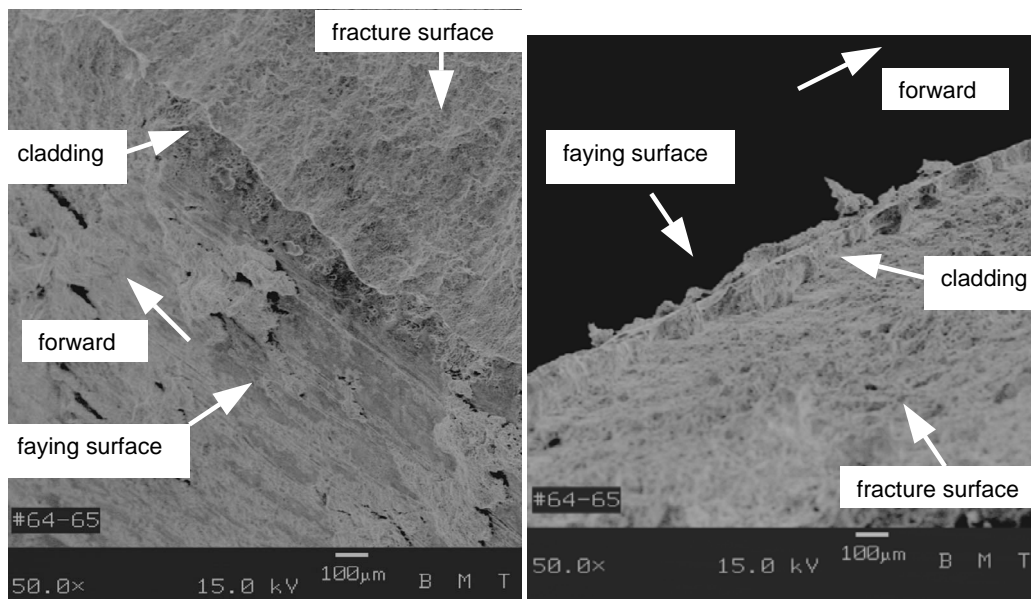
Figure 22, opposing angle SEM photographs of the fracture segment between Holes 64 and 65 showing the cladding on the faying surface retaining its upward profile from the necking process during ultimate tensile separation without subsequent crack closure.

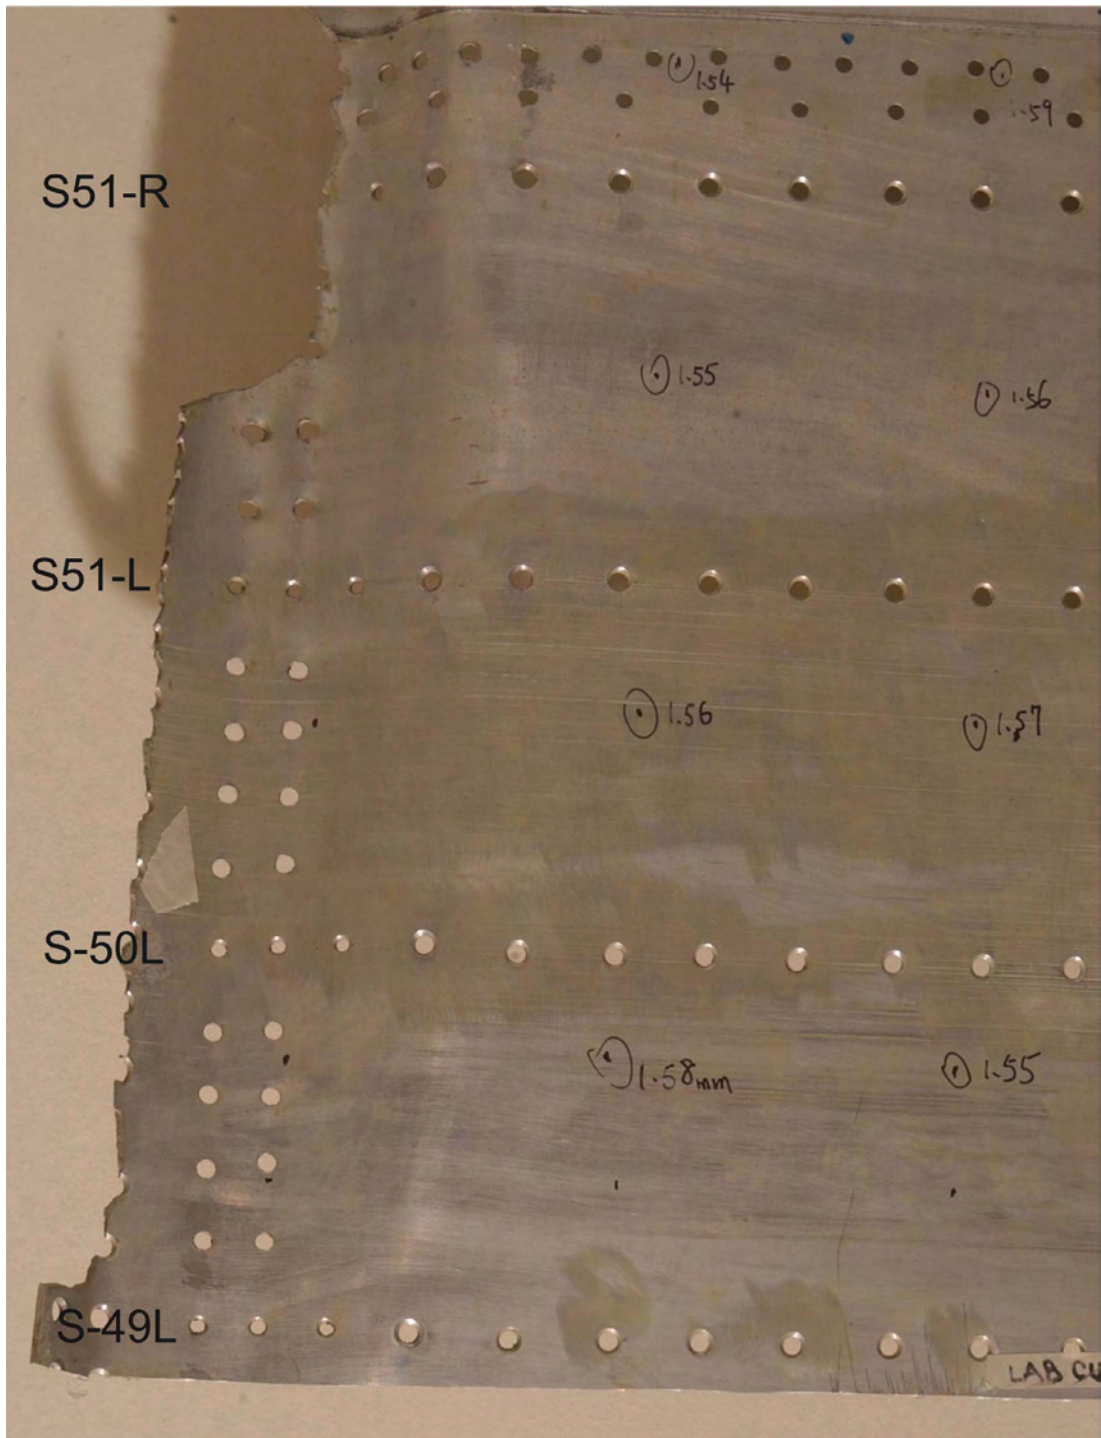
FIGURE 28 – EXTENT OF DAMAGE CONSISTENT WITH A TAIL STRIKE – Scratches may be noted at S-50L and S-51L. Numerical information on skin are results of thickness measurements at the CSIST. Scratch severity increases as you move forward on the panel as shown in the following photographs.

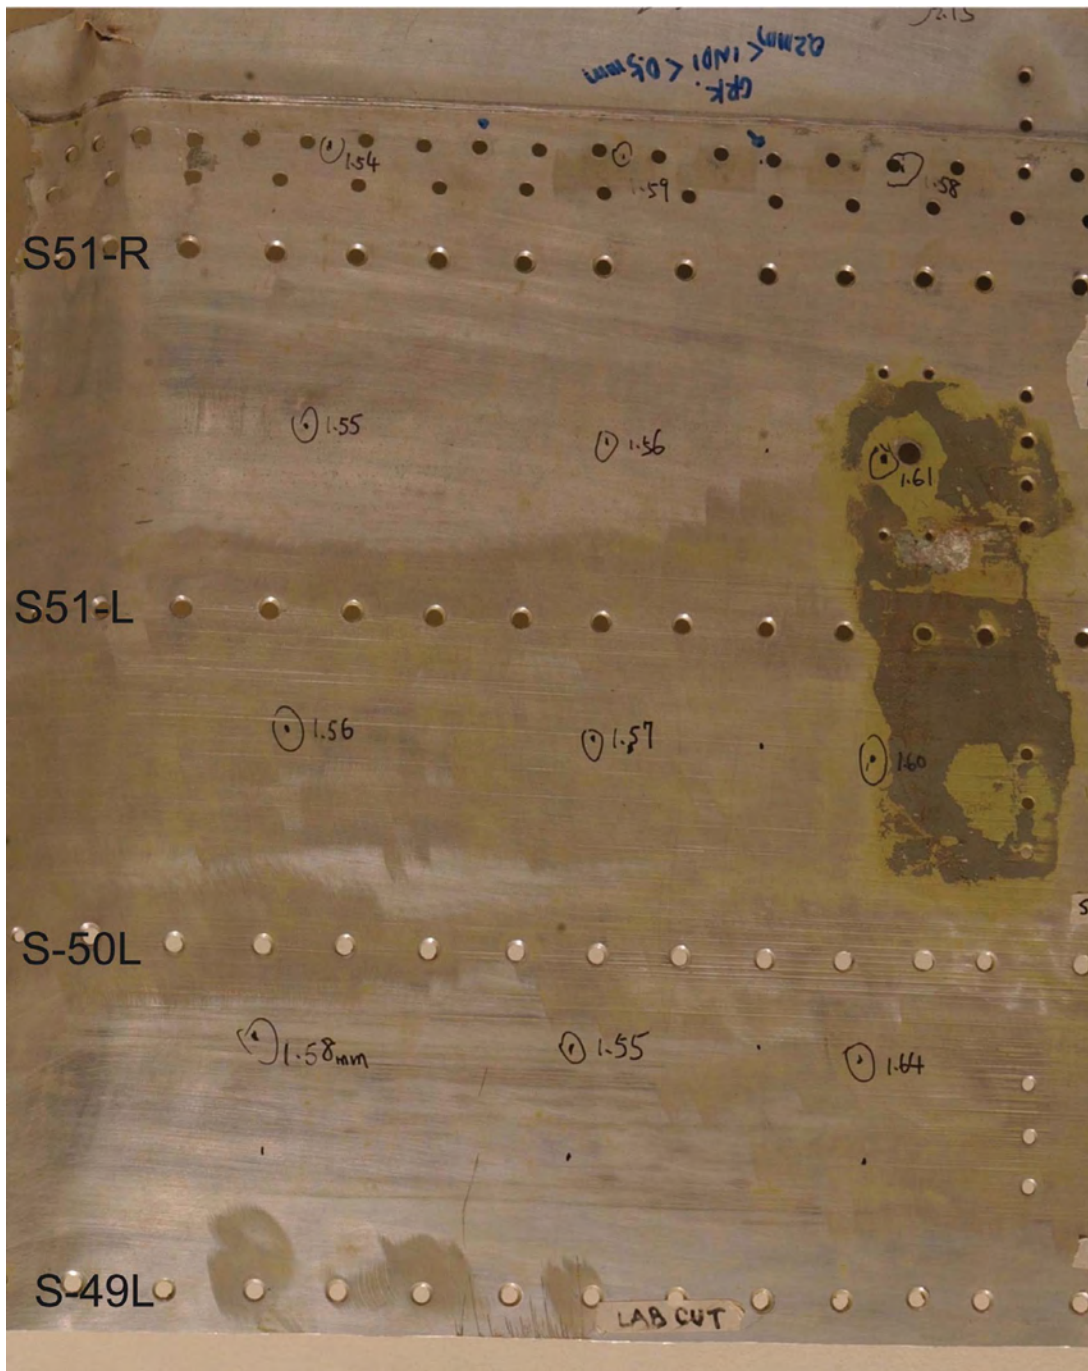
FIGURE 29. EXTENT OF DAMAGE CONSISTENT WITH A TAIL STRIKE – Scratches may be noted at S-50L and S-51L. Scratches may also be noted at the shear tie between S-49L and S-50L.

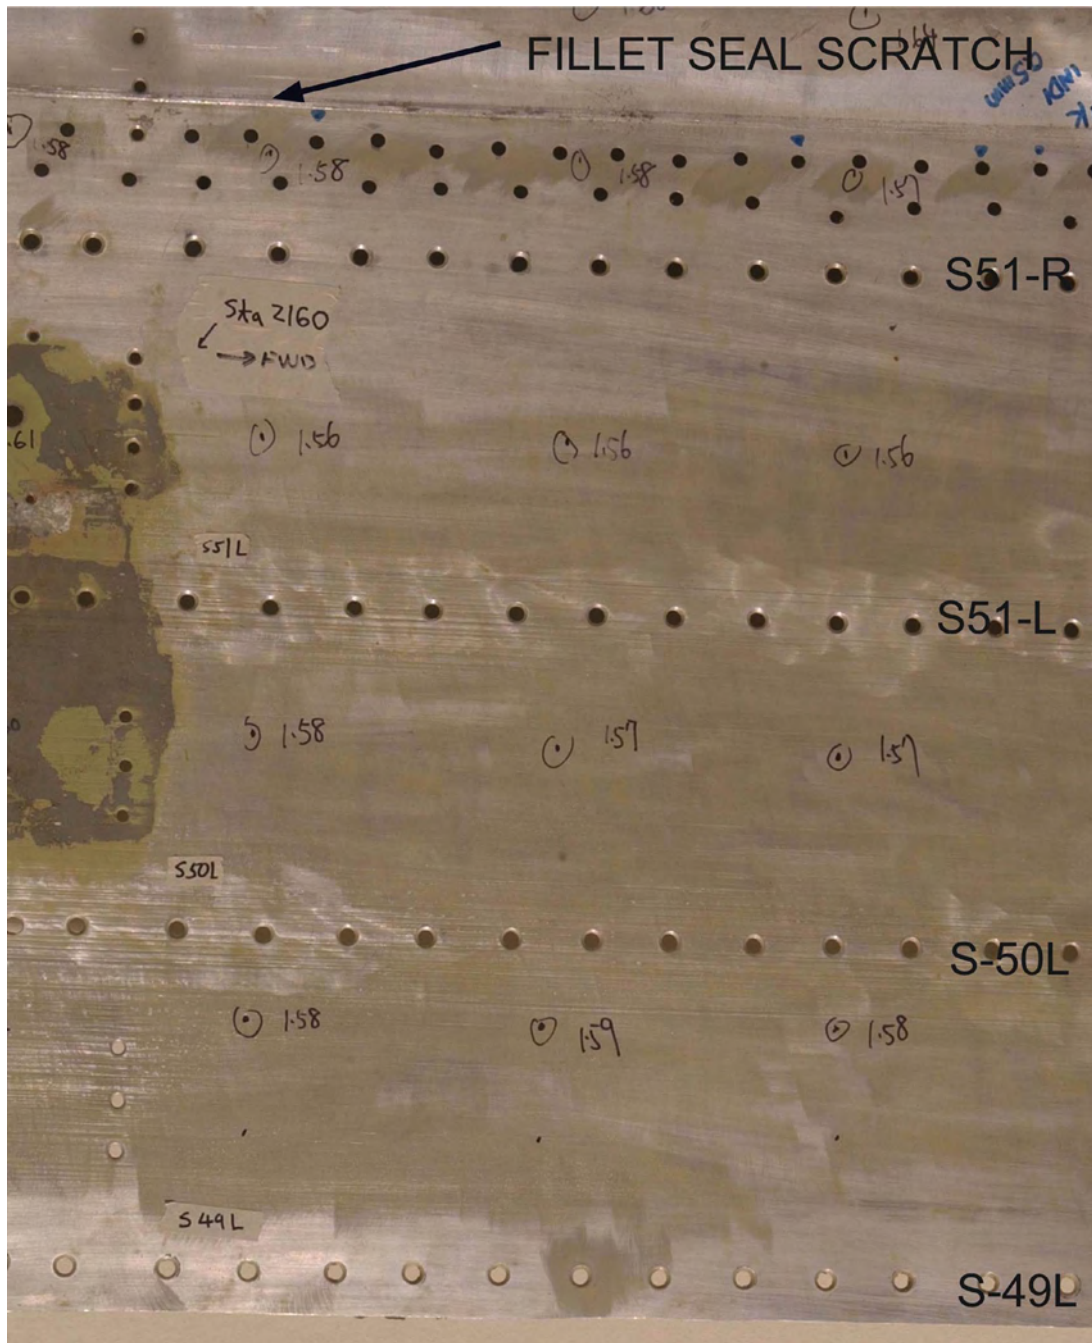
FIGURE 30. EXTENT OF DAMAGE CONSISTENT WITH A TAIL STRIKE - Note that minimal damage occurs on the right hand side of the repair area. Scratching in the doubler fillet seal area may also be seen in this photo.
