飛航事故調查報告 第二冊

ASC-AOR-05-02-001

中華航空公司 CI611 班機

行政院飛航安全委員會
AVIATION SAFETY COUNCIL
中華民國九十四年六月

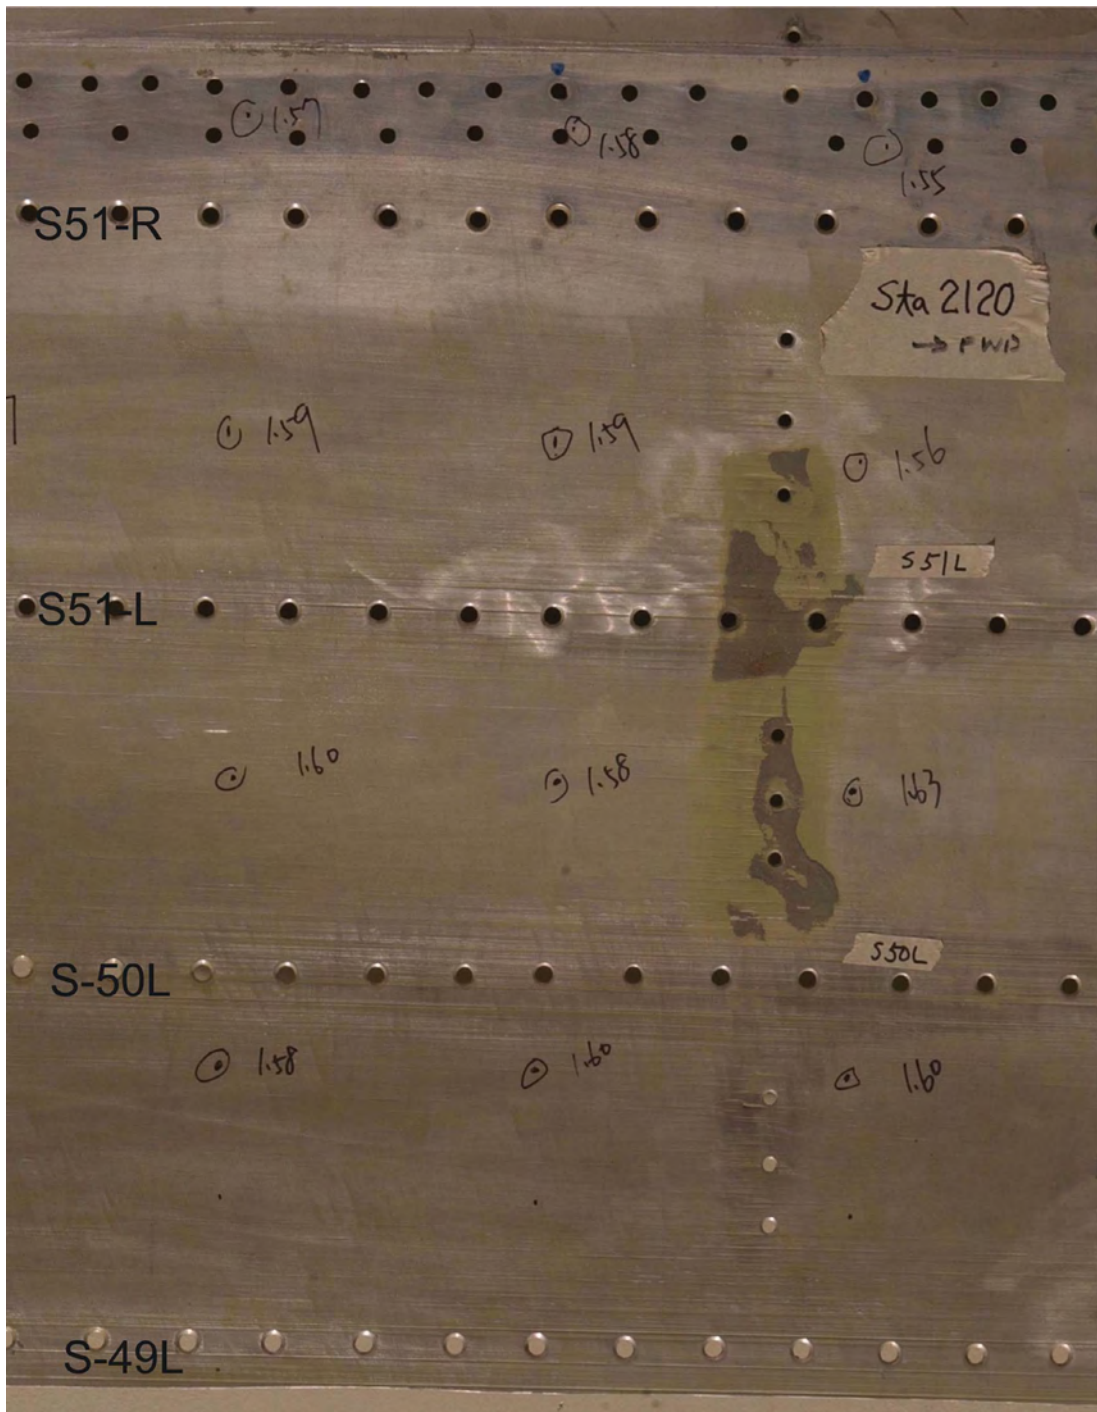
FIGURE 32. EXTENT OF DAMAGE CONSISTENT WITH A TAIL STRIKE – Deep scratches can be noted at S-49L, S-50L, AND S-51L.

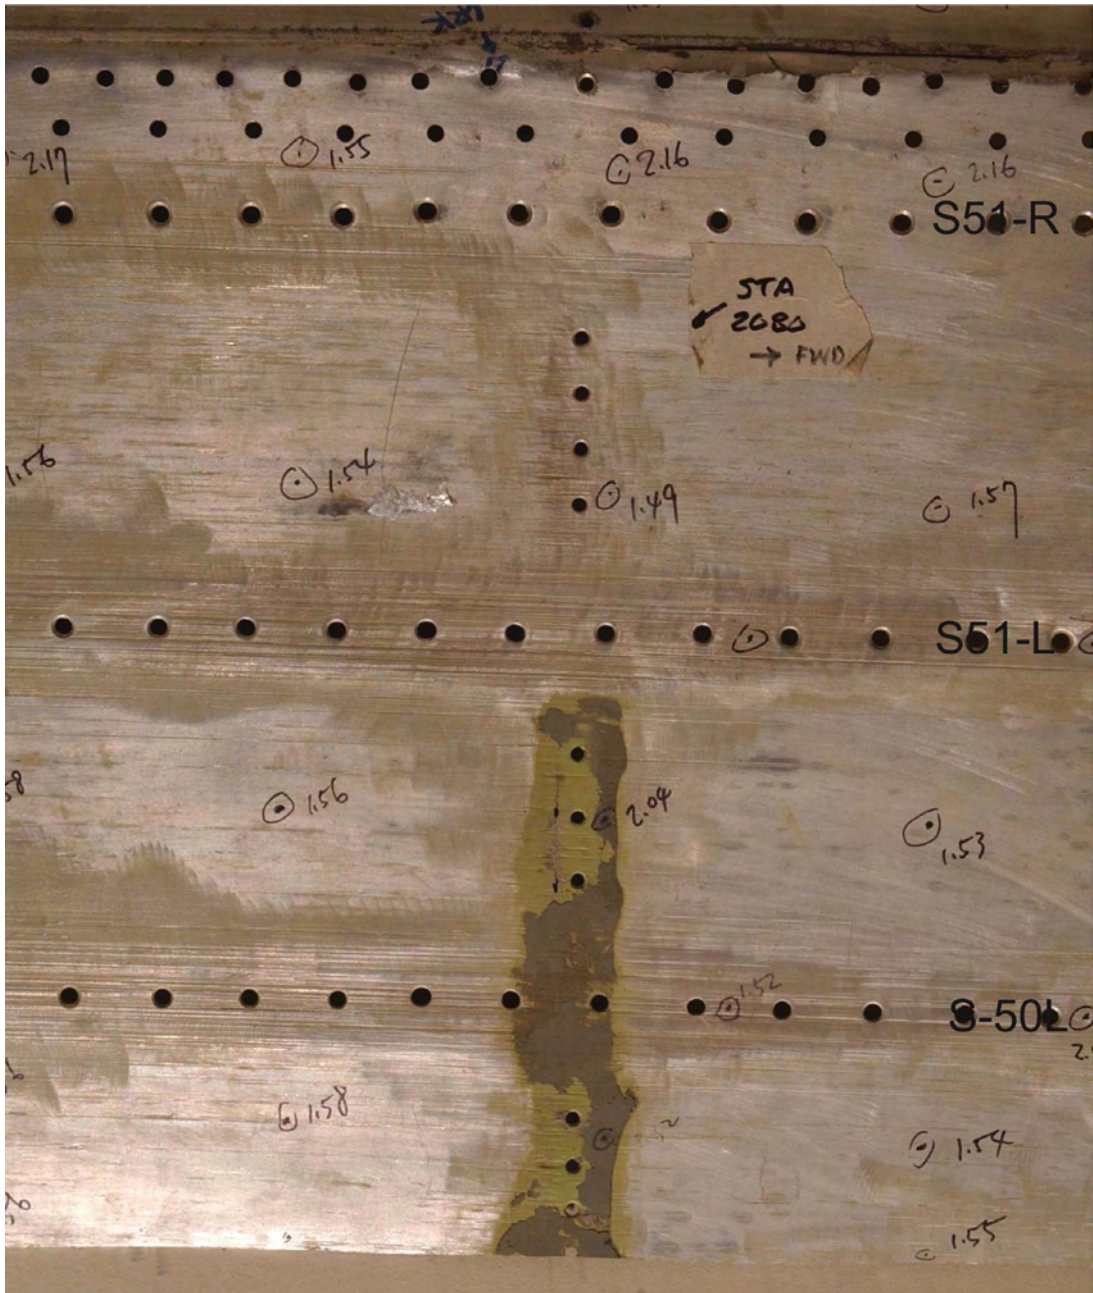
FIGURE 35. EXTENT OF DAMAGE CONSISTENT WITH A TAIL STRIKE – Note the severity of damage in this photo.

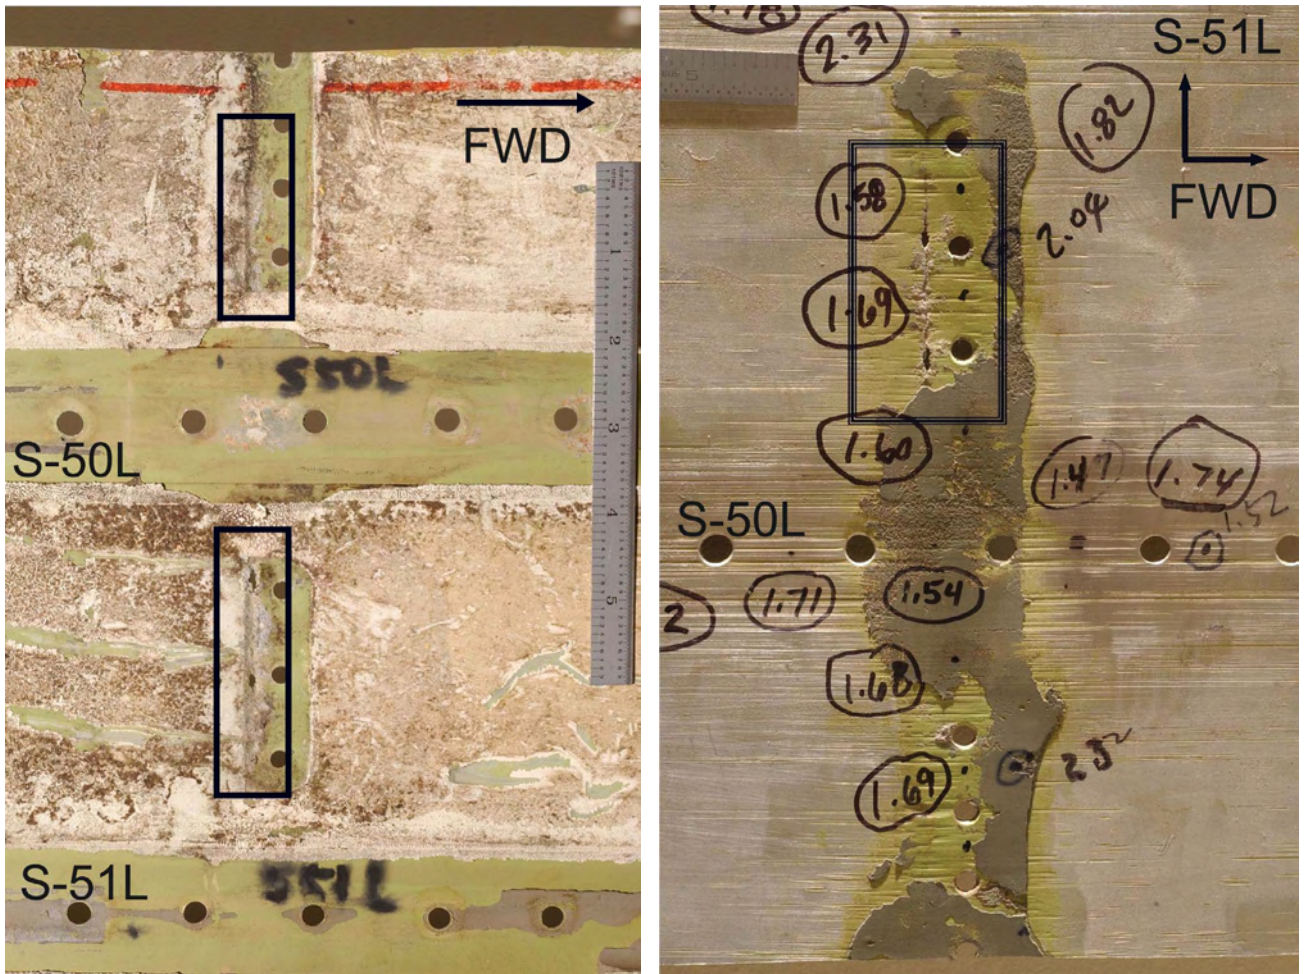
Figure 47. SKIN CORROSION FEATURES AT STA 2080 - Areas of corrosion are identified with rectangles above. Corrosion penetrated completely through the skin thickness at the shear tie located between S-50L and S-51L.

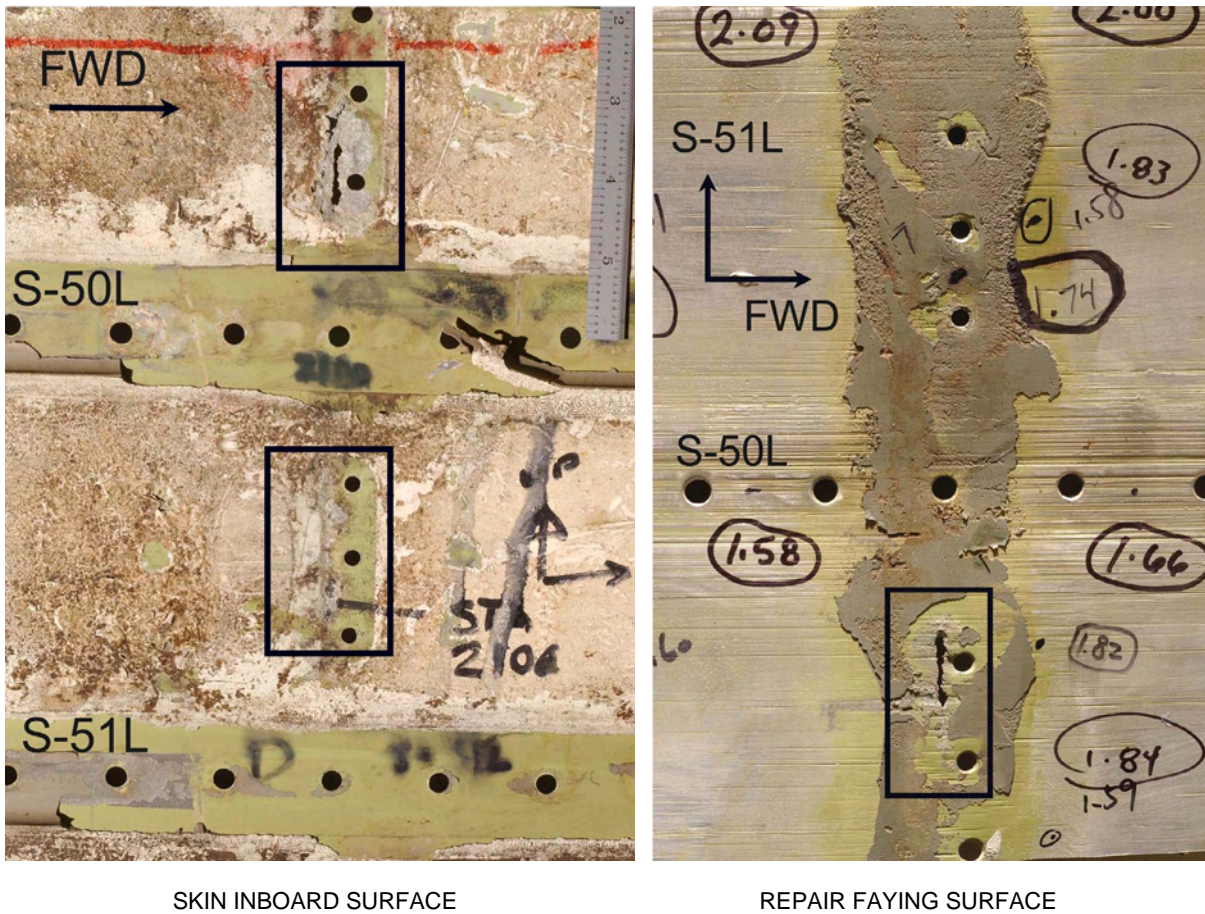
Figure 48. SKIN CORROSION FEATURES AT STA 2100 - Areas of corrosion are highlighted with rectangles. Corrosion penetrated completely through the skin thickness between S-49L and S-50L.

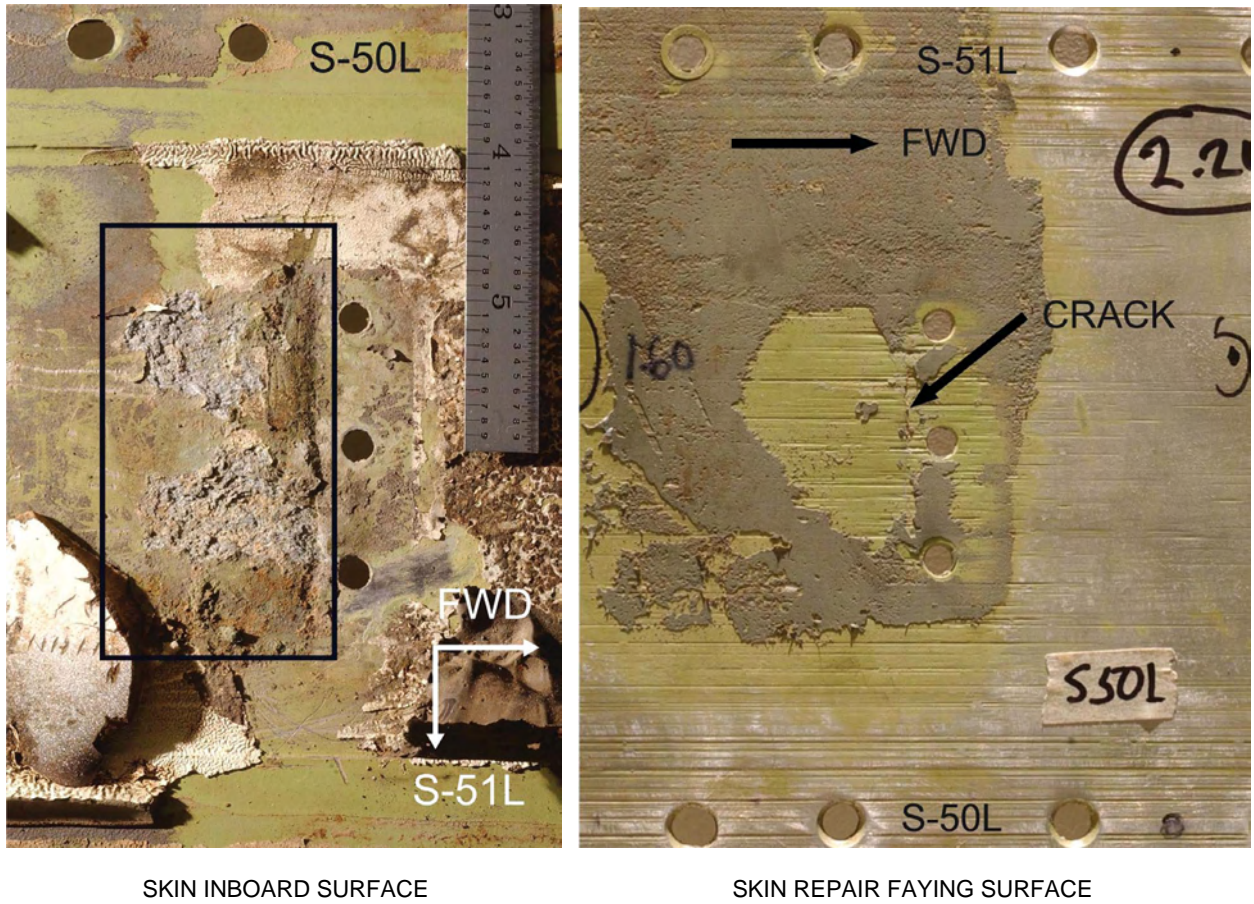
Figure 49. CORROSION FEATURES AT STA 2160, INBOARD SURFACE - The area of corrosion is identified with a rectangle above. A crack noted on the skin faying surface may have been the result of exfoliation corrosion penetrating from the skin inboard surface.

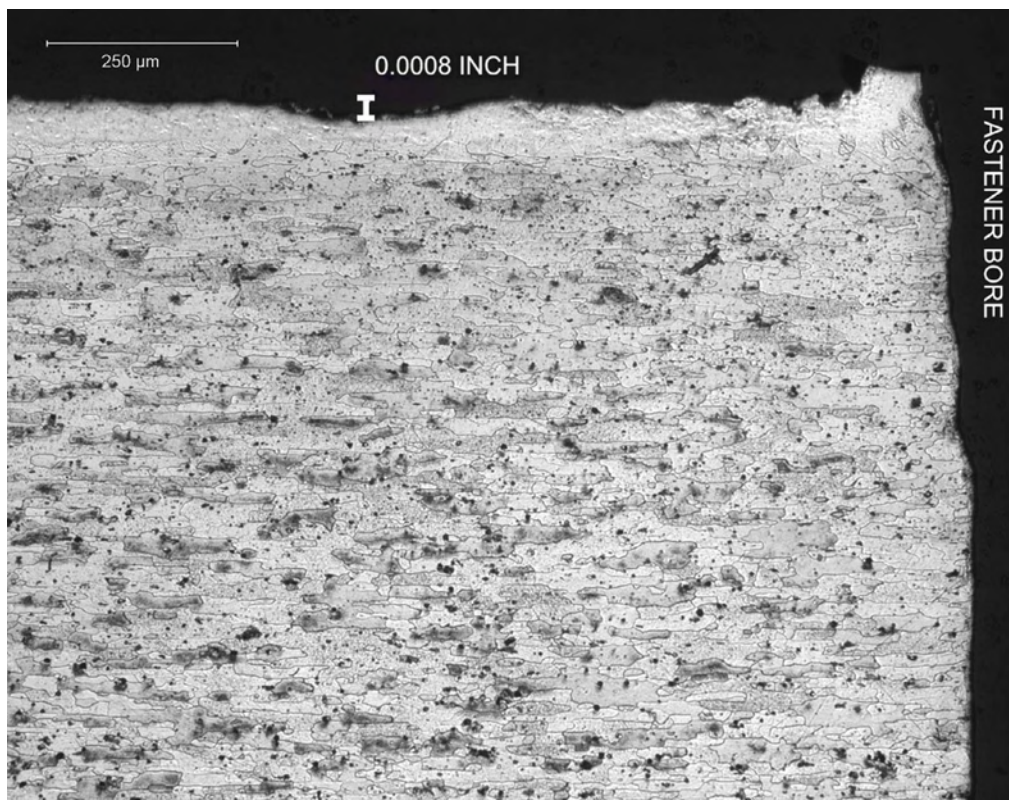
Figure 59. OUTER FASTENER ROW SCRATCH FEATURES AT PLANE A-A – Skin damage at this location was much less severe than on the left hand side of repair doubler. Skin cladding was not compromised by surface damage in this view.

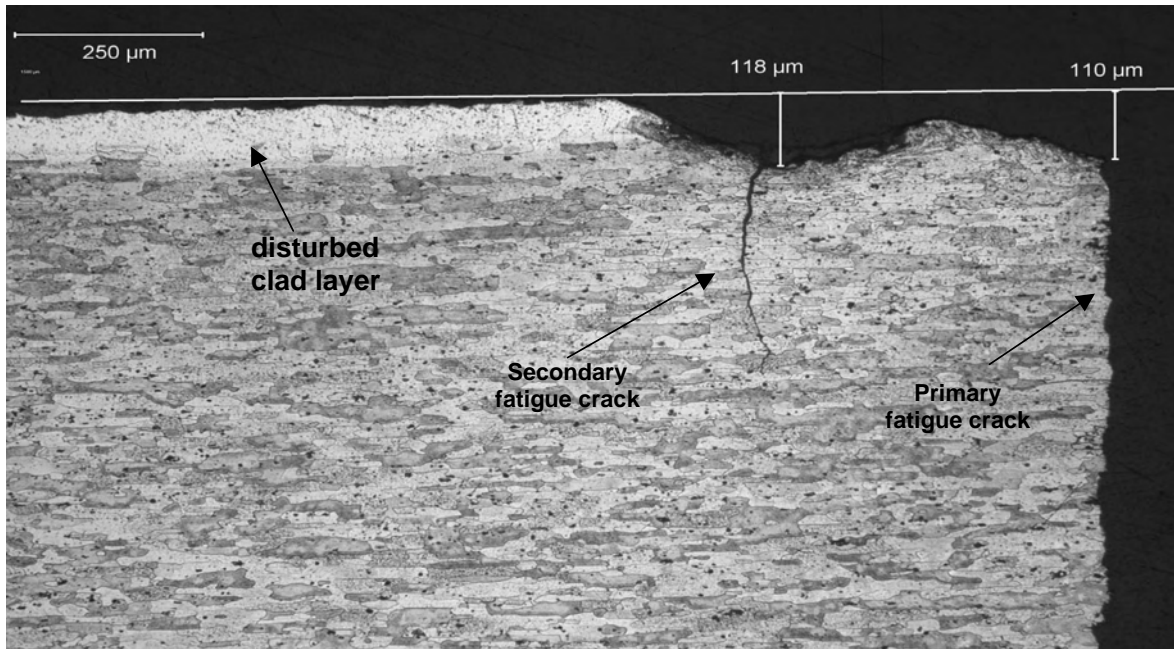
Figure 62. Metallographic specimen through the area indicated in Figure 61 above. The line shown was projected back to an area of undisturbed clad material to determine the depth of the scratches at the primary and secondary fatigue cracks present in this area.

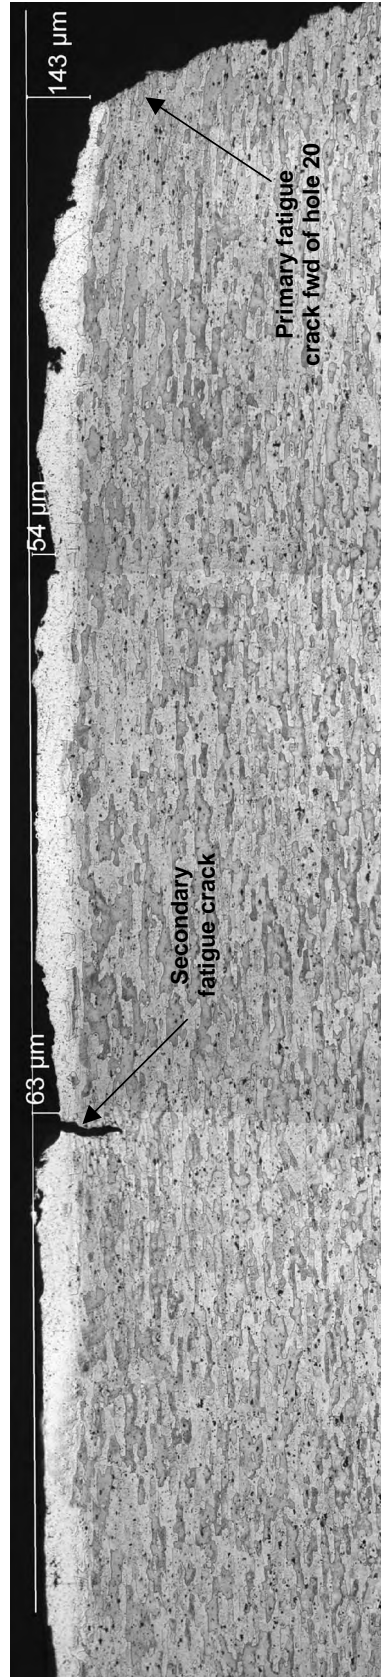
Figure 64. Metallographic montage through the area indicated in Figure 63 above. The line shown was projected back to an area of undisturbed clad material to determine the depth of the scratches at the primary and secondary fatigue cracks present in this area.

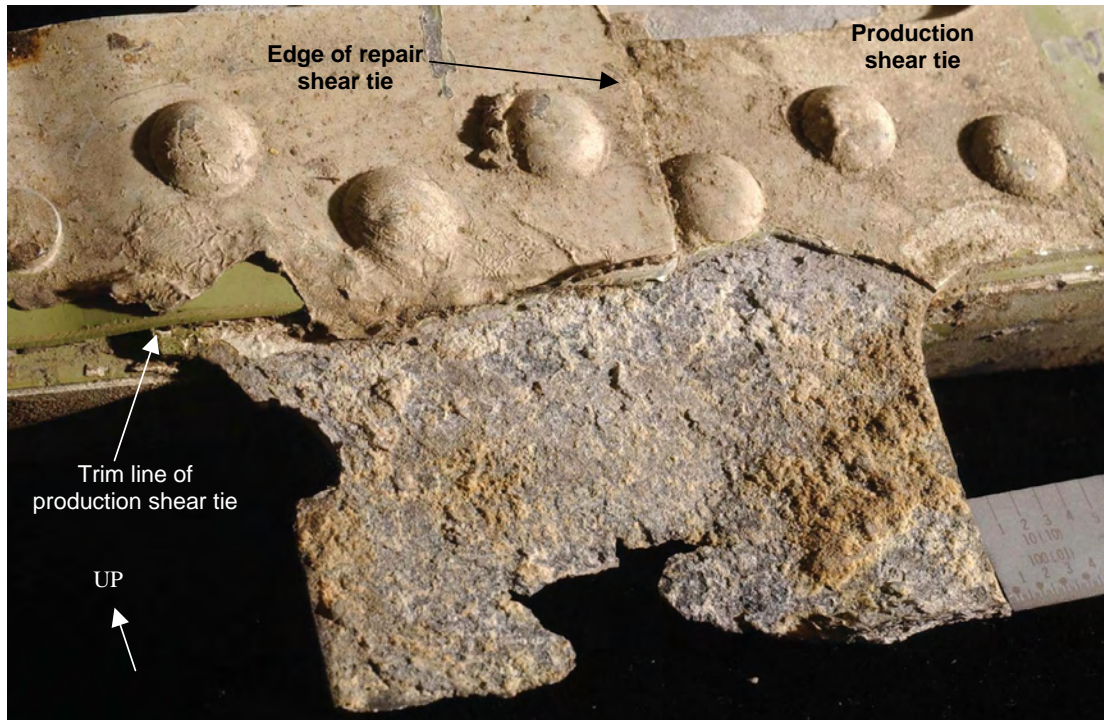
Figure 73.
Exfoliation corrosion present at shear tie between S-50L and S-49L of STA 2160 frame segment.

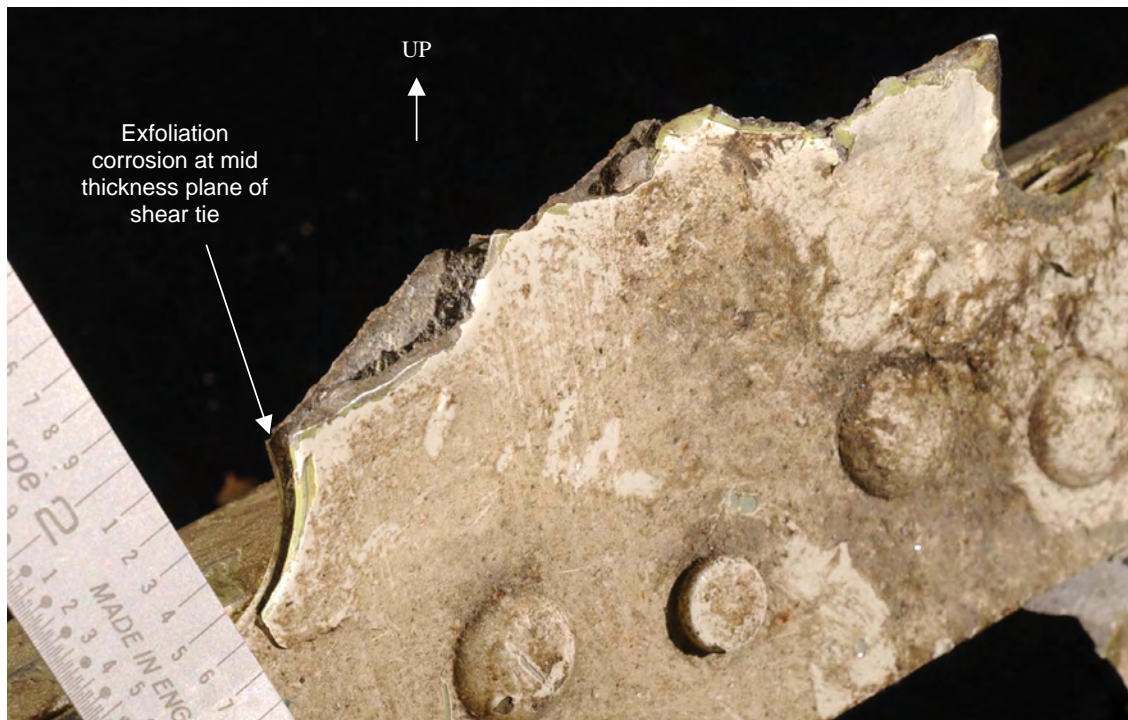
Figure 74.
Exfoliation corrosion present at shear tie between S-49L and S-48L of STA 2160 frame segment.

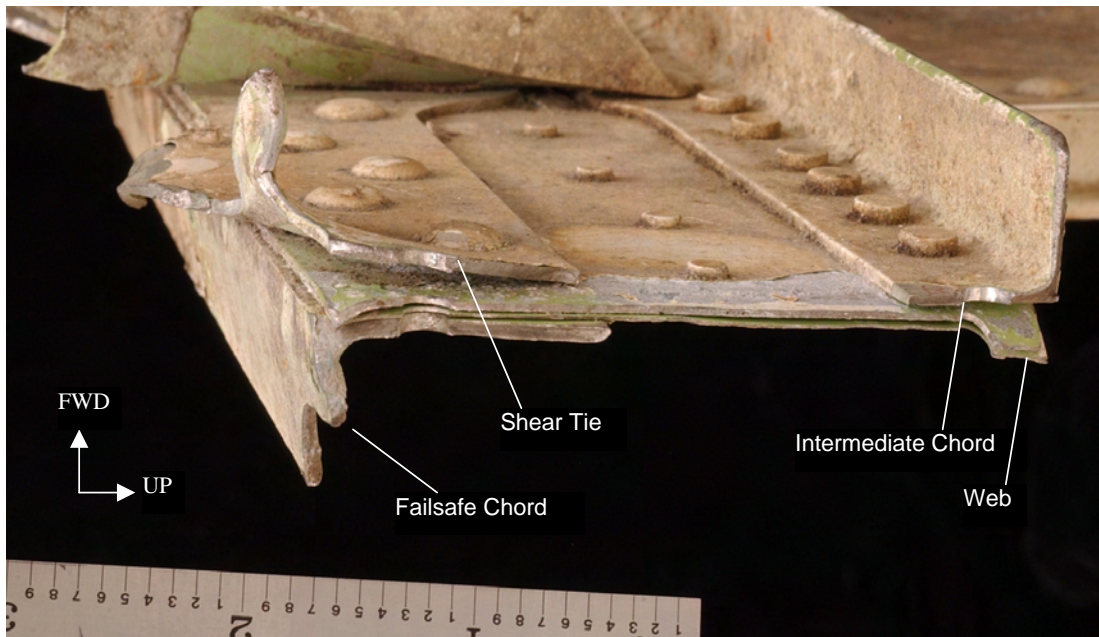
Figure 77.
Fracture at S-49L of the STA 2100 frame segment showing deformation in shear tie and web.

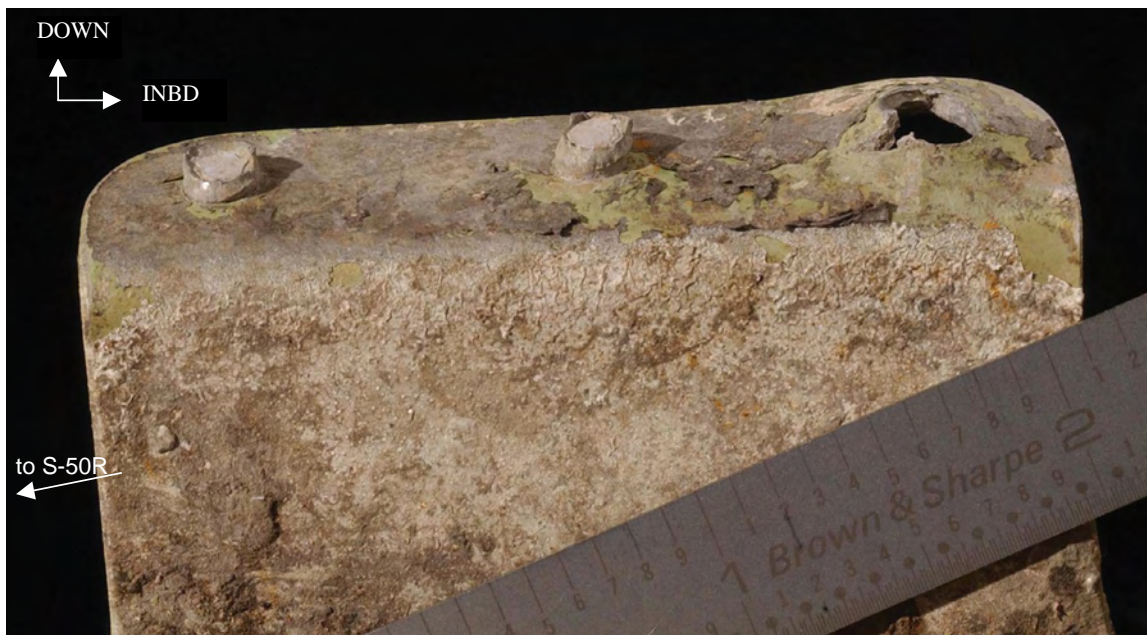
Figure 78.
Shear tie between S-51R and S-50R of the STA 2100 frame segment showing downward deformation in skin flange and pull through of the fastener hole at the inboard most fastener hole.

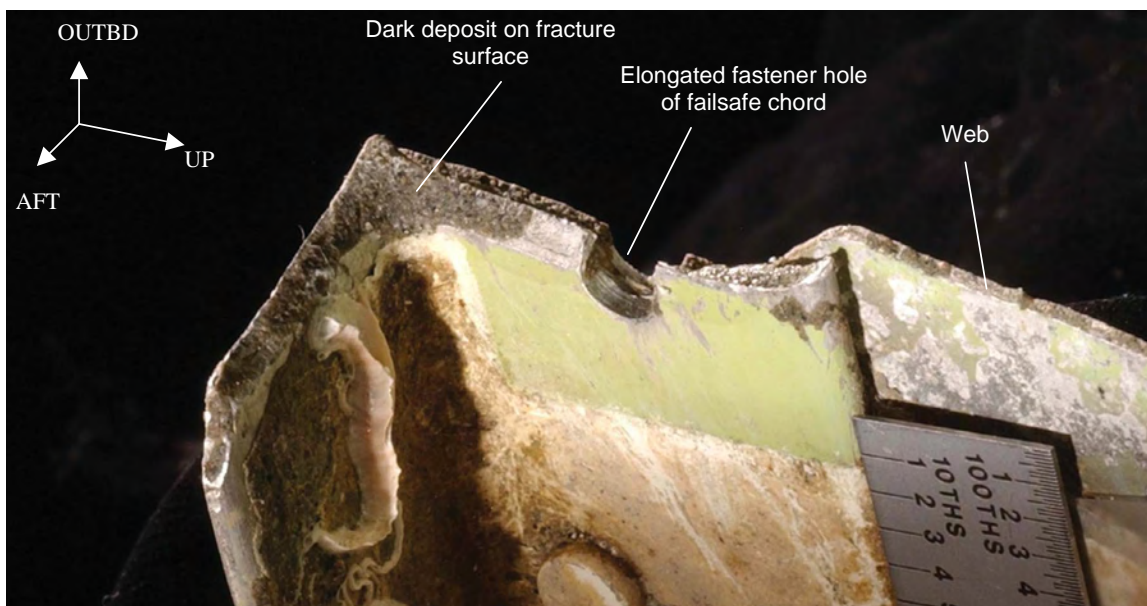
Figure 82.
Fracture surface of failsafe chord and web common to S-49L of the STA 2060 frame segment.

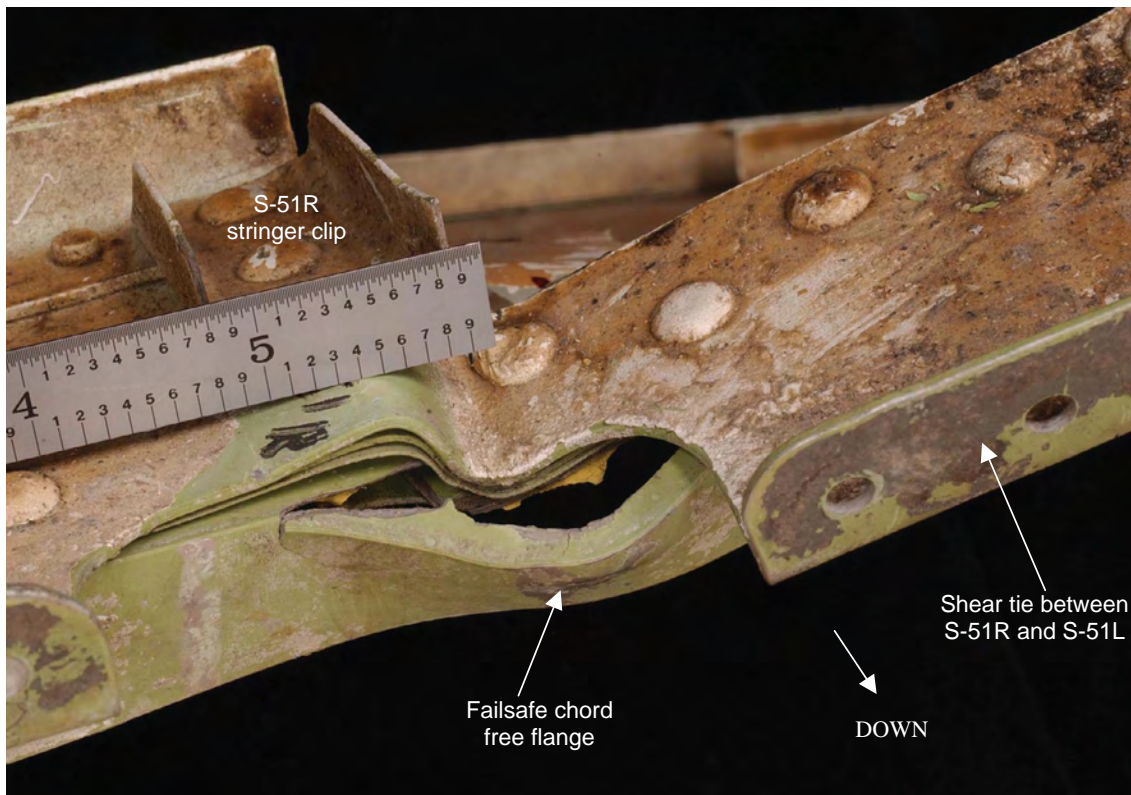
Figure 86. Fracture in failsafe chord free flange radius at S-51R of the STA 2040 frame segment.

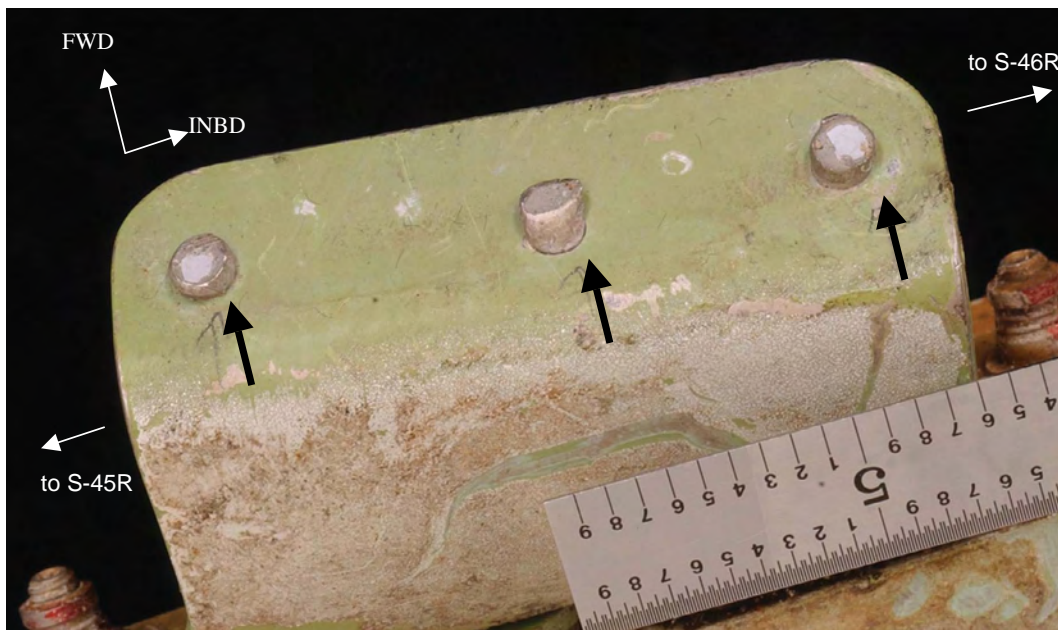
Figure 87. Skin flange rivet fractures at shear tie between S-45R and S-46R of the STA 2040 frame. Black arrows indicate the direction of loading.

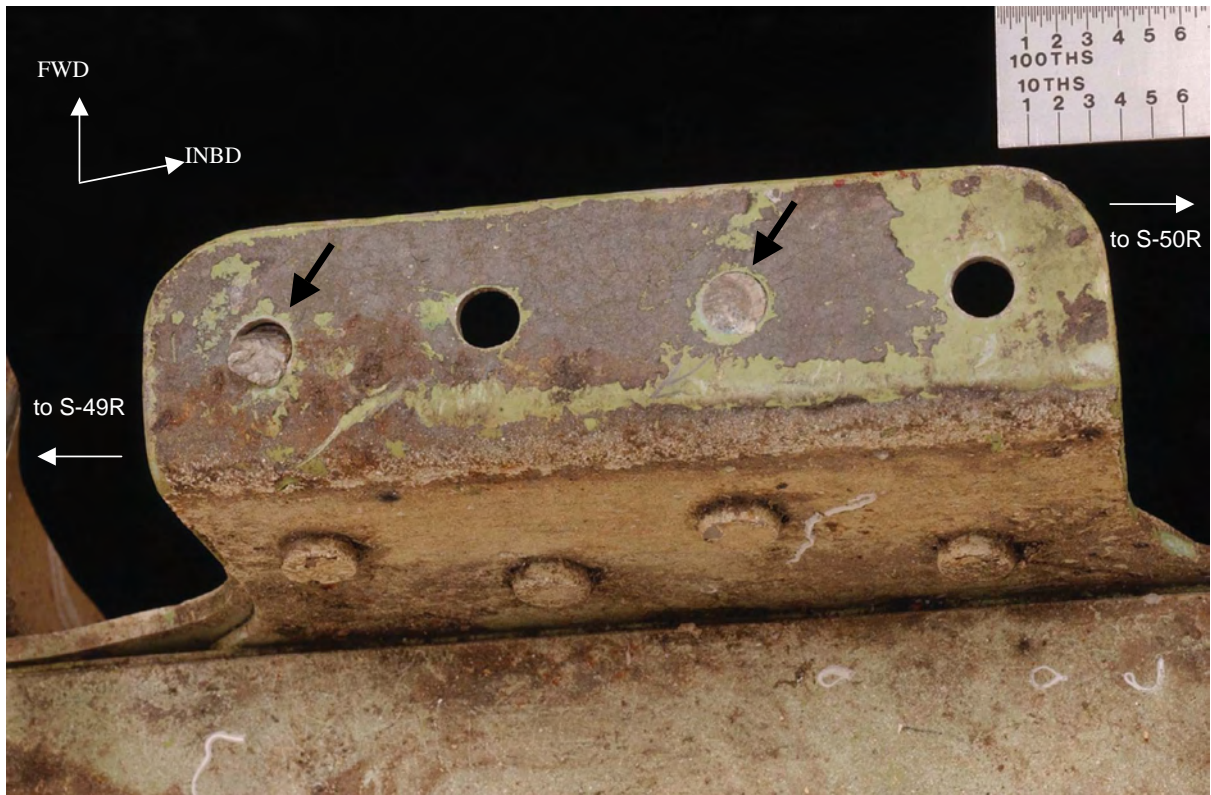
Figure 88. Skin flange rivet fractures at shear tie between S-49R and S-50R of the STA 2040 frame segment. Black arrows indicate the direction of loading.

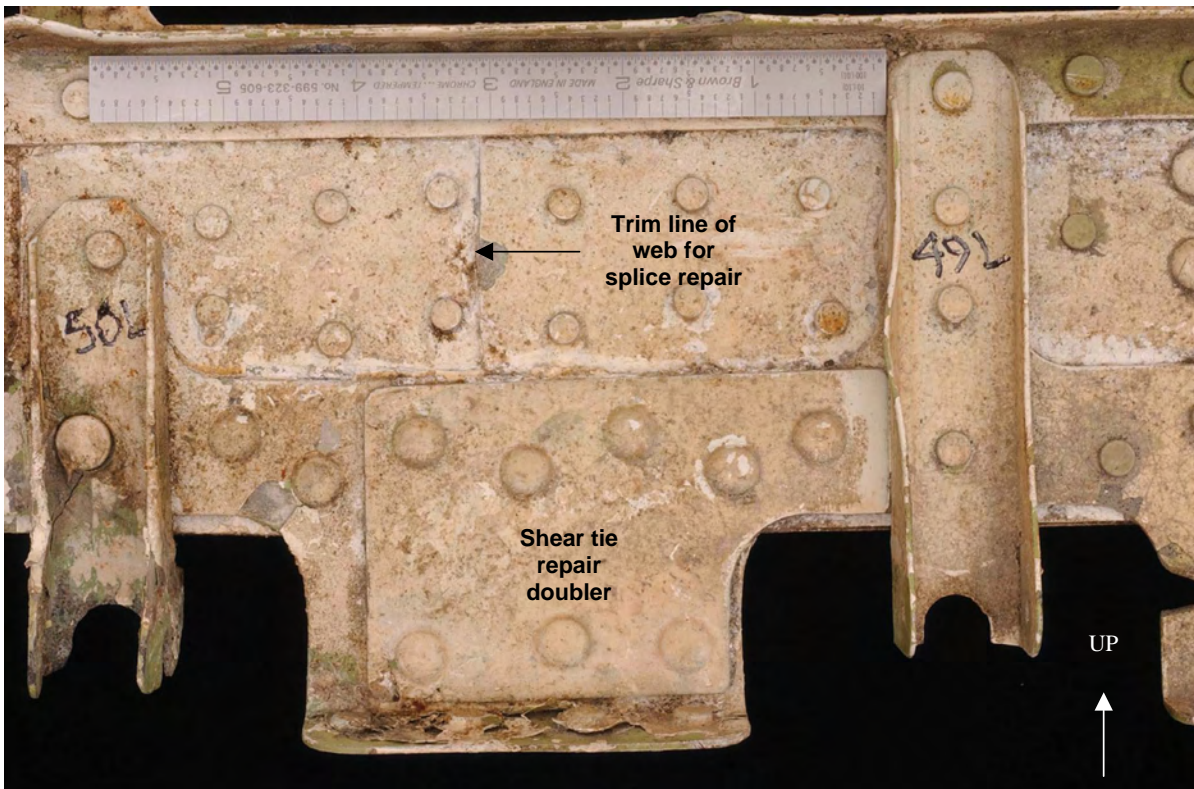
Figure 91.
STA 1940 frame segment showing the shear tie repair doubler and web splice repair
at the location between S-50L and S-49L.

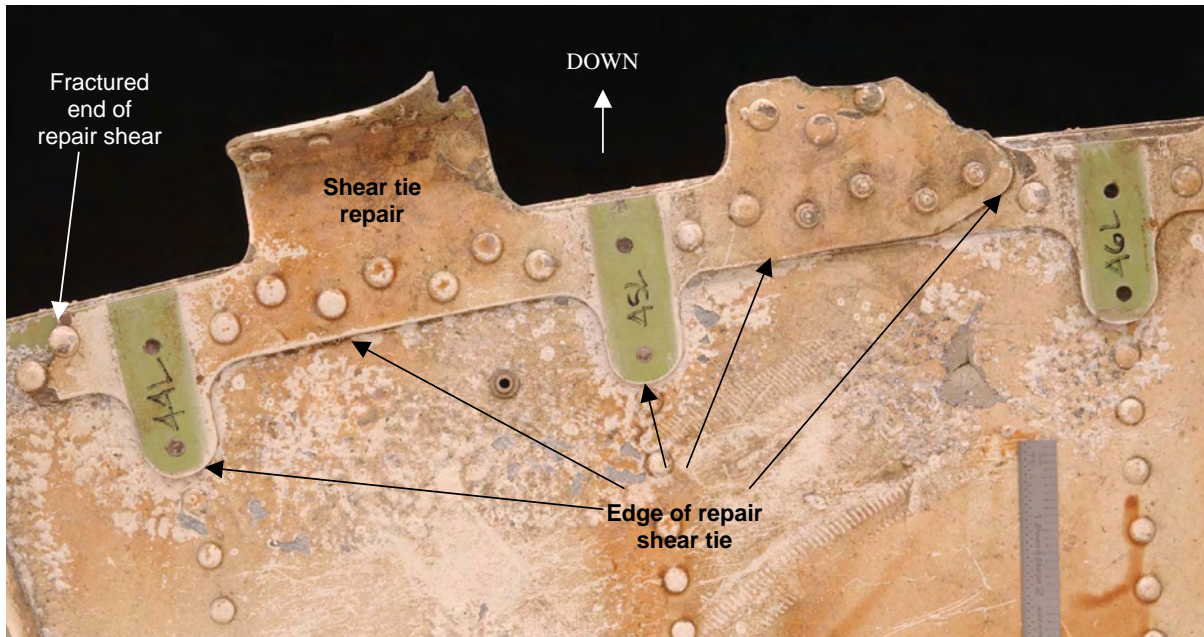
Figure 92.
STA 1940 frame segment showing the shear tie repair between S-46L and S-44L.

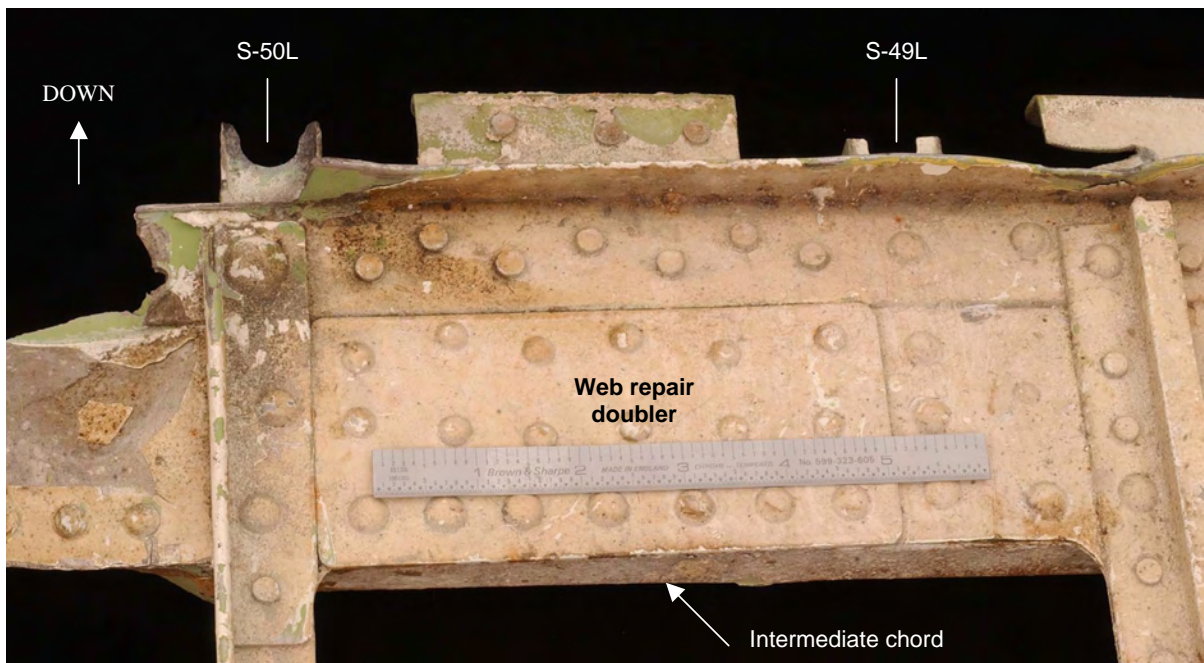
Figure 93.
STA 1940 frame segment showing the web repair doubler on the aft side between S-50L and S-49L.

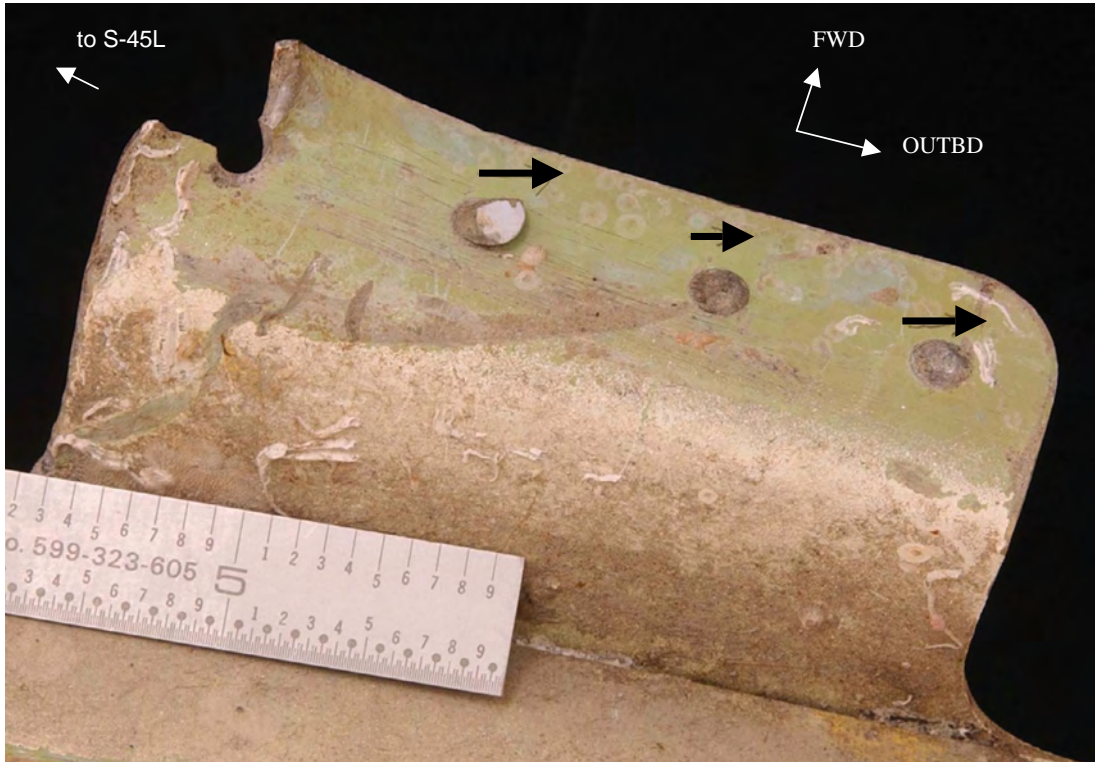
Figure 94. Shear tie between S-45L and S-44L of STA 1940 frame segment.
Black arrows indicate the direction of loading.
