航空器意外事件調查報告

ASC-AIR-03-06-001

中華民國91年7月19日
新加坡航空公司SQ029班機
波音747-400型機
國籍登記號碼9VSPB
中正國際機場

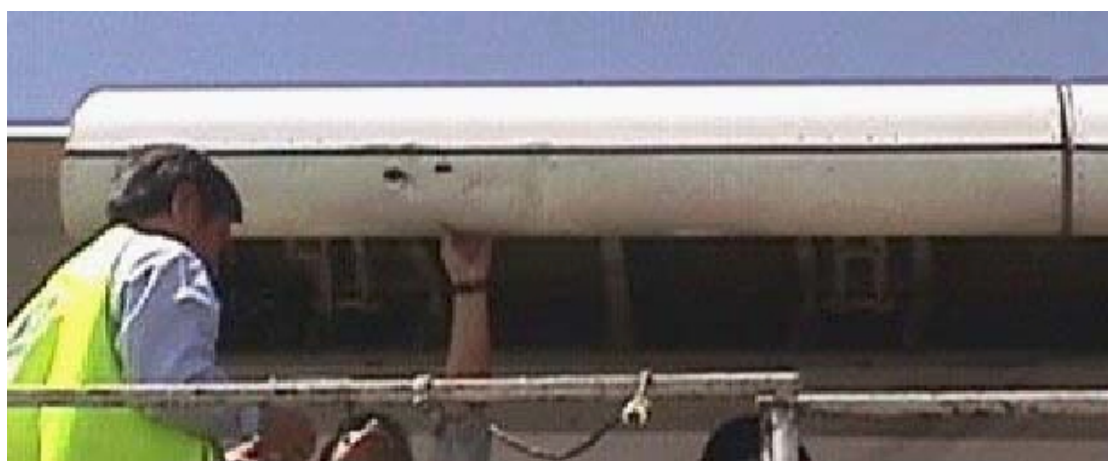
圖 1.2-1

SQ029 班機於飛抵新加坡樟宜國際機場落地後檢查，發現該機右前緣襟翼（leading edge flap）下方蒙皮有大小約 3 公分 × 5 公分之洞孔兩處（如圖 1.2-1 及 1.2-2 照片），未發現其它損害情形。

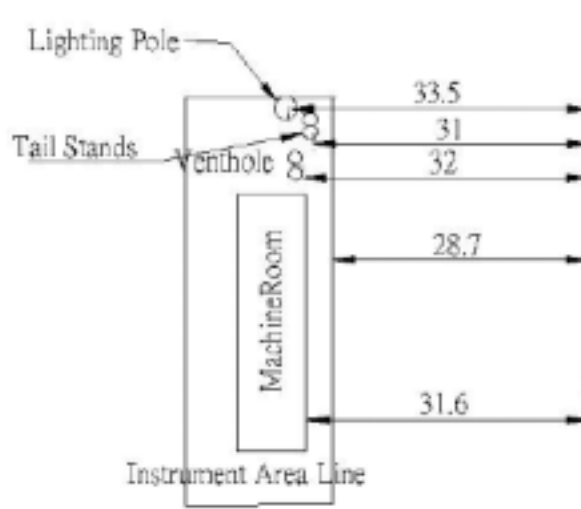
圖 1.4-2

在二期 611 接駁機坪與 610 號接駁機坪間有一機房（長 30 公尺、寬 8 公尺、高 3.5 公尺），其外圍東、西側為裝備區地面繪有黃線（東側距 610 號接駁機坪導入線 28.7 公尺），裝備區內二具高 6 公尺之飛機尾錐頂桿（距 610 號接駁機坪導入線 31 公尺，距機房北側 6 公尺）。在機房北側有一水泥混凝土結構之通風口（距 610 號接駁機坪導入線 32 公尺）。在機房北側 9 公尺處，有一直徑 1 公尺之照明燈柱（距 610 號接駁機坪導入線 33.5 公尺）。分如圖 1.4-2 及圖 1.4-3 所示。

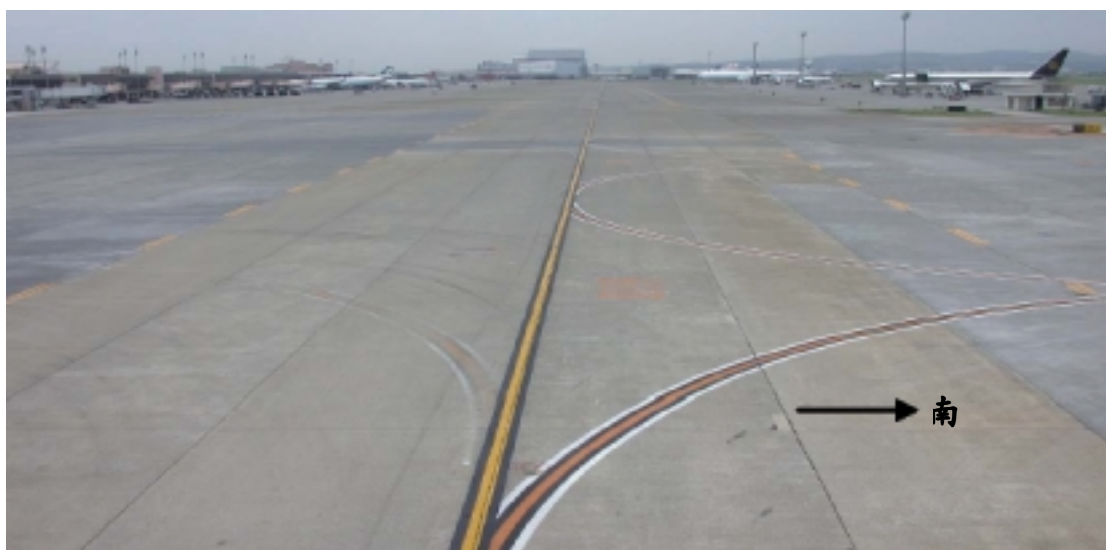
圖 1.4-6

接駁機坪之「機坪編號」標線繪置於兩側導入線與滑行道中心線間，長 2.8 公尺、寬 1.8 公尺，距兩側導入線交點 24 公尺，該接駁機坪編號標線之閱讀方向係朝南，即由機坪滑行道朝向接駁機坪，如圖 1.4-6 及 1.4-7 所示。

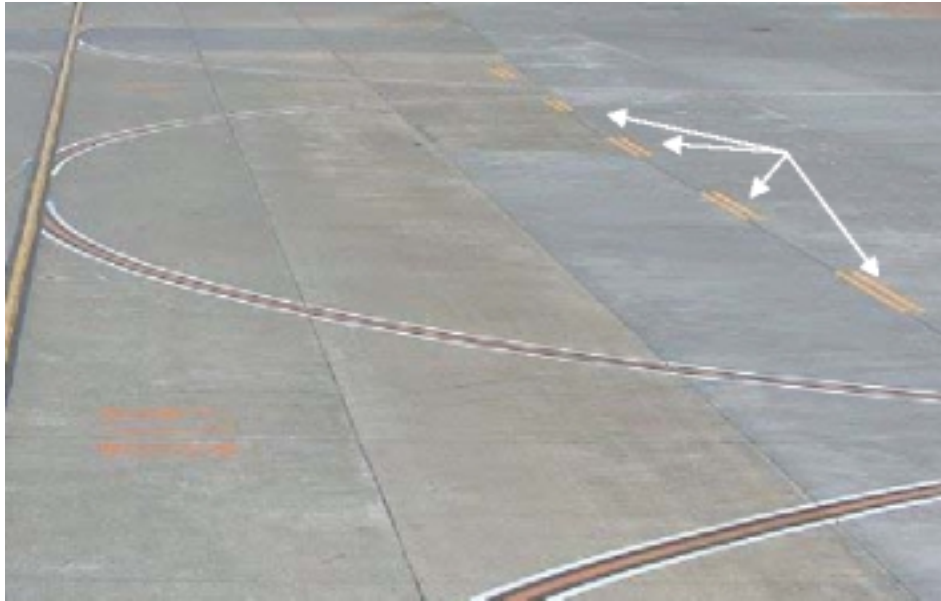
圖 1.4-8

SS 滑行道寬 30 公尺，其兩側與機坪（含接駁機坪）之交界，由多組寬 15 公分、長 4.5 公尺、間距 15 公分之一對黃色標線組成，每一對黃色標線組間距 7.5 公尺構成連續虛線，如圖 1.4-8 箭頭所示。SS 滑行道與 S5 滑行道之交界彎道，由一對連續黃色實線標線繪製。

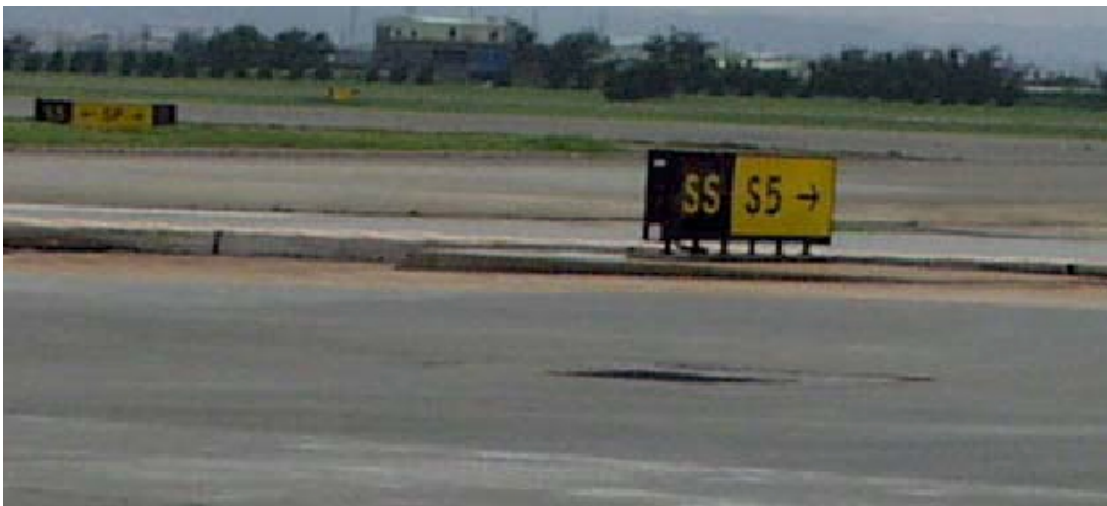
圖 1.4-9

「資訊性指示牌」² 距 S5 滑行道中心線 37.2 公尺，距 SS 滑行道中心線 49.6 公尺，係黑底黃字之 SS 滑行道位置指示及黃底黑字之「S5 →」方向性指示資訊。如圖 1.4-9 所示。

該指示牌長 2.97 公尺，高 0.8 公尺，牌面底部高 0.2 公尺，總高 1 公尺，牌面內字元高 0.4 公尺。

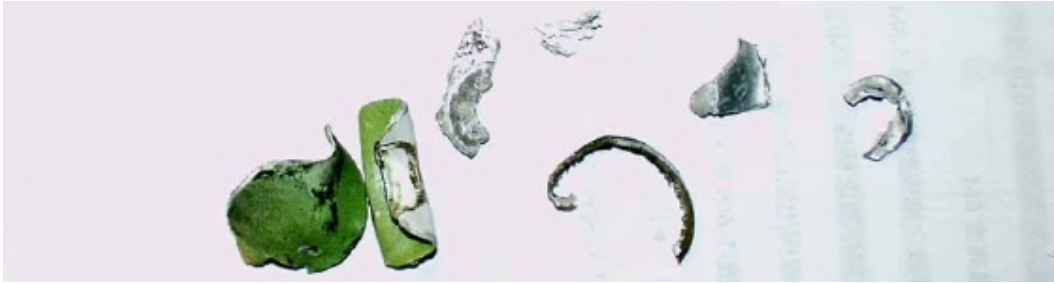
圖 1.5-1

當該協調中心值班協調員在機坪督導確認係 SQ029 班機撞擊尾錐頂桿時，該機已起飛滾行中。撞擊現場殘留之航機破片如圖 1.5-1 所示。根據訪談紀錄，中正站航務組係由乙公司之目擊者通報該公司簽派人員，再由該公司之另一簽派人員通報中正站航務組。
