# 行政院飛航安全委員會

## GE791 事故調查事實資料分組報告

### 飛航性能分組

報告編號：ASC-GRP-03-10-001

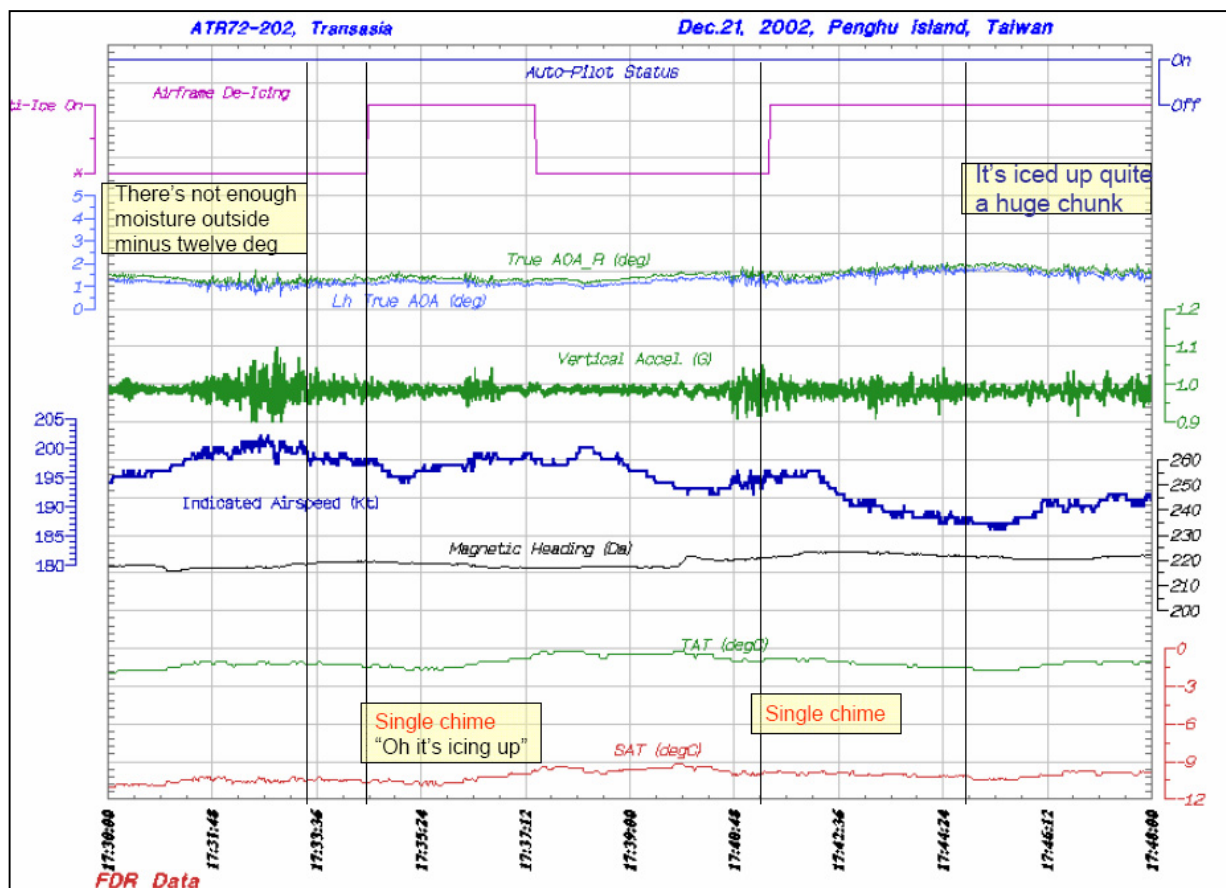
圖 1.16-4 GE791 遭遇積冰與兩次除冰裝置作動期間之機外溫度、空速、真實攻角、航向與 icing detector 之關係

根據附錄8-2 ATR分析報告，圖1.16-4與圖1.16-5為GE791遭遇積冰與兩次除冰裝置作動期間之機外溫度、空速、真實攻角、航向與 icing detector<sup>2</sup>之關係。圖1.16-6為GE791遭遇積冰至下墜期間之升力與阻力隨空速變化圖，圖1.16-7 GE791為遭遇積冰至下墜期間之升力與阻力係數隨攻角變化圖，ATR 72之乾淨機翼、積冰適航外型（failure ice shapes）與GE791積冰之不同攻角比較，如表1.16-3所示。

- (1) 第一次關掉 airframe de-icing(17:40:23)時：IAS=192 KT； $\Delta C_L=0$ ； $\Delta C_D=+0.004$ 。
- (2) 第二次啟動 airframe de-icing(17:41:25)時：IAS=196 KT； $\Delta C_L=0$ ； $\Delta C_D=+0.010$ 。

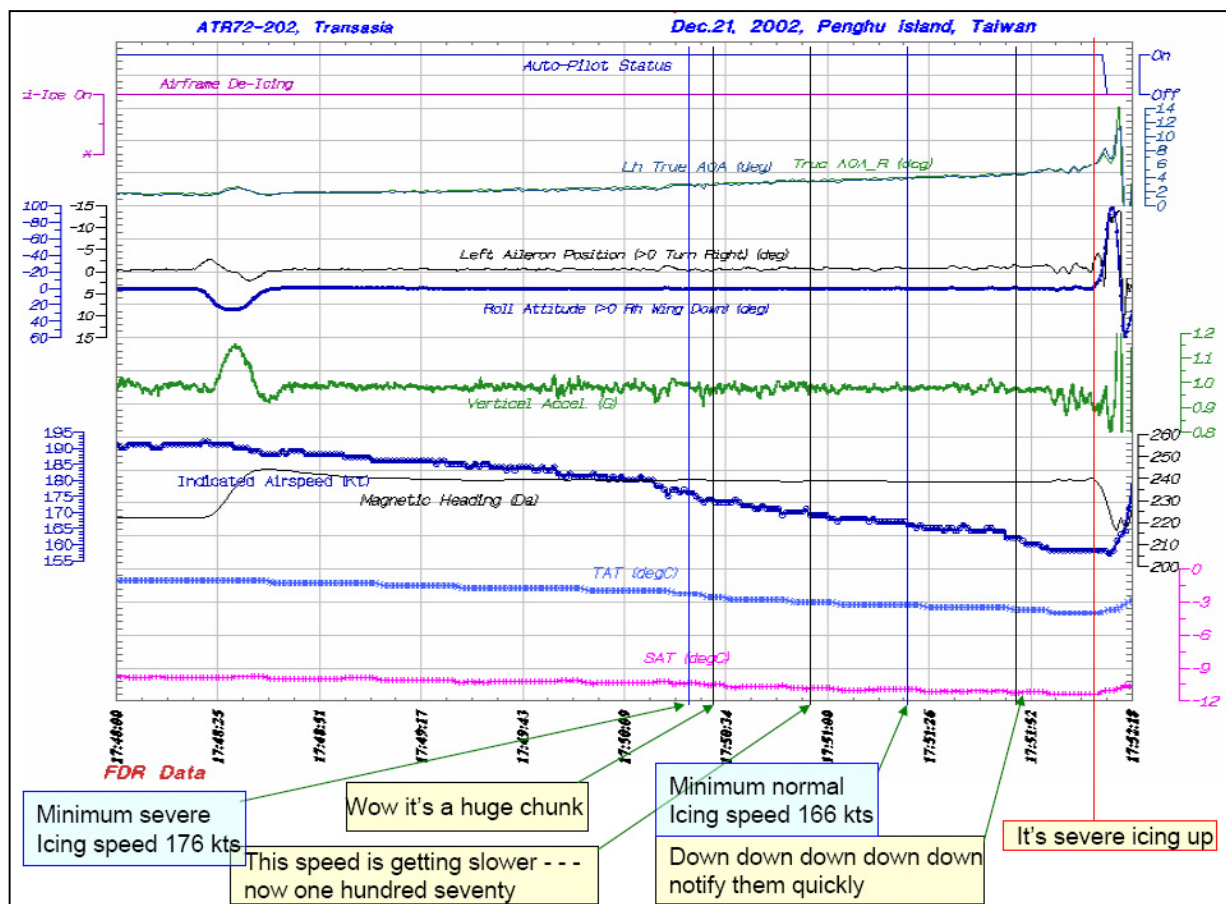
圖 1.16-5 GE791 第二次除冰裝置作動期間之機外溫度、空速、真實攻角、航向與 icing detector 之關係

- 第二次 airframe de-icing 作動期間(17:45:30~17:48:23)，真實攻角約 1.5 度至 2 度。無積冰與 GE791 積冰之升阻比分別為 14.2，及 11.3。
  - 第二次 airframe de-icing 作動期間(17:48:23~17:50:27)，真實攻角由 2 度增至 3 度。無積冰與 GE791 積冰之升阻比分別為 16.3，及 10.0。

- 第二次 airframe de-icing 作動期間(17:50:27~17:51:44)，真實攻角由 3 度增至 4.5 度。無積冰與 GE791 積冰之升阻比分別為 17.8，及 9.6。
  - 第二次 airframe de-icing 作動期間(17:51:44~17:52:05)，真實攻角由 4.5 度增至 5.5 度。無積冰與 GE791 積冰之升阻比分別為 17.7，及 8.0。

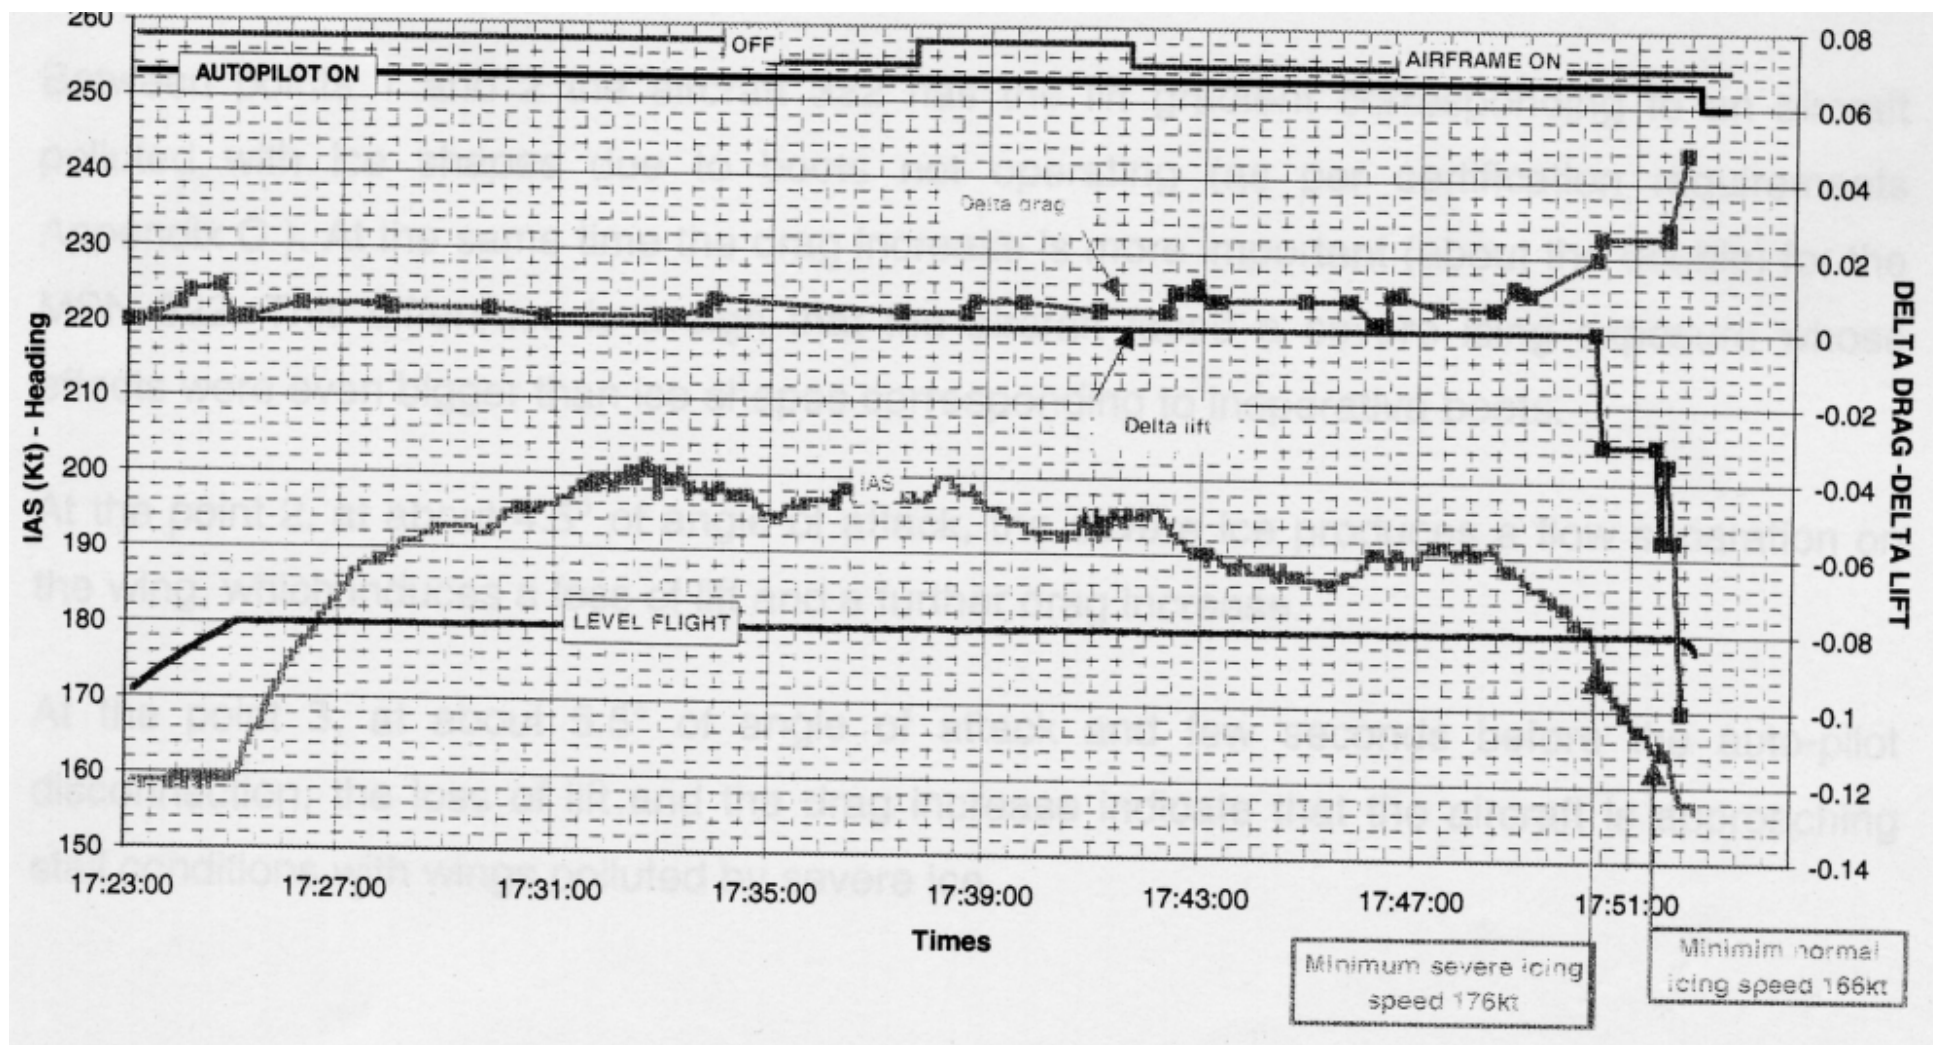
圖 1.16-6 GE791 遭遇積冰至下墜期間之升力與阻力隨空速變化圖

- (3) 達到 minimum severe icing speed(17:50:23)時：IAS=176 KT； $\Delta C_L=-0.025$ ； $\Delta C_D=+0.026$ 。
- (4) 達到 minimum normal icing speed(17:51:21)時：IAS=166 KT； $\Delta C_L=-0.056$ ； $\Delta C_D=+0.030$ 。

- (5) 達到最低空速(17:52:12)時：IAS=157 KT； $\Delta C_L=-0.1$ ； $\Delta C_D=+0.048$ 。
- (6) ATR 72 之乾淨機翼、積冰適航外型與 GE791 積冰之升阻比
  - 第一次 airframe de-icing 作動期間，真實攻角約 1 度至 1.5 度。無積冰與 GE791 積冰之升阻比(CL/CD)分別為 12.2，及 11.6。

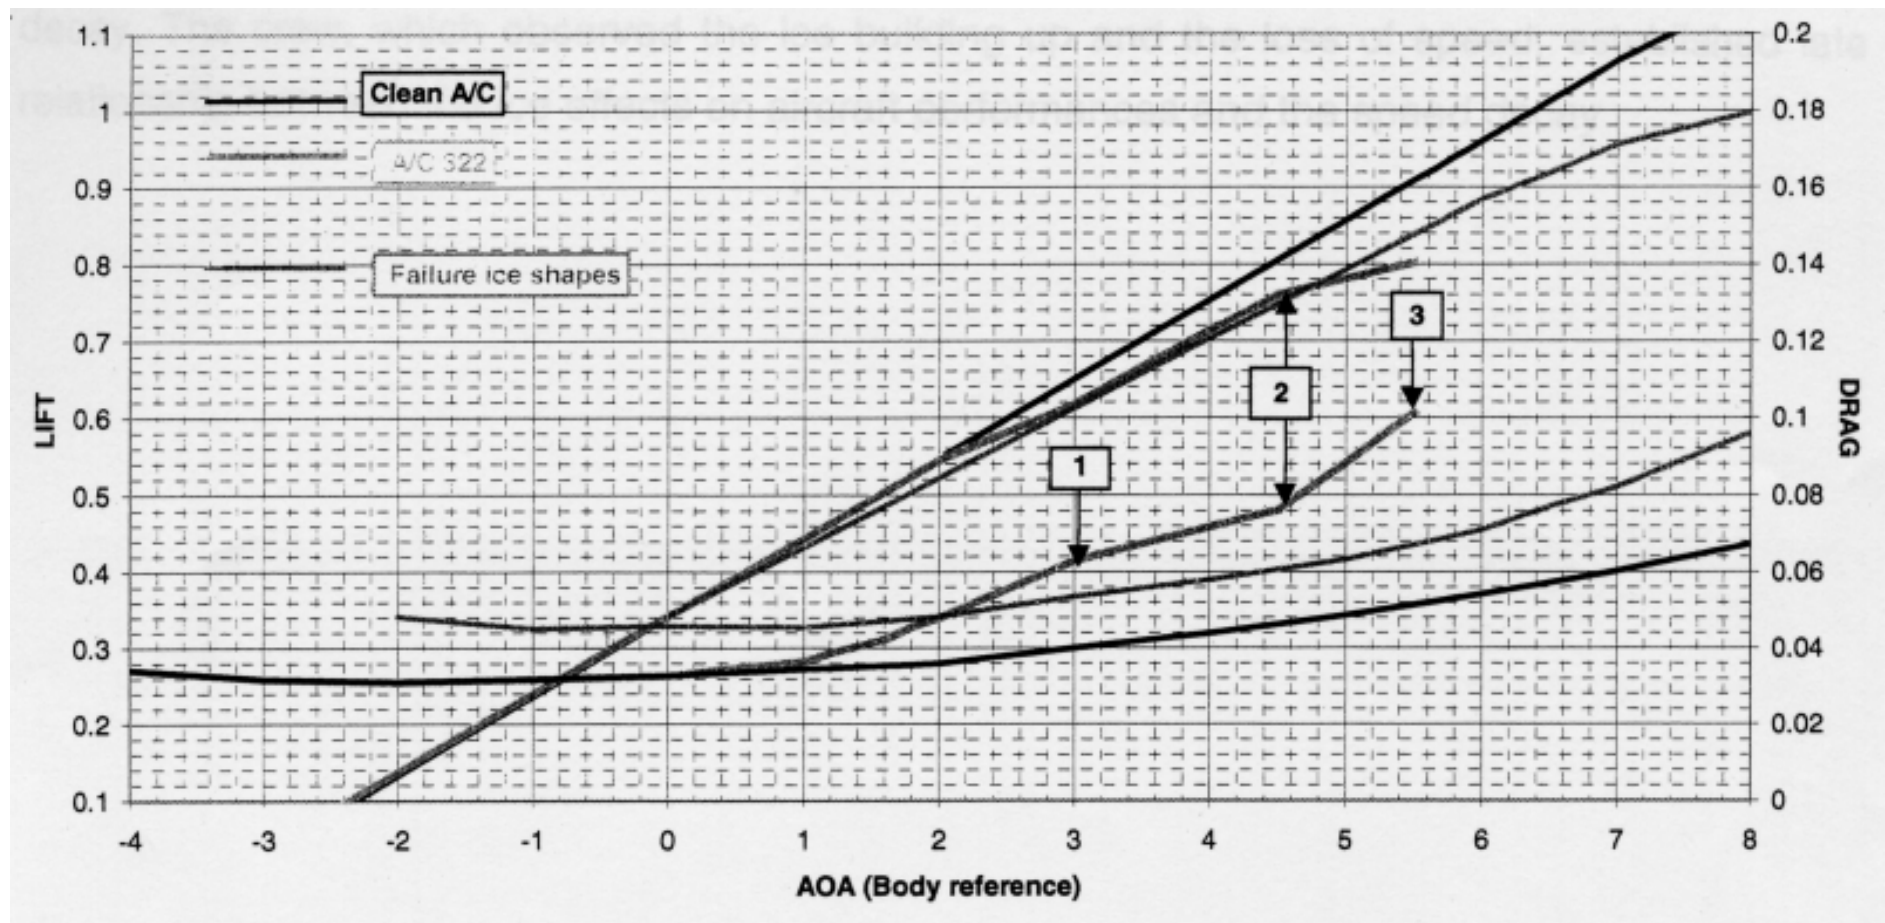
圖 1.16-7 GE791 遭遇積冰至下墜期間之升力與阻力隨攻角變化圖

- 第二次 airframe de-icing 作動期間(17:52:05~17:52:12)，真實攻角由 5.5 度增至 8.3 度。無積冰之升阻比為 17.1。**ATR72 工程飛航模擬無提供攻角大於 5.5 度之 GE791 積冰外型的昇阻力變化。**

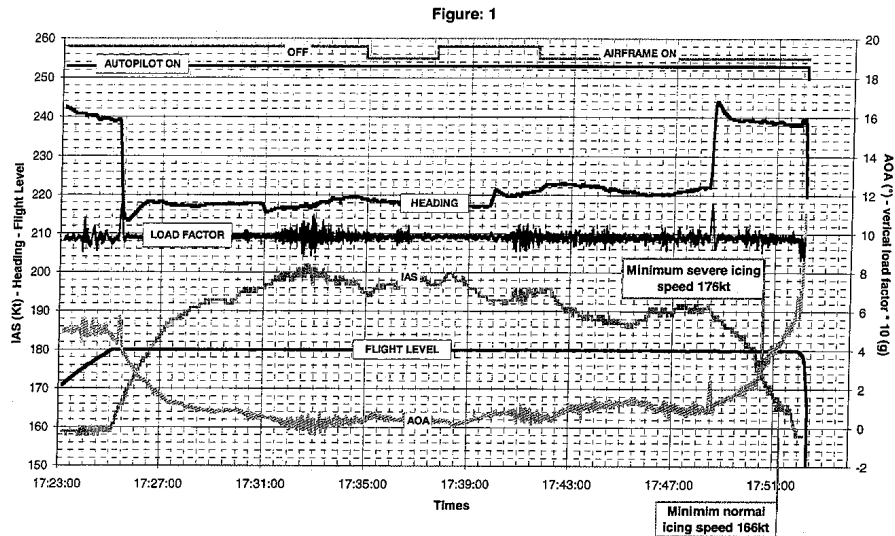
- Flight level 180: Speed decay (see figure 1)

The aircraft decelerated to 194Kt (-8kt) due to ice accretion (see vertical load factor activities). This deceleration has been stopped by the crew intervention to select level 3 of de-icing system (Airframe ON from 17h 34mn 52s to 17h 37mn 38)

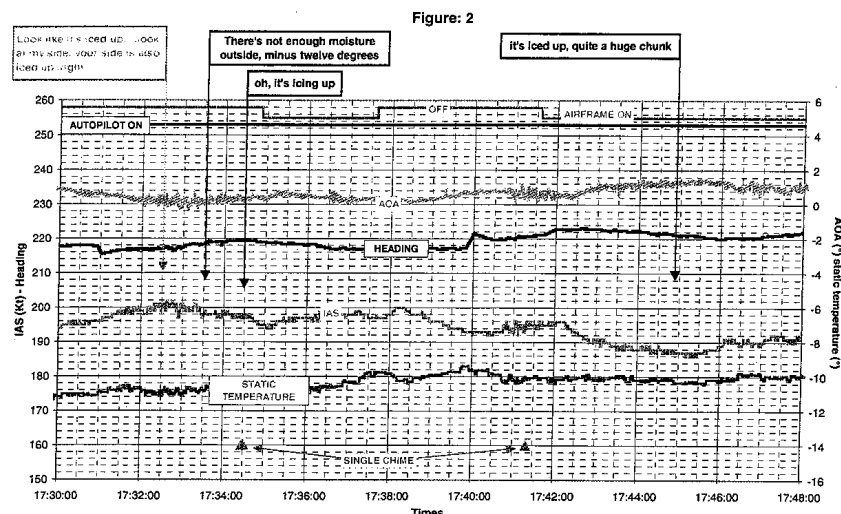
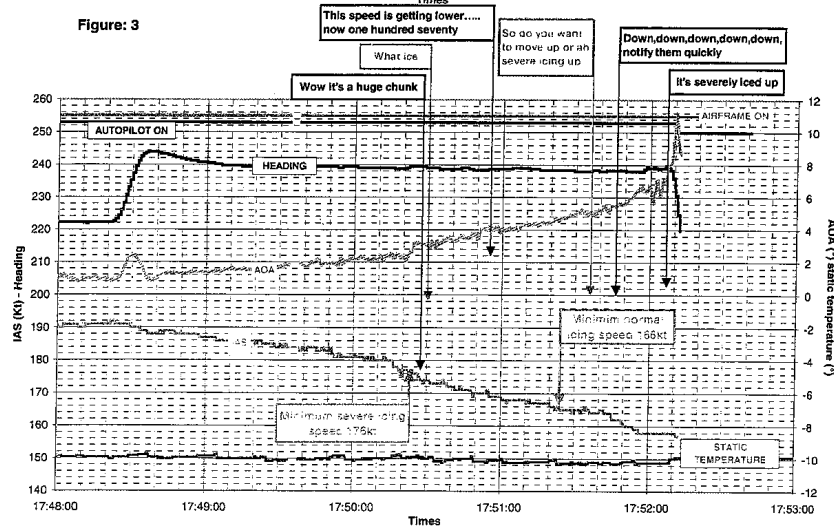
Note: Only the crew's conversation concerning icing events is reported on figure 2 and figure 3

The CVR transcription confirms that a single chime is the signal of ice detector because the first officer says just after the first single chime "Oh it's icing up". After both chime signals, crew action selected airframe de-icing system ON

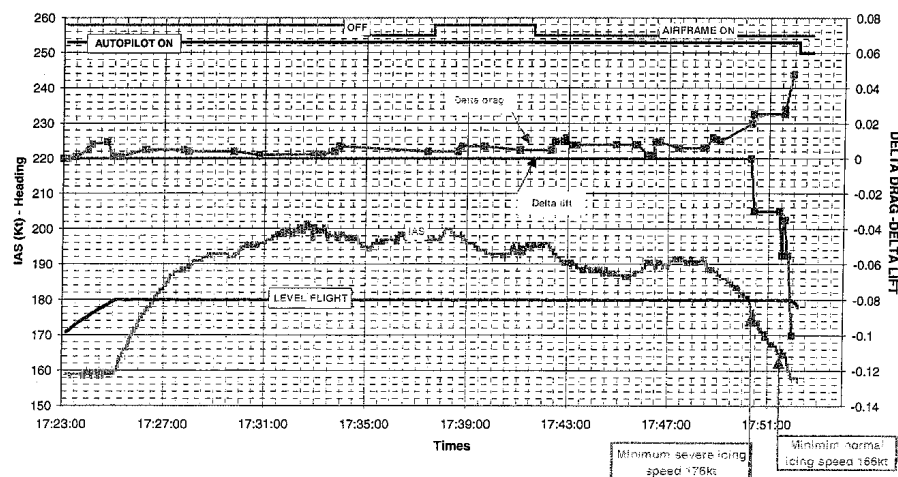
Figure: 4

The figure 4 shows that the aircraft staid exposed to icing conditions during 29mn. During the first 25 minutes the drag increased slowly (within 100 counts) inducing a speed diminishing about 10Kts. After that, the drag increased quickly and the speed dropped to 158 Kts in 4 minutes.

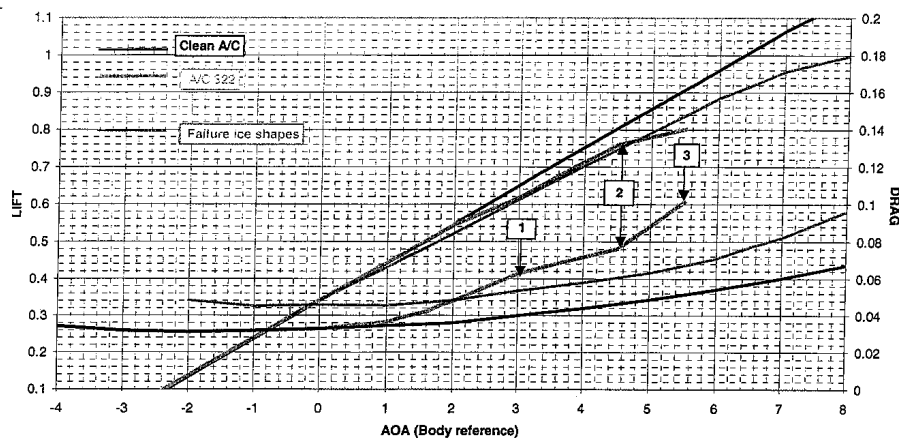
Figure: 5  
Performances comparison

This Figure 5 shows the drag and lift computed during the 30mn before autopilot disconnection compared to the drag and lift obtained in aircraft certification with and without normal icing.

Between points 1 and 2 the aircraft 322 has the lift gradient corresponding to an aircraft polluted with ice shapes due to boots not operating (as per certification requirements Appendix C ). At the same time the drag increase is more important (about the double) for the MSN 322. This difference is a sign that the aircraft faced a severe icing exposure whose effects were even bigger than ice shapes corresponding to inoperative boots.

At the point 2, at about 4.5° of angle of attack, the severe ice produces a flow separation on the wing, which induces a loss of lift and a further drag increase.

At the point 3, at about 5.5° of angle of attack and few seconds before the auto-pilot disconnection, the loss of lift and the drag increase indicate that the aircraft is approaching stall conditions with wings polluted by severe ice.
