飛航事故調查報告 第二冊

ASC-AOR-05-04-001

中華民國 91 年 12 月 21 日 復興航空公司 GE791 貨機 ATR-72 型機 國籍標誌及登記號碼 B-22708 澎湖縣馬公市外海墜海

> 行政院飛航安全委員會 AVIATION SAFETY COUNCIL 中華民國 94 年 4 月

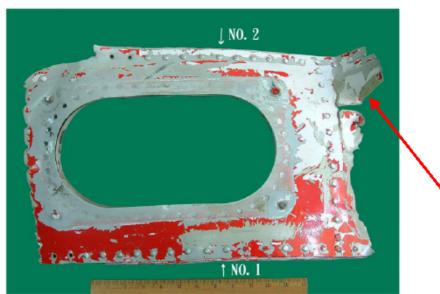
圖 1. 客艙窗戶結構破損件之外觀觀察。

圖 1(a)、(b)分別為客艙窗戶結構損壞件之內面及外面的外觀觀察,其外 圍輪廓斷面均呈現崎嶇不平的斷面形態,尤其是右邊斷面(編號 2 端朝上, 從窗戶結構外面往裡瞧)呈現很大的變形及撕裂的破壞形態。

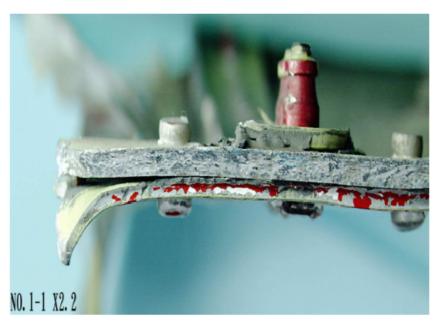
圖 2. 客艙窗戶結構破損件編號 1-1 端斷面的巨觀觀察。(2.2X)

如圖 2~圖 8 分別為斷面編號 1-1、1-2、1-3、1-4、1-5、1-6,及 1-7之 斷面巨觀觀察,斷面從頭到尾均呈現崎樞不平的斷裂形態。而圖 9~圖 13 則分別為斷面編號 2-1、2-2、2-3、2-4,及 2-5 之斷面巨觀觀察,斷面從頭 到尾也是呈現崎樞不平的斷裂形態。至於破壞模式須由 SEM 確認。

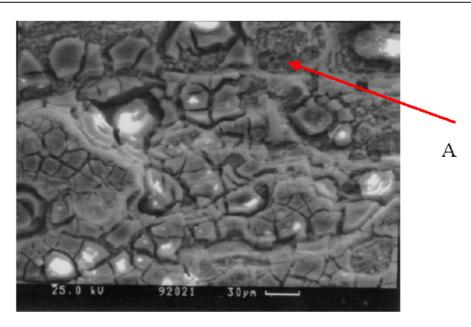
客艙窗戶結構破損件編號 2-3 端斷面的 SEM 觀察。(340X)

圖 14 為客艙窗戶結構破損件編號 2-3 端斷面的 SEM 照片,本破損件係由海中撈起所以表面已覆蓋查層嚴重氧化物,不利 SEM 觀察。圖 15 為圖 14 上斷面 A 點區域的 SEM 觀察,明顯可見其凹渦組織(DIMPLE STRUCTURE)的痕跡,屬過負荷斷裂。

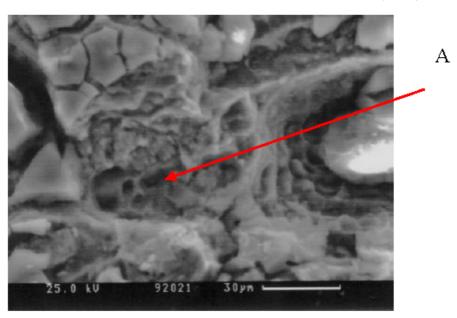
1.客艙窗戶結構破損件的破壞模式為過負荷斷裂。

圖 14 上 A 點的 SEM 觀察,凹渦組織明顯可見。(790X) 🗃 15.

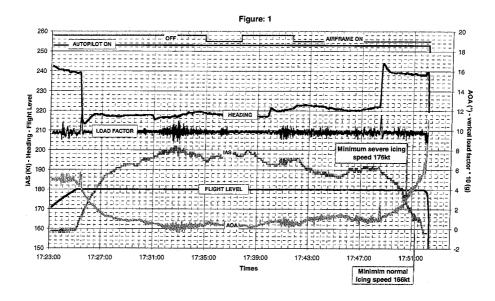
• Flight level 180: Speed decay (see figure 1)

The aircraft decelerated to 194Kt (-8kt) due to ice accretion (see vertical load factor activities). This deceleration has been stopped by the crew intervention to select level 3 of de-icing system (Airframe ON from 17h 34mn 52s to 17h 37mn 38)

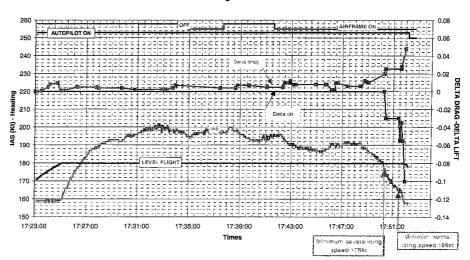
Figure: 4

The figure 4 shows that the aircraft staid exposed to icing conditions during 29mn. During the first 25 minutes the drag increased slowly (within 100 counts) inducing a speed diminishing about 10Kts. After that, the drag increased quickly and the speed dropped to 158 Kts in 4 minutes.
