飛航事故調查報告

ASC-AOR-05-08-001

復興航空公司 GE006 班機

於松山機場落地滾行時發動機失火

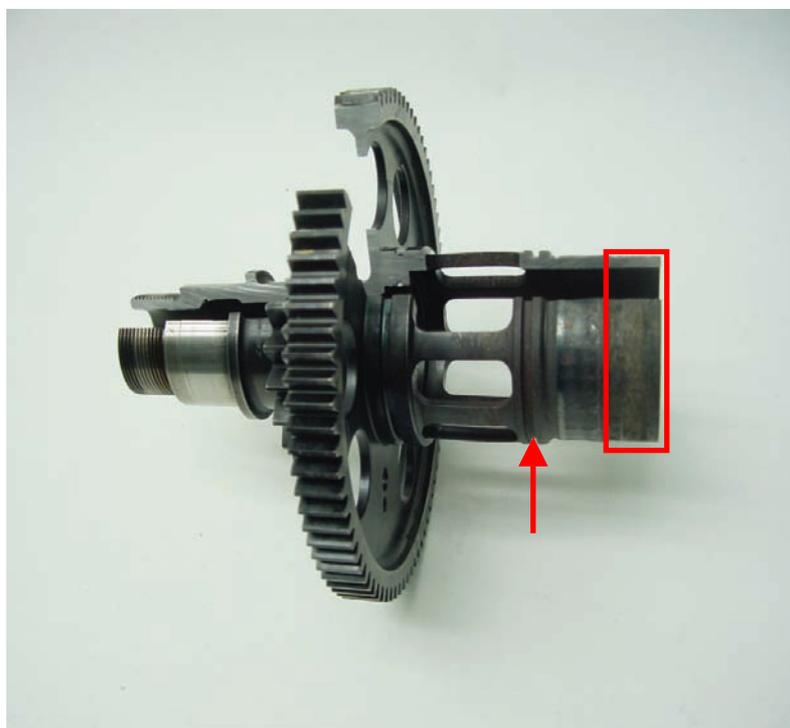
圖 1.8-1 軸封膠圈（紅箭處）及碳晶油封（紅框處）安裝位置圖

民國 93 年 1 月 11 日至 18 日間，在 EADS SECA 維修廠拆檢該發動機。發現發動機之動、靜葉片與轉軸正常。七只軸承除六號軸承滾軸有磨損現象外其餘正常。洞穿之機匣內面有解體油氣分離器之撞擊痕跡。據飛安委員會所提之拆檢報告（附錄 2）及 SECA 所提之拆檢報告（附錄 3），油氣分離葉輪由軸上解體脫離可能原因有二：一為運轉過程中無法承擔不確定之負荷而自然解體；一為於發動機翻修過程中油氣分離葉輪軸封膠圈（安裝位置如圖 1.8-1 所示）未安裝所致，使油氣分離葉輪失去避震效果，於長期高頻震動情形下運轉終至龜裂解體。該兩則可能原因需經進一步之材質化驗後方能揭曉。

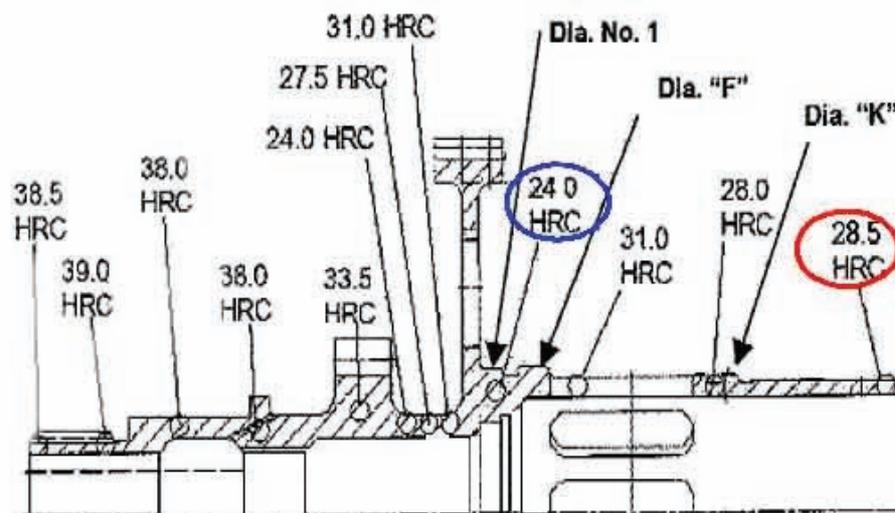
圖 2.3-1 該軸碳晶軸封處之硬度為 28.5 HRC（紅圈處），高於葉輪另一側之 24.0 HRC（藍圈處）

觀察圖 2.3-1，葉輪軸上退火最嚴重之處為碳晶軸封部位之另一側（24.0 HRC），該處可能受熱最嚴重亦可能與火源最為接近。此現象與 PWC 報告中所稱火源起始於油氣分離葉輪碳晶軸封附近之結論不盡相同。因火源如起源於碳晶軸封處附近，則該處距熱源最近及受熱時間亦應較長，應有較嚴重退火現象，但退火現象最嚴重部位卻在葉輪之另一側。飛安會認為 PWC 所稱熱源來自油氣分離葉輪碳晶軸封附近之一說尚難確定，但由退火現象確定曾產生高溫甚至起火燃燒則已有共識。

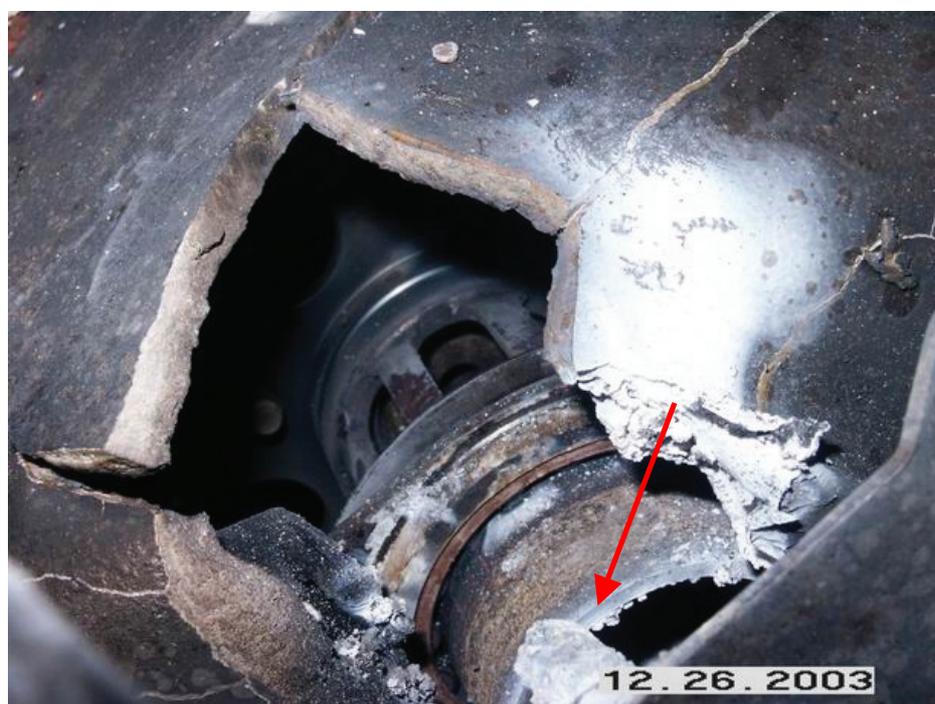
擦而生高熱，又位於附件齒輪箱匣破損處附近白色灰漬顯示曾遭火勢（詳圖 2.3-2），該處退火現象可能係上述原因所致。

圖 2.3-2 輪軸外徑嚴重磨損並呈褐色（紅箭指處）；附件齒輪箱匣破洞外具白色灰漬

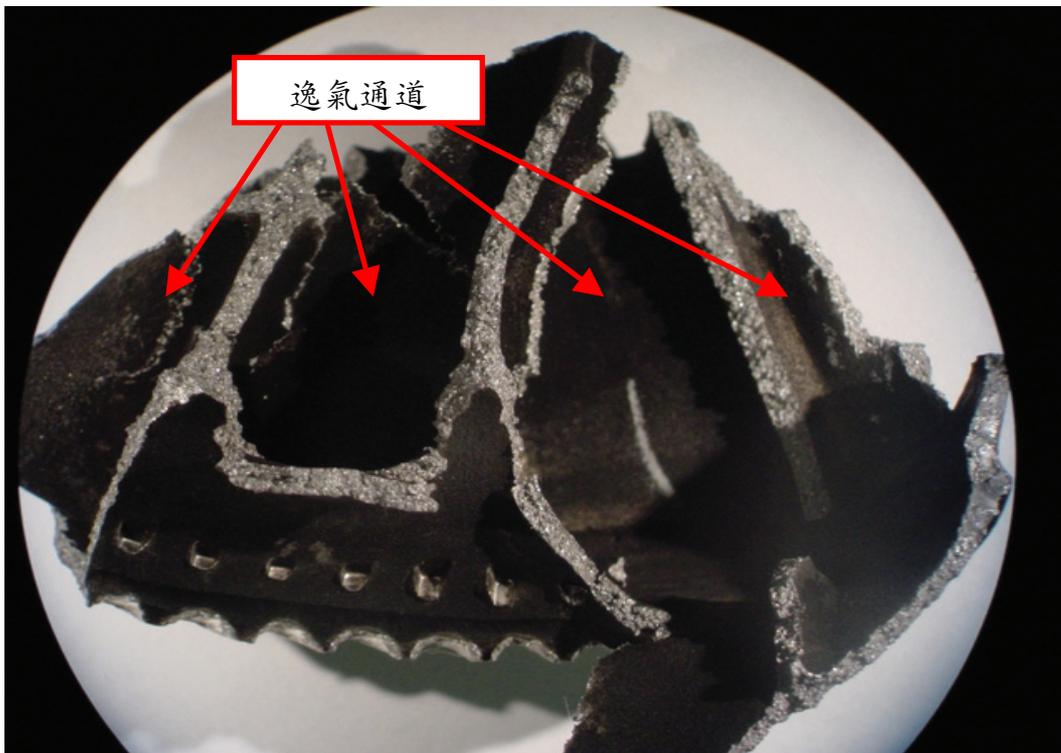
葉輪軸中段為葉輪包覆，亦有退火及硬度降低現象（31.0 HRC），顯示該處曾遭高溫。葉輪內之逸氣通道呈黑色（詳圖 2.3-3），顯示葉輪曾在高溫環境下運轉，所生之黑煙灌入逸氣管內通道呈黑色積碳。

圖 2.3-3 葉輪內之逸氣通道呈黑色

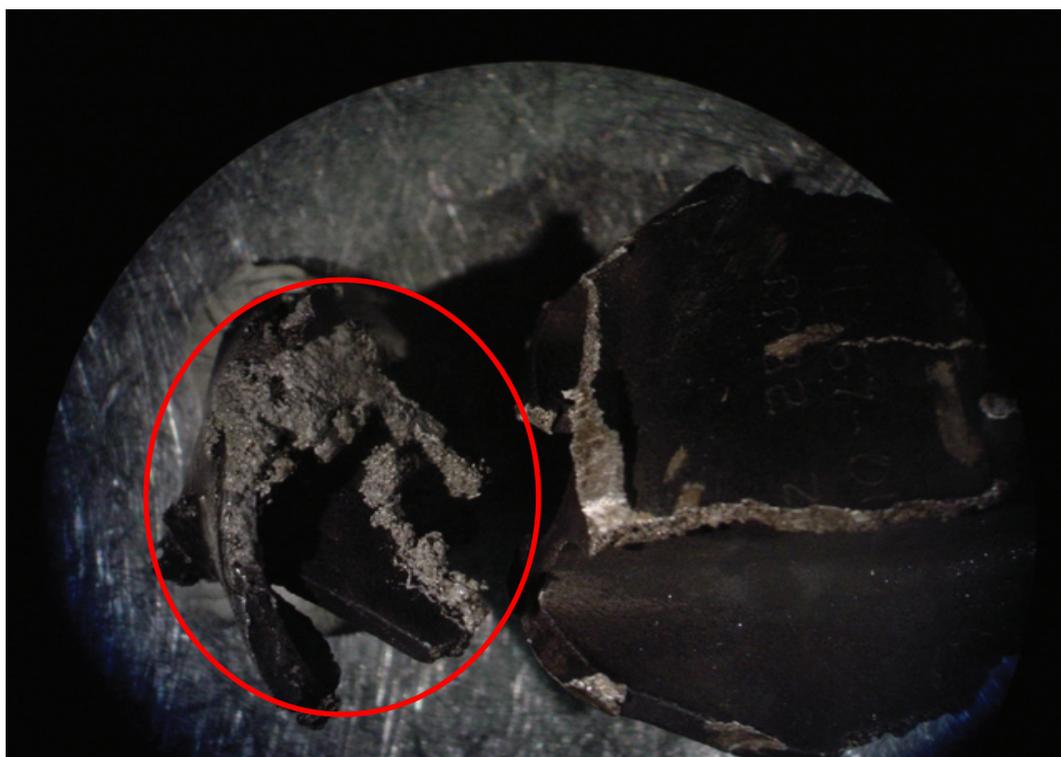
附著於附件齒輪箱匣內壁上之鎂鋁合金融熔顆粒，顯示油氣分離葉輪於運轉時受高熱，致葉輪金屬晶粒產生位移析出後（詳圖 2.3-4），被離心力甩出而附著於附件齒輪箱匣內壁上（詳圖 2.3-5,-6）。大量葉輪金屬晶粒析出及葉輪結構過熱使強度驟降，經快速旋轉所生強大離心力使葉輪解體飛脫。油氣分離葉輪解體原因雖有兩種不同說法，一為葉輪過熱晶粒析出以致強度變弱後離心飛脫；另一為葉輪軸膨脹致使葉輪崩裂。但不論葉輪過熱使材質強度改變或葉輪軸膨脹皆源於先有高溫之產生，飛安會與 PWC 對此看法一致。至於該熱源由何而來，如何導致油氣分離葉輪解體飛脫或葉輪軸受熱膨脹而崩裂，經本會與廠家一再調查仍無法確認。

圖 2.3-4 葉輪金屬晶粒位移析出情形（紅圈處）

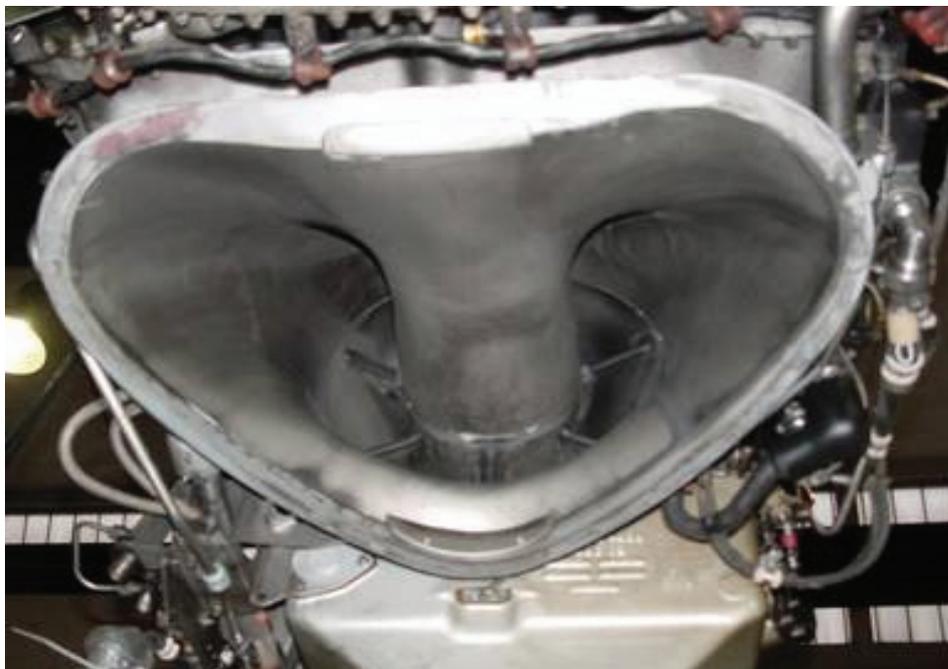
圖 3 發動機進氣口潔淨無外物堵塞情形

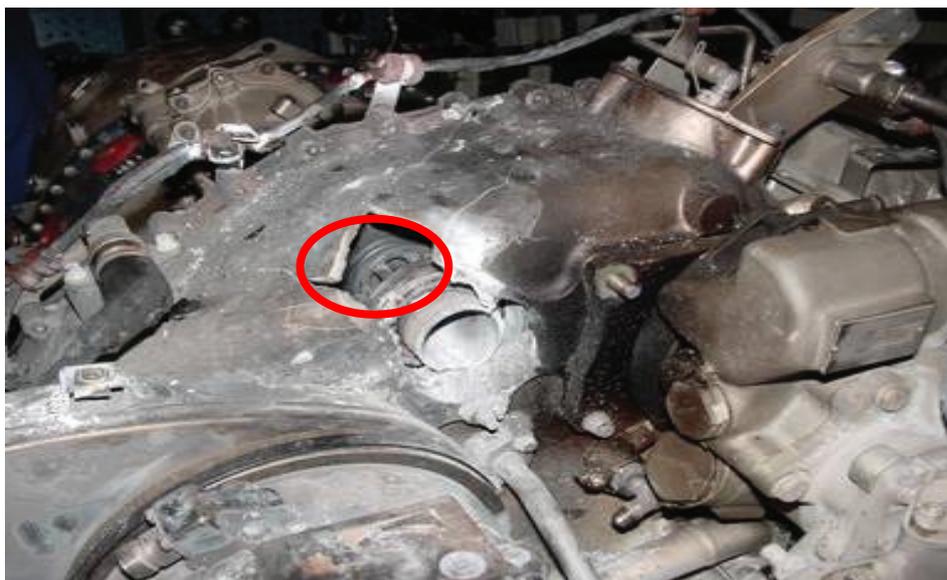
圖 4 附件齒輪箱匣前方上方機匣破裂，油氣分離葉輪輪失蹤，葉輪輪逸氣口（紅圈處）清晰可見

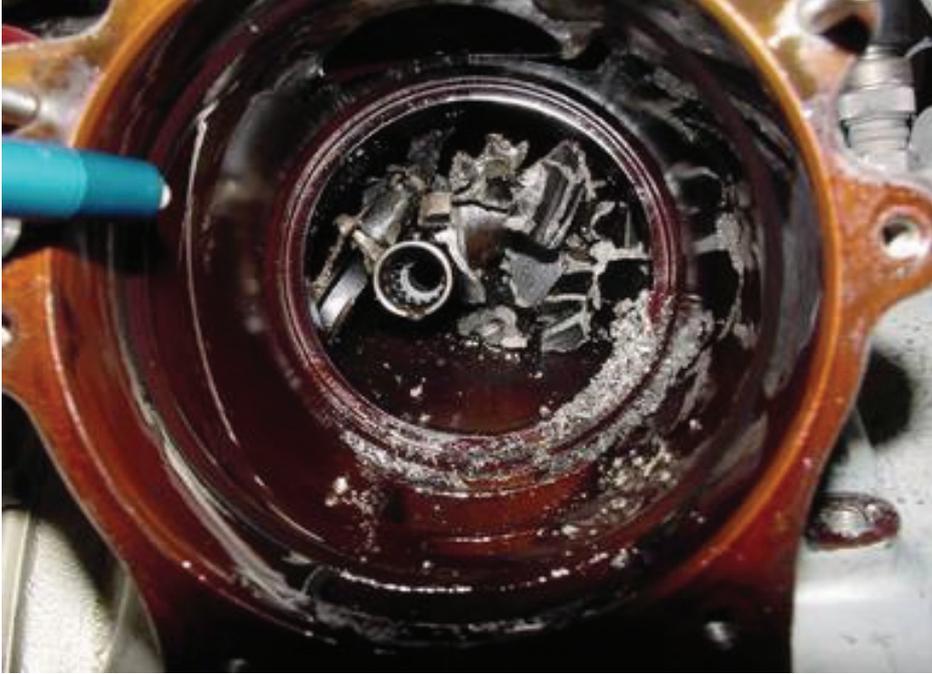
圖 5 油氣分離葉輪輪解體碎片堆擠於發動機滑油葉輪進口
由發動機拆下之滑油葉輪進口亦有逸氣葉輪輪解體碎片，詳圖 6。

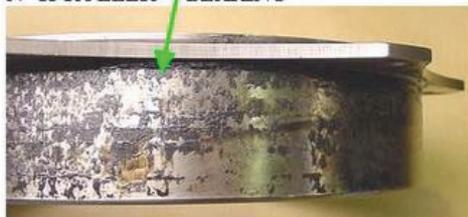
N° 15 ROLLER BEARING

The corresponding deposits are observed on the outer diameter of N° 15 Roller Bearing outer race, too.

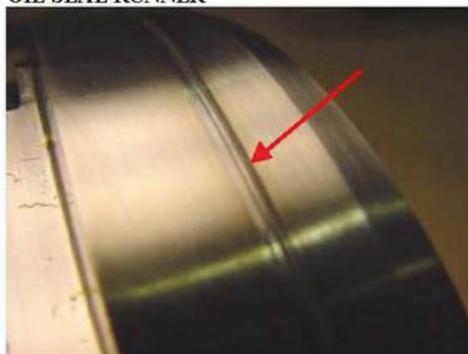
OIL SEAL RUNNER

Sealing diameter grooved.

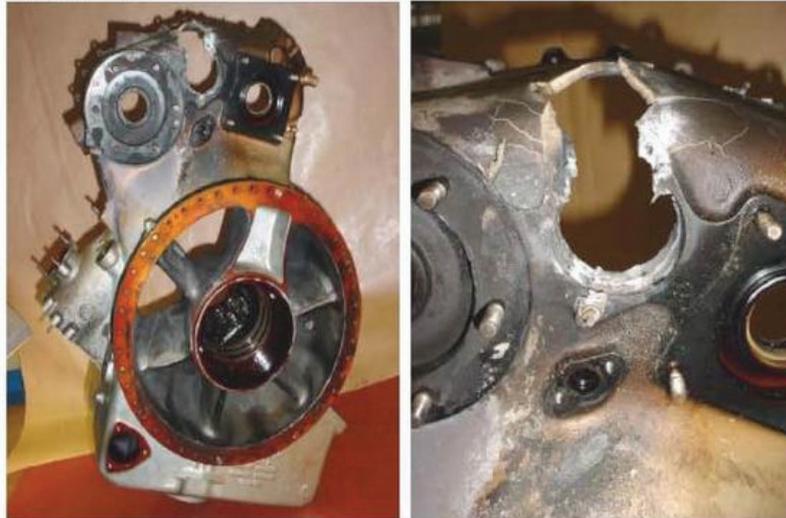
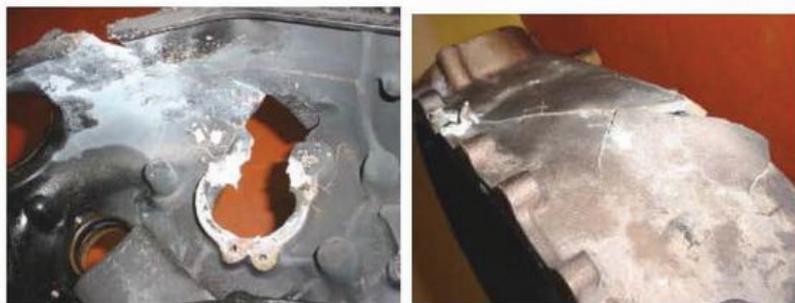
REAR INLET CASE

The upper area is fractured around the Accessory Drive Spur Gearshaft location. The base metal of housing (AMS 4439) is melted near the N° 25 Roller Bearing location.

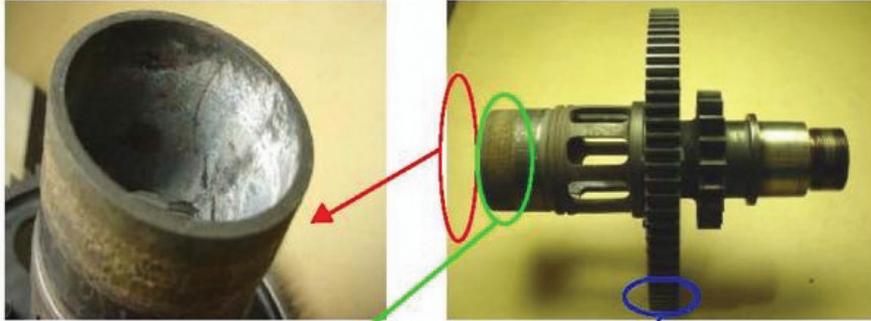
ACCESSORY DRIVE SPUR GEARSHAFT

The sealing face does not present major defect (red arrow).

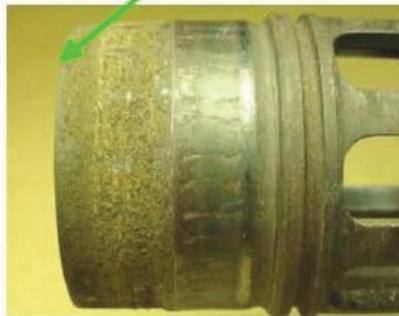
The journal of the N° 25 Roller Front Bearing is worn and brinelled.

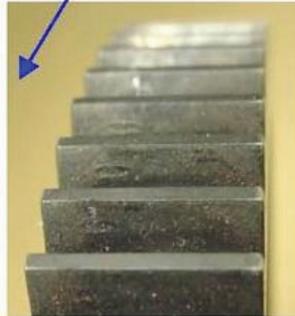
The gear teeth surface is spalled.

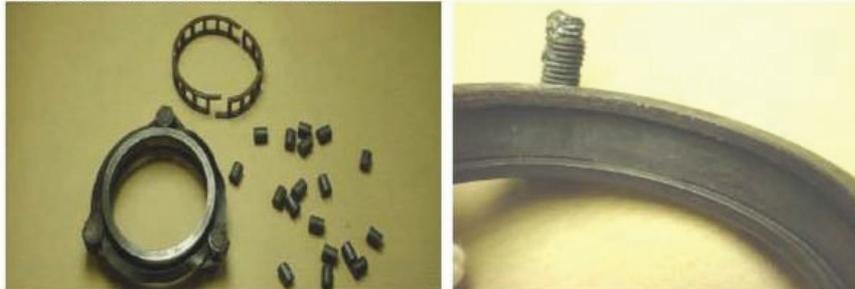
N° 25 FRONT ROLLER BEARING

The cage has been voluntarily fractured to accessed to the functional surfaces. The rollers are worn and the internal diameter of the inner raceway is galled.

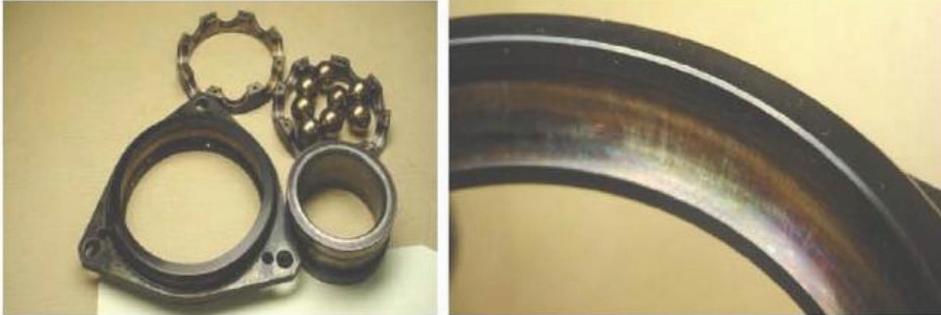
N° 25 REAR BALL BEARING

The bearing has been voluntarily separated to accessed to the functional surfaces. The outer raceway of the outer ring is brinelled.

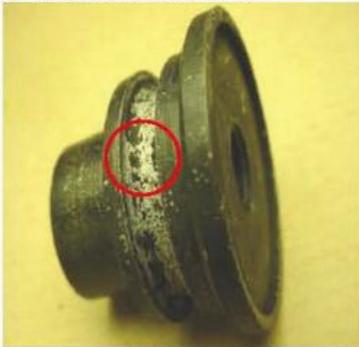
COUPLING SHAFT STOP

This part (located inside the Accessory drive spur gearshaft) is discolored. Preformed packing remaining traces are present on the sealing groove.

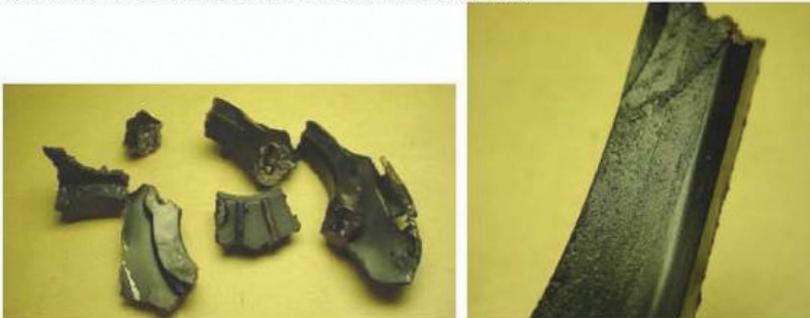
CENTRIFUGAL BREATHER IMPELLER ASSEMBLY

View of the main debris. On the sealing diameter which receives the preformed packing, a black deposit is observed and could result to the burn of the preformed packing.

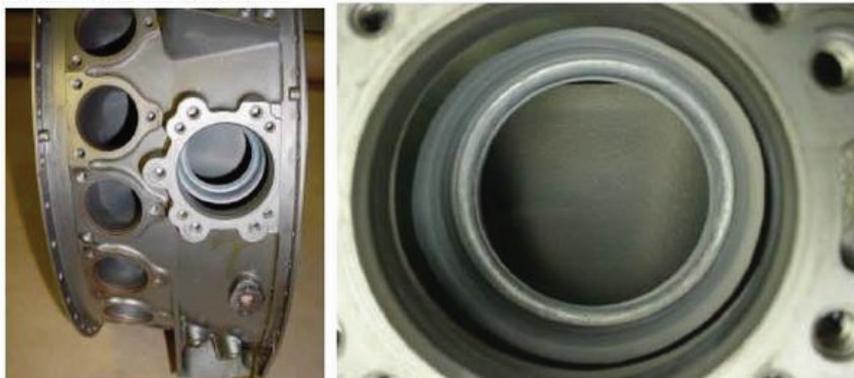
INTERCOMPRESSOR CASE

A fretting wear is observed on the face and on the adjacent diameter. This diameter receives an air transfer tube for P2.5 air supplying to the airframe purposes.

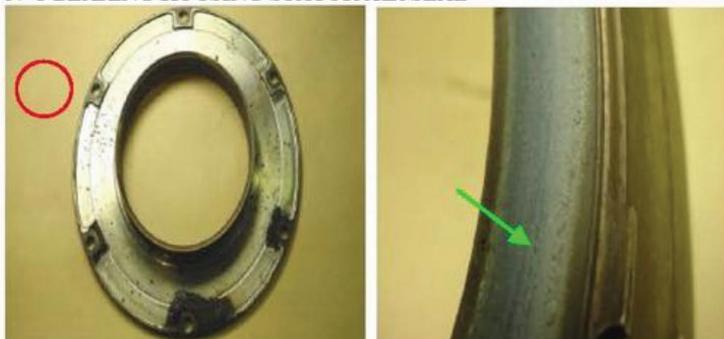
N° 5 BEARING HOUSING STATOR AIR SEAL

Fretting wear on the face (red circle) and loss of plasma coating on the air diameter.

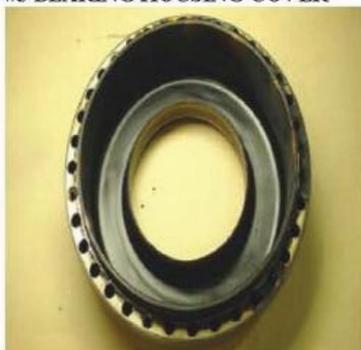
#5 BEARING HOUSING COVER

Important coked deposits on the internal surfaces of housing.

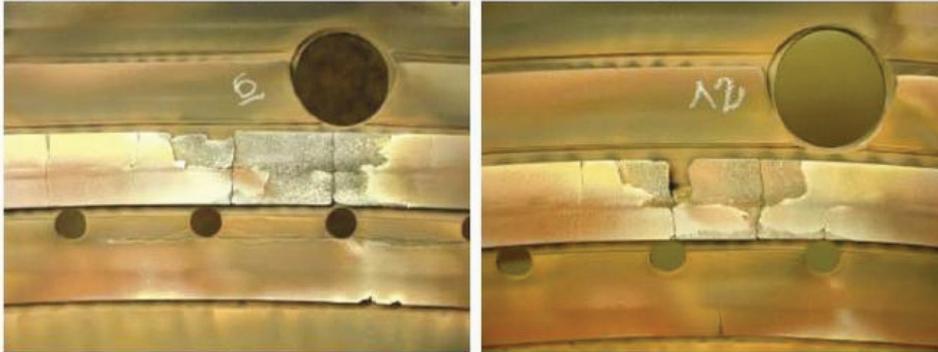
COMBUSTION CHAMBER OUTER LINER P/N 3052959-01 S/N 8L364

Dual cooling ring : axial cracks with missing material, loss of ceramic coating, distortion and hot gas path erosion in the vicinity of the fuel nozzle ports N° 6 & 12.

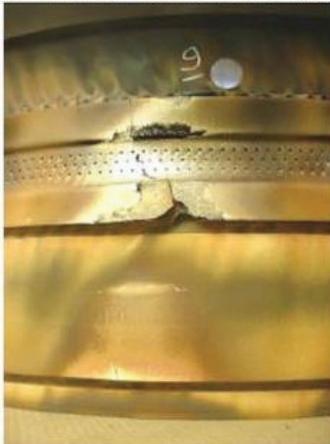
COMBUSTION CHAMBER INNER LINER P/N 3048934-01 S/N 4M535

Cooling ring : axial crack with missing material, loss of ceramic coating in the vicinity of the Fuel nozzle port N° 9.

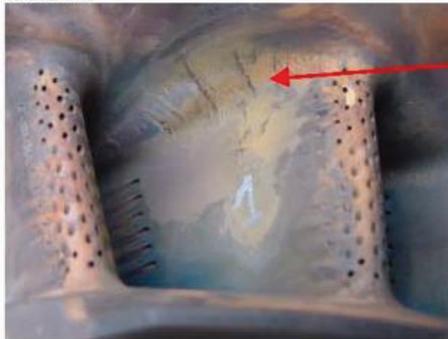
VANE #1

Many cracks extending through the airfoil fillet radii.

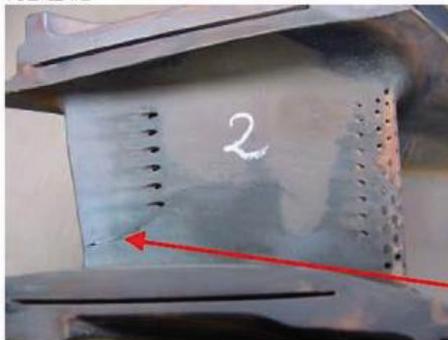
VANE #2

Airfoil trailing edge : crack on the both side on the airfoil with light missing material.

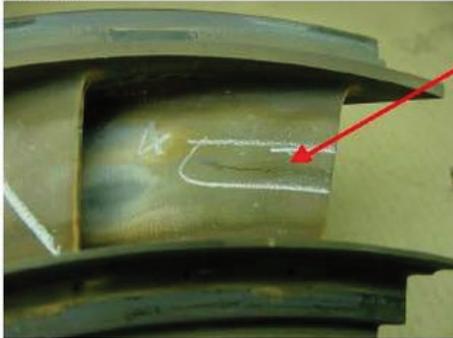
VANE #4

Airfoil trailing edge : crack on the both side on the airfoil.

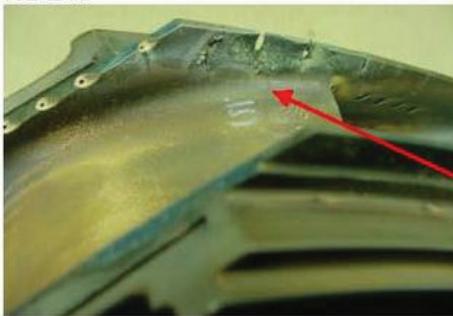
VANE #5

Axial cracks with erosion on the outer shroud surfaces trailing edge lips.

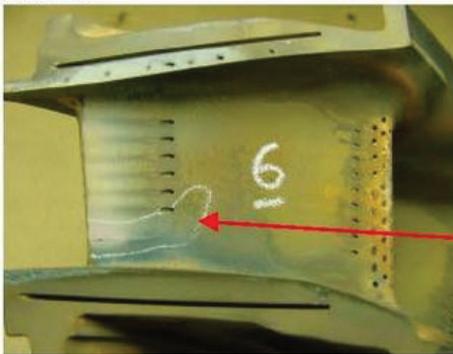
VANE #6

Airfoil trailing edge : crack on the both side on the airfoil.

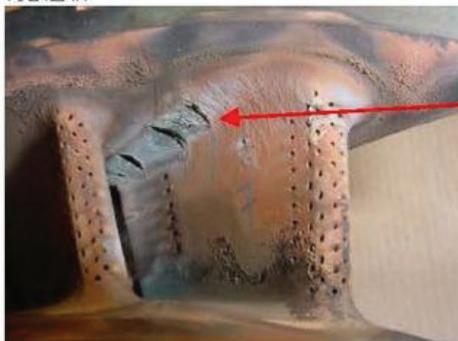
VANE #7

Many cracks extending through the airfoil fillet radii.

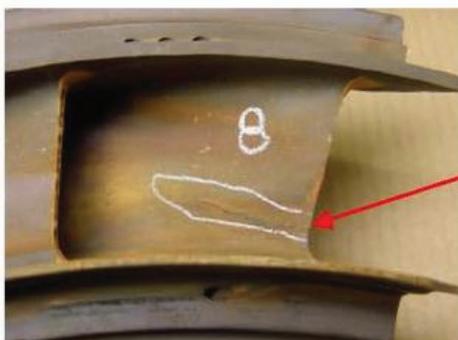
VANE #8

Airfoil trailing edge : crack on the both side on the airfoil.

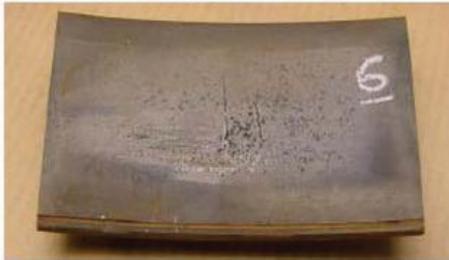
HP SHROUD SEGMENTS

Thermal cracks on the plasma coating and light oxydation.

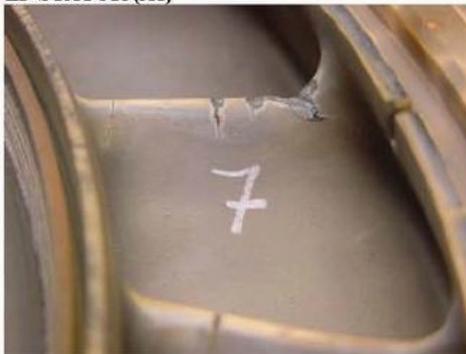
LP STATOR (A5)

Many cracks on some airfoil leading edges with erosion at 7 o' clock position.

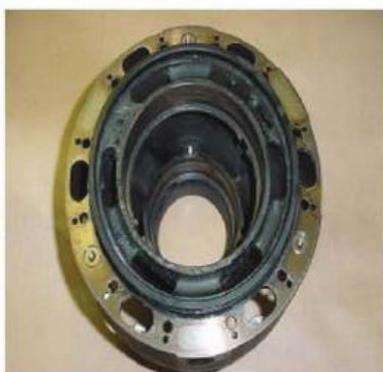
N° 6 & 7 BEARING HOUSING.

Coked oil deposits inside the housing. The strainer installed on the oil feed was found blocked by the coked oil deposit.

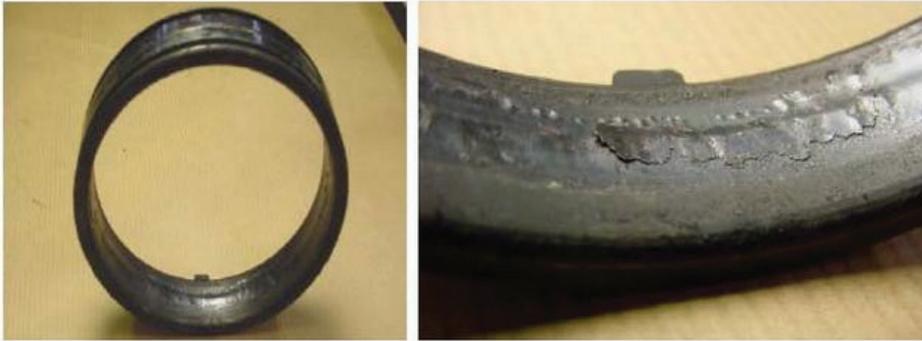
N° 6 ROLLER BEARING

The outer raceway presents heat discoloration, the inner raceway is galled and the rollers are worn. This bearing has suffered by the lubrication defect due to the low oil pressure but also by a blocking of oil

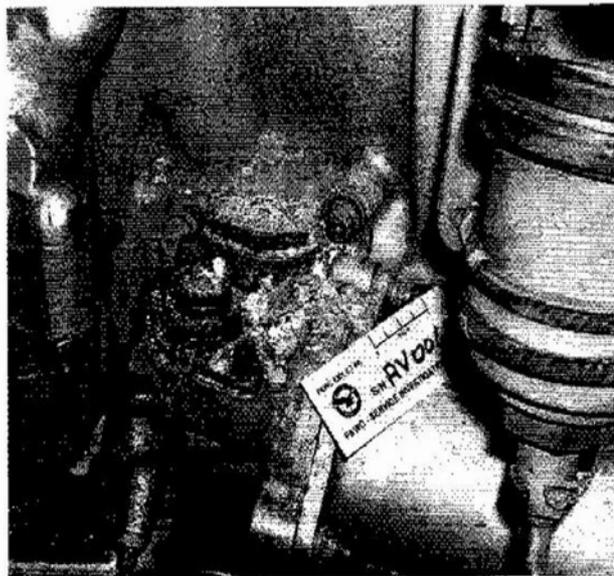
Photo No. 8
 Debris found on top of the RGB oil scavenge filter housing

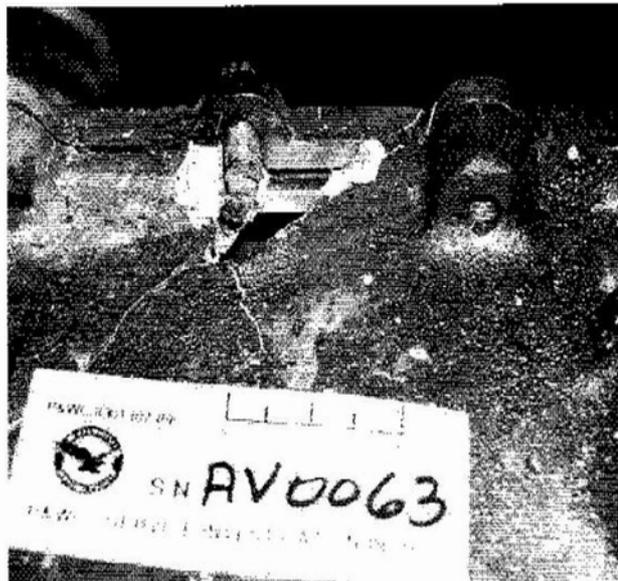
Photo No. 28
Paint damage and crack with missing piccc adjacent to the AGB cover bolting flange

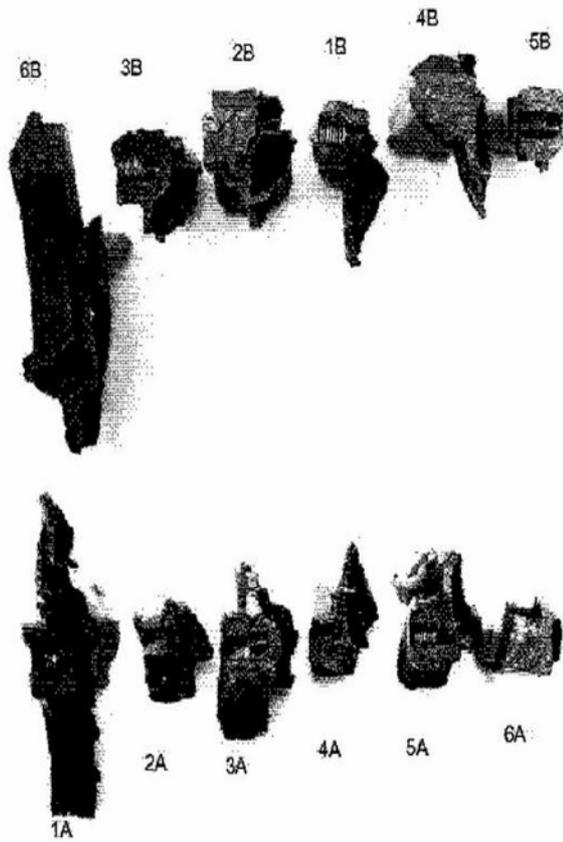
Photo No. 38
Impeller spigot fit fracture surfaces

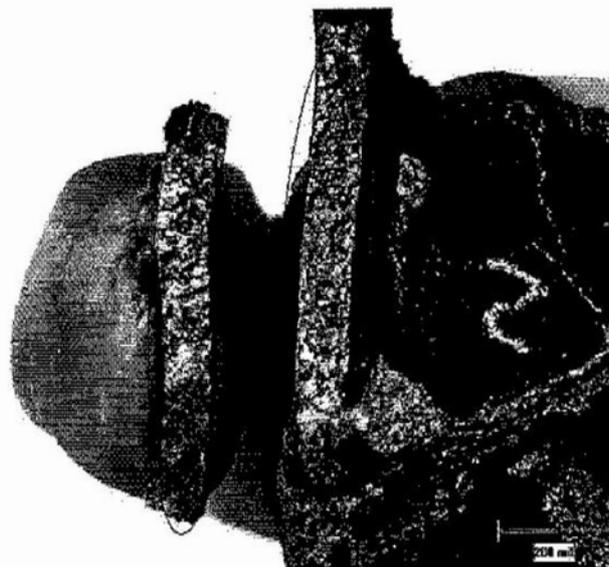
Photo No. 44
Discoloured fracture surfaces

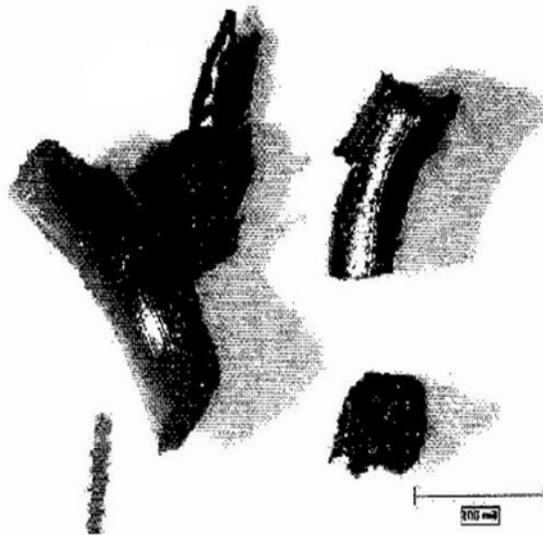
最初懷疑此軸封膠圈是否未安裝或未正確安裝。但該發動機自翻修後已使用了 3,715 小時，如未安裝或未正確安裝，則早已產生故障及損壞，不會延至使用 3 千多小時才損壞。又由化驗附件齒輪箱底部之殘餘物，檢驗出含有燒過的軸封膠圈材質。故此軸封膠圈未安裝或未正確安裝之情況排除。

Photo No. 60
Pieces of o'ring collected from the bottom of the oil tank
