# 飛航事故調查報告

ASC-AOR-06-03-001

復興航空公司 GE536 班機

台北/松山機場落地階段滑出跑道

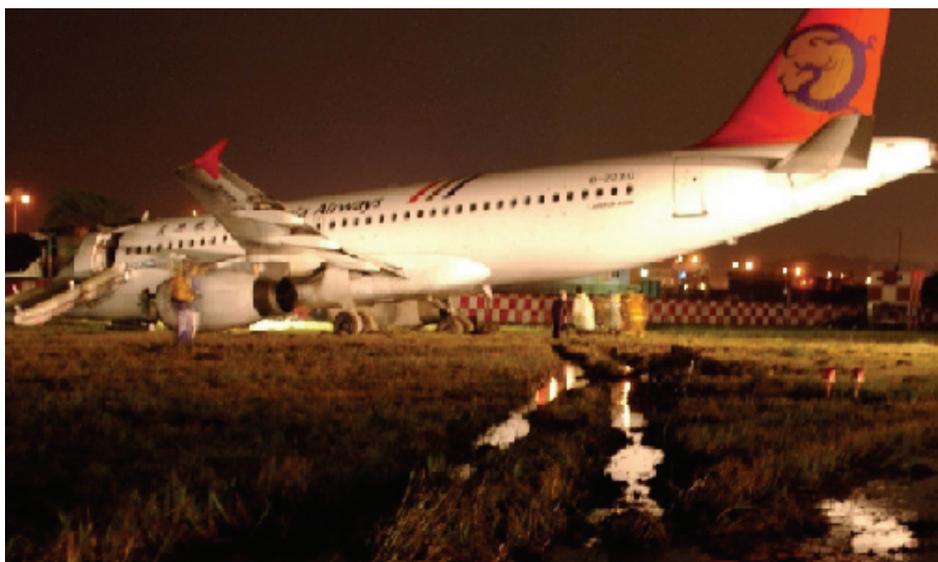
該機滑出跑道後，機身與跑道方向約呈垂直，停止於泥濘草地（如圖1.3-1），鼻輪起落架落入深約1公尺之排水溝（如圖1.3-2），前起落架減震支柱內筒折斷（如圖1.3-3），2號發動機罩底部與地面撞擊壓擠（如圖1.3-4），發動機部份葉片受損，2號發動機吊艙結構受損。

圖 1.3-1 該機停止後之情形

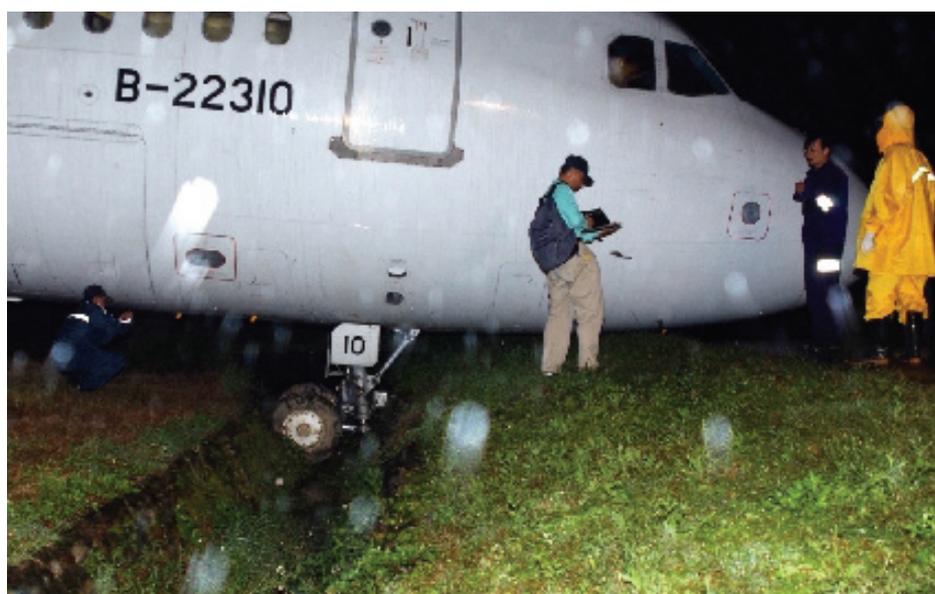
圖 1.3-2 鼻輪起落架滑入排水溝之情形

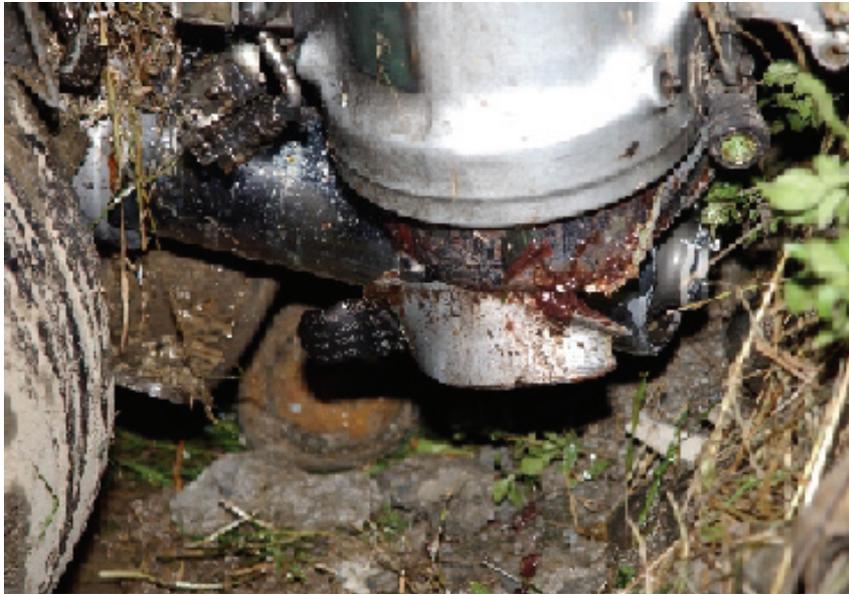
圖 1.3-3 前起落架減震支柱內筒折斷

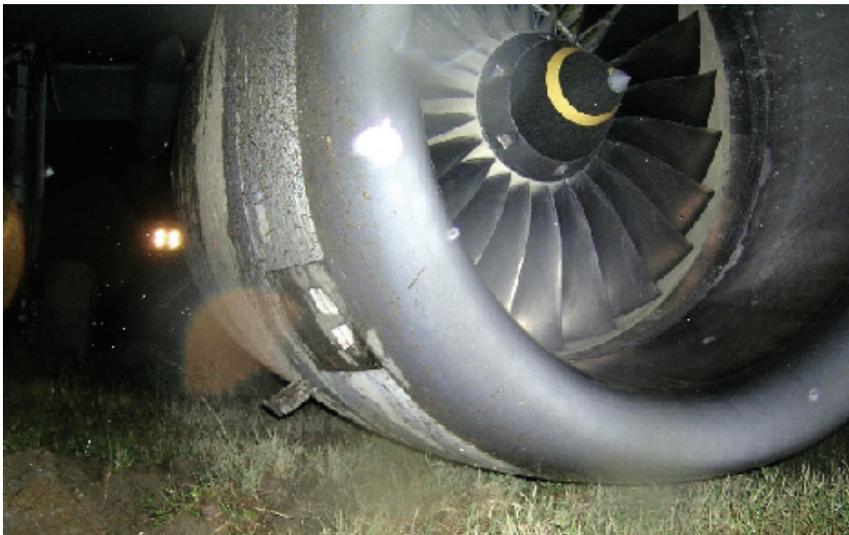
圖 1.3-4 2 號發動機罩底部與地面撞擊壓擠

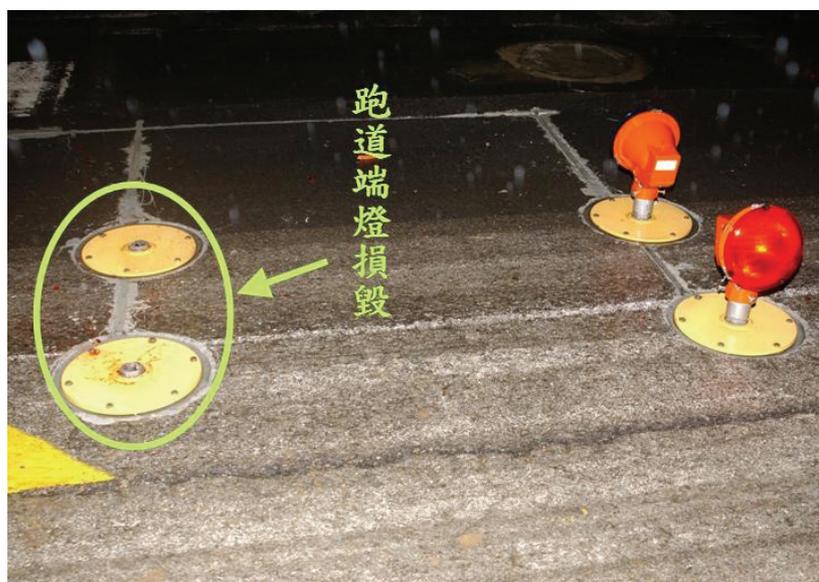
該機鼻輪胎痕通過兩跑道端燈，如圖 1.4-1；右主輪胎痕通過位於草地上之電力手孔 (Electrical Handhole)，電力手孔損毀情形如圖 1.4-2。

圖 1.4-1 跑道端燈損毀情形

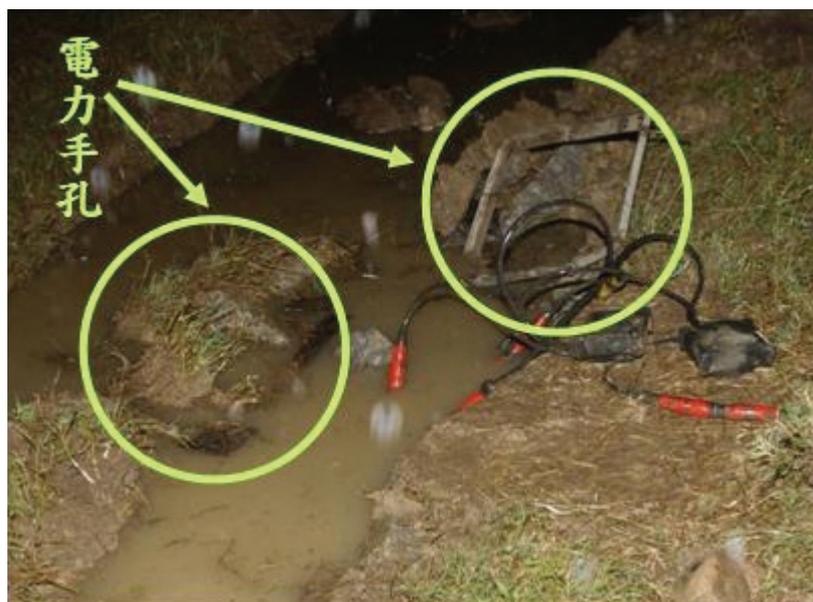
圖 1.4-2 電力手孔損毀情形

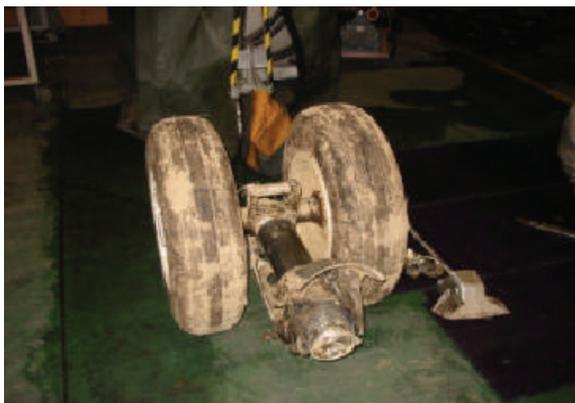
- 目視檢查鼻輪起落架締結處結構及鼻輪艙結構無損壞；
- 鼻輪起落架減震支柱內筒（Sliding Tube）折斷，電線損壞，如圖1.12-2及1.12-3；
- 後鼻輪艙門受損，如圖1.12-4。

圖 1.12-2 鼻輪及減震支柱內筒折斷，電線損壞

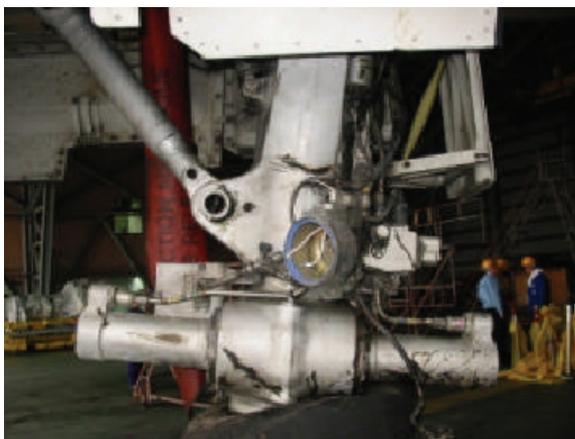
圖 1.12-3 鼻輪起落架失去鼻輪及減震支柱內筒情形

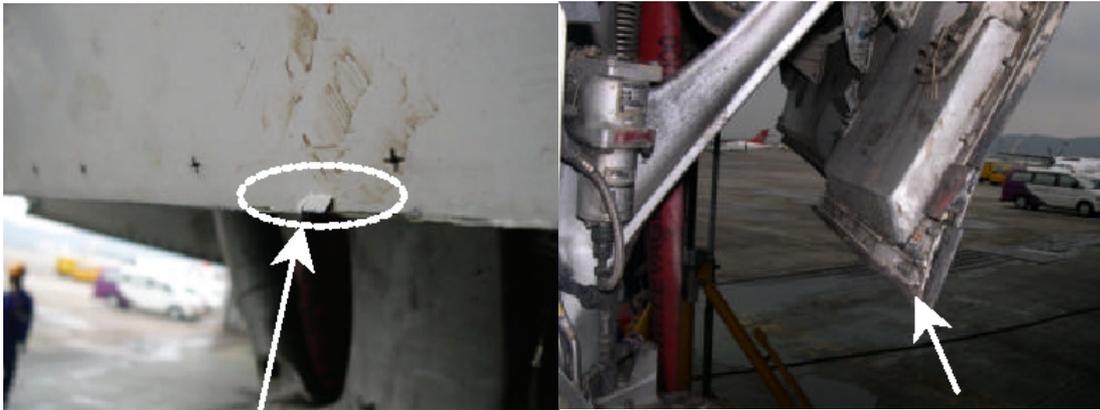
圖 1.12-4 後鼻輪艙門變形及損壞情形

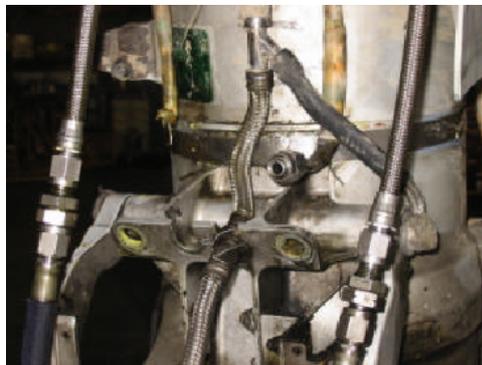
- 主起落架締結結構及其輪艙結構無損壞；
- 左起落架輪胎胎面損壞；
- 左、右起落架電氣及液壓系統於該機拖吊作業時壓擠損壞，如圖1.12-4及1.12-5；
- 左起落架輪艙門膠封（Door Seal）輕微損壞。

圖 1.12-5 左起落架電氣及液壓系統損壞情形

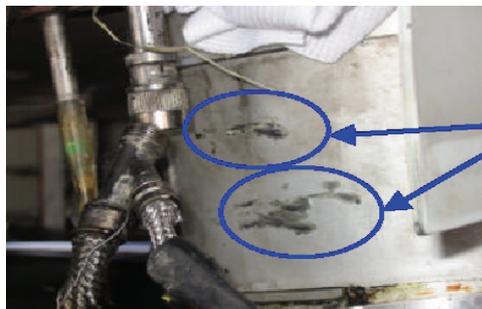
圖 1.12-6 左起落架刮痕-最深處 0.5mm

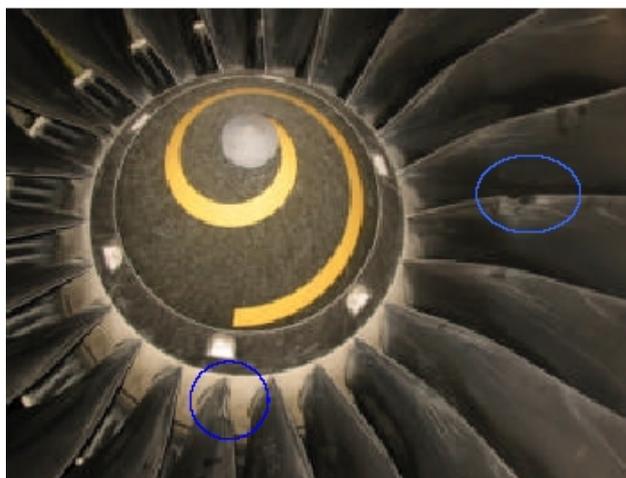
圖 1.12-7 扇葉損壞

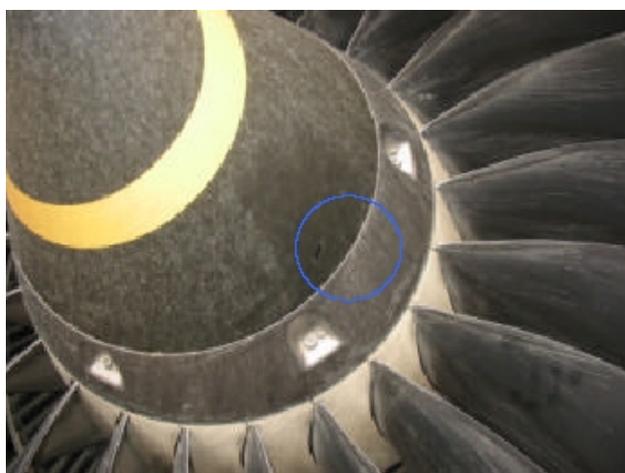
圖 1.12-8 心錐刮損

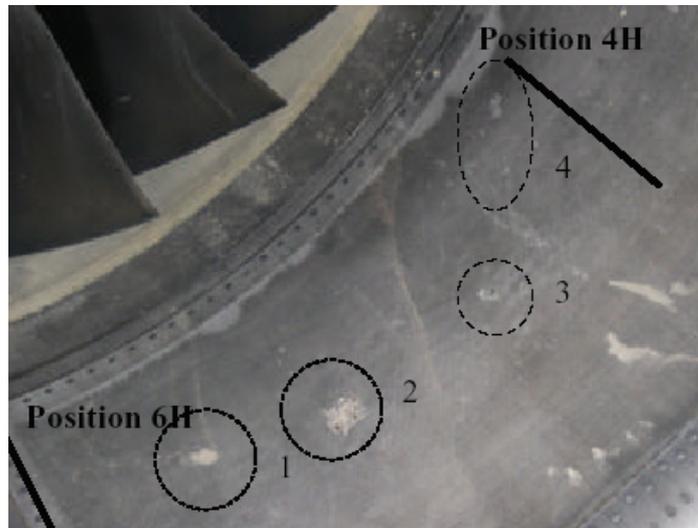
圖 1.12-9 進氣罩內部 4 處損壞

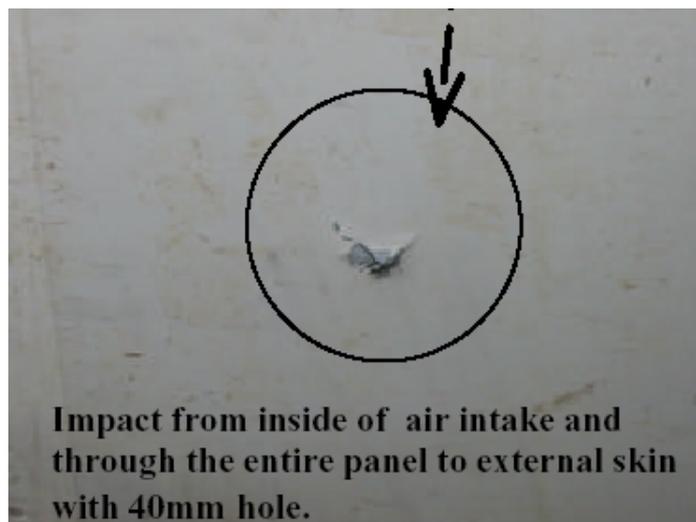
圖 1.12-10 進氣罩外部 1 處損壞

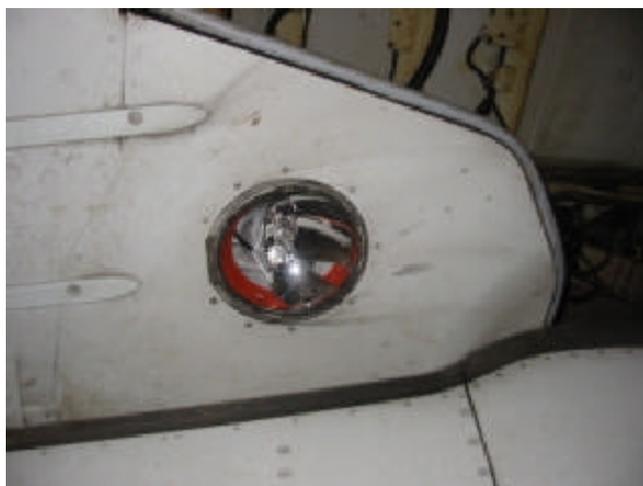
圖 1.12-11 落地燈破損

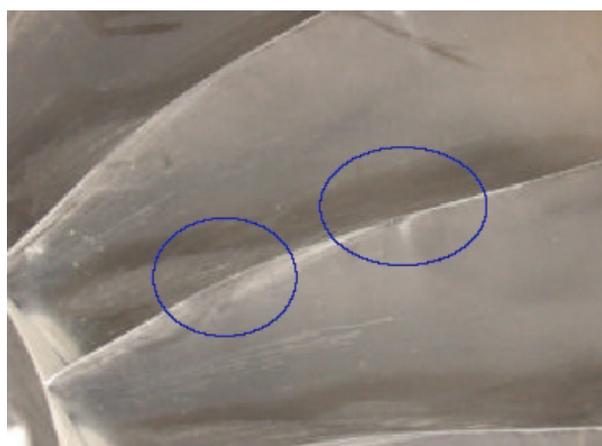
圖 1.12-12 扇葉損壞

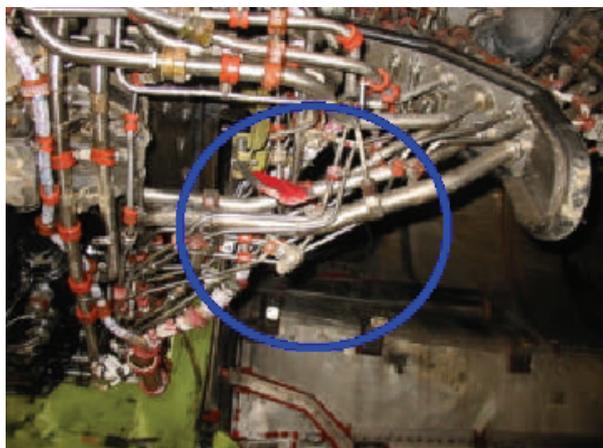
圖 1.12-13 管路彎曲變形，底部疏油涵管失蹤

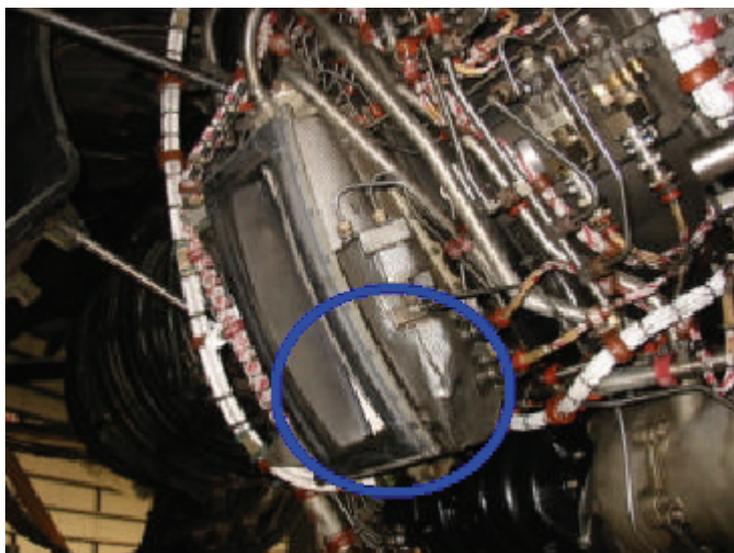
圖 1.12-14 滑油冷卻器損壞

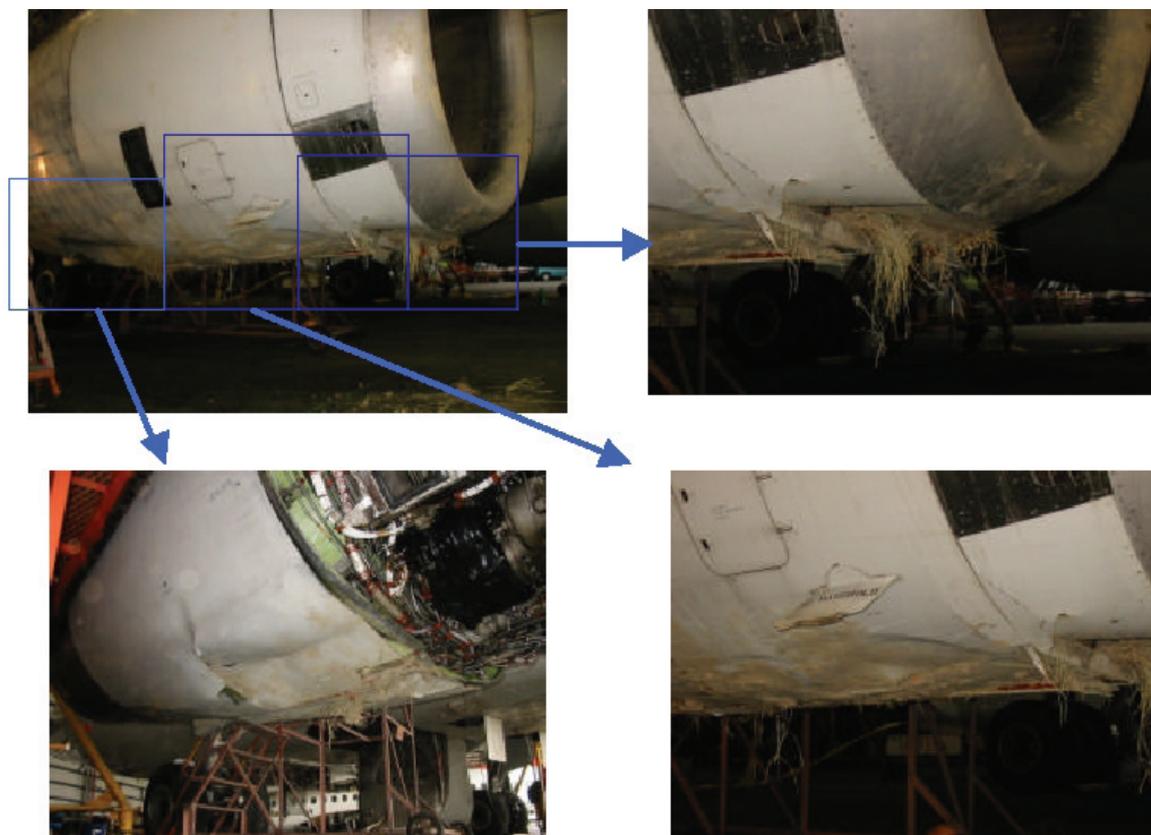
圖 1.12-15 發動機罩損壞情形

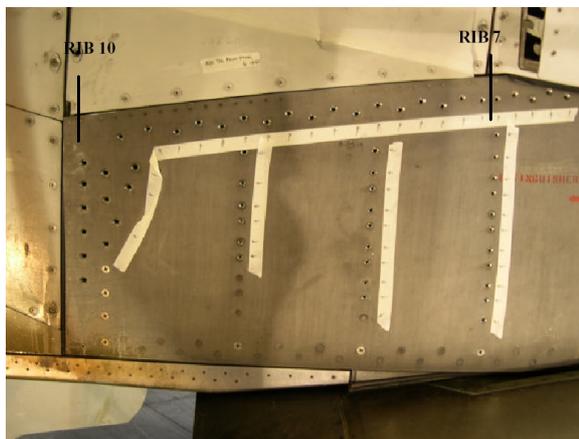
圖 1.12-16 上部及側邊蓋板螺栓拔出

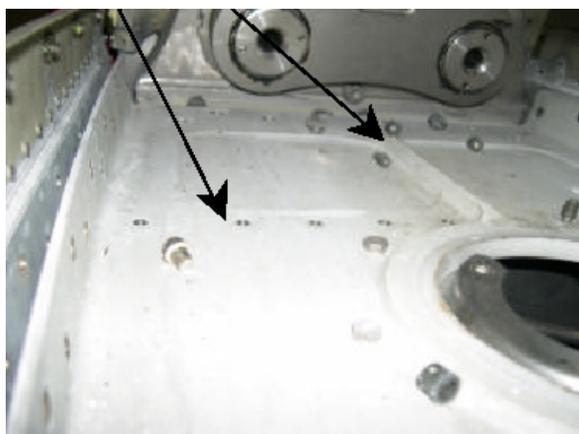
圖 1.12-17 頂盤螺栓拔出

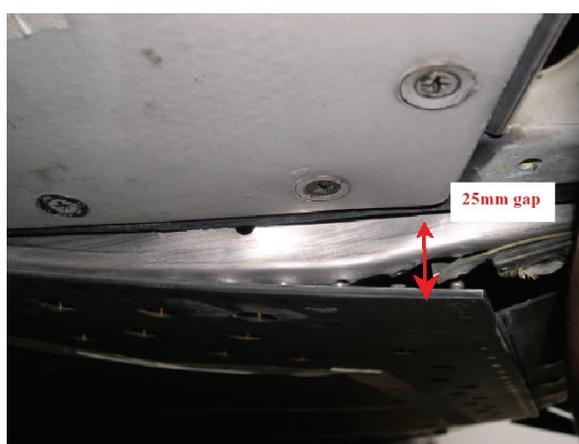
圖 1.12-18 螺栓拔出結構變形

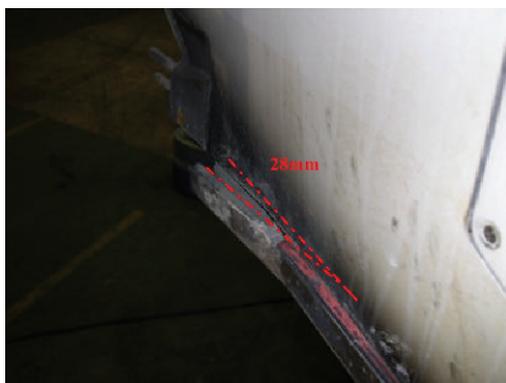
圖 1.12-19 底部結構流線扭曲變形

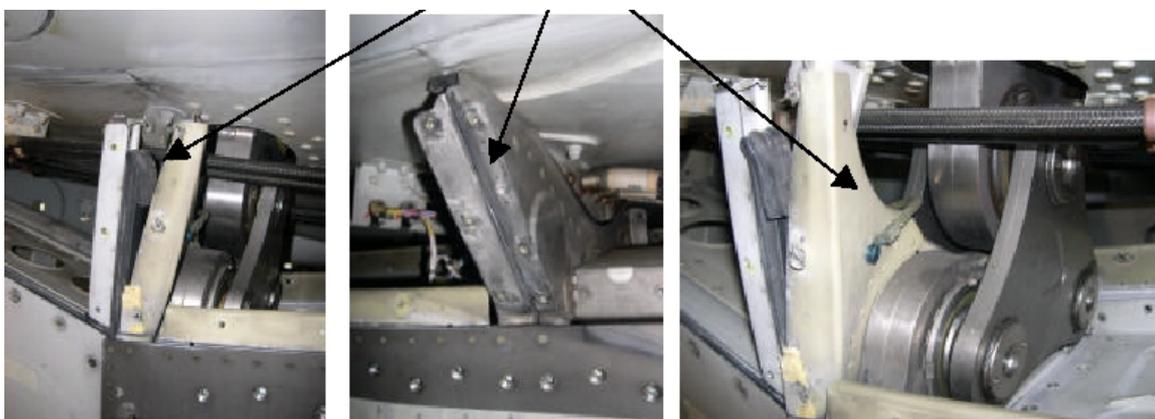
圖 1.12-20 垂直結構變形

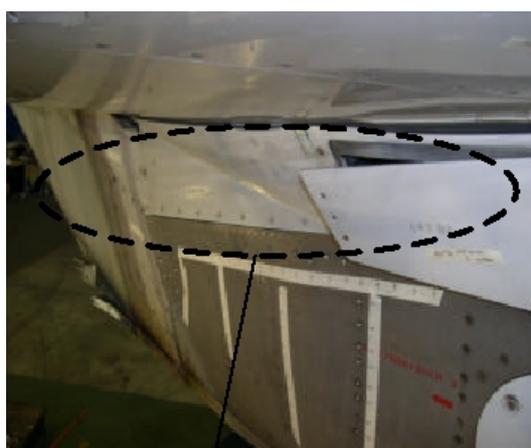
圖 1.12-21 整流蓋板變形

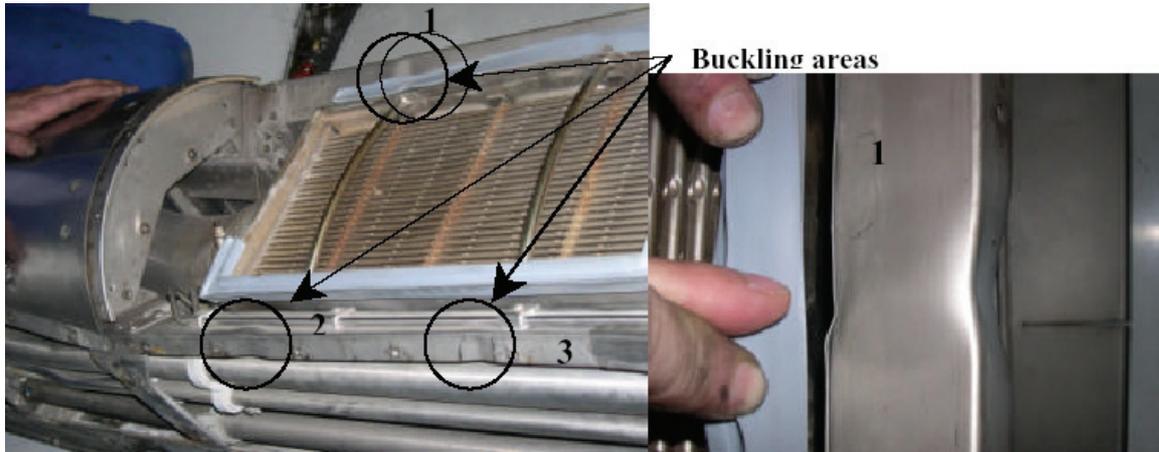
圖 1.12-22 上部懸桁角鋼皺摺變形

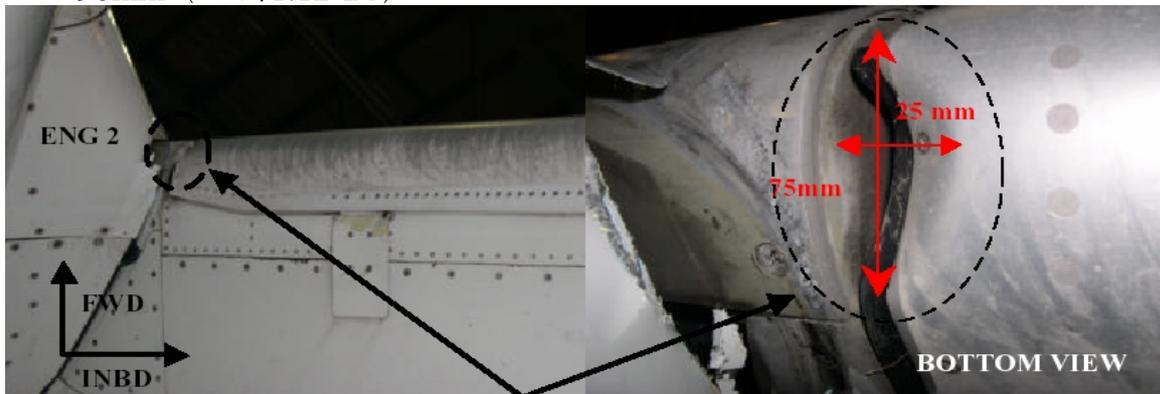
- 1號前緣襟翼（Slat）於靠近發動機吊艙處擠壓變形，前緣下方蒙皮凹陷，損壞區域約25mm×75mm（如圖1.12-23），前緣上方蒙皮凹陷，損壞區域約25mm×90mm（如圖1.12-24）。

圖 1.12-23 1號前緣襟翼損壞情形（1）

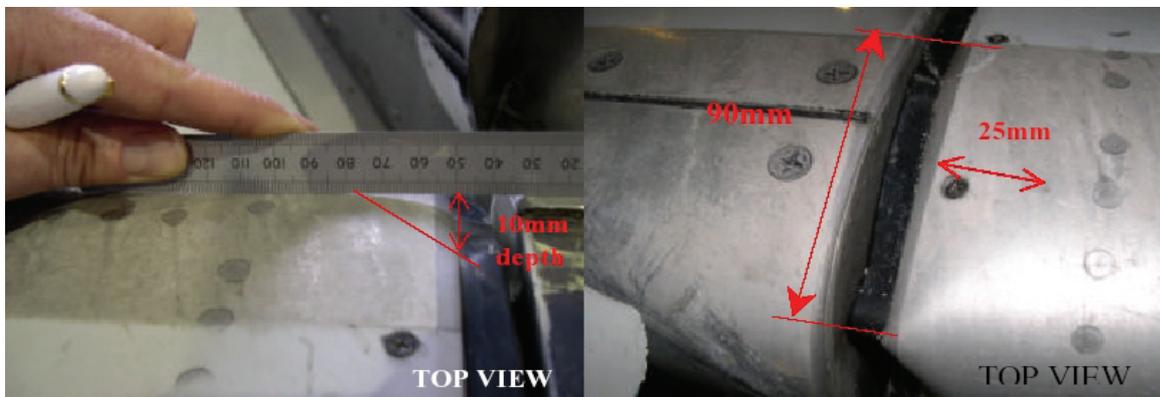
圖 1.12-24 1號前緣襟翼損壞情形（2）

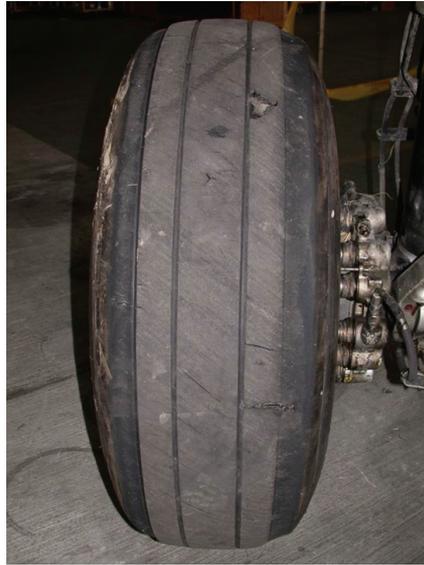
圖 1.16-1 輪胎有深切割與斜向刮痕

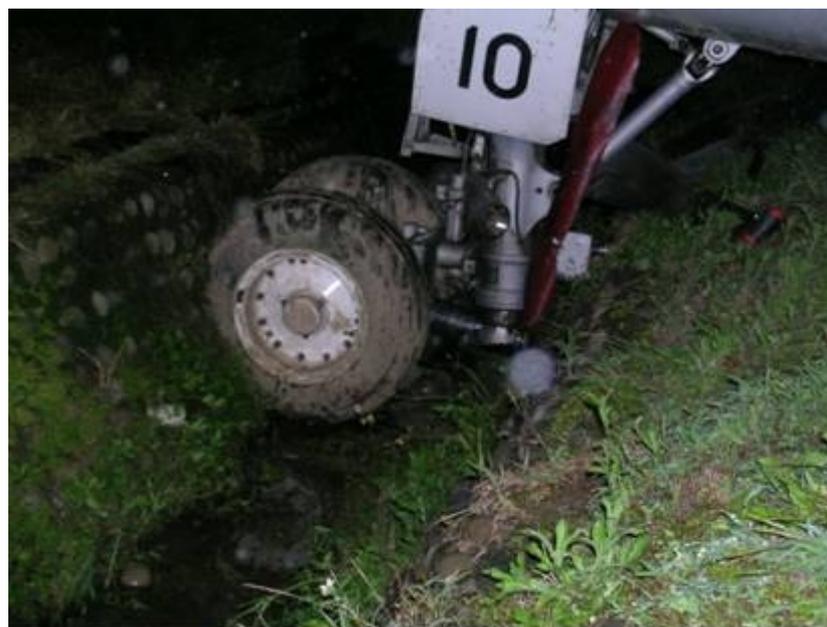
依據現場量測結果，該機鼻輪於 10 號跑道末端外 321 呎處滑出緩衝區，停止於緩衝區北側約 130 呎處之明溝內（如圖 1.18-2），航向 002 度，機身略為前傾。

圖 1.18-2 該機鼻輪滑入明溝之情形

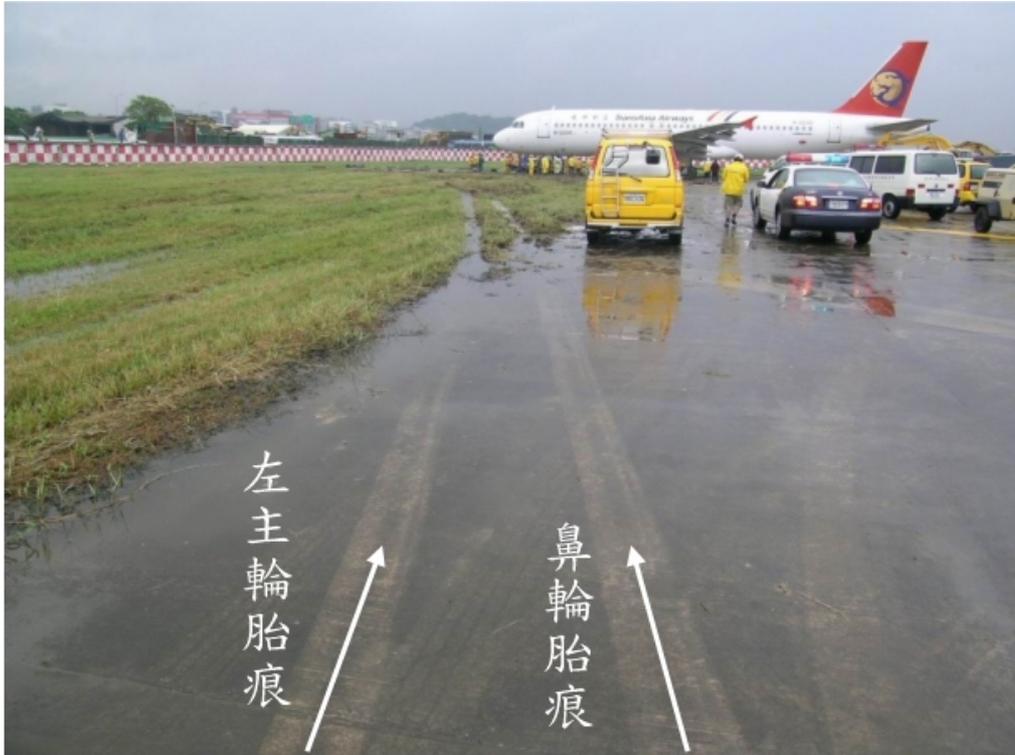
該機之胎痕軌跡可由停止位置追溯至緩衝區（如圖 1.18-3），至 28 號跑道頭標線區域止。

圖 1.18-3 該機之胎痕軌跡

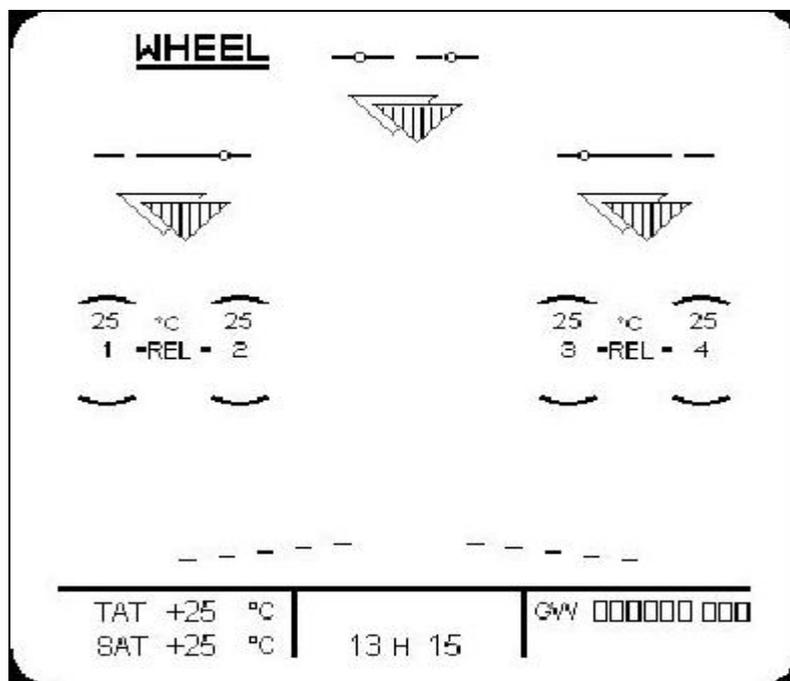
圖 2.3-4 地面擾流板未伸出 ECAM 之顯示

1959:27 時，該機左/右主輪同時著陸，1959:29 時，CM-1 呼叫「spoiler one reverse green and」。依 2.3.3.2 節分析，地面擾流板未致動伸出，故 ECAM 之顯示應為「-」符號，如圖 2.3-4。CM-1 之該型機飛航時間已逾 8,700 小時，對落地時之呼叫已甚為熟悉，雖 ECAM 顯示地面擾流板未致動，仍習慣性叫出「spoiler」，顯示監控駕駛員於著陸時，未按標準操作程序先檢查 ECAM 之顯示後再呼叫。另因下雨、順風，及當時該機僅單邊反推力器可致動，作用中易產生偏側情況，將注意力轉向該機之滾行方向及減速情況，忽略了地面擾流板未致動之狀況。
