飛航事故調查報告

ASC-AOR-07-03-001

龐巴迪爾 BD700 型機

於高雄國際機場落地時偏出滑行道

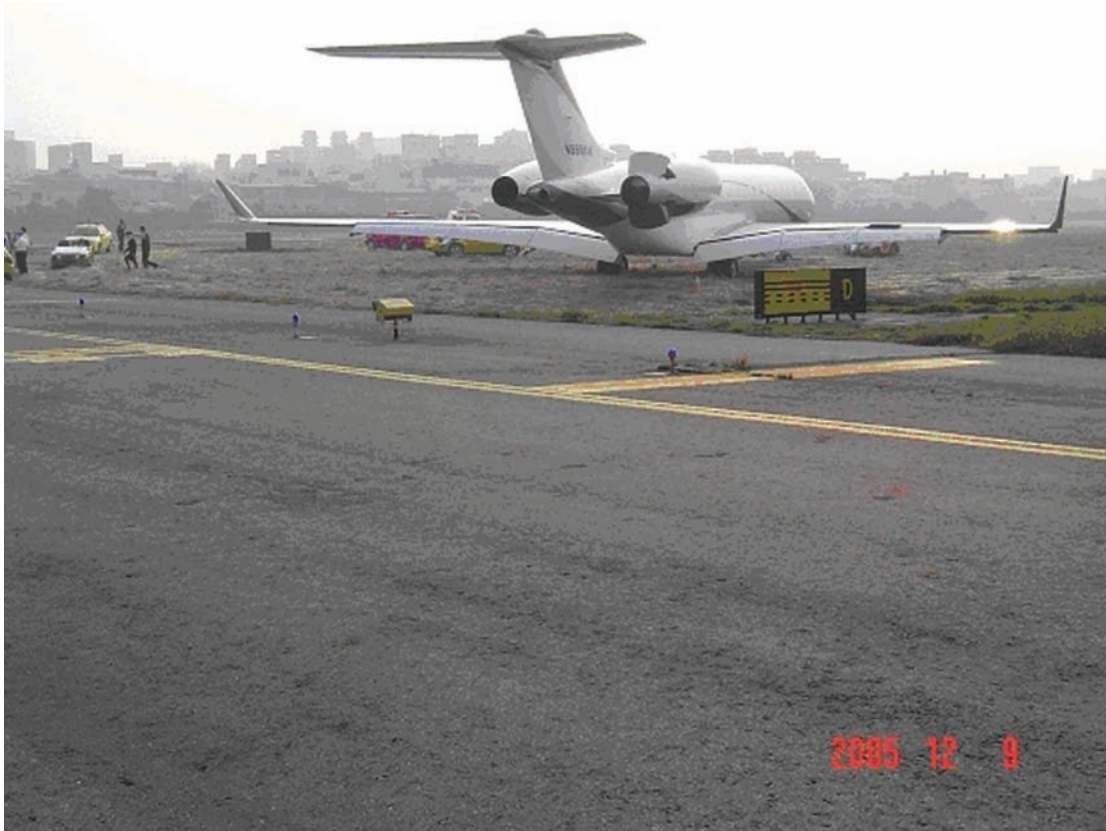
停！」¹²，PF 則道「飛機完全失去控制！完全失控！」¹³，該機繼續向右偏轉，偏出 D 滑行道並停於 D 滑行道右側約 30 公尺處之草地上（詳圖 1.1-1），人員無傷。

圖 1.1-1 航機停於 D 滑行道右側約 30 公尺處之草地上

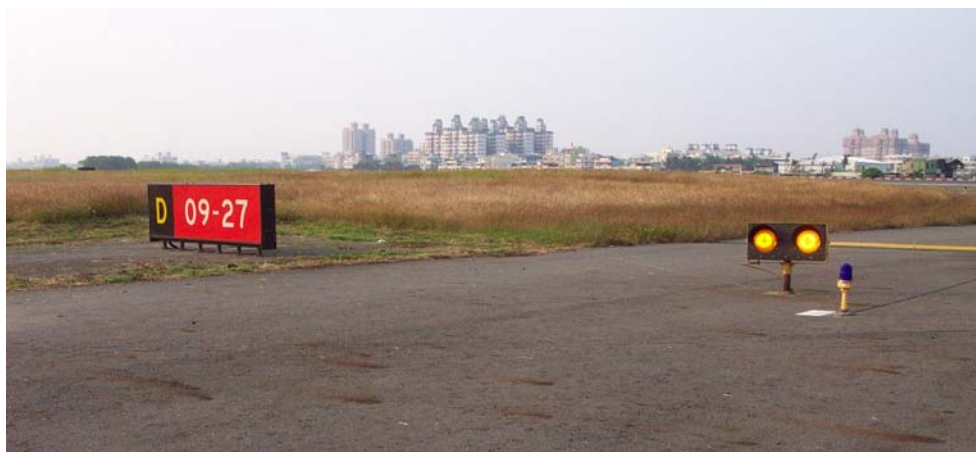
該機滑出 D 滑行道前經過之強制性指示牌為 OCEM 公司製造，全高 1020 公厘，牌面最小值高度 800 公厘，字體高 400 公厘，滑行道鋪面邊緣與指示牌接近側之垂直距離 12 公尺，具原廠易斷接頭之設計，如圖 1.6-3 及圖 1.6-4 所示。

圖 1.6-3 事故地點之目視助航設施

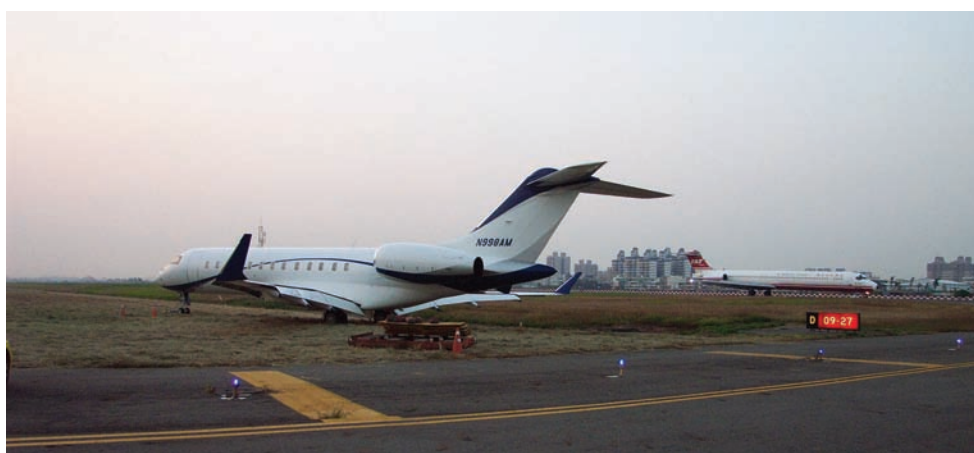
圖 1.6-4 航機與相關目視助航設施

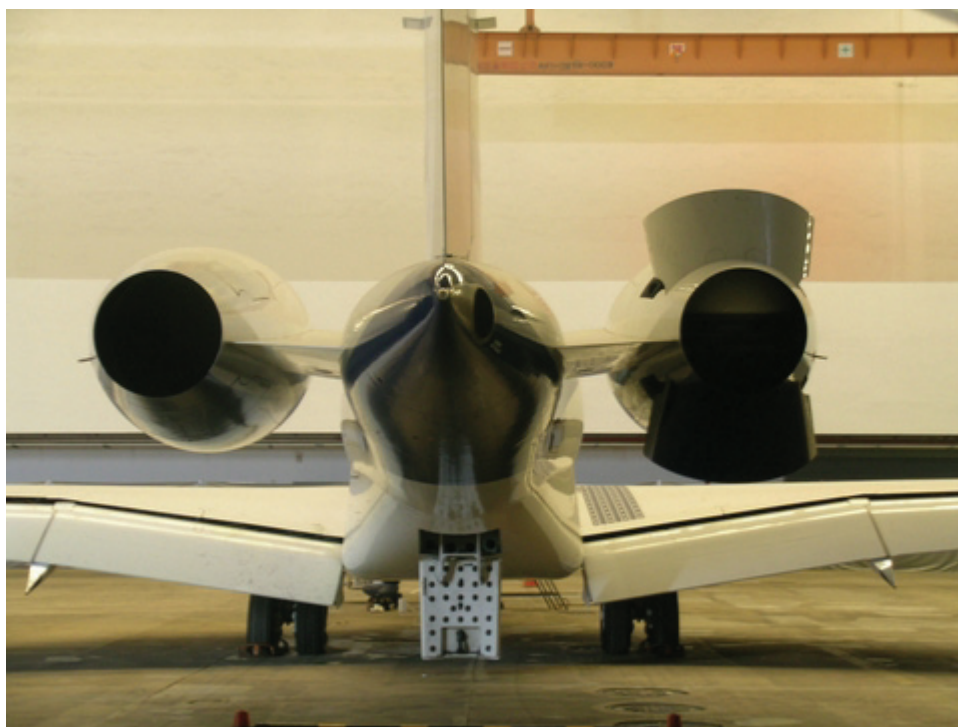
右發動機反推力器仍於開展位置（詳圖 1.8-1），左內側主輪爆胎（詳圖 1.8-2），左內側主輪上方機翼次結構破裂，2、3 號液壓系管線斷折，左後襟翼扭力管斷裂，部分電線斷落（詳圖 1.8-3）。

圖 1.8-1 右發動機反推力器仍於開展位置

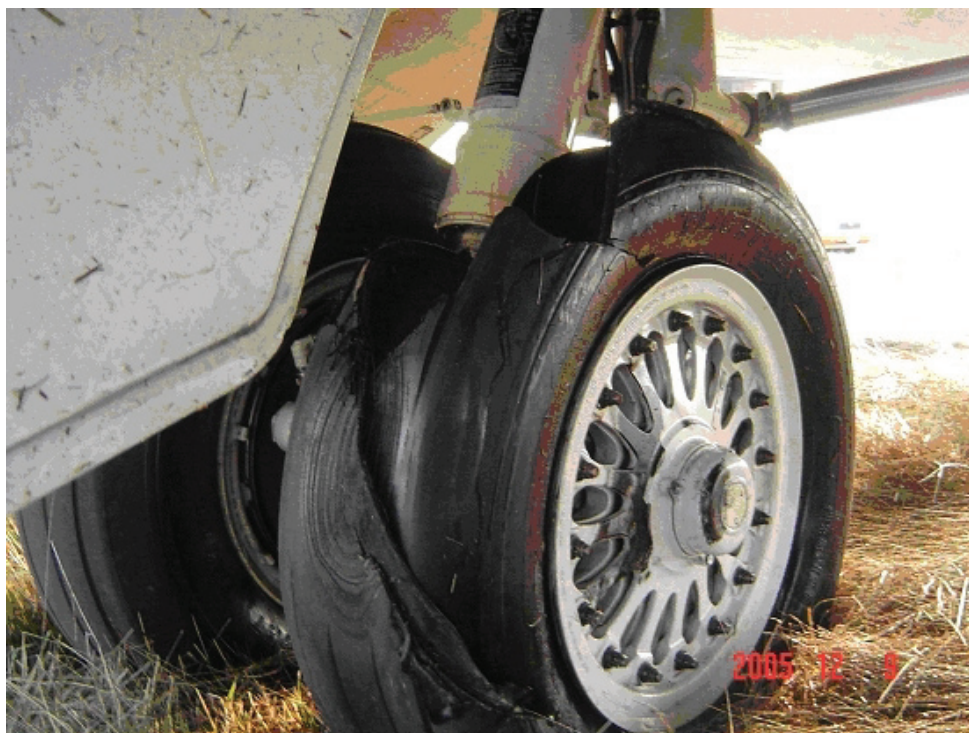
圖 1.8-2 左內側主輪爆胎

檢查結果，輪胎本身並無熱生成及外物割切現象，胎環及胎壁檢視正常，內部些許皺折應係爆裂所致。觀察損壞情形，輪胎爆裂顯然是切西瓜現象（flat spot）或磨爆現象（skid burn）深入輪胎橡膠疊層，胎內高壓氣體推出輪胎碎片被機輪高速離心力的甩動與撞擊週遭結構的情形下與輪胎分離。

該機鼻輪轉向及煞車系統失效致使航機失控滑出跑道，係因液壓管路斷裂造成 2、3 號液壓系統失效所致，觀察斷裂液壓管路並非過載或疲勞因素，乃為外力撞擊所致，撞毀液壓管的外物即是管路下方 2 號主輪爆裂之輪胎。爆裂輪胎上有一類似削洋蔥的 flat spot（平面），flat spot 後方胎面有交叉斜向裂口（diagonal-break）。依據固特異輪胎工程報告書結論，該機左內側主輪爆裂係為航機於落地後煞車鎖死所導致。龐巴迪爾工程報告書指出煞車鎖死之原因可能為 2 號 BCV（煞車控制閥）內部橡膠密封圈因組裝不善使細微橡膠剝離卡住 2 號煞車控制閥，當 2 號主輪輪速低於航機速度時（主輪滑動之意），BCV 未能正確釋放足夠之煞車壓力，導致車輪鎖死。

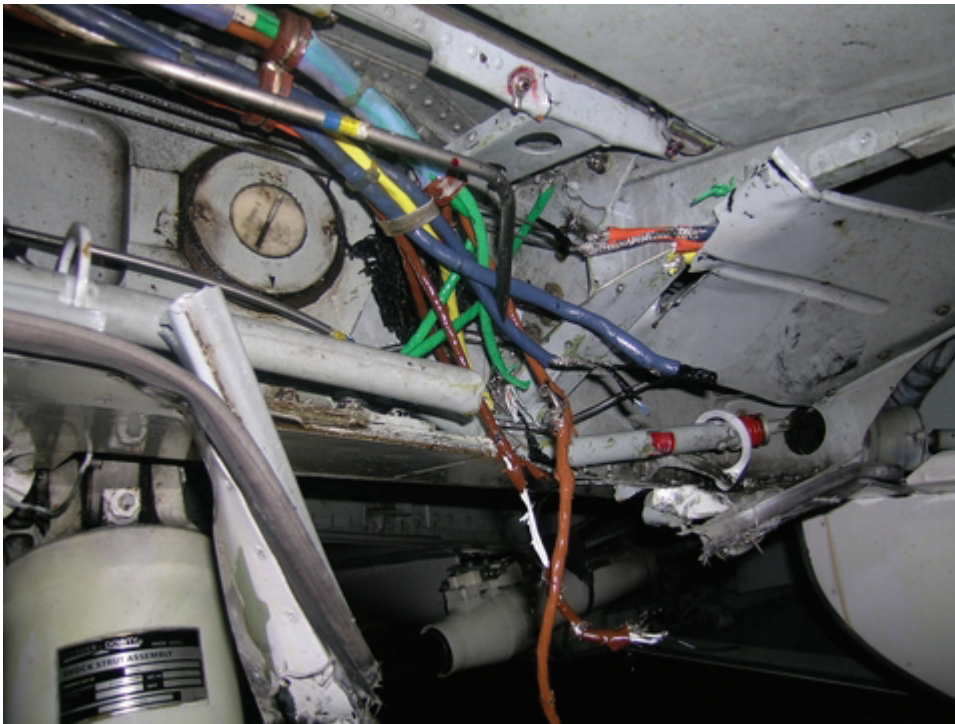
圖 1.8-3 左內側主輪上方機翼次結構破裂

該機係因輪胎爆裂打斷液壓管路，失去液壓及煞車系統以致偏出滑行道，若於起飛滾行時發生類似事故，則將使航機於空中增加操控難度，落地時之穩定進場及減速煞車亦無法確保。若於主輪上方改置防撞能力更強之保護蓋板，使集中於該區之液壓管路、傳輸電線、扭力管等不致於爆胎時損壞，該類事故發生當可避免。

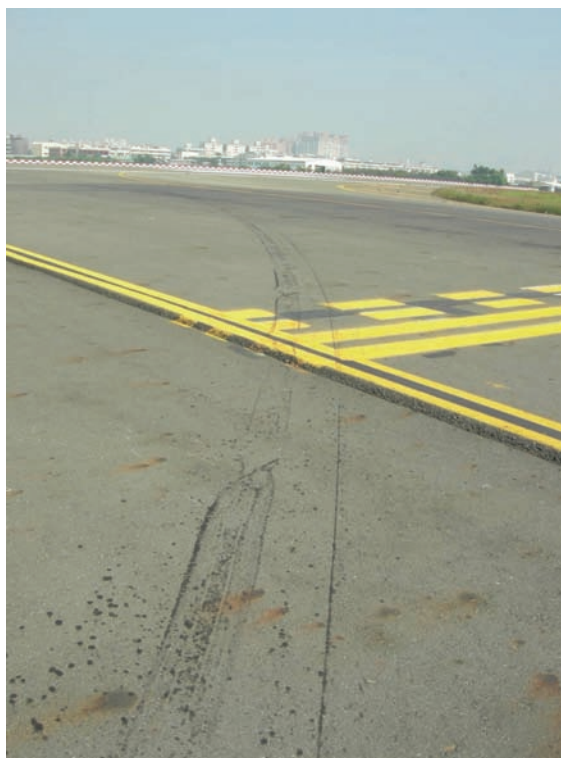
2、3 號液壓系洩漏之液壓油波濺於左側內、外主輪上，遺留左側內、外主輪軌跡及洩漏之液壓油痕跡在跑道及 D 滑行道上，如圖 1.8-4 所示。航機左主輪遺留於跑道及 D 滑行道之胎痕軌跡如圖 1.8-5 所示，鼻輪及右主輪於草地上之軌跡及停止位置無法清楚辨識，左主輪停止位置為 E120°21'31.37" N22°34'33.21"，離 D 滑行道邊緣垂直距離為 25 公尺。

圖 1.8-4 左側內外主輪軌跡及液壓油洩漏痕跡圖

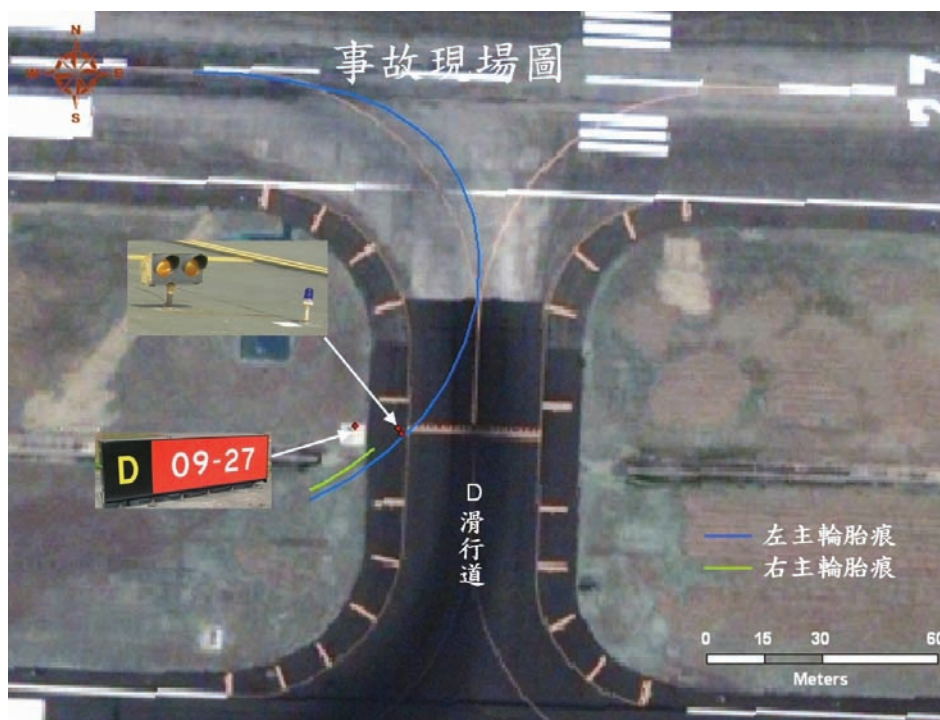
圖 1.8-5 事故現場航機左主輪遺留於跑道及 D 滑行道之胎痕軌跡

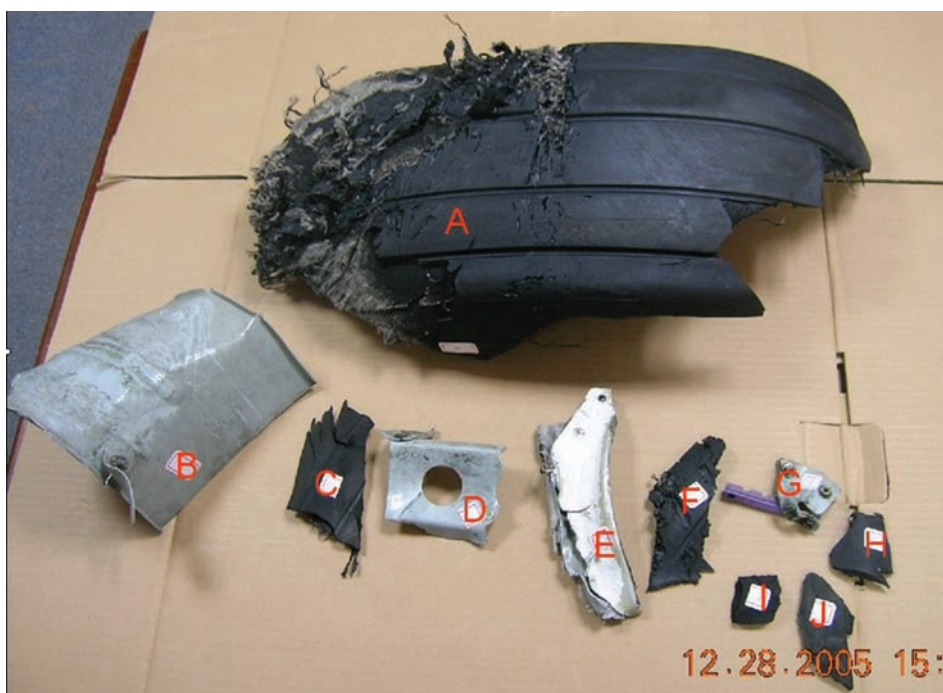
高雄機場航務組所提供由航機脫落之零件及其分布情形如圖 1.8-6 及圖 1.8-7 所示，觀察強制性指示牌發現上方有機翼擦過之痕跡，如圖 1.8-8 所示。

圖 1.8-6 由航機脫落之零件

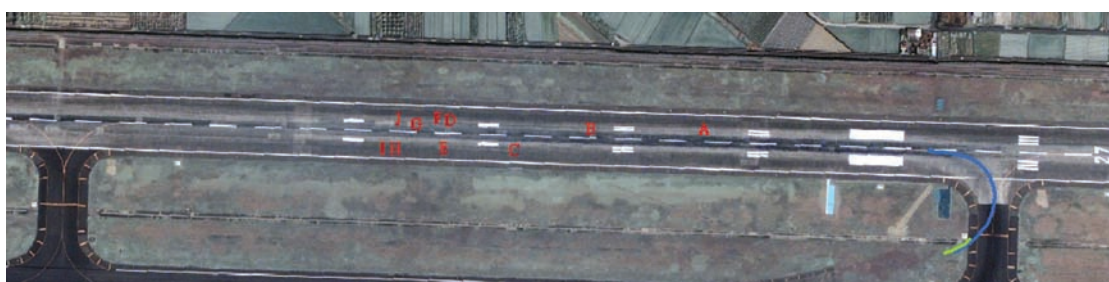
圖 1.8-7 由航機脫落之零件及其分布情形圖

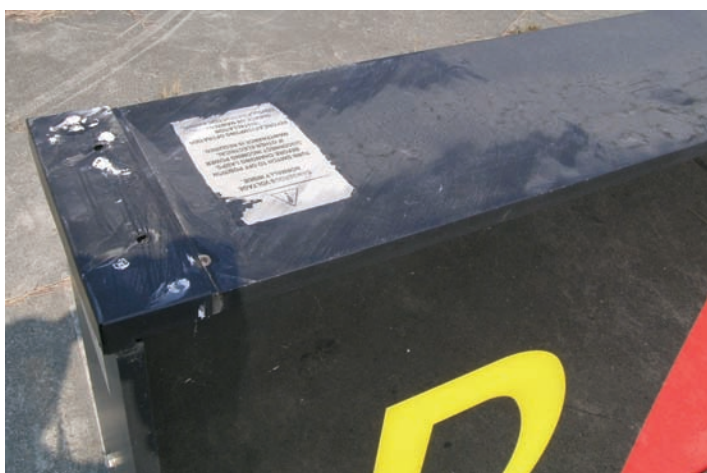
圖 1.8-8 強制性指示牌磨損情形

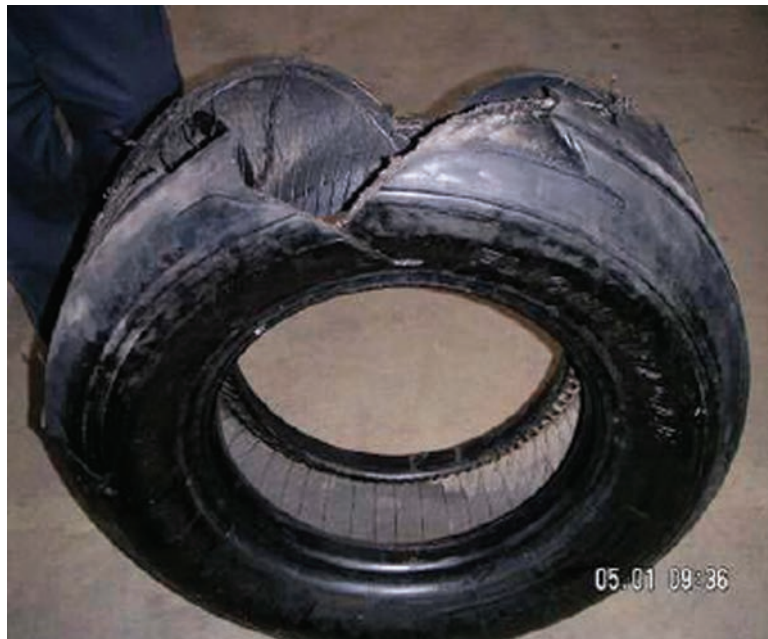
一約 10 英吋×8 英吋大小之胎面碎片，從輪胎的 12 點鐘位置至 3 點鐘位置脫離，留下一菱形缺口約佔胎面²¹面積的四分之一，損壞部位沒有熱生成和外物切割的現象（詳圖 1.9-2,3,4），胎環²²（bead）和胎壁²³（side wall）正常，內壁²⁴（inner liner）有輕微皺紋。

圖 1.9-2 2 號輪胎損壞

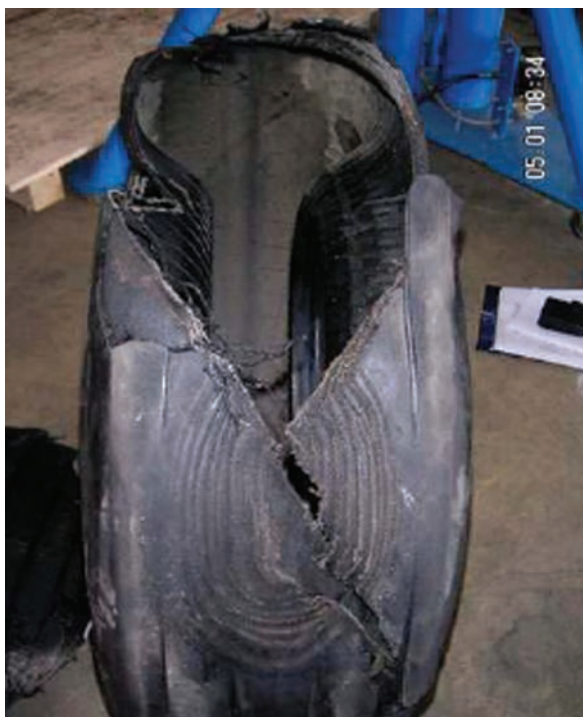
圖 1.9-3 損壞部位沒有熱生成和外物切割的現象

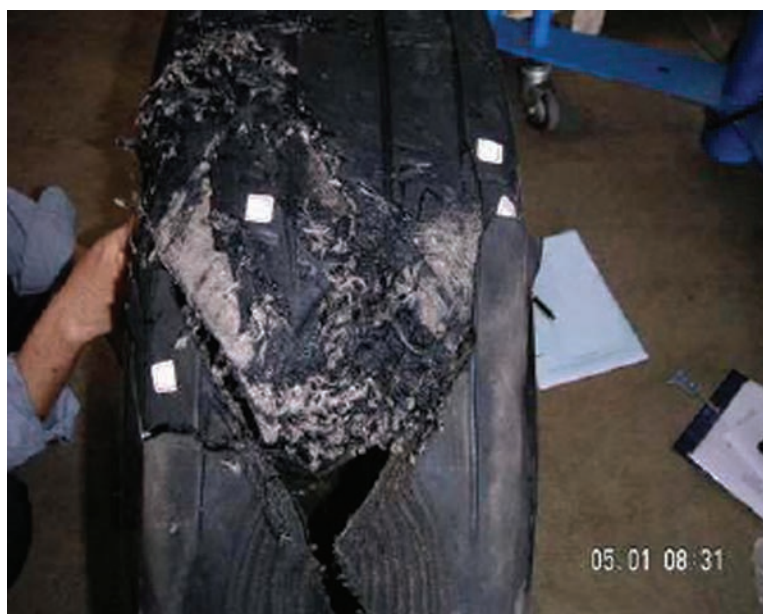
圖 1.9-4 胎面碎片自輪胎的 12 點鐘位置至 3 點鐘位置脫離

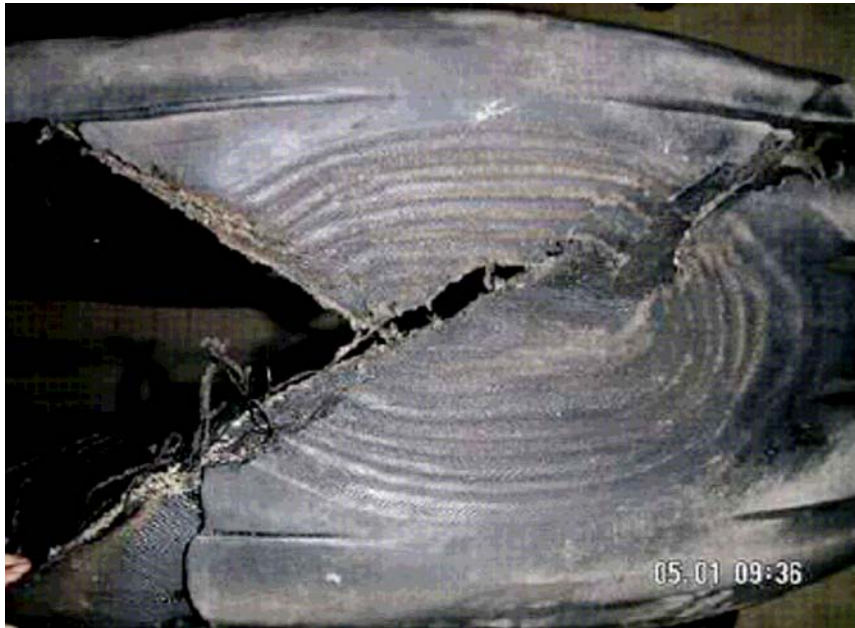
胎面中間部位有一平面²⁵（flat spot），並有一斜向裂紋（diagonal-break）貫穿其上（詳圖 1.9-5）。

圖 1.9-5 胎面上有一平面，並有一斜向裂紋貫穿其上

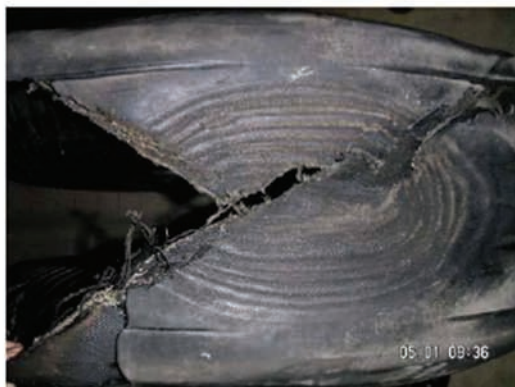
There is a large flat spot at 12 o'clock (in relation to the tire serial number, as viewed from the tire serial number) along with a diagonal-break (see photo 4).

Photo 4: Flat spot along with a diagonal-break

From the appearance of the tire, it is obvious that the tire failed due to flat spot or skid burn in the tread rubber down to casing plies causing the tire blew out then the aforementioned piece was detached due to high inflation pressure of the tire and combined with the high centrifical force.

Brake lock might be the cause of skid burn but could not be determined what was the root cause of brake lock at this time.

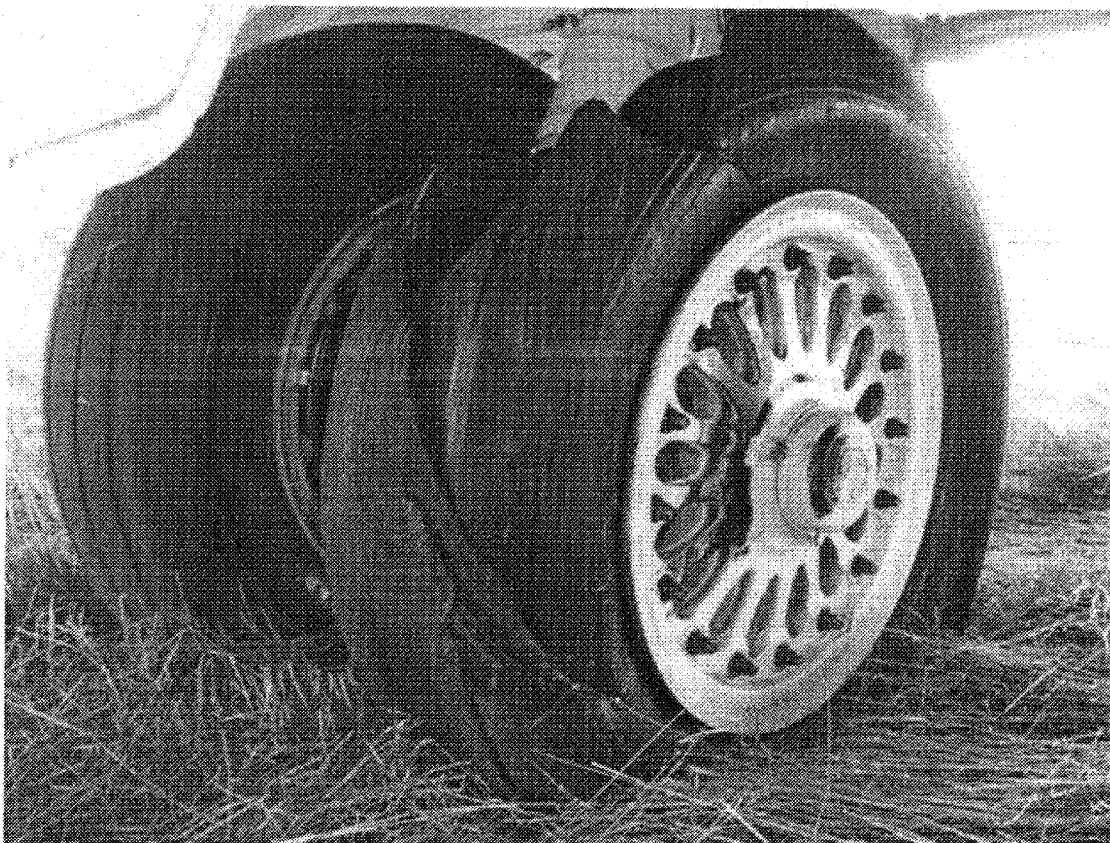
PHOTO 1 - AIRCRAFT FINAL POSITION - TIRE SKID PATCH AND MISSING PART

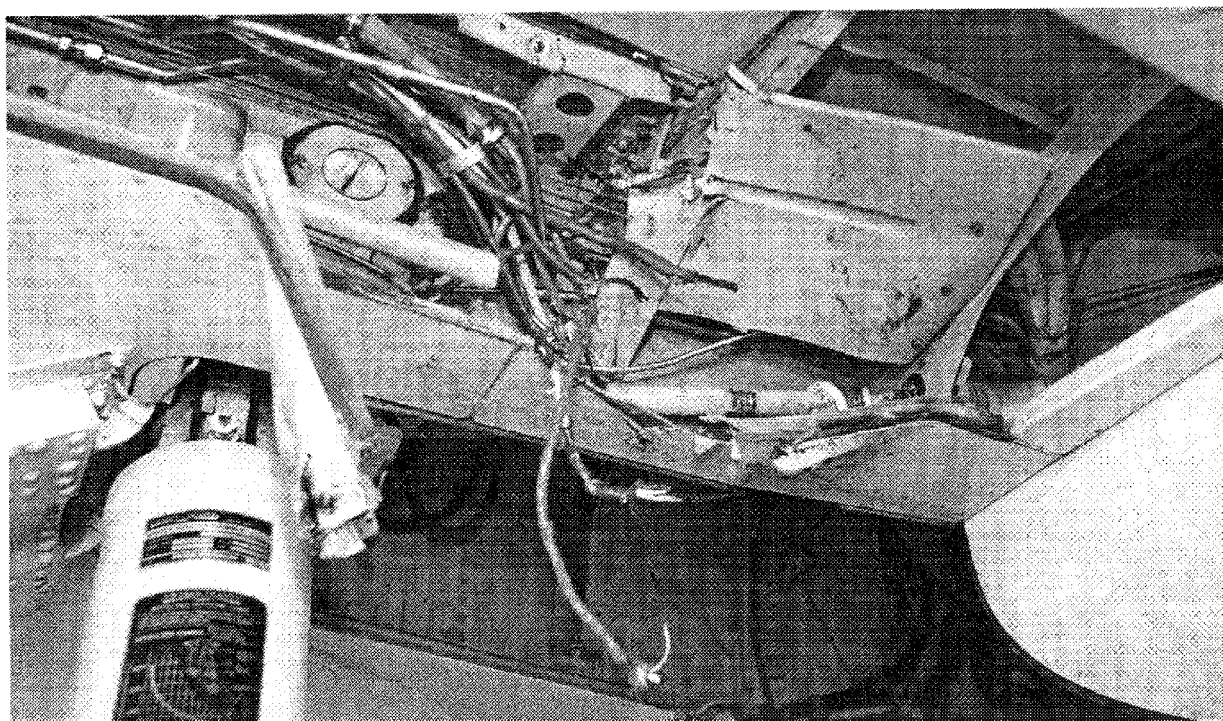
An inspection of the aircraft after it had come to stop, revealed failure of # 2 tire (Left Inboard), and damage to aircraft system installations in the left wing Aft Auxiliary Spar area. The damage was limited to hydraulic systems #2, #3 tubing, flap actuation components, harnesses installation for the spoiler and flap system, and structural and bracket components in the spar area, and slight damage to right inboard flap was also reported. (Photos 2,3,4)

PHOTO 2 - DAMAGE TO SYSTEMS IN THE AFT AUXILIARY SPAR

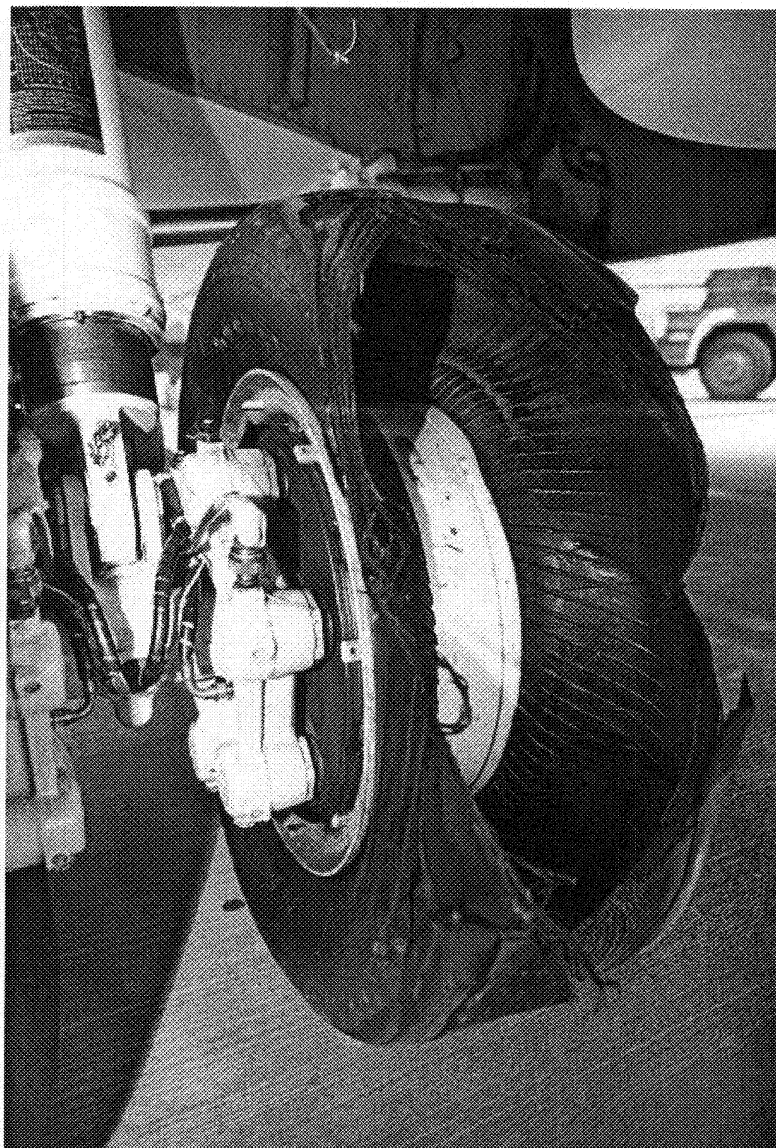
PHOTO 3 - VIEW OF TIRE DAMAGE AND LEFT MAIN LANDING GEAR

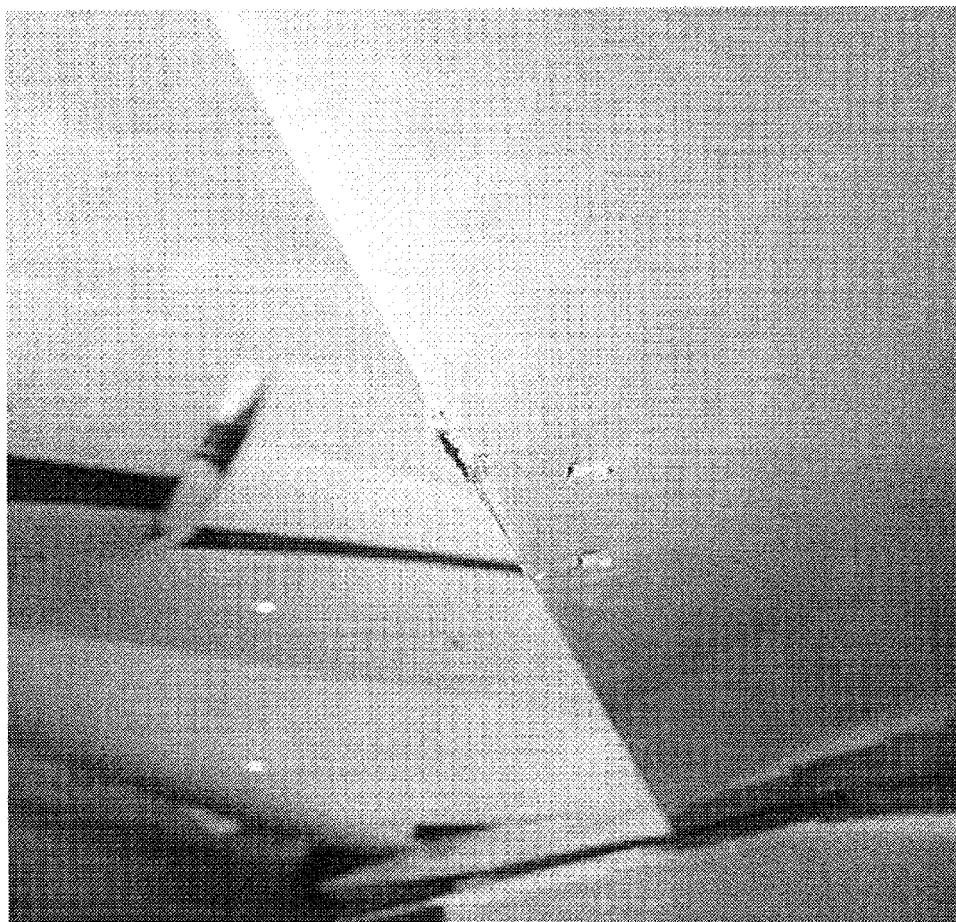
PHOTO 4 - RIGHT INBOARD FLAP DAMAGE

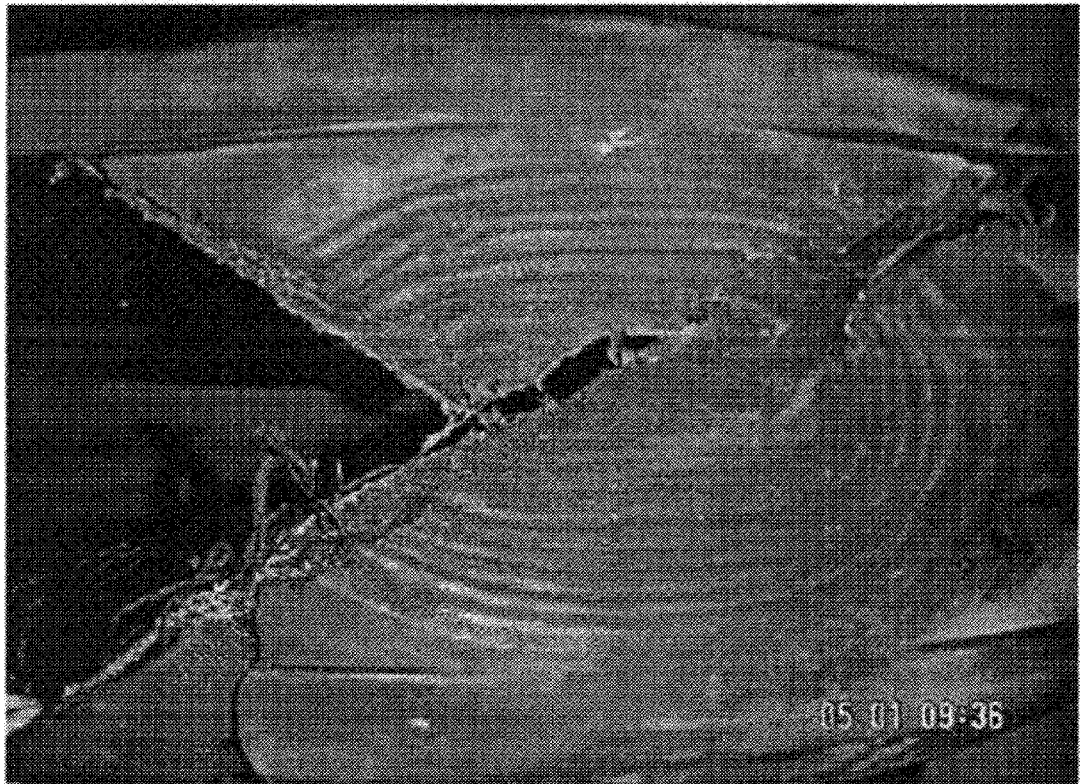
PHOTO 5 - TIRE FAILURE

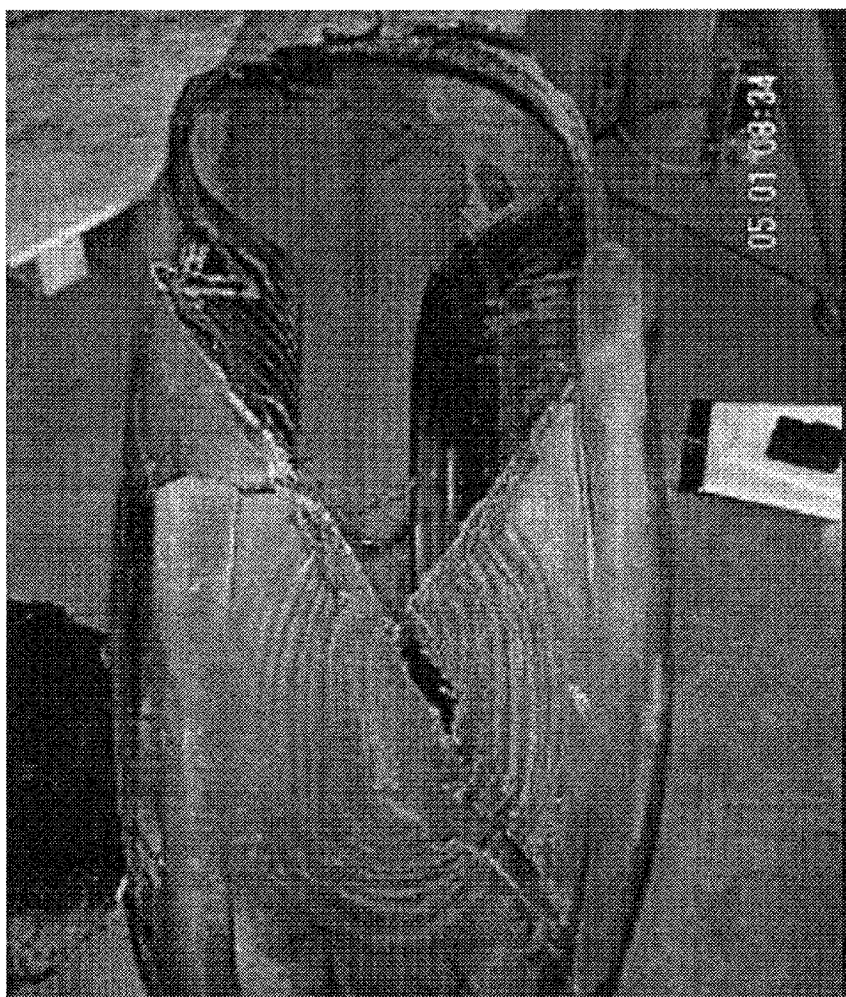
PHOTO 6 - TIRE FAILURE

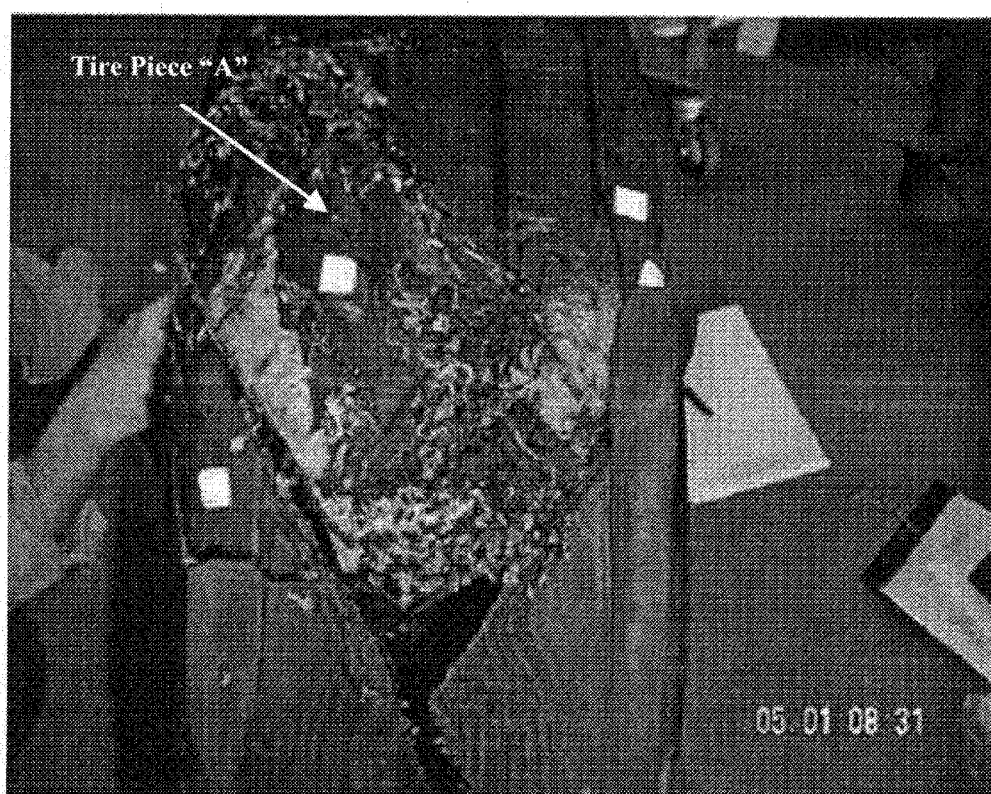
PHOTO 7 - TIRE FAILURE - RECONSTRUCTED TIRE

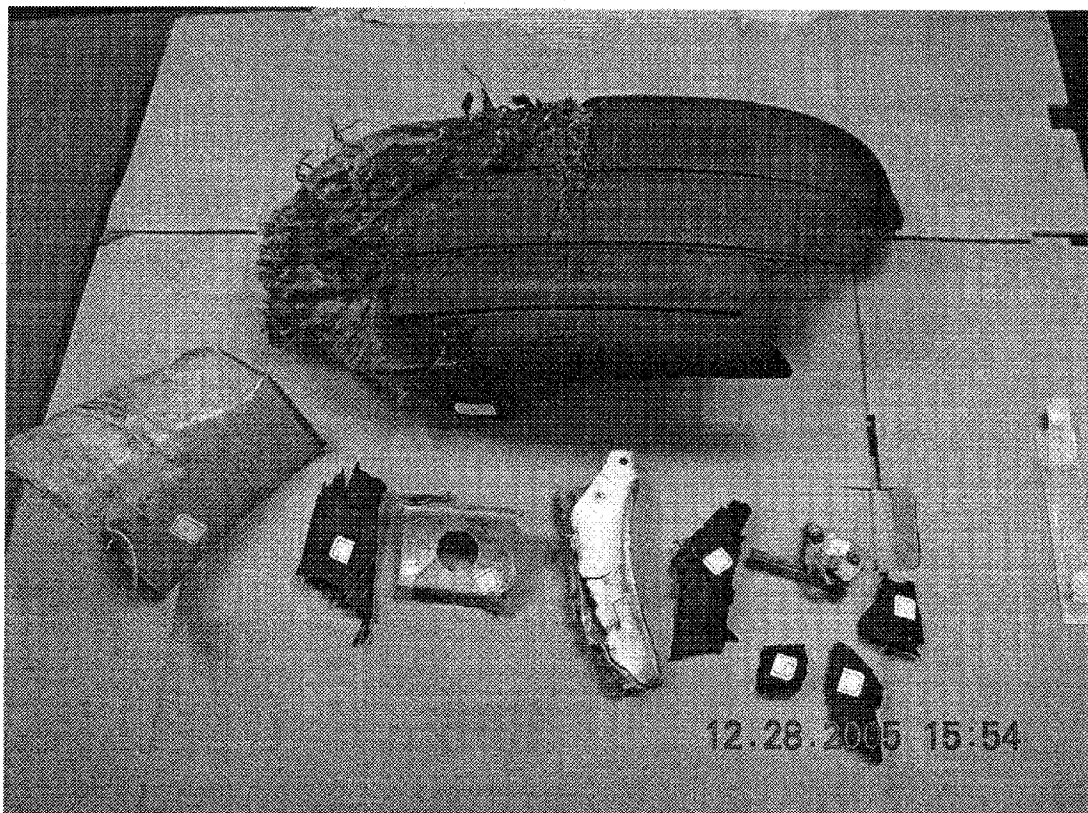
PHOTO 9 - SEPERATED AIRCRAFT PIECES COLLECTED FROM RUNWAY

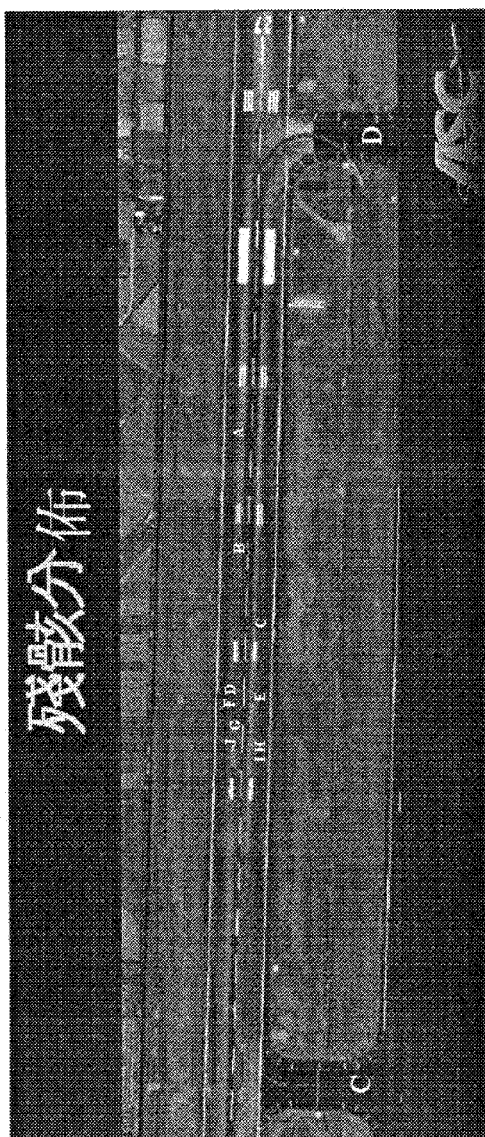
PHOTO 10 - LOCATION OF TIRE PIECES ON THE RUNWAY
