Aviation Safety Council

Investigation Report

Korean Air Flight 691

**Loss Cabin Pressure at FL320, 30
NM South of Waypoint SALMI**

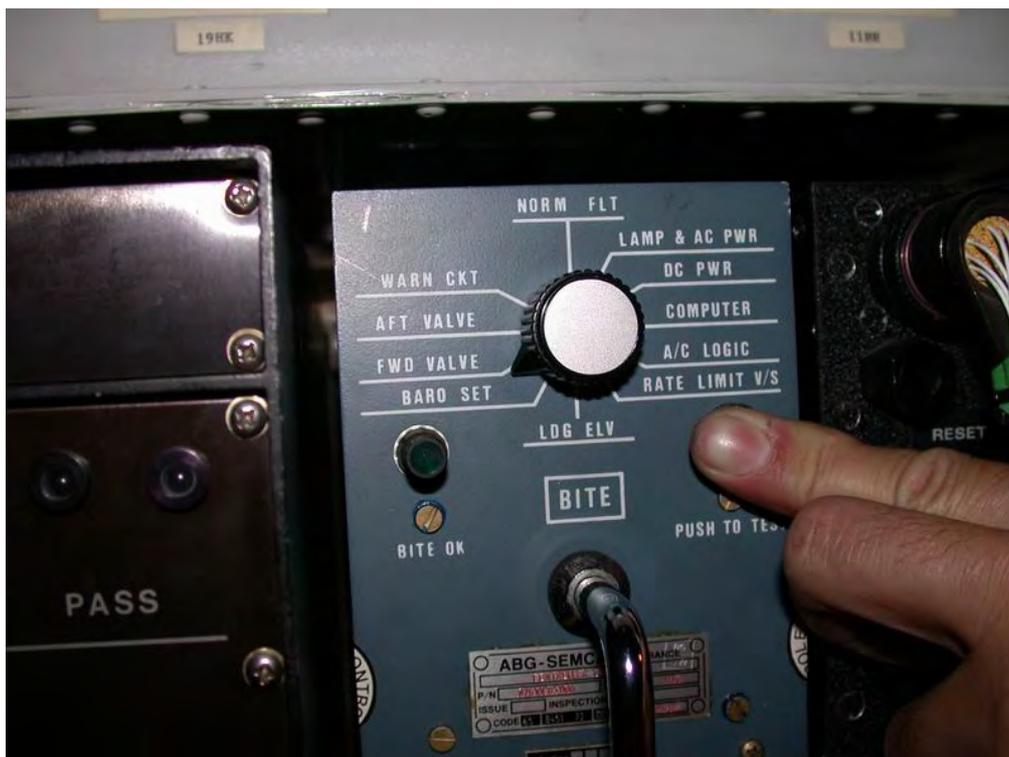
Figure 1.4-1 BITE test results

The contracted maintenance staff in Taipei (China Airlines, CAL ground staff) performed the Built in Test Equipment (BITE) test in accordance with Aircraft Maintenance Manual (AMM) to FWD out flow valve on Cabin Pressure Controller panel after the aircraft landed at CKS International Airport. The result showed the valve was failed (shown as Figure 1.4-1). The function of the Cabin Pressure Control System met the operational requirements after the replacement of the FWD out flow valve.

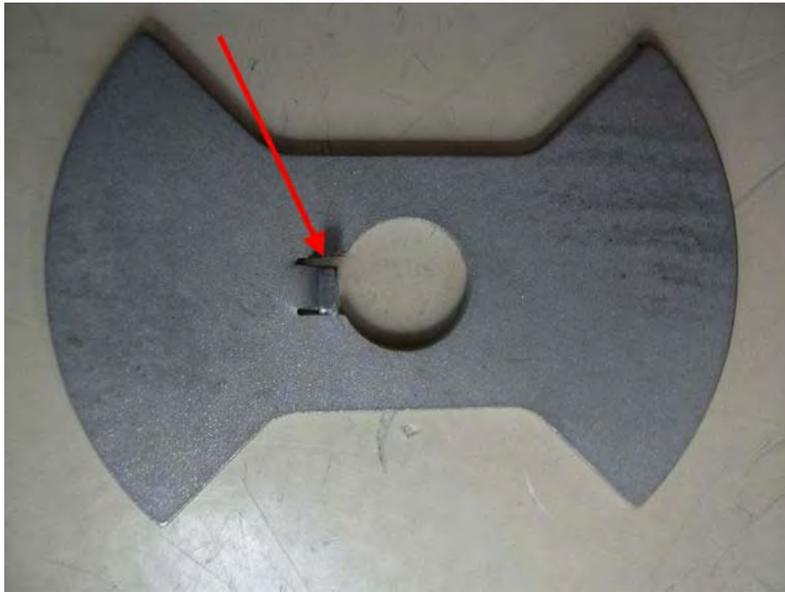
Figure 1.8-1 Normal flange

After further dismantling of the motor (P/N S4090, S/N 815D), the flange was found free on the shaft(item 220 of Figure 1.8-1). The stop pin of the flange was broken. Figure 1.8-1 and 1.8-2 illustrate the differences.

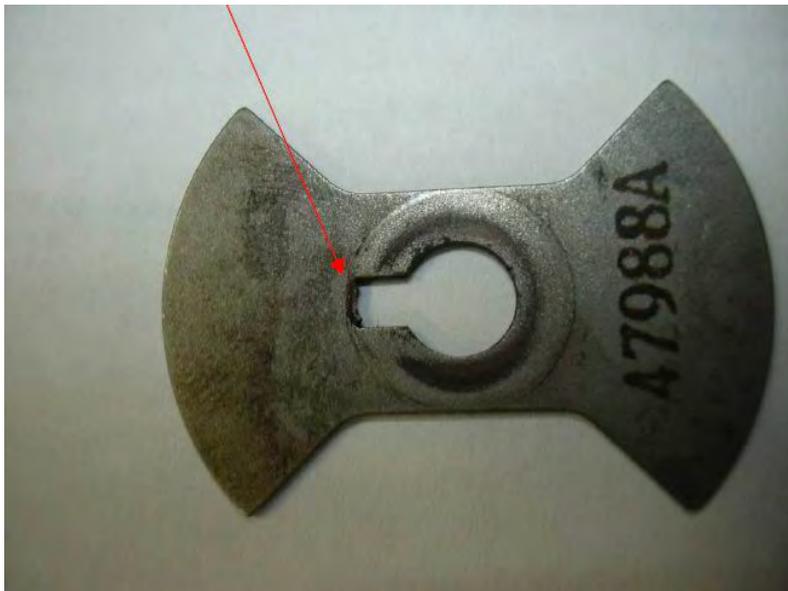
Figure 1.8-2 Damaged flange

The test report concluded that the broken pin on the flange explained the malfunction of the motor on both modes 1 & 2. It was randomly ordered by the variation of position of the flange.

In accordance with the inspection of the failed FWD outflow valve, it showed that a flange in the reduction gearbox which drove the FWD outflow valve was broken (Ref. Fig1.4-3 and 1.4-4). That damaged flange resulted in the malfunction of both auto modes input to drive the FWD outflow valve.

1. Conduct more detailed exploration on the damaged flange of the motor drive component (ASC-ASR-07-10-004)

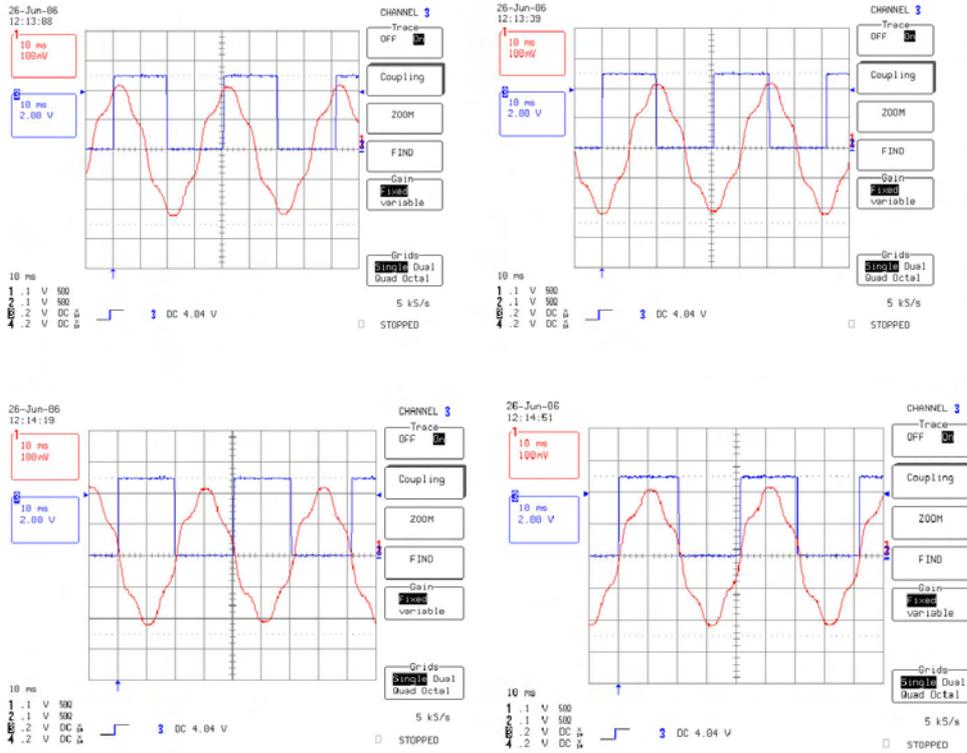
- During manipulation of the motor in investigation, failure appears instantaneously. We can see an increasing shift of sensor signal in proportion of FEM

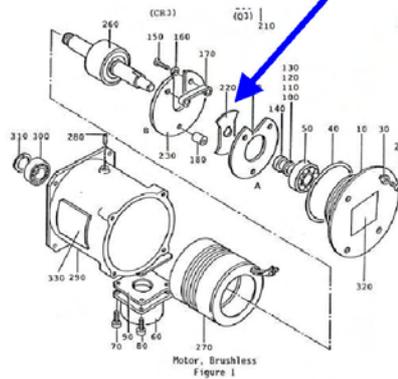
View of broken flange

- Dismantling of the motor: the flange (rep 220) is free on the shaft. That explains the random running of the equipment. The flange is broken on its stop pin.

The broken flange explains the malfunction of the motor on both modes 1&2 . It was randomly ordered by the variation of position of the flange. So, windings were not in accordance with sensors. This failure is considered as an isolated case.
