# 行政院飛航安全委員會

## 0915 RAPID 200 超輕型載具飛航事故調查報告

調查報告編號：ASC-AOR-08-06-001

發布日期：中華民國 97 年 06 月 10 日

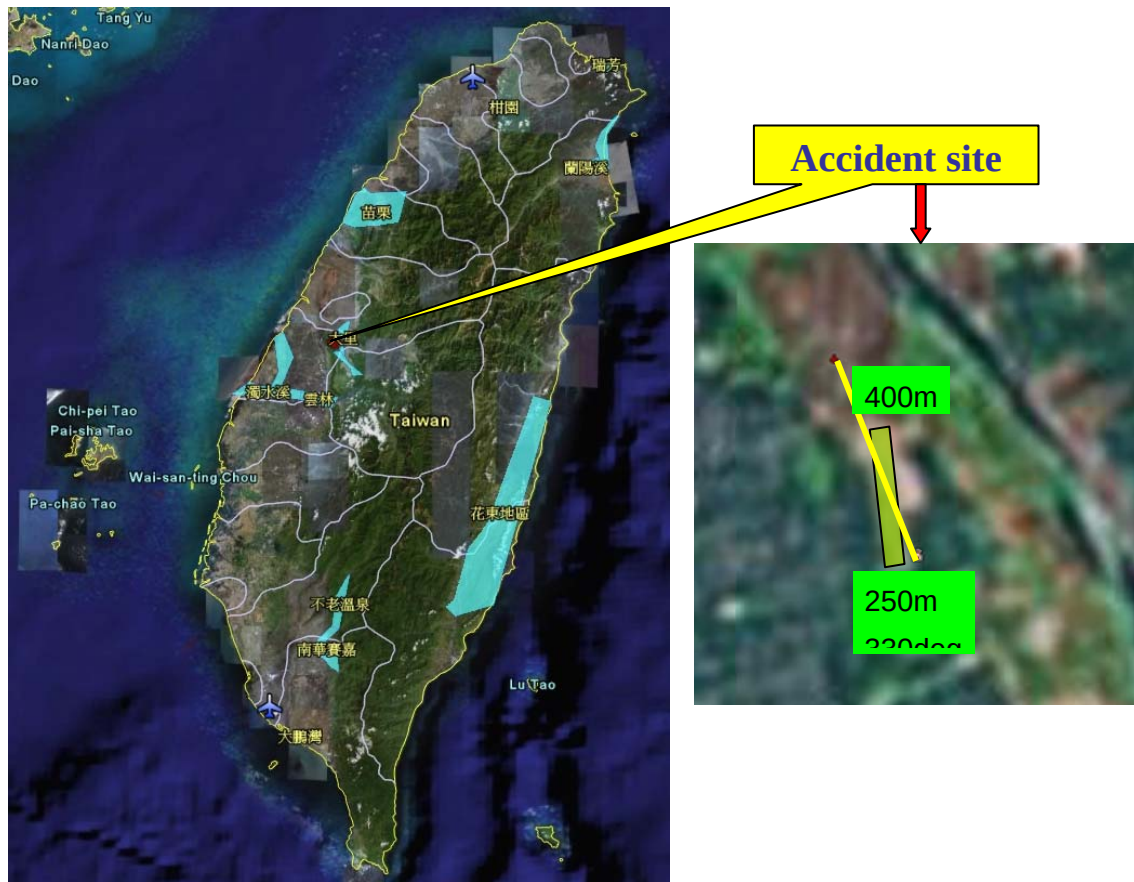
圖 1：事故場地

民國 96 年 9 月 15 日約 1630 時，一架 RAPID 200 型超輕型載具，載具上載有操作人及乘員各 1 人，由彰化縣芬園鄉利民橋北方一處空地(約位於東經 120 度 37 分 59.0 秒，北緯 24 度 01 分 17.3 秒)起飛，該載具離地後約於高度 40 呎時，螺旋槳停止轉動，左偏向下墜落於距該機起飛前停機位置約 300 度方位、400 公尺處之田埂(如圖 1)。載具機首及機翼毀損，操作人重傷昏迷，乘員雙腿骨折。

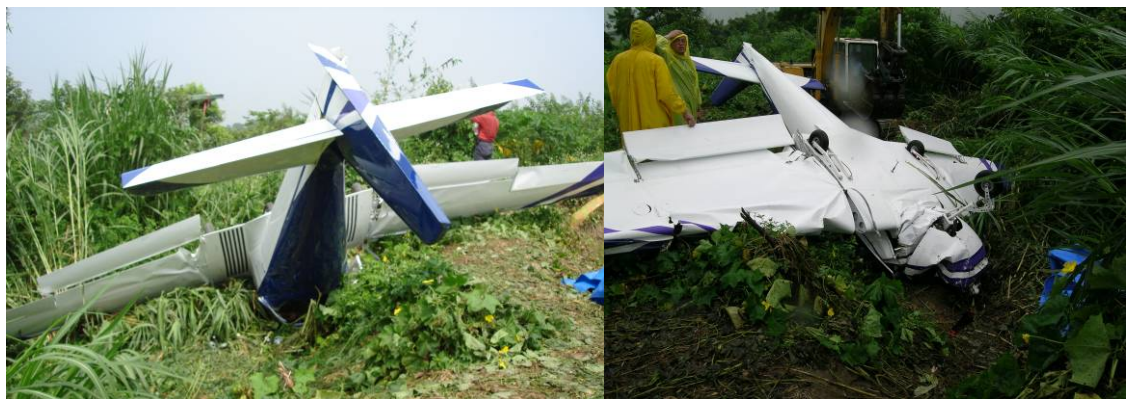
圖 2：全機狀況

飛機墜落於起飛場地北端一稻田田埂西側一處有邊坡之草地，機首整流罩破裂，左側變形較嚴重，機首下部（腹部）左側受擠壓、扭曲變形（如圖 2）；檢視三片槳葉後發現葉面平整，無扭曲變形現象，1 號及 2 號槳葉於根部折斷，3 號槳葉仍附著於槳葉轂上，1、2、3 號槳葉之翼前緣自根部裂開，長度分別為 40cm、29cm、35cm（如圖 3）；左翼翼尖整流罩翼前緣部份結構向內擠壓，延伸至前緣翼根結構蒙皮破裂及變形，右翼前緣蒙皮輕微變形。後機身部份大致完整，襟翼係伸放狀態，但並未在完全伸放位置，與翼根連接處結構變形，主輪起落架位於收上位置，鼻輪起落架位於半伸放位置（如圖 4）。

依殘骸檢視及墜落地形比對結果，該機係以機腹朝向約 330 方位，以接近與地面垂直姿態撞擊地面，第一撞擊點為該機之左翼撞及該地形東側之邊坡；之後機首撞及與田埂邊坡落差約 80 公分之地面；造成左機翼及機首嚴重損毀。該機 2 片槳葉均自根部折斷，另 1 片未斷附著於槳轂上，葉片表面完整無損，依葉片之完整程度，槳葉於墜地時，處於未旋轉狀態，判斷當時發動機應失去動力，與目擊者之證詞相符。

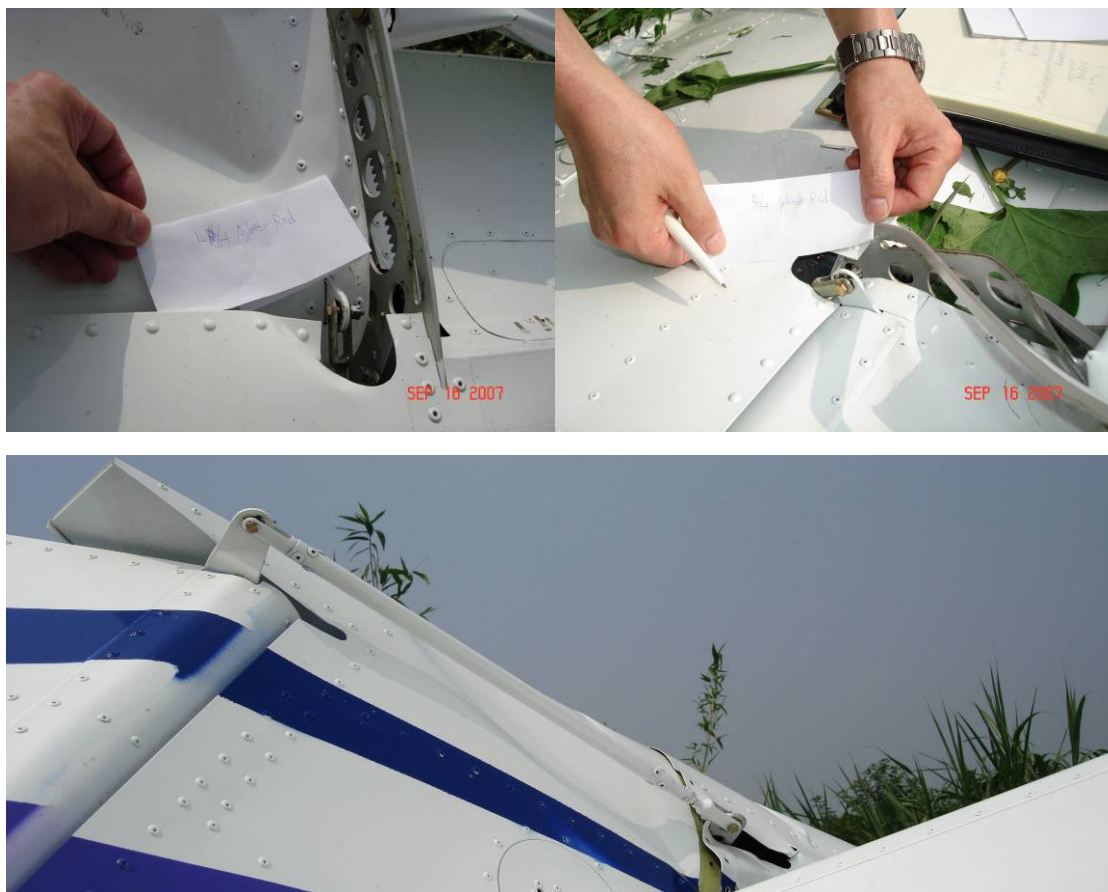
圖 5：飛操系統連桿

副翼至駕駛桿間之連桿連接正常，升降舵至駕駛桿間之連桿連接正常，方向舵至駕駛桿間之連桿連接正常（如圖 5）。

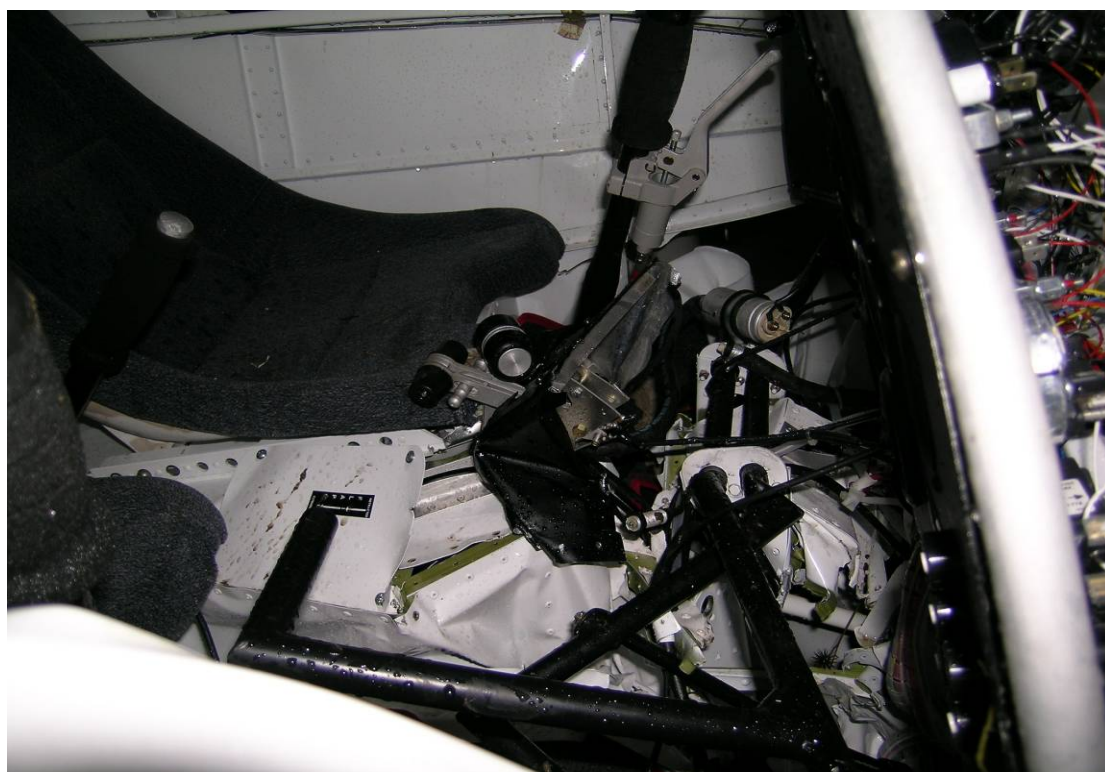
圖 6：座艙控制：

駕駛桿變形移位，方向舵變形向座椅方向擠壓，襟翼在“extend II”位置。起落架手柄及油門控制面板變形，起落架手柄位於“down”位置，油門在“max”位置（如圖 6）。G 表指示為 6.5 最大值為 10，燃油泵電門變形，指示中間至“OFF”位置，主電門位於“ON”位置，點火電門位於“OFF”位置（如圖 7）。垂直速率表損壞，指針指示“DN 15”位置（如圖 8）。

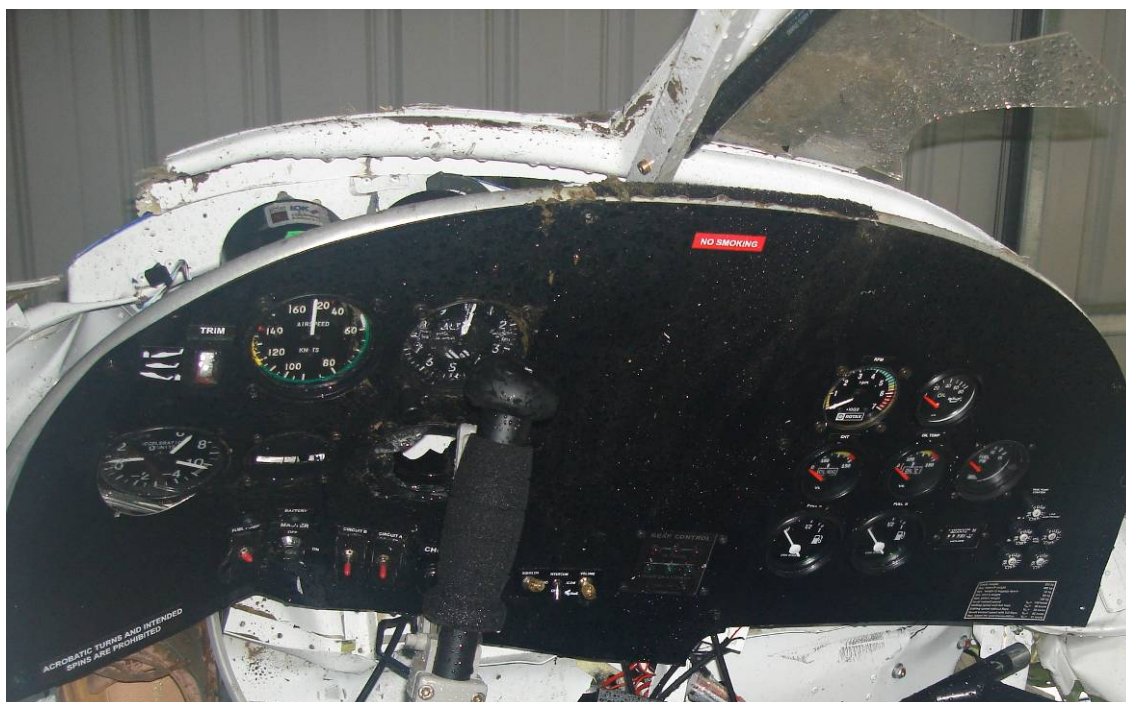
圖 7：座艙儀表及電門位置

座艙殘骸檢視結果，電動燃油泵電門雖位於中間至 OFF 位置，依其損壞痕跡及座艙遭擠壓形狀判斷，該電門於墜毀前應位於 ON 之位置。

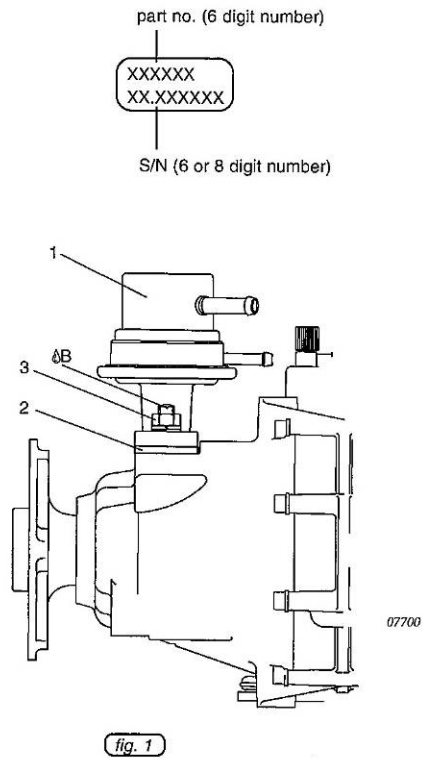
Due to high fuel pressure, caused by exceeding pressure in front of the mechanical fuel pump (e.g. due to an electrical fuel pump), in limited cases a deviation in the fuel supply could occur. This can result in exceeding of the fuel pressure and might cause engine malfunction and/or massive fuel leakage.

1. Remove fuel pump (1).

2. Gasket (2) replaced by new part.

3. Install fuel pump.

4. Tighten uniformly hex. nuts (3) with LOCTITE 243. Tightening torque 15 Nm (133 in.lb).
