飛航事故調查報告

ASC-AOR-09-09-001

中華民國 96 年 9 月 20 日
中華航空公司 CI7552 班機
波音 737-800 型機
國籍標誌及登記號碼 B-16805
於日本佐賀機場過境檢查發現
機腹蒙皮 30 吋 (77 公分) 裂縫

行政院飛航安全委員會
AVIATION SAFETY COUNCIL

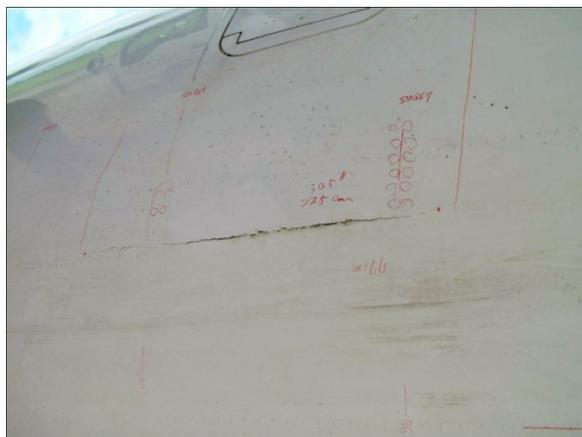
圖 1.12-1 (A) 機腹裂縫外觀照片

航機外部裂縫照片，如圖 1.12-1 (A) ~ (D)所示；航機裂縫所在蒙皮內表面，以及其他機腹結構於鏽蝕被打磨移除前之照片，詳圖 1.12-2(A) ~ (S)所示。由照片除了可確認裂縫位置之外，另可判讀機腹結構腐蝕之位置，均分佈於編號 S-27L 之縱桁左側蒙皮，與 S-27L 縱桁凹槽，另位於廢水櫃出口接頭正下方的縱向連接片底側也嚴重腐蝕。

航機於 2007 年 9 月 20 日於佐賀機場落地後，由華航地勤人員執行過境檢查，發現機身 46 段機腹蒙皮長 30 吋（77 公分）裂縫。華航派赴當地緊急維修小組，在波音公司技術支援的電文協助之下（NTSB 稱波音現場支援工程師於鏽蝕移除後始抵達現場），於 2007 年 9 月 22 日至 9 月 25 日在佐賀機場對事故機進行檢驗，並依據華航暫時性修理工程指令 EO 738-53-00-0068 Fuselage Skin Damage from Approx. Sta 839.2 to 869.7 Outboard of S-27L 完成暫時性修補後飛渡回台。

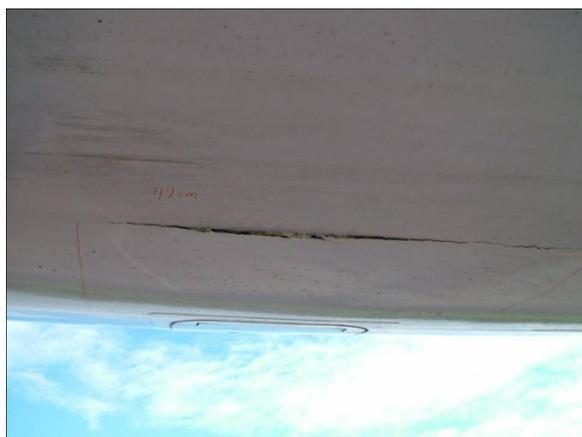
圖 1.12-1 (B) 機腹裂縫位置照片

飛安會綜整所有結構損傷資料，發現該貫穿式裂縫位於機身縱桁 S-27L 外側 (outboard)，且介於機身 BS 839.2 至 BS 869.7 之間，結構損傷分佈，如本節圖 1.12-3。

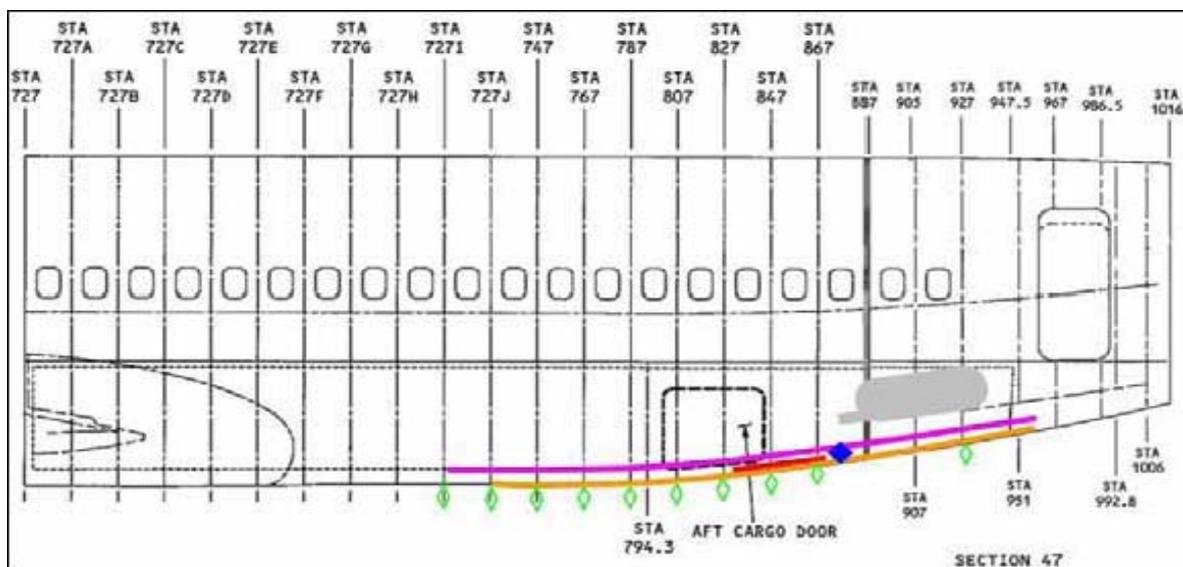
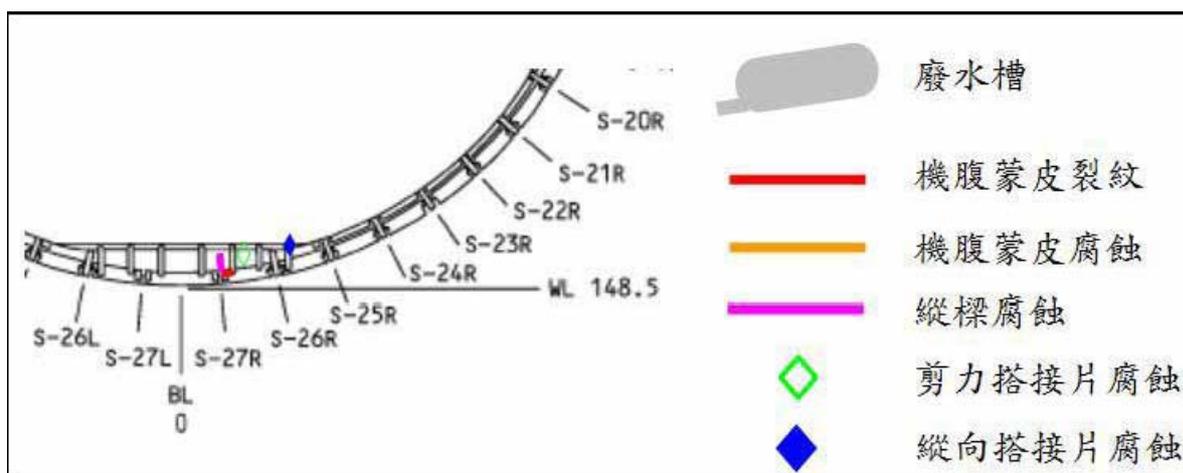
圖 1.12-4 損害分布圖

事故航機經華航發布之工程指令 EO 738-53-00-0068 完成暫時性修理，包括蒙皮輕微腐蝕區域之打磨，以及蒙皮嚴重腐蝕區域，包含 30 吋（77 公分）蒙皮破裂處，以 40.25 吋乘 20.45 吋大小之外補片進行修補，並沿著 S-27L 縱桁之機身外，安裝一具角樑以修補腐蝕之縱桁後，飛渡回台。其中於佐賀安裝之 40.25 吋乘 20.45 吋暫時性修補之外補片，於事故機回台後本會實地調查時拆除，以供詳細檢查蒙皮嚴重腐蝕區域，本會並同時取樣該嚴重腐蝕區蒙皮試片，以進行更進一步詳細檢驗。此外本會對於蒙皮破裂處之後貨艙進行實地檢查，包含廢水系統、機腹蒙皮、機身縱桁、縱向搭接片以及剪力搭接件之損害狀況。結果其損害分布詳圖 1.12-4。

由第 1.12.1 節至 1.12.6 節航空器損害檢查結果，並參照圖 1.12-4 損害分布圖，顯示損害侷限於航機內部，皆為廢水系統滲漏之廢水流動和匯集之處。1.12.7 節描述除鏽蝕區域外之其他後貨艙及其地板下區域，舷邊蒙皮結構防鏽劑有被沖刷痕跡，底部有凝水與防鏽劑之混合物沉澱，皆係航機正常操作時因機艙內外溫差造成艙內空氣中水份凝結、流動及匯集，然蒙皮結構均無腐蝕現象，顯示廢水系統滲漏之廢水係為該機結構蒙皮腐蝕之原因。腐蝕過程詳附錄九。

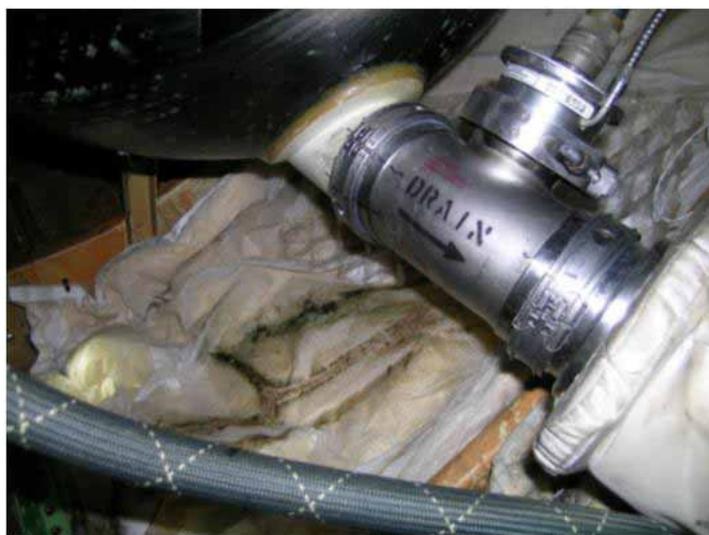
圖 1.12-5 隔熱棉污染痕跡

本會調查裂痕所在位置之後貨艙，發現廢水槽出口下方絕緣毯有污水滴漏污染痕跡，污染痕跡起源於廢水槽出口與短管之接口正下方，呈向下流動痕跡，並於絕緣毯表面留下約 20 吋長之黃綠色與黑色乾燥污漬，經移除絕緣毯後發現下方機身蒙皮亦有污水滴痕，詳圖 1.12-5 至圖 1.12-7。

由圖 1.12-5 隔熱棉上的污漬流向與起始點，顯示塑膠材質之廢水槽出口與金屬廢水排放管兩者之連接處有滲漏跡象。

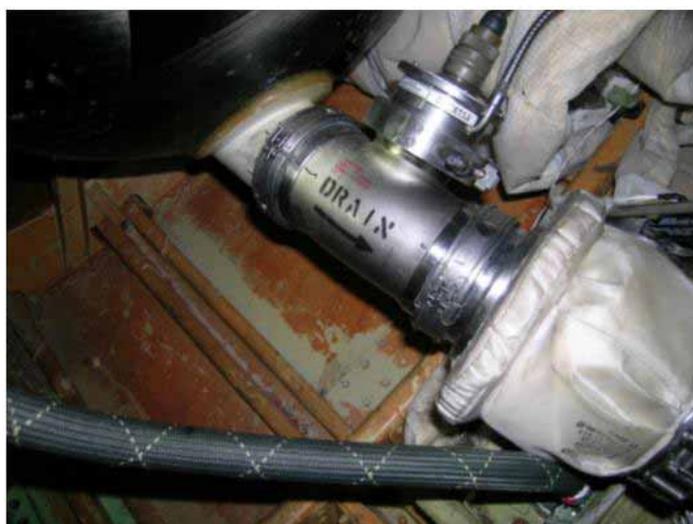
圖 1.12-6 隔熱棉下蒙皮結構

本會進一步移除沾有污漬的隔熱棉後，調查發現如圖 1.12-6 所顯示，廢水槽滲漏物已穿透隔熱棉到達機身蒙皮，並留下污漬痕跡（詳圖 1.12-7）。

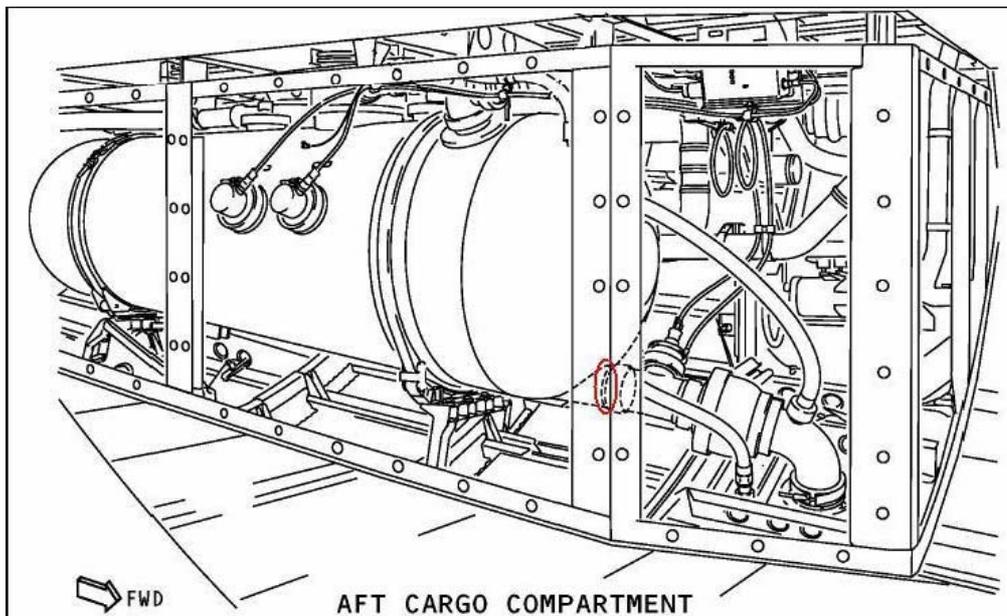
圖 1.12-8 廢水櫃出口管損害位置圖

拆檢廢水櫃系統，發現廢水櫃出口管與廢水管接合處之接合面凸緣損害，詳圖 1.12-8 紅圈處，斷裂區域位於廢水櫃出口管端凸緣右下緣，長約 5 吋，詳圖 1.12-9。

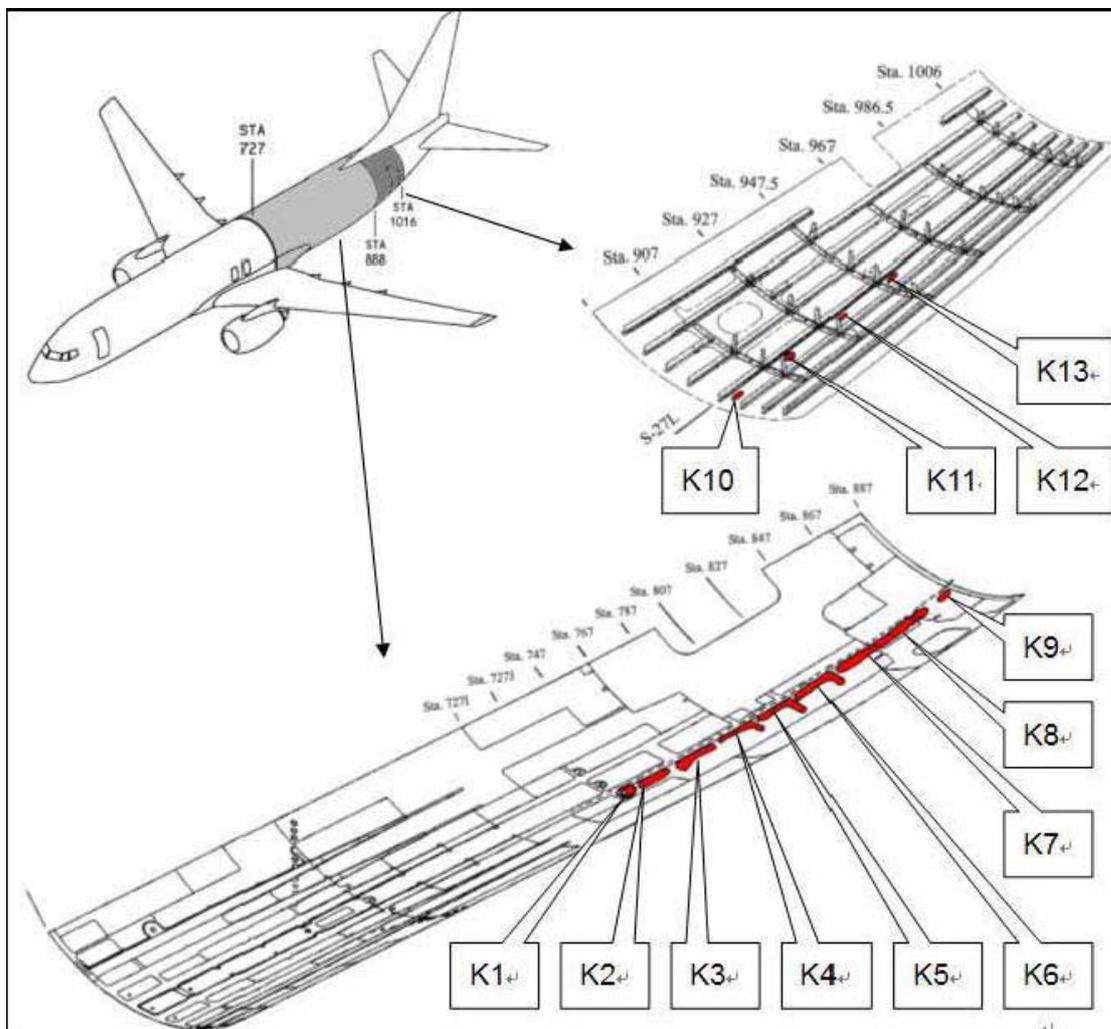
圖 1.12-11 後貨艙蒙皮損害分布圖

由華航提出之 9 月 28 日損傷報告與 10 月 17 日更新版前後兩篇損傷報告，對照本會於華航桃園檢修棚廠實地調查比對發現，後貨艙蒙皮內表面沿機身 46 段與 47 段底部縱桁 S-27L，自 BS 727J 至 BS 967 蒙皮，皆發現輕重不等之腐蝕，且集中於 S-27L 外側 (Outboard)，腐蝕區域於飛渡前已完成暫時性修理的打磨程序以除去腐蝕物，回台後因永久性修理之故，該機身 46 段之機腹蒙皮由維修單位由機體拆下，由本會進行細部檢驗，茲分別以機身站位為區分，將各腐蝕區域標註以 K1 至 K13，詳表 1.12-1。

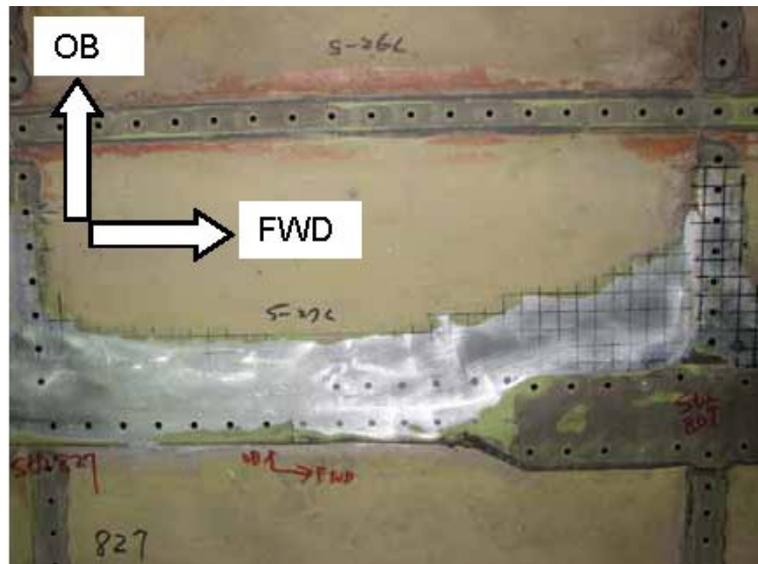
圖 1.12-16 K6 區腐蝕情形

K6 區：腐蝕區域 K6 起於 BS 807 之橫框剪力搭接處，沿 S-27L 縱桁邊緣向後延展至 BS 827 剪力搭接之下方，而以最低水平處腐蝕較為嚴重，詳圖 1.12-16，圖中機身縱桁 S-27L、橫框及附屬結構件已經拆除，腐蝕區已打磨。

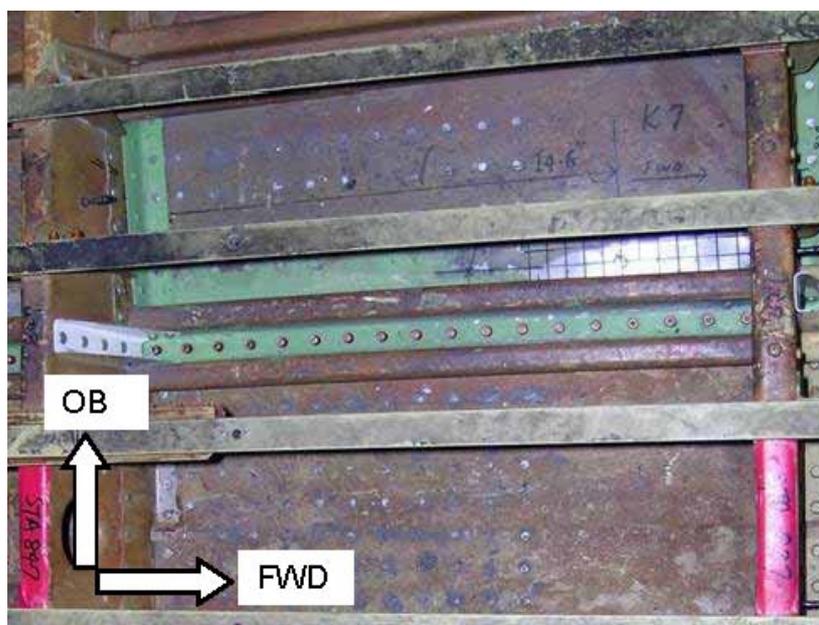
圖 1.12-17 K7 區腐蝕情形

K7 區：腐蝕區域 K7 起於 BS 827 之橫框剪力搭接處，沿 S-27L 縱桁邊緣向後延展至 BS 847 剪力搭接之下方，而以最低水平處腐蝕較為嚴重，詳圖 1.12-17，圖中機身蒙皮腐蝕區已打磨。貫穿式裂縫前端點位於本區機身 BS 839.2，詳圖 1.12-18。

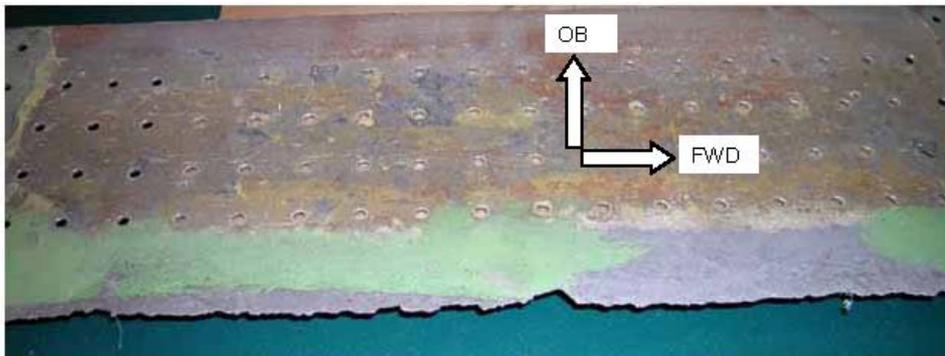
圖 1.12-19 K8 區腐蝕情形

K8 區：腐蝕區域 K8 起於 BS 847 之橫框剪力搭接處，沿 S-27L 縱桁邊緣向後延展至 BS 867 剪力搭接之下方，再越過 BS 867 橫框剪力搭接直到 BS 872，而以最低水平處腐蝕較為嚴重。貫穿式裂縫後端點位於本區 BS 869.7，詳圖 1.12-19 與 1.12-20。

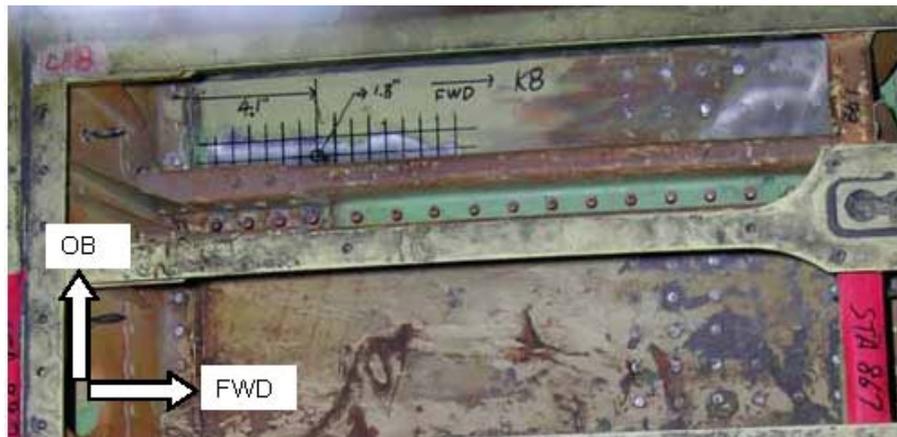
圖 1.12-21 K9 區腐蝕情形

K9 區：腐蝕區域 K9 起於 BS 877 處，沿 S-27L 縱桁邊緣向後延伸至 BS 887 剪力搭接之下方，而以最低水平處腐蝕較為嚴重，詳圖 1.12-21，圖中腐蝕區已打磨，右側打磨區為腐蝕區域 K8 之局部，而腐蝕區 K9 位於圖之左半，圖中央橫互者為 S-27L 縱桁。

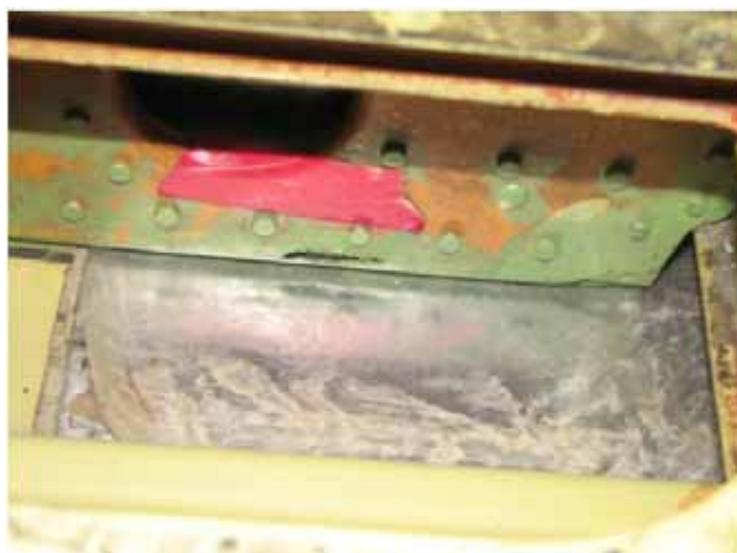
圖 1.12-49 肋間片貫穿性腐蝕

本會於華航桃園檢修棚廠實地調查發現 BS 867 至 BS 887 之 S-26L 及 S-27L 之肋間片有貫穿性腐蝕，詳圖 1.12-49。廢水櫃出口管位於 BS 867 至 BS 887 之 S-26L 及 S-24L 外側上游，正位於廢水櫃出口管滲漏處下游，詳圖 1.12-50 及 1.12-51

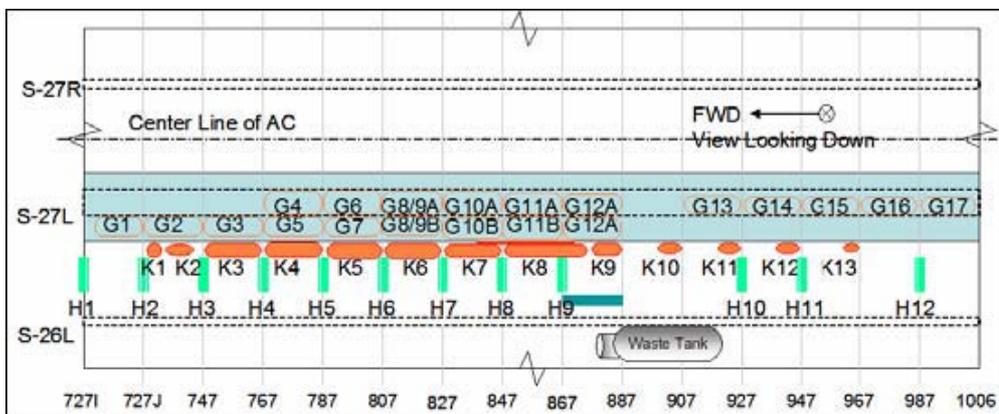
圖 1.12-54 結構腐蝕損傷圖

本會綜合上述損傷發現該機各結構件遭受腐蝕損害之相對位置，集中於廢水櫃出口接頭滲漏污水滲流路徑各處，且腐蝕區域打磨輪廓與污水蓄積於機體結構低窪點一致，綜整所有已發現之結構件腐蝕相對位置詳圖 1.12-54。

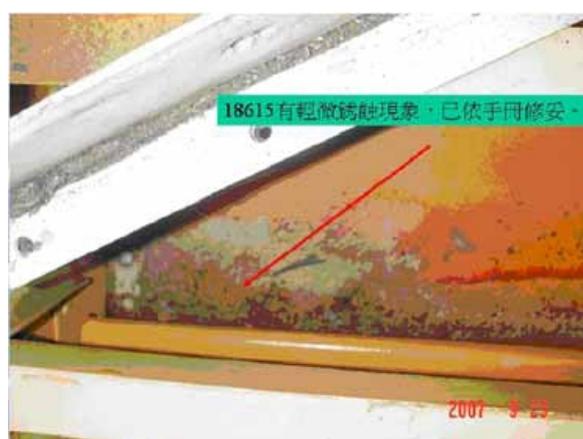
圖 1.16-1 飛機編號 B-18615 機腹蒙皮銹蝕

民國 96 年 9 月 22 日至 24 日，華航針對 737-800 機隊共 12 架機執行廢水櫃滲漏之一次性檢查，結果發現其中 3 架機廢水櫃出口管凸緣有裂縫狀況，其中 2 架機廢水櫃出口管有廢水滲漏痕跡，機腹蒙皮有銹蝕現象，詳圖 1.16-1 及 1.16-2，已依維修手冊修妥；經查該 2 架機維修資料，其中 1 架曾於民國 95 年 7 月 1 日執行 AV4 之廢水櫃艙區域檢查，發現廢水櫃艙區有污漬現象，已依維修手冊清潔，另 1 架

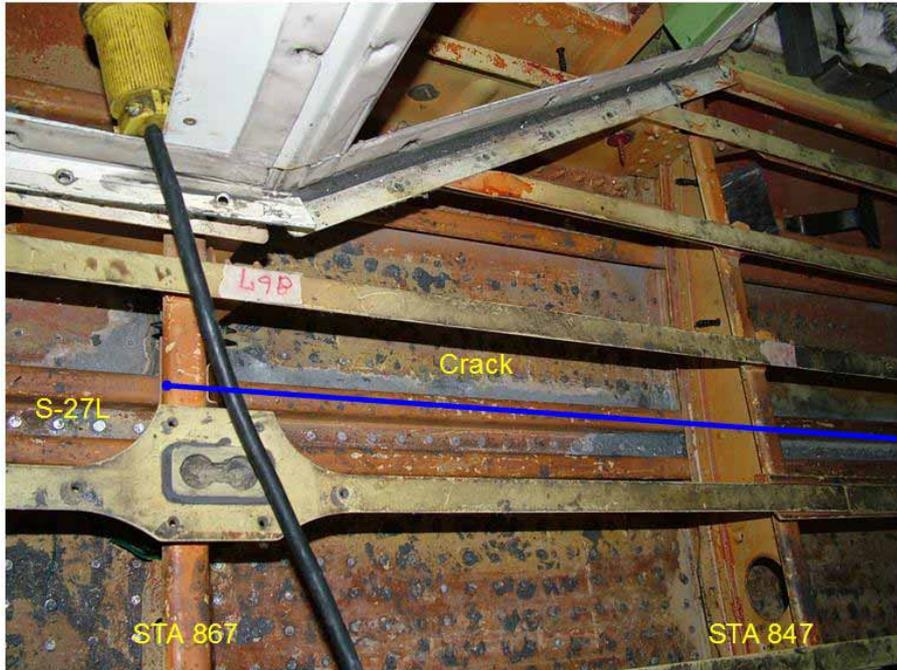
圖 1.16-3 裂縫相對位置圖

圖 1.16-3 顯示機腹受損蒙皮與機身之相對位置，裂縫範圍介於 BS 839.2 至 BS 869.7 以及縱桁 S-27L 附近，為執行材料測試，將受損蒙皮作適當裁剪，詳圖 1.16-4。該蒙皮之測試項目包括：外觀目視觀察及照相、受損蒙皮斷裂面掃描式電子顯微鏡（Scanning Electron Microscope，以下簡稱 SEM）觀察、火花放電分光光譜儀（Spark）與能量散射光譜儀（Energy Dispersive System，以下簡稱 EDS）之化學成份分析、材料硬度及導電度測試、金相組織觀察以及離子層析（Ion Chromatography）比對試驗等，以瞭解其破壞模式。

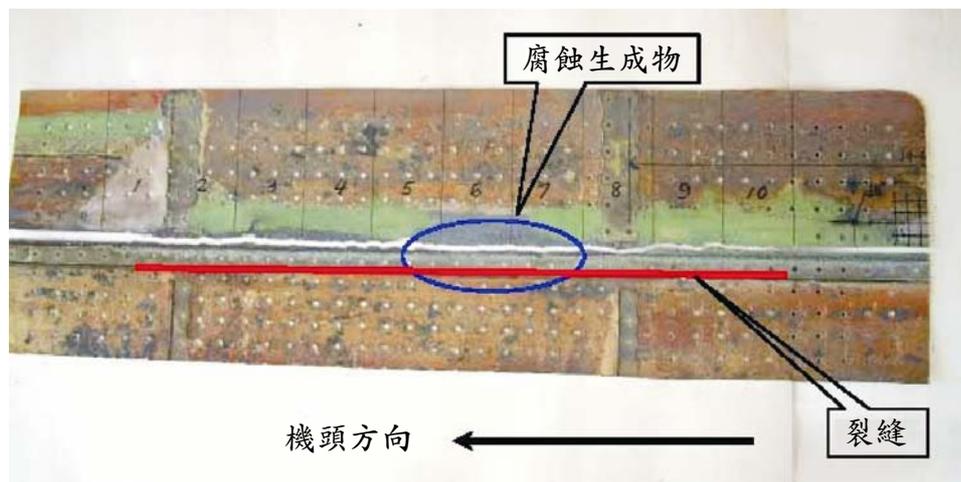
圖 1.16-5 受損蒙皮之內部表面

取樣送檢之蒙皮詳圖 1.16-5 及 1.16-6，檢視受損蒙皮之內表面與外表面，在內表面發現腐蝕生成物，詳圖 1.16-5 灰色區塊（藍圈）。另外檢視受損蒙皮之斷裂面，斷面粗糙且附著腐蝕生成物。將裂縫右側蒙皮裁切成 10 段，巨觀觀察及照相，其中圖 1.16-7 及 1.16-8 分別是編號 1 號蒙皮及 9 號蒙皮之放大照片，其斷裂面呈現凹凸不平，且具有腐蝕之破壞特徵。這些腐蝕生成物已造成鋁合金基材剝離（Exfoliation），可輕易地以外力刮除。其它蒙皮斷裂面亦有同樣之破壞特徵，其放大照片詳附錄四。

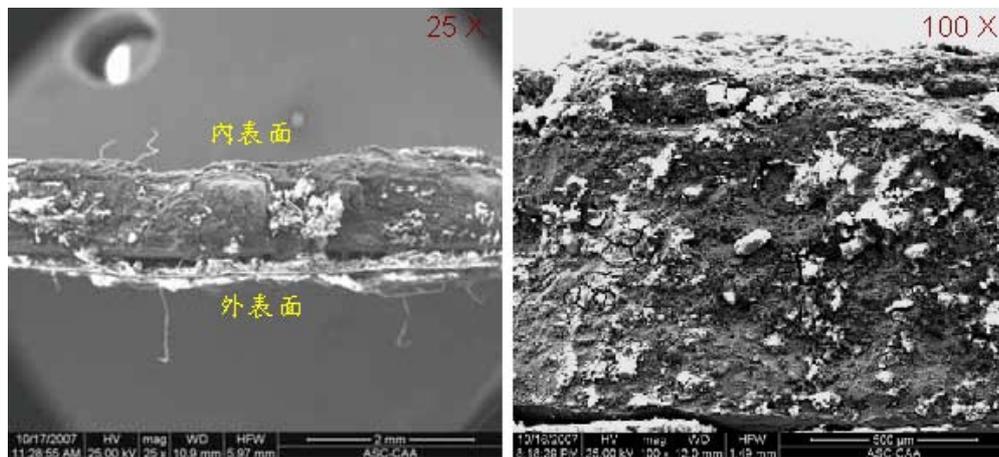
圖 1.16-9 1 號試片斷裂面

以掃描式電子顯微鏡 SEM 檢視蒙皮斷裂面，圖 1.16-9 為編號 1 號試片斷裂面之 SEM 微觀觀察，圖中顯示蒙皮外表面還存有面漆保護，但內表面則呈現嚴重剝離之破壞特徵。圖 1.16-10 為編號 9 號試片斷裂面 SEM 微觀觀察，斷裂面內側（蒙皮內表面）呈現延晶破裂模式，詳圖 1.16-10 右下方；而斷裂面外側（蒙

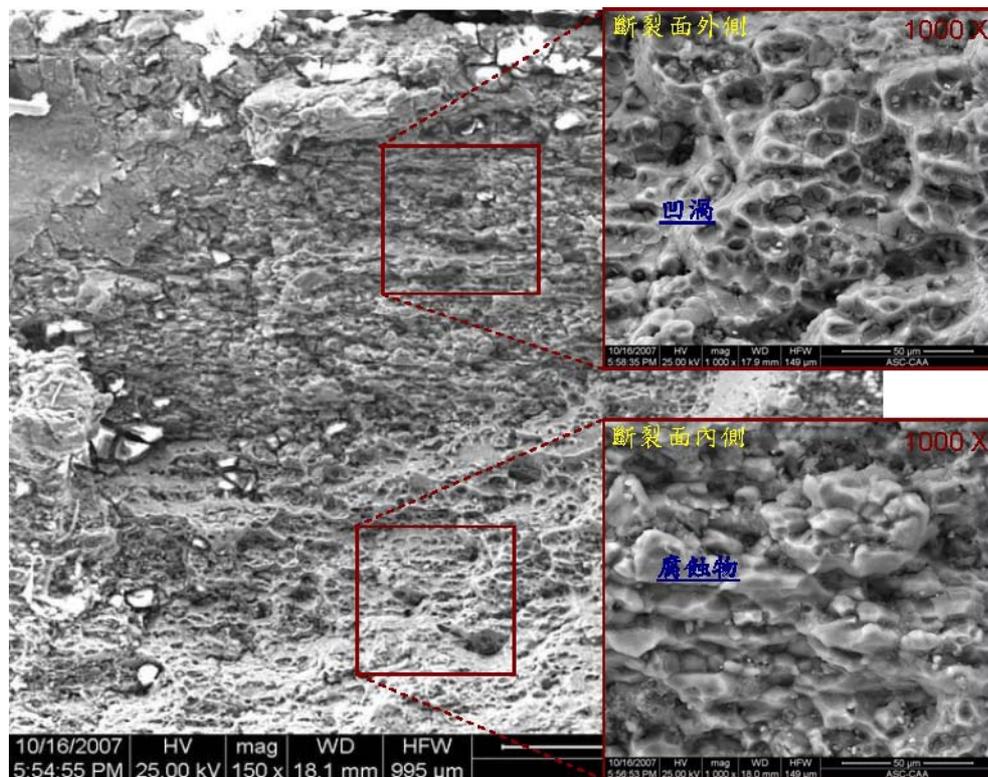
圖 1.16-10 9 號試片斷裂面

皮外表面) 則呈現強制破裂模式，具備凹渦 (Dimple) 特徵，詳圖 1.16-10 右上方。

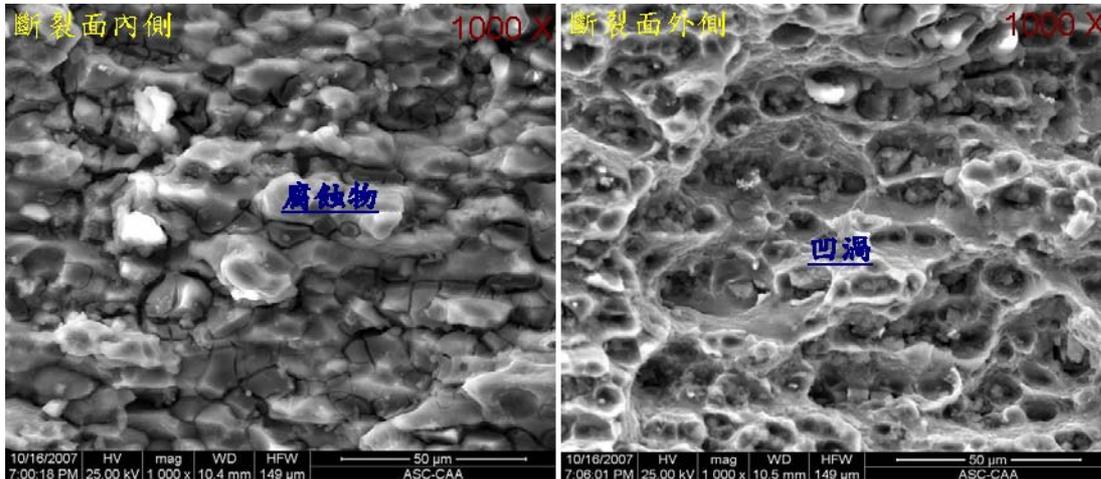
圖 1.16-11 5 號試片斷裂面

圖 1.16-11 為編號 5 號試片斷裂面 SEM 微觀觀察，其延晶破裂面積大於強制破裂面積。

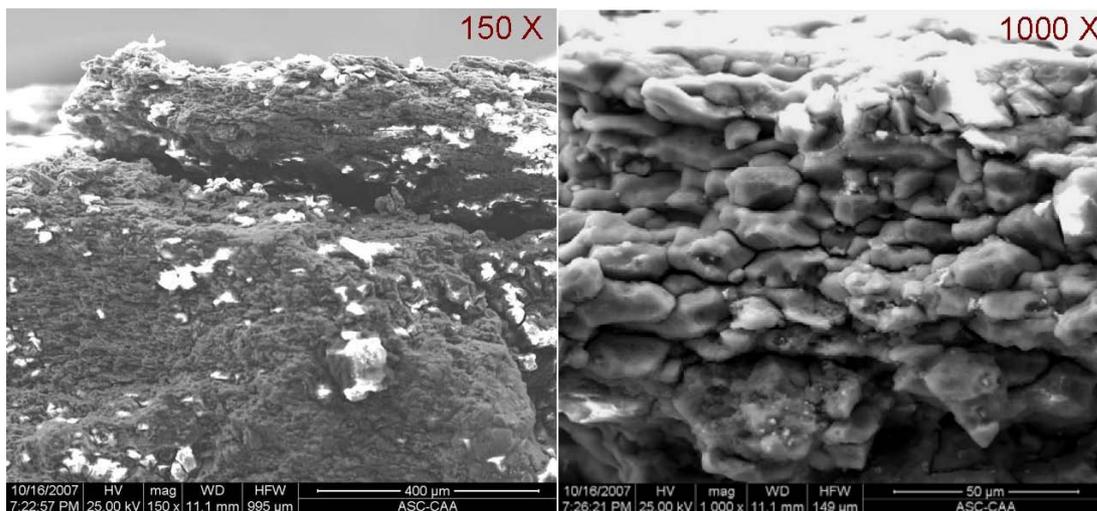
圖 1.16-12 5 號試片斷裂面（蒙皮內表面）

觀察 5 號蒙皮斷裂面內側（蒙皮內表面），同樣呈現典型之延晶破裂模式，此破裂模式由蒙皮內表面沿蒙皮厚度方向成長，直到殘餘蒙皮受力面積不足以承受負載，最後發生過載（Overload）破壞，詳圖 1.16-12。

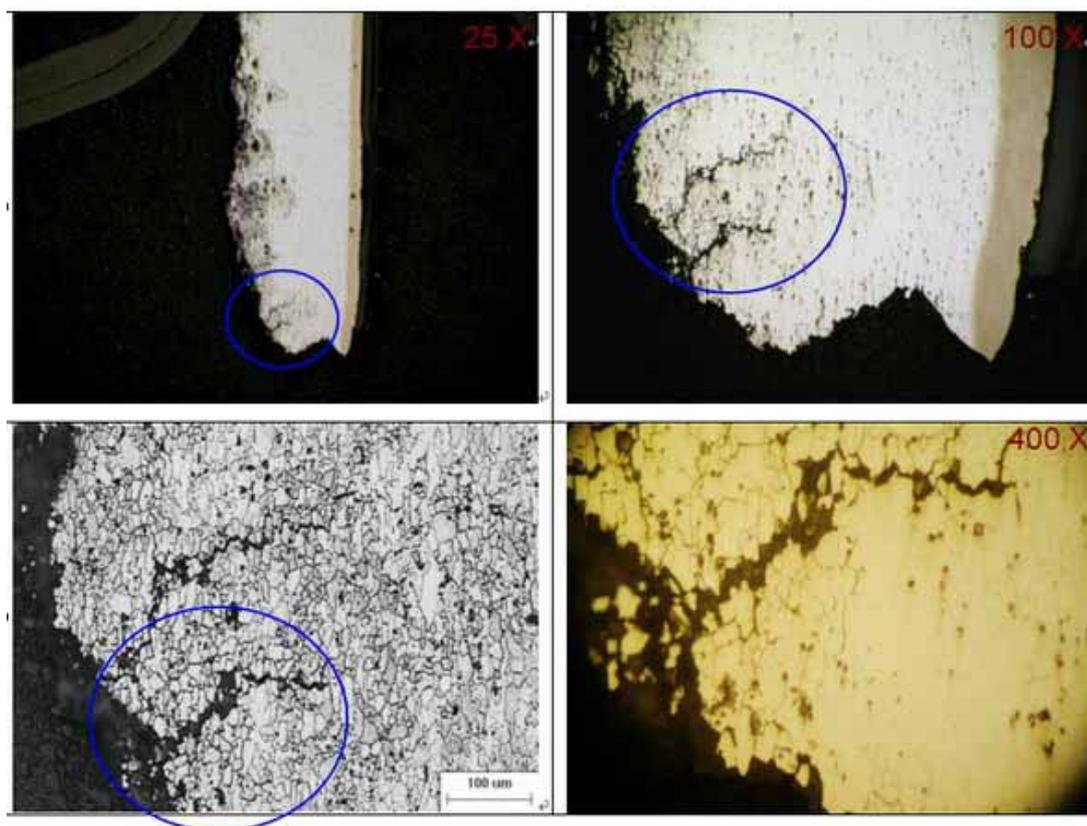
圖 1.16-13 4 號試片金相組織觀察

4 號試片於裂縫 T 方向³金相組織觀察，靠近蒙皮內表面有數條沿晶裂縫，從 T 方向觀察，位於蒙皮內表面孔蝕甚為明顯，詳圖 1.16-13。觀察金相照片（100 倍），純鋁層在斷裂面附近厚度變薄，且在斷裂處呈現突出形狀。

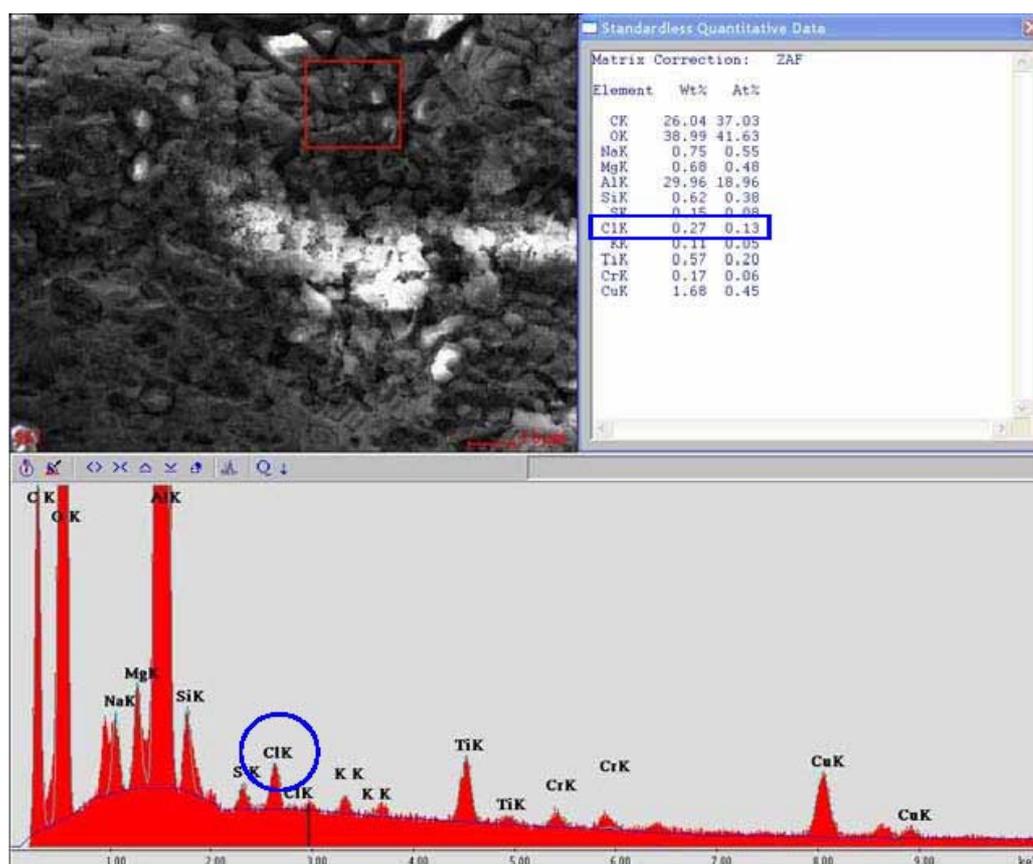
圖 1.16-14 9 號試片於 SEM/EDS 下之微觀觀察

爲了確認斷裂面腐蝕生成物與延晶破裂模式之關聯性，以 EDS 分析該腐蝕生成物化學成份，發現少許氯（Cl）元素，詳圖 1.16-14，氯是造成鋁合金腐蝕的重要元素，不過考量儀器精確度以及可能來自大氣環境影響的因素，另以離子層析儀來檢定其腐蝕物型態。

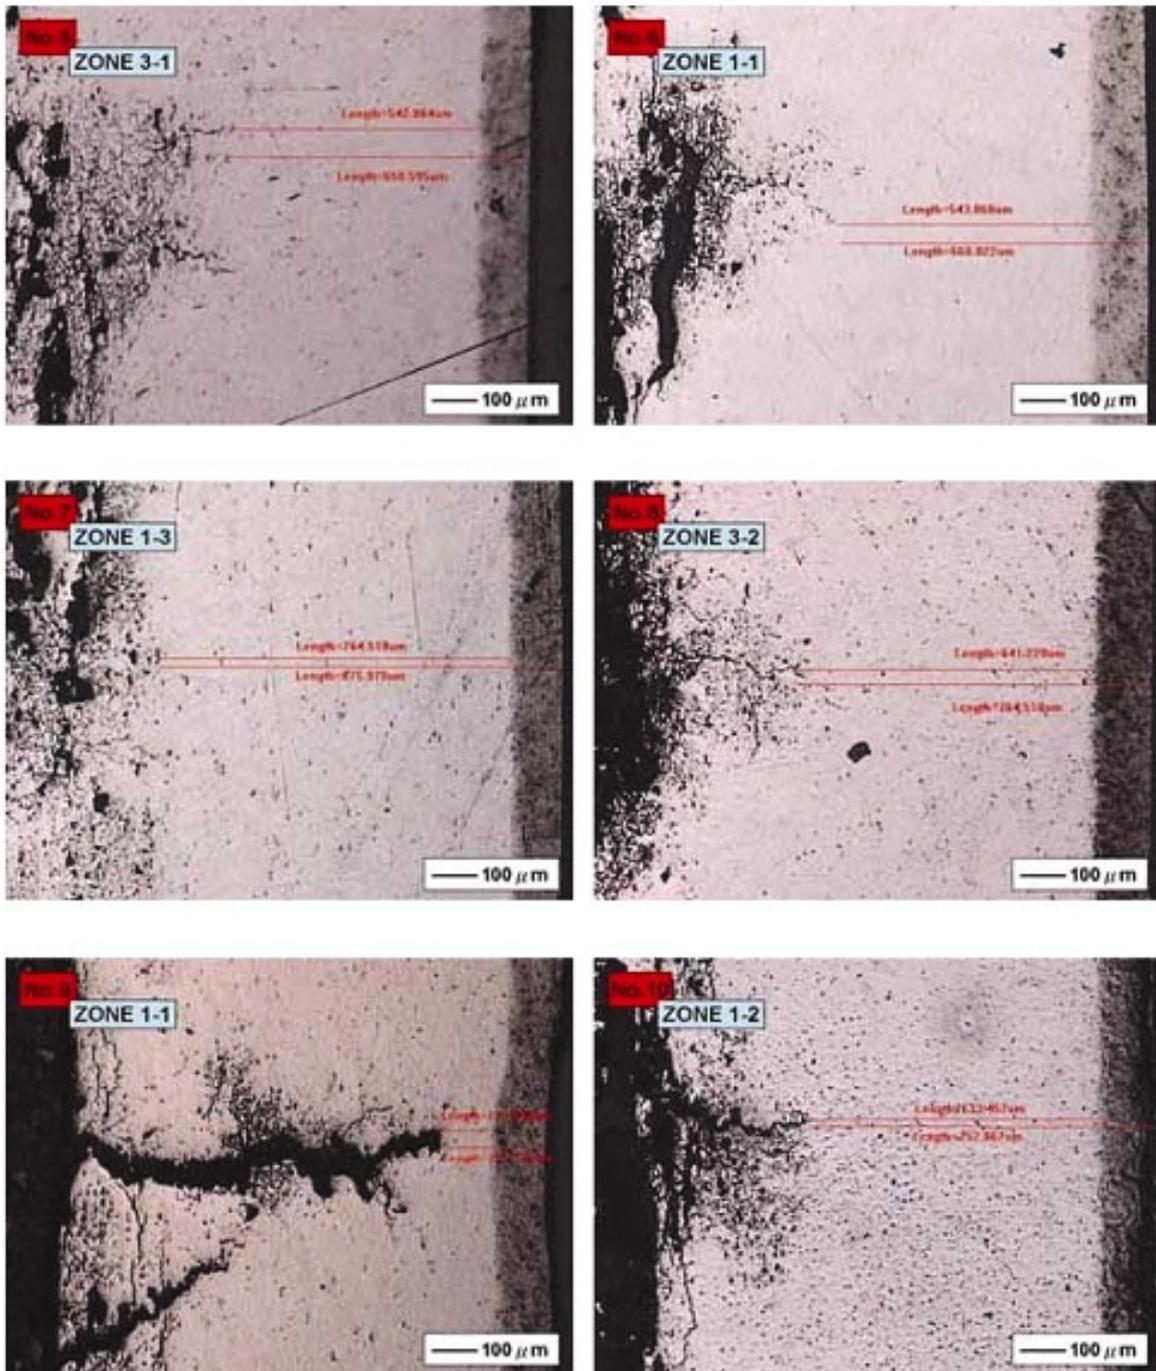
圖 1.16-16 金相試片放大觀察

金相試片均發現明顯孔蝕及沿晶裂縫，圖 1.16-16 為金相試片放大照片，有些區域腐蝕破壞情形嚴重，編號 2-3-3 試片⁴、4-1-1 試片及 9-1-1 試片，孔蝕幾乎貫穿蒙皮，量測後發現蒙皮殘餘厚度分別為 0.0054 吋、0.0037 吋及 0.0044 吋（蒙皮厚度規範為 0.063 吋），其它金相照片參閱附錄五。每個金相試片取樣位置及量測之殘餘厚度詳表 1.16-1；圖 1.16-17 為蒙皮斷裂面受腐蝕破壞情形及殘餘厚度示意圖，空白區域表示受腐蝕破壞，灰藍色區域代表蒙皮殘餘厚度。

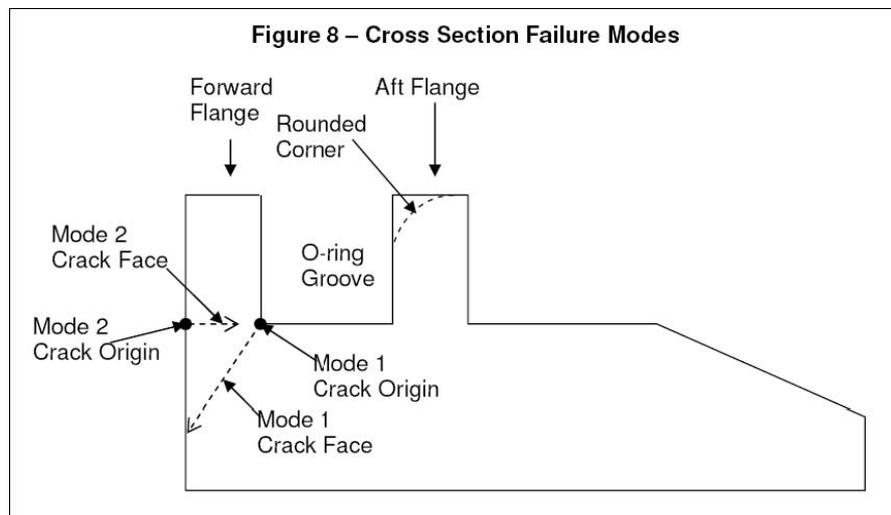
圖 1.16-18 凸緣裂縫之模式

1. 接頭前緣端面與相鄰管路無接觸現象；
2. 後凸緣圓化之部位大部份於 270 度至 20 度之方位，接近模式 1 裂縫之反面，可能係套管組件包括襯套及 O 環接觸造成；
3. 模式 1 之複雜裂縫顯示錯綜性的應力負荷情況，凸緣前緣之模式 2 之裂縫顯示不同之失效模式，該失效模式發生於接近模式 1 裂縫端點處，顯示該處曾為兩力耦之支點 (詳圖 1.16-18)；
4. 兩裂縫模式於物理檢驗發現如附錄八圖 8，與有限元素分析之結果相似 (詳圖 1.16-18)；
5. 模式 1 及模式 2 之裂縫相互接近顯示凸緣曾受有一支點之彎曲應力 (詳圖 1.16-19, 1.16-20)。

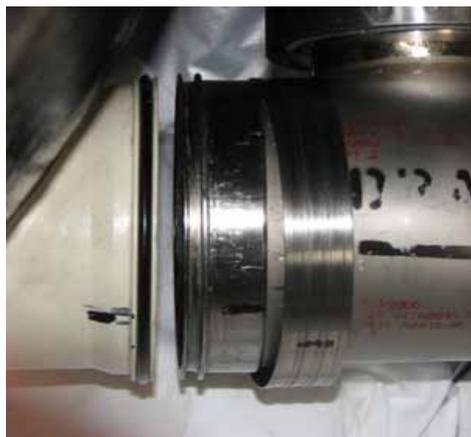
圖 1.18-2 廢水櫃出口管接頭間距

飛機編號#1 量測尺寸係於更換妥善廢水櫃後所得結果，飛機編號#1、#2 及#3 拆換之廢水櫃經送回原廠檢修，發現於出口管凸緣均有裂縫存在且都位於 3 至 6 點鐘位置上，另飛機編號#4、#5、#7 及#10 之廢水櫃出口管凸緣於量測過程中均發現有裂縫存在並更換妥善件，廢水櫃出口管接頭間距詳圖 1.18-2。

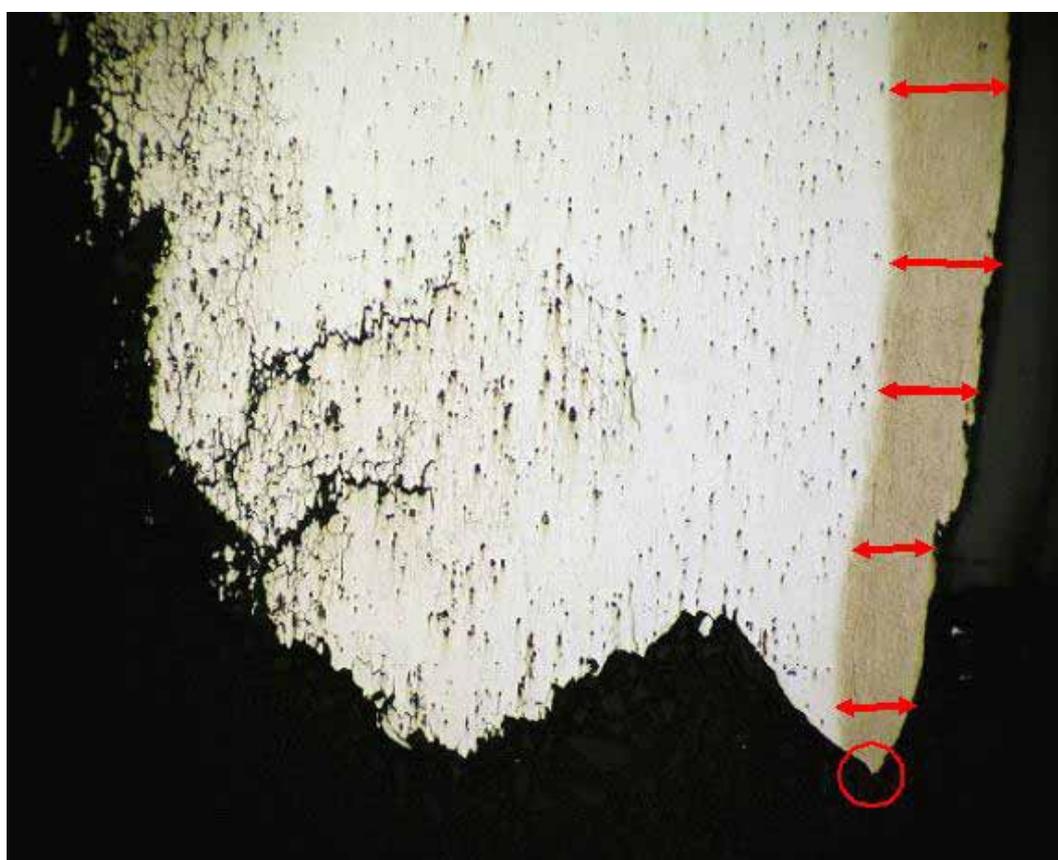
圖 2.1-1 觀察 4 號試片放大 100 倍之金相照片

詳圖 2.1-1，觀察 4 號試片 100 倍金相照片，右側灰色表層為純鋁層，紅色箭頭顯示純鋁層厚度向斷裂面方向逐漸變薄，紅圈顯示純

鋁層於斷裂面呈水滴狀現象，以上現象顯示該蒙皮係承受平行於純鋁層之拉

力，故延展性較高之純鋁鍍層朝斷裂面方向逐漸變薄，最後於斷裂處呈水滴狀形狀現象，顯示中科院材料試驗結論所稱之「外載力量」係於航空器運作過程中所產生之環狀拉力。

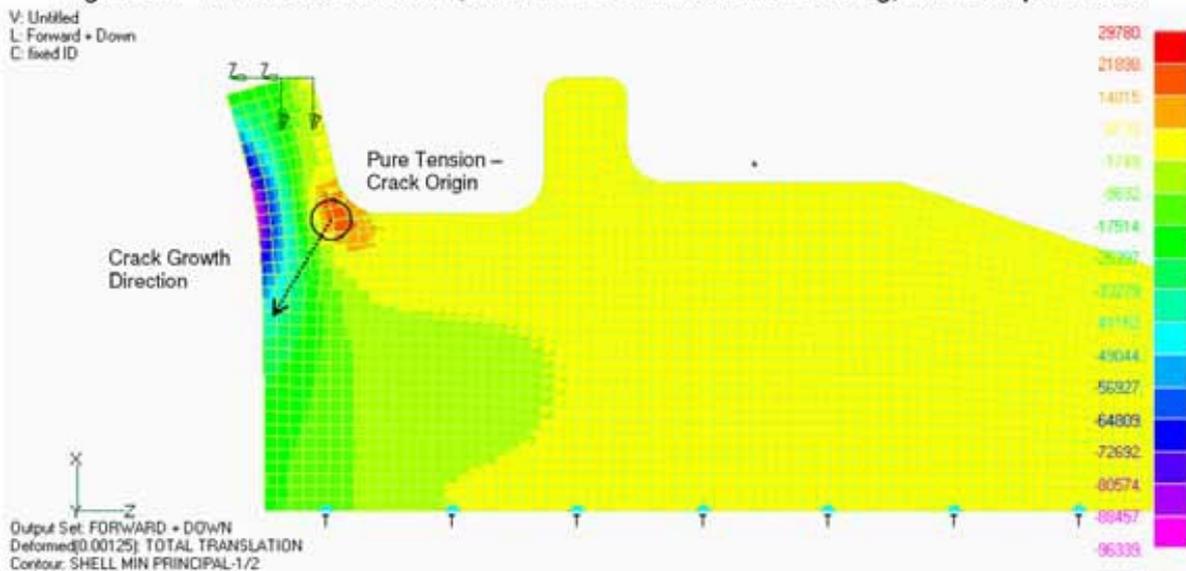
圖 2.3-5 向前及向下之合應力產生模式 1 裂縫

2.3-5)，遂發生原廠檢測報告圖 8 描述之模式 1 裂縫（詳圖 2.3-7）；於大間距處產生徑向及軸向之合應力，即如原廠檢測報告圖 21 及圖 22 描述之向後及向下之合應力（詳圖 2.3-6），遂發生原廠檢測報告圖 8 描述之模式 2 裂縫（詳圖 2.3-7）。根據波音公司所提供測試報告（QUALIFICATION TESTING OF HYDRAFLOW 15J02/14F02 SERIES COUPLINGS AND FLANGES TO THE REQUIREMENTS OF BELL-BOEING DRAWING NO. 901-366-582 REV. N/C, JANUARY 29, 1987），管凸緣與套管接合界面之設計經測試可容許兩端中心線在接合面有 3 度角的偏差量，接合界面有中心線偏斜狀況存在是有可能，然只要偏斜角度小於 3 度就不會有應力作用在接合界面兩端。

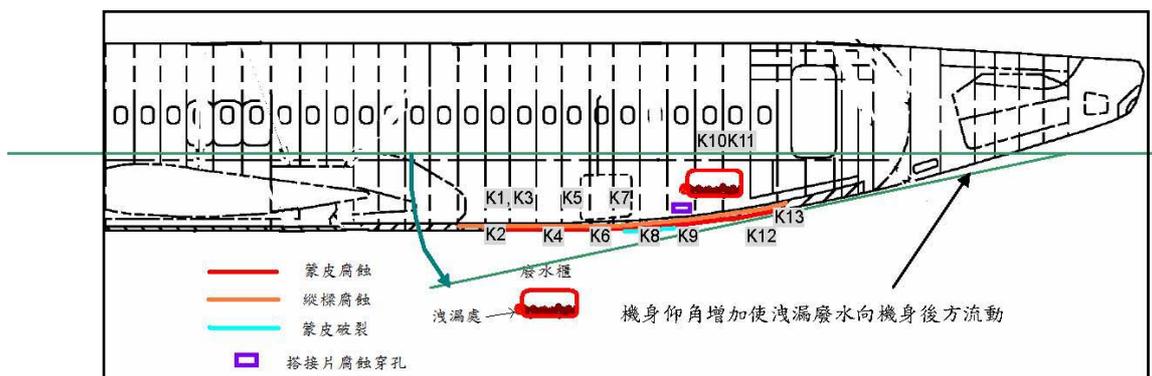
圖 2.2-A 機身仰角增加使滲漏廢水向機身後方流動

1. 廢水系統之接頭損壞滲漏廢水並污染下方隔熱棉（圖 1.12-5）
2. 廢水滲透隔熱棉在蒙皮表面留下污漬（圖 1.12-6, 1.12-7）
3. 廢水受重力向較低處的前方流動，浸潤 Sta. 867 ~ Sta. 887 S-26L ~S-27L 間之縱向搭接片，並造成該縱向搭接片腐蝕（圖 1.12-49, 1.12-7）
4. 廢水通過縱向搭接片的疏水孔繼續向前方低處行進至縱樑 S-27L，並沿其外側低處流動，導致：
 - A. 沿線機腹蒙皮腐蝕
 - B. 沿線 S-27L 縱樑左側表面腐蝕
5. 廢水通過 S-27L 左側疏水孔進入 S-27L 中間部位，造成縱樑內側表面腐蝕。
6. 飛航中於機體姿態改變成仰角時，廢水流向水線（water line）較高的 S-27L 後方（此時相對機腹為較低點），引發機身 47 段 S-27L 縱樑內側表面腐蝕及 S-27L 外側沿線機腹蒙皮腐蝕，詳圖 2.2-A。

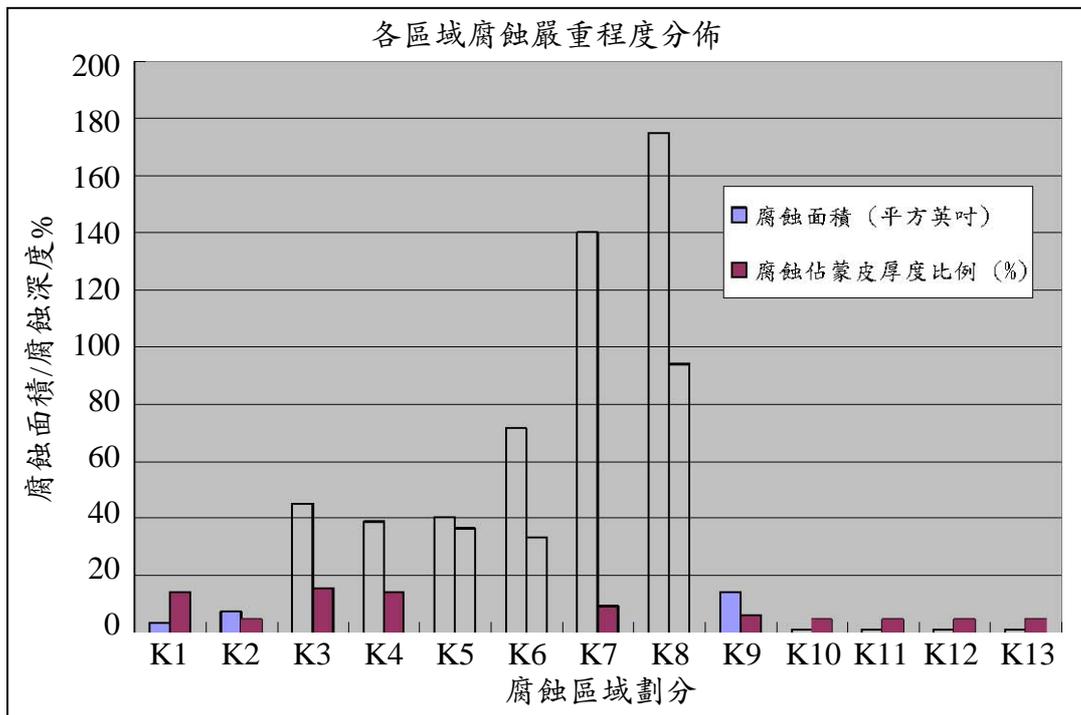
圖 2.2-B 蒙皮遭受腐蝕的嚴重程度分佈表

7. 蒙皮腐蝕程度由表 1.12-1 得知位於編號 K8 (BS 847 ~ BS 872) 前方約五個隔框範圍 (K3~K8) 腐蝕面積較大且深度較深，顯示為大部分時間滲漏廢水匯集

之處，見圖 2.2-B¹⁰。腐蝕深度以華航暫時性修理打磨之深度計，由於接近 K8 蒙皮破裂處的腐蝕並未打磨，但由第 1.16.2 節顯微金相試片觀察得知蒙皮殘餘厚度最低為 0.0037 吋，腐蝕程度是原 0.063 吋厚度的 94%。
