# 飛航事故調查報告

ASC-AOR-10-07-001

編號 NA-518

花蓮鳳林馬太鞍溪堤防迫降事故

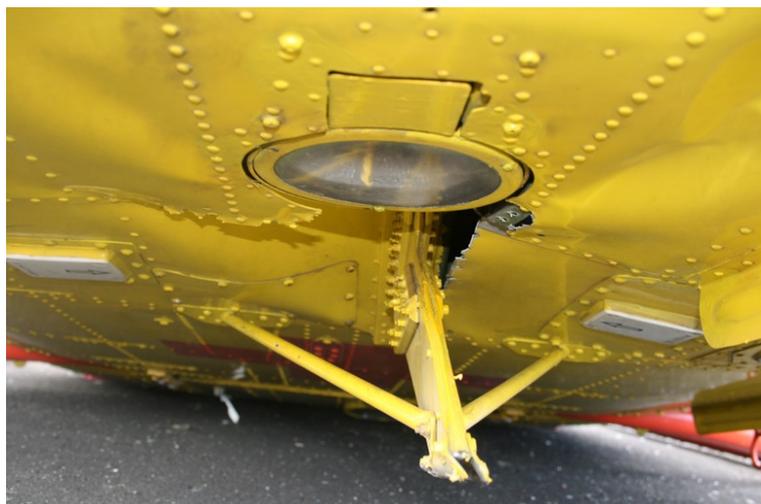
圖 1.12-2 機鼻下方蒙皮破裂 (後視圖)

安裝於航機機鼻下方之切纜器，因撞擊地面而斷裂，並於地面留下點狀印痕。其底座因觸地而壓迫蒙皮，導致該區域機身蒙皮沿切纜器底座向內撕裂並產生皺褶，詳圖 1.12-2。

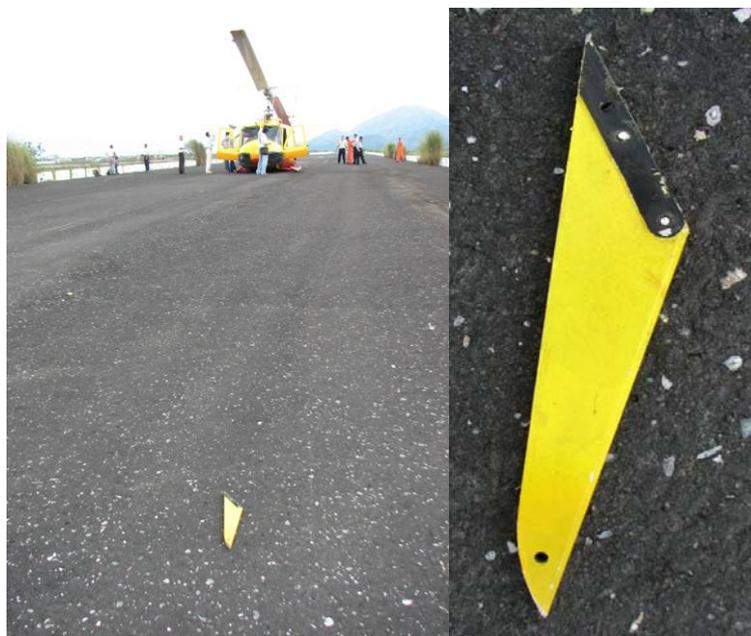
圖 1.12-3 切纜器之刀尖

切纜器之刀尖，因撞擊而脫落，並於航機最終停止點左前方約 12 公尺處尋獲，如圖 1.12-3。

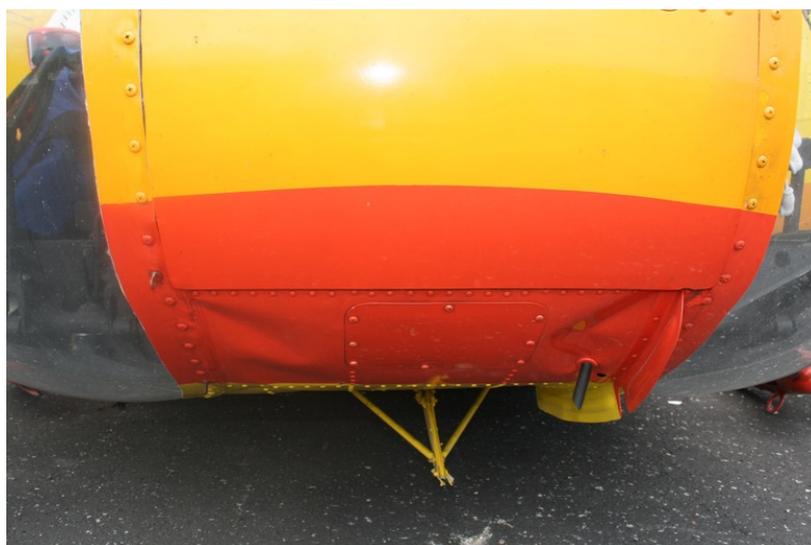
圖 1.12-4 電瓶艙下方鋁合金蒙皮損傷

機鼻下方之鋁合金蒙皮，因慣性衝擊而向外突出，並在兩側產生皺摺，詳圖 1.12-4 所示。

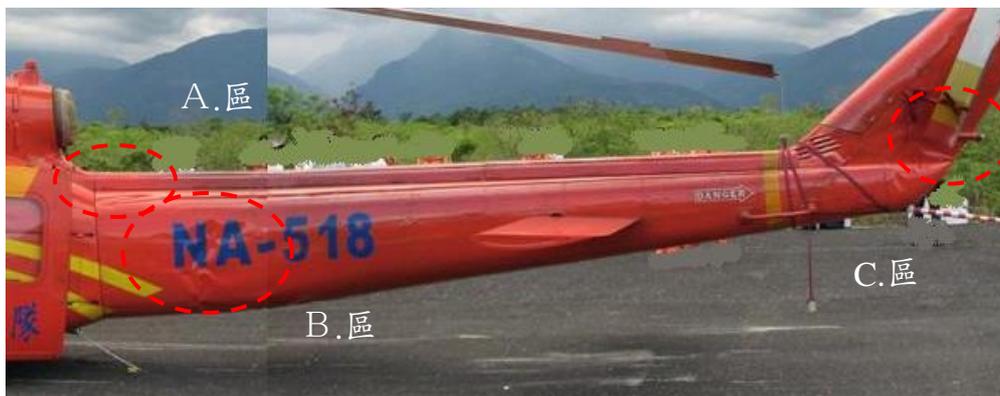
圖 1.12-5 尾桁左側蒙皮損傷

尾桁結構之損傷，主要表現於蒙皮之壓縮挫曲，以及剪力皺摺。尾桁結構之各處損傷，分別區分為：尾桁左側蒙皮之 A、B、C 三區，尾桁右側蒙皮之 D、E、F 三區，與尾桁底側蒙皮之 G 區。如圖 1.12-5 顯示尾桁左側 A、B、C 三區之蒙皮損傷。

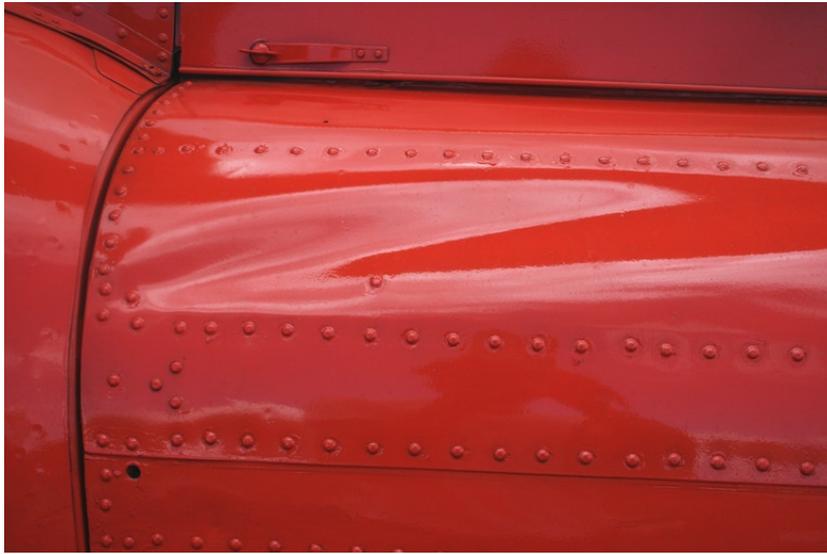
圖 1.12-6 尾桁左側前段 A 區蒙皮之皺褶變形

尾桁左側蒙皮，在接近與機身連接根部上方側，如圖 1.12-5 之 A 區，有介於兩縱桁與隔框之間的皺摺變形，顯示該區域尾桁之上側承受一張力之作用，傳導至蒙皮、縱桁與隔框組合之框架結構，由主應力方向轉換為對角線之剪應力，而在兩縱桁與隔框間，顯現剪力挫曲之對角線方向波浪皺紋，方向為前下方至後上方之走向，詳圖 1.12-6 所示 A 區之放大照片。

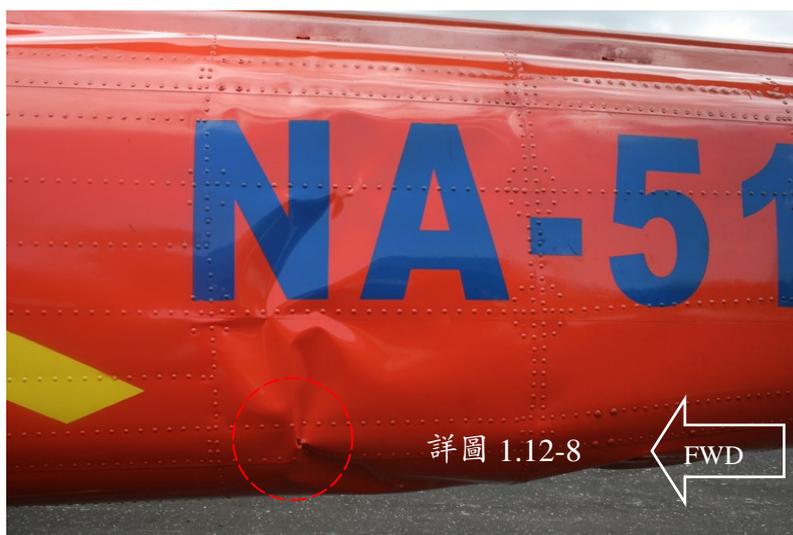
圖 1.12-7 尾桁左側 B 區之蒙皮皺摺變形

於尾桁前端左側前端，距離尾桁與機身接合處約 50 吋至 100 吋之間，亦即尾桁第二與第三隔框之間，詳圖 1.12-5 之 B 區，在該兩隔框前後與兩隔框之間的蒙皮，有大面積之壓縮挫曲及皺摺變形，詳圖 1.12-7 所示。B 區蒙皮變形範圍內，接近尾桁側蒙皮與尾桁下蒙皮之接合處上方，有因擠壓造成的蒙皮皺摺及破裂，詳圖 1.12-8 所示。

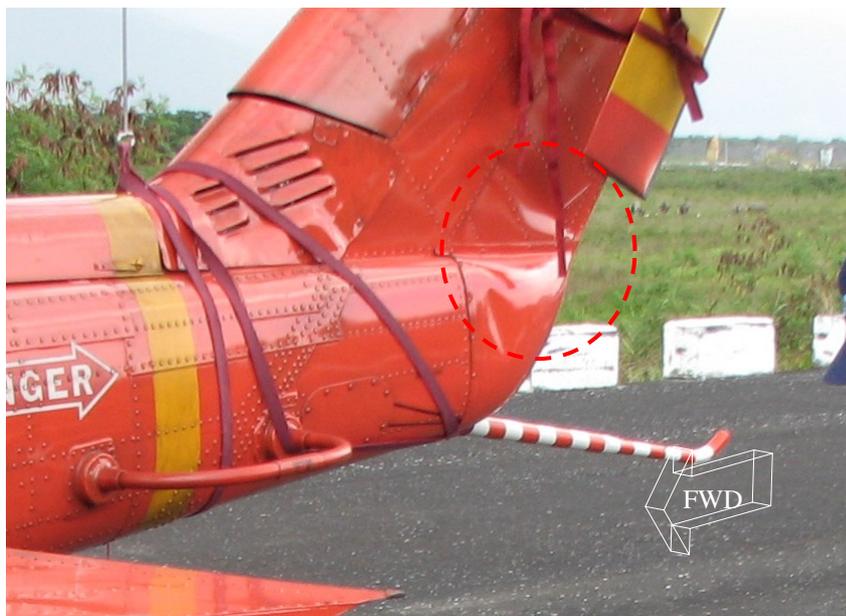
圖 1.12-9 壓縮挫曲型態之尾椎罩蒙皮皺摺變形

詳圖 1.12-9，尾桁之尾椎罩，承受由上方來之順時鐘方向力量擠壓，而產生表面壓縮挫曲皺摺變形。

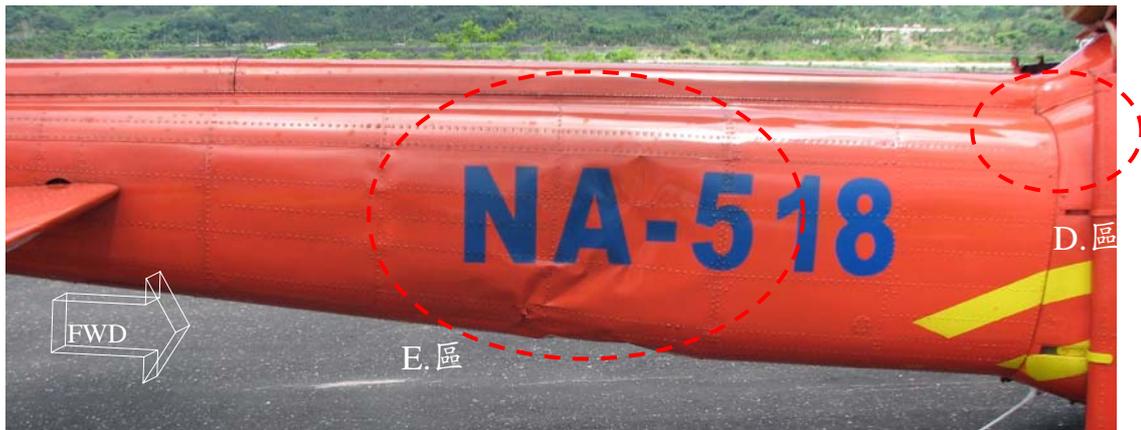
圖 1.12-10 尾桁右側蒙皮損傷分佈圖 - D 區與 E 區

尾桁右側之蒙皮結構損傷與左側型態一致，分佈之位置也與尾桁左側類似損傷之位置大致對稱，但尾桁右側之蒙皮結構損傷分佈區域較廣，且蒙皮皺摺與破裂程度較左側為嚴重。詳圖 1.12-10 分佈圖顯示 D 區與 E 區之損害狀況，以及圖 1.12-11 顯示尾桁後段 F 區之損害狀況。

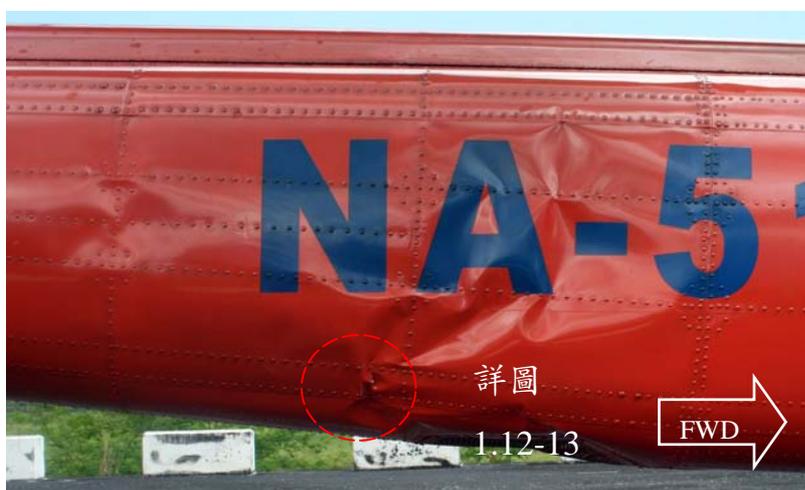
圖 1.12-12 尾桁右側 E 區之蒙皮皺摺及變形

於尾桁前端左側蒙皮，距離與機身連接處約 100 吋至 200 吋之間，亦即尾桁第三與第五隔框之間，如圖 1.12-10 之 E 區，在第三與第四隔兩隔框之間的蒙皮，有大面積之壓縮挫曲皺摺變形，且壓縮挫曲之蒙皮變形跨過第四隔框，而影響到第五隔框安裝處之蒙皮，詳圖 1.12-12 所示。同時於第四隔框後側，接近尾桁側蒙皮與尾桁下蒙皮之接合處上方，也發現如同左側蒙皮擠壓造成的蒙皮皺摺及破裂，詳圖 1.12-13 所示。

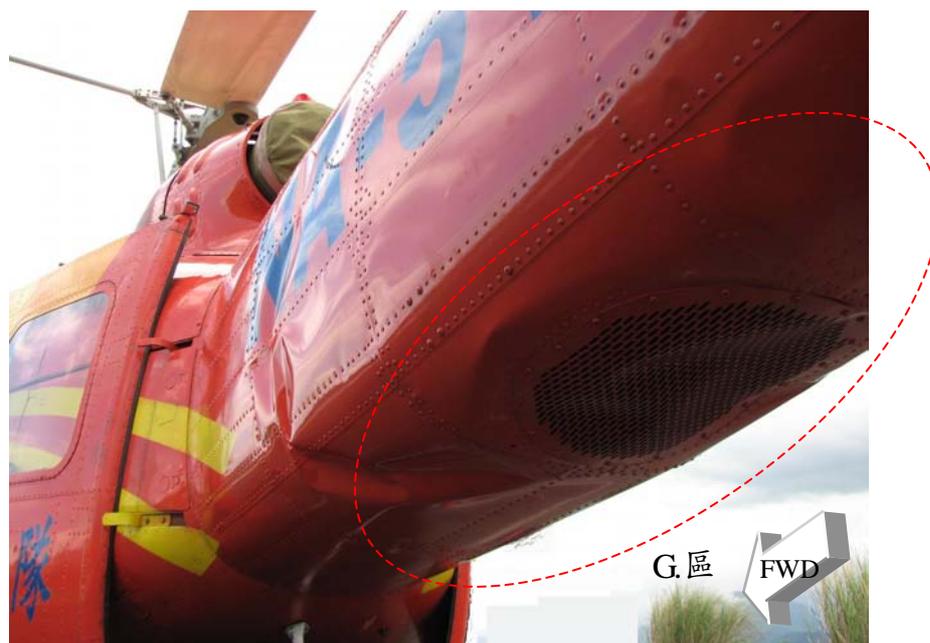
圖 1.12-14 尾桁底部 G 區之蒙皮損傷

尾桁底部蒙皮結構之壓縮挫曲變形區域，與尾桁左側 B 區和右側 E 區之大面積壓縮挫曲變形連接。其結構變形區域，由尾桁第二隔框向後延伸至第五隔框，呈現一典型細長樑柱遭受偏心軸向壓力之向下彎矩，導致下側承受擠壓應力，終致超過其挫曲穩定度 (Buckling Stability)，而發生材料挫曲變形與破壞的現象，見圖 1.12-14。

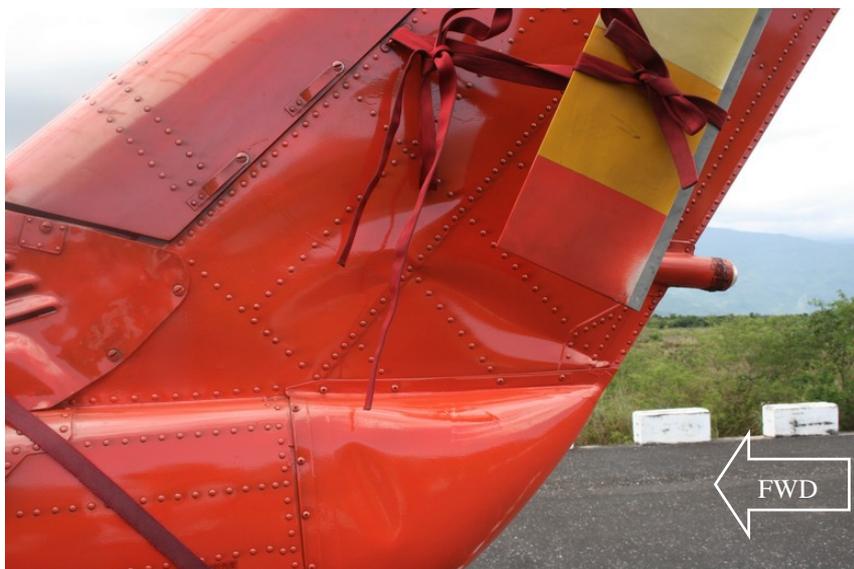
圖 1.12-15 垂直安定面左側蒙皮皺摺變形

垂直安定面左右兩側蒙皮，均發現往下之挫曲變形，詳圖 1.12-15 與圖 1.12-16 所示。

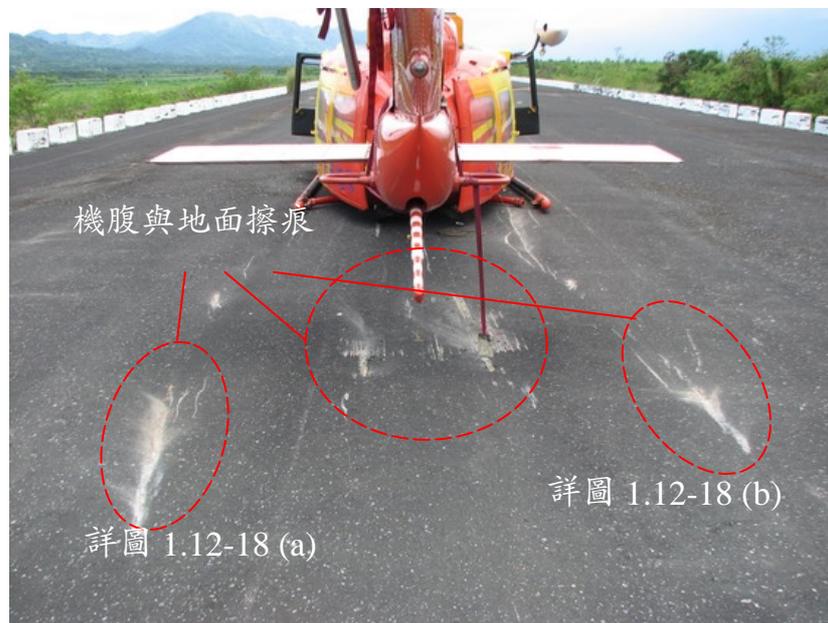
圖 1.12-17 滑槳與地面擦撞痕跡

詳圖 1.12-17 地面撞擊痕跡，顯示事故機滑橈與地面擦撞，滑橈腳架因衝擊而向後翻折，並於腳架和滑橈連接處斷裂，遂令機腹著地並向前方彈跳，滑橈並於地面留下如圖 1.12-18 之紅色漆痕，左右兩擦痕相距 246 公分。滑橈腳架向後翻折並於腳架和滑橈連接處斷裂，如 1.12-19 圖所示。

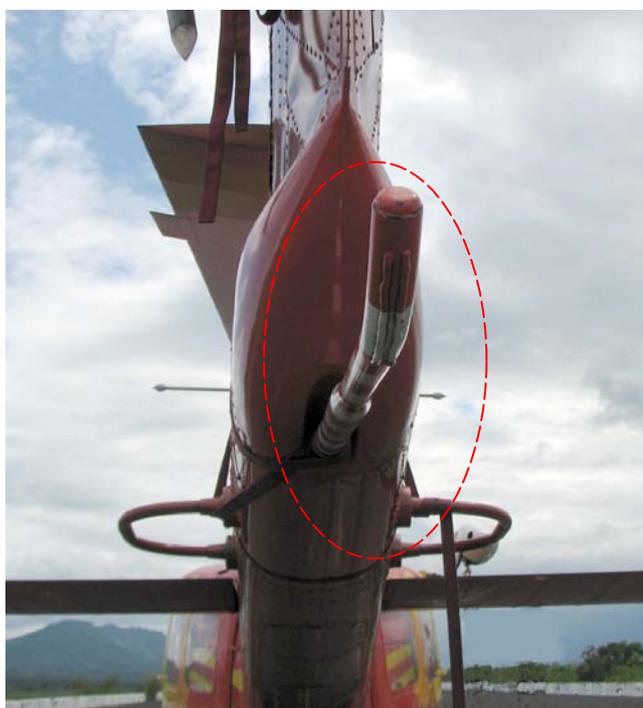
圖 1.12-20 尾橈

未發現其他明顯航機結構損傷；尾橈亦無位移變形且未超出標示之彎折上下限度，尾橈底部亦無與地面接觸痕跡，詳圖 1.12-20。

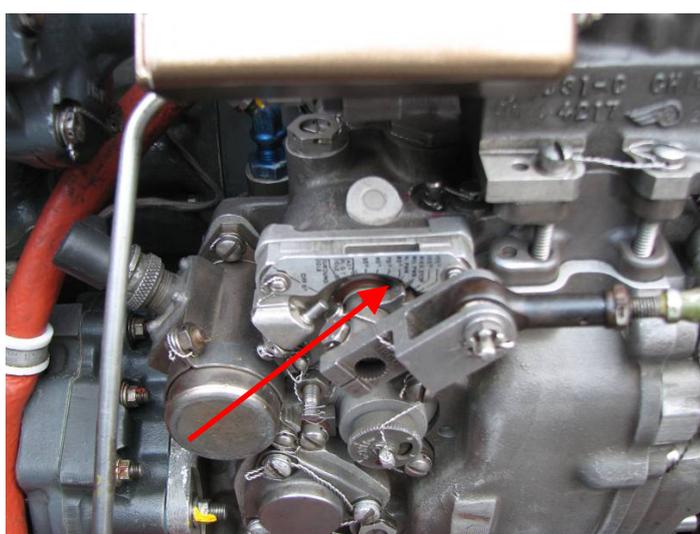
圖 1.16-1 油門流量指示全馬力位置（箭指處）

1. 請該機駕駛員設定發動機油門於全馬力及關斷位置，檢視駕駛艙至發動機之燃油操作連桿作動正常，燃油流量指示器於全馬力（詳圖 1.16-1）及關斷（詳圖 1.16-2）之油門設定時皆於正確位置。

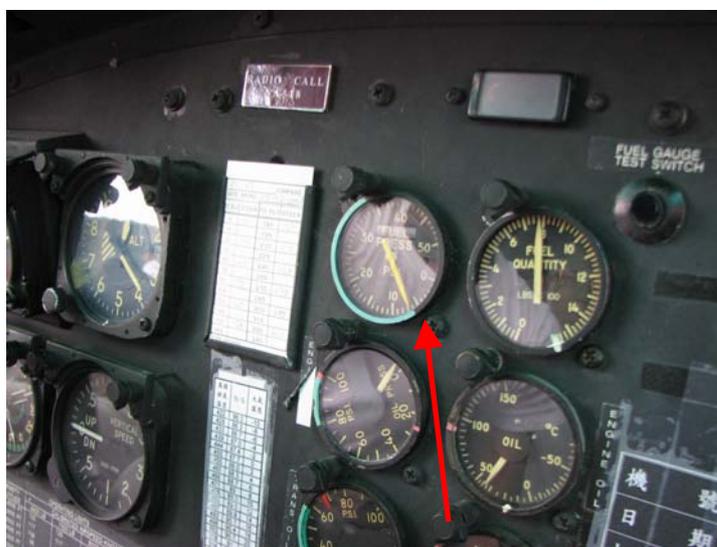
圖 1.16-3 燃油增壓泵壓力指示於正常綠線範圍內 (箭指處)

2. 請該機機工長接上飛機電瓶，駕駛員打開駕駛艙電源開關，電瓶電力供應至飛機，置燃油增壓泵開關於 ON，檢視其出口燃油壓力指示為 6 psi，指針介於該錶蓋邊框綠線範圍內 (如圖 1.16-3)，為正常操作壓力範圍。

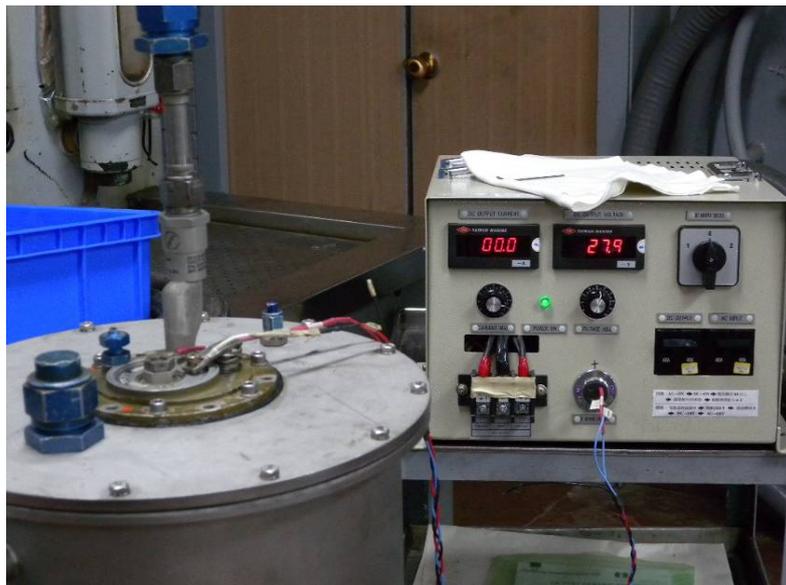
圖 1.16-12 燃油增壓泵功能測試

民國 98 年 10 月 8 日，飛安會、空勤總隊及亞航代表組成之調查小組於亞航公司直升機棚廠進行事故機燃油系統裝備檢測，燃油加壓系統之加壓泵及管路配置（詳圖 1.16-11），計測試燃油增壓泵 2 具及燃油供應管 8 根（詳圖 1.16-12），燃油管經壓力測試結果均無洩漏，測試記錄詳附錄 6。安裝於右側臥式油箱內之燃油增壓泵（料號 1C64-1，序號 8AD2470，）設定 1000 磅／每小時之燃油流量時，測得壓力值為 7 psig，未達額定之 13.0~25.0 psig 範圍，設定 300 磅／每小時

之燃油流量時，測得壓力值為 11 psig，未達額定之 12.5~25.0 psig 範圍；左側燃油增壓泵（料號 1C64-1，序號 4Ak597），設定 1000 磅／每小時之燃油流量時，測得壓力值為 13 psig，達額定之 13.0~25.0 psig 範圍，設定 300 磅／每小時之燃油流量時，測得壓力值為 14.8 psig，達額定之 12.5~25.0 psig 範圍，測試結果正常，兩具增壓泵測試紀錄詳附錄 7。

事故發生之現場，調查小組執行燃油關斷瓣功能測試，其開關功能正常。燃油增壓泵功能測試，燃油出口壓力達 6psi，壓力介於正常綠線之範圍內，執行燃油增壓泵測試台功能測試時，事故機左側燃油增壓泵增壓供油功能正常，可正常供應發動機燃油消耗，右側燃油增壓泵之出口壓力低於設定值，然仍具增壓功能，事發當時為兩具增壓泵一起供油情形，現場測試燃油壓力於正常綠線範圍，顯示應無燃油增壓泵壓力不足之情形。左、右兩具燃油增壓泵出口至發動機前關斷瓣之間各有 4 根燃油供應管，左、右共 8 根，該 8 根燃油供應管經壓力測試結果均無洩漏，事故現場測試燃油壓力於正常綠線範圍，以上分析顯示該機燃油系統之燃油供應應係正常。
