# 飛航事故調查報告

ASC-AOR-10-08-002

國泰航空公司 CX 521 班機

因暫時性艙壓供氣異常緊急下降事故

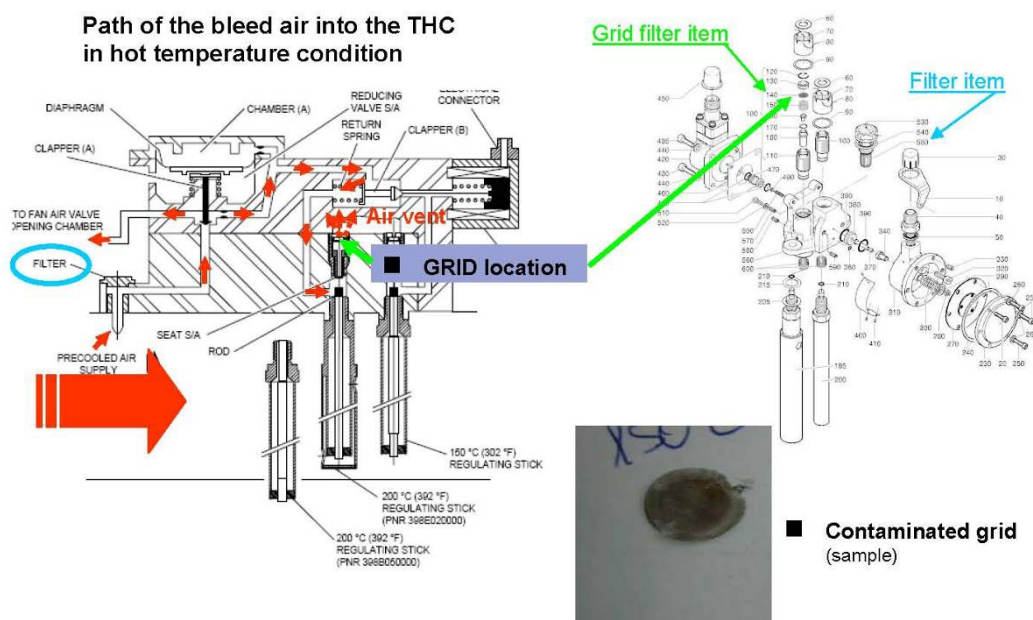
At high temperature condition the reduced pressure normally vents through the grid filter thanks to the thermal expansion of the regulation stick (see figure hereunder for air bleed path into the THC)

The contamination of the grid has affected the flow of the reduced pressure (causing a pressure loss) coming from the bleed air through the THC .

The removal of the THC is confirmed due to level of contamination at the grid filter location.  
The contamination level of the grid filter has caused a drift of the reduced pressure (muscle pressure) below the nominal tolerance to the FAV which could lead to prevent a correct full opening of the FAV and causing an overtemperature condition on the bleed system of the engine 1.

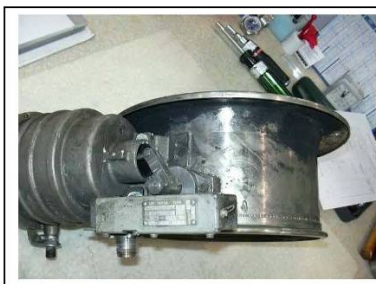
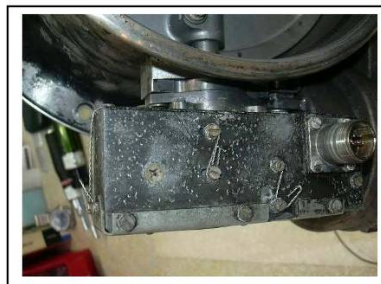
#### ➤ \_ Visual inspection

High level of external pollution

The removal of the FAV is not confirmed/ justified due to the Overtemperature condition of the engine 1 bleed system.

Due to the high level of pollution a complete disassembly will be carry out for cleaning plus an overall repair.

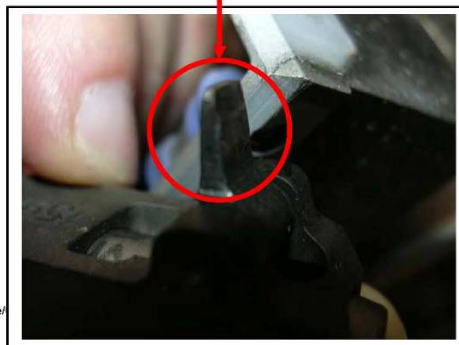
##### Switch lever wear

This test has also revealed a no indication of the FAV closing position due to wear between the switch lever and the lever causing a drift of the initial switch setting.

At bleed system level AIRBUS said the missing closing indication would have an impact in case of bleed low temp only.

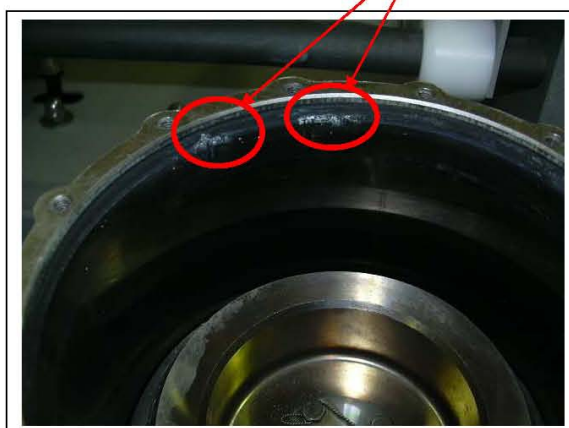
Moreover some traces of corrosion have been noted in the piston which could lead to degrade the actuator piston seal too. This corrosion could be explained by humidity environment in Asia area.
