**ASC-AOR-12-04-001**

**中華民國 99 年 12 月 29 日**

**長榮航空公司 BR 61 班機**

**於巡航時兩套供氣系統失效導致艙壓異常**

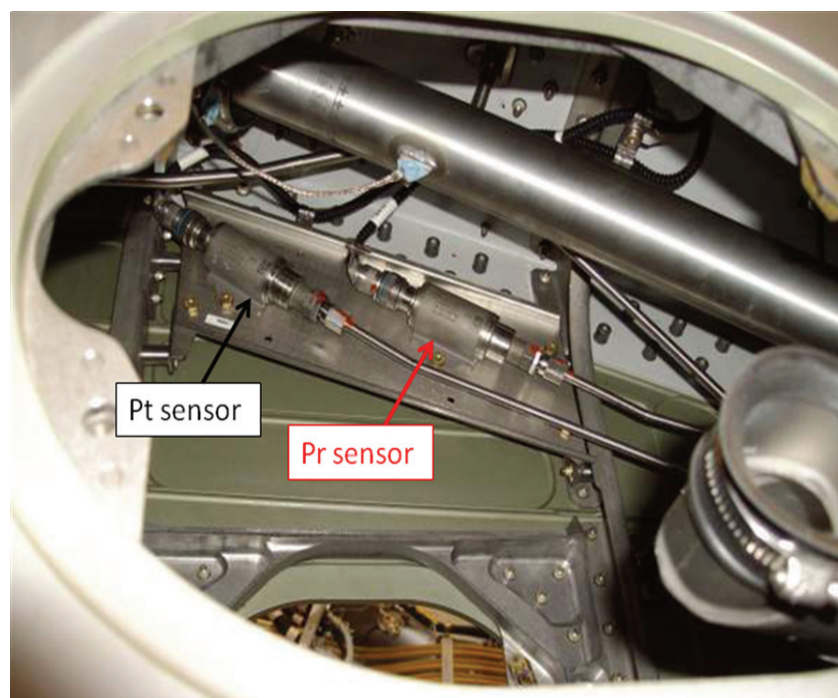
該機裝用 AIRBUS 公司（以下簡稱 AIRBUS）設計製造之 GE 發動機吊艙（PYLON），本事故之故障組件 Pressure Regulated Sensor（壓力調節感測器，以下簡稱 Pr 感測器）詳圖 1.6-2，其於 GE 發動機吊艙中之安裝位置如圖 1.6-3 所示。

圖 1.6-2 Pr 感測器於 GE 發動機吊艙內之裝置情形

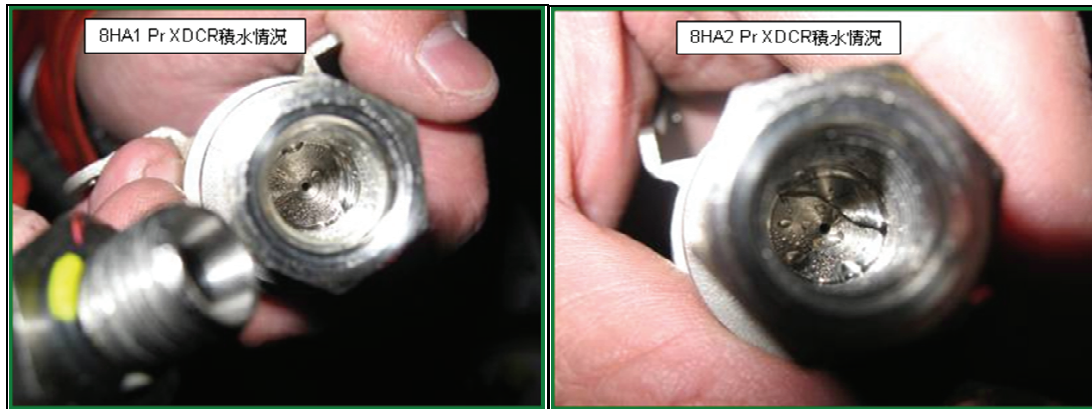
依據零件更換紀錄，該機 1、2 號供氣系統原均裝用料號為 ZRA380-00 之 Pr 感測器，經長榮航太派遣 AOG team<sup>12</sup>（航機地停救援小組）赴 SIP，維修員拆檢 1、2 號供氣系統 Pr 感測器，發現其內部均有積水現象如圖 1.6-4 所示（左 1 號，右 2 號）。

圖 1.6-4 Pr 感測器內部積水現象

- 目視檢查兩具 Pr 感測器外表均有鏽蝕現象，鏽蝕成因可能為暴露於潮濕環境造成。
- 依原廠程序執行測試，兩具 Pr 感測器於接收檢查時，發現內部壓力空間（pressure port）均有積水存在。測試過程中當溫度降到零度以下，Pr 感測器壓力偵測空間內之積水開始結冰，固態體積膨脹擠壓感測壓力之金屬薄膜，使感測器輸出之壓力訊號上升；當測試溫度回復到零度以上，結冰融化，使原先因積水結冰膨脹擠壓導致上升之壓力得以釋放，該金屬薄膜隨之恢復正常運作，壓力輸出訊號回復正常。
- 兩具 Pr 感測器置於 100°C 烤箱 2 小時後，依相同測試程序執行測試，壓力輸出訊號均回復正常。確認該兩具 Pr 感測器之故障為內部壓力偵測空間積水結冰所致。

為因應 2010 年 12 月發生 7 件雙供氣系統故障(Dual Bleed Loss)事件，造成航空器緊急下降，駕駛員需使用氧氣面罩，對民航運作造成衝擊乙事，AIRBUS 成立專案小組研究解決方案。目前製造廠亦已發展一料號 ZRA 691-00 之新型 Pr 感測器，其偵壓室新增凝結水排除功能，並除去偵壓薄膜前方的格網，且在面對水和冰的環境亦通過較 DO-160F 更嚴格之測試。AIRBUS SB A330-36-3039（詳附錄六）顯示該新產品在 2011 年 9 月 7 日開始供應業者為替換舊件使用。

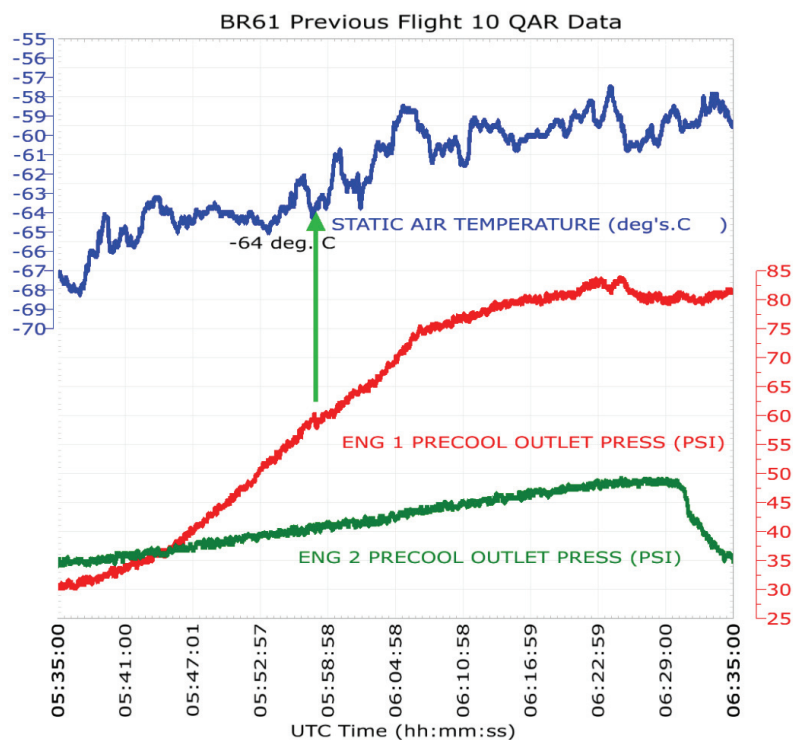
依據維修紀錄，該機於民國 99 年 12 月 25 日第一次發生 1 號供氣系統故障，經查閱該航班快速擷取紀錄器（Quick Access Recorder, 以下簡稱 QAR）資料顯示，1 號供氣系統 Pr 感測器壓力超過 60 PSI 且持續 15 秒以上，同時間並伴隨主警告「Master Caution」啟動；經查閱本次事故航班 DFDR 及 QAR 資料，亦顯示 1、2 號供氣系統 Pr 感測器壓力超過 60 PSI 且持續 15 秒以上，同時伴隨主警告啟動，以及「Engine 1/2 Bleed Fault」之紀錄訊息；由該兩次航班資料顯示，兩次事件均發生在航機巡航階段（FL400），當時航機外界大氣溫度約為-64°C（詳圖 1.6-5 及 1.6-6）；由該機第一次發生供氣系統故障之 QAR 資料顯示，於供氣系統 Pr 感測器發生超壓狀況前約 82 分鐘，航機外界大氣溫度約為-70°C，持續時間約 52 分鐘；依據事故航班 DFDR 資料，該機雙供氣系統 Pr 感測器發生超壓狀況前約 95 分鐘，航機外界大氣溫度約為-70°C~-72°C，且持續時間約 65 分鐘；上述兩航班之航機均曾於-70°C~-72°C 機外大氣溫度狀況下飛航約 1 小時，之後機外大氣溫度回升至約

圖 1.6-5 Pr 感測器壓力與機外大氣溫度圖（前一故障航班）

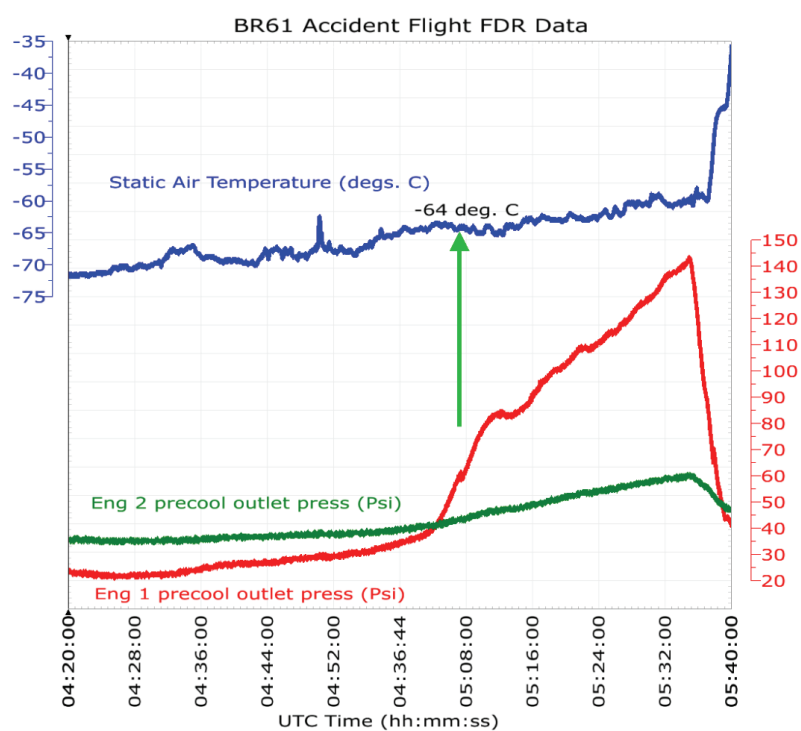
圖 1.6-6 Pr 感測器壓力與機外大氣溫度圖（事故航班）

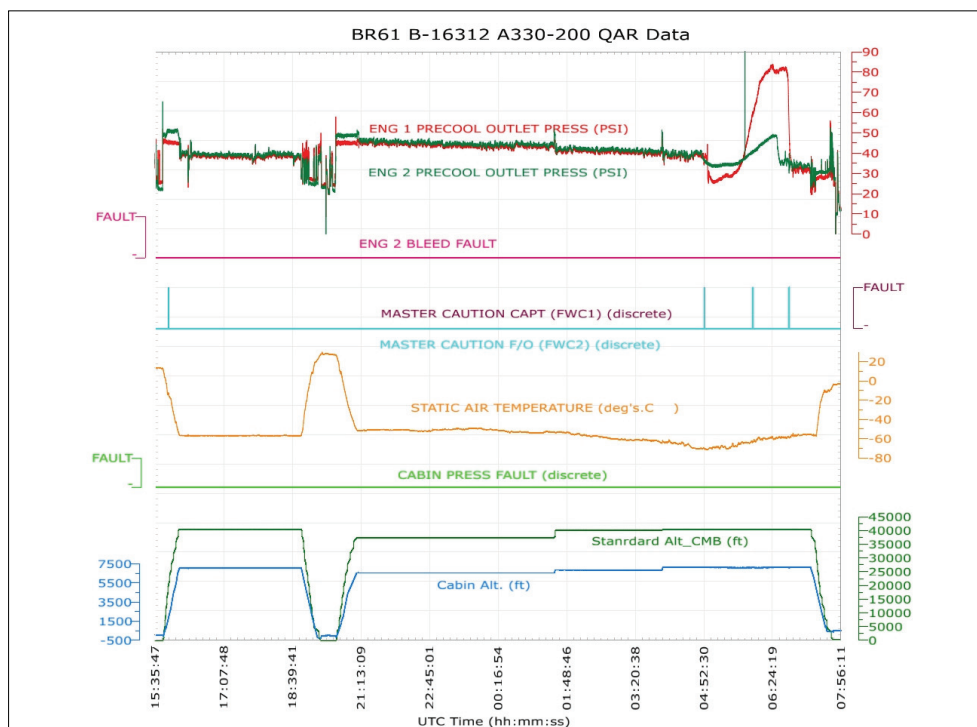
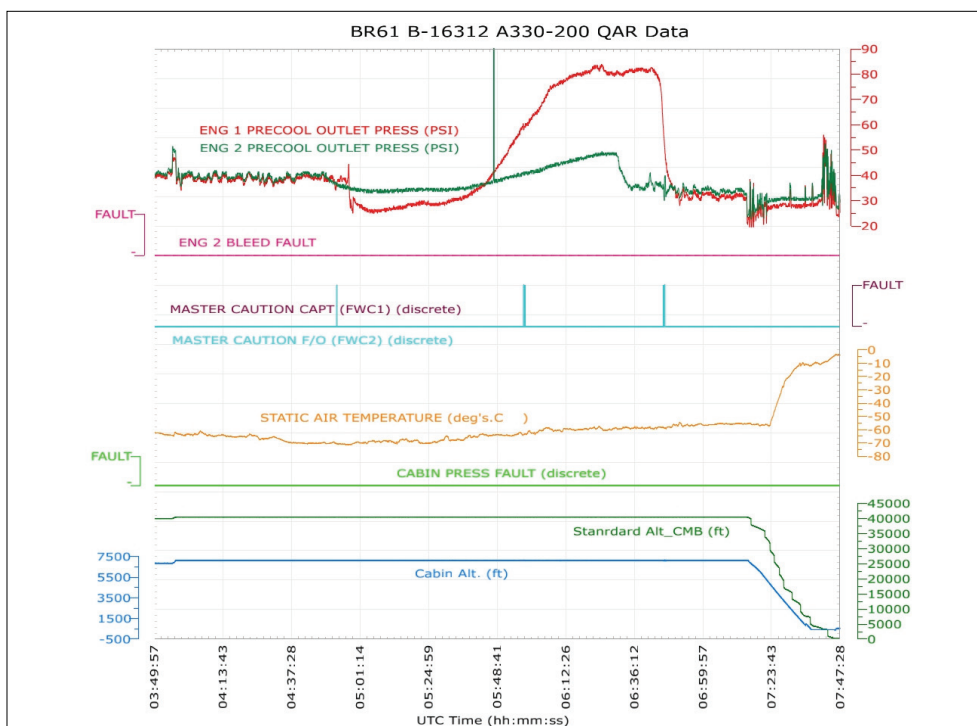
另取得該機 12 月 25 日由泰國曼谷國際機場飛往奧地利維也納國際機場之 QAR 資料，重要參數解讀結果詳圖 1.11-7 及圖 1.11-8，解讀摘要如下：

1. 民國 99 年 12 月 25 日 2040:20 時，該機於泰國曼谷國際機場起飛，「LDG Squat Switch-RH」參數由「Compressed」轉為「Not compressed」。
2. 0507:21 時，「Eng 1 precool outlet press」參數由 25PSI 開始上升，0557:29 時約 60PSI，0622:21 時上升至 84PSI，「Static Air Temperature」紀錄為-69°C。
3. 0515:54 時，「Eng 2 precool outlet press」參數由 33PSI 開始上升，0625:02 時上升至 50PSI，「Static Air Temperature」紀錄為-68°C。
4. 0453:17 時至 0453:18 時、0557:56 時至 0557:58 時、0558:20 時至 0558:21 時、0646:22 時至 0646:23 時及 0646:41 時至 0646:46 時，該機之左右 2 套「Master Caution」參數紀錄為「Fault」。
5. 0745:49 時，該機降落於奧地利維也納國際機場，「LDG Squat Switch-RH」參數由「Not compressed」轉為「Compressed」。

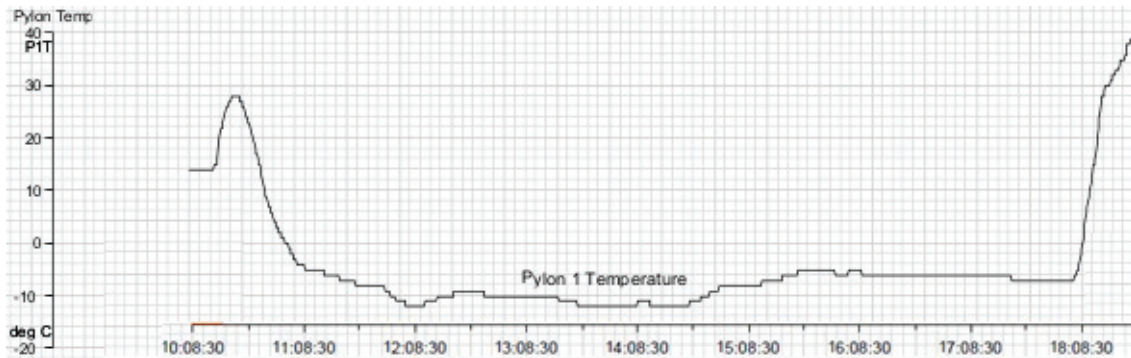
PW 發動機吊艙測試結果詳圖 1.16-1，測試日期為民國 99 年 3 月，時間紀錄長度約 9 小時；起飛前 Pr 感測器周圍環境溫度為 15°C，起飛時上升至 30°C，於飛機爬升階段，Pr 感測器周圍環境溫度以每分鐘約 0.7°C 速率下降，約 1 小時後其溫度約為 -12°C，之後溫度趨於穩定不再下降；該機於巡航階段之外界大氣溫度範圍約為 -55°C~-66°C。

圖 1.16-1 裝用 PW 發動機吊艙之 Pr 感測器環境溫度變化

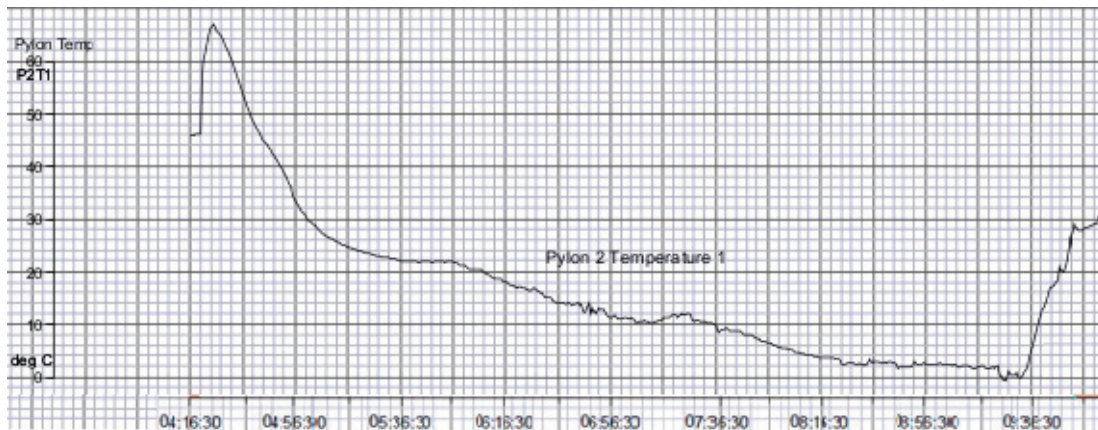
GE 發動機吊艙測試結果詳圖 1.16.2，測試日期為民國 99 年 6 月，紀錄時間約 5 小時；起飛前 Pr 感測器周圍環境溫度為 40°C，起飛時上升至 70°C，於飛機爬升階段，Pr 感測器周圍環境溫度以每分鐘 0.7°C 速率下降，該機於全程飛航過程中其溫度持續下降，最低溫度約為 0°C；該機於巡航階段之外界大氣溫度範圍約為 -50°C 至 -64°C。

圖 1.16-2 裝用 GE 發動機吊艙之 Pr 感測器環境溫度變化

時，因此相較於該 5 小時飛測歷程，本案 Pr 感測器週遭環境之溫度呈線性下降趨勢，且低於 0°C 以下的期間可能超過 3 小時。以上顯示造成 Pr 感測器內部凝結水之形成與 GE 發動機吊艙內較不穩定之溫度有關，且長時間巡航於溫度 0°C 以下之環境，易使凝結水積冰。根據 1.18.4.1 節雙供氣系統失效案例，近 2 年（2009 年及 2010 年），使用 GE 發動機吊艙之 A330 型機之雙供氣系統故障紀錄每年發生 10 次。以上顯示使用 GE 發動機吊艙之 A330 型機，與使用他型發動機吊艙之 A330 型機相較，使用 GE 發動機吊艙之 A330 型機具有較高供氣系統失效之風險。

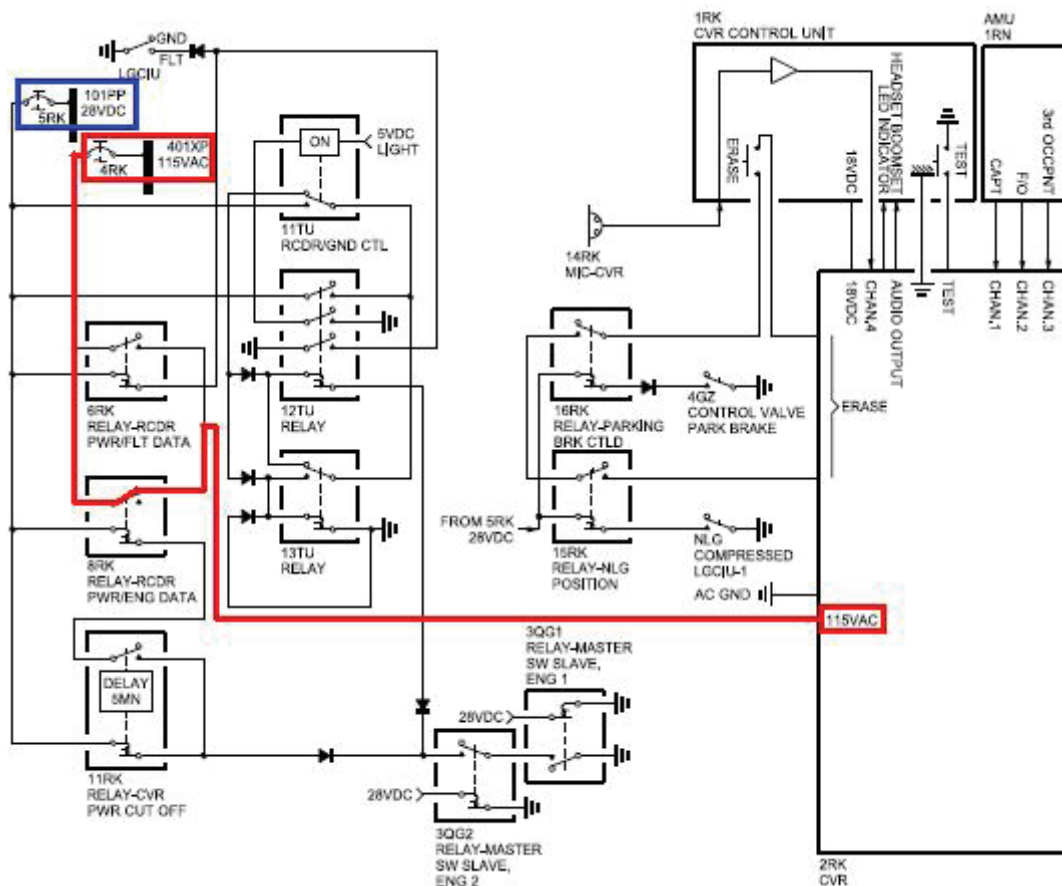
CB（如圖 1.18-1 紅框部分）可控制供應 CVR 之 115V 交流電，拔出編號 4RK 之 CB 可切斷 CVR 錄音功能，該 CB 位於電子艙 Q67 位置；CVR 相關之邏輯電路作用為控制 CVR 自動或手動錄音等功能，其電源為 28V 直流電，經由編號 5RK CB<sup>28</sup>（如圖 1.18-1 藍框部分）控制，編號 5RK CB 被拔出後，飛機在通電狀況下 CVR 立即錄音，失去預設之自動啟動及停止錄音之控制功能，該 CB 位於電子艙 V09 位置。

圖 1.18-1 CVR 系統電源供應概要圖

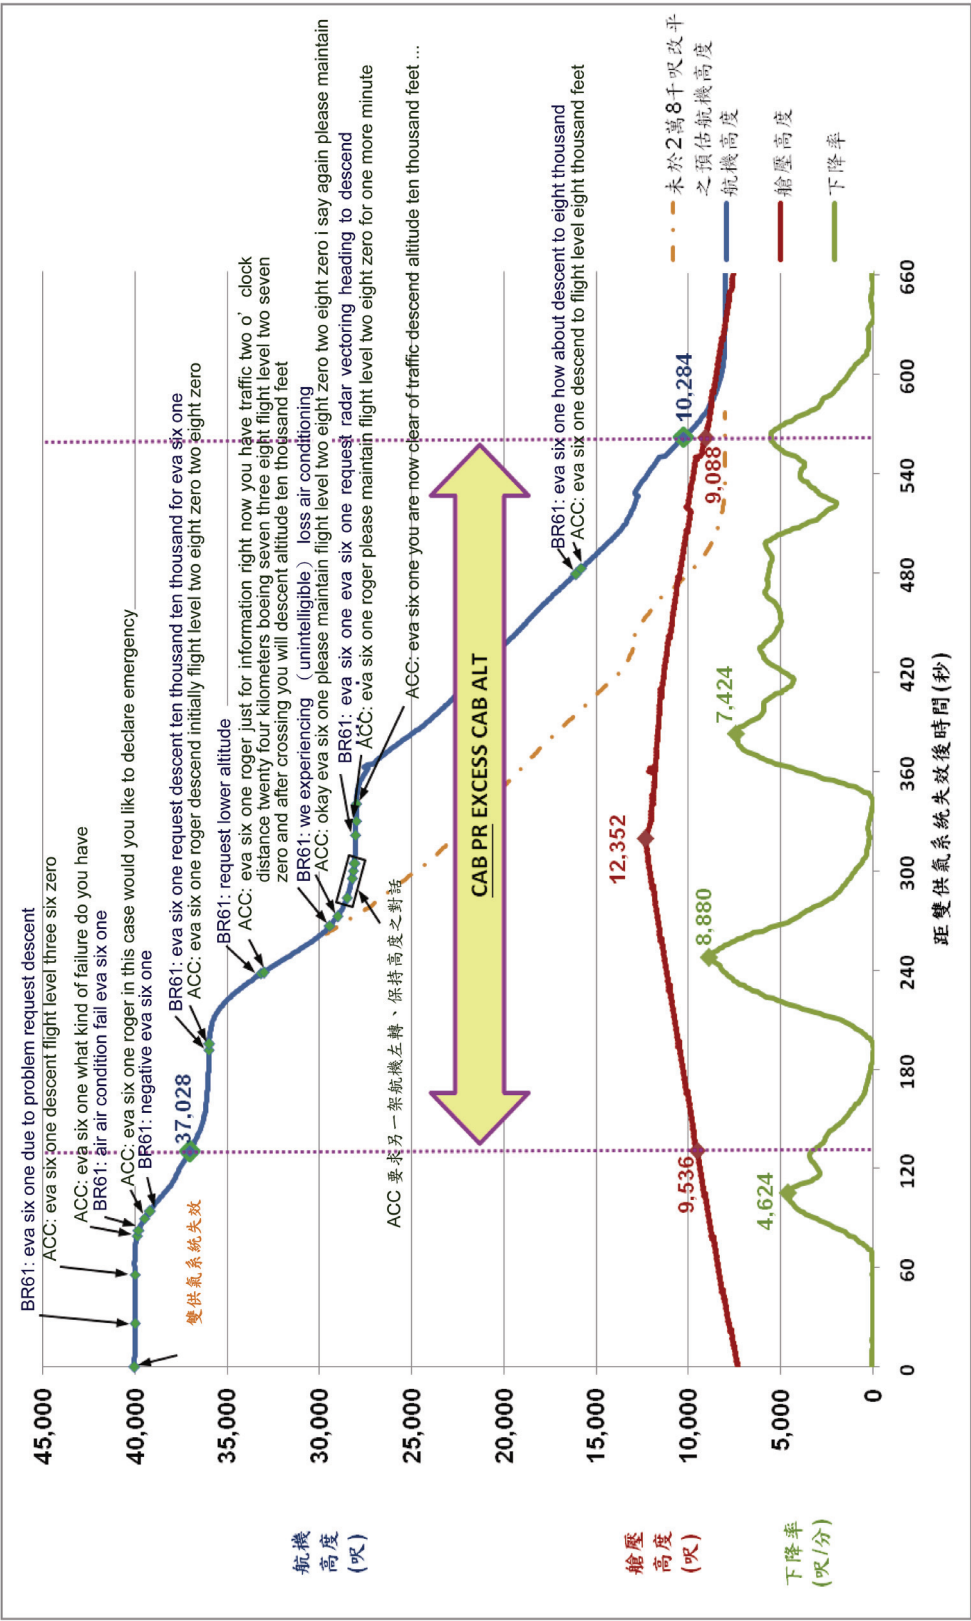
依 DFDR 資料，該機 1、2 號供氣系統分別於 1307:33 時及 1333:34 時先後故障，駕駛員因該機遭遇雙供氣系統故障情況，故自 40,000 呎巡航高度緊急下降至 8,000 呎高度。過程中航機高度、艙壓高度、下降率等變化及航管對話內容摘要等資料，如圖 2.1-1 所示。

因 2 號供氣系統重置無效，故艙壓高度持續上升，於該機高度下降至 37,028 呎、艙壓高度上升至 9,536 呎時，「CAB PR EXCESS CABIN ALT」警告訊息致動。依長榮 A330 飛航組員操作手冊，當此警告訊息出現而航機高度高於飛航空層 160 時，駕駛員應執行緊急下降程序，以最大之適當速度下降至 10,000 呎高度。本次事故駕駛員於「CAB PR EXCESS CABIN ALT」警告訊息出現後，依程序向航管請求下降至 10,000 呎，惟未明確說明該機遭遇艙壓失控情況，亦未申請緊急下降或宣告緊急狀況，致航管依正常程序處理，並因隔離因素僅許可該機先下降至飛航空層 280。下降期間巡航駕駛員雖持續要求下降至更低之高度，但航管因須先行調離飛航空層 270 之另一架對向航機而未能立即同意，故該機須於飛航空層 280 改平，待該對向航機應航管要求轉向後，始獲許可繼續下降至 10,000 呎。

圖 2.1-1 緊急下降過程中航機狀態及航管對話內容摘要
