飛航事故調查報告

ASC-AOR-12-03-001

長榮航空公司BR 757班機

於桃園機場落地時短暫偏離跑道

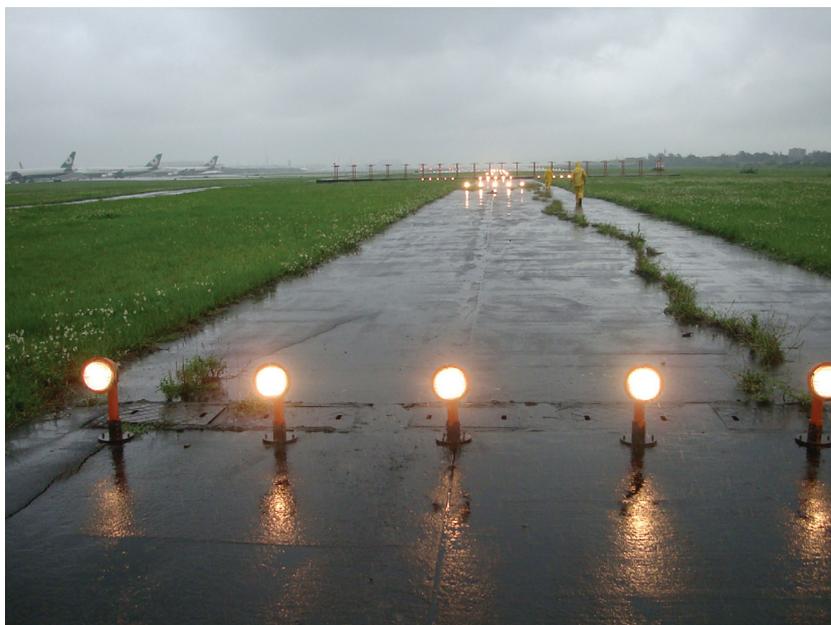
圖 1.10-3 06 跑道進場燈光圖

比較上述 2 進場燈光系統，以提供駕駛員進場時之目視參考而言，本會認為：國際民航組織所提供第 I 類進場燈光系統，其長度及配置應較美國聯邦航空總署 SSALR 為佳。桃園機場雖因部份土地取得困難，而需採用美國聯邦航空總署相關規定，限縮進場燈光系統的長度及配置樣式，惟我國國際機場跑道進場燈光系統應符合國際民航標準，依國際民航組織第 14 號附約或「民用機場設計暨運作規範」之標準或建議辦理。

1. 研擬設置 06/24 跑道之跑道中心線燈之可行性，以強化飛航組員於落地前對正跑道之目視參考依據。(ASC-ASR-12-03-002)
2. 設置國際民航組織第 14 號附約規範之跑道進場燈光系統樣式，以力求符合國際標準。(ASC-ASR-12-03-003)
3. 強化桃園機場跑道進場燈光系統、跑道邊燈、跑道頭燈及跑道末端燈之單燈即時監測、失效警告及紀錄之功能。(ASC-ASR-12-03-004)

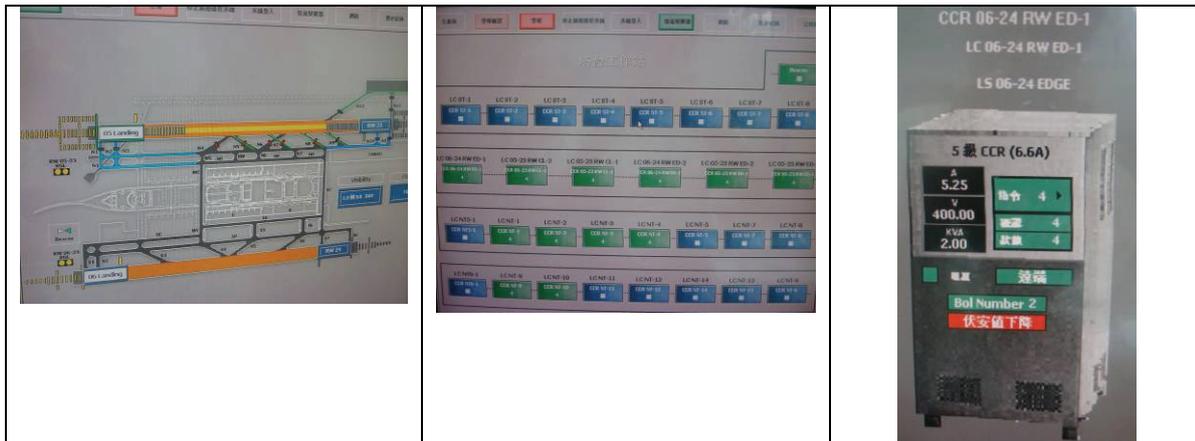
圖 1.10-4 桃園機場場面燈光監控面板

桃園機場 06/24 跑道進場燈光系統及跑道邊燈，設有即時自動監視系統，其迴路監視及迴路失效警告功能正常。

該機場場面燈光系統個別燈具檢測、檢視及記錄功能現行係以定期/不定期巡場方式執行；其 05/23 跑道停止線燈、停止線微波偵測及感應線圈之監視、控制、失效警告及記錄功能停用。

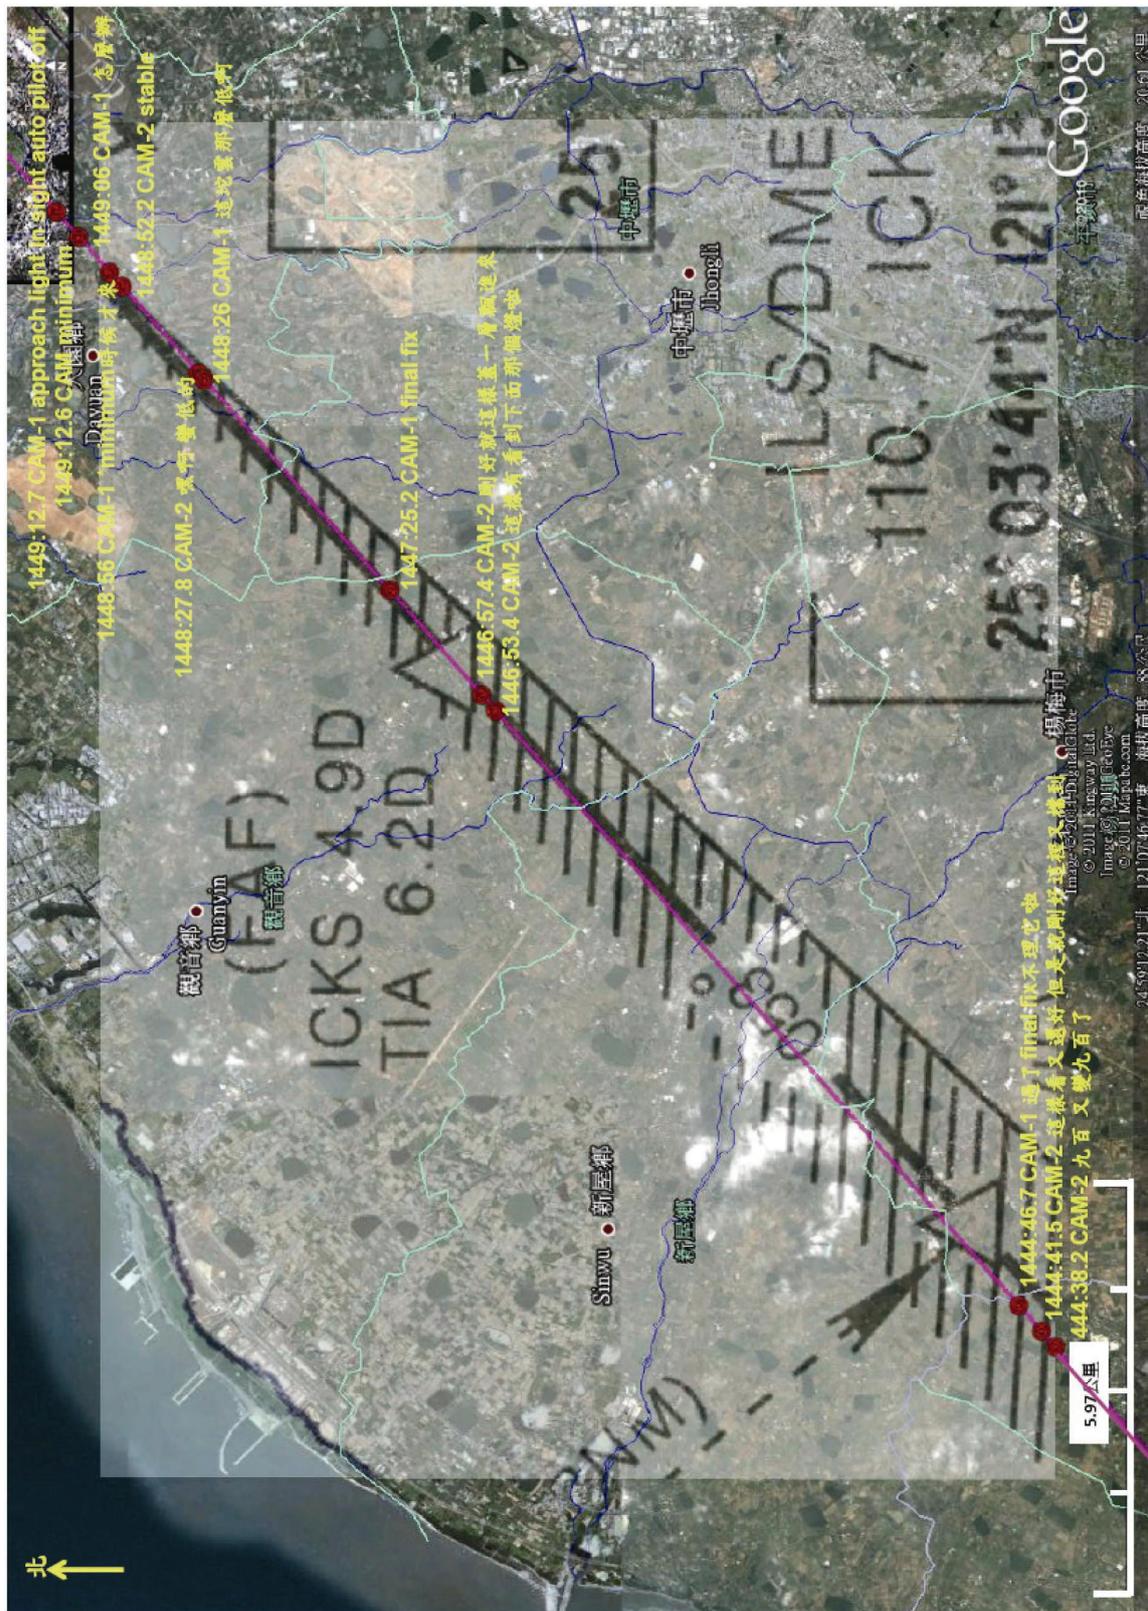
圖 1.11-4 最後進場飛航軌跡整合圖

1. 該機可能於最後進場時，遭遇低空稀雲及局部霧之影響，短暫斷續失去目視參考，仰轉時所需之目視參考不足，著陸前並未發現左翼偏低而造成航機著陸時偏離至跑道中心線左側。觸地剎那正駕駛員雖企圖修正航機左偏現象，但已無法停止其偏出跑道之趨勢。
2. 該機飛航組員於落地前應有之狀況警覺不足，未對當時天氣變化，作出周延之判斷及處置。
3. 該機飛航組員已認知天氣為該次飛航之威脅，但於最後進場階段到達決定高度後，所需之目視參考不足時未立即下決心重飛。

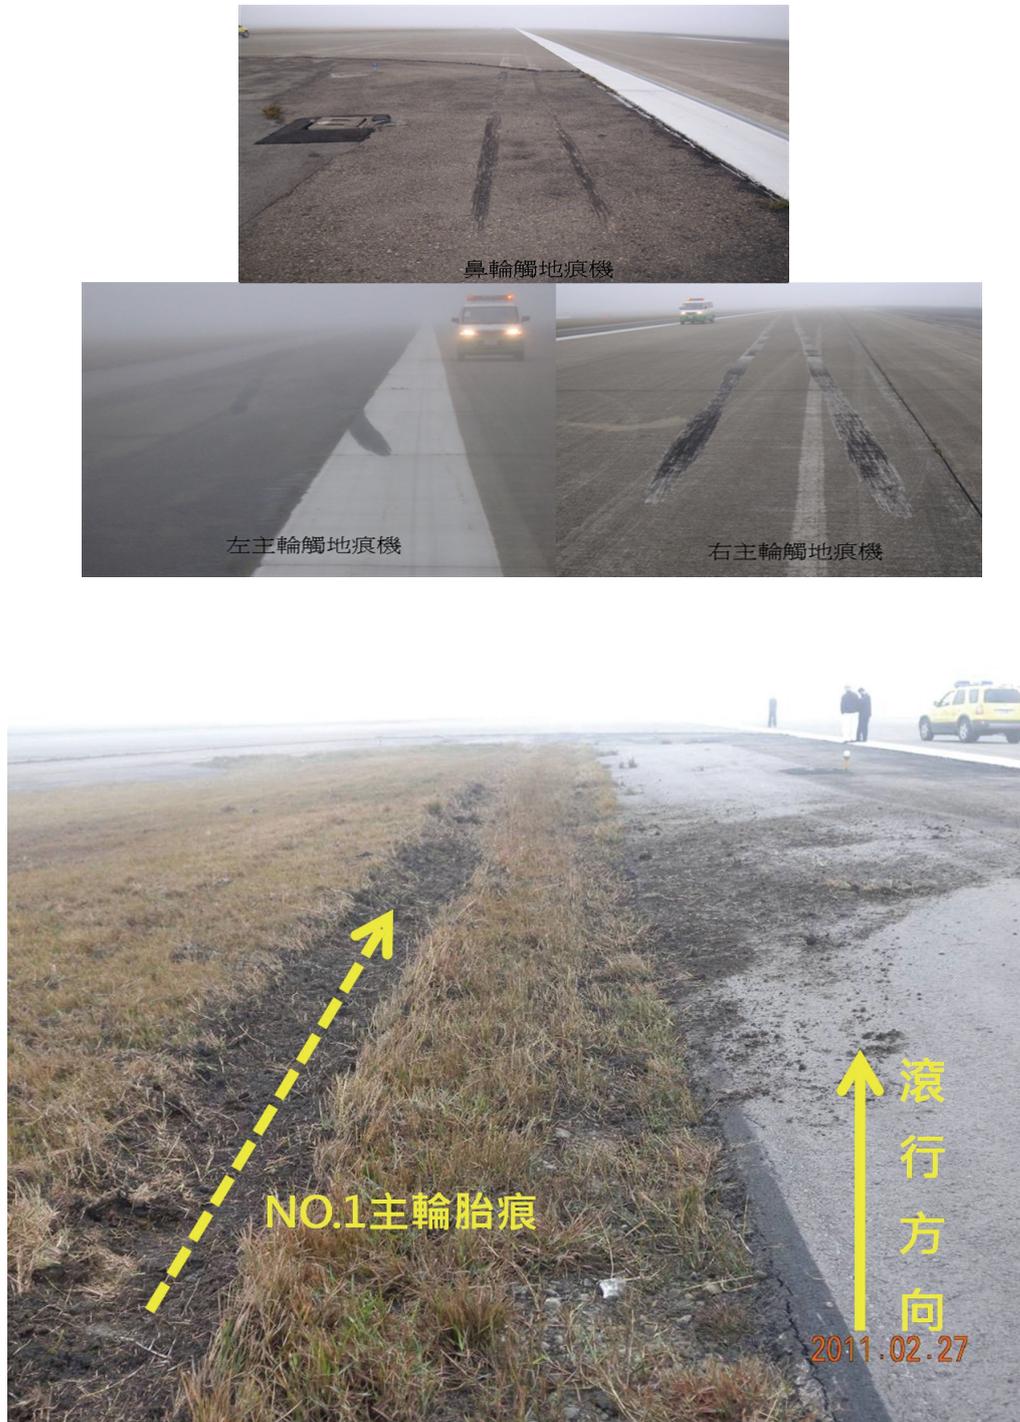
圖 1.12-1 輪胎痕跡

依據現場勘查結果，位於跑道道面上相關胎痕軌跡均位於 06 跑道中心線左側，且未與跑道中心線平行。左右主輪地面胎痕最初出現於距 06 跑道頭約為 2,100 呎處，此時 NO.1 主輪距 06 跑道中心線垂直距離約為 30 公尺，NO.4 主輪距跑道中心線垂直距離約為 19 公尺。NO.1 主輪偏出 06 跑道最遠距離約距跑道邊線 10

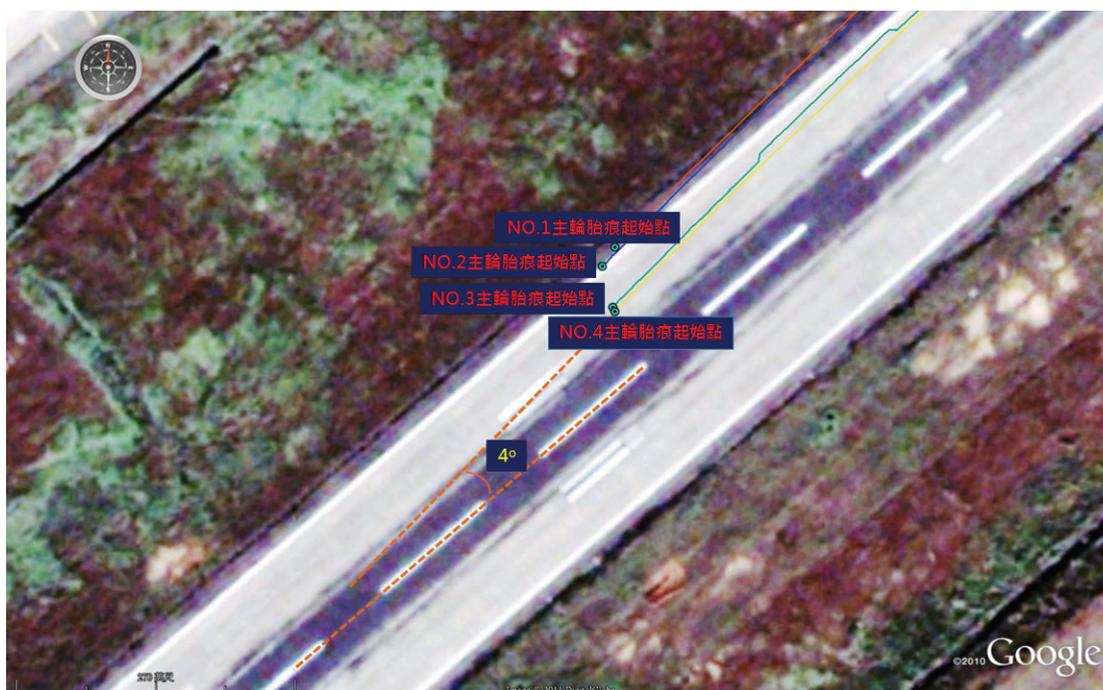
圖 1.12-5 落地滾行痕跡與跑道中心線之夾角

公尺 (如圖 1.12-4)。經量測 NO.4 胎痕與跑道中心線相關位置，其與跑道中心線之夾角約為 4 度偏左 (如圖 1.12-5)。
