飛航事故調查報告

ASC-AOR-12-05-001

立榮航空公司執行 BR 806 班機任務

於桃園機場落地時偏離跑道

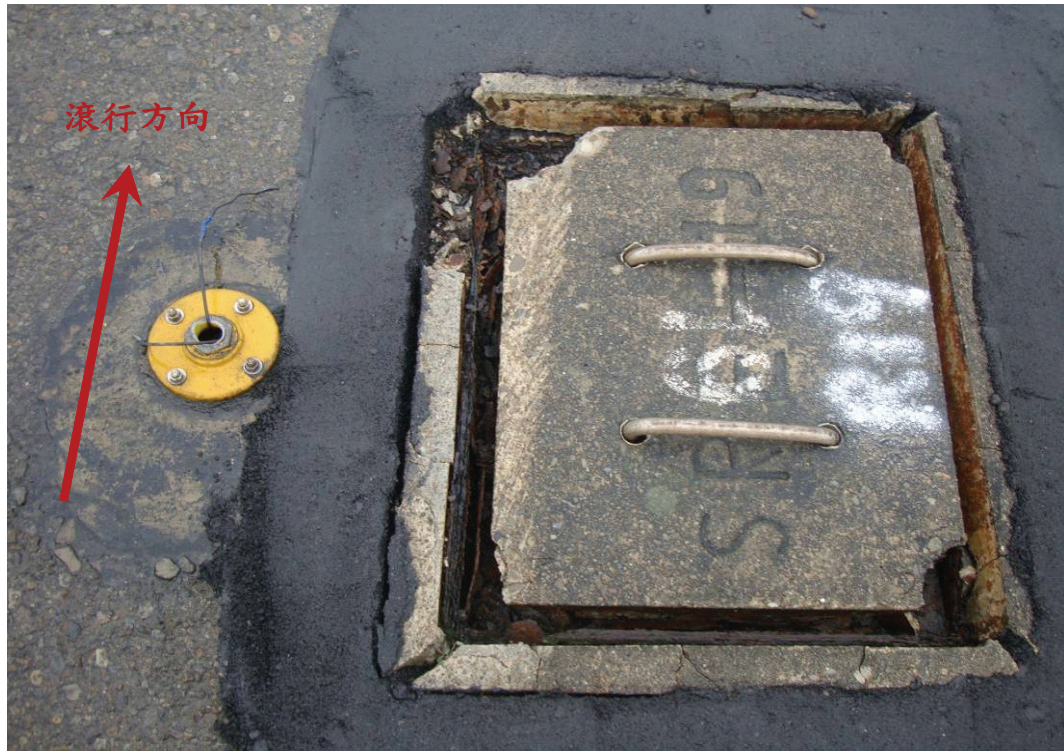
地面檢查後發現，航機起落架擋水板變形，1、2、3、4 號主輪刮傷，2 號發動機外部及進氣導片有損傷痕跡，06 跑道右側 4 具跑道邊燈損壞。

圖 1.12-1 損壞之跑道邊燈 (編號 R19)

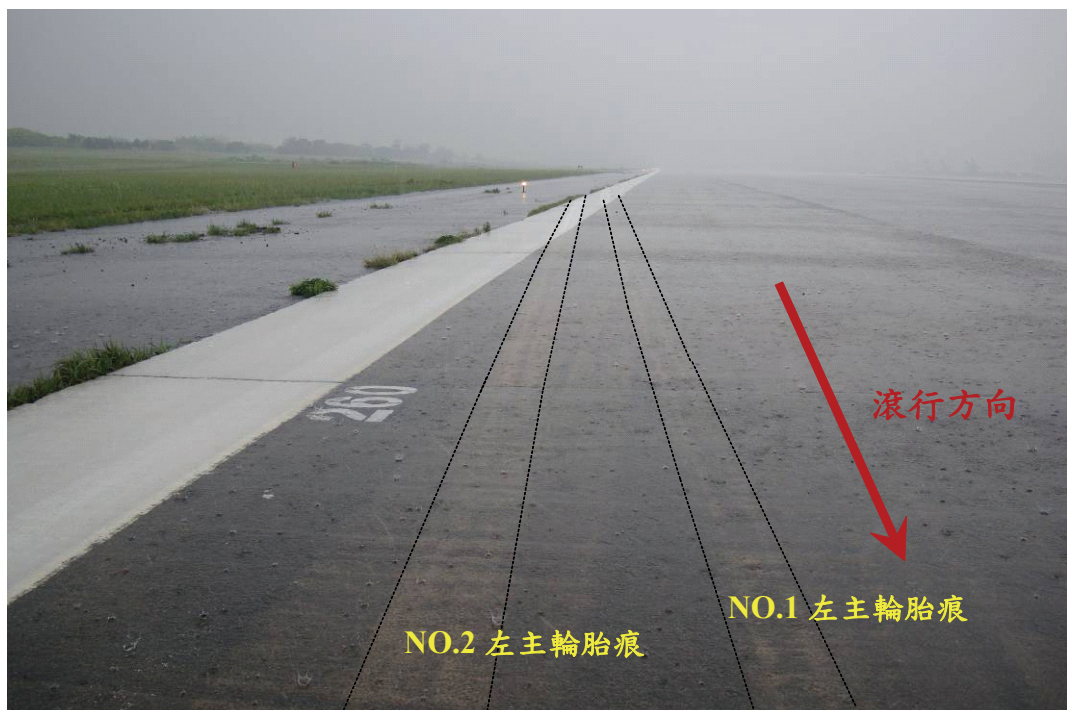
圖 1.12-2 左主輪重返跑道之胎痕 (距 06 跑道頭約 4,850 呎)

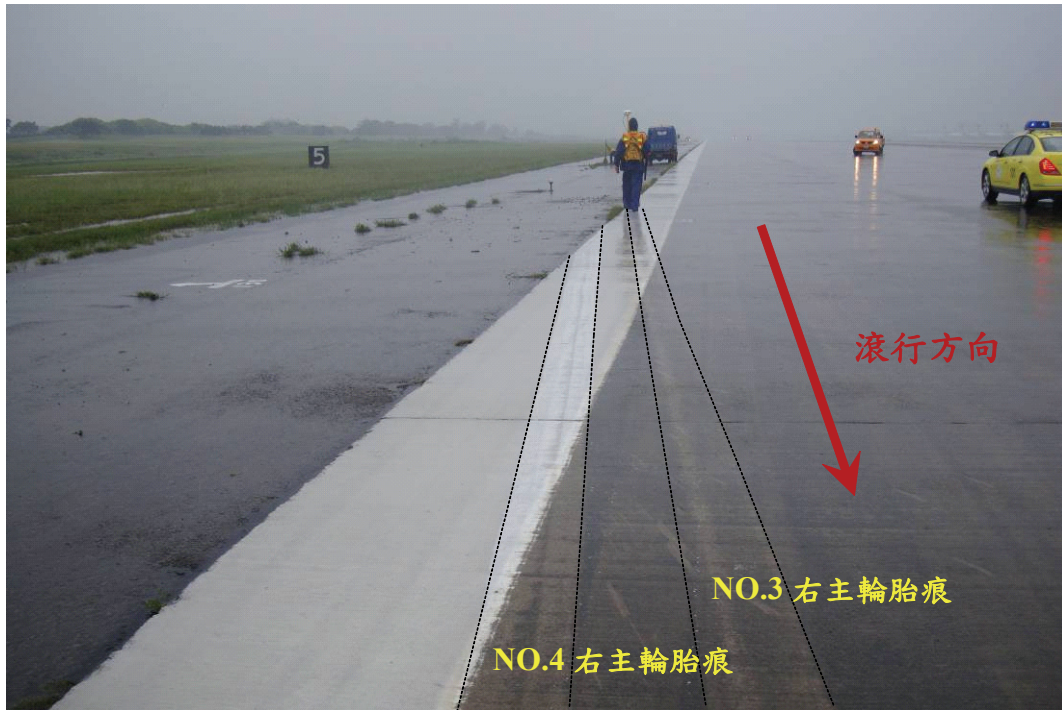
圖 1.12-3 右主輪重返跑道之胎痕 (距 06 跑道頭約 5,100 呎)

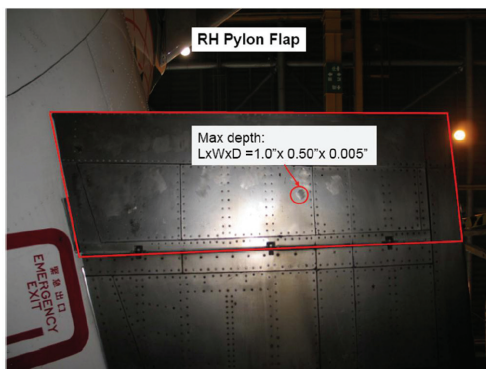
機身外部受外物撞擊損害情形詳圖 1.12-6，1.12-7。

圖 1.12-6 外物撞擊損害 (1)

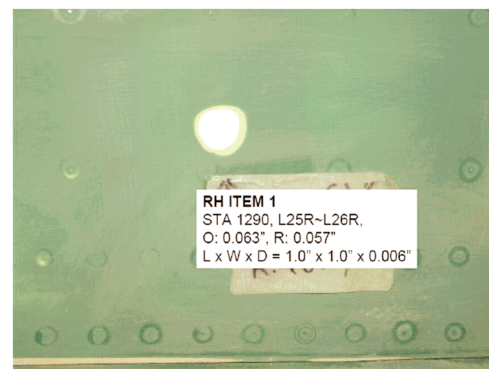
圖 1.12-7 外物撞擊損害 (2)

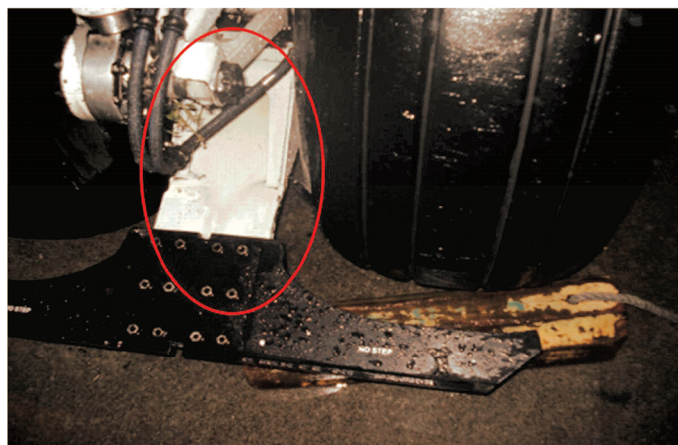
右側起落架擋水板變形，詳圖 1.12-8

圖 1.12-8 右側起落架擋水板變形

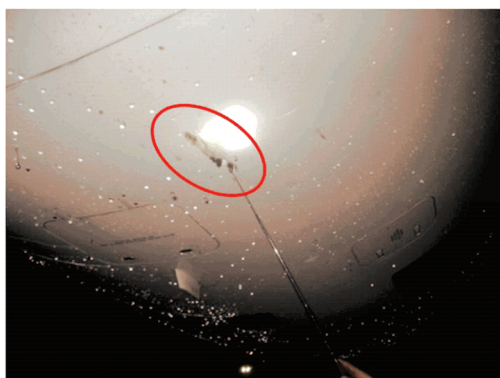
右側發動機外部整流罩受外物撞擊，詳圖 1.12-9，1.12-10。

圖 1.12-9 外物撞擊痕跡

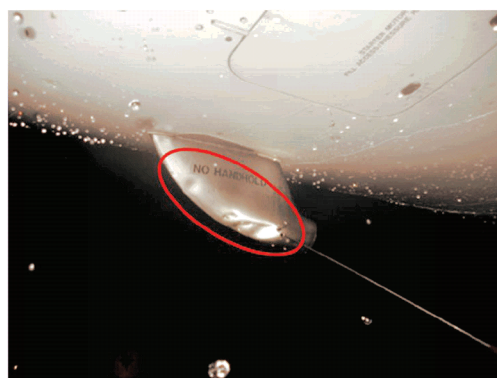
圖 1.12-10 外物撞擊凹痕

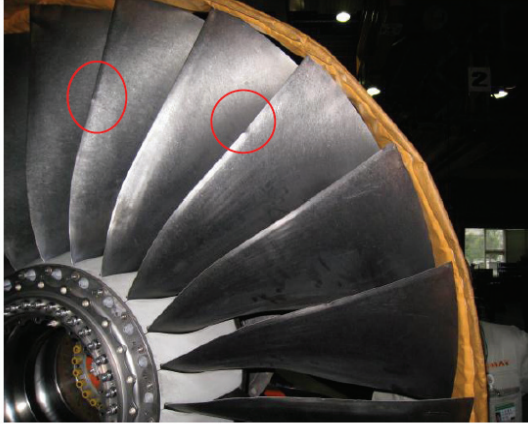
部分風扇葉片前緣有外物撞擊損害，詳圖 1.12-11 至 1.12-14。

圖 1.12-11 葉片前緣凹陷

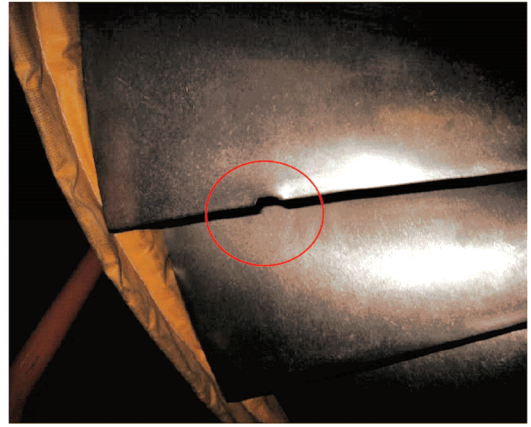
圖 1.12-12 葉片前緣凹陷

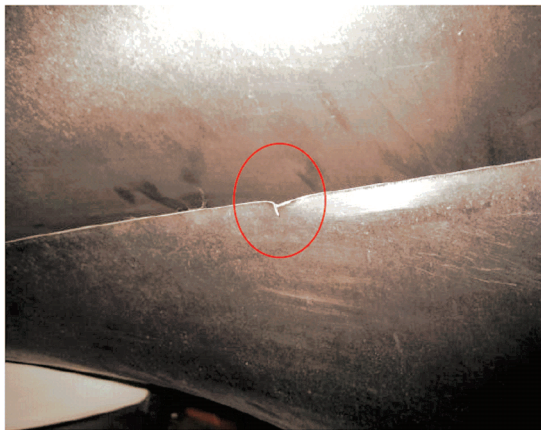
圖 1.12-13 葉片前緣裂紋

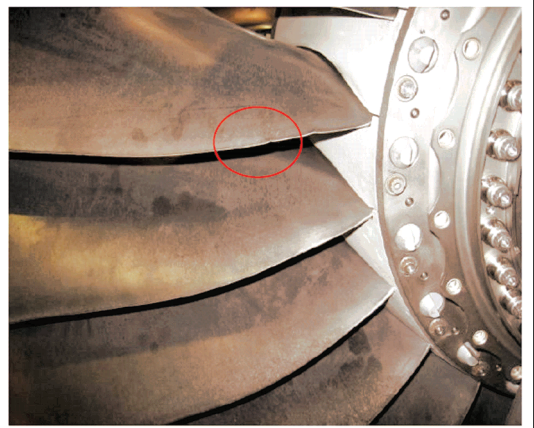
圖 1.12-14 葉片前緣曲折變形

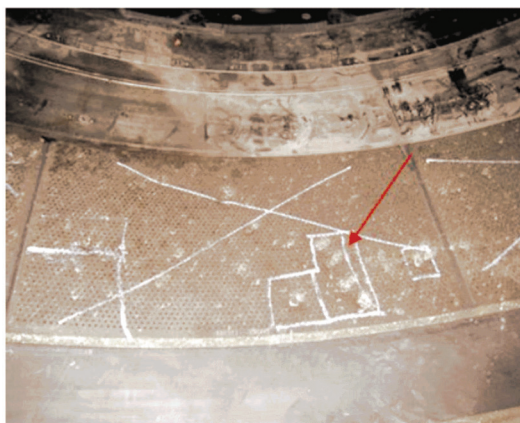
所有（12 片）隔音板皆受外物撞擊損害，詳圖 1.12-15 至 1.12-20。

圖 1.12-15 隔音板損害情形 (1)

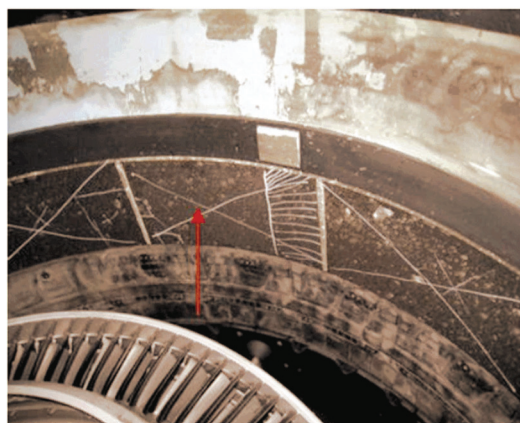
圖 1.12-16 隔音板損害情形 (2)

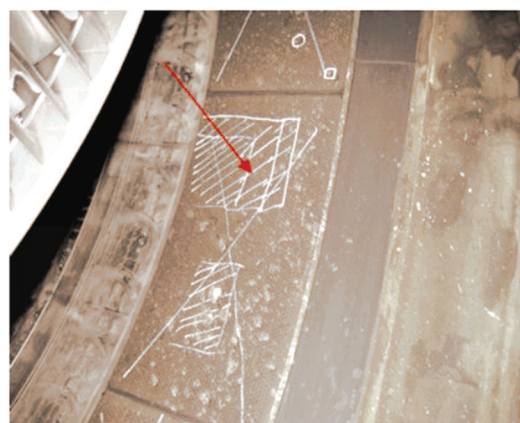
圖 1.12-19 隔音板損害情形 (5)

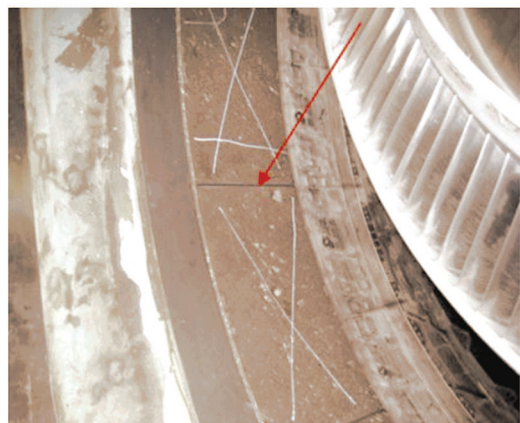
圖 1.12-20 隔音板損害情形 (6)

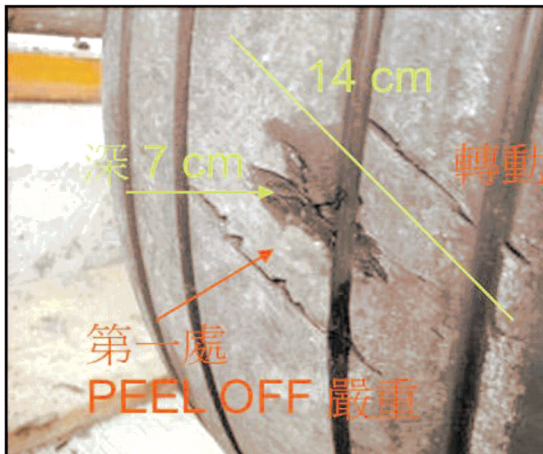
輪胎號碼	序號	胎紋溝深	損害情形
1	SEP96-0434	7 mm	側邊胎皮嚴重剝落一處,胎面刮痕嚴重,深度及寬度超限兩處,輪轂外觀無損傷。(詳圖 1.12-21)
2	MAR98-0872	8 mm	輪胎正面嚴重刮痕一處,輪胎側面大面積刮痕二處,輪轂外觀輕微刮痕。(詳圖 1.12-22)
3	JAN97-0519	5 mm	輪胎側面刮痕一處,輪轂外觀無損傷。(詳圖 1.12-23)
4	JUN98-0960	8 mm	側邊胎皮嚴重剝落兩處,輪轂外觀無損傷。(詳圖 1.12-24)

圖 1.12-21 側邊胎皮剝落

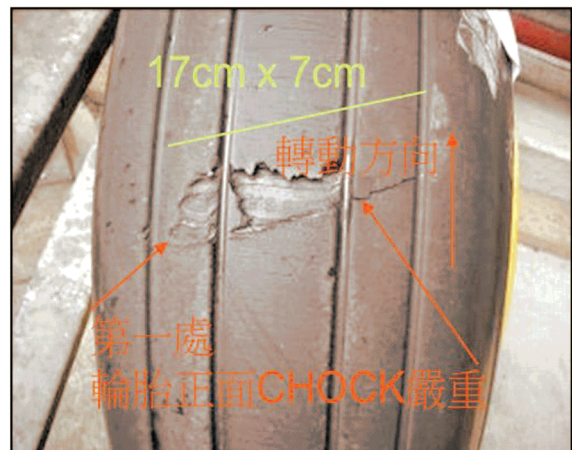
圖 1.12-22 輪胎正面刮痕

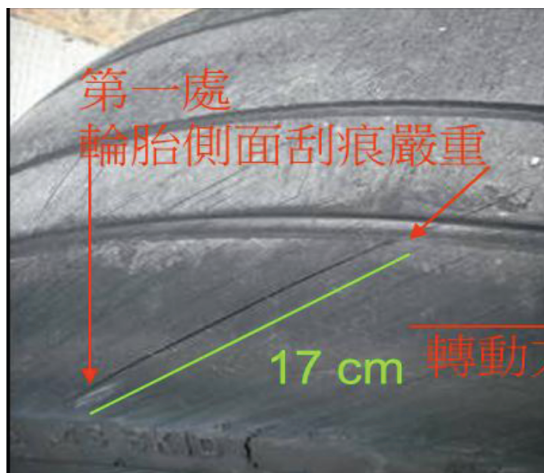
圖 1.12-23 輪胎側面刮痕

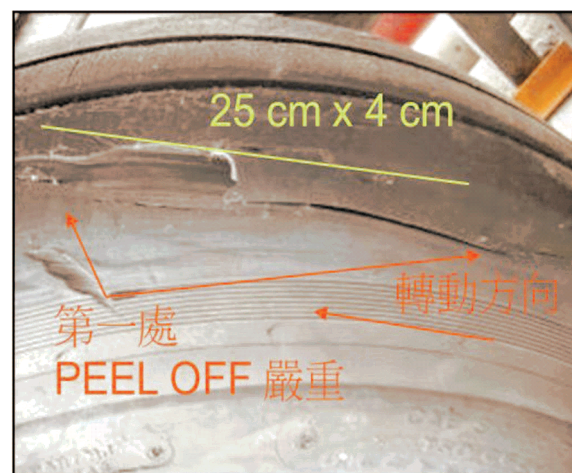
圖 1.12-24 側邊胎皮剝落

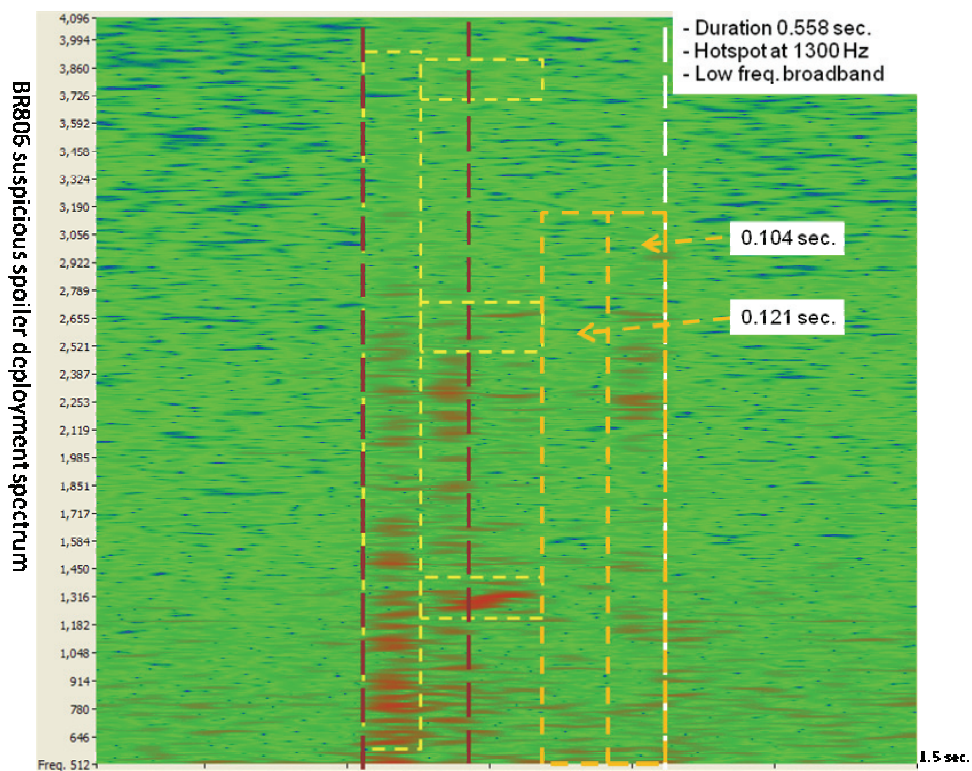
5. 前述事故航機落地時之不明聲響寬頻音，熱點多集中在 2,600Hz 以下之頻帶。
6. 地面測試中，藉由推動油門造成減速板手柄自動收回之頻譜特徵音頻特性為：作動時間持續 0.31 秒，由 0.122 秒之寬頻音開始至另一 0.122 秒之寬頻音結束，兩段寬頻音 0.066 秒間，並無任何特徵音頻出現（圖 1.16-10）。

圖 1.16-9 BR806 落地時不明聲響之頻譜
