行政院飛航安全委員會

事實資料報告

立榮航空公司 B7 642 班機

於台南機場降落於未經指定之跑道

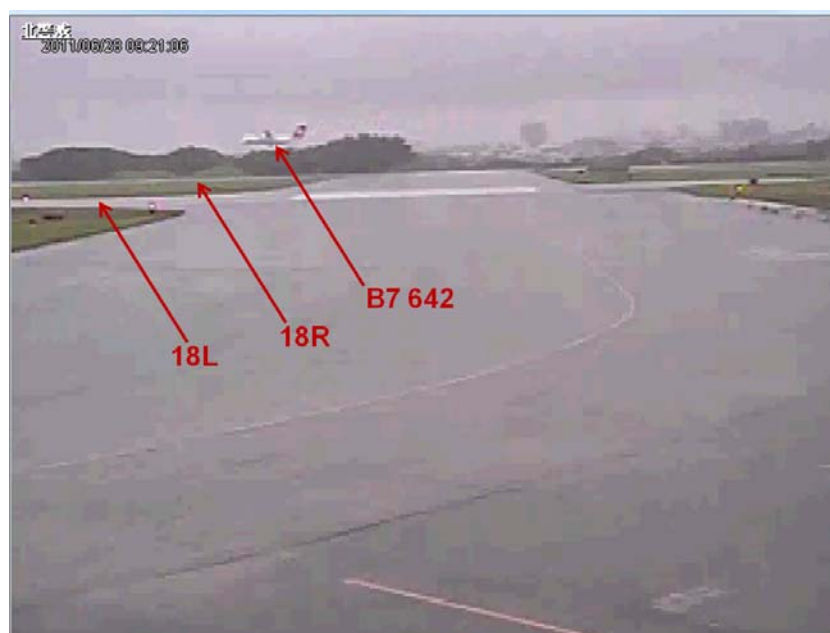
圖 1.10-8 臺南機場北警戒處監視器紀錄圖

依空軍提供之北警戒、地面雷達、南警戒等 3 處機場監視紀錄，其位置及監視紀錄詳圖 1.10-1，圖 1.10-8，圖 1.10-9，圖 1.10-10，顯示該機落地期間 18L 及 18R 跑道邊燈開閉狀況。

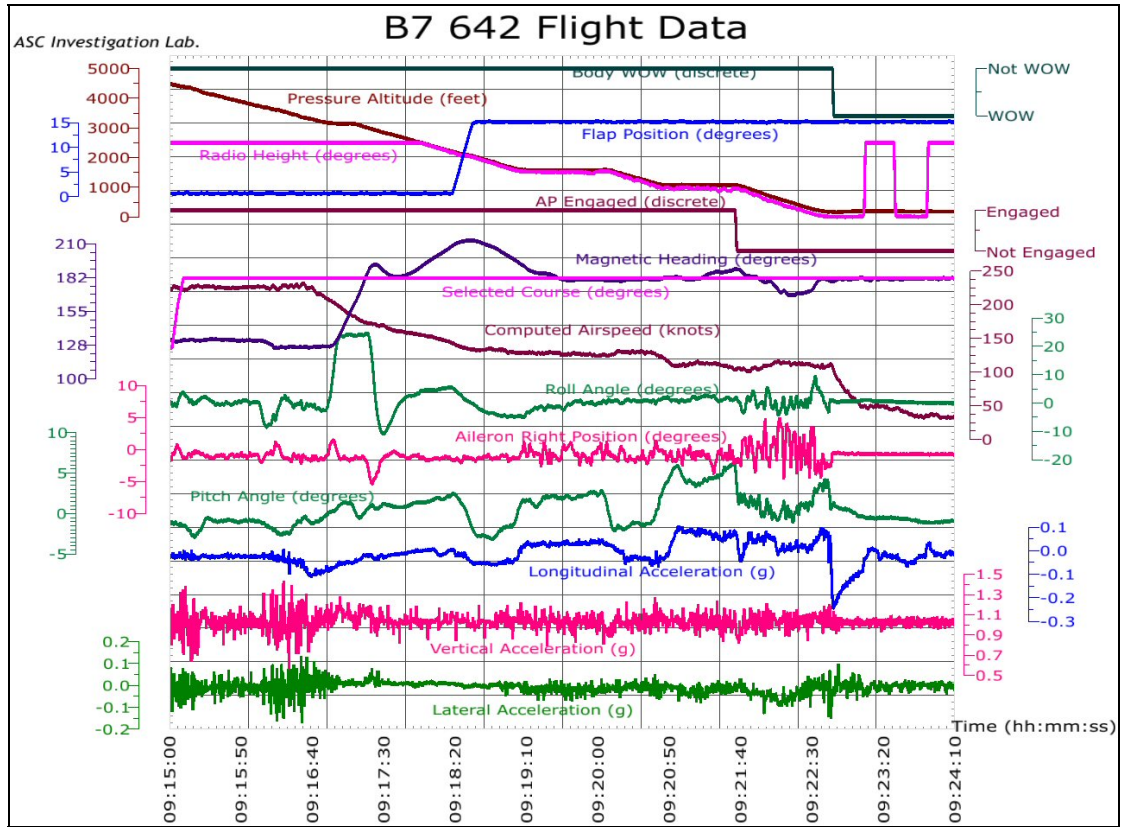
圖 1.11-1 事故班機部份飛航參數 (0915:00 時至 0924:10 時)

事故航班 FDR 解讀結果, 資料下載正常, 其法定必要參數記錄值正常, 部份參數解讀結果詳圖 1.11-1。檢視該具 FDR 記錄之飛航資料, 自 FDR 記錄之第一筆資料至事故前五航班間, 副翼參數記錄值異常, 詳圖 1.11-2。

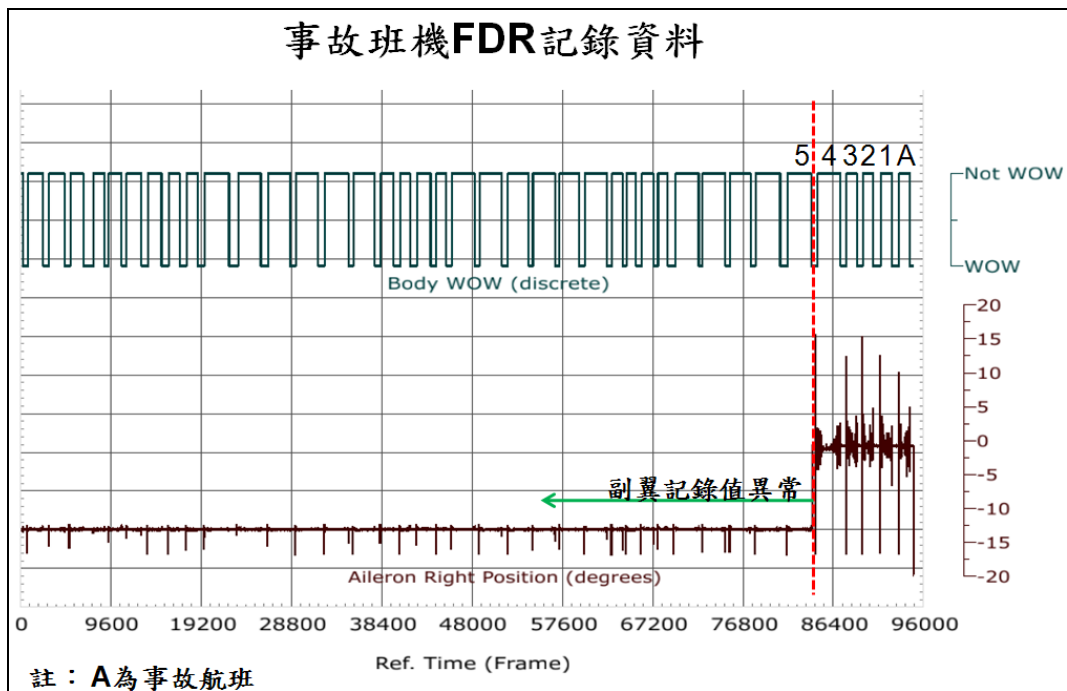
圖 1.11-2 事故班機 FDR 副翼參數與航機起降紀錄

經檢視立榮飛航操作品質保證系統 (簡稱 FOQA) 歷史資料, 該機於民國 100 年 6 月 15 日執行 B7 637 航班任務, 自該任務至事故前五航班間, 副翼參數記錄值異常; 但檢視該機近三年 FDR 年度檢查報告及 FDR 原始資料 (民國 97 年 10 月 24 日、民國 98 年 9 月 16 日及民國 99 年 9 月 17 日), 副翼參數記錄值皆正常。

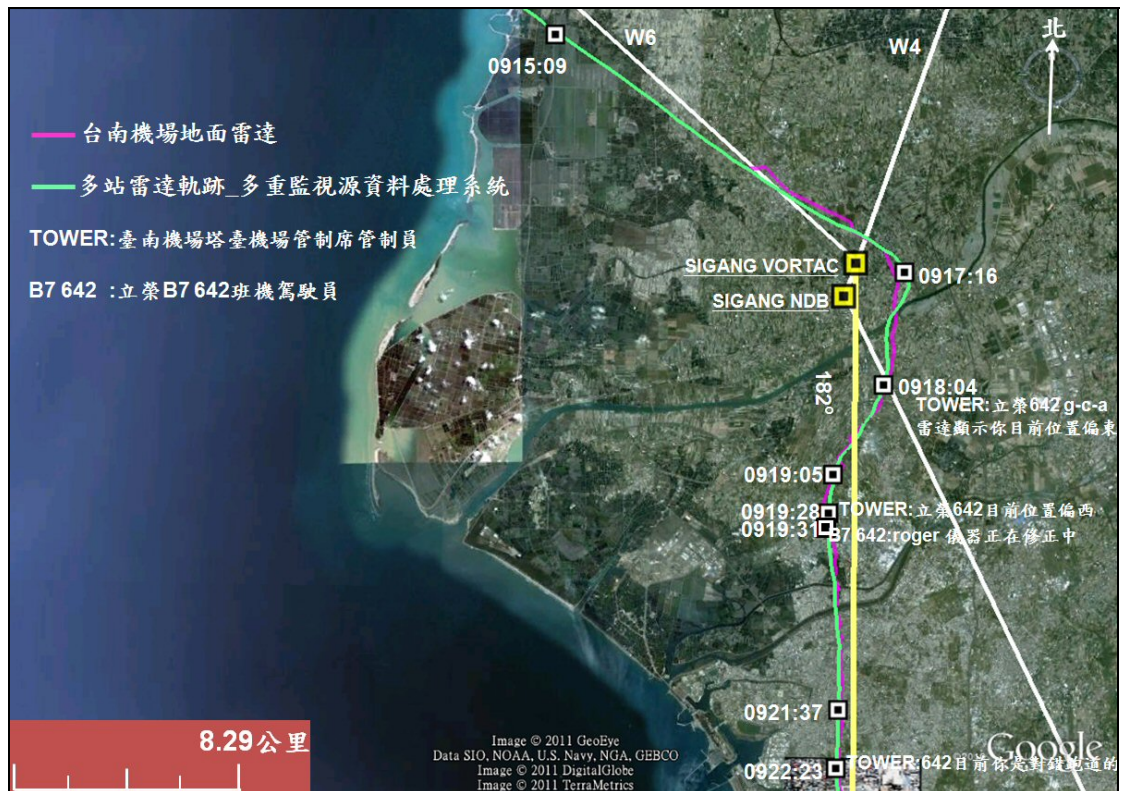
圖 1.11-3 雷達軌跡與臺南塔臺錄音部份抄件

此外，本會取得民航局飛航服總臺提供之多重監視源資料處理系統 (Multi Surveillance Tracking System, MSTS) 記錄之多站雷達軌跡及軍方臺南機場地面雷達軌跡，MSTS 之 UTC 時間經轉換至臺北時間後，加 1.5 秒即與臺南塔臺時間同步；地面雷達時間加 4 秒即與臺南塔臺時間同步。整合雷達軌跡與臺南塔臺錄音部份抄件，詳圖 1.11-3。

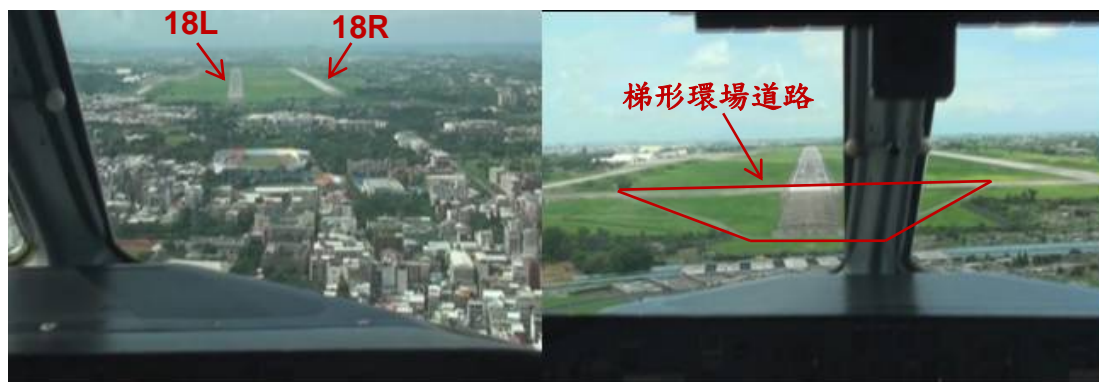
圖 1.16-2 18 跑道地標

- 第二航次B7 646班機通過西港導航臺上空時，指針失效但距離仍指示0.2浬，指針恢復後之距離指示1.7浬，全程距離指示無失效情形。
- 於目視對正跑道情況下，CDI指示無偏移不穩情形。
- 第二航次，距西港導航臺10浬/時，速度由180漸調整至160浬/時。距西港導航臺5浬/時，到達3,000呎，通過182度邊，並開始右轉，通過西港導航臺上空時攔上182度邊。
- 於西港導航臺上空高度3,000呎可目視跑道，比較18L與18R道面情況，18R道面較明亮，18L道面較黑暗。(如圖1.16-1)
- 越過西港導航臺8.5浬（距跑道頭約2浬），航機高度400呎，飛越一運動場，為一可目視之地標。距西港導航臺9.5浬、高度100呎時，進入清除區，跑道頭有一狀似梯形之環場道路。(如圖1.16-2)
- 有關事故航班及上述機上觀察航班之飛航軌跡資料如附錄5。
