# 飛航安全調查委員會

### 事實資料報告

復興航空公司 GE515 班機

報告編號：ASC-AFR-12-09-001

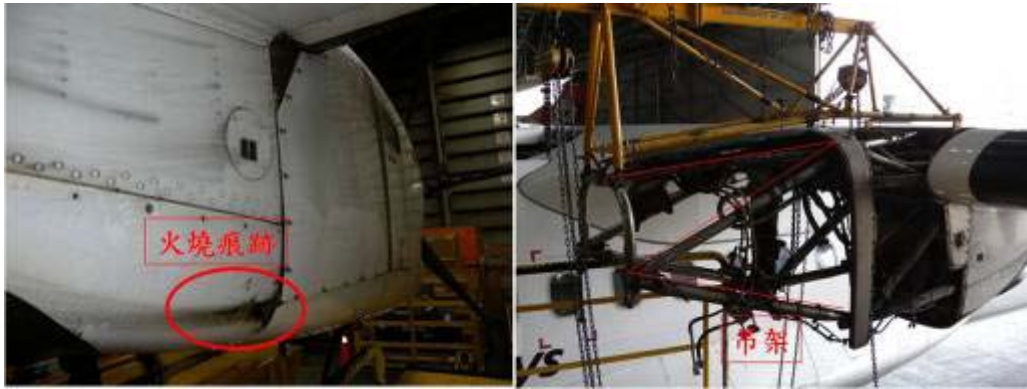
- 機翼下箱型結構整流罩飛行火燒痕跡及吊架遭受熱損

圖 1.14-1 機翼下箱型結構整流罩火燒痕跡及吊架遭受熱損

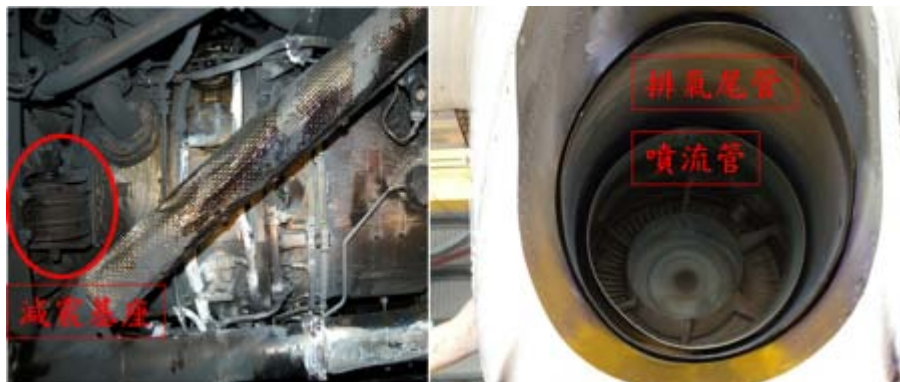
- 發動機減震基座、排氣尾管及噴流管遭受熱損

圖 1.14-2 發動機減震基座、排氣尾管及噴流管遭受熱損

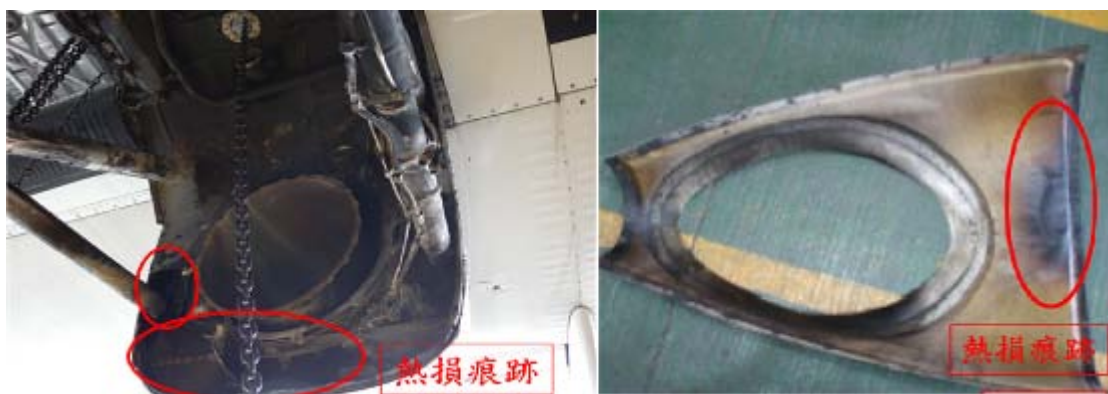
- 機翼下箱型結構、整流罩遭受熱損

圖 1.14-3 機翼下箱型結構、整流罩遭受熱損

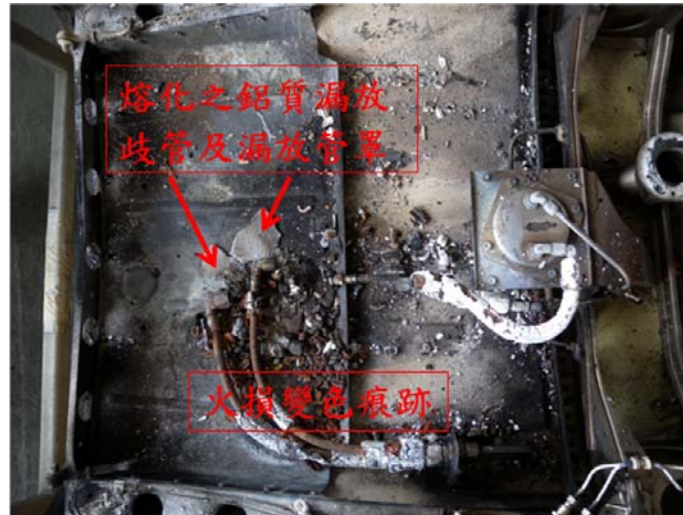
- 進氣口後段底部整流罩結構遭受火損

圖 1.14-4 進氣口後段底部整流罩結構火損

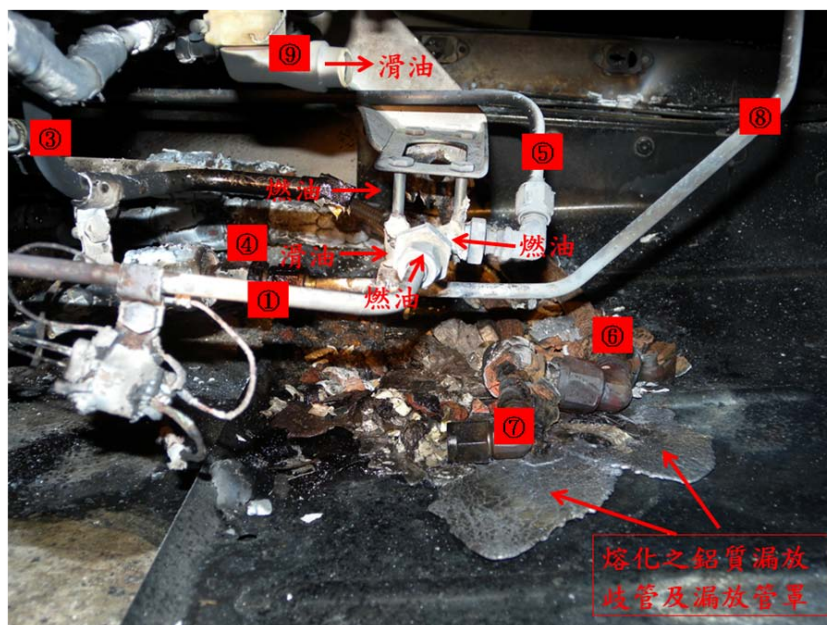
事故發生後，專案調查小組於民國 101 年 5 月 3 日至復興棚廠勘驗發生火災之 1 號發動機，發現鋁質漏放歧管 (draining manifold) 已熔化崩塌，與其相連接之 4 根燃油/滑油排放管 (如圖 1.14-5 標號①、③、④、⑤) 自與漏放歧管接合處脫開，2 根燃油/滑油出口管 (如圖 1.14-5 標號⑥、⑦) 自與漏放歧管接合處掉落於進氣口底部後整流罩上。

圖 1.14-5 發動機漏放歧管火損狀況

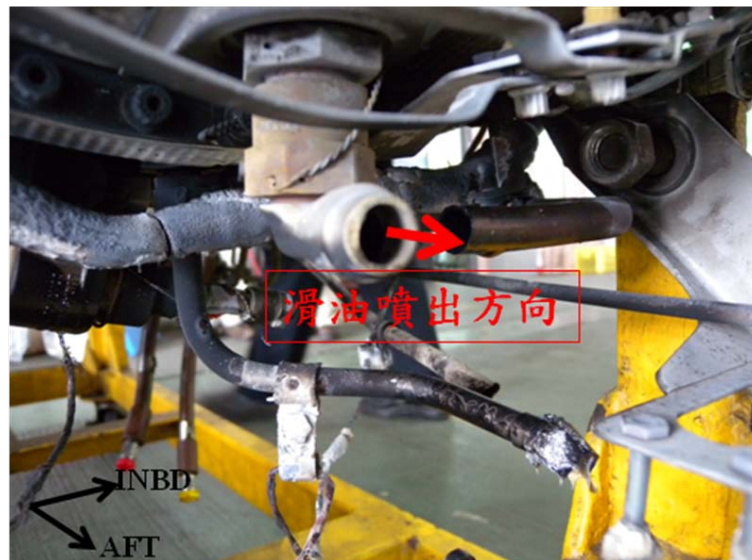
1 號發動機 6,7 號軸承滑油回油管自管件接頭處斷裂，管件斷裂口由原朝發動機右側方向轉為向後方向（詳圖 1.14-7）。

圖 1.14-7 6,7 號軸承滑油回油管斷裂口

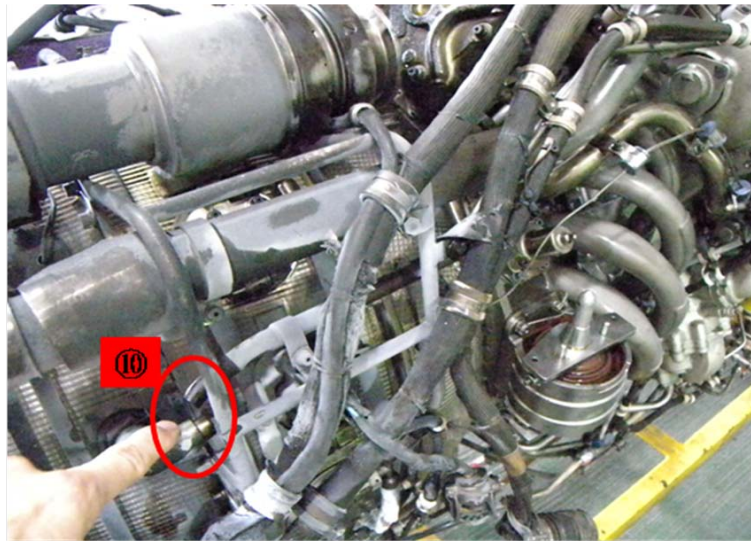
如圖 1.14-8 所示，圖中標號⑩為 1 號發動機 6,7 號軸承通氣管，位於發動機右側，自管路接頭處斷裂，且管件斷裂口前方之機匣及管

圖 1.14-8 6,7 號軸承通氣管斷裂

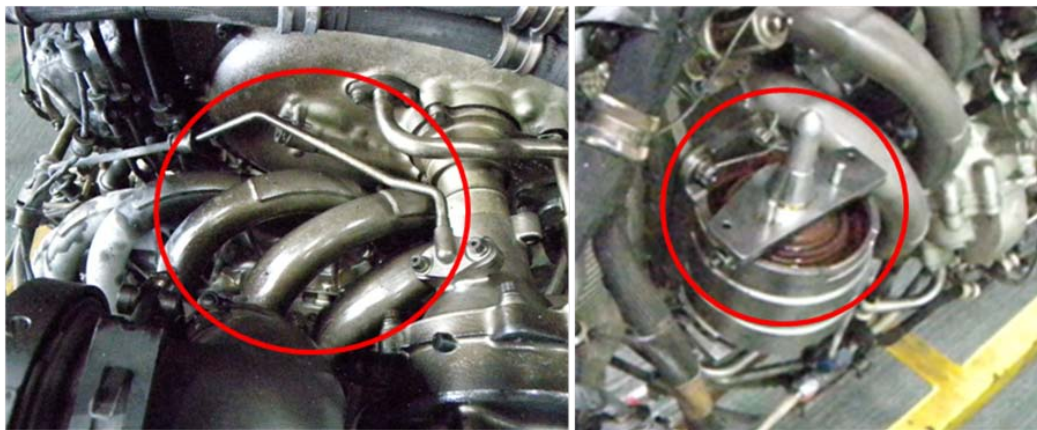
路表面發現有滑油散佈跡象（詳圖 1.14-9）。

圖 1.14-9 滑油散佈痕跡

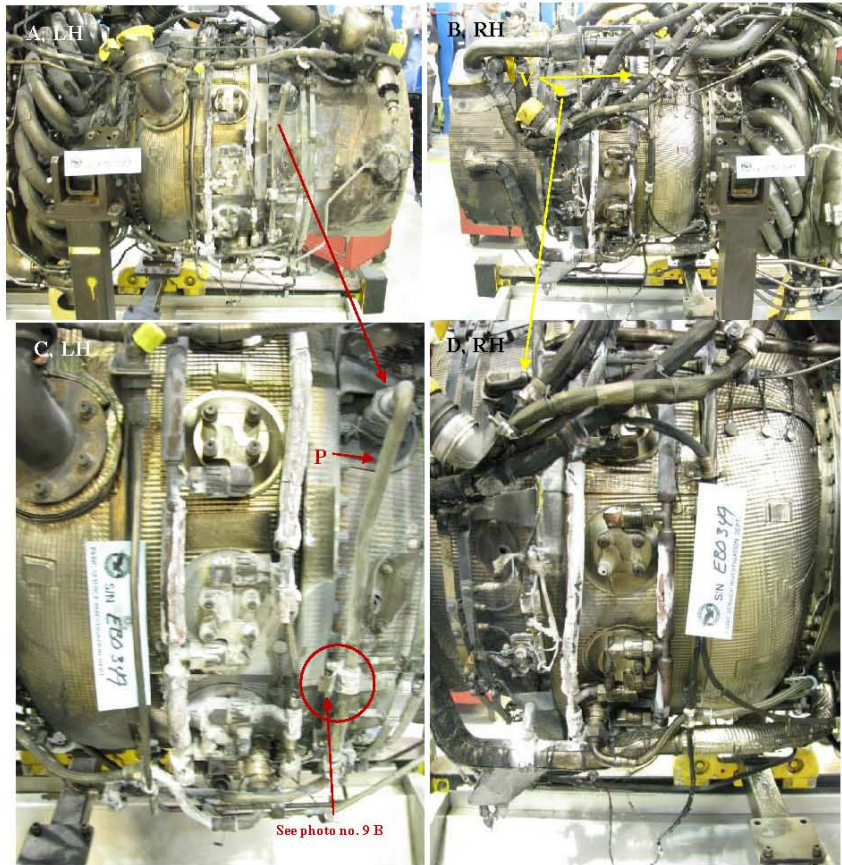
Photo no's 3 A to D

- 2.2 Visual inspection of the engine externals located from the rear inlet case (RIC) to the exhaust duct revealed that the primary and secondary fuel manifold hoses, the inter-turbine temperature (ITT or T6) thermocouples and bus-bars insulation, the engine electrical wiring and harnesses, insulation blankets of the gas generator case (GGC) and turbine support case (TSC), fuel manifold adapters and flow divider/dump valve unit, air/oil delivery lines, ignition cables, bleed valve and LP exit ducts displayed areas of wetness, varnishing stains, a film of whitish dust and soot deposits. Various extents of fire damages such as heat-discoloration and degradation and oxidation to the engine externals from being exposed to elevated temperatures, were noted. Refer to photo no's 3 A to D, 4 and 5.

Left (LH) and right (RH) hand views of the TM rear section showing the damaged externals.

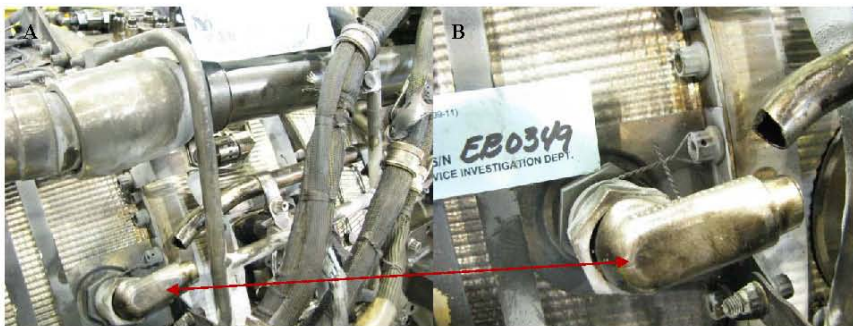
Photo no's 6 A &amp; B

- 2.3 The vent and scavenge oil tube assemblies individually attached to the transfer-tubes of the No. 6 & 7 bearings housing were noted to be fractured (photo no's 6 A & B). Some of the 90° holding brackets of the vent (photo no. 7 A) and scavenge tube assemblies were found fractured at the bracket creasing area. The fracturing of the vent and scavenge tubes was along the edge of the brazed weld of the tube and ferrule fitting (photo no's 8 A to D). The oil pressure-tube assembly attached to the transfer-tube of the No. 6 & 7 bearings housing was intact (photo no's 3 C and 9 A) but a holding bracket of the tube was fractured (photo no. 9 B). The vent, scavenge and pressure oil transfer-tubes were tightly attached to their respective ferrule fitting "B" nuts of the tube assemblies and to the No. 6 & 7 bearings housing. The vent, scavenge and pressure oil transfer-tubes of the No. 6 & 7 bearings housing were not fractured (photo no. 10). The fractured vent and scavenge tubes with the holding brackets were taken to the P&WC Materials Investigation Laboratory for further analysis.

View of the fractured vent tube assembly in-situ.

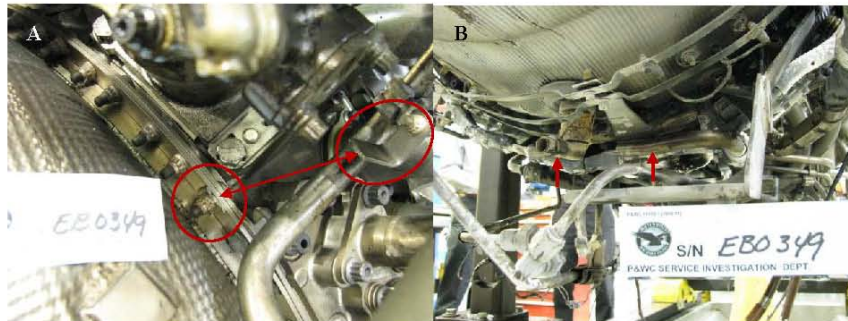
Photo no. 7 A  
View of the fractured bracket of  
the vent tube assembly.

Photo no. 7 B  
View of the fractured scavenge-tube  
assembly (arrows) in-situ.

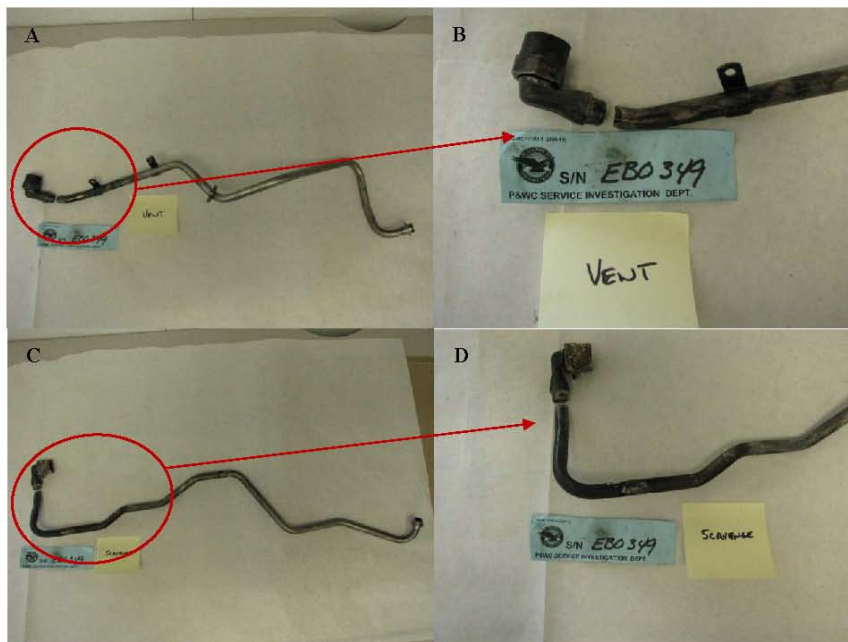
Photo no's 8 A to D  
View of the fractured vent and scavenge tube assemblies after removal.

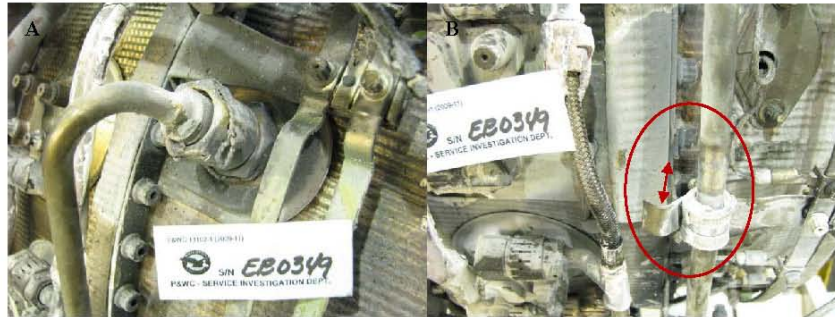
Photo no's 9 A & B  
Views of the tight-secured "B" nut (9 A) and fractured bracket (9 B) of the pressure tube assembly.

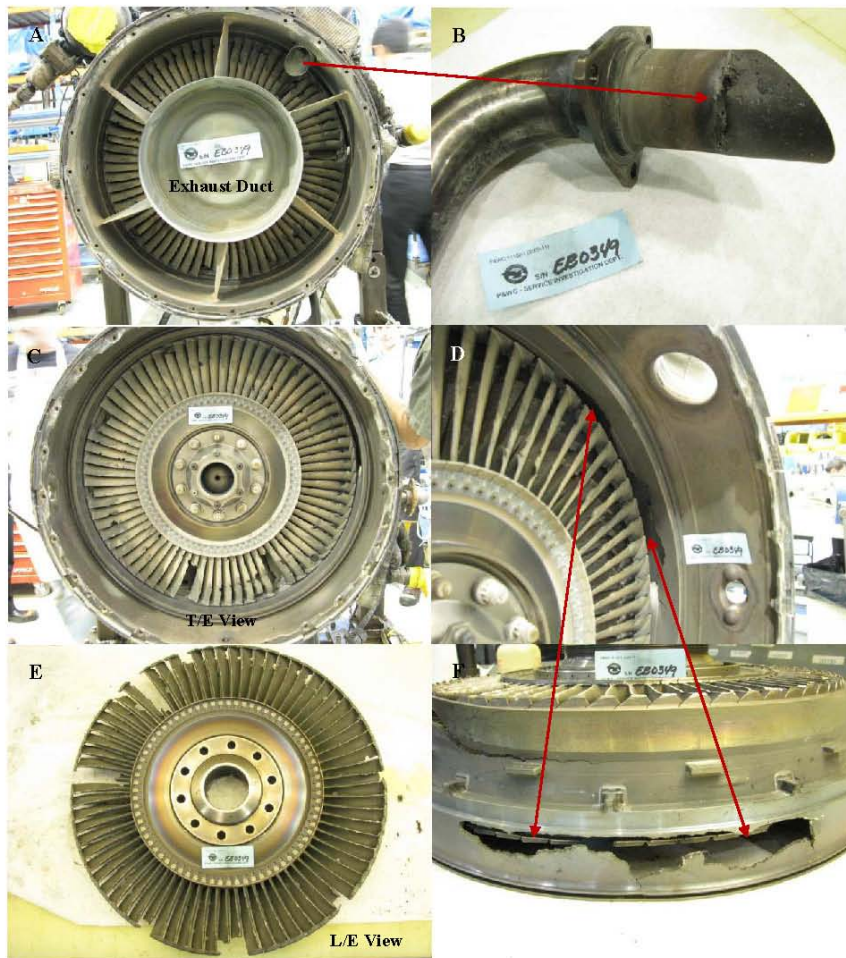
Photo no's 11 A to F

- 2.4 The engine disassembly showed the accessory gearbox (AGB) breather tube assembly at the exhaust duct adjacent to the PT 2 blades was gouged and punctured from debris impacts (photo no's 11 A & B, arrow). The airfoils of the PT2 blades (photo no's 11 A, C & E) and stator vanes showed various extents of fracturing and battering damages from debris impacts. The outer shroud integral to the PT2 stator assembly, located radial to the PT2 blades, was fractured and battered by debris impacts (photo no's 11 D & F, double head arrows).

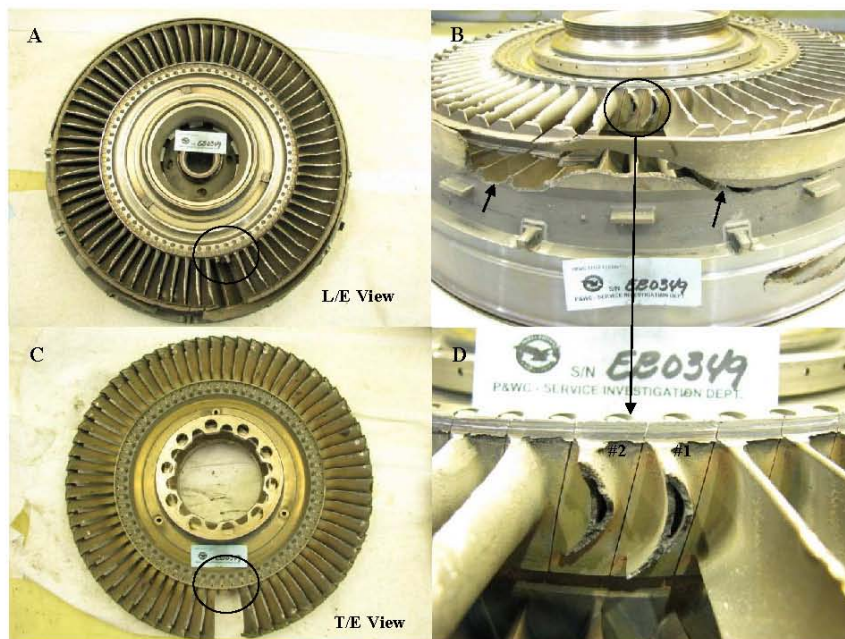
- 2.5 Two consecutive PT1 blades were fractured through the airfoil at the lightening hole, approximately 0.280 inches above and near the platform(photo no's 12 A to D). The airfoil fracture surface of one of the two fractured blades displayed two distinct features and likely being the primary. This blade was numbered as # 1 (photo no. 12 D) for the investigation purpose. The fracture surface of the adjacent fractured PT1 blade numbered #2 showed overload feature. The airfoil of the other PT1

blades showed impact damages. The two fractured PT1 blades identified as #1 & #2 with an airfoil fragment were taken to the P&WC Materials Investigation Laboratory for further analysis. These PT1 blades were Post Service Bulletin No. 21419 configuration.

Photo no's 12 A to D  
Views of two fractured PT1 blades & PT2 stator.

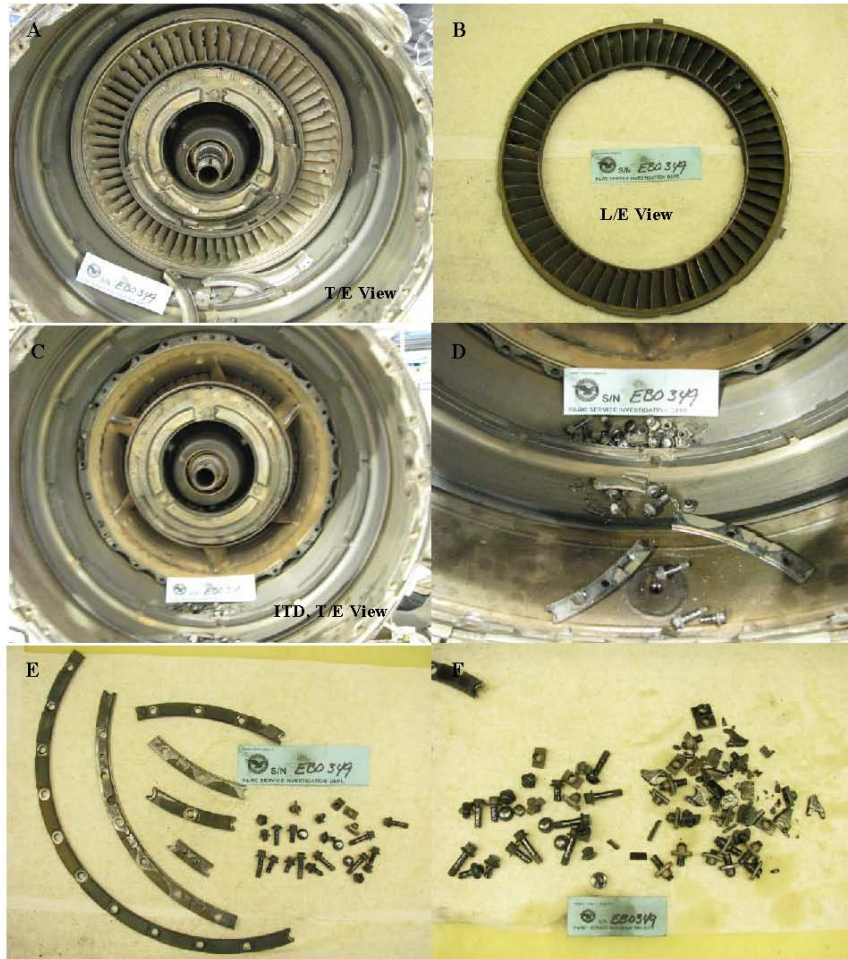
Photo no's 13 A to F

- 2.6 The PT1 stator assembly and baffle were in place (photo no. 13A). The trailing edge (T/E) of several vanes and outer shroud of the PT1 stator showed impact denting and gouging damages. The interstage turbine baffle of the PT1 stator was battered and fractured (photo no. 13 A). The vane leading edges (L/E) were intact (photo no. 13 B). The anti-rotation lugs at the outer shroud of the PT1 stator assembly were fretted and several of them fractured (photo no. 13 B). The twenty-six (26) retention bolts with the retaining ring that retained the inter-stage turbine duct (ITD) to the LPT housing assembly were fretted, and most of them fractured (photo no's 13 C to F, and 14 A). A section of the bolting flange of the LPT housing assembly showed cracking and fracturing damages (photo no's 14 A & B, parabolic).

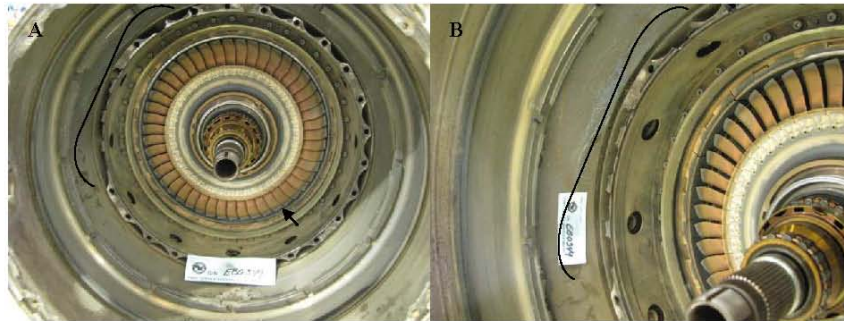
Photo no's 14 A & B  
LPT housing and disc assemblies.

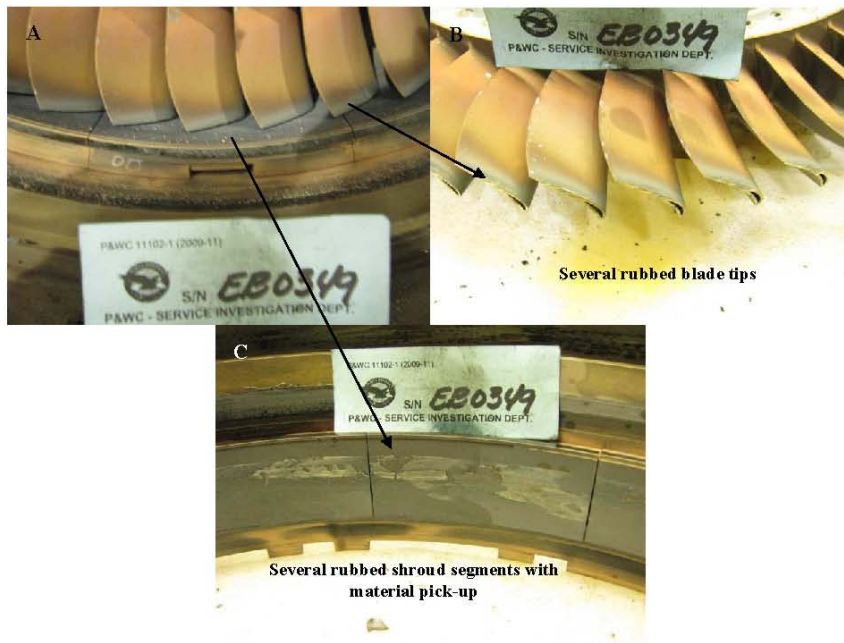
Photo no's 17 A to C

- 2.8 The tip of the low-pressure turbine (LPT) blades had rubbed against several shroud segments (photo no's 14 A, and 17 A to C, arrows). There was no impact damage on the blade L/E's airfoils except for nicking noted at the airfoil T/E's (photo no's 18 A & B). The front and rear faces of the LPT disc did appear intact. The LPT stator vanes were in a satisfactory condition (photo no. 19).

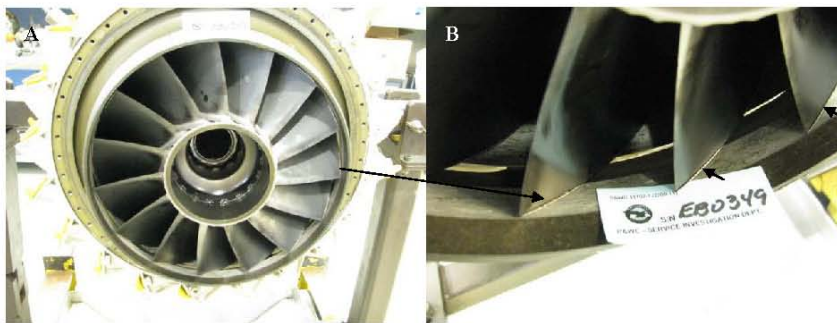
- 2.11 The tip of the LP and HP impeller vanes had rubbed against its respective shroud housing (photo no's 26 & 27, A & B). The back-face of the LP impeller had rubbed against the LP diffuser case front wall (photo no's 28 A to D). The HP impeller back-face was clean (photo no. 29).

View of the rubbing of the LP impeller vane tips and shroud.

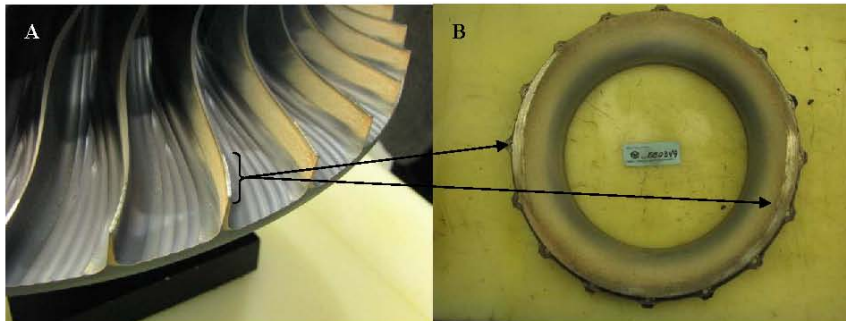
Photo no's 27 A & B  
View of the rubbing of the HP impeller vane tips (exducer) and shroud.

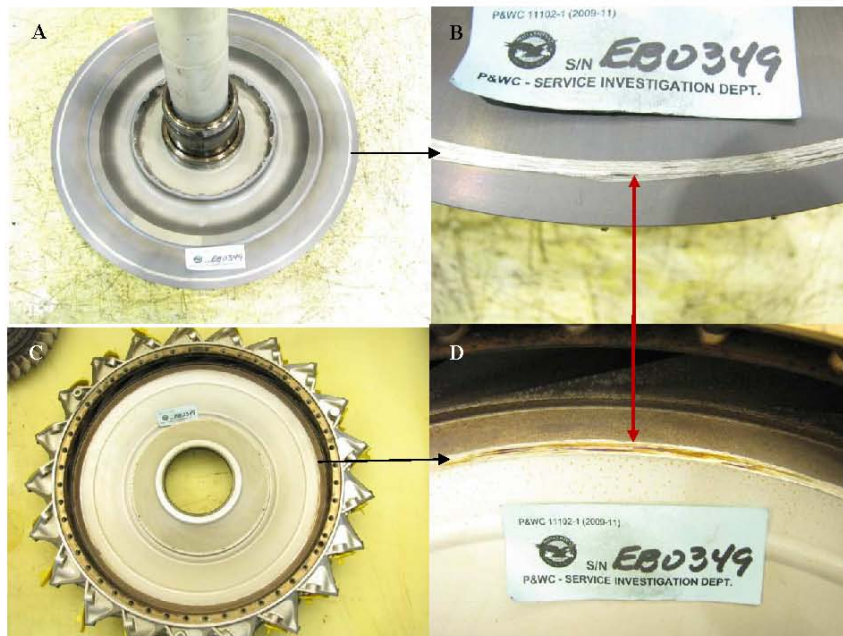
Photo no's 28 A to D  
Views of the rubbing of the LP impeller backface and diffuser case front wall.

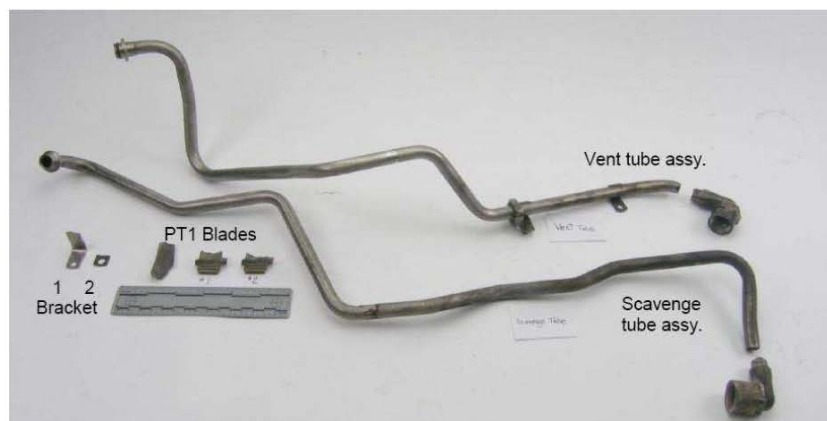
3.1 Photo no. 30 is a general view of the fractured vent and scavenge tube assemblies of the No. 6 & 7 bearings, brackets #1 & #2, PT1 blades #1 & #2 with a blade airfoil fragment in the as received condition.

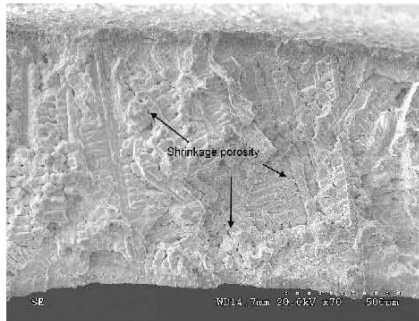
Photo no. 35

- 3.4 SEM image (photo no. 35) of the PT1 blade #1 fracture surface, taken on the convex side, revealed a dendritic solidification pattern with features consistent with shrinkage porosity. SEM image (photo no. 36) of one of the photo no. 34 insert showed shrinkage porosity feature and flat zone (circle).

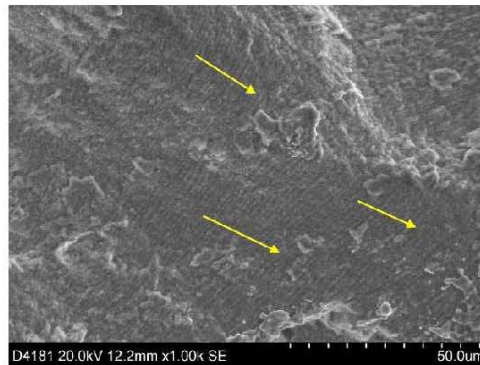
Photo no. 37

- 3.5 The higher magnification (photo no. 37) of the flat zone highlighted in photo no. 36 (circle) shows fatigue striations suggesting that the crack initiated from the shrinkage porosity zone. The yellow arrows indicated the fatigue crack propagation direction.

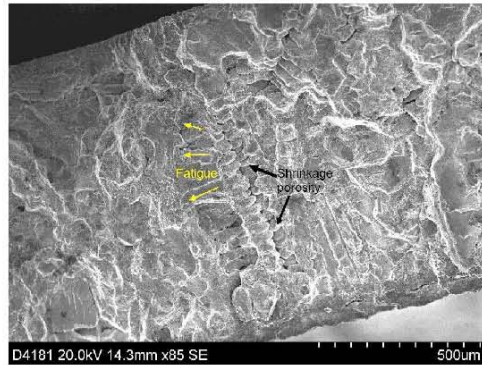
Photo no. 38

- 3.6 SEM image (photo no. 38) of the blade #1 fracture surface at the airfoil pressure side showed also fatigue zone (yellow arrows) emanating from the shrinkage porosity feature.

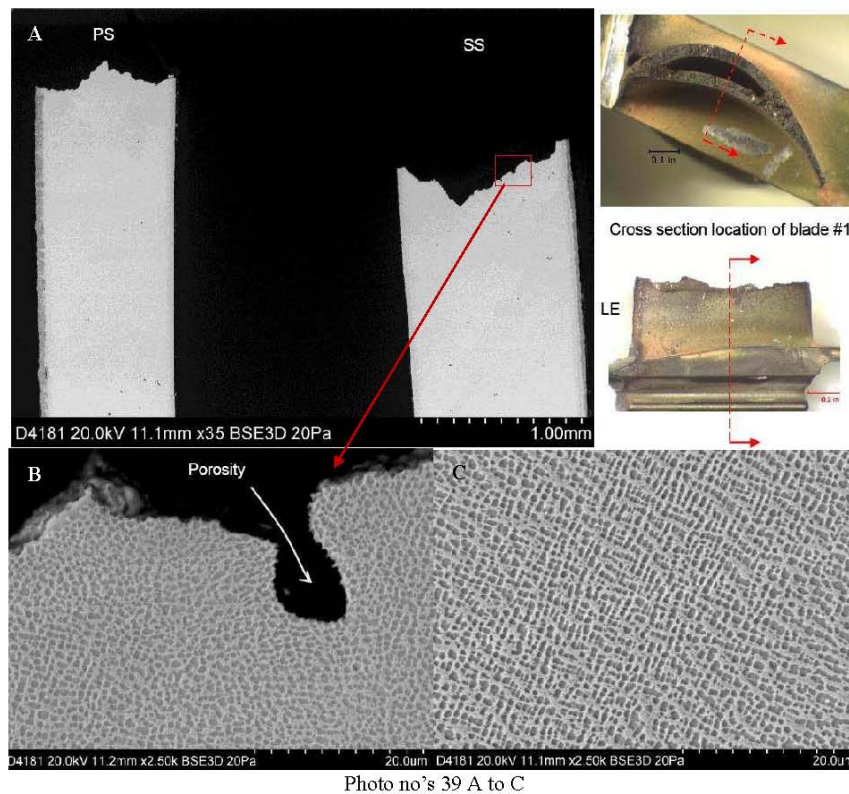
- 3.7 Cross-section through the blade #1 fracture surface (photo no. 39 A) showed feature consistent with shrinkage porosity (photo no. 39 B). No other evidence of metallurgical anomaly beneath the fracture surface was observed. Back Scattered Electron (BSE) image (photo no. 39 B) showed rounded gamma prime ( $\gamma'$ ) precipitates in a gamma matrix that is almost similar to the microstructure observed in the root area (photo no. 39 C) showing typical  $\gamma'$  precipitates. This microstructure is considered representative of unaffected material.

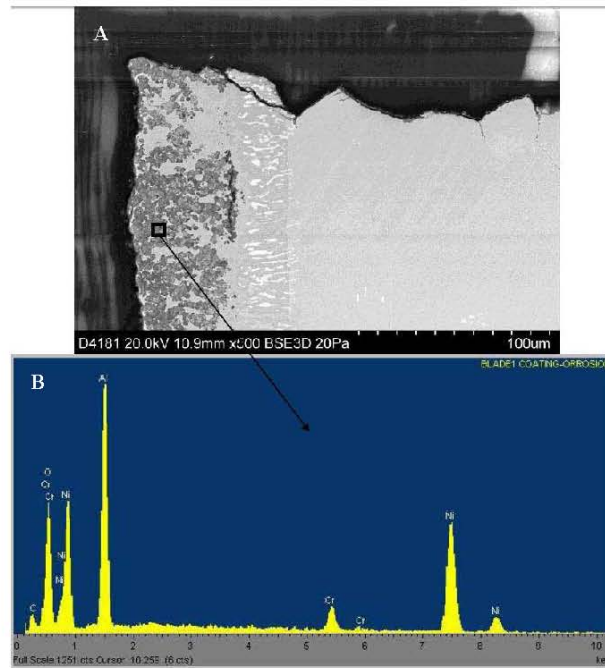
Photo no's 40 A &amp; B

- 3.8 BSE image through the PT1 blade #1 fracture surface showed corrosion in the top layer of the coating (photo no. 40 A). Energy Dispersive Spectroscopy (EDS) spectrum of the corrosion in the top layer of the coating showed oxygen rich element indicative of oxidation (photo no. 40 B). The average coating thickness was 0.0030 inches and met requirements.

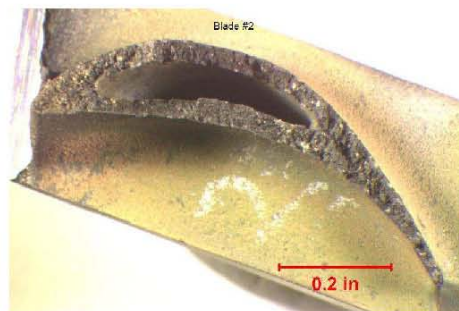
Photo no. 41

- 3.9 Magnified view of the fracture surface of the PT1 blade #2 exhibited a rough dendritic aspect typical of overload (photo no. 41).

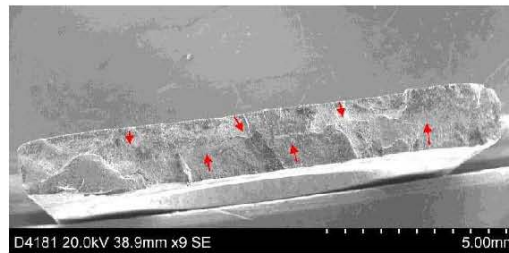
Photo no. 43

- 3.12 SEM image (photo no. 43) of the bracket #2 fracture surface showed a flat zone with river lines typical of fatigue. The red arrows indicate the crack propagation in opposite direction typical of reverse bending fatigue.

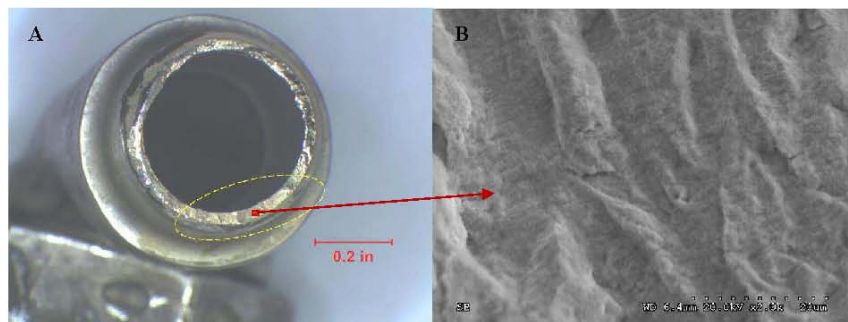
Photo no's 44 A &amp; B

- 3.13 Magnified view (photo no. 44 A) of the fracture surface of the No. 6 & 7 bearing vent tube assembly showed a flat zone with river lines, indicative of fatigue, emanating from the OD of the tube. SEM image (photo no. 44 B) of an area of the vent tube fracture surface displayed fatigue striations.

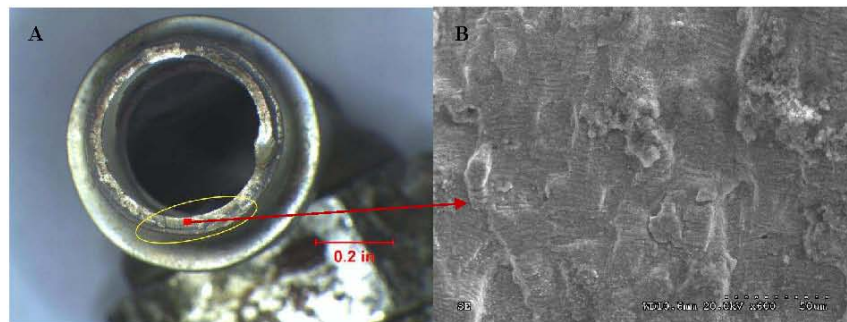
Photo no's 45 A &amp; B

- 3.14 Magnified view (photo no. 45 A) of the fracture surface of the No. 6 & 7 bearings scavenge tube assembly showed a flat zone indicating of a fatigue mechanism. SEM image (photo no. 45 B) of the fracture surface of the scavenge tube confirmed the presence of fatigue striations.
