飛航事故調查報告

ASC-AOR-13-05-001

復興航空公司GE 515班機

於爬升過程中發生左發動機火警

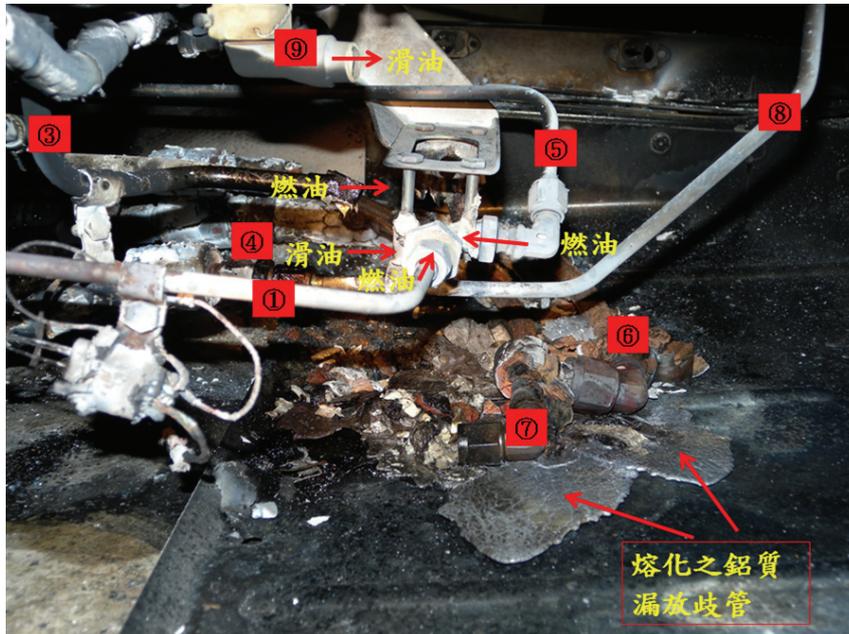
圖 1.14-1 發動機漏放歧管火損狀況

事故發生後，專案調查小組於民國 101 年 5 月 3 日至復興棚廠勘驗發生火災之左發動機，發現鋁質漏放歧管（draining manifold）已熔化崩塌，與其相連接之 4 根燃油/滑油排放管（如圖 1.14-1 標號①、③、④、⑤）自與漏放歧管接合處脫

開，2 根燃油/滑油出口管（如圖 1.14-1 標號⑥、⑦）自與漏放歧管接合處掉落於進氣口底部後整流罩上。

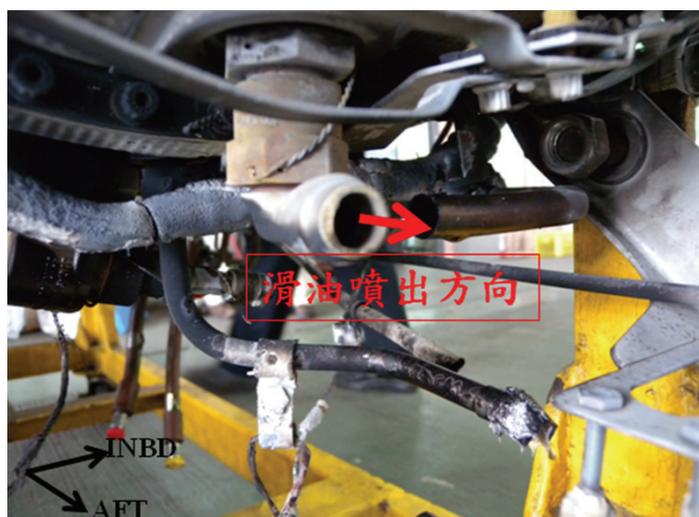
圖 1.14-7 6,7 號軸承滑油回油管斷裂口

左發動機 6,7 號軸承滑油回油管自管件接頭處斷裂，管件斷裂口由原朝發動機右側方向轉為向後方向（詳圖 1.14-7）。

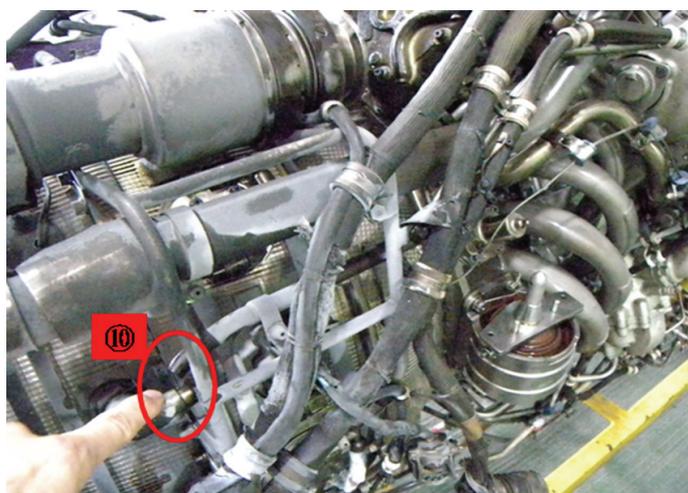
圖 1.14-8 6,7 號軸承通氣管斷裂

如圖 1.14-8 所示，圖中標號⑩為左發動機 6,7 號軸承通氣管，位於發動機右側，自管路接頭處斷裂，且管件斷裂口前方之機匣及管路表面發現有滑油散佈跡象（詳圖 1.14-9）。

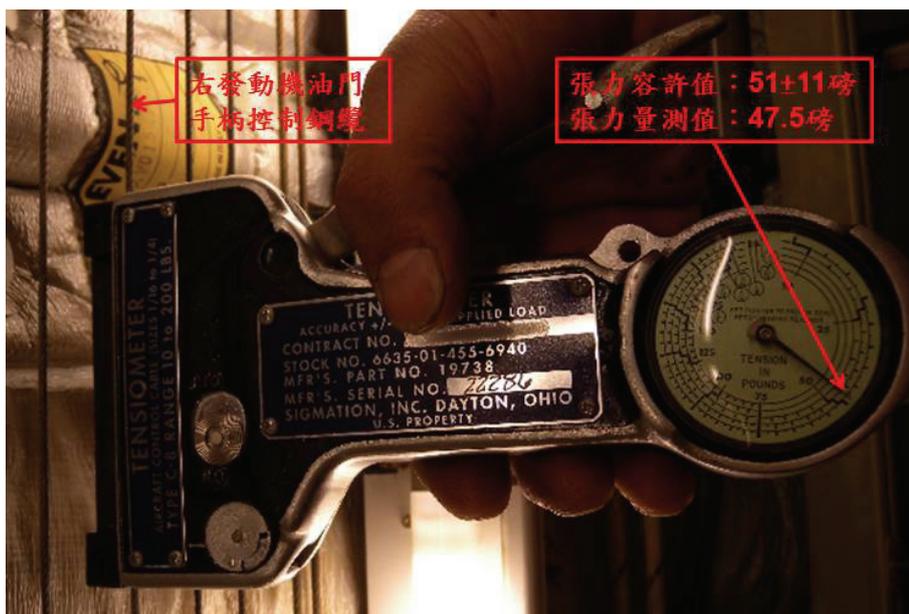
圖 1.16-2 油門手柄控制鋼纜張力量測

專案調查小組於民國 102 年 3 月 12 日至復興棚廠，查證該機發動機油門鋼纜張力 (Tension) 之維護狀況；依據復興維護計畫，油門手柄鋼纜張力為 2C 定檢時執行檢查，該機上次執行檢查日期為民國 100 年 12 月 5 日，左、右油門手柄控制鋼纜張力檢查結果為 47.5 磅至 50 磅；本次鋼纜張力查證日期在該機預劃下次 2C 定檢日期民國 104 年 12 月之時距內，查證結果為左、右油門手柄控制鋼纜張力為 45 磅至 47.5 磅 (詳圖 1.16-2)，均在最低 40 磅之可接受範圍內。

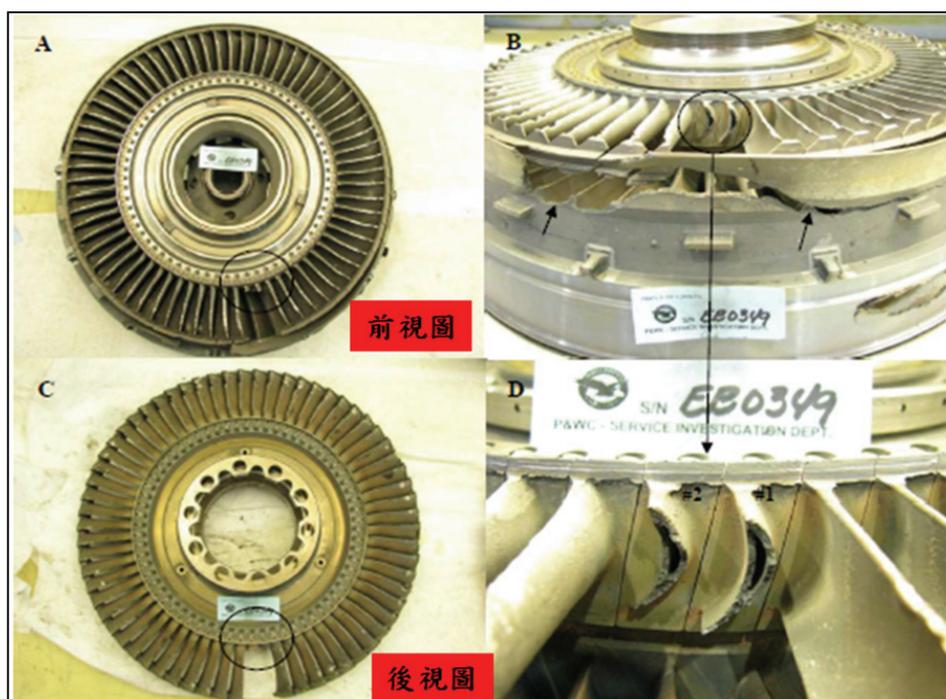
圖 2.1-1 斷裂之第 1 級動力渦輪葉片

1. 左發動機第 1 級動力渦輪轉子 1 片葉片因鑄造過程問題，葉片口袋區域附近之材料產生縮孔缺陷，疲勞裂紋從葉片口袋區域附近材料之縮孔缺陷開始發展終致斷裂；葉片斷裂脫落後於動力渦輪段內部來回撞擊，造成其它第 1 級動力渦輪葉片、外罩、低壓渦輪罩損壞；因動力渦輪段轉子轉動不平衡所產生震動傳遞至 6、7 號軸承室，使固定於支架上之 6、7 號軸承回油管斷裂；大量滑油從斷裂口向後噴出，接觸高熱之發動機尾管後被引燃，造成發動機火警。(1.6.3, 1.14.1, 1.16.1, 2.1.1)

依附錄 6 之 P&WC 事故之發動機調查報告，拆檢結果發現 2 片第 1 級動力渦輪轉子葉片斷裂，斷面位於葉片根部，靠近葉片平台之位置（詳圖 2.1-1）。

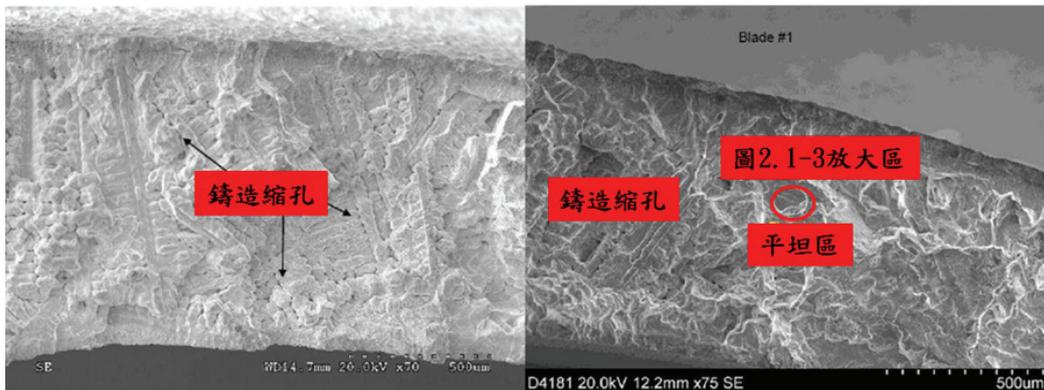
圖 2.1-2 1 號葉片斷面 SEM 影像

Solidification Pattern)，應為材料製程產生缺陷之縮孔特徵（圖 2.1-2）；以更大倍數 SEM 觀察圖 2.1-2 右之平坦區，可見材料疲勞之疲勞紋典型特徵，疲勞紋路起始於葉片口袋區域附近材料之縮孔缺陷，裂紋成長方向如圖 2.1-3 箭頭所示，1 號葉片斷裂面之 SEM 影像均顯示相同之疲勞紋特徵；編號 2 號葉片斷面呈現粗糙、顆粒狀表面，且無平坦區域，應為 1 號葉片斷裂後撞擊導致過載破壞。

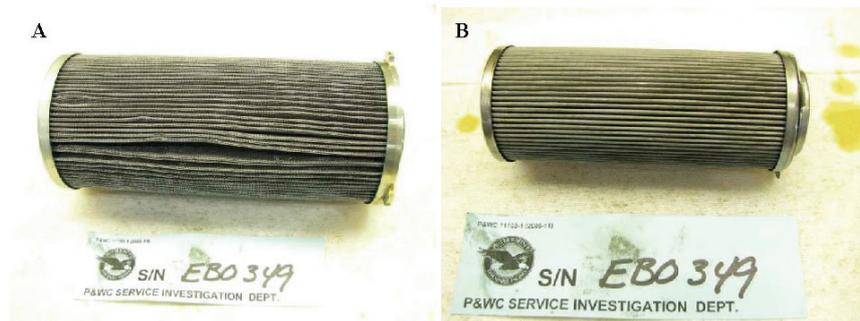
Photo no's 1 A (Main) & B (Scavenge)

- 2.1 The main and scavenge oil filters (photo no's 1 A & B) with the reduction gearbox (RGB) chip detector (photo no's 2 A & C) were clean. The turbomachine (TM) chip detector had collected some metallic slivers (photo no's 2 A & B). The slivers were taken to P&WC Chemical Laboratory for analysis, which they were identified as Stainless Steel (SST) air-seal material. The low (LP) and high pressure (HP) rotors rotated freely. The PT rotor was difficult to rotate. No foreign object damage (FOD) was noted on the leading edge of the LP impeller full vanes.

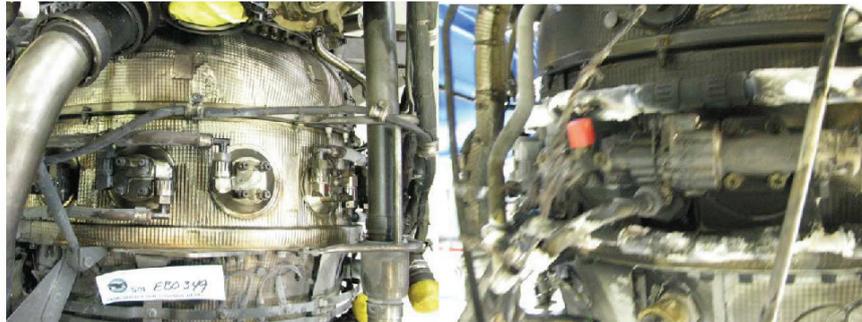
Photo no. 4 (Top view) Photo no. 5 (Bottom view)
 Top and bottom views of the GG section showing damaged externals.

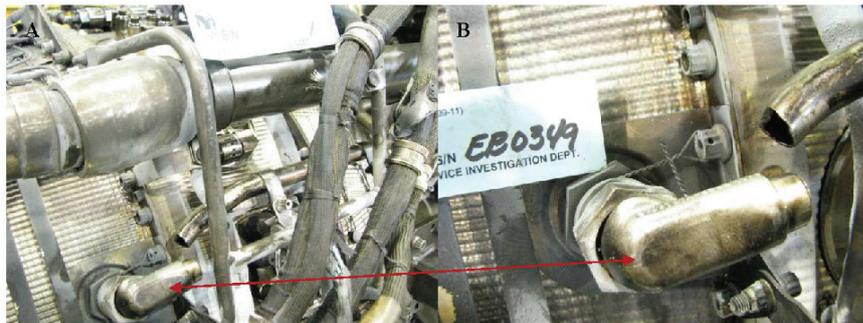
2.3 The vent and scavenge oil tube assemblies individually attached to the transfer-tubes of the No. 6 & 7 bearings housing were noted to be fractured (photo no's 6 A & B). Some of the 90° holding brackets of the vent (photo no. 7 A) and scavenge tube assemblies were found fractured at the bracket creasing area. The fracturing of the vent and scavenge tubes was along the edge of the brazed weld of the tube and ferrule fitting (photo no's 8 A to D). The oil pressure-tube assembly attached to the transfer-tube of the No. 6 & 7 bearings housing was intact (photo no's 3 C and 9 A) but a holding bracket of the tube was fractured (photo no. 9 B). The vent, scavenge and pressure oil transfer-tubes were tightly attached to their respective ferrule fitting "B" nuts of the tube assemblies and to the No. 6 & 7 bearings housing. The vent, scavenge and pressure oil transfer-tubes of the No. 6 & 7 bearings housing were not fractured (photo no. 10). The fractured vent and scavenge tubes with the holding brackets were taken to the P&WC Materials Investigation Laboratory for further analysis.

Photo no's 6 A & B
 View of the fractured vent tube assembly in-situ.

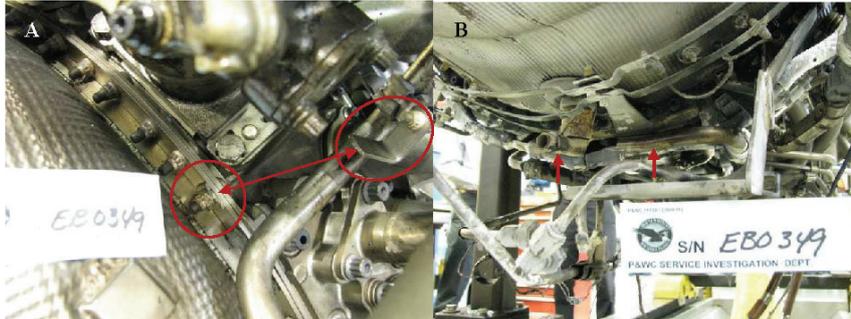
Photo no. 7 A
View of the fractured bracket of the vent tube assembly.

Photo no. 7 B
View of the fractured scavenge-tube assembly (arrows) in-situ.

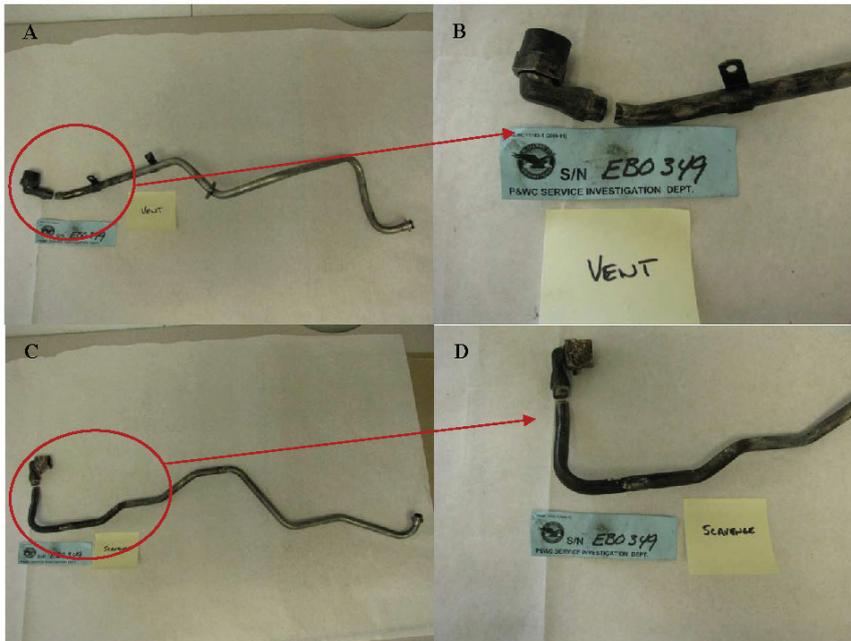
Photo no's 8 A to D
View of the fractured vent and scavenge tube assemblies after removal.

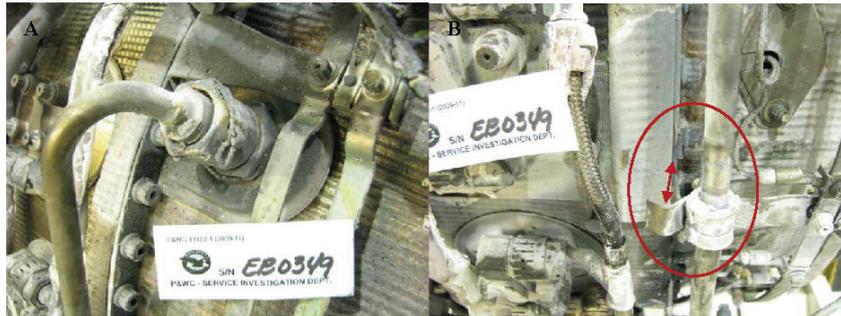
Photo no's 9 A & B
 Views of the tight-secured "B" nut (9 A) and fractured bracket (9 B) of the pressure tube assembly.

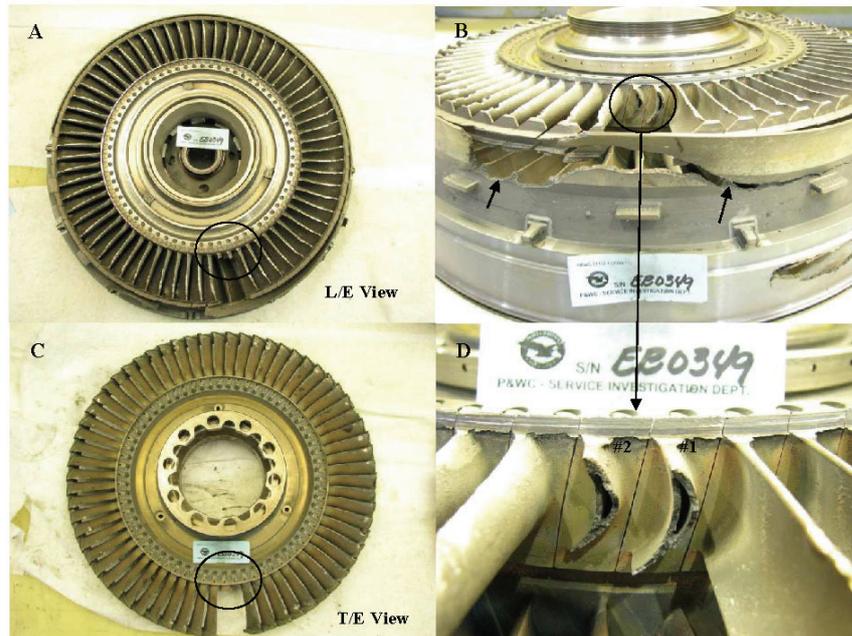
blades showed impact damages. The two fractured PT1 blades identified as #1 & #2 with an airfoil fragment were taken to the P&WC Materials Investigation Laboratory for further analysis. These PT1 blades were Post Service Bulletin No. 21419 configuration.

Photo no's 12 A to D
Views of two fractured PT1 blades & PT2 stator.

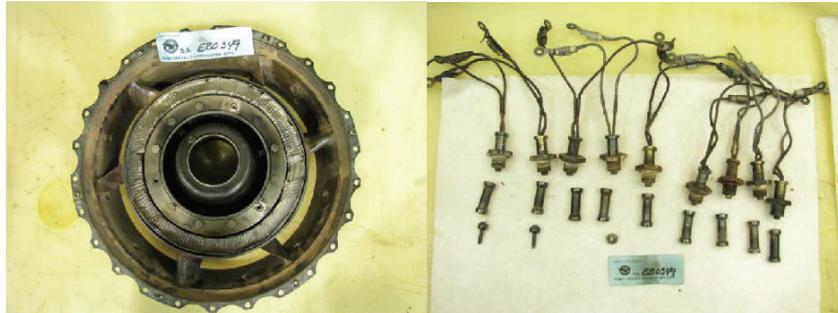
- 2.7 The twelve (12) retention bolts that retained the No. 6 & 7 bearings housing to the ITD with the inter-stage baffle were all in place (photo no. 13 A & 15). The inter-turbine temperature thermocouples (T6) were fractured in which most of them during their removal (photo no. 16).

Photo no. 15
 Photo no. 16
 Views of the No. 6 & 7 bearings housing retained to the ITD (15) and T6's (16).

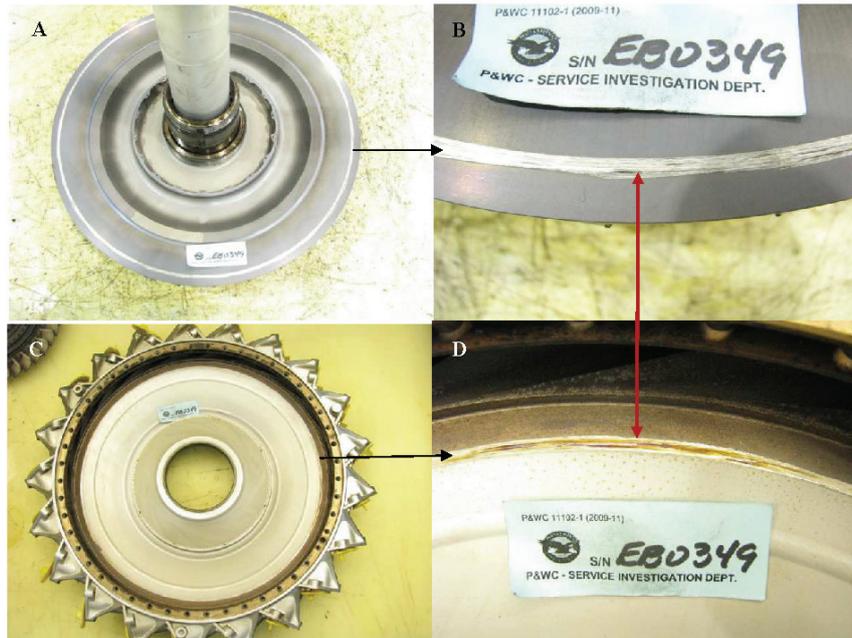
Photo no's 28 A to D
 Views of the rubbing of the LP impeller backface and diffuser case front wall.

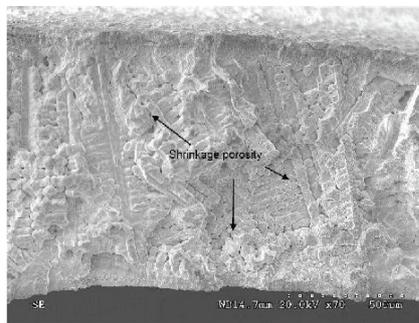
Photo no. 35

3.4 SEM image (photo no. 35) of the PT1 blade #1 fracture surface, taken on the convex side, revealed a dendritic solidification pattern with features consistent with shrinkage porosity. SEM image (photo no. 36) of one of the photo no. 34 insert showed shrinkage porosity feature and flat zone (circle).

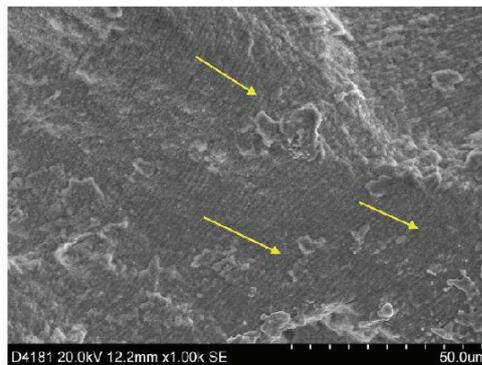
Photo no. 37

3.5 The higher magnification (photo no. 37) of the flat zone highlighted in photo no. 36 (circle) shows fatigue striations suggesting that the crack initiated from the shrinkage porosity zone. The yellow arrows indicated the fatigue crack propagation direction.

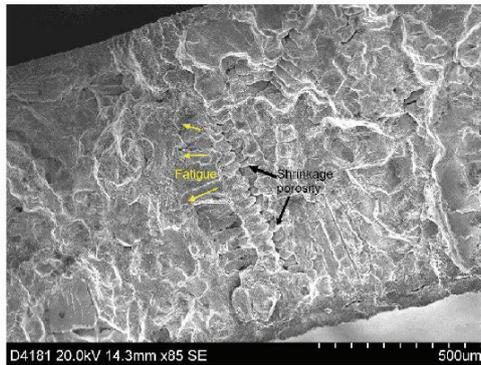
Photo no. 38

3.6 SEM image (photo no. 38) of the blade #1 fracture surface at the airfoil pressure side showed also fatigue zone (yellow arrows) emanating from the shrinkage porosity feature.

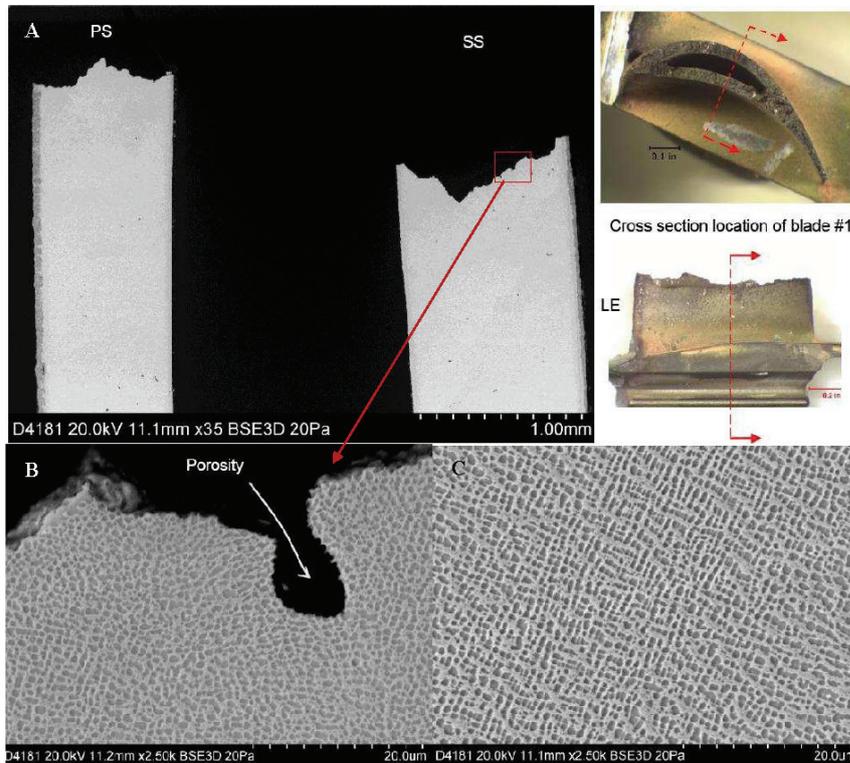
Photo no's 39 A to C

3.7 Cross-section through the blade #1 fracture surface (photo no. 39 A) showed feature consistent with shrinkage porosity (photo no. 39 B). No other evidence of metallurgical anomaly beneath the fracture surface was observed. Back Scattered Electron (BSE) image (photo no. 39 B) showed rounded gamma prime (γ') precipitates in a gamma matrix that is almost similar to the microstructure observed in the root area (photo no. 39 C) showing typical γ' precipitates. This microstructure is considered representative of unaffected material.

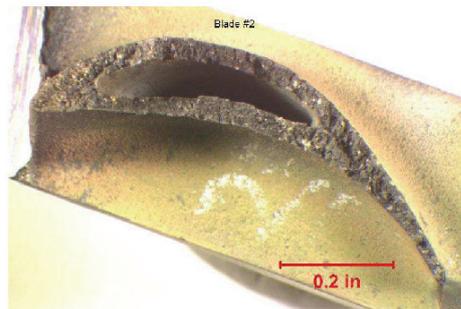
Photo no. 41

3.9 Magnified view of the fracture surface of the PT1 blade #2 exhibited a rough dendritic aspect typical of overload (photo no. 41).

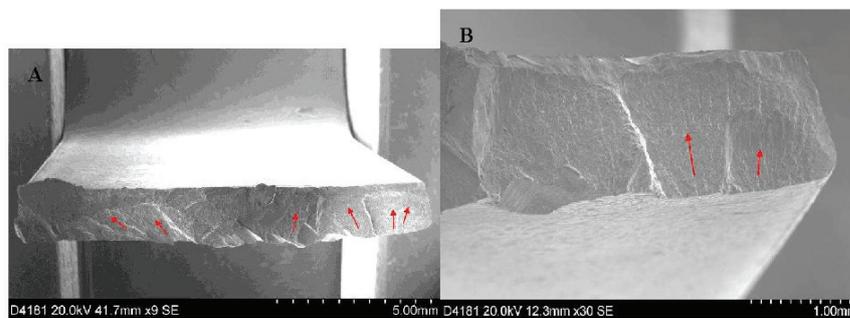
Photo no's 42 A & B

3.11 SEM image (photo no. 42) of the bracket #1 fracture surface showed a flat surface with river lines and arrest lines typical of fatigue. The red arrows indicated the crack propagation direction. Fatigue features covered almost completely the fracture surface suggesting a low nominal stress suggesting High Cycle fatigue (HCF). Higher magnified view (photo no's 42 A & B) of fatigue origin region (arrows) did not show any mechanical damage.

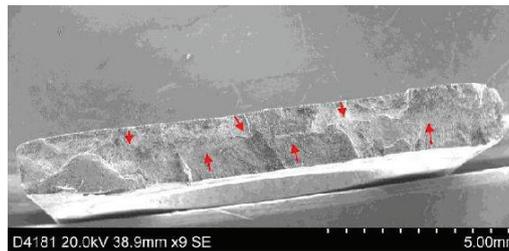
Photo no. 43

3.12 SEM image (photo no. 43) of the bracket #2 fracture surface showed a flat zone with river lines typical of fatigue. The red arrows indicate the crack propagation in opposite direction typical of reverse bending fatigue.

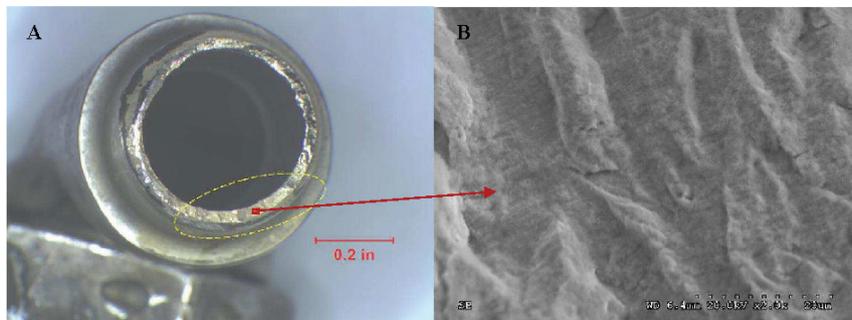
Photo no's 44 A & B

3.13 Magnified view (photo no. 44 A) of the fracture surface of the No. 6 & 7 bearing vent tube assembly showed a flat zone with river lines, indicative of fatigue, emanating from the OD of the tube. SEM image (photo no. 44 B) of an area of the vent tube fracture surface displayed fatigue striations.
