# 飛航事故調查報告

ASC-AOR-13-09-003

中華航空公司CI 947航班

遭遇艙壓異常航機緊急下降

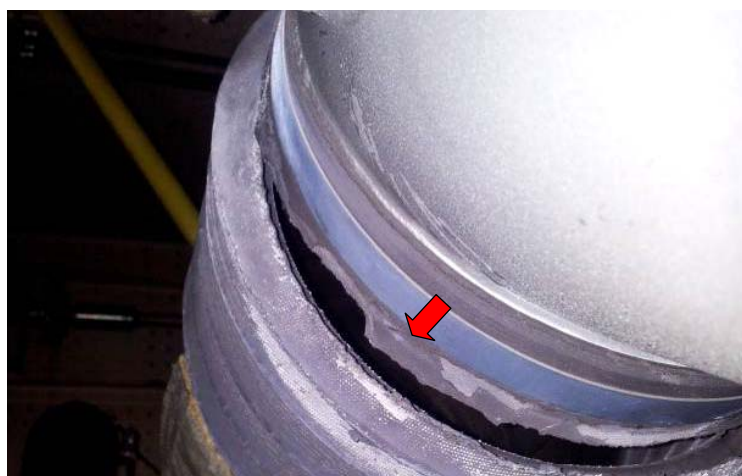
圖 1.6-4 一號空調機冷凝器與混合器間連接管路破損

- CI 947 起飛後 40 分鐘, 監控人員收到「ECAM AIR ENG2 BLEED FAULT」(供氣系統二號發動機供氣系統故障)、「ADV CABIN ALTITUDE (艙壓高度異常警示)」、「CAB PR EXCESS CAB ALT (艙壓高度過高)」, 以及「CAB PR LO DIFF PR (艙壓壓差過低)」等訊息。聯絡飛航組員後, 得知依飛機操作手冊 (Airplane Operations Manual, AOM) 程序緊急下降。當飛行高度 34,000 呎時, 「ECAM ADV CAB ALTITUDE」訊息出現, 組員自述艙壓高度約 10,000 呎, 客艙氧氣面罩施放未致動<sup>12</sup>, 航機立即降低高度, 沒有嘗試手動控制 FWD/AFT OUTFLOW VALVE (前/後外流閥)。另向高雄機場澄清得知前段航班 (AE996) 發生 ENG2 HPV (二號發動機高壓閥) 故障, 已將二號 HPV deactivated 並轉至故障延遲改正頁面。
- 下載 ECS (環控系統) 故障報告得知當時 ENG1 供氣正常, 但 ENG 2 無供氣, PFR ENG2 HPV/PRV FAULT (二號發動機高壓閥/調壓閥故障)。
- 地面檢查發現一號空調機冷凝器 (Condenser) 與混合器 (Mixer) 間連接氣管的襯套破損 (詳圖 1.6-4), 及一號空調機連接到冷凝器的熱空氣管斷裂 (詳圖 1.6-5)。更換受損管路後, 客艙可加壓至 8.6 psi, 洩漏率 (LEAKING

參考 1.6.3 維修資訊，事故後 B-18353 航機於香港機場之故障排除作業，維修人員以一號供氣系統供給一號空調系統情況下，執行航機艙壓測試，測試結果顯示，在此情況下系統無法建立足夠之艙壓，後續檢修發現位於非加壓艙之一號空調機輸出管路襯套破損。經維修人員更換該破損襯套，再以一號供氣系統供給一號空調系統情況下，艙壓測試恢復正常。參考圖 1.16-1 為本事故一號空調機輸出管路拆下之襯套，約有 3/4 圈破損，此破損襯套將使空調機輸出之低溫壓縮空氣

洩漏至外部（非加壓區），而流入加壓艙之空氣流量便減少，當飛機高度升高，因大氣壓力降低，管路及外界差壓增加，其洩漏將更嚴重。維修作業之測試顯示，即使在地面上，此破損襯套已造成一號空調系統無法單獨作業建立足夠之艙壓。

ACTION : T/S FOUND A HOSE AND SLEEVE AT PACK 1 CONDENSER BROKEN REF IPC 21-52-41-05A ITEM 140 AND 21-53-03-04B ITEM 30. HOSE AND SLEEVE REPLACED AND LEAK CHECK SATIS. SUB CABIN PRESSURIZATION TEST TO 5.8 AND 8.7 PSI NORMAL LEAKAGE RATE FROM 8.38 TO 8.27 WITH 8 SEC WITHIN LIMIT IAW AMM 05-53-00-780-803-A01 (維修作為：故障排除發現一號空調機 1 條襯套破損及 1 條熱空氣管斷裂，參考 IPC 21-52-41-05A 項目 140 及 21-53-03-04B 項目 30。更換破損料件後，試漏檢查正常，艙壓加壓測試，8 秒鐘時間壓力 8.38 psi 降到 8.27，根據 AMM 05-53-00-780-803-A01 在容許範圍。)

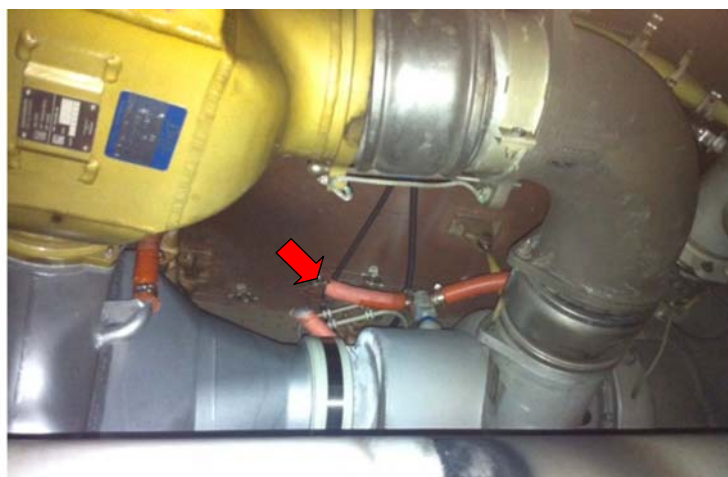
圖 1.6-5 一號空調機連接到冷凝器的熱空氣管斷裂

4. 一號空調機輸出管路襯套破損，使該壓縮低溫空氣洩漏至非加壓區之情況，飛機製造廠表示此種狀況造成的漏氣，飛機上無相關監視系統可直接顯示在駕駛艙儀表。發現此類缺點之方法包含根據 MPD/MRB<sup>23</sup> 重複性的檢查計畫，及對的空調系統故障現象之故障排除。
5. 一號空調系統斷裂破損之小軟管（件號：1601-0008），其功能為加熱冷凝器，以防止結冰，與本事故發生無關。
6. 二號供氣系統 PRV 在整個事故航班均關閉，飛機製造廠認為可能是結合以下兩種因素的影響：
  - 介於 PRV 及 THS（溫控電磁閥）之偵測管路漏氣，形成調節壓力偏低，視漏氣的大小甚至會使 PRV 全關閉，
  - PRV 的受損使壓力調節偏移及受到限制。

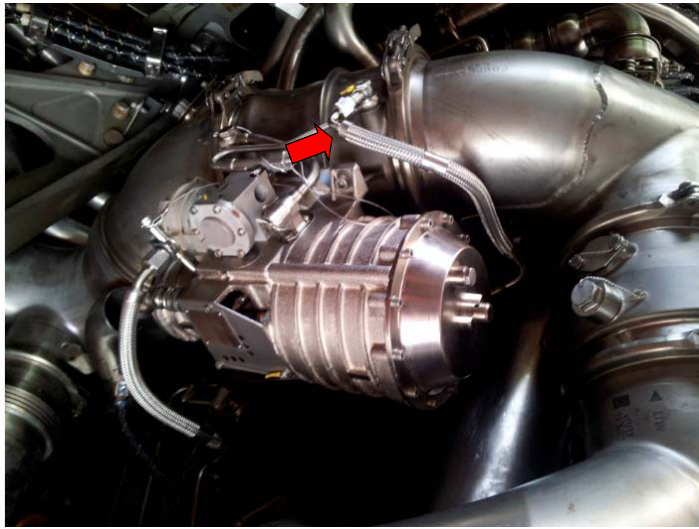
圖 1.6-6 二號發動機 PRV 偵測管漏氣處

- 執行二號發動機供氣系統故障排除，進行供氣閥偵測管 (BLEED VALVE SENSING LINE) 試漏檢查，發現兩根控制 PRV 偵測管漏氣 (詳圖 1.6-6)，造成 HPV 及 PRV 無法正常開啟<sup>13</sup>。更換兩根偵測管，二號發動機恢復正常供氣。

<sup>13</sup> 根據飛機製造廠資料及 HPV 原廠檢修報告摘要 (附錄 8)，HPV 無法開啟乃因為本身嚴重受損，此處之偵測管漏氣與 HPV 無法正常開啟無關。

參考 1.6.3 維修資訊，事故後有關二號供氣系統之維修，更換 HPV、PRV、感知器（代號 9HA2）、溫控電磁閥（代號 7HA2）及 2 條偵測管（代號 S/L2 及 S/L3），更換後上述料件後系統測試恢復正常。參考 1.16 測試與研究，上述料件進廠檢查，確認 HPV、PRV 及 2 條偵測管均故障。參考原廠資料 2 條偵測管之功能，代號 S/L2 為連接 PRV 上游氣壓感知器（代號 9HA2）之管路，當此管路漏氣會使 9HA2 感知器所偵測之壓力偏低；代號 S/L3 管路為連接 PRV 與溫控電磁閥（代號 7HA2）之管路，當此管路漏氣嚴重時會使 PRV 關閉。

ACTION: REFER CASL NRW: 307239, 307241 & 307243 ENG 2 BLEED VALVE, XDCR (9HA2), SOLENOID (7HA2) , SENSE HOSE REPLACED, ENG 2 BLEED OPERATION CHECK NORMAL AMM 36-11-52, 36-11-51 WITH ENG IDLE RUN (維修作為：更換二號發動機供氣閥、感知器、溫控電磁閥及偵測管，依 AMM36-11-52 及 36-11-51 運轉二號發動機，供氣系統操作檢查正常。)

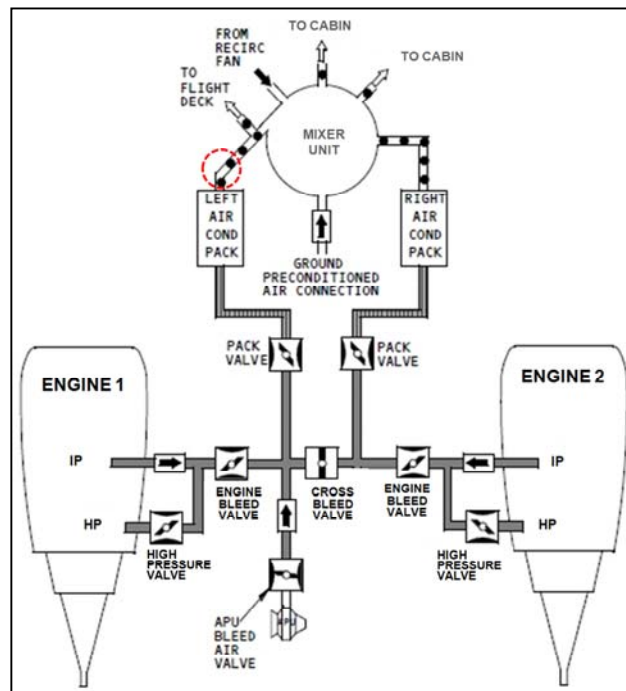
圖 1.6-7 供氣系統與空調系統示意圖

Flow Control Valve, FCV) 以控制流量，從發動機送出之氣源為高溫壓縮空氣，經過空調機之冷卻及調節後，成為低溫壓縮空氣，此低溫壓縮空氣再經過管路接至混合器 (Mixer)，自客艙之循環空氣與壓縮的新鮮空氣在混合器混合後，進入各區客艙前，系統可依溫度設定加入調溫熱空氣 (Trim air) 以控制各艙之空調溫度。本事故發現破損之襯套即介於空調機末端之冷凝器與混合器之管路，如圖 1.6-7 所示，紅色圓圈處。

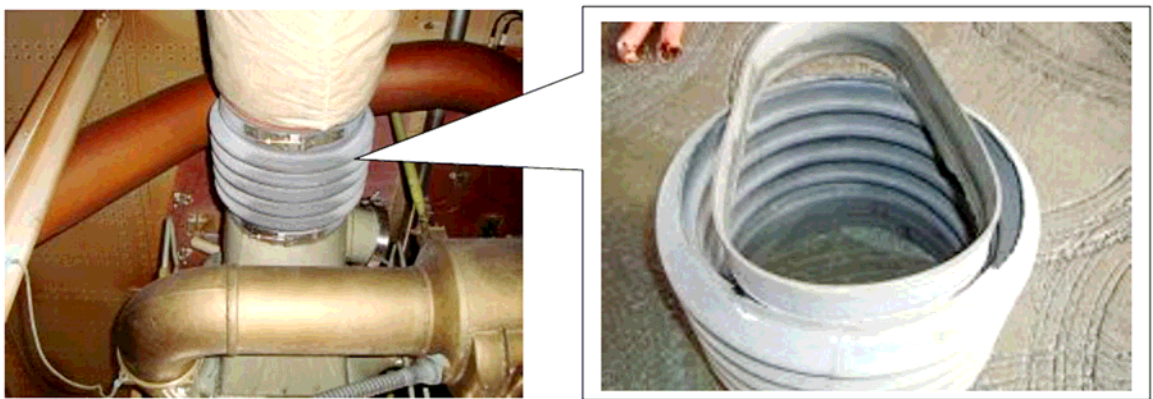
圖 1.16-1 襯套安裝位置及破損情形

民國 101 年 9 月 12 日，專案調查小組前往華航修護工廠，調查該機與事故相關供氣系統與空調系統狀況。觀察華航同型 A330-300 航機 (B-18308) 一號空調機冷凝器與混合器間連接氣管的襯套 (Sleeve)，詳圖 1.16-1，左圖為機上正常之襯套，右圖為本事故拆下之接頭其破損情形；觀察一號空調機連接到冷凝器的熱空氣管情形，詳圖 1.16-2，左圖為機上正常之熱空氣管，右圖為本事故拆下之熱空氣管斷裂情形；觀察二號發動機供氣系統 PRV 之偵測管路，詳圖 1.16-3，左圖為發動機上之 PRV 及偵測管路，右圖為本事故拆下之管路，紅色圓圈處為其破損處，以目視外觀檢查，無法發現內部是否破損，將該偵測管接上加壓清水，可發現清水自破損處流出，如圖 1.16-4。

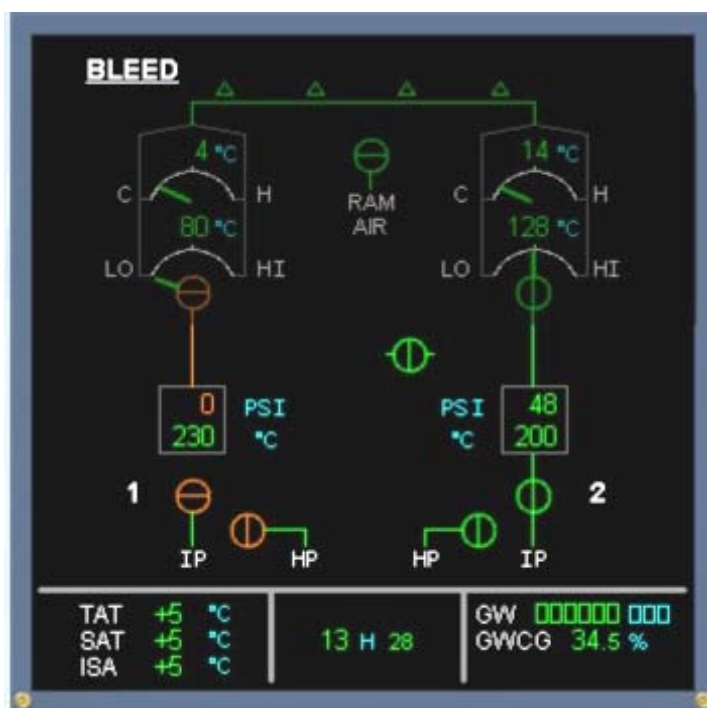
圖 2.5-1 供氣系統頁面示意圖

按鍵內之故障 (FAULT) 警示燈不會亮，ECAM 警示亦未及時發出，如飛航組員於重置時檢視相關系統頁面，不正常之參數及指示皆應顯示琥珀色如圖 2-1 所示（圖中是以一號供氣系統失效為例），應可發現二號發動機供氣系統並未恢復正常。華航 A330 QRH 電腦重置程序中，未有飛航組員於重置時須檢視相關系統頁面之要求，以確定相關系統是否恢復正常。如 1.18.2.2 ECAM 處理程序，華航 330/340 飛航組員訓練手冊 (FCTM) 操作觀念 (Operational Philosophy) ECAM 章節中敘述，操作系統開關或按鍵時，PM 應檢視系統頁面，確定該動作已執行。
