# 飛航事故調查報告

ASC-AOR-13-08-001

中華民國101年9月13日  
長榮航空公司BR 189航班  
A330-300型機  
國籍標誌及登記號碼B-16331  
於松山機場落地時偏出跑道

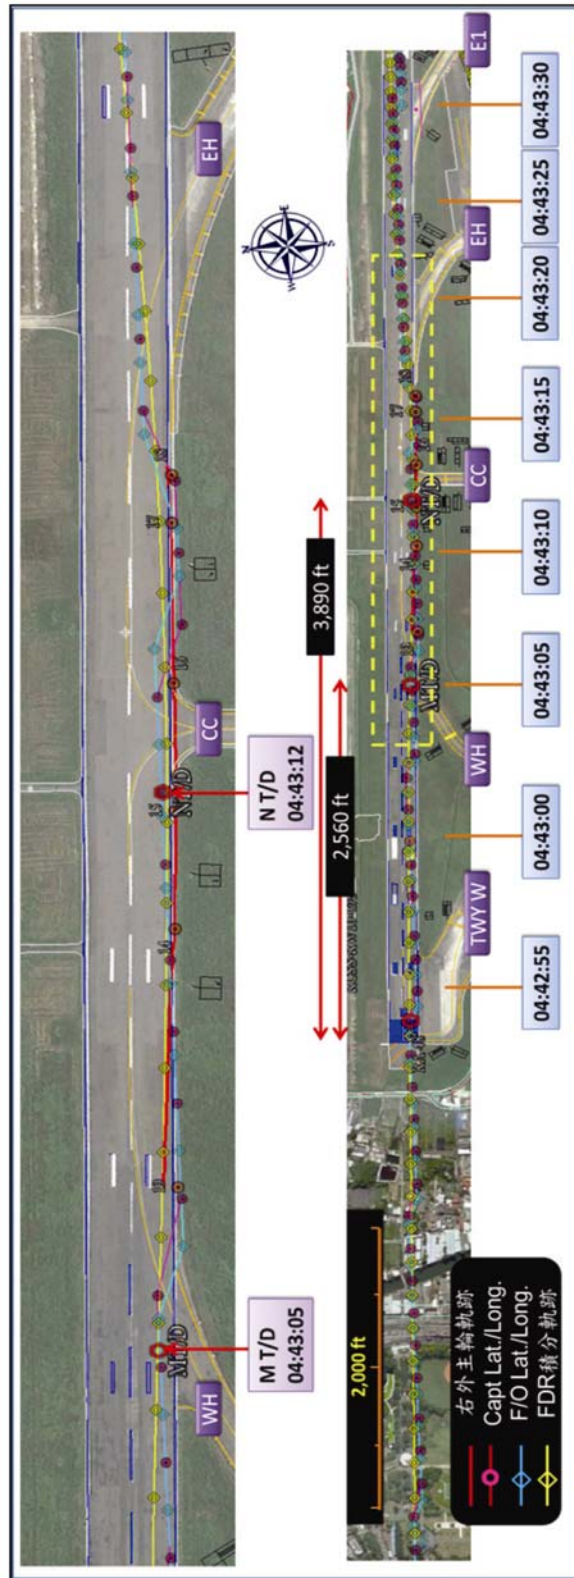
圖 1.1-2 BR189 落地階段之飛航軌跡與衛星影像套疊圖

。滾行過程中於距 10 跑道頭 3,630 呎處右主輪偏出跑道右側，沿跑道邊線外側之草地滾行，於通過 CC 滑行道後，距 10 跑道頭 4,610 呎右主輪始返回跑道，航機偏離跑道邊線之最大距離為 1.8 公尺(約 6 呎)。滾行過程中，飛航組員並未感覺有偏出跑道。於脫離跑道及滑行過程中，塔臺曾詢問航機之狀況及是否可持續滑行，且地面人員通知下機後需至航務組進行酒測，飛航組員始感覺航機落地時可能撞及外物。該機之飛航軌跡如圖 1.1-1、最後進場及落地階段之軌跡如圖 1.1-2。

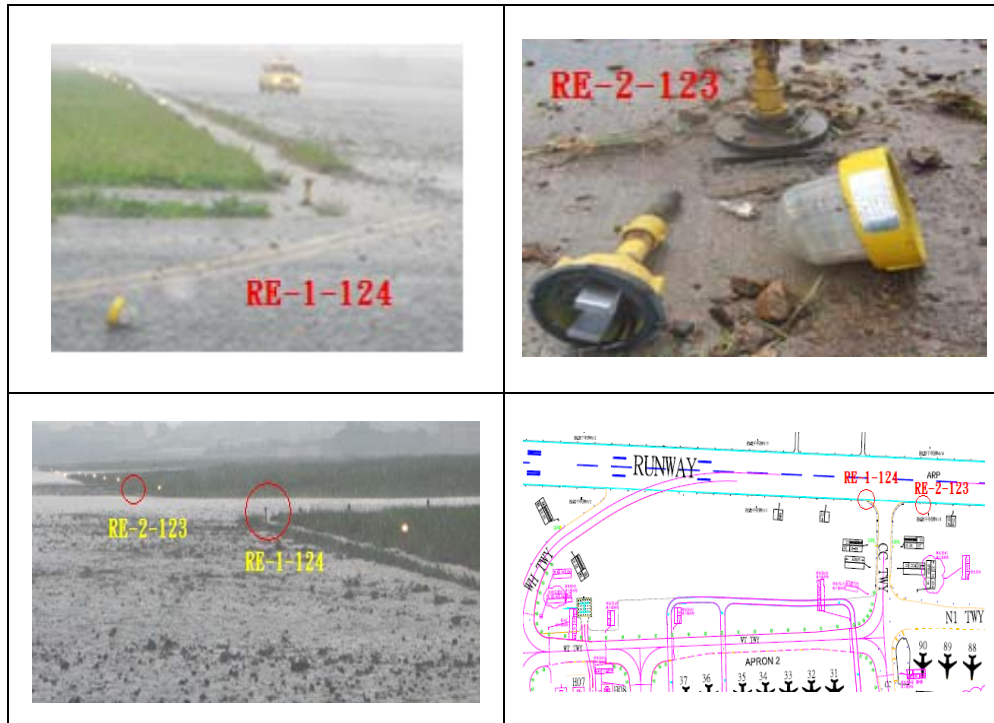
圖 1.10-2 跑道邊燈損毀狀態

松山機場跑道 2 具編號分別為 RE-1-124 及 RE-2-123 之邊燈損壞。

損壞之跑道邊燈計 2 具；編號 RE-1-124 為第 1 迴路，編號 RE-2-123 為第 2 迴路 (如圖 1.10-2)。

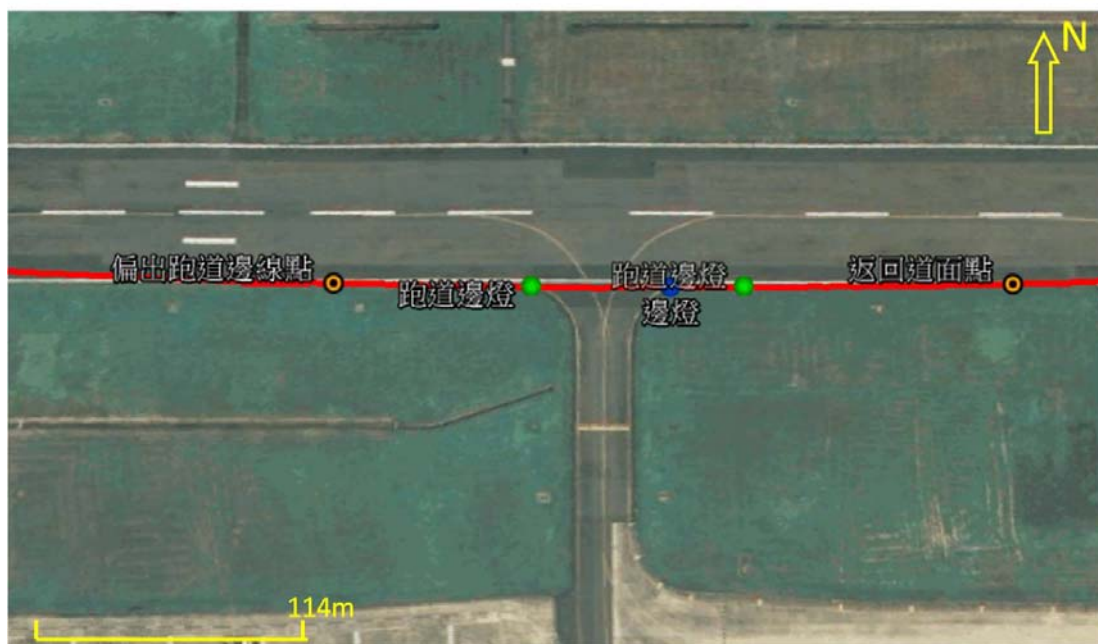
圖 1.12-4 事故現場圖

項次	距 10 跑道頭位置	量測物	說明	圖例
1	---	WH 滑行道待命線	參考基準	---
2	1,300 呎	10 跑道右著陸點標線	參考基準	---
3	3,030 呎起	NO.4 右主輪胎痕	右主輪胎痕外側	紅色
4	3,630 呎	NO.4 右主輪偏出跑道邊線	軌跡與跑道夾角約為 1.2° 向右	---
5	3,920 呎	損壞之 跑道邊燈	編號 RE-1-124	⊙綠色
6	4,130 呎	NO.4 右主輪偏出跑道最遠處（距跑道邊線 6.06 呎）	此處軌跡與跑道平行	---
7	4,230 呎	損壞之跑道邊燈	編號 RE-2-123	⊙綠色
8	4,610 呎	NO.4 右主輪滑進跑道邊線	軌跡與跑道夾角約為 1.8° 向左	---

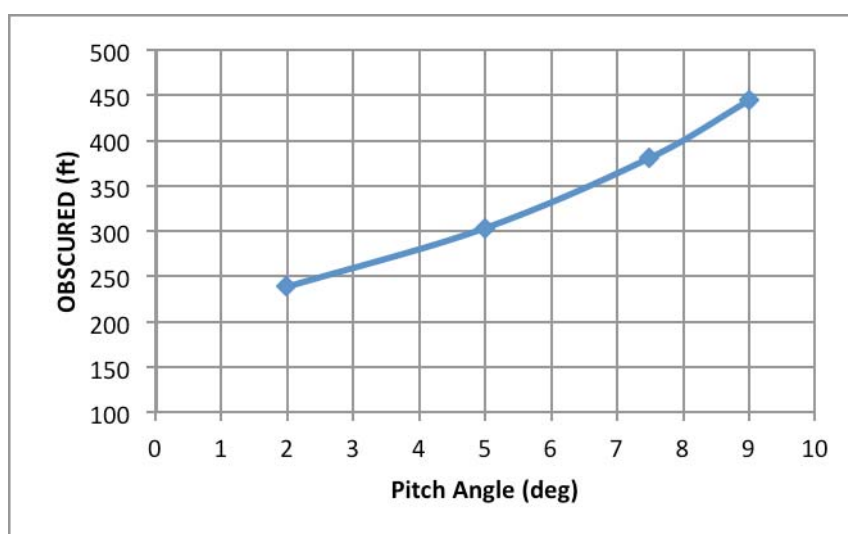
圖 2.4-1 進場仰角與遮蔽距離之關係

1. 飛航組員相關飛航證照，符合現行民航法規之規定。無證據顯示飛航組員於該次飛航中曾受任何酒精藥物之影響。
2. 無證據顯示本次事故與航機之維修及適航有關。
3. 該型機使用 Flap 3 進場時平飄之遮蔽距離較使用 Flap Full 進場時為長。則如於低能見度情況下使用 Flap3 落地，飛航組員對外界之目視參考將減少。
4. 松山機場跑道燈光設置符合民航局機場設置規範之規定，但如能考量設置跑道中心線燈，應可有效強化飛航組員於落地前對正跑道之目視參考。

該機於下降前提示時，預計使用 Flap Full 進場及落地，於落地前約 3 分鐘（1240 時）正駕駛員告知副駕駛員改使用 Flap 3 落地，依據模擬機測試結果（參考 1.16.1 節）；於距地 50 呎時，使用 Flap 3 進場平飄時之仰角約為 9 度，使用 Flap Full 進場平飄之仰角約為 7.5 度，約相差 1.5 度，參考表 2.4-1 資料得知以 Flap 3 進場平飄之遮蔽距離較以 Flap Full 進場時約多 63 呎。
