飛航事故調查報告

ASC-AOR-13-11-001

**中華民國102年6月3日
中華航空公司CI 781航班
AIRBUS A330-300型機
國籍標誌及登記號碼B-18317
於胡志明市東北方110哩
遭遇艙壓異常航機緊急下降**

報告日期：民國 102 年 11 月

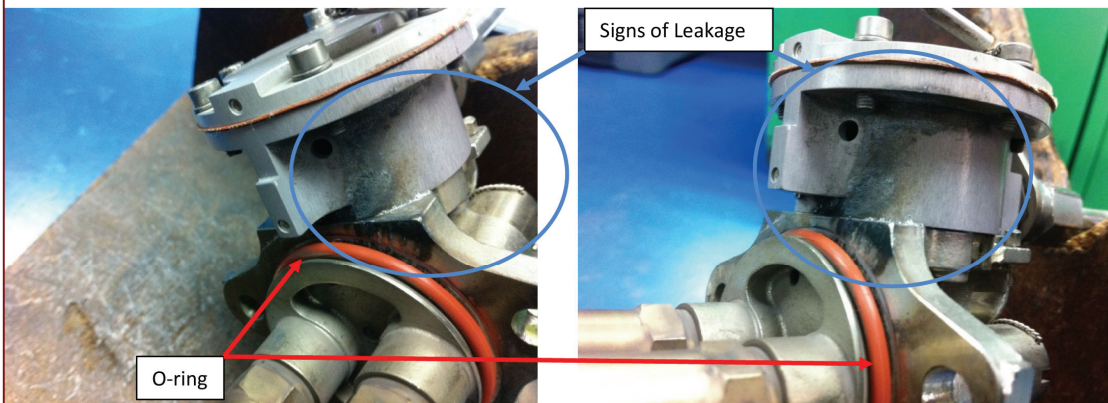
依據 1.16.2 節，LIEBHERR 原廠調查報告及 AAIB Singapore 見證測試報告 3.1.2 及 3.2.2 節內容，顯示 THC SN 01404 之故障現象，並非導致 2 號發動機供氣系統超溫之原因，而係 O-RING 硬化缺損而發生 THC 與發動機供氣系統管路間接頭處漏氣，致使進入 THC 本體之供氣減弱而無法建立驅動 FAV 之壓力，使 FAV 開度變小，冷卻效果不足導致超溫，使 PRV 關閉，引起 2 號發動機供氣系統失效。另依據 DFDR 資料，航機起飛時「Eng.2 Pre Cooler Outlet Temperature」參數由 259°C 上升至最高 304°C，再下降至 257°C，亦證實 2 號發動機供氣系統發生超

- No O-ring was attached to the component (China Airlines commented that the ring may have been removed during the removal process from the aircraft). OEM replaced the O-ring to conduct the above mentioned tasks.
- There was signs of leakage near the position of the O-ring (see below pictures for leakage location)

Pictures showing the leakage of SN 01404 Thermostat

3.1.3 Per the CMM tasks, the component failed the cold test. The hot test revealed minor drift from the intended results. Please see the attached for the test results.

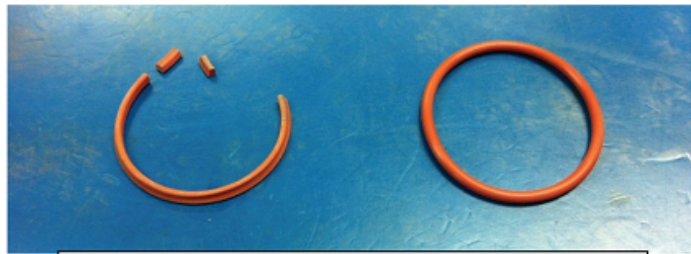
- The O-ring attached to the component was found broken and brittle. The China Airline representatives have brought back the damaged O-ring. OEM replaced the O-ring to conduct the above mentioned tasks.
- There were signs of leakage near the position of the O-ring. (see below picture for leakage location)

Left: Broken and brittle O-ring found on the SN 00715
Right: New O-ring (supply by OEM)

3.2.3 Per the CMM tasks, the component passed the cold test. The hot test revealed drift from the intended results. Please see the attached for the test results.

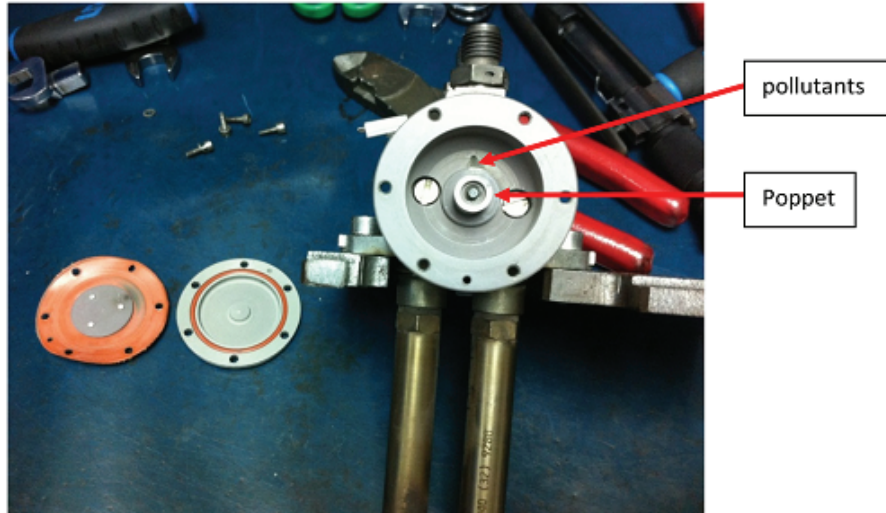
Clapper: The poppet surface was found to be slightly sticky. The poppet was hard to push. Some pollutants found at the 12 o'clock position. Passed the manual leak check of the clapper.

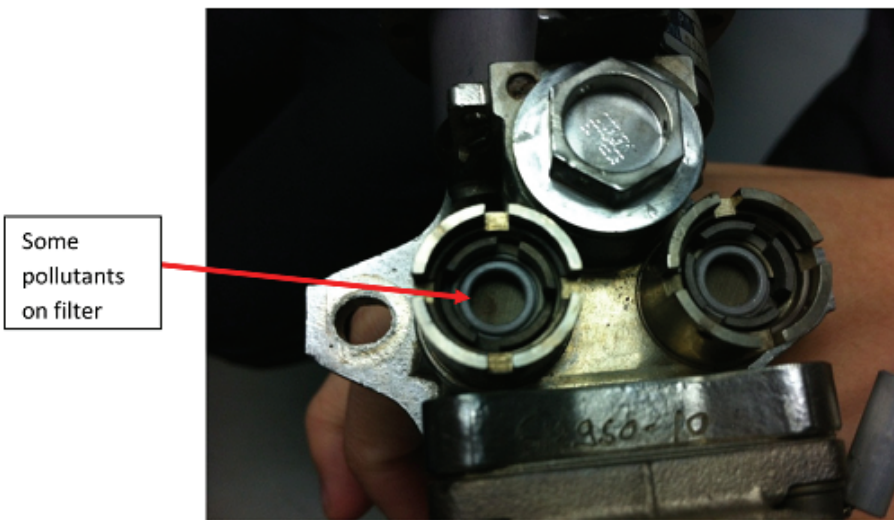
Grease Filter: Did not disassemble the grease filter. Some pollutants seen on the filter.

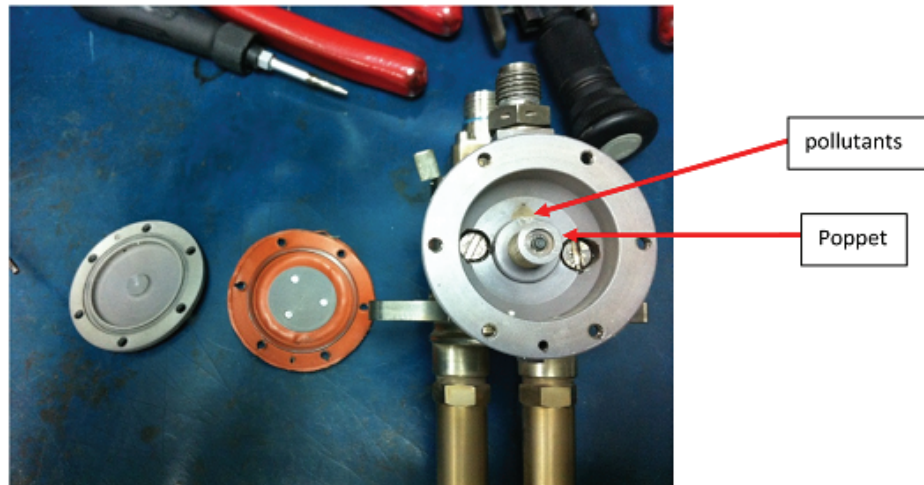
Clapper: The poppet surface was found to be slightly sticky. The poppet was hard to push. Some pollutants found at the 12 o'clock position. Failed the manual leak check of the clapper.

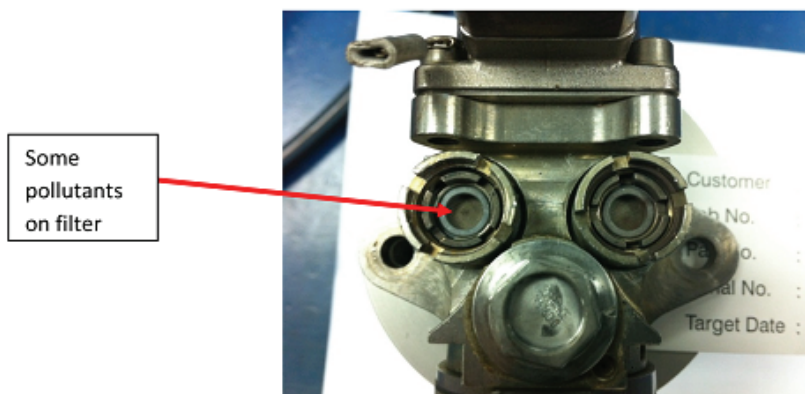
Grease Filter: Did not disassemble the grease filter. Some pollutants seen on the filter.

6 The OEM also recommended checking the fan air valves and the sense line for the bleed system of the aircraft.

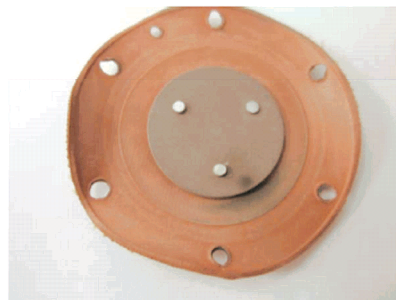
Diaphragm found harden and lightly polluted

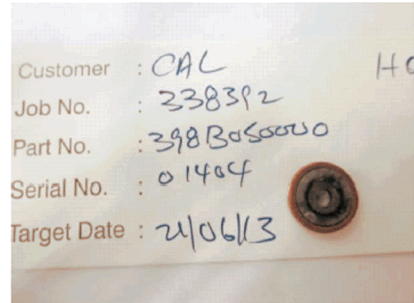
The seat is marked and contaminated

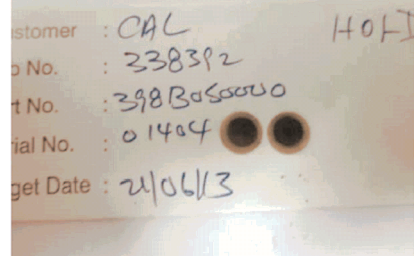
The mesh filters are contaminated

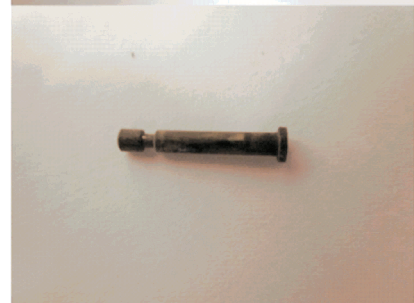
The clapper is worn

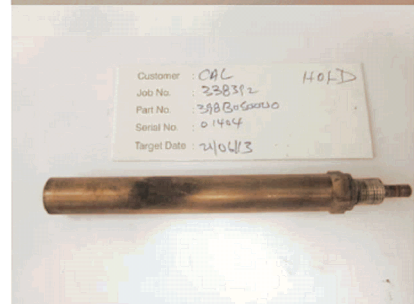
Sticks are slightly corroded

The return is justified:
some values are out of CMM tolerances. The wears are considered as normal in regard with the flight hours accumulated by the sensor.

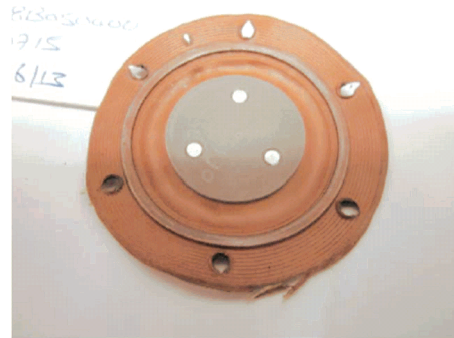
Diaphragm harden and torn

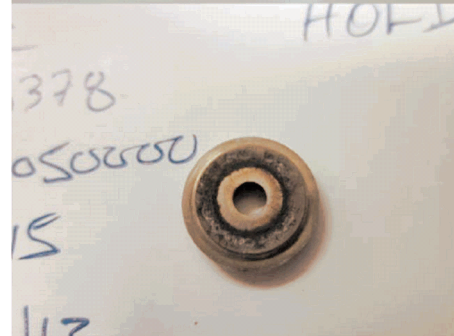
Seat found contaminated with graphite powder

The sensor was contaminated by graphite powder. This contamination is probably linked to an improper servicing (the use of graphite powder to install packing's) performed during the previous shop visit. This contamination has migrated inside the body, contaminating filters and the clapper seat. This contamination could reduce the flow sent to Fan Air Valve and explain a possible over temperature condition on aircraft.

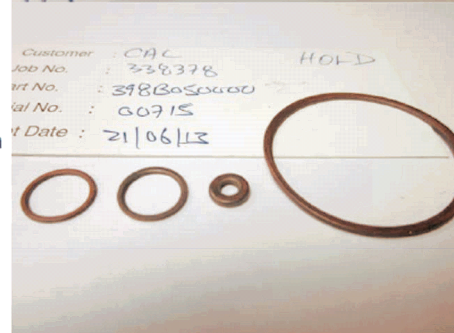
Packings found harden and installed with Graphite powder (not permitted)

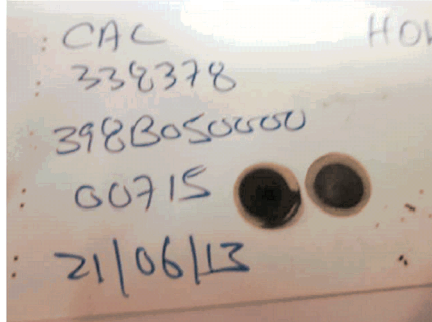
Mesh filters found highly contaminated

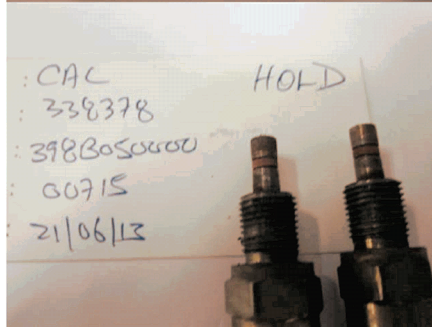
Sticks found corroded
