# 飛航安全調查委員會

## 飛航事故 事實資料報告

復興航空公司 GE 5111 航班

松山機場起飛爬升時駕駛艙出現高溫氣體

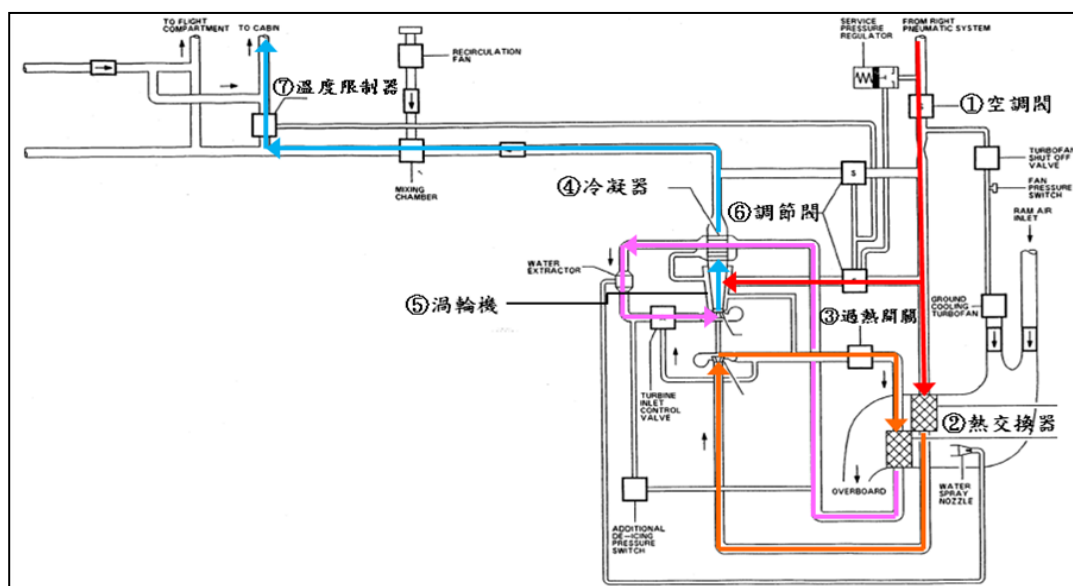
圖 1.6-1 空調系統

如圖 1.6-1 所示，冷卻空氣與自客艙之循環空氣混合後，在進入機艙前，會再與自標號①空調閥引出之適量熱氣混合，熱空氣的流量由如圖標號⑥調節閥（Modulating valve）控制，經標號⑦管路溫度限制器（Duct temperature limiter）由管路導引排放至駕駛艙及客艙；當前端之溫度限制器感測溫度超過 88°C 時，限制器會逐步將調節閥關閉。另一種控制調節閥門開合之訊號源，來自駕駛艙溫度控制面板之溫度選擇開關及溫控選擇鈕，溫控訊號依旋鈕位置自駕駛艙溫度控制面板傳遞至溫度控制器，再傳至多功能電腦（Multi Function Computer, MFC），經 MFC 處理後發出訊號，控制調節閥門之開合，溫控訊號顯示及傳遞，以及本次事故後送修確認故障之溫度感測器如圖 1.6-2 所示。

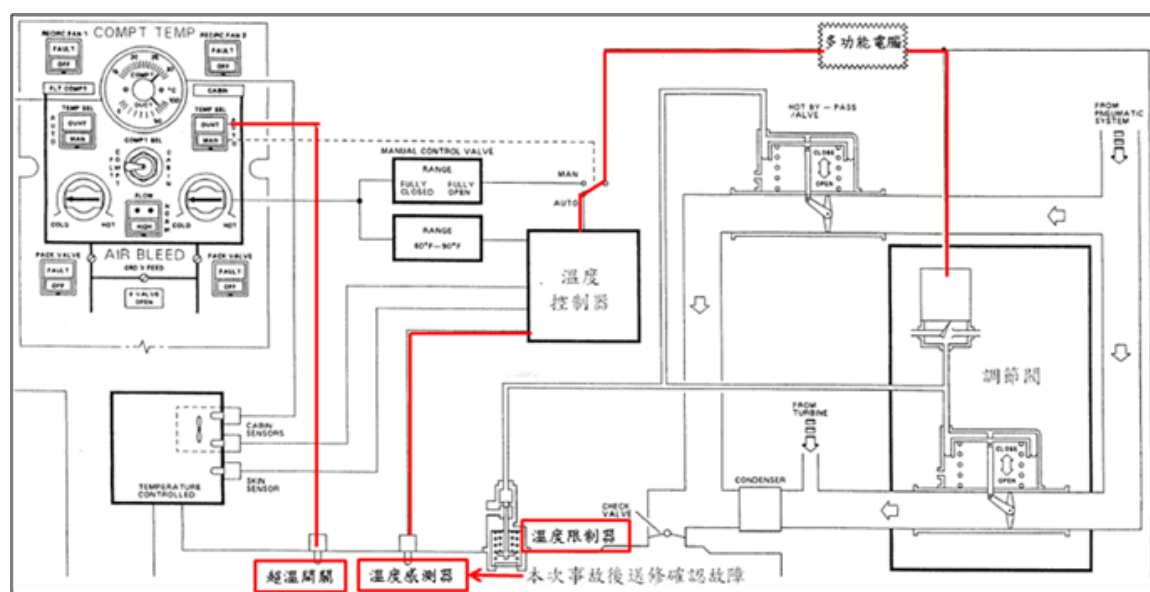
圖 1.6-2 溫控訊號顯示及傳遞

前述維修作為項目之電子艙煙霧偵測器經復興測試正常後，回裝原機續用；事故後復興故障維修作為計更換：溫度控制器、空氣調節閥及溫度感測器，復興將該 3 項料件送 Honeywell 公司檢修，檢修結果溫度控制器及空氣調節閥均正常，溫度感測器 (Temperature sensor, 件號/序號：627962-2/627962-22956) 中間溫度阻抗測試不合格 (FAILED MID TEMP RESISTANCE TEST)，檢修報告詳附錄 3。

為防止進入駕駛艙及客艙空調溫度過高，位於地板下之低壓空調配送管內裝置管路超溫開關，當管內空氣溫度達  $92\pm4^{\circ}\text{C}$  時，開關送出訊號，使駕駛艙「TEMP SEL」超溫燈亮 (如圖 1.6-2 左側紅框處)，同時將警示訊息送至飛機中央組員警告系統 (Centralized Crew Alerting System, CCAS)。該超溫開關附近一具管路溫度感測器 (件號 627962-2)，其所感測之溫度訊號同時會傳遞至如前段所述之溫度控制器及 MFC。

- ④ *IAW JIC 21-61-83 REPL FLT COMPT TEMP CONTROLLER (9HH) AND CHK NML* (依據工卡 21-61-83 更換駕駛艙溫度控制器後檢查正常。)
- ⑤ *IAW JIC 21-61-51 REPL #1 TRIM AIR VLV AND CHK NML* (依據工卡 21-61-51 更換 1 號空氣調節閥後檢查正常。)
- ⑥ *IAW JIC 21-61-26 REPL FLT COMPT DUCT SENSOR (13HH) CHK NML* (依據工卡 21-61-26 更換駕駛艙供氣管路溫度感測器後檢查正常。)
- ⑦ *IAW JIC 26-15-21 REMOVE AND RE-INSTALLD ELEC SMOKE DETECTOR AND TEST NML* (依據工卡 26-15-21 拆裝電子艙煙霧偵測器，測試正常。)
- ⑧ *PACK OPT AND #1 TRIM AIR VLV LEAK TEST, AS PER JIC 72-00-00 ERU PERFORMED PACK VALVE FUNCTION TEST THE TESTED NML, LEAK CHK FOLLOW JIC 21-51-00 AND NO LEAK FOUND* (依據工卡 72-00-00 啟動發動機，執行空調閥功能測試，結果正常，依據工卡 21-51-00 執行 1 號空氣調節閥洩漏檢查，結果無洩漏。)

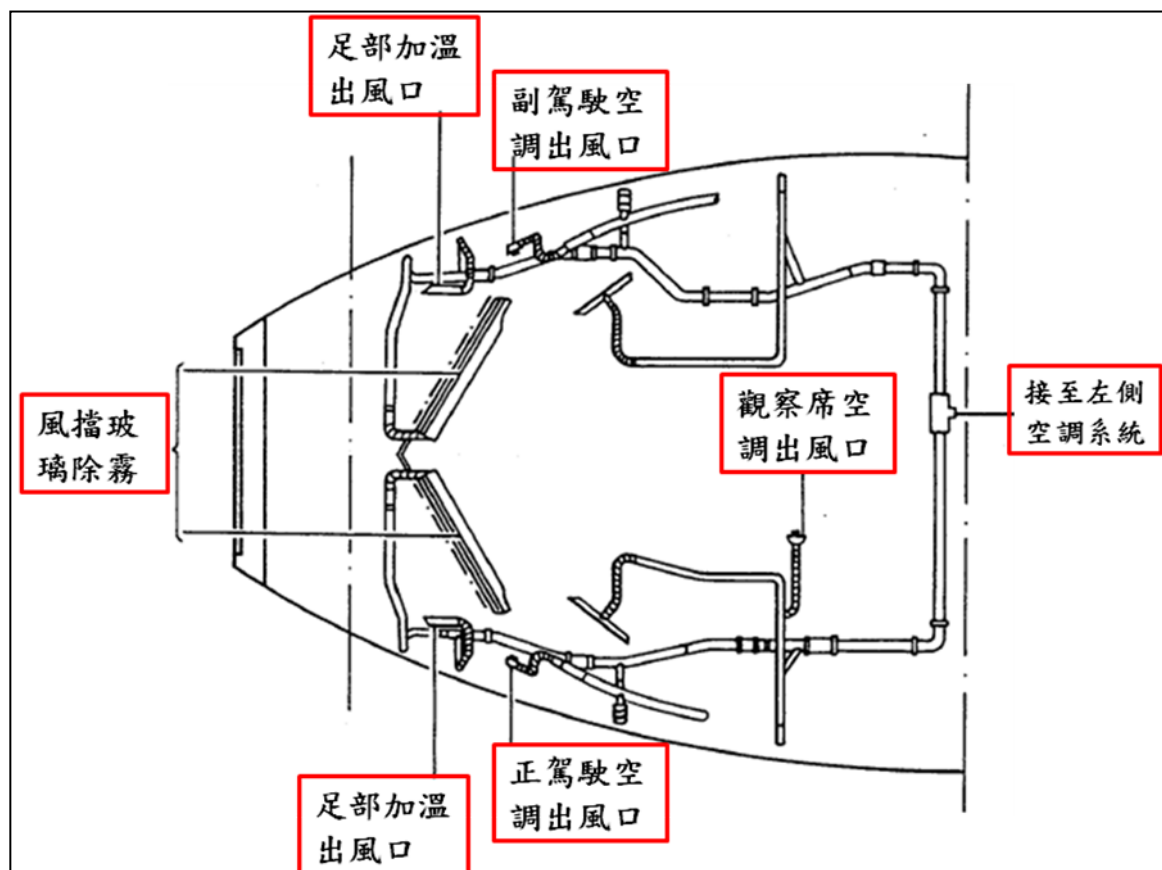
圖 1.16-1 駕駛艙空調出風口

復興維修員啟動左、右發動機後，分別開啟左、右空調系統，此時正、副駕駛側空調出風口（如圖 1.16.1-1）有較大出風量，但無熱空氣

自出風口吹出；選擇溫度控制面板之開關至「FLT COMP」，將左發動機油門手柄自慢車推至介於地面慢車（Ground idle）及飛行慢車（Flight idle）間之油門位置，復興維修員將左側空調溫度開關向右旋至最熱（Hot）位置，此時坐於副駕駛位置之人員可以感受到駕駛艙內逐漸充滿熱空氣，但無焦味或異味夾雜其中；請復興維修員將左側之駕駛艙空調溫度開關向左旋至最冷（Cold）位置，駕駛艙內燥熱感覺無改善；再將左發動機油門手柄置於慢車位置，駕駛艙同樣充滿熱空氣，燥熱感覺均未改變，詢問坐於客艙第一排人員，亦可感受到當時該機前艙充滿燥熱空氣，請復興維修員將左側空調閥門關閉後，駕駛艙內燥熱感覺始逐漸減低；觀察駕駛艙空調各出風口，僅有熱空氣排出，無焦味或異味夾雜，駕駛艙內環境無霧狀現象，亦無水蒸氣或煙霧自各出風口排出。
