飛航事故調查報告

ASC-AOR-14-03-001

復興航空公司GE 5111航班

松山機場起飛爬升時駕駛艙出現高溫氣體

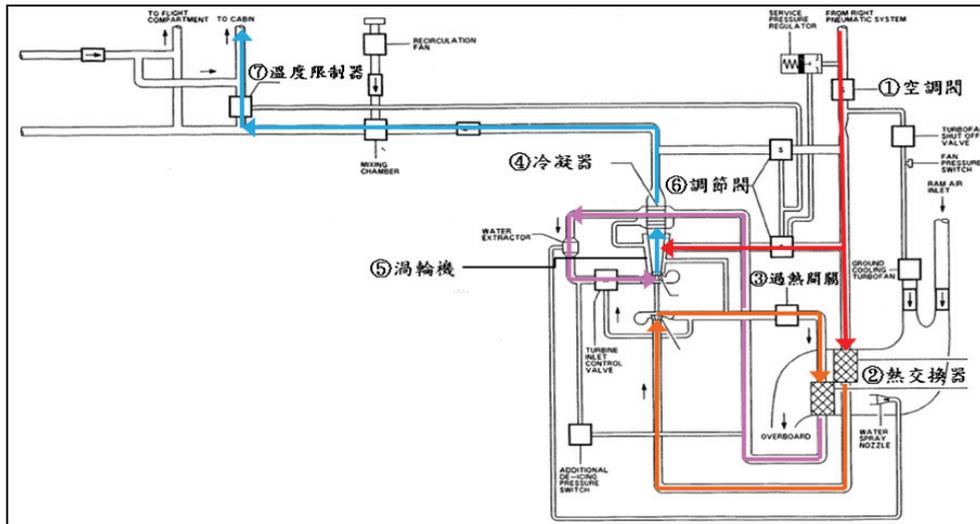
圖 1.6-1 空調系統示意圖

由發動機壓縮器引出之高溫壓縮熱空氣經空調閥（pack valve）（如圖 1.6-1 標號①）控制流量及冷卻後，分別進入 2 具氣冷式熱交換器（heat exchangers），主熱交換器用以冷卻自空調閥送出之熱氣，初步冷卻後進入空調壓縮器（air cycle machine）壓縮，壓縮器出口裝置一過熱開關（temperature switch，標號③），當壓縮出口空氣溫度達 $204 \pm 6^{\circ}\text{C}$ 時，過熱開關會送出訊號關閉空調閥。高壓之壓縮空氣再進入次級熱交換器，完成 2 次冷卻後進入冷凝器（condenser，標號④），壓縮空氣中之水分凝結後經氣水分離器（water extractor）排出，乾燥空氣再進入空調渦輪機（cooling turbine，標號⑤）進行膨脹降溫，成為乾燥低溫之冷卻空氣，

如圖 1.6-1 所示，冷卻空氣與自客艙之循環空氣混合後，在進入機艙前，會再與自標號①空調閥引出之適量熱氣混合，熱空氣的流量由如圖標號⑥調節閥（modulating valve）控制，經標號⑦管路溫度限制器（duct temperature limiter）由管路導引排放至駕駛艙及客艙；當前端之溫度限制器感測溫度超過 88°C 時，限制器會逐步將調節閥關閉。另一種控制調節閥門開合之訊號源，來自駕駛艙溫度控制面板之溫度選擇開關及溫控選擇鈕，溫控訊號依旋鈕位置自駕駛艙溫度控制面板傳遞至溫度控制器，再傳至多功能電腦（Multi Function Computer, MFC），經 MFC 處理後發出訊號。控制調節閥門之開合，溫控訊號顯示，以及本次事故後送修確認故障之溫度感測器如圖 1.6-2 所示。

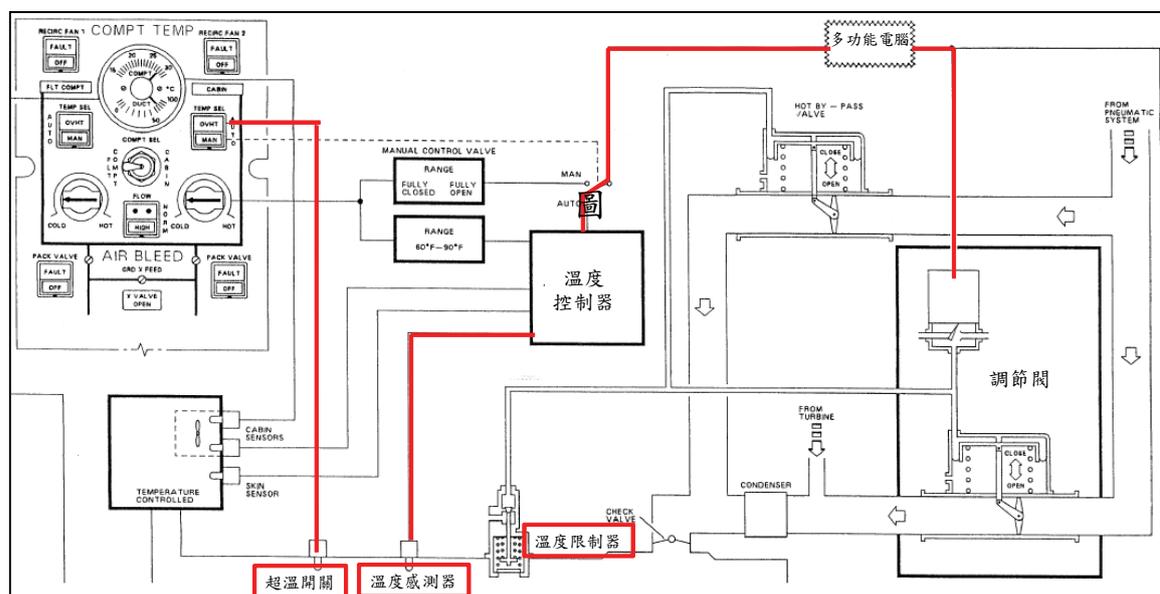
1.6-2 溫控訊號顯示及傳遞

前述維修作為項目之電子艙煙霧偵測器經復興測試正常後，回裝原機續用；事故後復興故障維修作為先依故障排除程序更換：溫度控制器、空氣調節閥及溫度感測器，航機經地面試車正常後恢復妥善；其後復興依飛安會及 ATR 建議，將左側空調系統管路溫度限制器及左側空調系統冷凝器及氣水分離器拆下送檢修。前述 6 項料件經送 Honeywell 公司檢修，結果冷凝器、氣水分離器、溫度控制器及空氣調節閥均正常，溫度感測器（temperature sensor，件號/序號：627962-2/627962-22956）中間溫度阻抗測試不合格（「FAILED MID TEMP RESISTANCE TEST」），管路溫度限制器檢修結果為，該限制器之功能測試不合格，檢修及測試報告詳附錄三。

為防止進入駕駛艙及客艙空調溫度過高，位於地板下之低壓空調配送管內裝置管路超溫開關，當管內空氣溫度達 $92\pm 4^{\circ}\text{C}$ 時，開關送出訊號，使駕駛艙「TEMP SEL」開關之超溫燈亮（如圖 1.6-2 左側紅框處），同時將警示訊息送至飛機中央組員警告系統（Central Crew Alerting System, CCAS）。該超溫開關附近一具管路溫度感測器（件號 627962-2），其所感測之溫度訊號同時會傳遞至如前段所述之溫度控制器及 MFC。

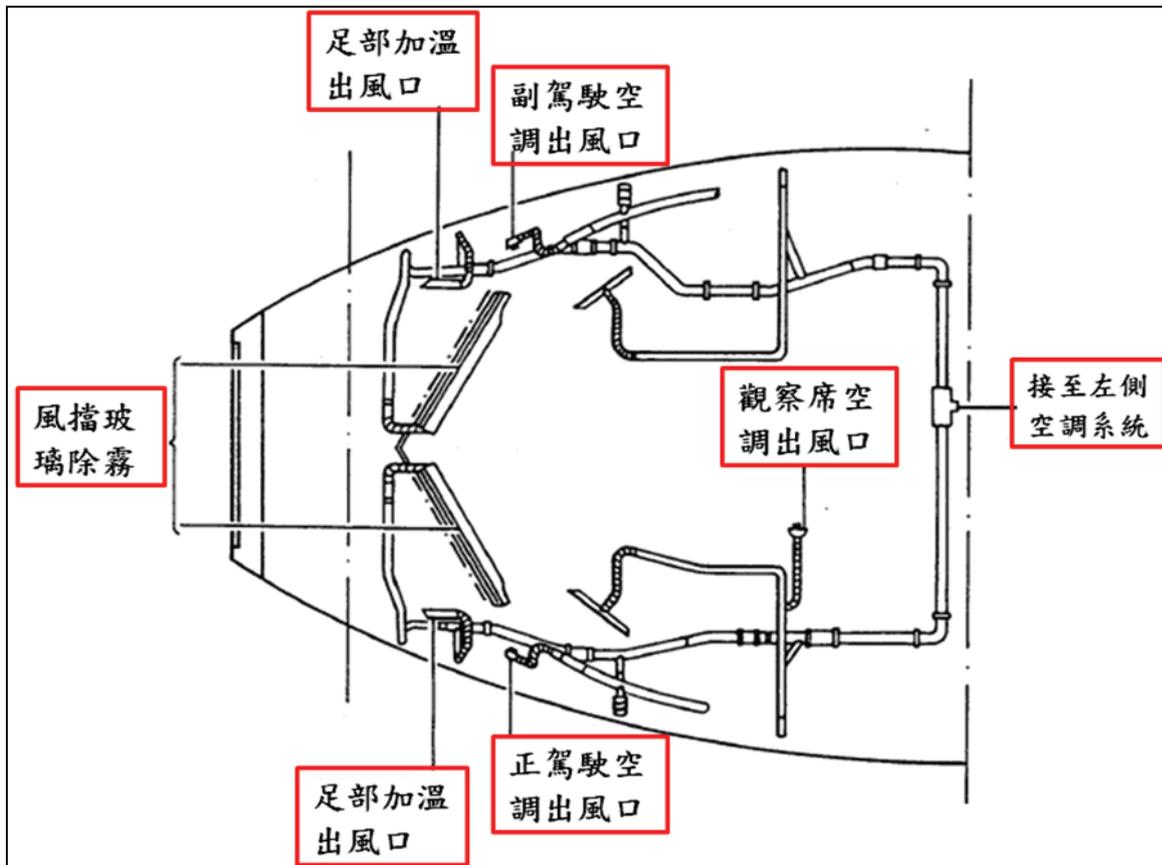
圖 1.16-1 駕駛艙空調出風口

復興維修員啟動左、右發動機後，分別開啟左、右空調系統，此時正、副駕駛側空調出風口（如圖 1.16.1-1）有較大出風量，但無熱空氣自出風口吹出；選擇溫度控制面板之開關至「FLT COMP」，將左發動機油門手柄自慢車推至介於地面慢車（ground idle）及飛行慢車（flight idle）間之油門位置，復興維修員將左側空調溫度開關向右旋至最熱（hot）位置，此時坐於副駕駛位置之人員可以感受到駕駛艙內逐漸充滿熱空氣，但無焦味或異味夾雜其中；請復興維修員將左側之駕駛艙空調溫度開關向左旋至最冷（cold）位置，駕駛艙內燥熱感覺無改善；再將左發動機油門手柄置於慢車位置，駕駛艙同樣充滿熱空氣，燥熱感覺均未改變，詢問坐於客艙第一排人員，亦可感受到當時該機前艙充滿燥熱空氣，請復興維修

員將左側空調閥門關閉後，駕駛艙內燥熱感覺始逐漸減低；觀察駕駛艙空調各出風口，僅有熱空氣排出，無焦味或異味夾雜，駕駛艙內環境無霧狀現象，亦無水蒸氣或煙霧自各出風口排出。

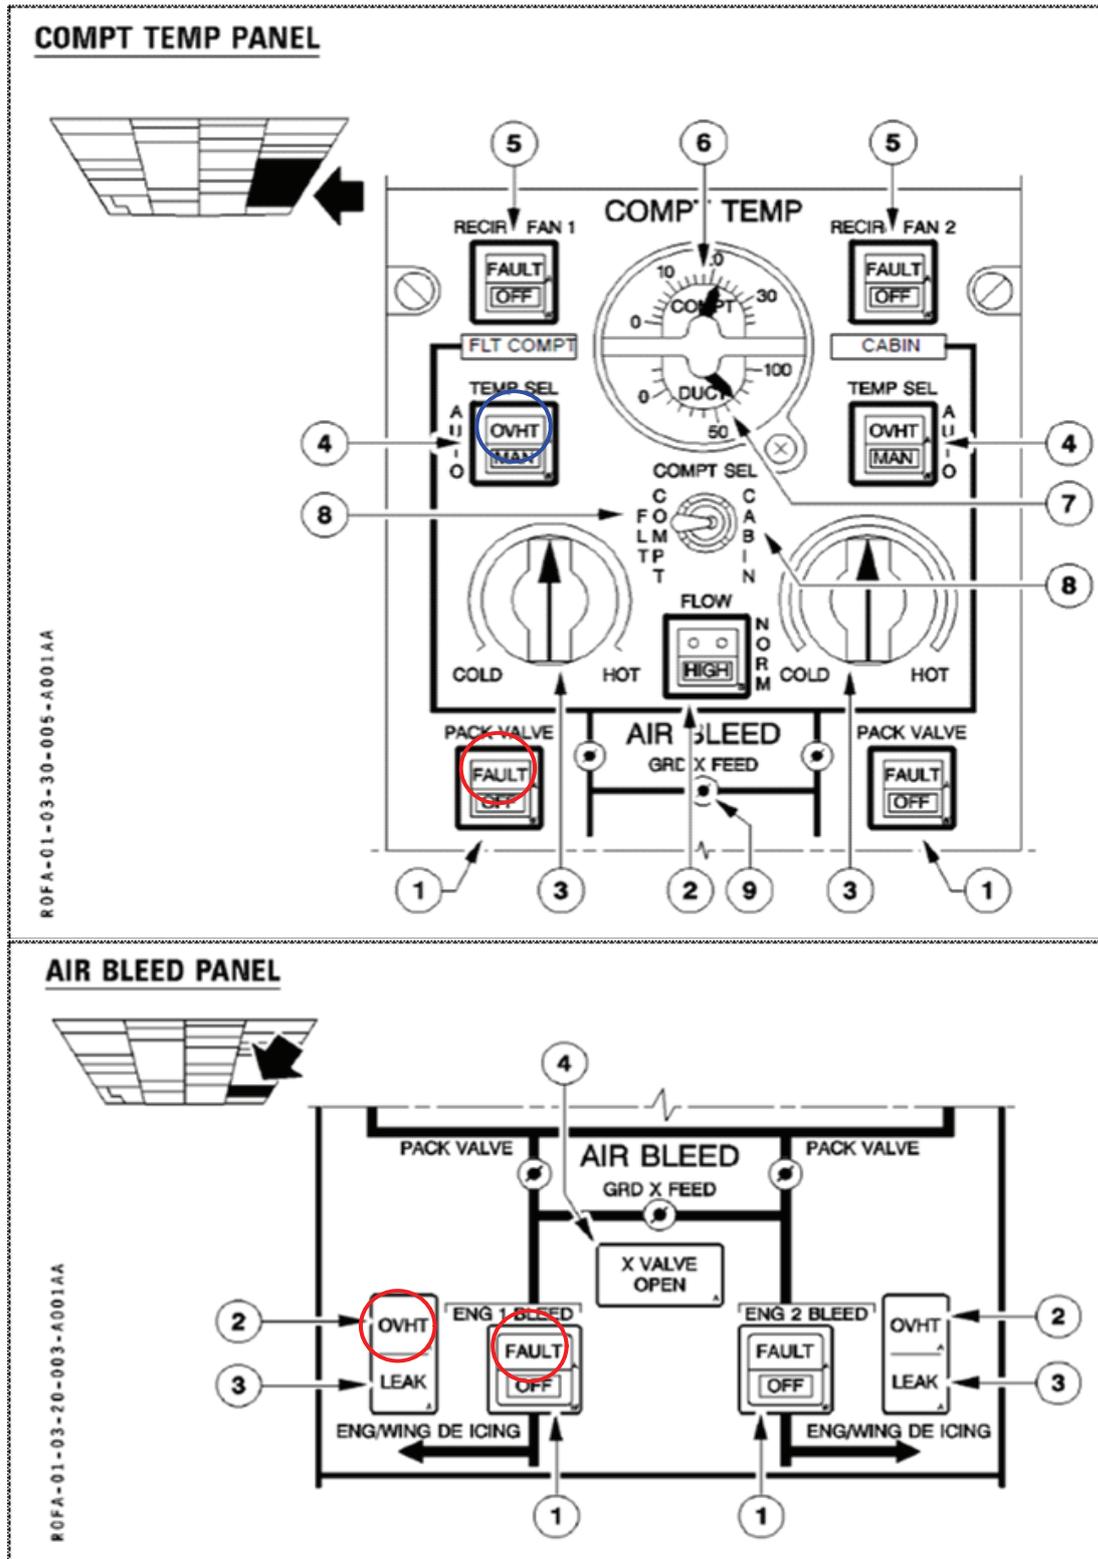
圖 1.18-6 頭頂面板指示燈顯示狀況示意圖

注意部分指出：當發動機供氣管路（bleed duct）溫度大於攝氏 274 度/華氏 525 度時，主警示燈（master caution）會閃琥珀色，並有單一警示聲響；組員警告面板（CAP）的「AIR（供氣系統）」燈會亮琥珀色；頭頂面板中，若是 1 號發動機的供氣超溫，圖 1.18-6 中三個紅色圓圈標記處的燈會亮琥珀色，分別是 1 號發動機供氣（ENG 1 bleed）「OVHT」燈、「FAULT（故障）」燈、以及 1 號空調閥（pack valve）的「FAULT」燈。
