飛航事故調查報告

ASC-AOR-17-06-001

**中華民國105年4月17日
中華航空公司CI025班機
BOEING 737-800型機
國籍標誌及登記號碼B-18609
於關島西北方約150海浬上空艙壓異常返航**

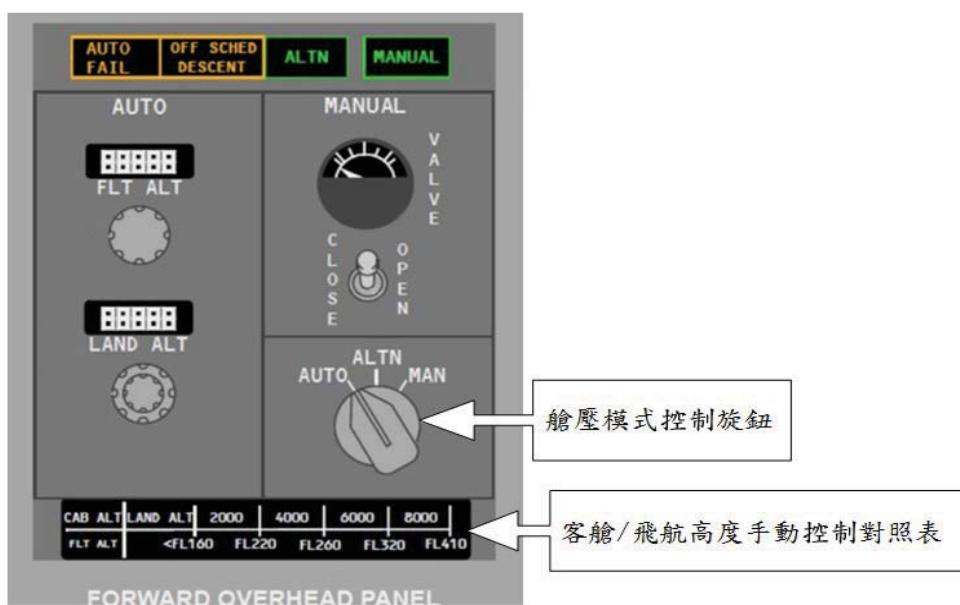
圖 1.1-1 艙壓控制模組面板

1421:37 時，該機爬升通過 27,434 呎高度，駕駛艙主警示³作動，伴隨艙壓控制模組（cabin pressure control module, CPCM）面板（詳圖 1.1-1）之「AUTO FAIL」（自動失效）及「ALTN」（替代備用）燈亮，飛航組員隨即執行快速參考手冊（quick reference handbook, QRH）AIR SYSTEMS 章節之「AUTO

FAIL/UNSCHEDULED PRESSURIZATION CHANGE」處置程序，將艙壓控制模式旋鈕⁴由「AUTO」（自動）位置切換至「ALTN」位置，因艙壓自動控制仍然失效，遂續依該程序將艙壓控制模式旋鈕切換至「MAN」（手動）位置。飛航組員比對該機當時高度約 28,000呎、艙壓高度約 5,000呎⁵，低於客艙/飛航高度手動控制對照表⁶6,000呎之設定值，判斷艙壓仍處於可控狀態，遂決定減低爬升率繼續爬升。

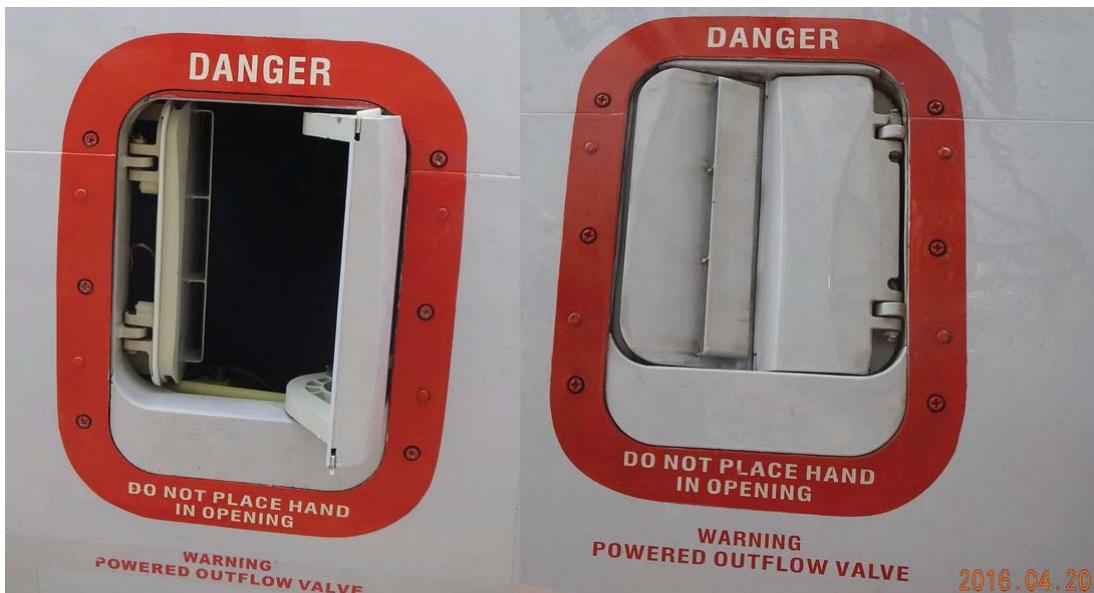
圖 1.6-3 OFV 閥門打開（左）關閉（右）位置圖

OFV 包含 2 具自動控制馬達、1 具手動控制馬達、齒輪連動裝置以及閥門等，在「AUTO」模式時，主控之 CPC 控制訊號驅動自動控制馬達，帶動齒輪組及連桿以控制 OFV 閥門之開合(如圖 1.6-3)，OFV 閥門之位置訊號亦回傳至 2 具 CPC；在「MAN」模式時，OFV 閥門開合直接由駕駛員操作 CPCM 之 OPEN/CLOSE 撥動開關控制手動馬達作動，閥門開口大小顯示於 CPCM 之 VALVE 儀表上。

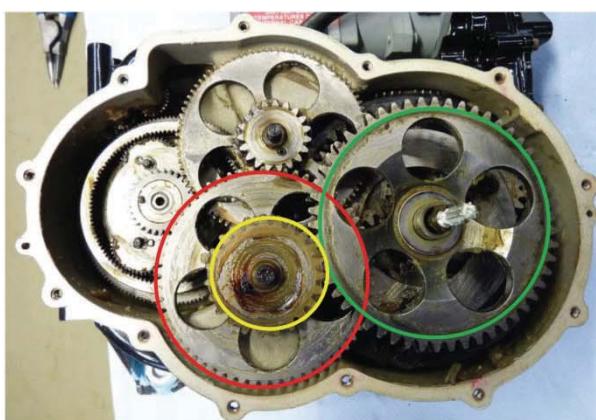
Picture 1 Gear Train

1. 航機艙壓系統外流閥齒輪插銷斷裂，使外流閥門無法控制，導致航機艙壓異常返降關島。

事故後該機之 OFV、CPCM 及 2 具 CPC 被拆下送至位於德國之 NORD-MICRO 原廠授權修理廠執行檢查及測試，1 號艙壓控制器壓力測試值未達測試標準但與本事故肇因無關；2 號艙壓控制器及艙壓控制模組檢查結果均正常；OFV 拆檢後發現，馬達傳動至閥門之兩只齒輪插銷斷裂，導致駕駛員無法以「AUTO」、「ALTN」及「MAN」模式控制 OFV 閥門開合。

After the Gearbox has been opened, it could be easily noticed that the green marked gear was decoupled from the red marked gear, which normally drives the green marked gear via the yellow one.
