國家運輸安全調查委員會

重大運輸事故 事實資料報告

遠東航空股份有限公司 FE3060 班機

於臺中清泉崗機場落地時短暫偏出跑道

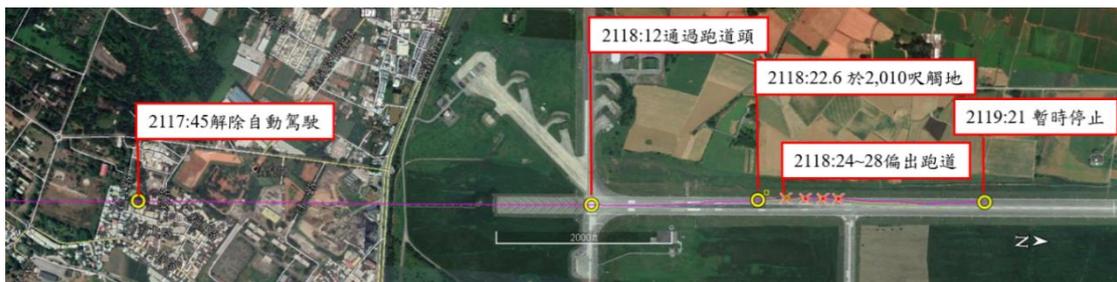
圖 1.1-2 事故機落地軌跡圖

PM 於訪談時表示距跑道頭約 1 哩時，目視航機落地燈照到跑道道面有反光，且可看到水波紋，表示跑道有積水。PF 表示航機觸地剎那，瞬間向左偏，立刻放下鼻輪修正，但航機仍然向左偏出跑道，修正回跑道後，將航機停止於距跑道頭約 7,000 呎處並通知塔臺航機可能因出跑道受損，建議派員至現場檢視。經地面人員確認航機除右主輪轂有草外無其他損傷後，始將航機滑回停機位置。該機自馬公機場起飛至臺中機場全程飛航軌跡如圖 1.1-1，落地期間偏出跑道之軌跡如圖 1.1-2。

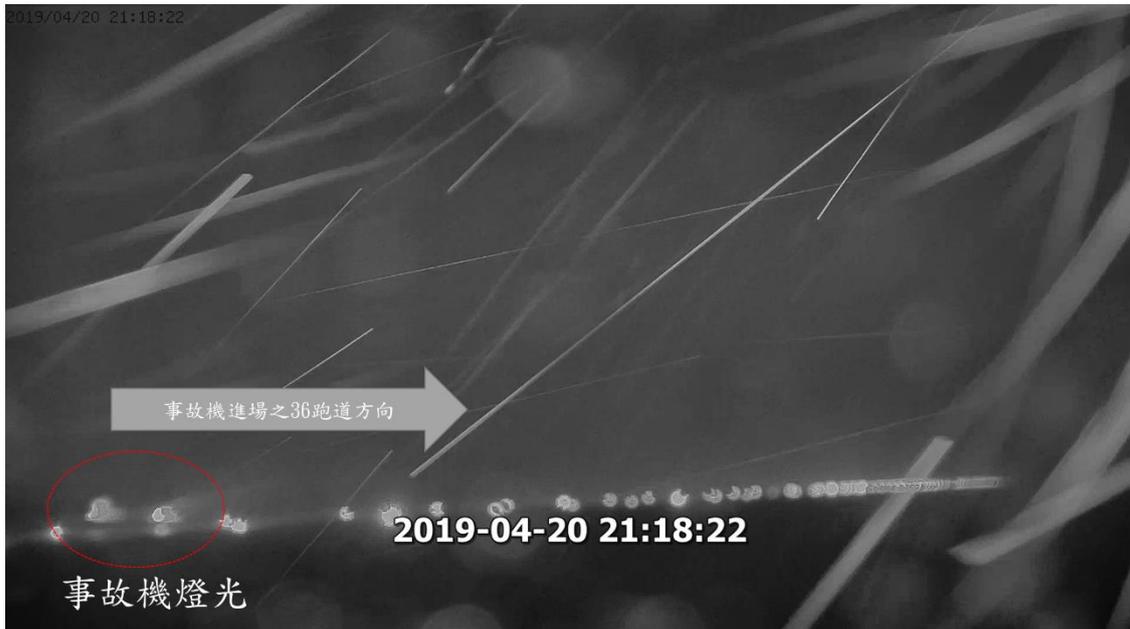
另依據事故當時 36 跑道頭安裝之監視攝影機紀錄畫面顯示，該機落地時，攝影機紀錄畫面顯示為中至小雨狀況，如圖 1.7-7。

圖 1.7-7 該機落地時 36 跑道頭監視攝影機紀錄畫面

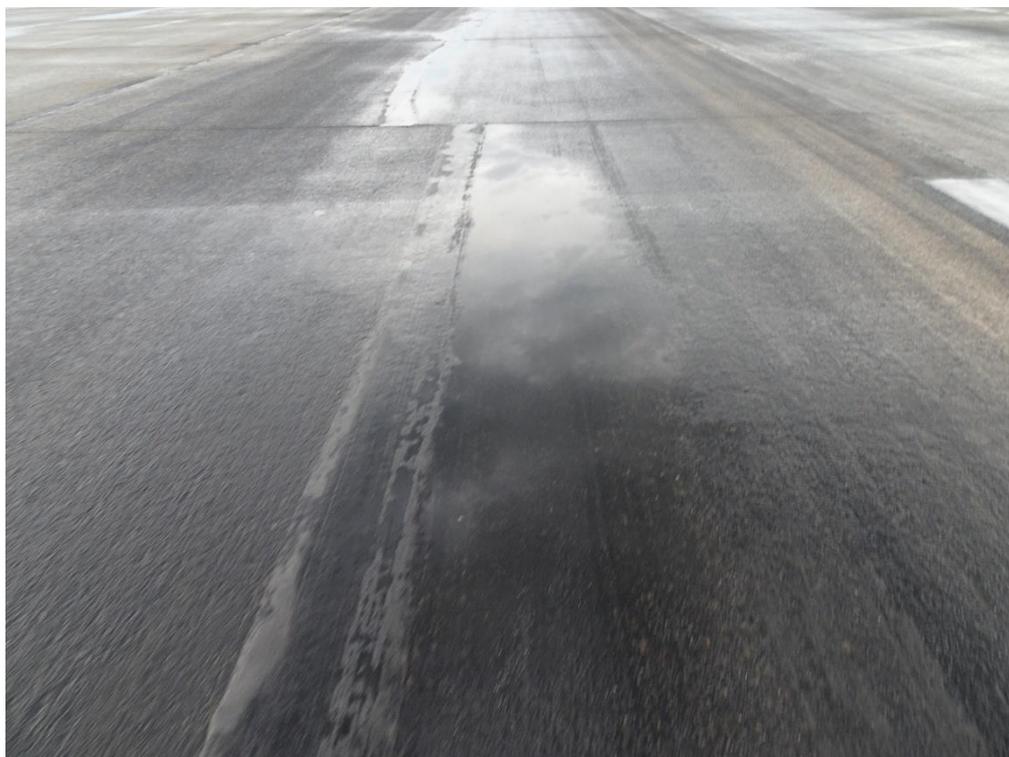
本會調查小組於事故後隔日，即 108 年 4 月 21 日約 0500 時於臺中機場進行事故現場量測與鋪面檢視，發現 36 跑道著陸區之鋪面存在局部之水窪（如圖 1.10-3 與 1.10-4）、以及不規則之鋪面補塊與裂紋（如圖 1.10-5）；以及距 36 跑道頭約 2,000 呎至 4,500 呎間之兩側跑道邊緣鄰近區域存在有積水，如圖 1.10-6 與 1.10-7。

圖 1.10-3 跑道著陸區之局部水窪(一)

5.5 跑道隨時間之變形也可能增加形成水窪之可能性。當水窪約達 3mm 深時，特別是當降落飛機高速滑行中遭遇水窪，將導致飛機之飄滑 (aquaplaning)，如浸濕 (WET) 之跑道上存在有許多水窪時，漂滑之影響將會持續。

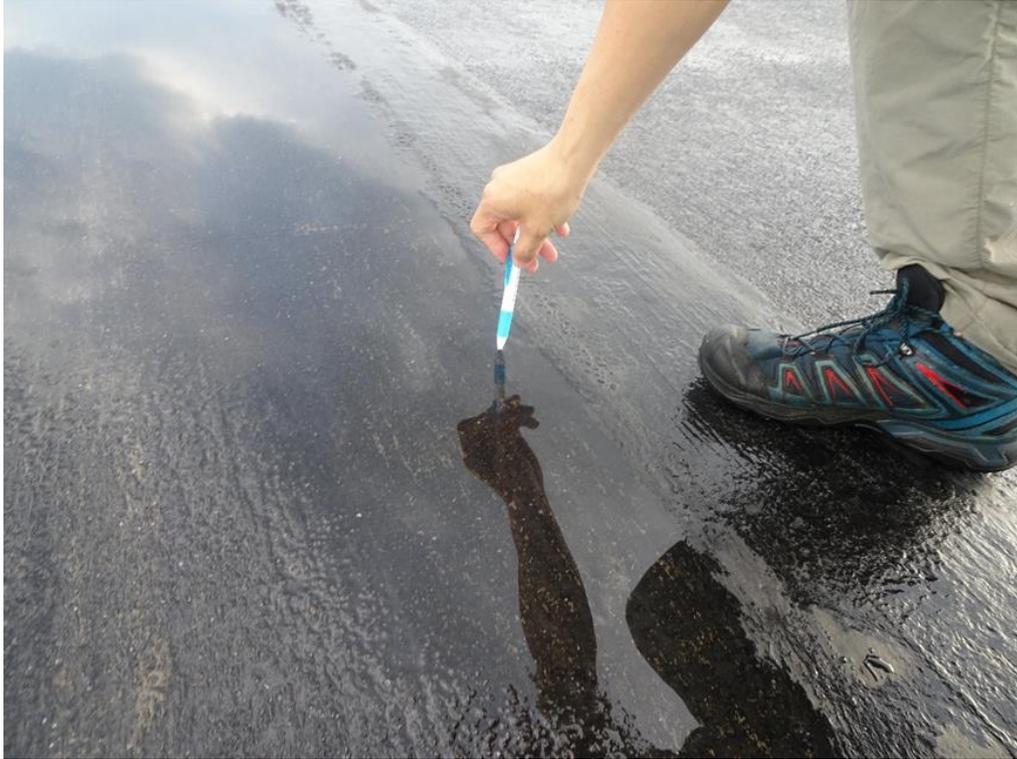
圖 1.10-4 跑道著陸區之局部水窪(二)

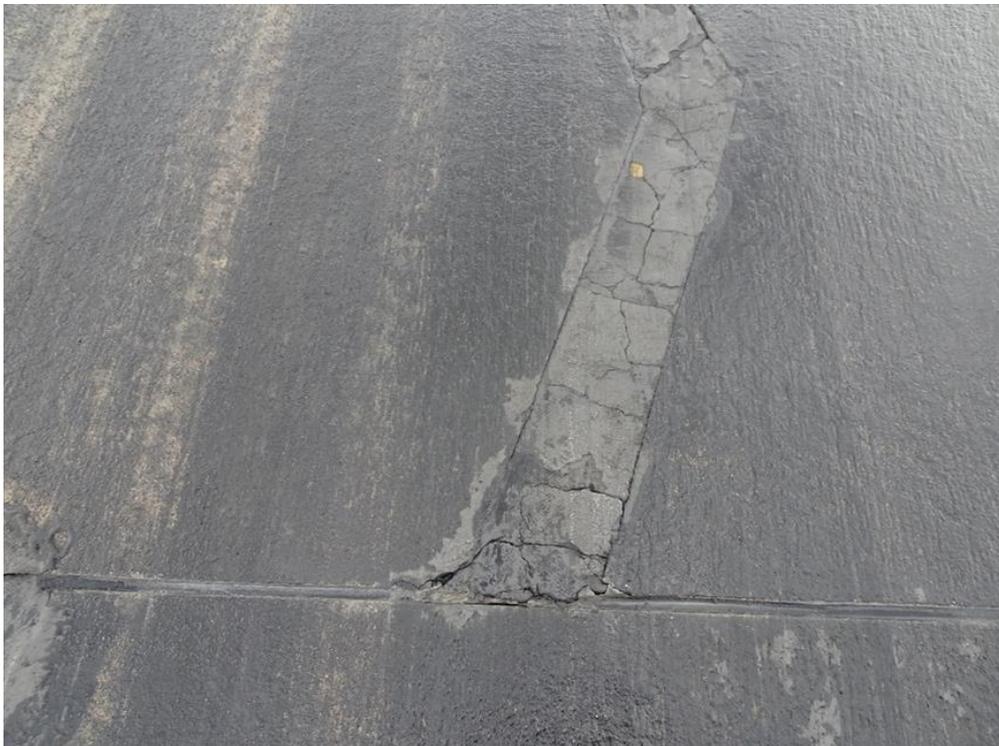
圖 1.10-5 不規則之鋪面補塊與裂紋

10.2.2 跑道道面應妥善維護，不可有危害航空器之不平坦情況。

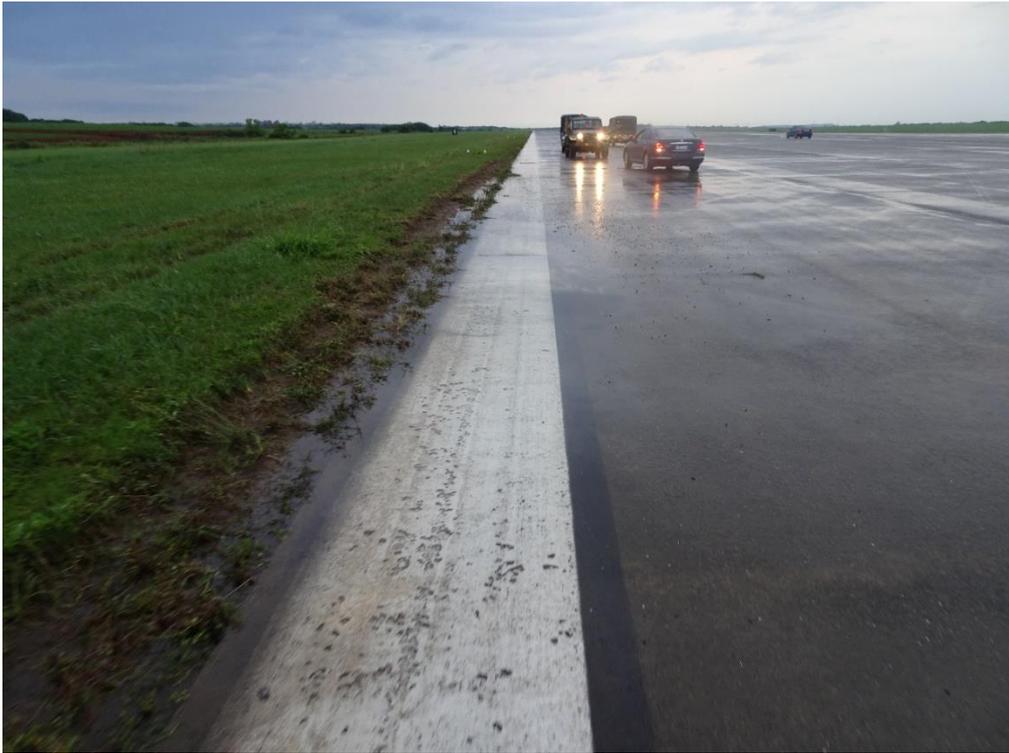
圖 1.10-6 跑道邊線鄰近區域之積水(一)

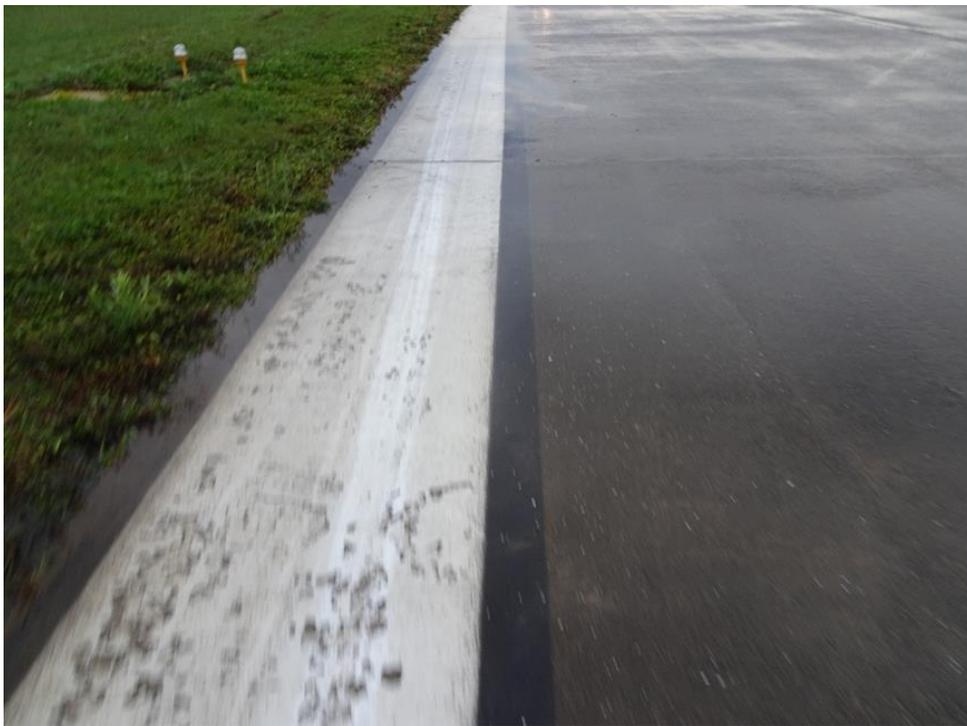
圖 1.10-7 跑道邊線鄰近區域之積水(二)

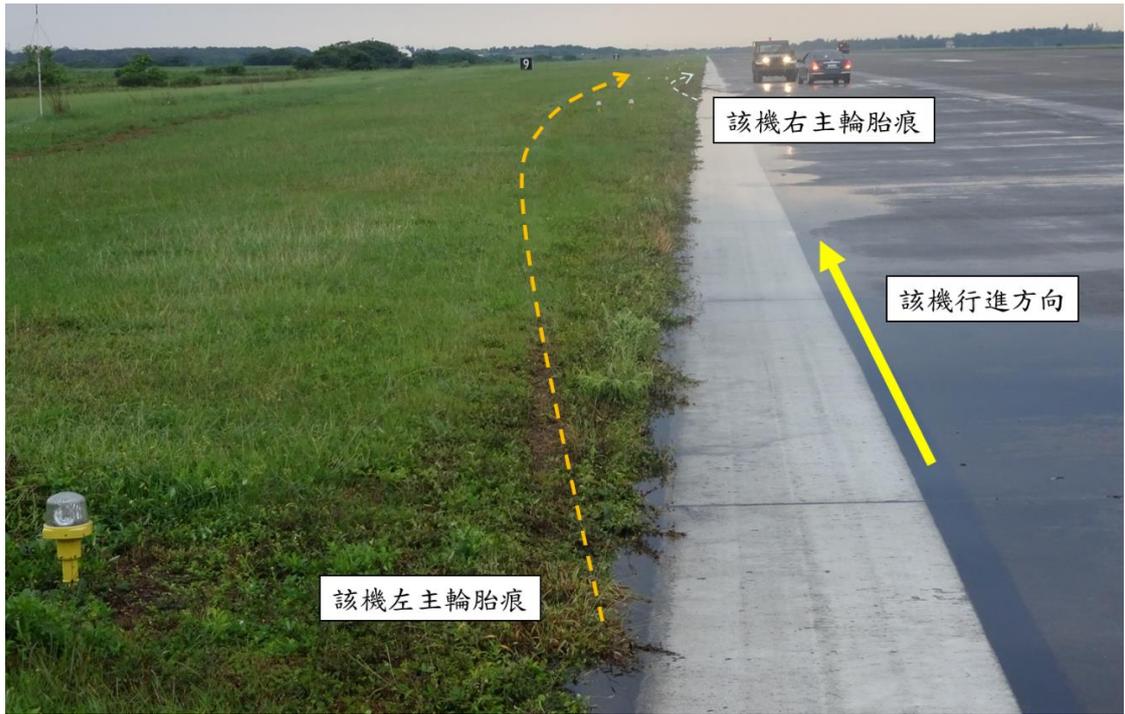
距 36 跑道頭約 2,280 呎處發現事故機偏出跑道胎痕，向左偏出 36 跑道邊線，胎痕與跑道方向夾角約 4 度，事故機在草地上遺留之胎痕軌跡如圖 1.12-1 及圖 1.12-2 所示，事故機於距 36 跑道頭約 2,880 呎處返回跑道道面，停止位置座標為東經 120 度 37 分 14.88 秒、北緯 22 度 15 分 39.59 秒。量測成果與該機 FDR 飛航軌跡套疊如圖 1.12-3

圖 1.12-1 事故機偏出跑道胎痕

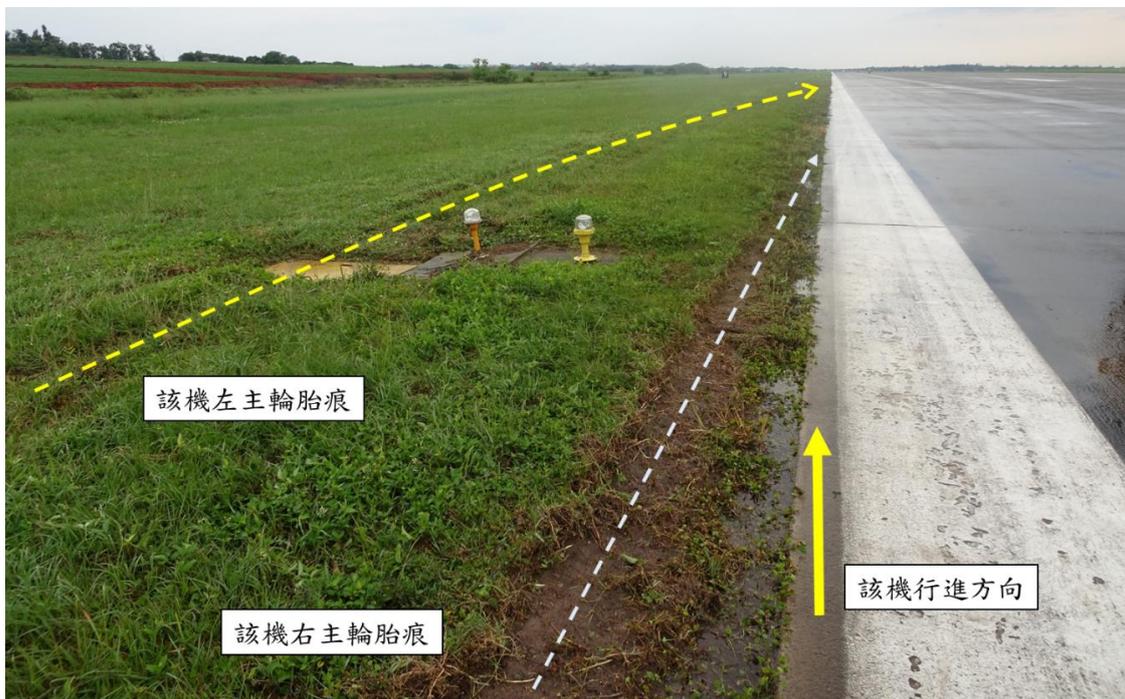
圖 1.12-2 事故機返回跑道道面胎痕
