# 國家運輸安全調查委員會

## 事實資料報告

國籍標誌及登記號碼 NA-103

執行模擬尾旋翼失效程序時墜毀

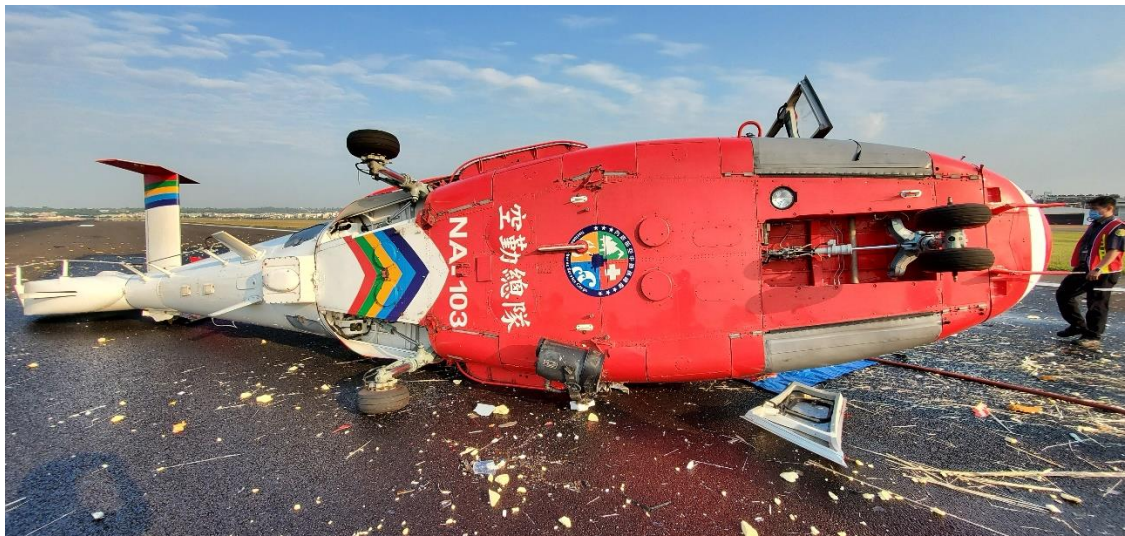
圖 1.1-3 停止於跑道之事故機

50 呎，繼續沿跑道穩定飛航並下降至距道面約 20 呎，速度約為 60 浬/時；1530 時，該機開始建立右偏角度，於 1530:15 時到達約 30 度之右偏角（機頭向右）並沿跑道前行，前進姿態穩定，速度減少至約 28 浬/時。至 1530:48 時前，該機保持約 20 度至 40 度之右偏角、保持距地約 20 呎之高度沿跑道方向前行，速度開始繼續減少至約 16 浬/時。1530:54 時航機右偏角度加大至約 40 度，呈滯空狀態，速度已遞減至 0，至 1530:59 時，航機開始快速右偏，約於 1531:01 時主旋翼打地，並冒出大量白煙。1531:06 時，白煙向南飄散，航機側翻於跑道上，機身左側向下，主旋翼全毀，機首方向約為 260 度。該機於進入跑道後之飛航軌跡，如圖 1.1-2，停止於跑道上之姿態，如圖 1.1-3。

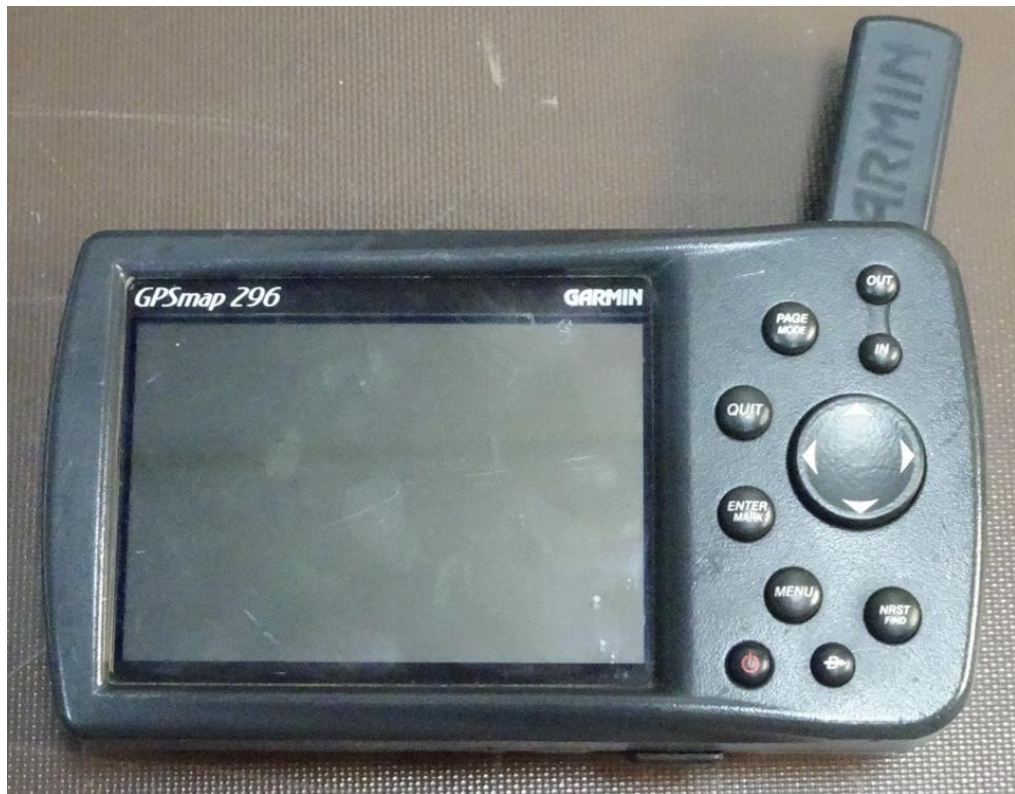
圖 1.11-2 該機 GPS 外觀檢視

事故機飛航中裝有 Garmin 296 型 GPS 接收機（如圖 1.11-2），依原廠技術文件<sup>2</sup>，其水平位置精度約 15 公尺。事故後取得該 GPS，無明顯損傷及受潮跡象，可正常開機。

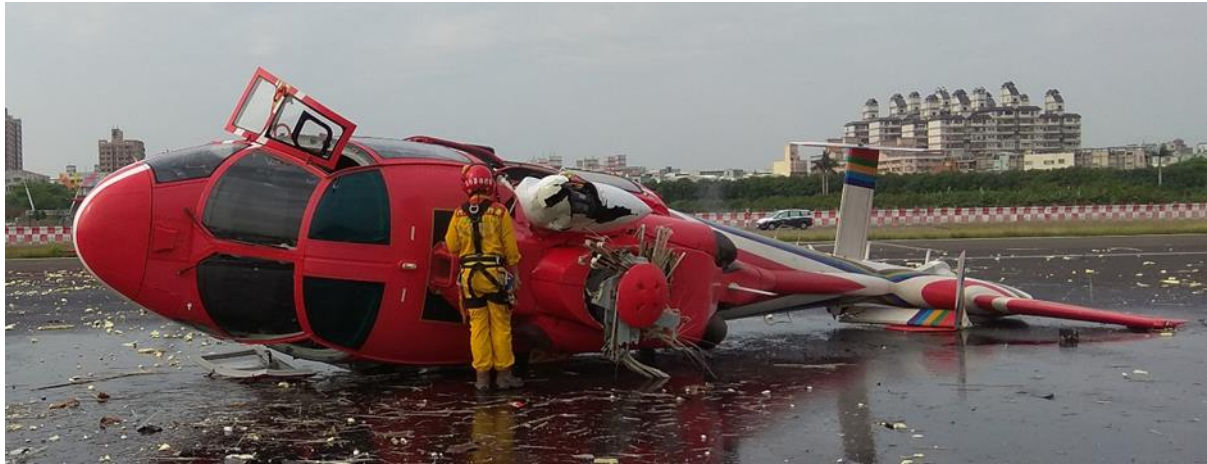
圖 1.12-1 事故機於現場照片

依事故現場照片顯示：事故當時明顯之損壞包含主旋翼全毀，機身向左翻覆、前機身左側磨損、左駕駛艙門脫落，左水平安定面折斷，尾桁末段受損，事故機於現場照片如圖 1.12-1。航機損壞狀況如後：

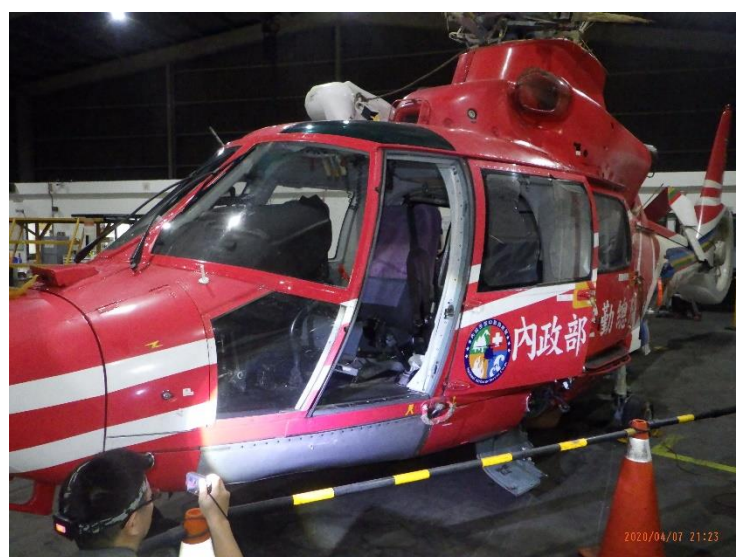
圖 1.12-2 機身左側受損情形

左側機身：機身左側因左傾翻覆，左駕駛艙門脫落、前乘客門玻璃破裂、左中乘客門玻璃破裂且無法關閉、左浮筒檔環折斷及蓋板破損管線外露、探照燈吊架折斷、左後門玻璃與開關周邊破損、左後門鉸鏈及滑軌變形等（如圖 1.12-2）。

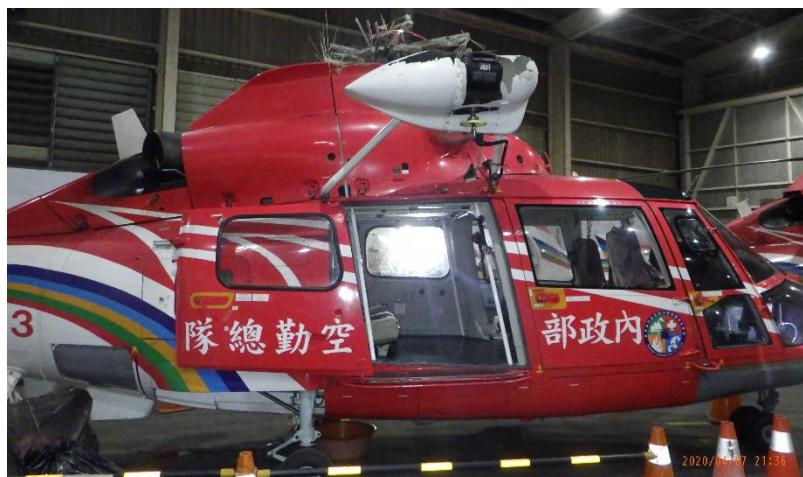
圖 1.12-3 機身右側受損情形

右側機身：因航機向左傾翻覆，機身右側在上，外觀相對完整，主要受損為人員吊掛毀損、尾段接合面結構摺痕。整體而言，右機身各部大致連結完整（如圖 1.12-3）。

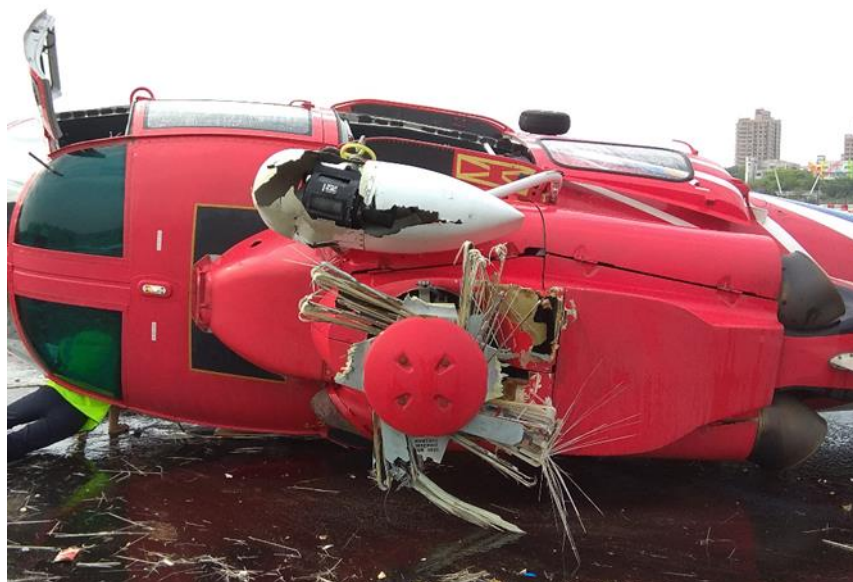
圖 1.12-4 主旋翼受損情形

主旋翼系統：主旋翼頭、4片主旋翼、包含連接器，已全數毀損，主旋翼軸變形，主傳動箱外罩破損（如圖 1.12-4）。

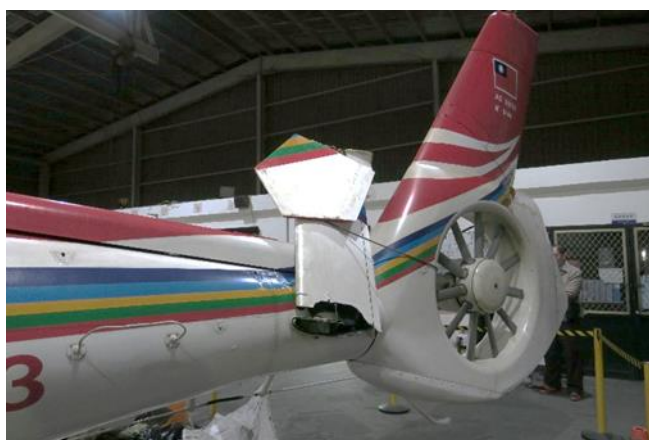
圖 1.12-5 尾桁及尾旋翼受損情形

尾桁／尾旋翼：左水平安定面折斷、尾旋翼下方受損與外框擦痕、防撞燈底座破損、尾桁末段向右側擠壓變形及外殼上部裂開、尾旋翼進氣通

道磨損、左側 VOR 天線折損，尾旋翼齒輪箱滑油磁性塞（magnetic chip detector）檢查無金屬屑（如圖 1.12-5）。

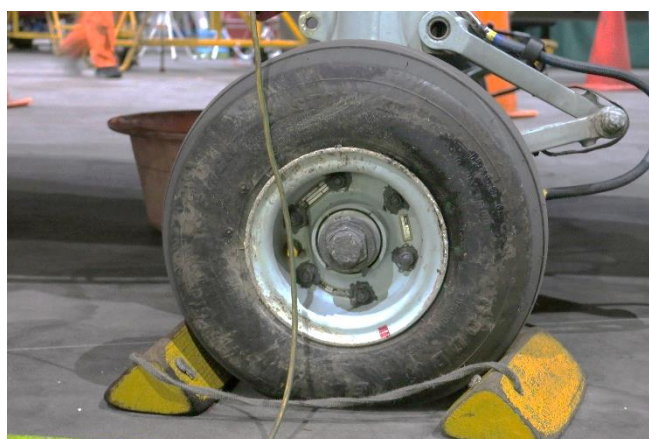
圖 1.12-6 左起落架輪轂及輪胎

起落架：鼻輪起落架減震支柱、左/右主起落架減震支柱均有滲油現象、左起落架輪框外側有明顯摩擦痕跡（如圖 1.12-6）。

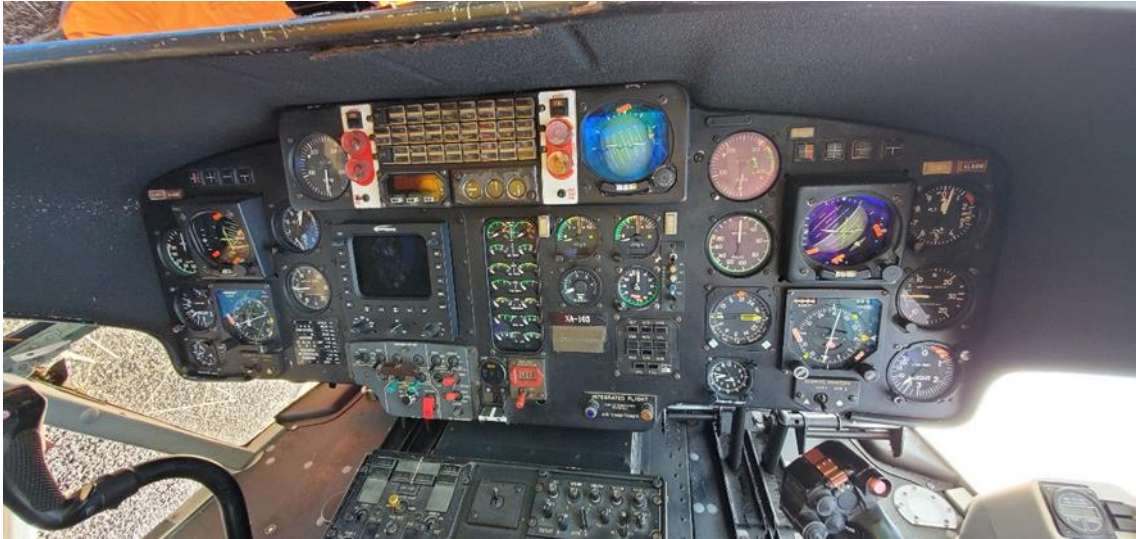
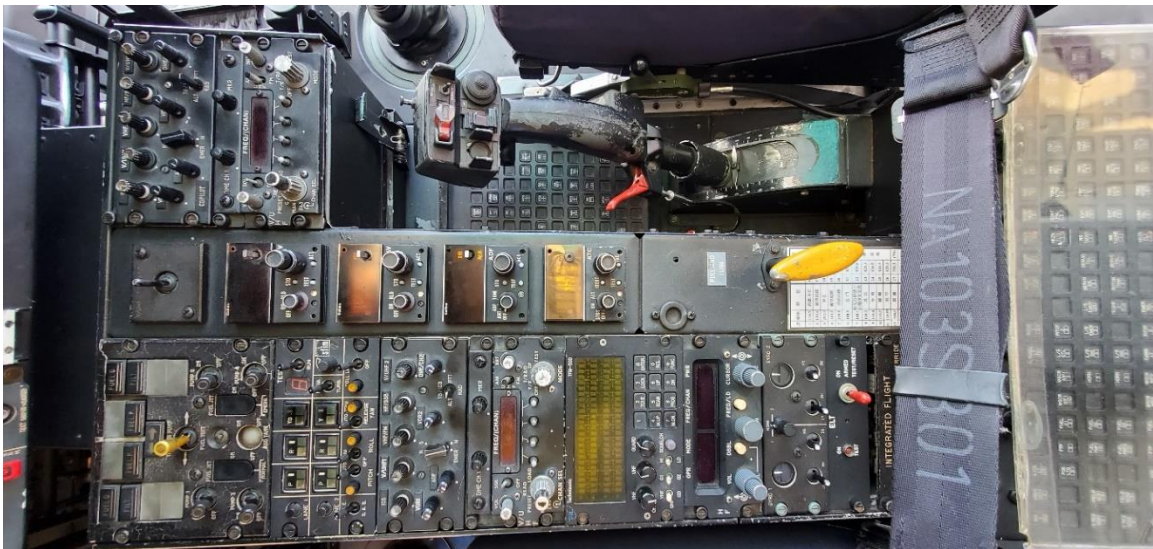
駕駛艙儀表及操作開關：駕駛艙內部並無明顯撞擊痕跡，儀表指示均已歸零或無顯示，如圖 1.12-7 及圖 1.12-8。集體桿位置無異狀（如圖 1.12-9）、方向舵踏板顯示左舵稍前（如圖 1.12-10）、yaw damper 及 yaw control 開關位於關斷位置（如圖 1.12-11）、油門位於關斷位置（如圖 1.12-12）。

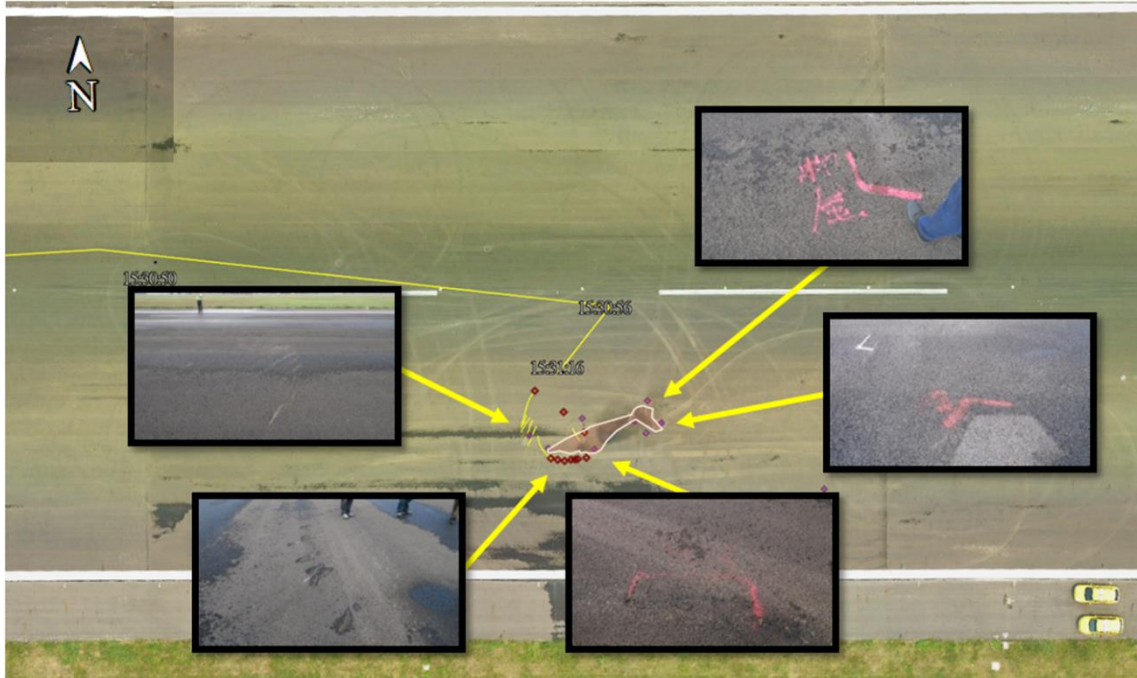
圖 1.12-14 現場量測整合圖

相關測量成果搭配該機 GPS 軌跡，並與遙控無人機拍攝及後製之 1 公分解析度正射影像套疊如圖 1.12-14 所示。根據現場測量結果，該機於 09 跑道進場後因機身傾轉，導致主旋翼接觸跑道產生多處刮痕，刮痕區域離 09 跑道頭約 4,960 呎，離跑道中心線右側約 35 呎，該機停止位置離 09 跑道頭距離約 4,980 呎，離跑道中心線右側約 46 呎，機鼻參考方向為 253 度。
