# 國家運輸安全調查委員會

## 重大運輸事故 調查報告

華信航空股份有限公司 AE7931 班機

於下降過程客艙短暫失壓

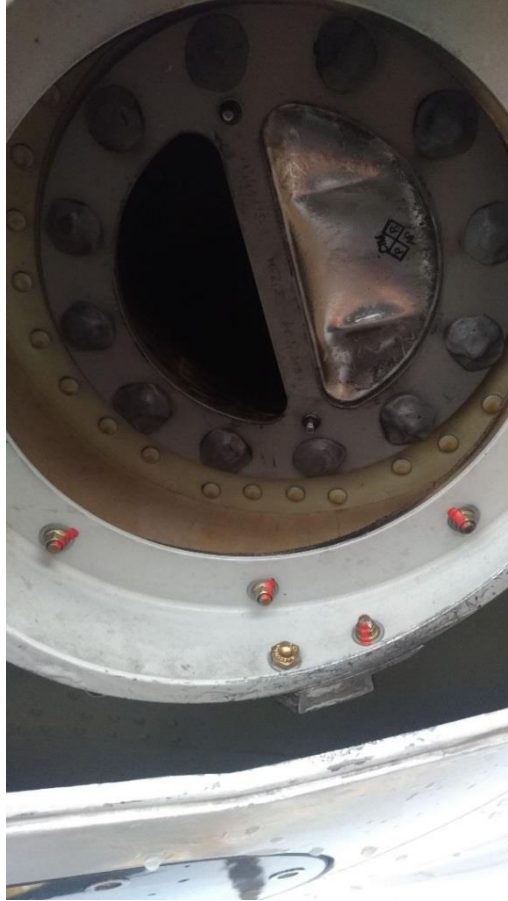
圖 1.6-1 空調地面連接單向閥失效位置

事故機於飛航過程中發生艙壓異常狀況，航機降落花蓮機場後，地面維修人員依維修手冊檢查航機，發現件號為 41125A01 之空調地面連接單向閥 (ground connection check valve) 故障，無法維持在全關閉位置 (如圖 1.6-1 所示)，同時檢查發現閥門下游之空調分布管凹陷受損。維修人員依維修手冊更換該閥門及其下游之空調分布管，經檢查測試後，航機恢復正常。

事故機於事故航班前曾在高雄機場地停時使用地面空調機，依據事故後航機於花蓮機場地面檢查之發現，空調地面連接單向閥閥門上施予閥門葉片壓力之彈簧斷裂，閥門無法維持在全關閉位置。此單向閥連接加壓艙內與艙外，在航機地停時，地面空調機管路接上單向閥後可提供空調空氣至航機客艙及駕駛艙。此閥門正常工作時，空調空氣由機外往機內單向流通，當撤離地面空調機管路後，閥門葉片因有彈簧加壓，閥門會自動回復到關閉位置；當機艙開始加壓時，因機艙內外壓差，此閥門亦會保持於關閉狀態。

依據事故後航機之檢視發現，施予閥門葉片壓力將閥門關閉之彈簧斷裂，致閥門無法維持在全關閉位置，當閥門未關閉時，如同將飛航中已加壓之飛機機艙與艙外大氣環境接通，造成機艙內部空氣自未閉合之單向閥門洩出機外，在發動機供氣量較少狀況下，會使飛機客艙高度增加，無法保持額定之客艙壓力。

- 本次事件飛機(B-16851)已於事件發生後更換新型 *Air conditioning ground check valve*，其餘 4 架 ATR72(B-16852~B-16856 機)於 2019 年 5 月 14 日~5 月 15 日執行更換新型 *check valve*；本公司今年引進之新機(B-16857、B-16858)出廠時已配置新型 *check valve(standard modification)*。
- 依 TPS 21-22-001 建議，機務部已於 2019 年 5 月 3 日修訂 *Pre-flight*、*Transit* 及 *Daily check* 工單，增列 NOTE：若當班次飛機有使用外接冷氣車，當外接冷氣車撤離後，機務人員應確認 *Air conditioning ground check valve* 在 *Fully close* 位置。
- 除依 MPD/AMP C check ZL192-GVI-100000-1 執行檢查項目外，另納

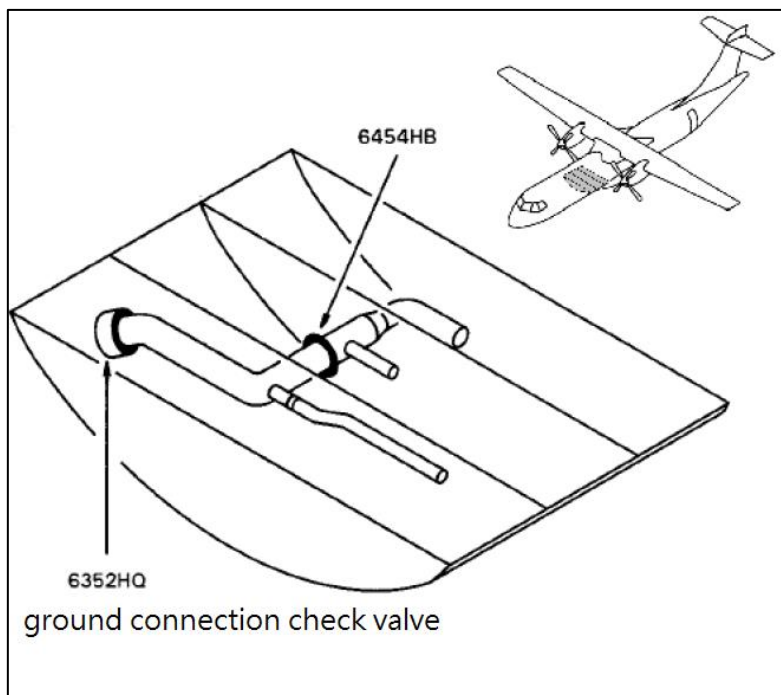
圖 1.6-2 空調地面連接單向閥裝置位置

空調地面連接單向閥裝置位於機腹右側，位置如圖 1.6-2 所示，裝備代號 6352HQ 所示，外觀如圖 1.6-3，其功能為當航機地停時，將機外空調系統連接此單向閥，可經由空調管將機外空調空氣供應至客艙及駕駛艙。

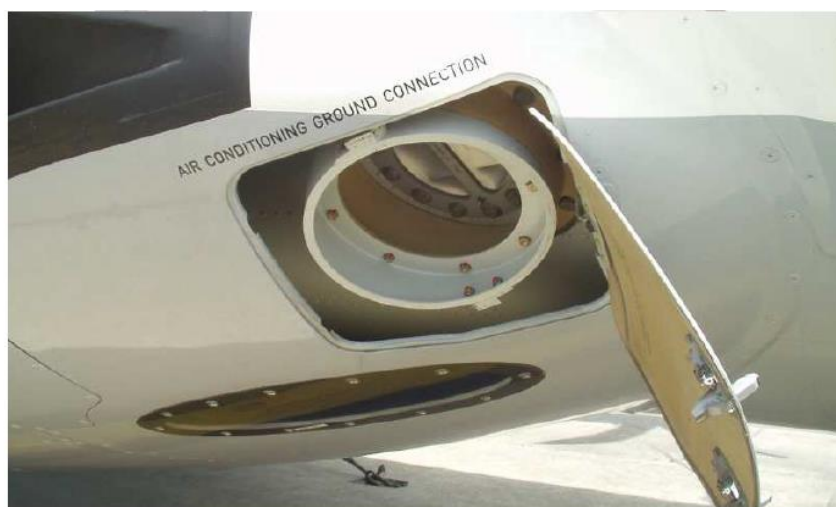
圖 1.6-3 空調地面連接單向閥外觀

航空器製造廠於 104 年 10 月以編號 TPS 21-22-001 發布技術進展狀況 (technical progress status, TPS)，其內容顯示件號 41125A01 之空調地面連接單向閥，曾發生因為閥門彈簧失效，造成閥門無法維持在全關閉位置，其結果可能使飛機艙壓無法建立，並可能在艙壓發生異常時，因為機艙內外差壓，使該閥門下游之空調分布管凹陷受損。為避免此狀況發生，製造廠建議在每次使用地面空調後，移除地面空調導管時，檢查此閥門的位置，

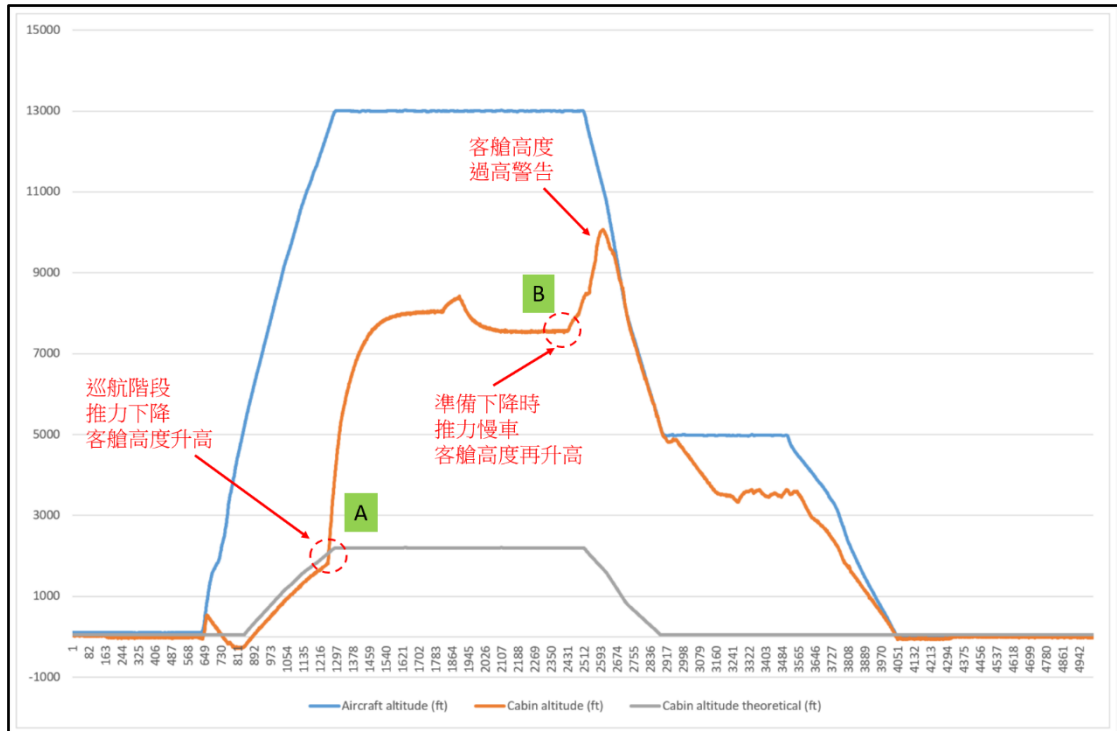
圖 2.2-1 客艙高度與相關資料繪圖

在空調地面連接單向閥未關閉狀況下，飛機客艙加壓系統性能會受到飛行高度及發動機供氣狀況之影響；依據事故航班 FDR 資料，在起飛及爬升階段，發動機推力較大，供氣量足以維持該機客艙高度在 2,000 呎以下（如圖 2.2-1A 點以前）；事故機到達巡航高度（13,000 呎）後，發動機推力下降同時使空調系統進氣量下降，導致航機客艙高度上升（圖 2.2-1A 點以後），惟仍控制在約 8,000 呎；但是在該機脫離巡航階段後（圖 2.2-1B 點），發動機推力降到慢車，空調供氣量再減少使航機客艙高度急速上升，約 2 分 30 秒後，於 1504:17 時發生客艙高度過高警告。

綜上所述，航機在起飛前，空調地面連接單向閥可能已經故障無法維持在全關閉位置，使該機加壓艙內與艙外大氣環境連通，航機自巡航高度下降過程中，客艙加壓系統受到當時飛行高度、空調系統進氣量下降及單向閥未關閉的影響，無法建立適當客艙壓力，導致觸發客艙高度過高警告。

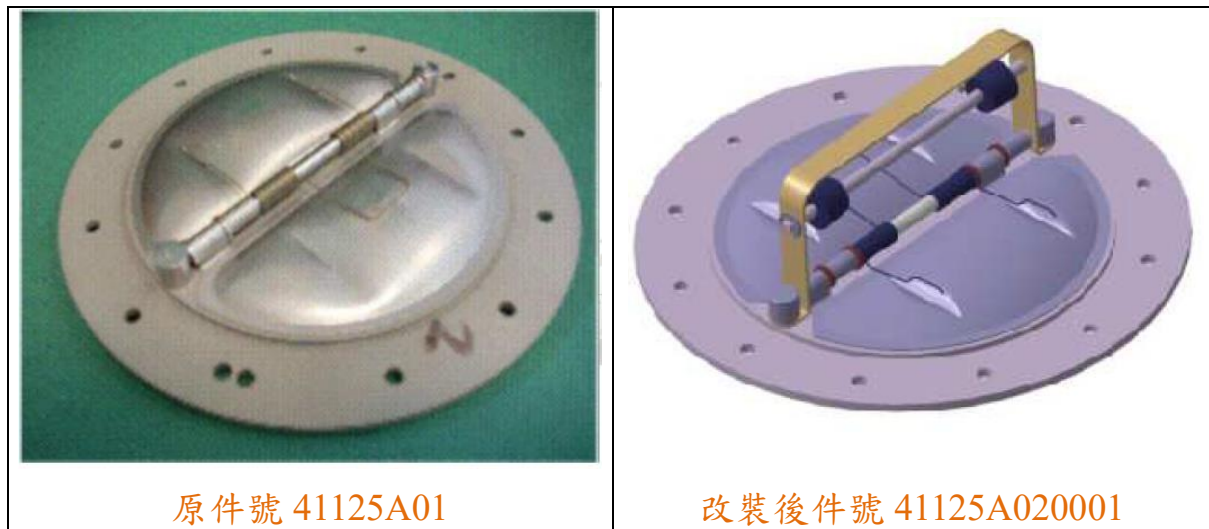
圖 2.2-2 原單向閥（圖左）與改良後單向閥（圖右）

改良後之單向閥與原單向閥（件號 41125A01）可互換使用，此二單向閥外觀示意圖如圖 2.2-2。

有關空調地面連接單向閥故障可能導致飛機無法建立艙壓之問題，航空器製造廠已提供相關改善資訊，華信航空亦已評估該資訊，採取對應之改善作為，除對空調地面連接單向閥增加日常性檢查及 500 飛時定檢外，該事故機型之機隊並已全面更新改良之單向閥。因此，有關本案空調地面連接單向閥故障可能導致飛機無法建立艙壓之議題，調查小組無相關安全改善建議。

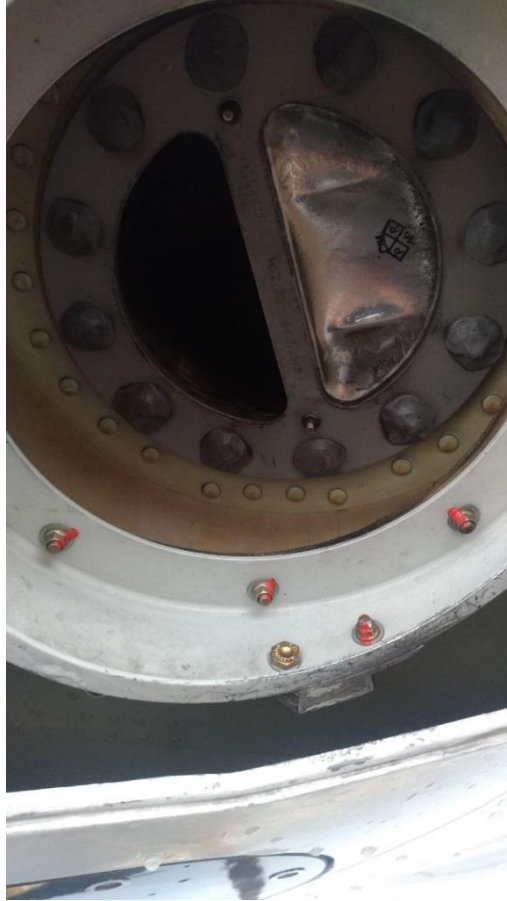
Figure 1.6-1 Failure Position of the Ground Connection Check Value

The occurrence aircraft experienced cabin pressure anomaly during the flight. After the aircraft landed at Hualien Airport, ground maintenance personnel examined the aircraft in accordance with the maintenance manual. The ground connection check valve, component number 41125A01, was found failure and could not be secured in the fully closed position (as shown in Figure 1.6-1). The examination also found that the air-conditioning distribution tube downstream the valve was dented. The check valve and the downstream air-conditioning distribution tube were replaced by the maintenance personnel according to the maintenance manual. After testing, the aircraft was in normal condition again.

Kaohsiung Airport before the occurrence. According to the ground inspection conducted after the occurrence at Hualien Airport, the valve spring applying pressure to the blade of the ground connection check valve was broken, resulting in the valve not being able to be secured in fully closed position. The check valve connected the pressurized cabin from inside to outside. When the aircraft was parked on ground, the ground air-conditioning unit can be connected to the aircraft through the check valve, providing the cockpit and cabin with conditioned air. When the valve functioned normally, conditioned air is supplied one-way from outside to inside the cabin. When the ground air-conditioning tube was removed, the spring applied pressure to the blade, so the valve was automatically spring-forced back to the closed position. When the cabin started to be pressurized, the valve can also be secured in the fully closed position because of the difference of pressure inside and outside the cabin.

According to the post-occurrence inspection, the spring applying pressure to the blade of the valve was broken, resulting in the valve not being able to be secured in fully closed position. When the valve was not fully closed, the pressurized cabin was connected to the atmosphere outside the cabin, and the air leaked out of the pressurized cabin from the check valve. When the engine air supply decreased, the cabin altitude rose and the cabin pressure cannot be maintained as a result.

- *The replacement of the air conditioning ground check valve for the occurrence aircraft (B-16851) was completed after the occurrence. The replacement of the new check valve for the other four ATR72 aircrafts (B-16852-B-16856) were implemented on May 14 and May 15, 2019. ATR72 aircrafts (B-16857, B-16858) delivered this year were manufactured with the new check valve (standard modification).*
- *According to the TPS21-22-001 recommendation, the Flight Crew Department revised the Pre-flight, Transit and Daily Checklist on May 3, 2019, with an additional note: if the ground air-conditioning unit is connected to a departing aircraft, the flight crew should confirm that the air conditioning ground check valve is secured at fully closed position after the unit is removed.*

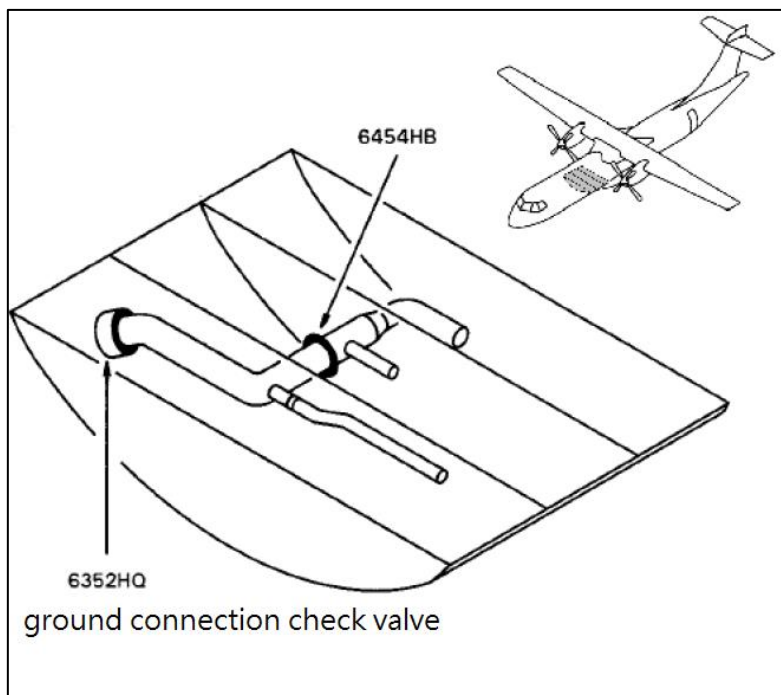
Figure 1.6-2 Installation Position of the Ground Connection Check Valve

The ground connection check valve is located on the right side of the belly of the fuselage, as shown in Figure 1.6-2, equipment number 6352HQ. Its exterior is shown in Figure 1.6-3. When the aircraft is parked on the ground, conditioned air can be supplied to the cockpit and cabin through the check valve from the air-conditioning unit.

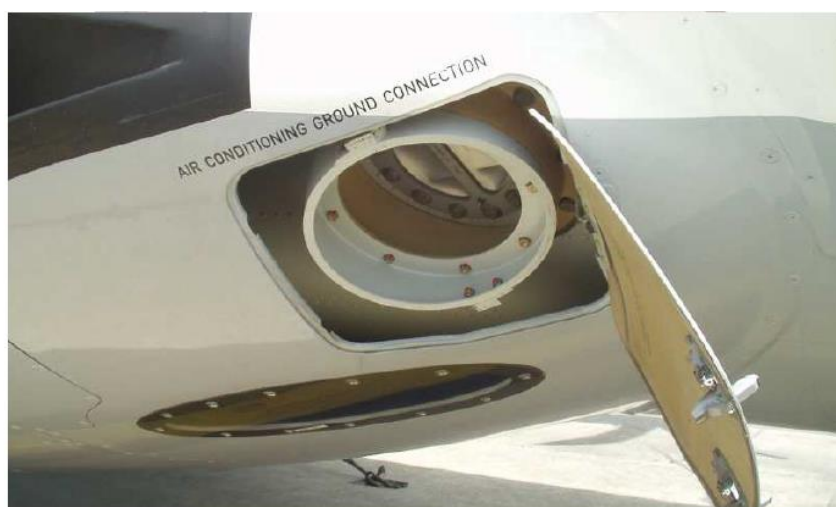
Figure 1.6-3 Exterior of the Ground Connection Check Valve

In October 2015, the aircraft manufacturer issued TPS21-22-001 Technical Progress Status (TPS). The TPS mentioned the occurrence of cabin pressure anomaly as a result of the ground connection check valve, component number 41125A01, not secured at a fully closed position due to the failure of valve spring. It also mentioned that when the cabin pressure was compromised, the air-

conditioning distribution tube downstream of the check valve might be damaged due to the difference between pressure inside and outside the cabin. To avoid this occurrence, the aircraft manufacturer recommended checking the check valve position and ensuring it is secured in the fully closed position after every time the air-conditioning unit is moved. The 8th edition released in April 2018 is the latest updated version for this TPS.

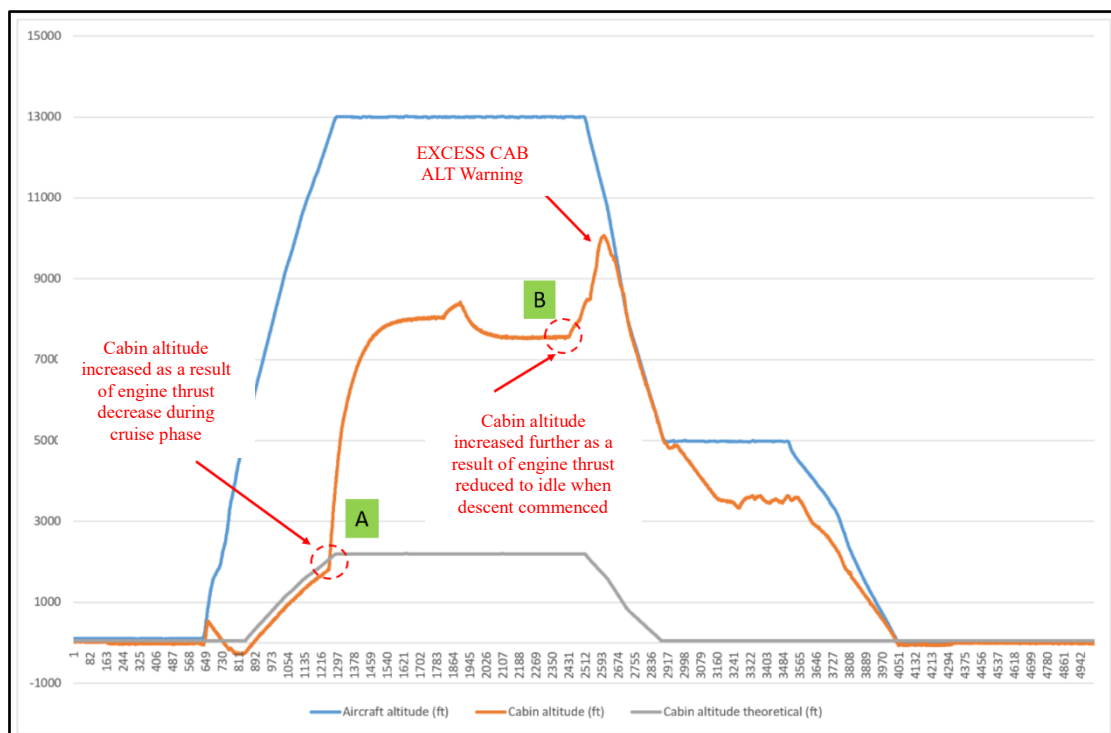
Figure 2.2-1 Cabin Altitude and Relevant Information Plot

When the ground connection check valve was not fully closed, the aircraft pressurization system would be influenced by the altitude and the engine air supply. According to the FDR data of the occurrence aircraft, the thrust of the engine during take-off and climbing provided sufficient air to maintain the cabin altitude below 2,000ft (before Point A in Figure 2.2-1). When the occurrence aircraft reached cruising altitude (13,000ft), the thrust of the engine decreased, and so did the airflow in the air-conditioning system, resulting in the rise of cabin

altitude (after Point A in Figure 2.2-1), but it was maintained at approximately 8,000ft. However, when the aircraft descended from cruising altitude (Point B in Figure 2.2-1), the thrust of the engine reduced to idle, therefore the cabin altitude rose rapidly as a result of the decrease in air supply from the air-conditioning system. After approximately 2 minutes and 30 seconds, at 15:04:17, the EXCESS CAB ALT warning was triggered.

To sum up, the check valve inside the ground air-conditioning connection might have been damaged before the occurrence flight took off. Therefore, the aircraft's pressurization system was connected to the atmosphere outside the cabin. As the aircraft descended from cruise altitude, the EXCESS CAB ALT warning was triggered when the cabin pressurization system failed as a result of the altitude, the reduction of cabin air inflow, and the check valve was not secured in closed position.

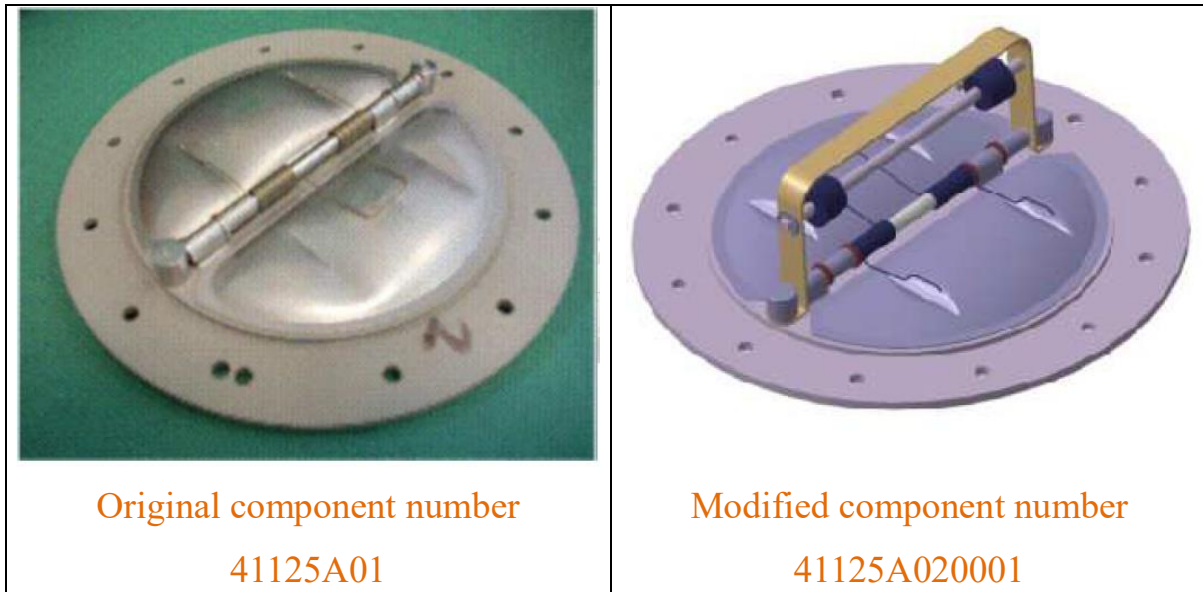
Figure 2.2-2 Original Check Valve (Left) and Modified Check Valve (Right)

- Two devices have been added to secure the valve blades in a stable position
- A middle dead point has been added to eliminate vibration
- A teflon-coated gasket between the shaft and the spring

The modified check valve is interchangeable with the original one (component number 41125A01). The exterior of the two check valves are shown in Figure 2.2-2.
