# **Aviation Occurrence Report Volume I**

**IN-FLIGHT BREAKUP OVER THE TAIWAN STRAIT**

**CHINA AIRLINES FLIGHT CI611**

**BOEING 747-200, B-18255**

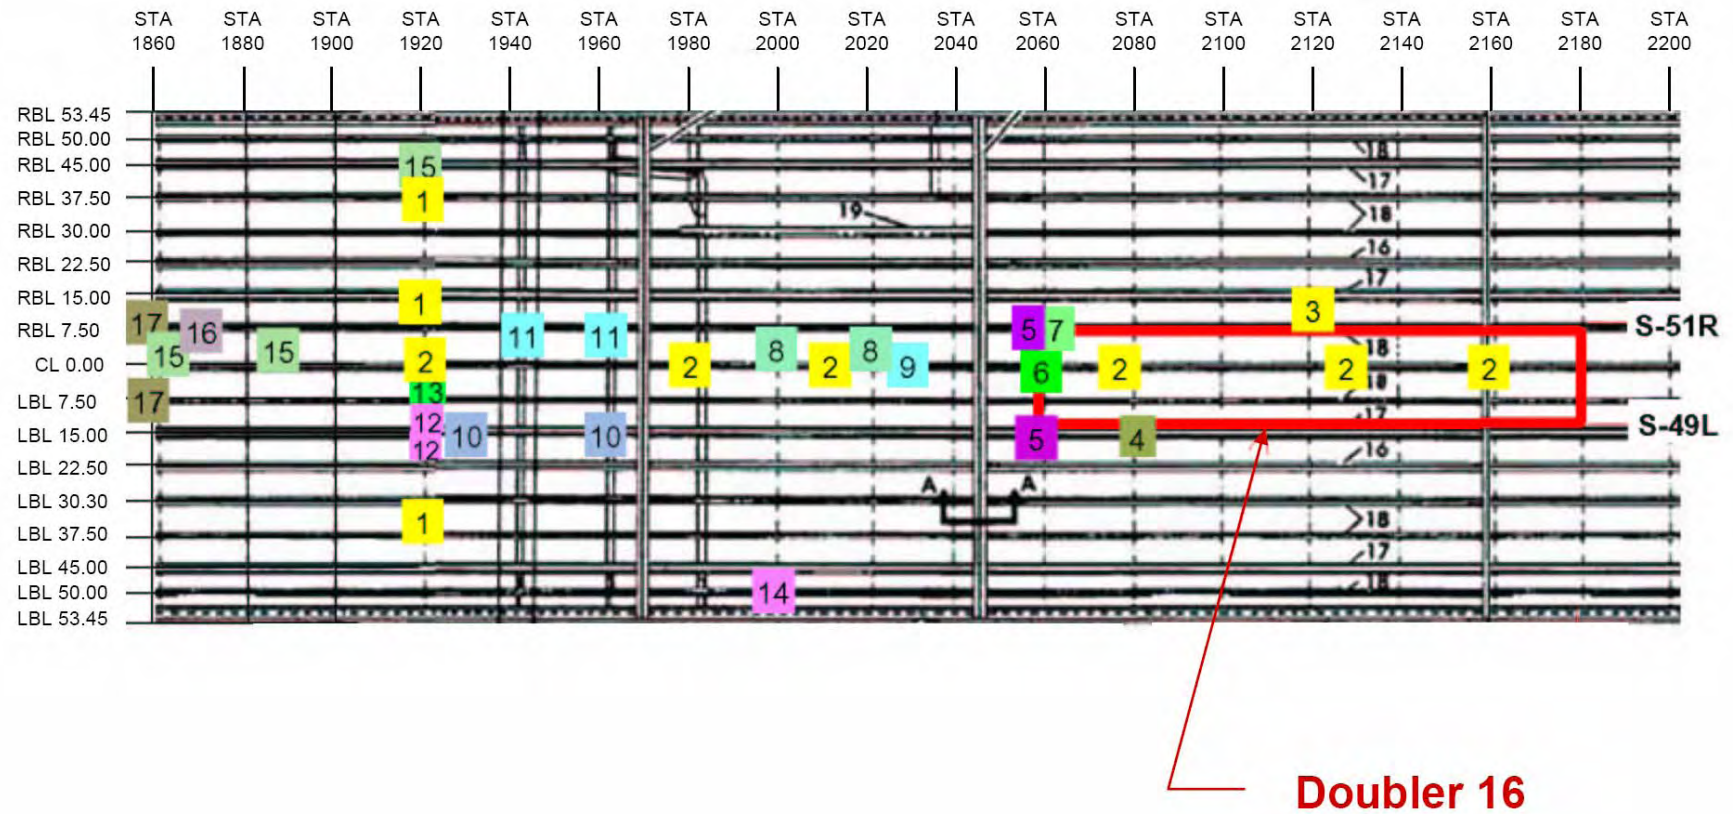
Figure 1.6-5 Locations of discrepancies adjacent to the STA 2060 doubler

The above defects were corrected by the approved methods.

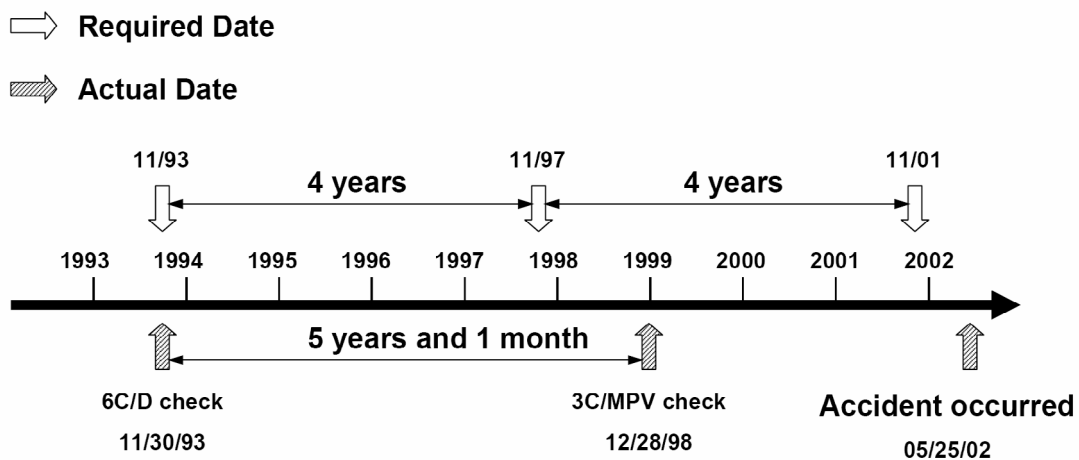
Figure 1.6-6 Deviations on CPCP item 53-125-01 required for B-18255

Deviations between AMP CPCP item 53-125-01 required and actual implementation dates for B-18255 aircraft are shown in Figure 1.6-6.

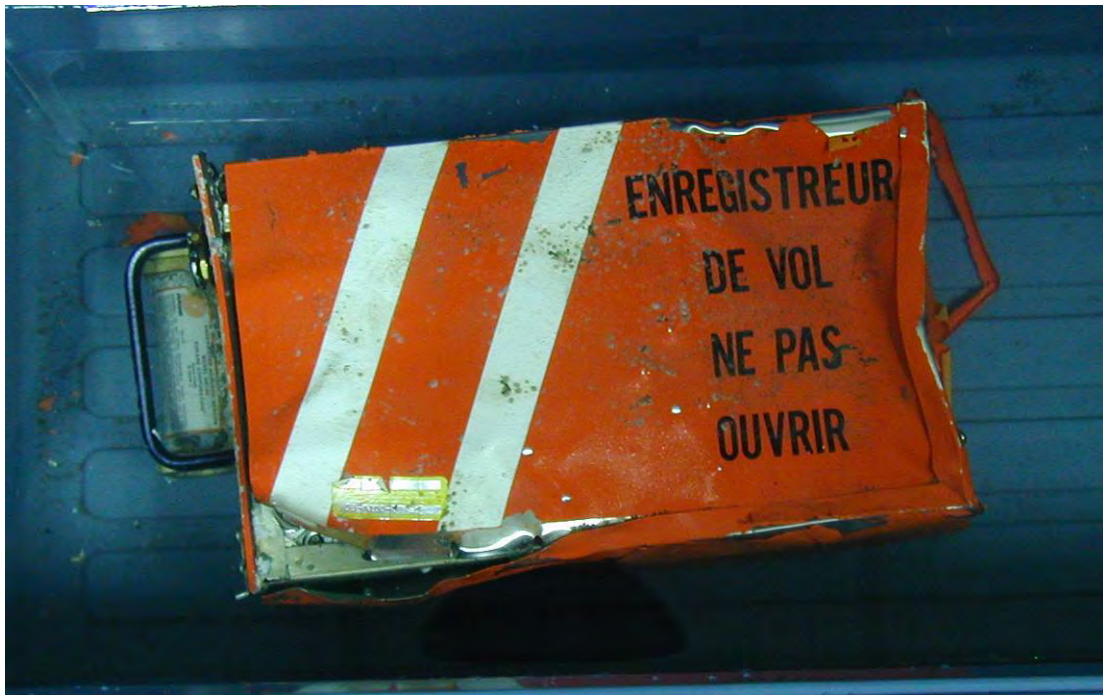
Figure 1.11-1 Damaged CVR in the water cooler

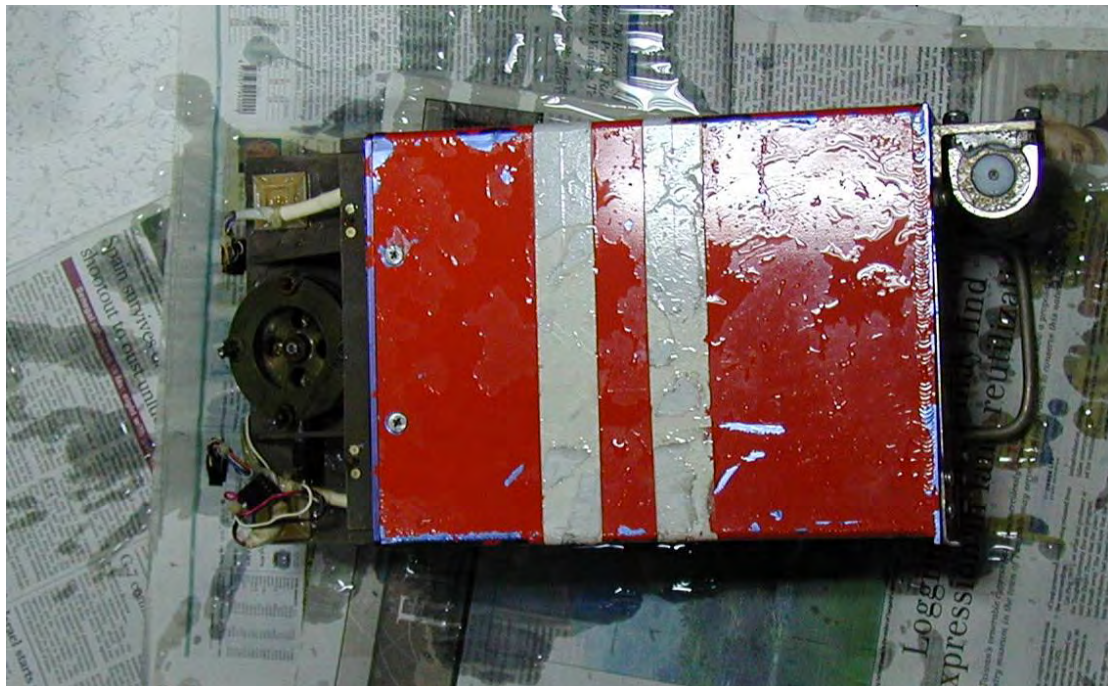
Figure 1.11-2 Damaged FDR in the water cooler

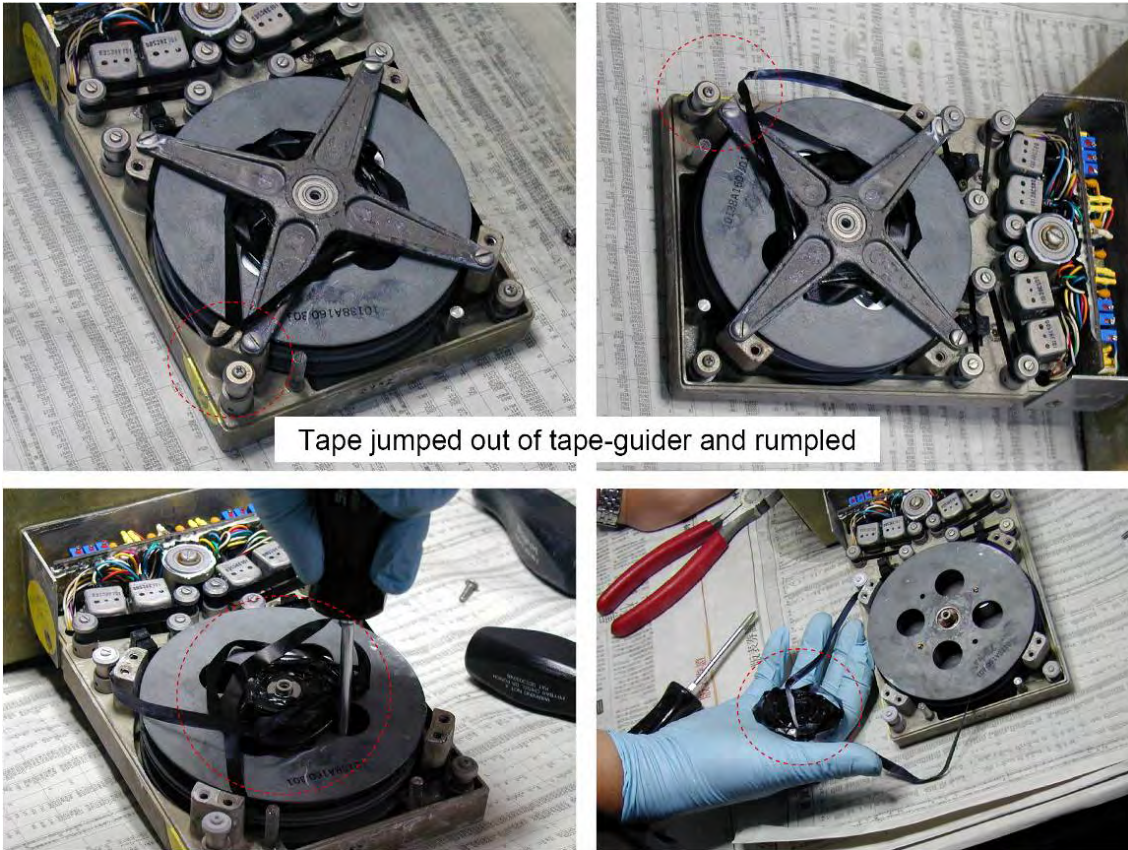
Figure 1.11-3 Photographs of damaged magnetic tape

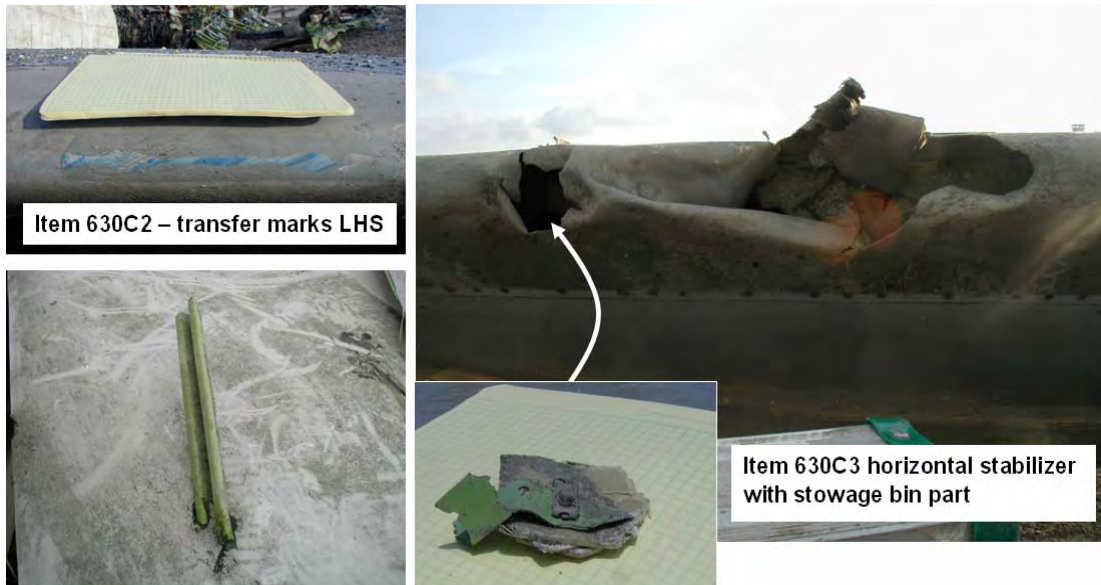
The right horizontal stabilizer (RHS) is considerably more damaged than the left horizontal stabilizer (LHS). The inboard portion of the RHS leading edge is deformed upwards. At the root of the RHS, the inboard 10 feet showed considerable impact damage along with upwards deformation of the compromised structure. A portion of seat support was found inside a puncture common to the lower surface of the LHS. A small segment of fuselage stringer was also found imbedded in the RHS elevator (Figure 1.12-10 left-down). A small fastener and shim from a stowage bin assembly were found inside a puncture common to the RHS leading edge (Figure 1.12-10 right).

Figure 1.12-10 A small segment of fuselage stringer imbedded in the RHS elevator (left-down). A small fastener and shim were found inside the RHS leading edge (right).

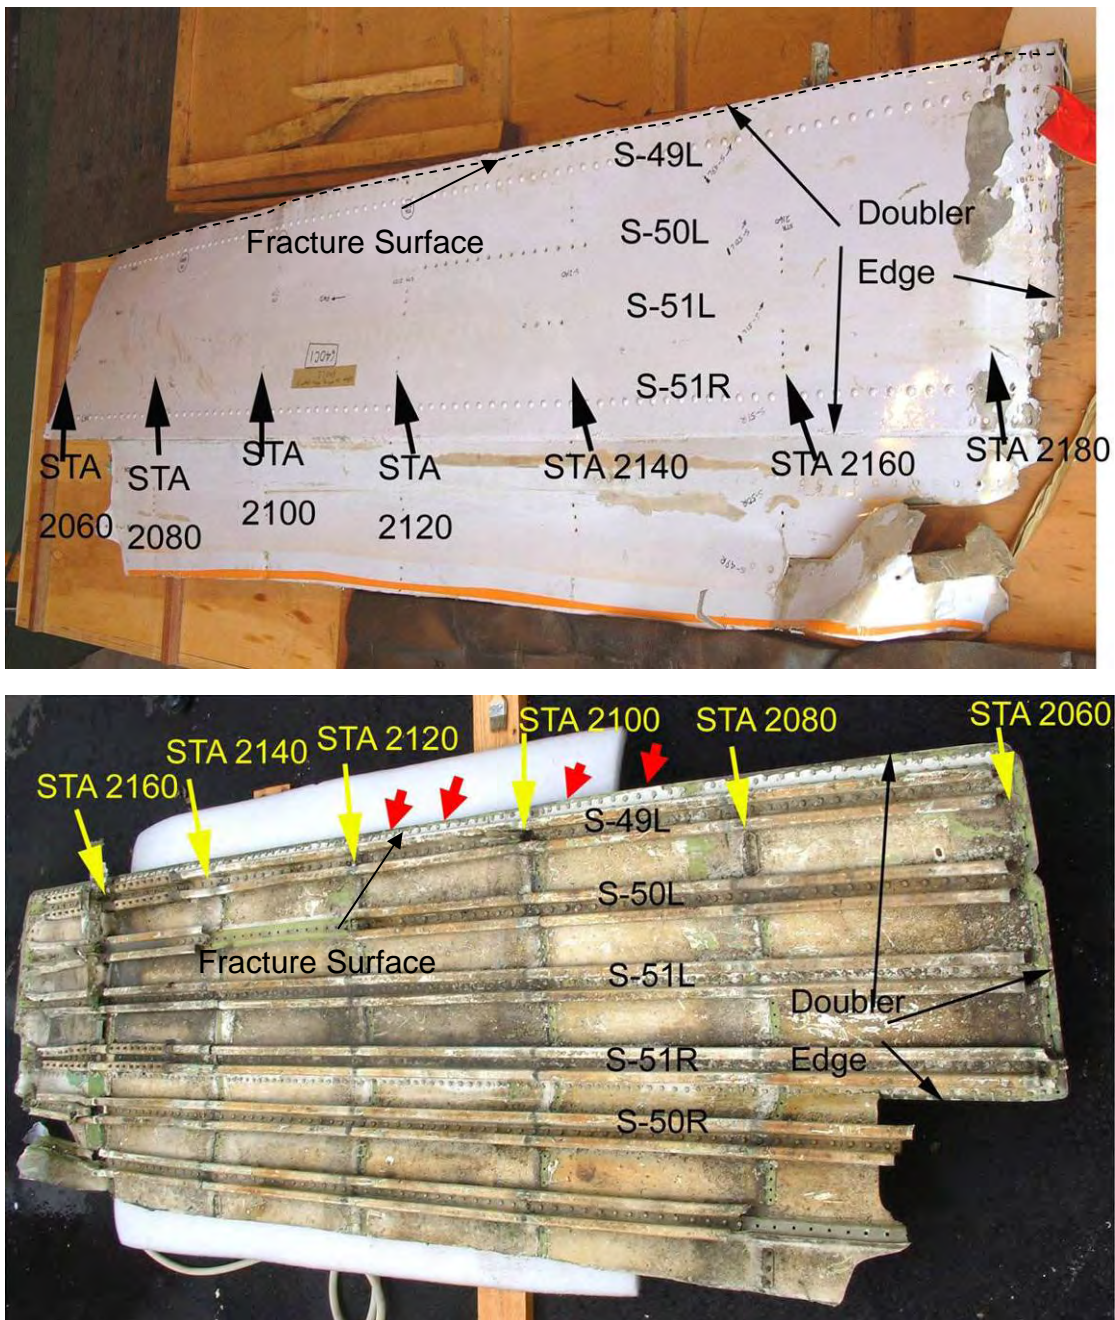
Figure 1.16-1 Exterior (up) and interior (down) of Item 640C1

Item 640C1 was a segment of Item 640 approximately from STA 2060 to 2180 and from S-49L to S-49R (Figure 1.16-1). A 23-inch wide, 125-inch long external repair doubler was attached to the skin by two rows of countersunk rivets around its periphery as well as by fasteners common to the stringer and shear tie locations. Universal head rivets were used at S-51R and S-49L while countersunk rivets were used at S-50L and S-51L.

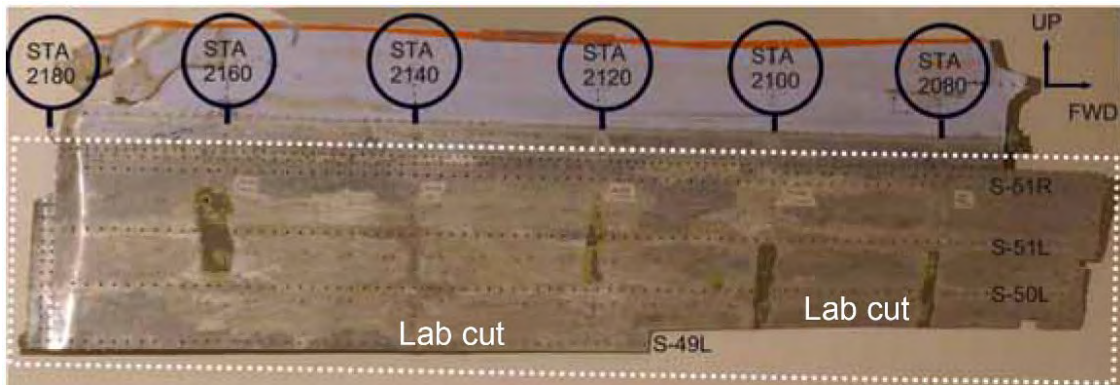
After disassembling the doubler from the skin and removal of the protective finishes, scratching damage was noticed on the faying surface of the skin (Figure 1.16-2). This damage consists of primarily longitudinal scratching distributed in an area of 120 inches by 20 inches. The most severe scratching typically occurred at the skin stiffening members such as skin stringers and body frame shear ties. Evidence of an attempt to blend out these skin scratches, in the form of rework sanding marks, was noted over much of the repair surface. A close view of the skin area near STA 2080 is shown in Figure 1.16-3.

Figure 1.16-2 Faying surface with the repair doubler and protective finishes removed

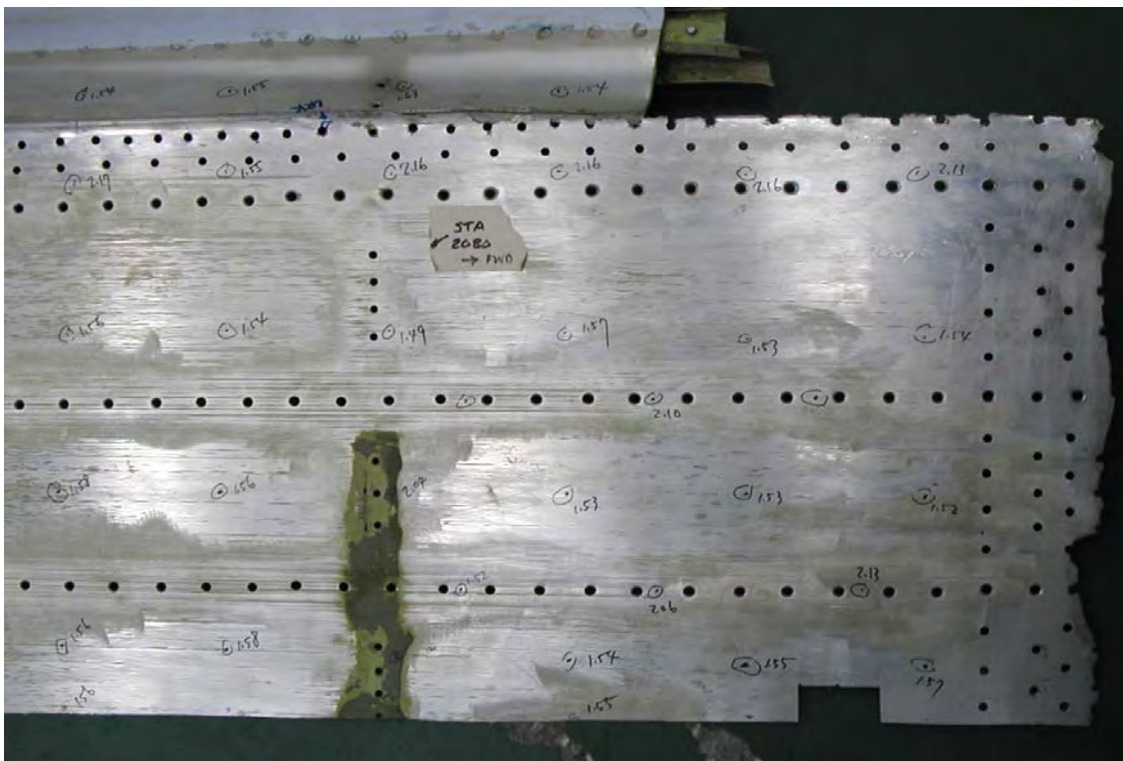
Figure 1.16-3 A close view of the repair faying surface near STA 2080

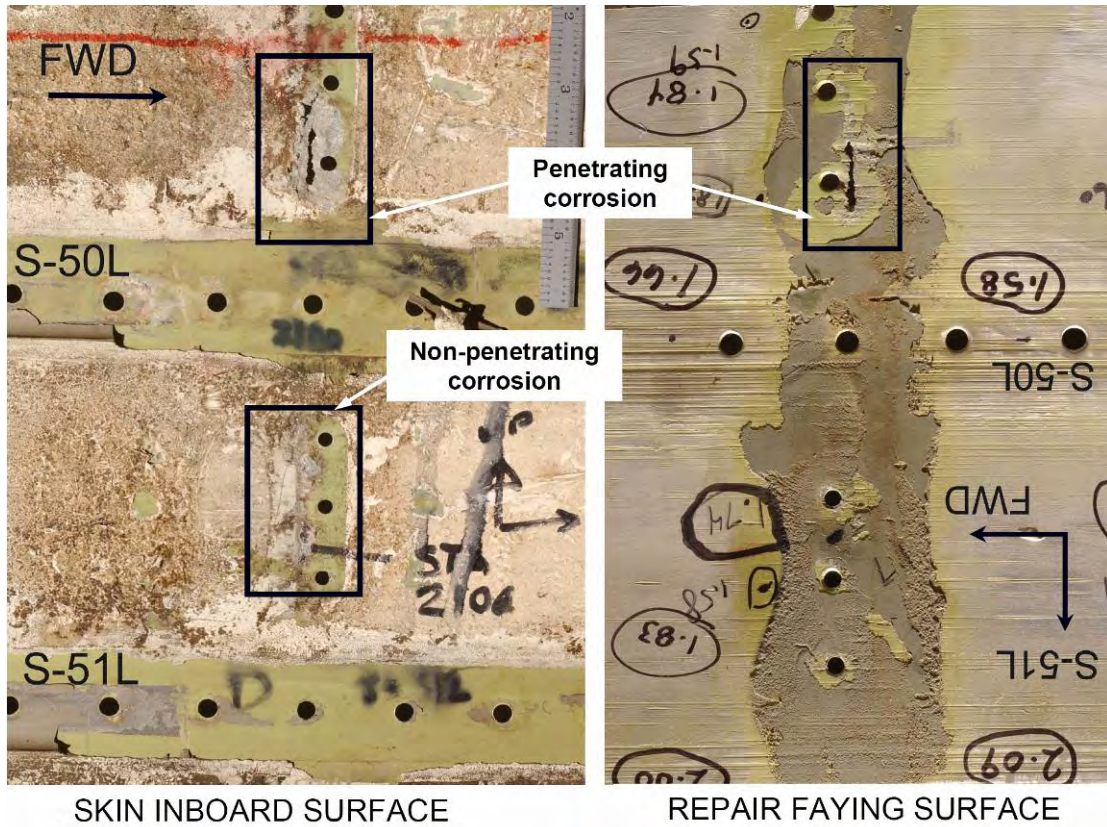
Corrosion was noted at several shear tie locations on the skin inboard surface sometimes penetrating completely through the skin thickness. Figure 1.16-5 shows the corrosion features near STA 2100. General features of this damage and condition of the skin indicate that the corrosion was not the result of salt-water immersion after the event. Table 1.16-2 displays all the corrosion features found on item 640C1.

Figure 1.16-5 Skin corrosion features at STA 2100

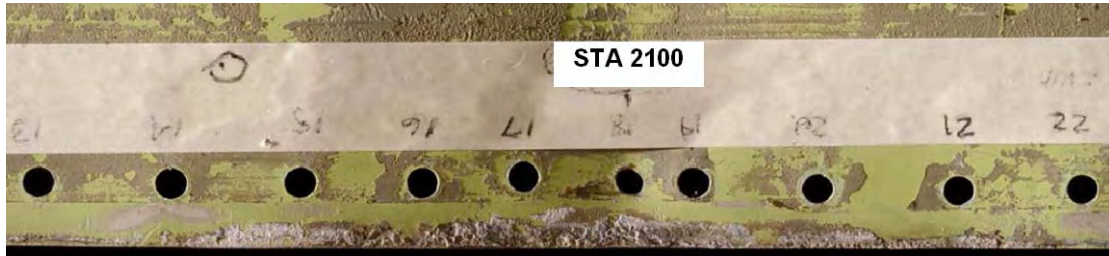
Figure 1.16-6 Light colored deposit on the faying surface of the repair

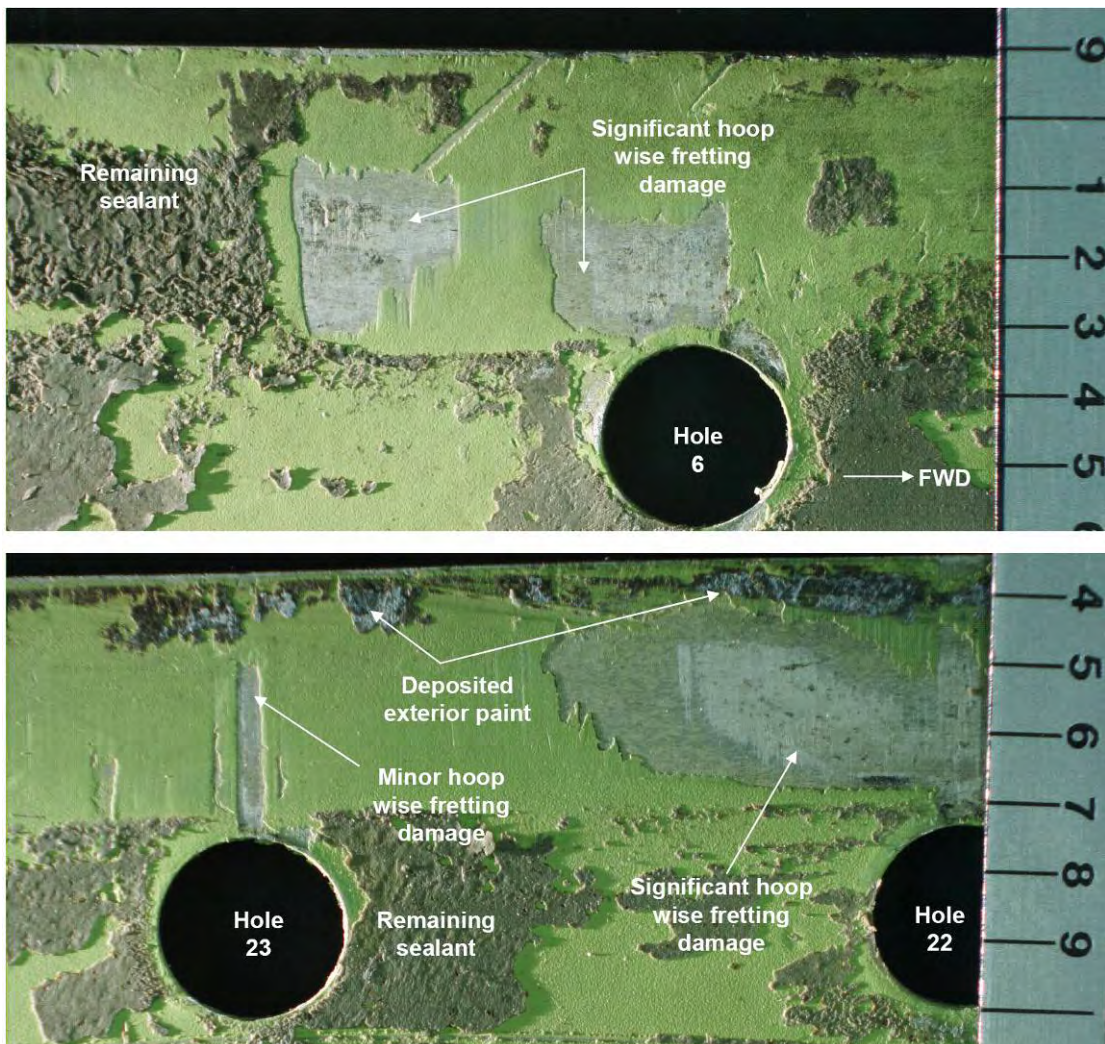
- The fretting marks observed from STA 2061 (hole +16) to STA 2132 (hole 49) are associated with most of the rivet locations. The most significant fretting damage was present between holes 8 and 43.
- The fretting marks near hole 32 and an optically magnified photograph of the area of contact is shown in Figure 1.16-9. It shows that the area of contact exhibits many colors and some hoop-wise scratches (marked by arrows).
- Two cross-section locations were chosen to characterize the area of contact. Figures 1.16-10 and Figure 1.16-11 show the metallographic photographs through the area marked by data sampling cut #1 and data sampling cut #2 respectively. It is observed that there was some material superimposed over the grooves of the scratches.

Figure 1.16-8 Fretting damage observed on faying surface of the repair doubler

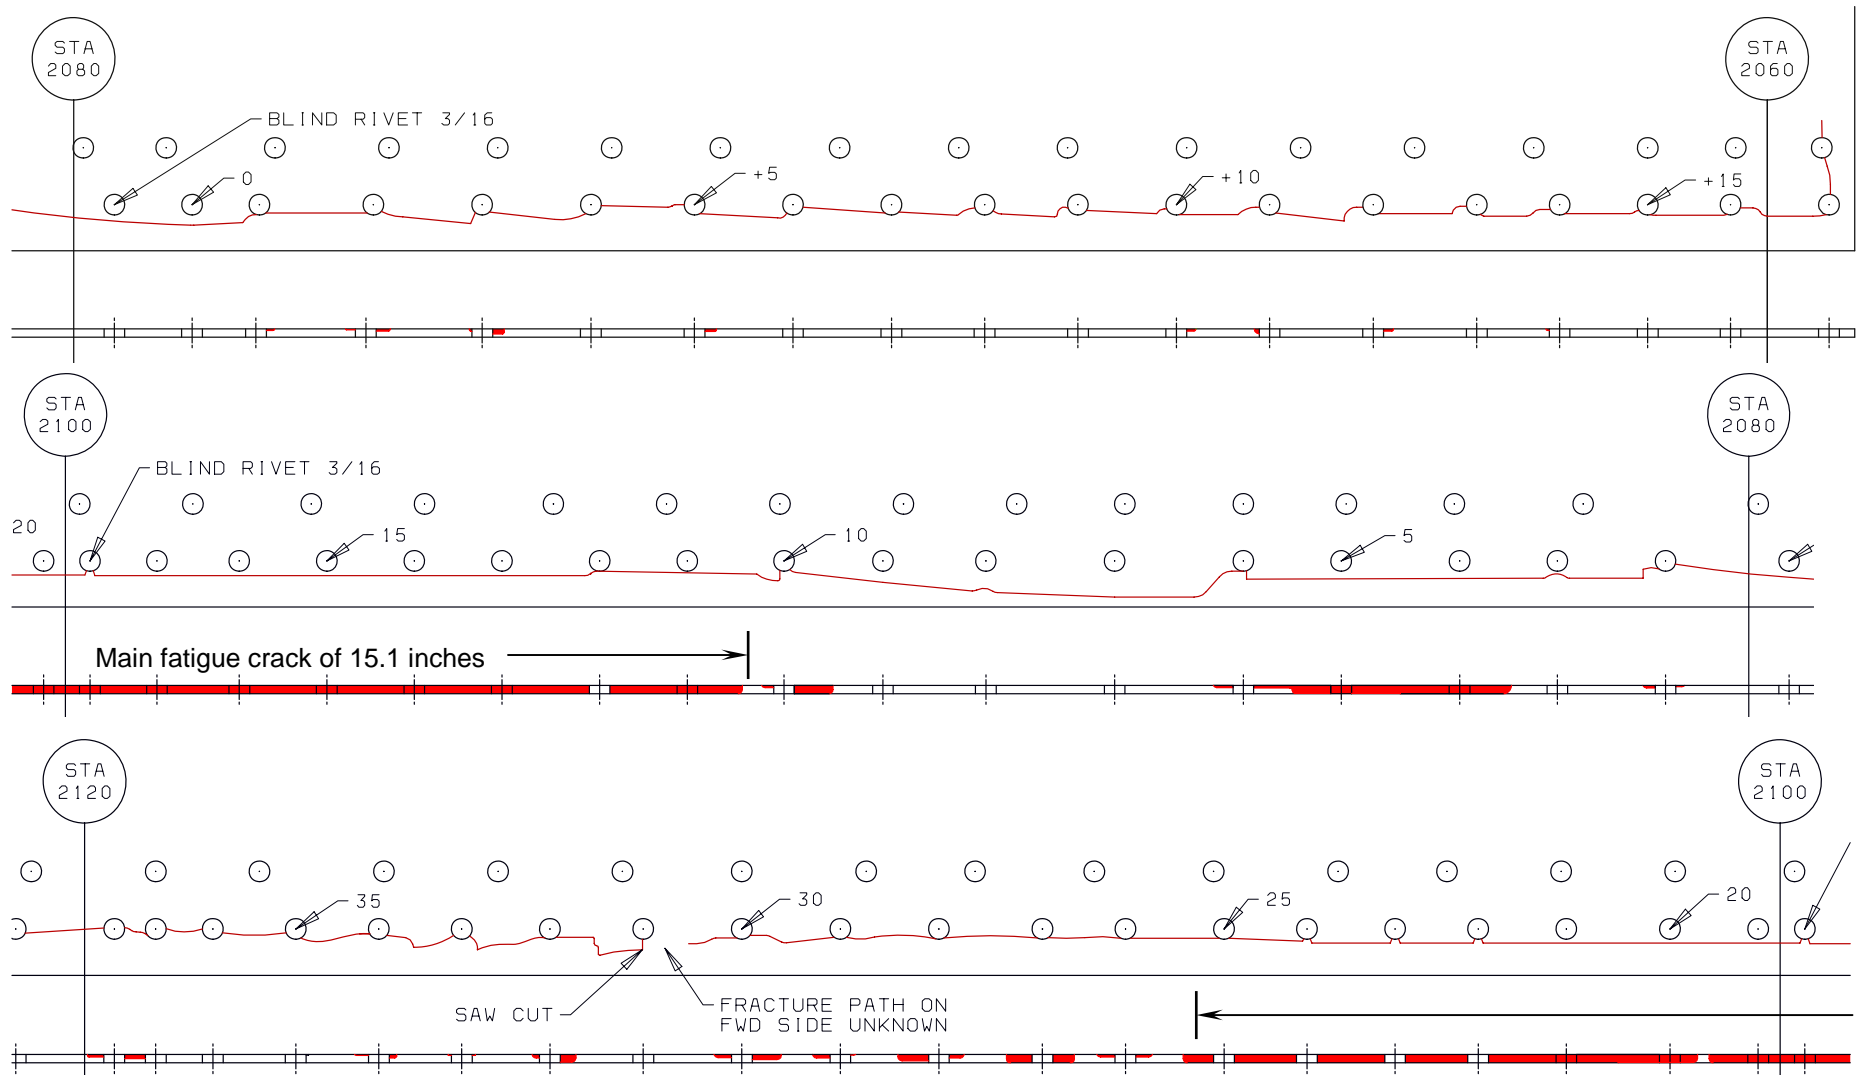
4. Evidence of fatigue damage was found in the lower aft fuselage centered about STA 2100, between stringers S-48L and S-49L, under the repair doubler near its edge and outside the outer row of securing rivets. Multiple Site Damage (MSD), including a 15.1-inch through thickness main fatigue crack and some small fatigue cracks were confirmed. The 15.1-inch crack and most of the MSD cracks initiated from the scratching damage associated with the 1980 tail strike incident. (1.16, 2.2)

Figure 1.16-12 Distribution of the fatigue cracks (from STA 2060 to STA 2120)

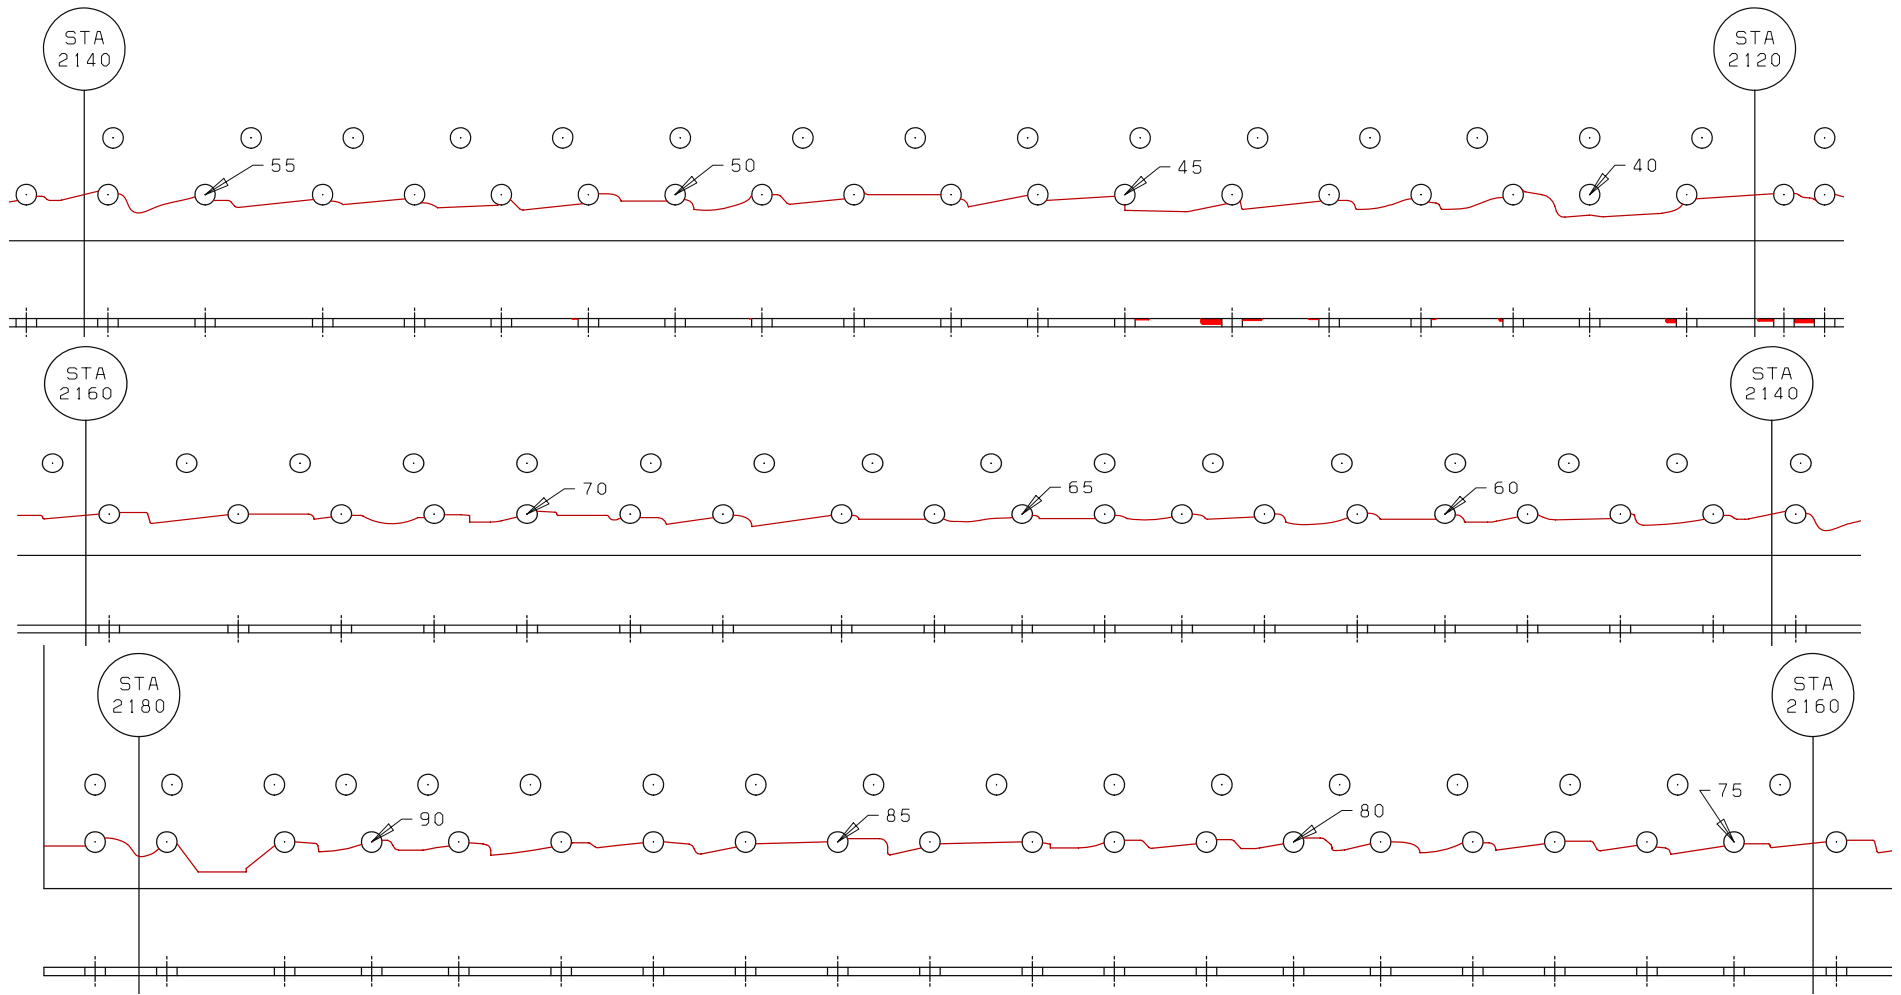
Figure 1.16-13 Distribution of the fatigue cracks (from STA 2120 to STA 2180)

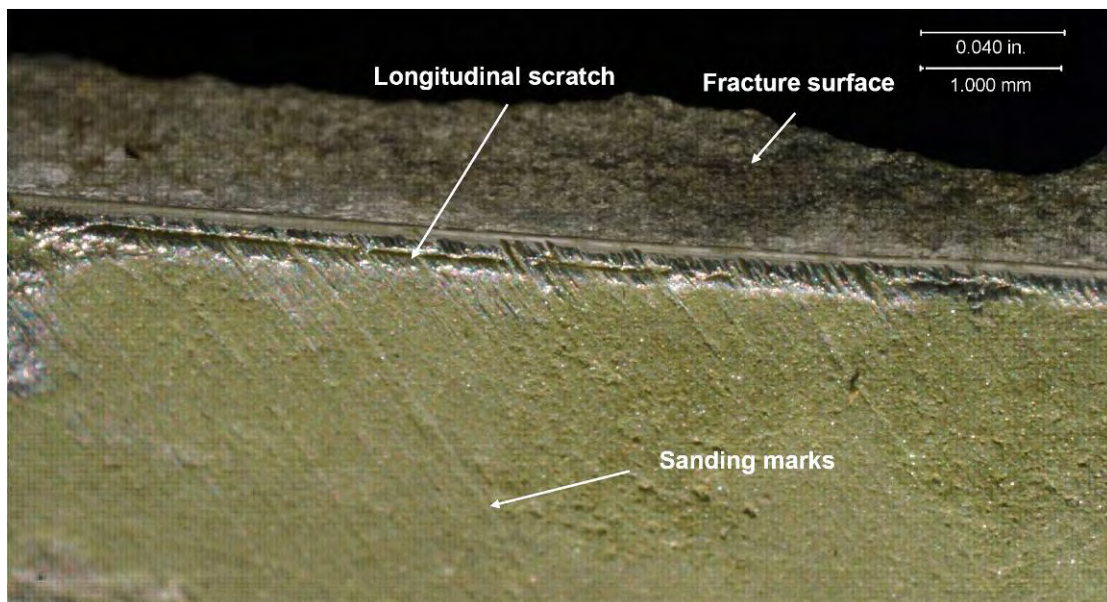
Figure 2.2-6 Fatigue crack originated from the scratch near hole 20

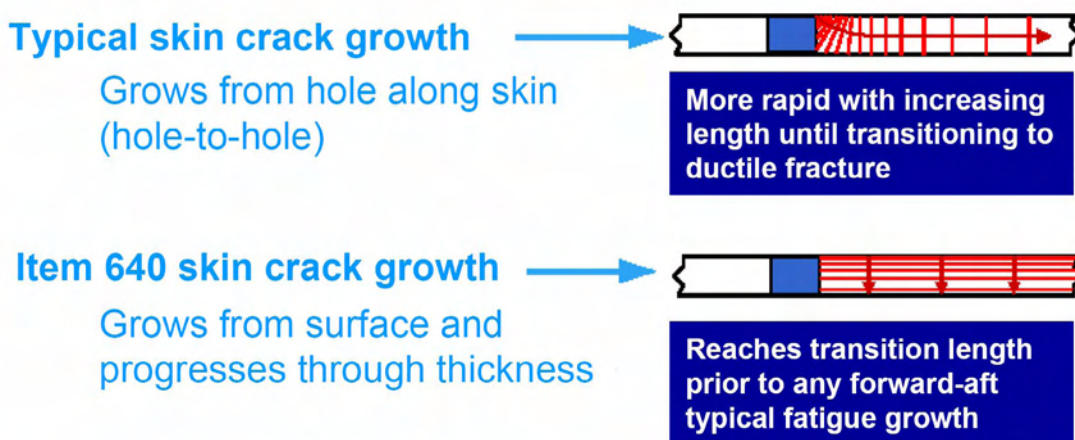
Figure 2.2-7 Cracking on Item 640 differs from typical fatigue crack

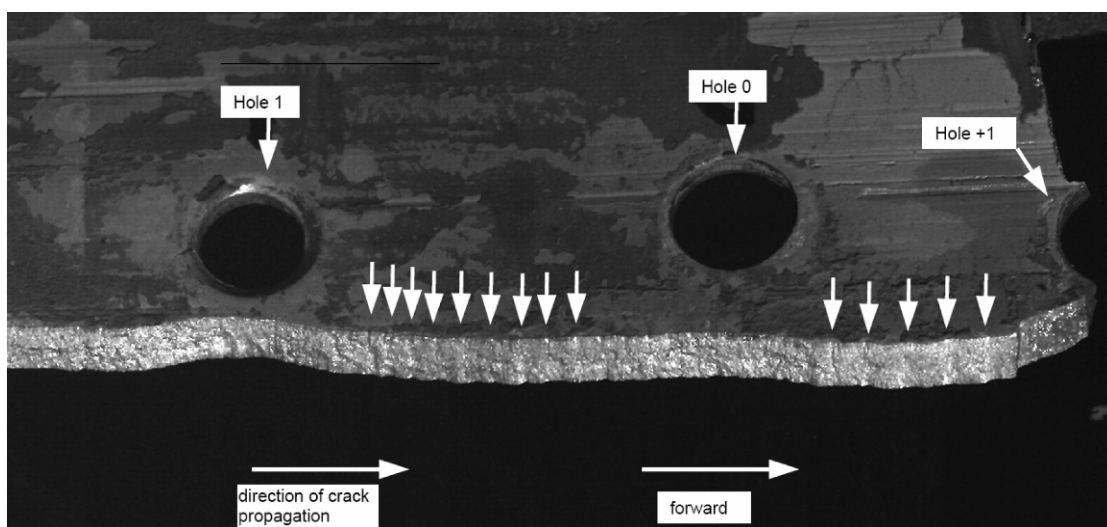
Figure 2.2-9 The regular spacing of cracking increments found on Item 640

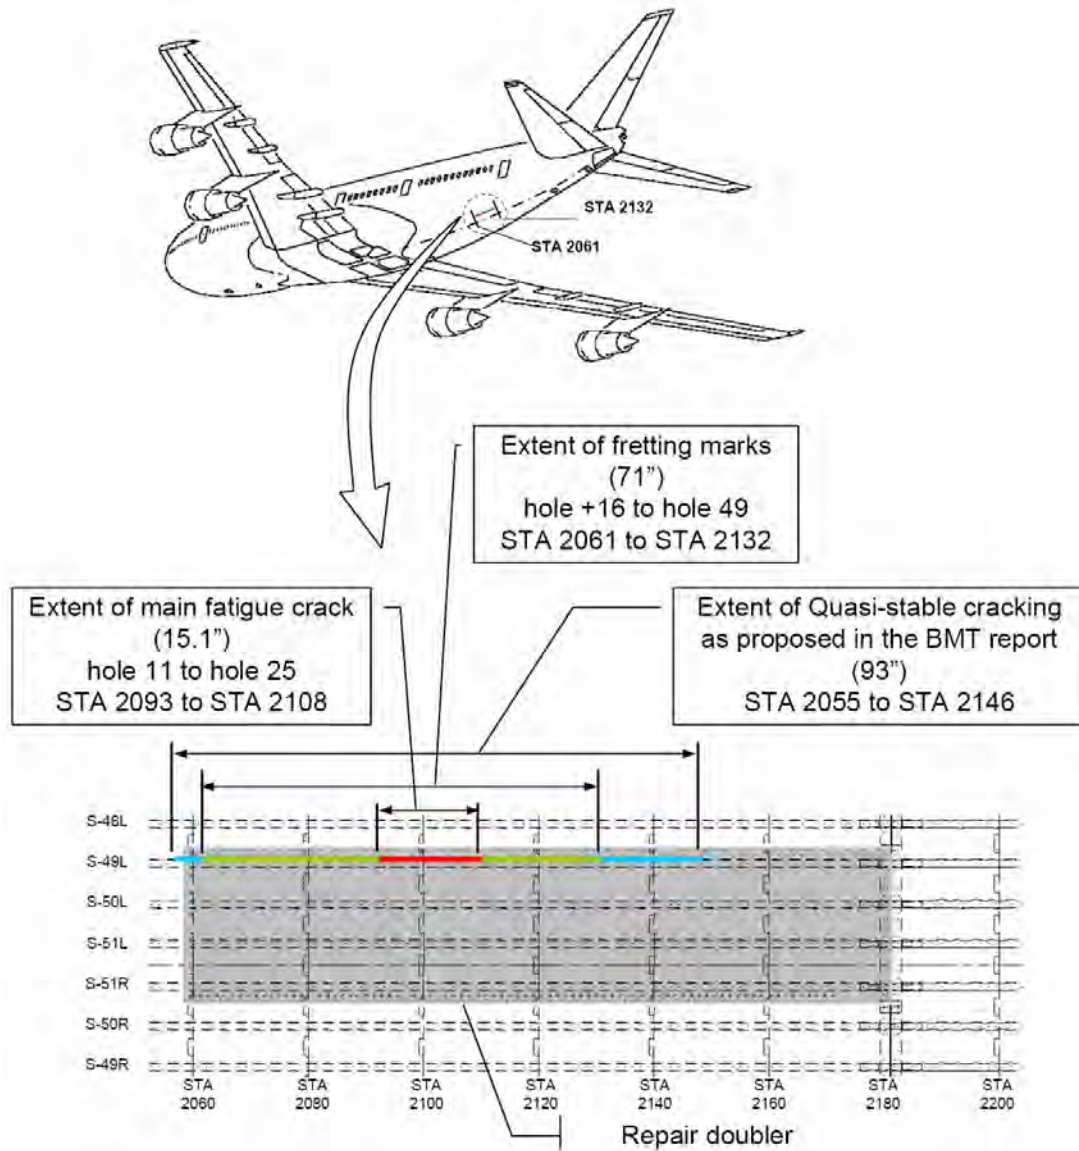
Figure 2.2-12 Different signs of cracks
