# **Aviation Occurrence Report Volume II**

ASC-AOR-05-02-001

**IN-FLIGHT BREAKUP OVER THE TAIWAN STRAIT**

**CHINA AIRLINES FLIGHT CI611**

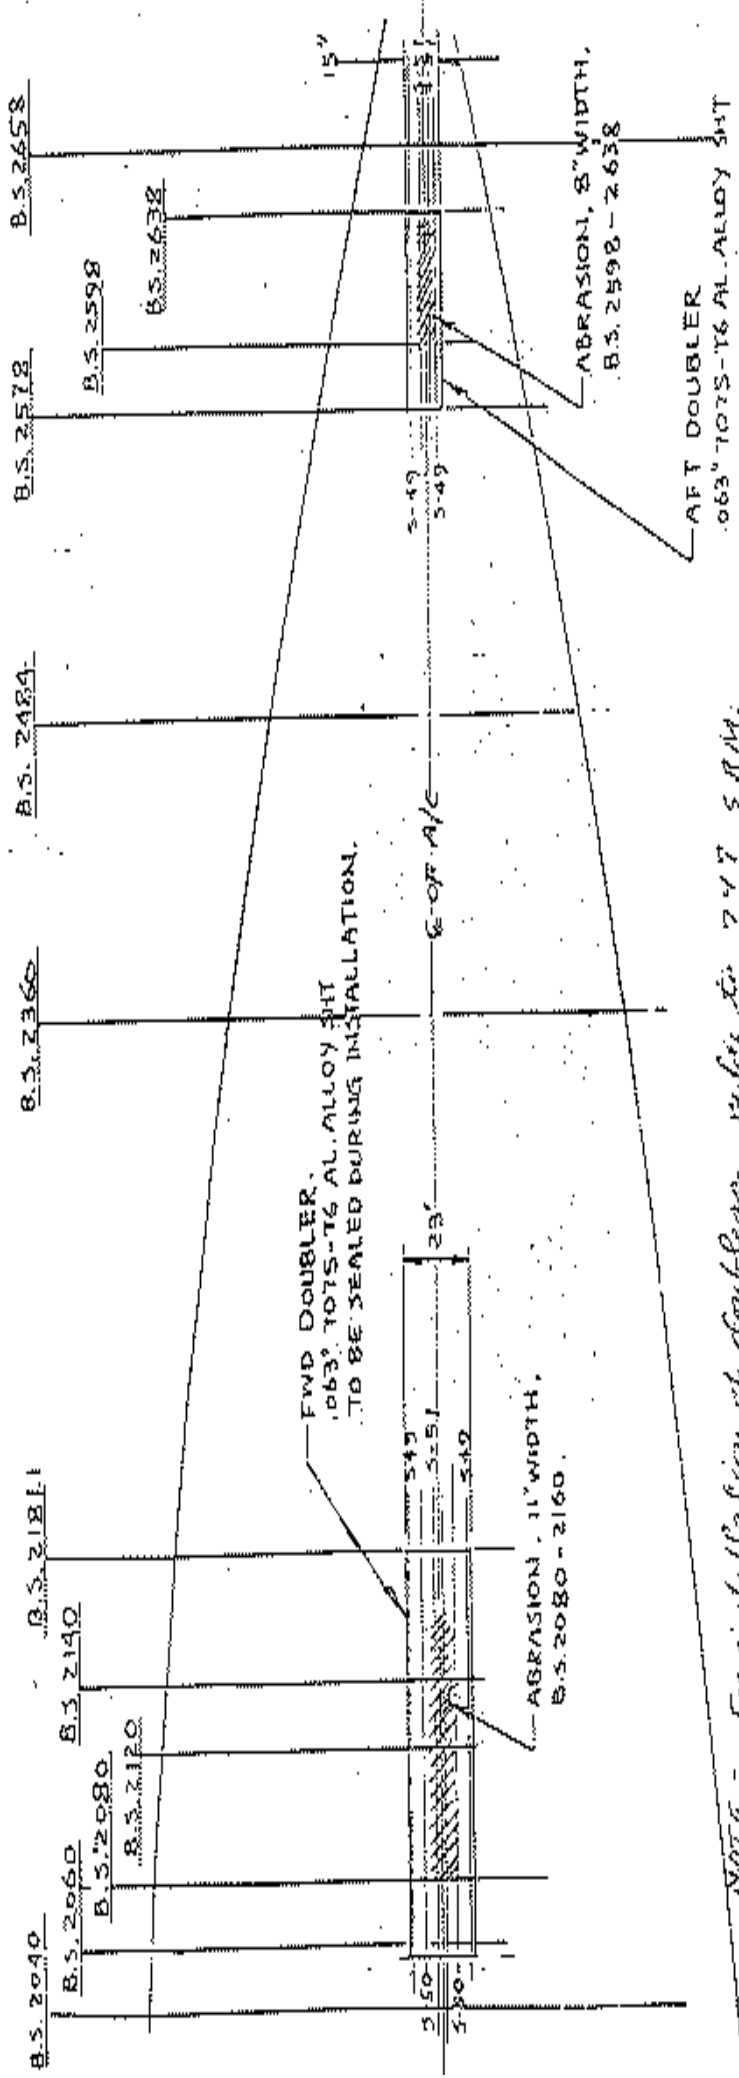
B-1866 low fuselage aft section damage occurred during landing with dragged tail on runway in HKG.

Preliminary inspection found the serious abrasion damages on fuselage tail portion bottom skin between F.S. 2080 and 2160 and between F.S. 2578 and 2638. The aft drain mast was missing. LH outflow valve door inb'd corner partially cut.

1. Close visual inspect internal structure for any defects inside the abraded skin.
2. Install two reinforcing doublers, made of .063" 7075-T6 Alum. Alloy plates at two places of the abraded area, forward 23"x125" (to be sealed during installation on this pressurized area) and aft 15"x54". See attach Figure.
3. Aft water drain mast reinstalled and functional test.
4. LH outflow valve door cut area temporarily repaired with 6061-T6 Alum. Alloy and functional test.
5. Conduct permanent repair IAW 747 SRM within four months.
6. The said temporary repair was concurred by Boeing Rep.

NOTE = For installation of doublers, refer to 747 S.M.

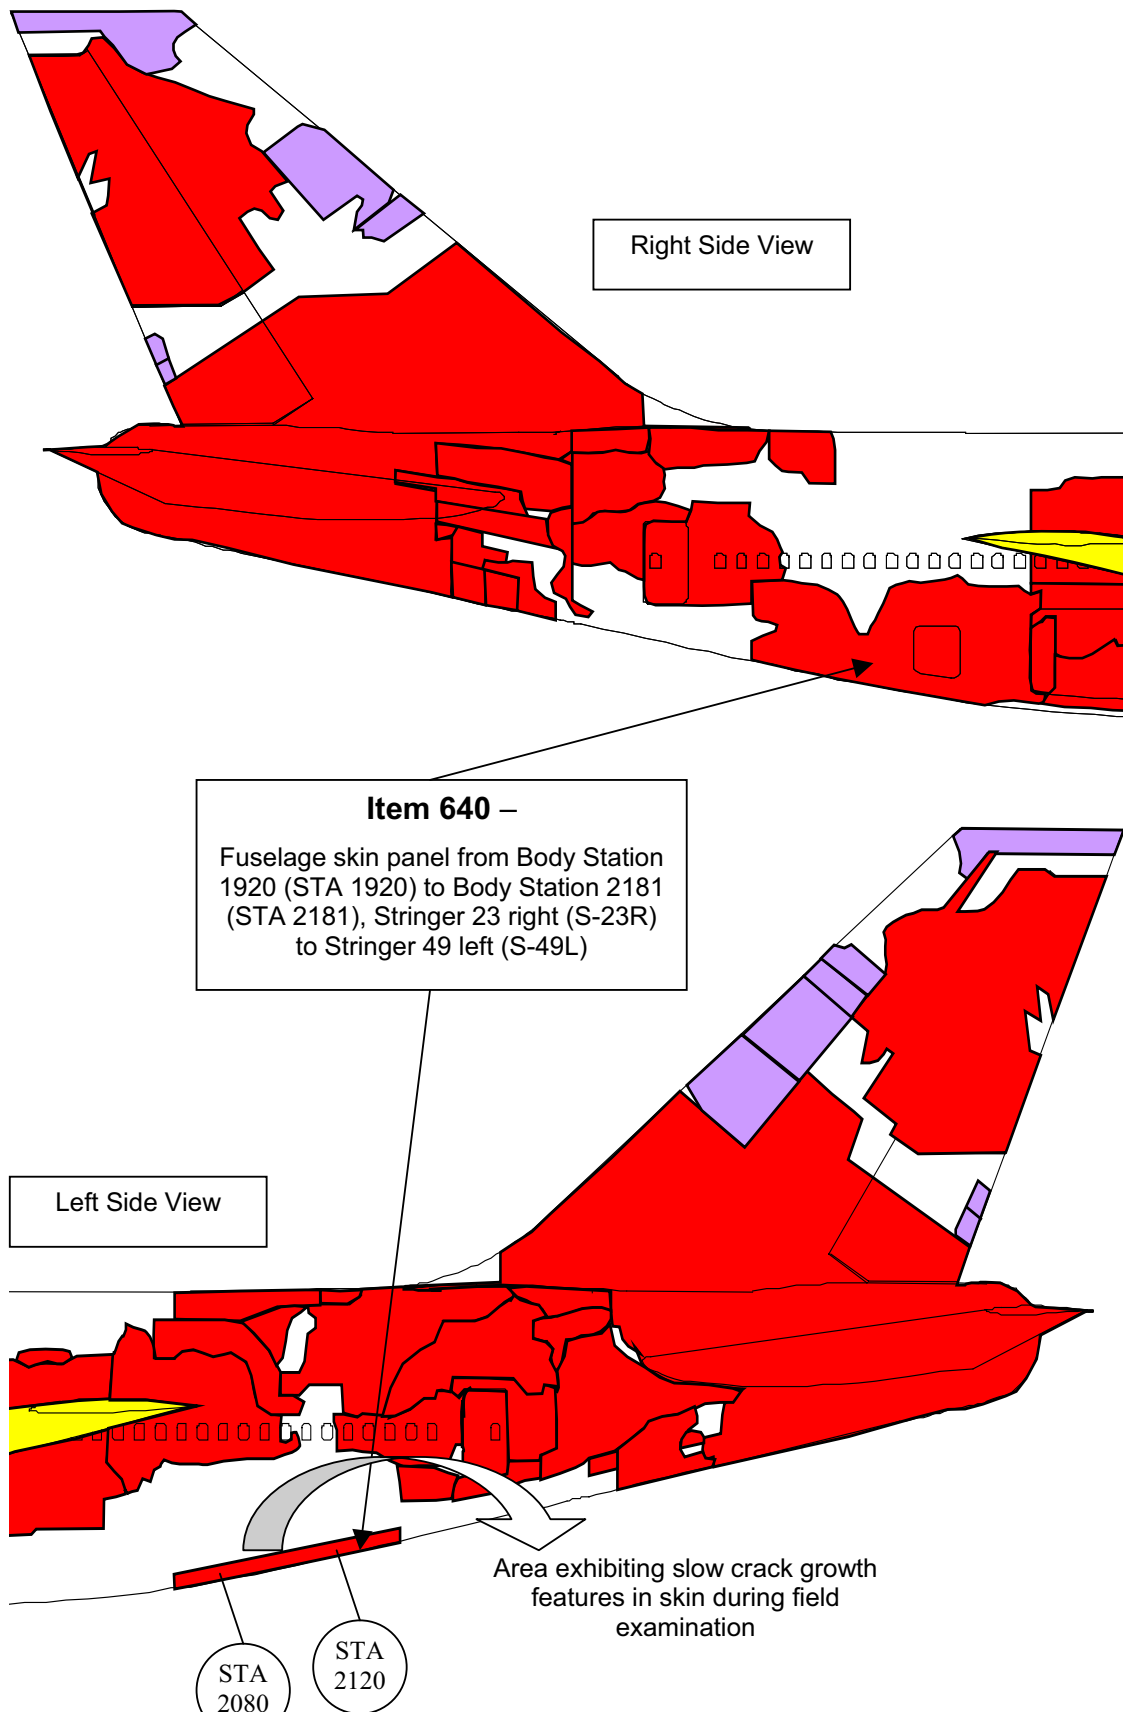
Figure 1.  
Partial wreckage recovery map for CI611 showing the location of the item 640 skin panel and the area where slow crack growth features were found in the skin along S-49L during field examination.

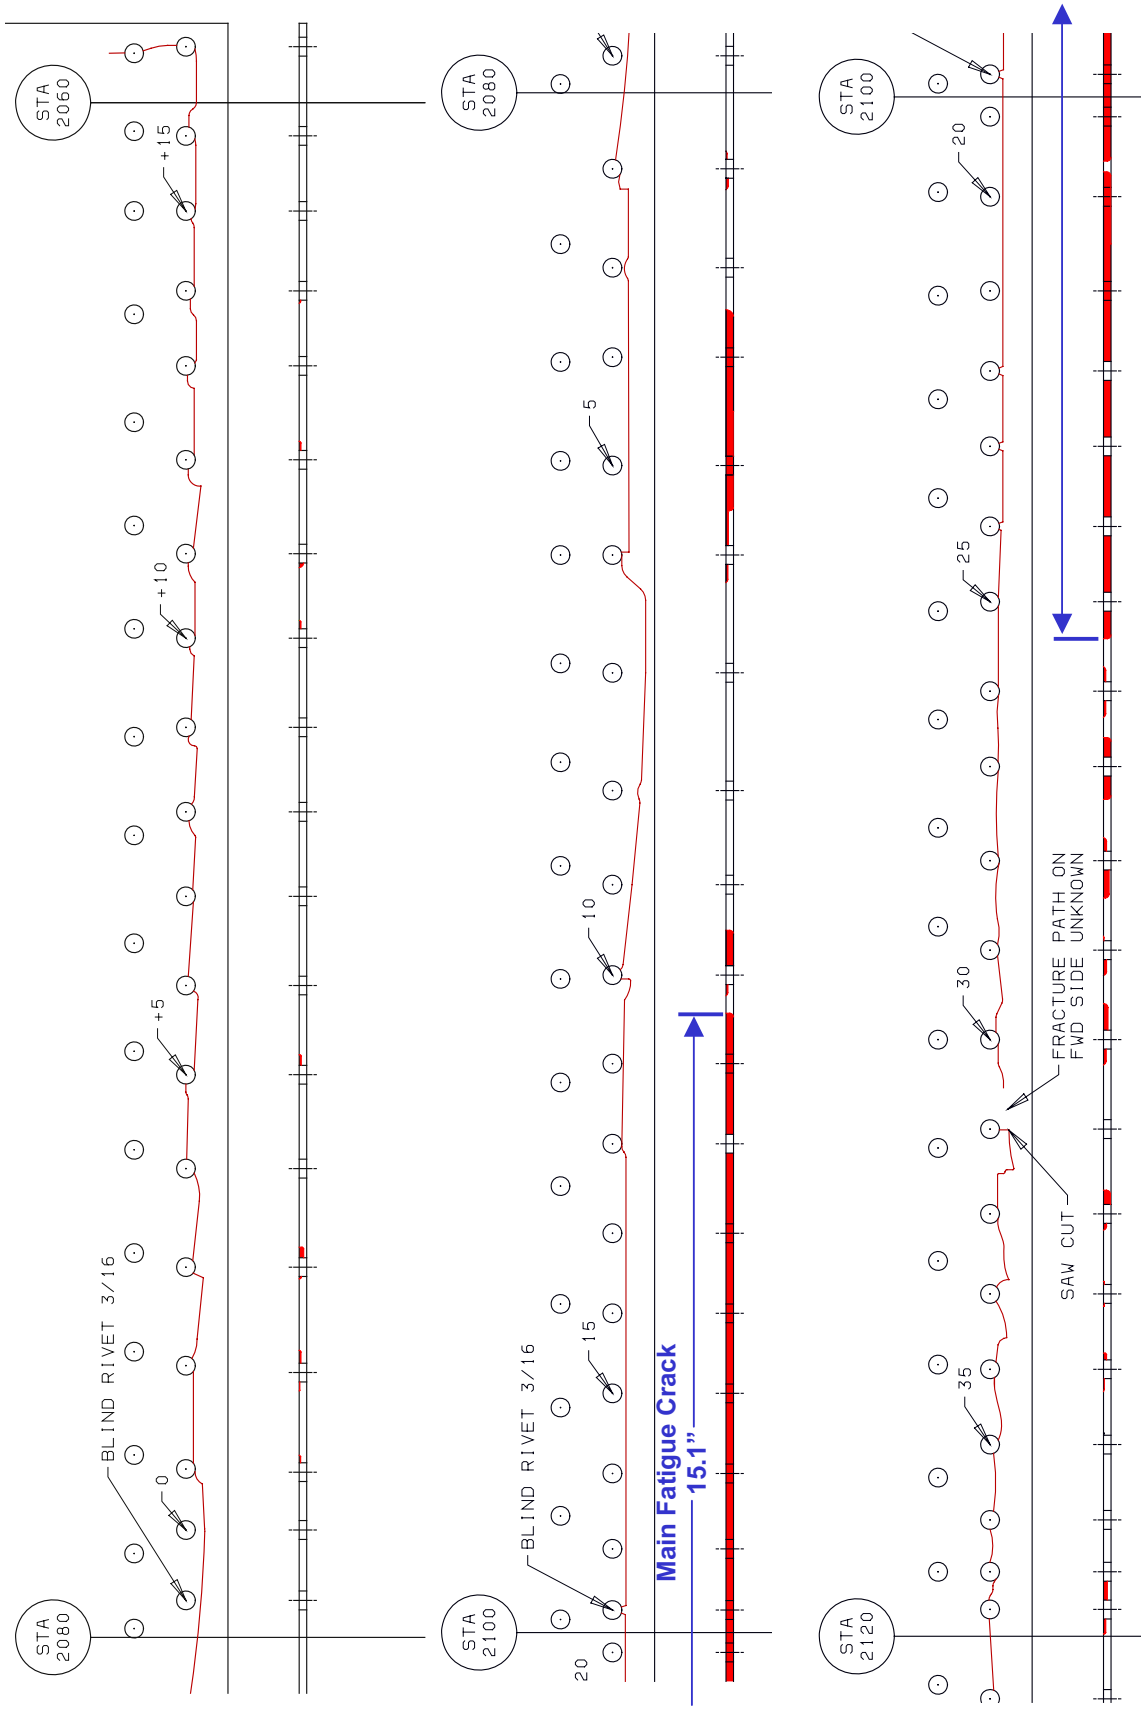
Figure 5. Map of fatigue cracking (red areas) observed on fracture above S-49L from STA 2060 to STA 2120. The length of the main fatigue crack centered about STA 2100 is shown. Refer to Table JVI for a complete list of fatigue crack lengths and depths.

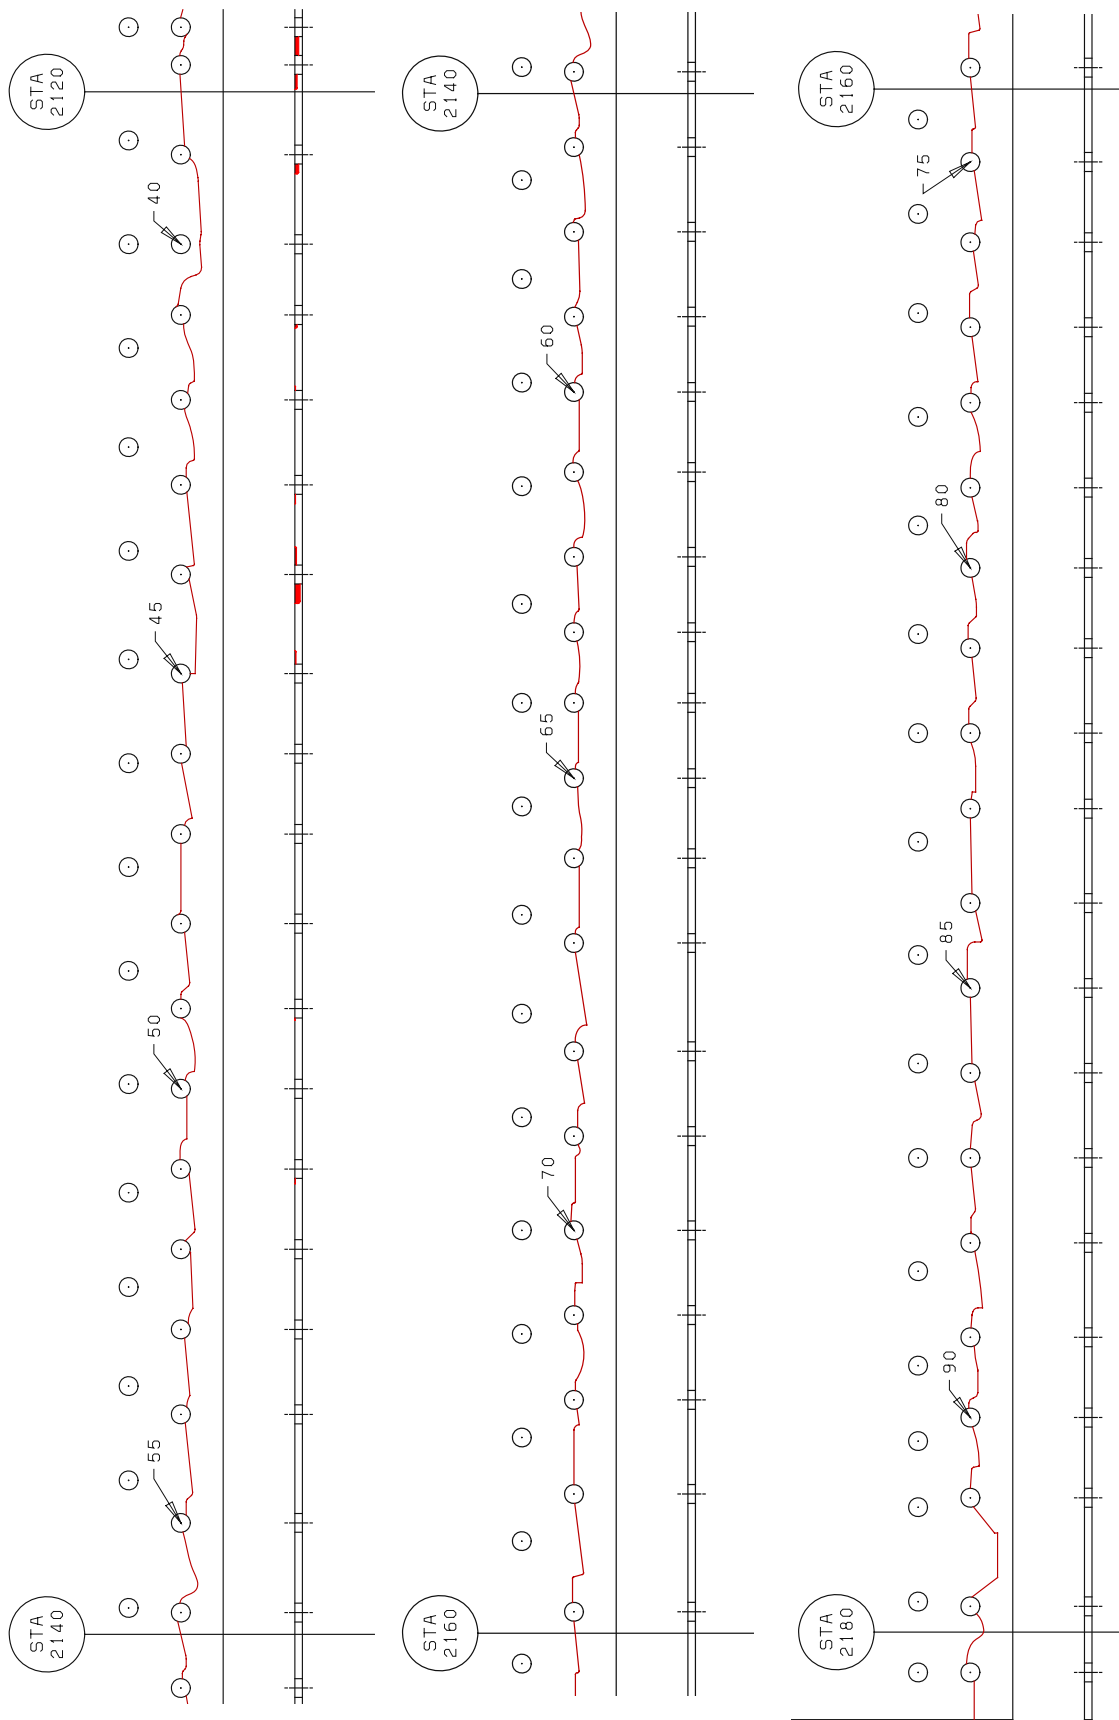
Figure 6.  
 Map of fatigue cracking (red areas) observed on fracture above S-49L from STA 2120 to STA 2180. Refer to Table JVI for lengths and depths of the fatigue cracks provided in this figure.

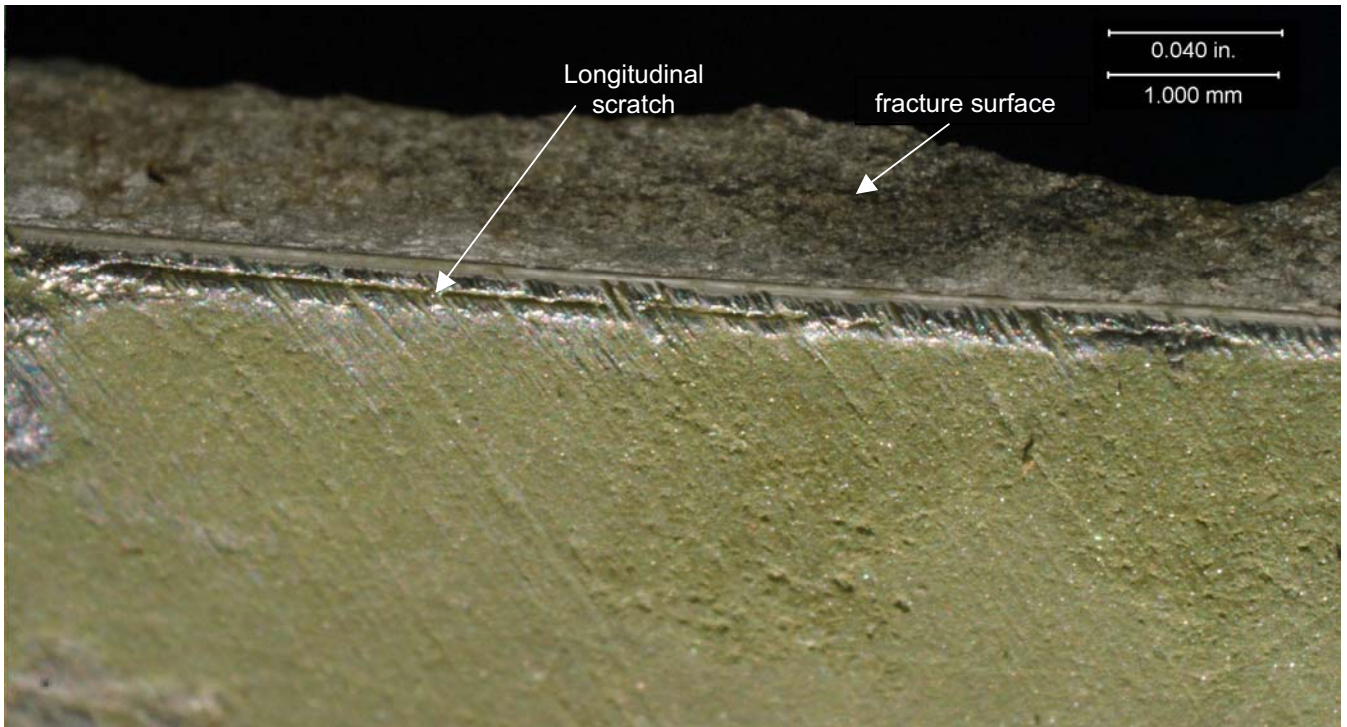
Figure 7.

Surface of skin faying with repair doubler near hole 20 showing the longitudinal scratch where fatigue crack initiation occurred from multiple origins. Also note the sanding marks induced during rework of the skin.

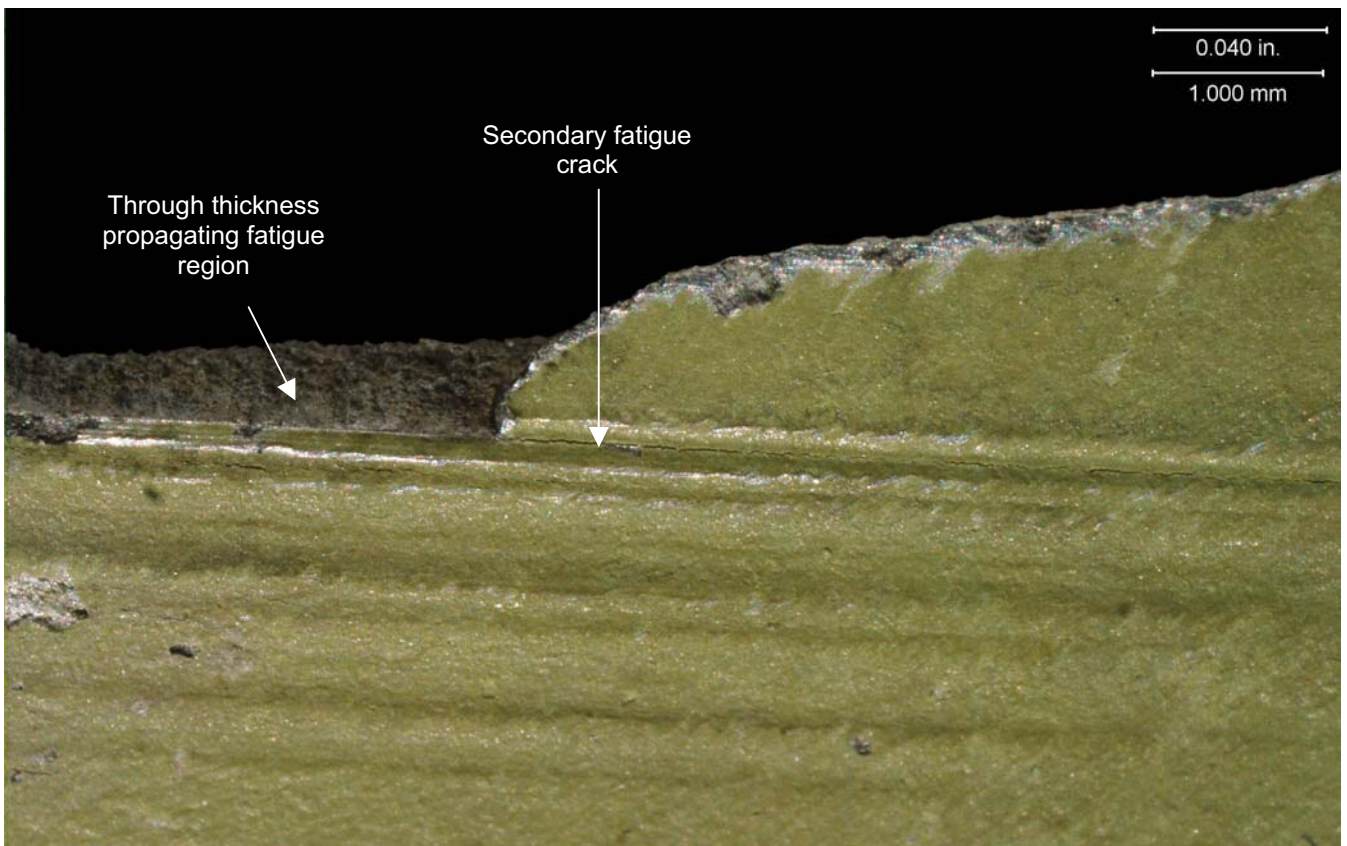
Figure 8.

Surface of skin faying with repair doubler between hole 29 and hole 30 showing the longitudinal scratches in relationship to this fatigue crack. Note the secondary crack extending out of this common scratch.

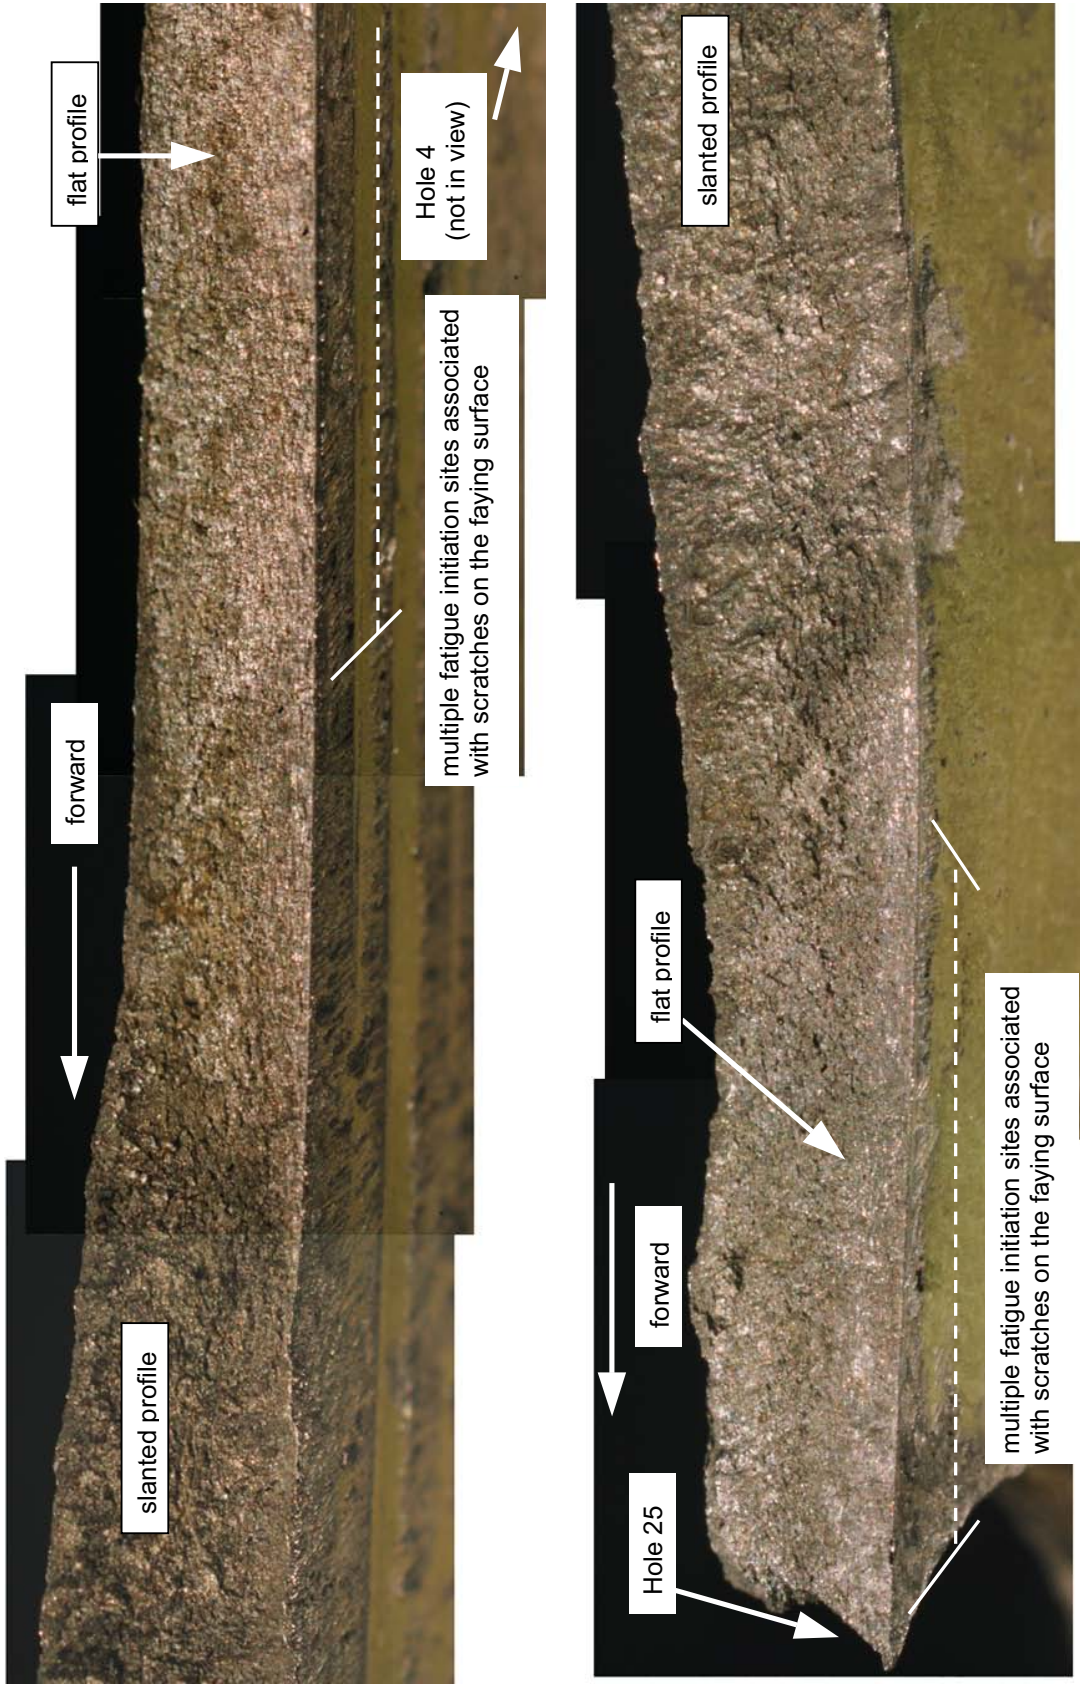
Figure 9, Photographs showing the transition regions from flat fracture profiles to slanted profiles just forward of fastener Hole 4 (top) and Hole 25 (bottom).

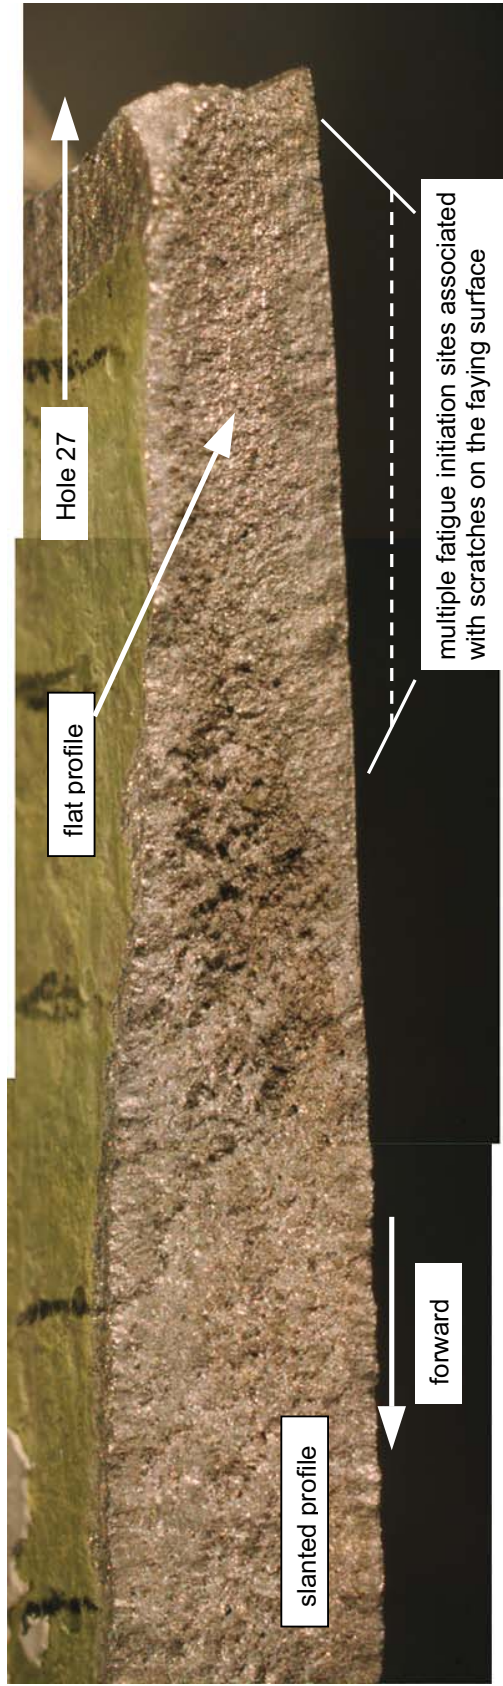
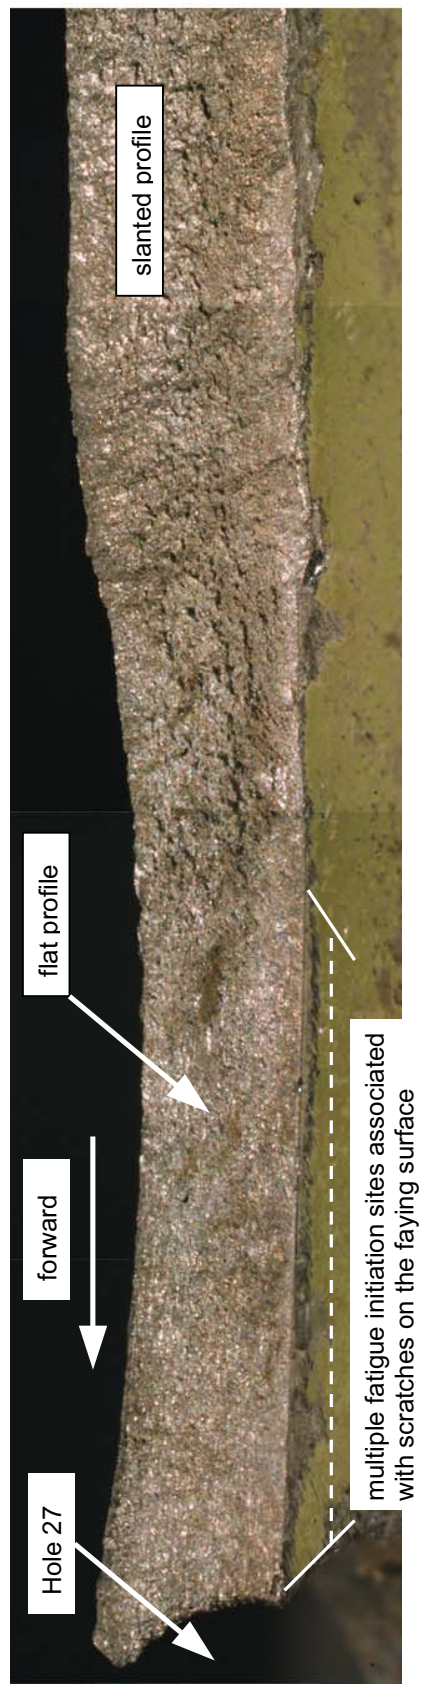
Figure 10. Photographs showing the transition regions from flat fracture profiles to slanted profiles at fastener Hole 27 in the forward direction (top) and the aft direction (bottom).

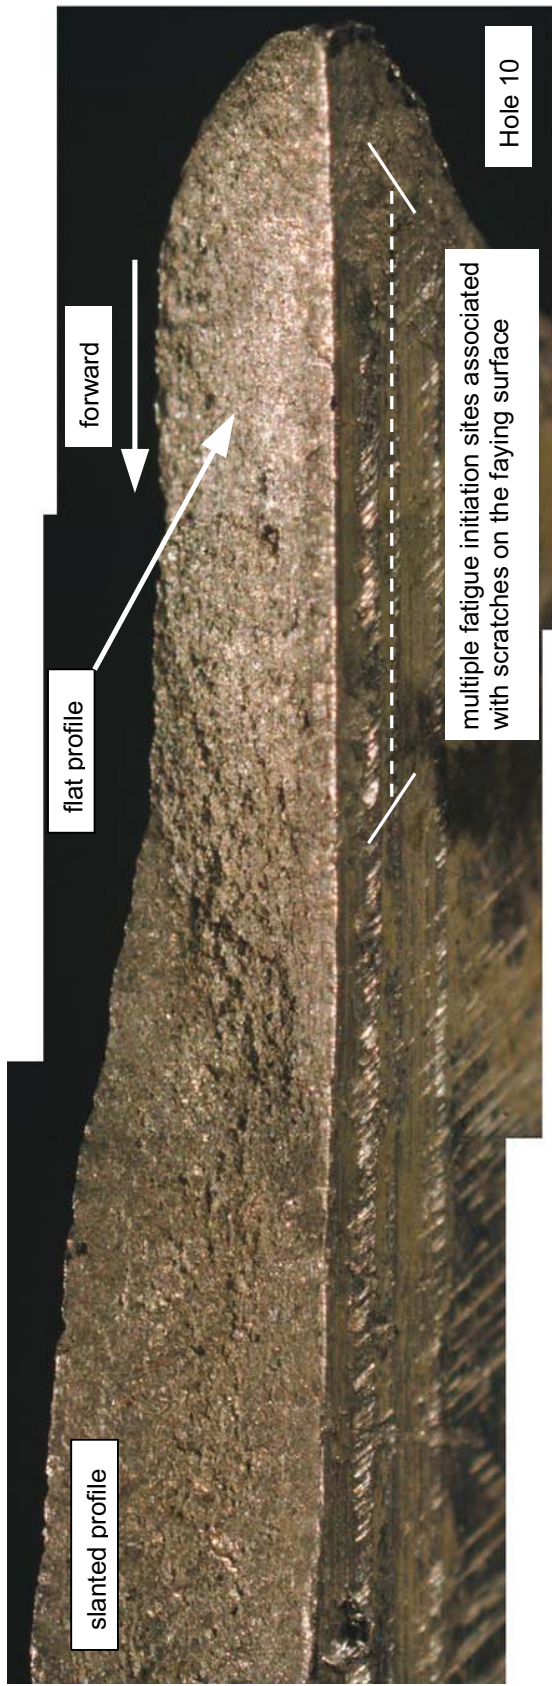
Figure 11, Photograph showing the transition region from a flat fracture profile to a slanted profile at fastener Hole 10 in the forward direction.

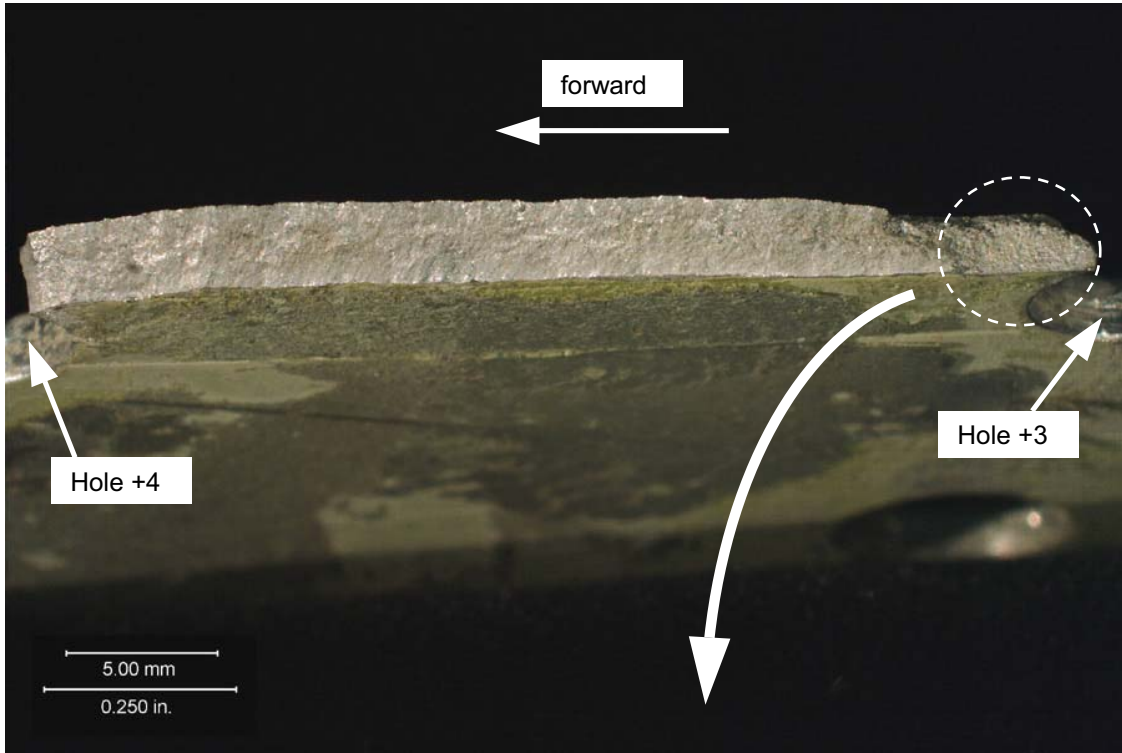
Figure 12, Photographs of the fracture segment extending from Hole +3 to +4 (top), and closer view of the flat profile fatigue region on the forward side of Hole +3 (bottom).

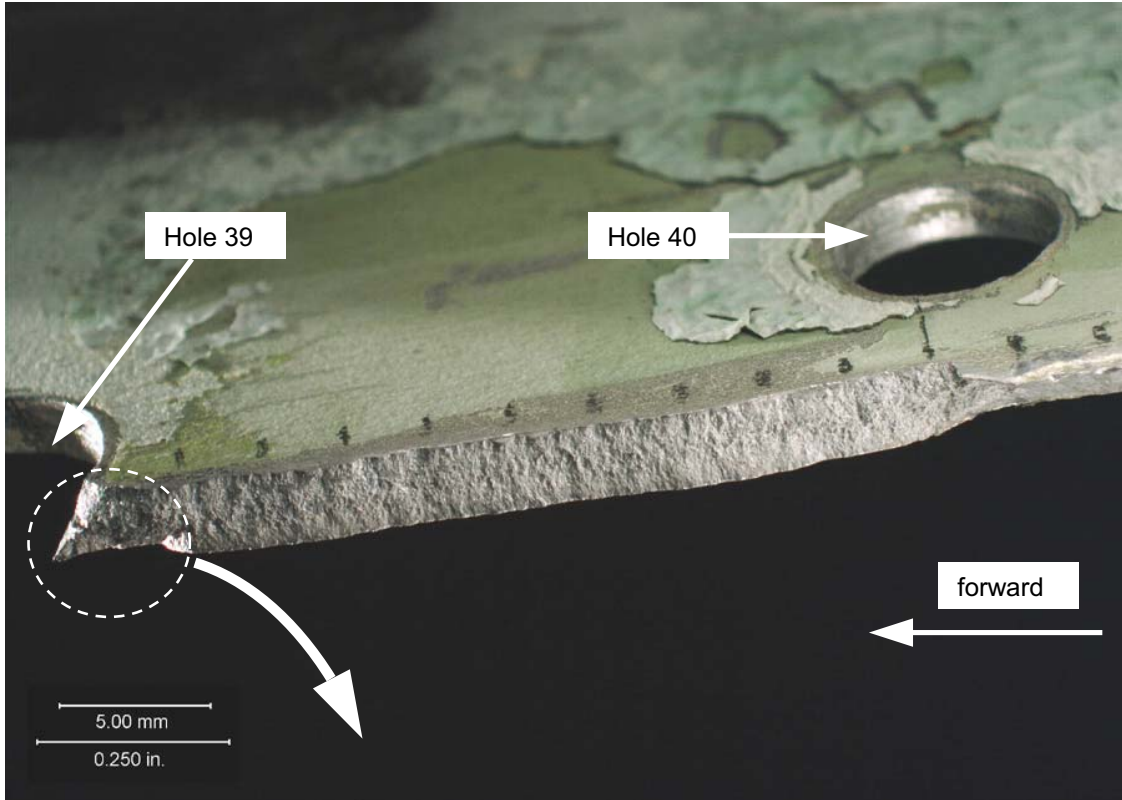
Figure 13, Photographs of the fracture segment extending from Hole 39 to Hole 40 (top), and closer view of the flat profile fatigue region and short transition zone on the aft side of Hole 39 (bottom). SEM photographs showing a dramatic increase in striation spacing near the extent of the flat fracture thumbnail (indicated area) are shown below in Figure 14.

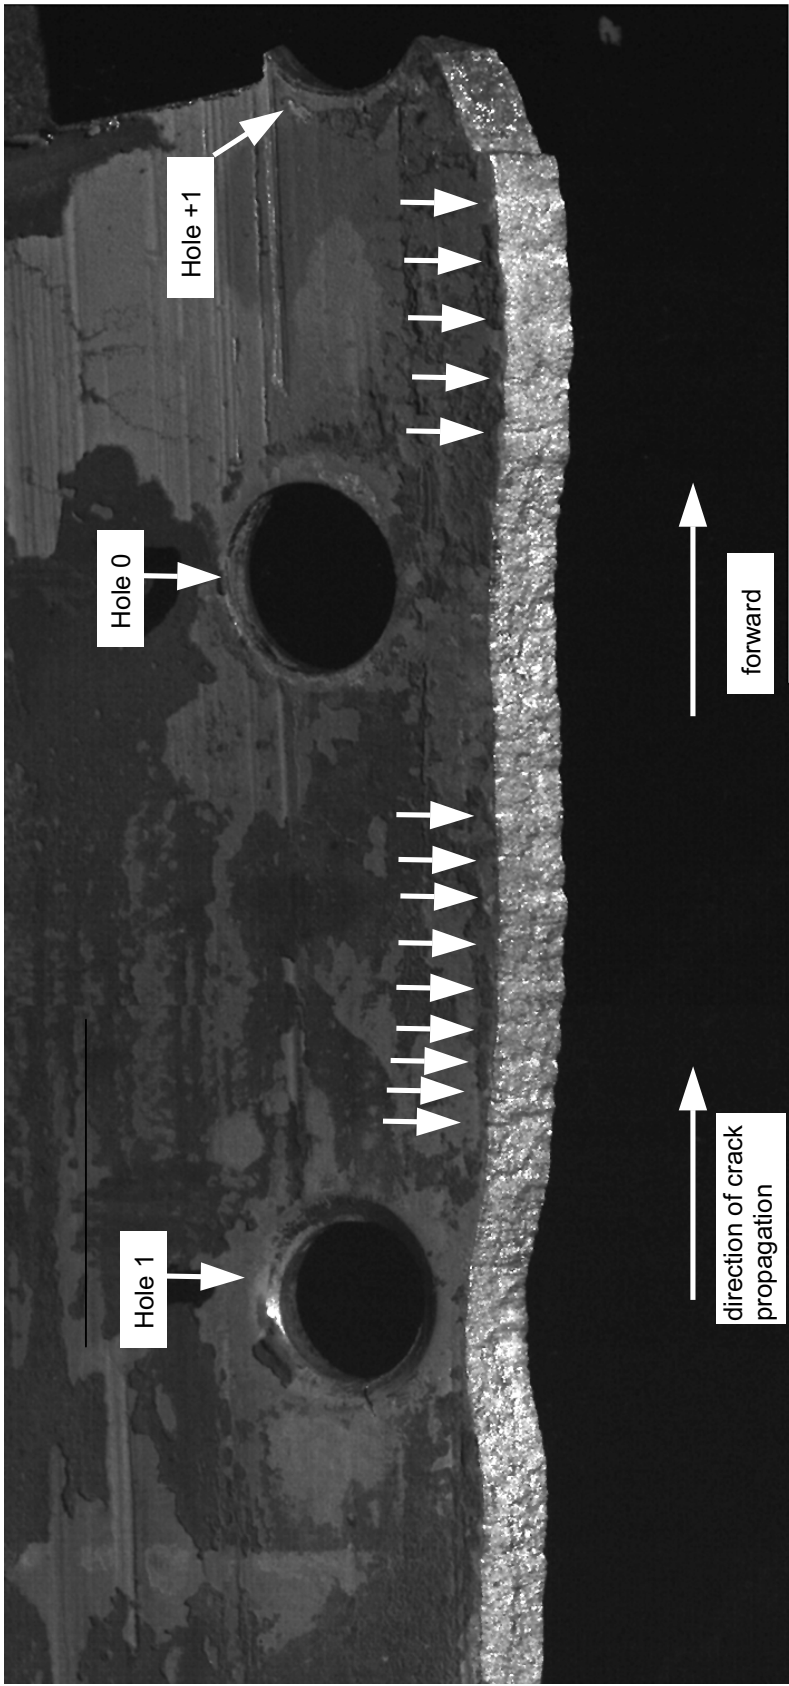
Figure 15, Photograph showing the incremental crack growth indications on the fracture segment from Hole 1 to Hole +1 with two groups of them identified with arrows. This area is just a few inches forward of the flat profile fatigue and transition areas of Hole 4 shown in Figure 9. Note that the regular spacing generally increases as the distance increases from the main cracking system at Holes 4 through 26. These features indicate that the dominant crack was growing at macroscopic rates in a forward direction here when these features were formed, rather than in a through-thickness direction as was the earlier fatigue initiation and propagation mechanism. This point is further exemplified in the following Figure 16.

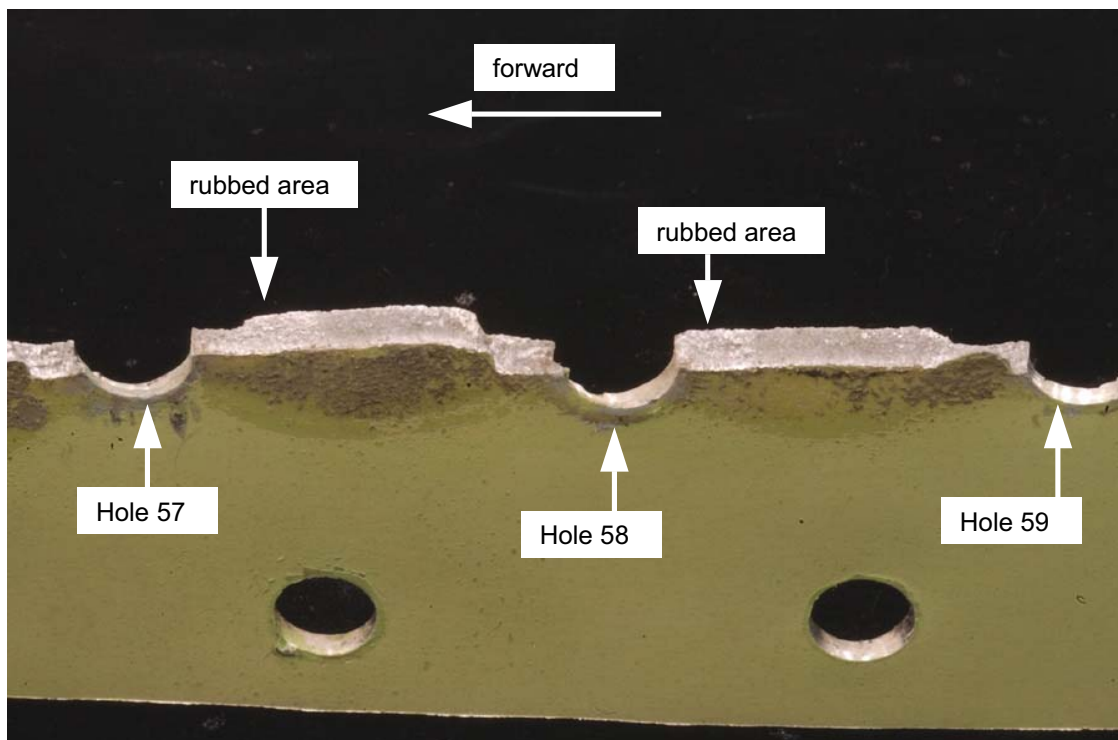
Figure 18, Photograph of the fracture surface at Holes 57, 58, and 59. The shiny areas are indicative of rubbing with the mating fracture surface and appeared consistently forward of this area, but were not present aftward beyond Hole 62.

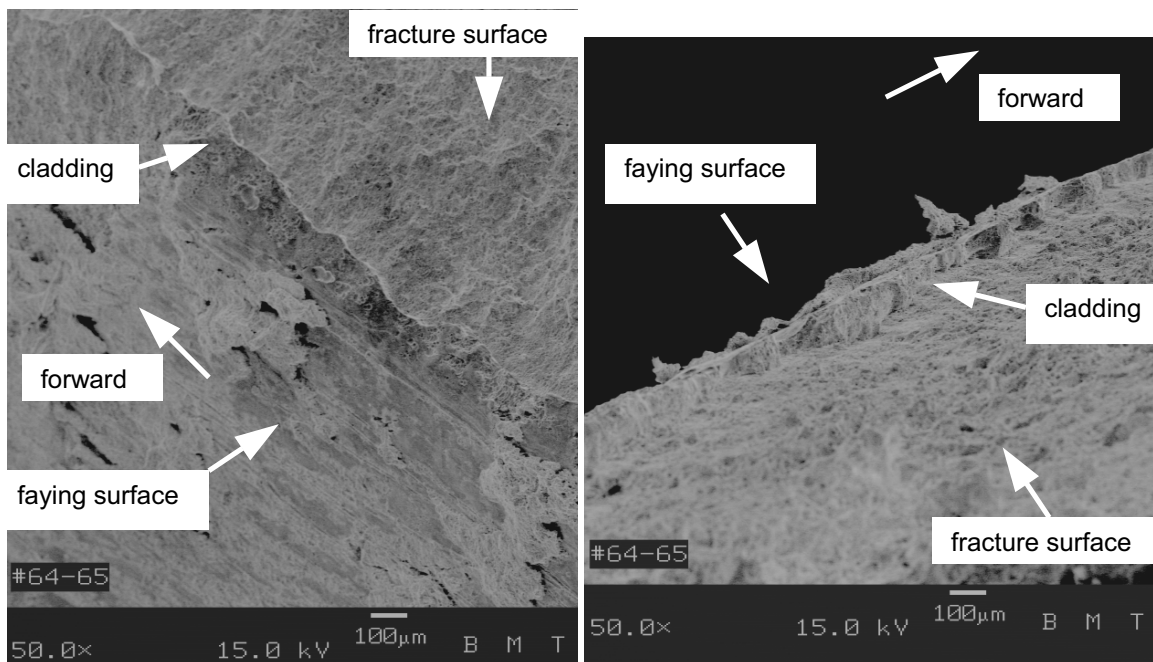
Figure 22, opposing angle SEM photographs of the fracture segment between Holes 64 and 65 showing the cladding on the faying surface retaining its upward profile from the necking process during ultimate tensile separation without subsequent crack closure.

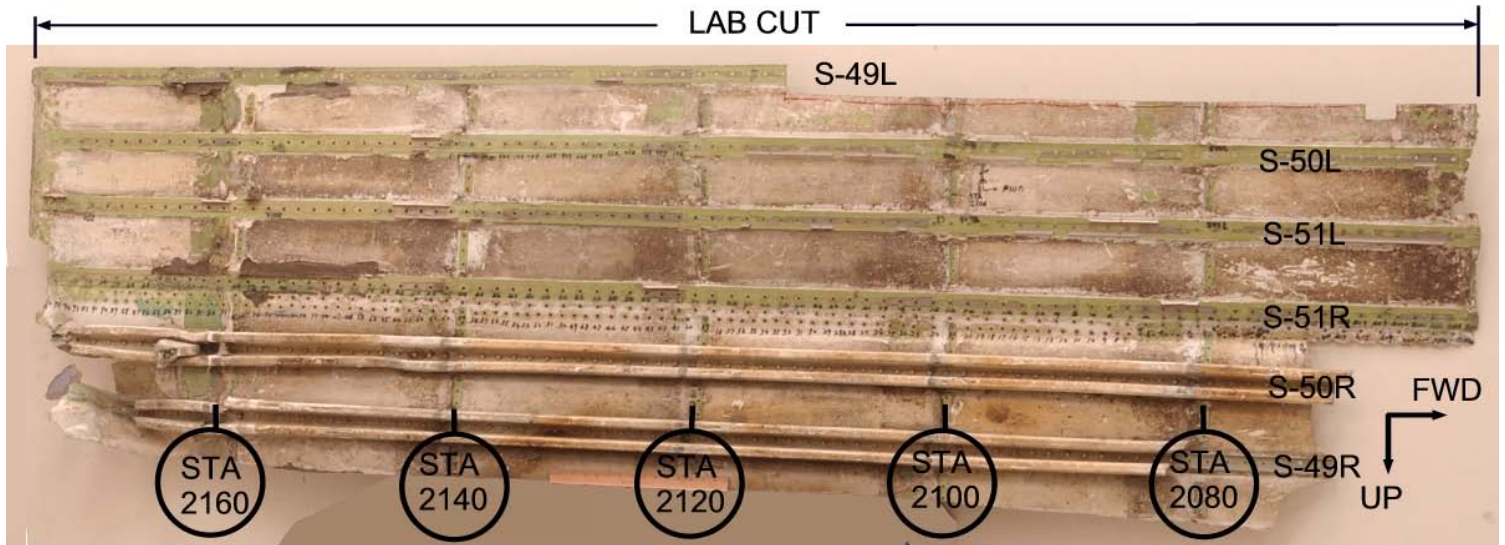
FIGURE 25. AS RECEIVED ITEM 640 CI SKIN INBOARD SURFACE- The S-49L fracture segment was removed at the CSIST during the initial examination.

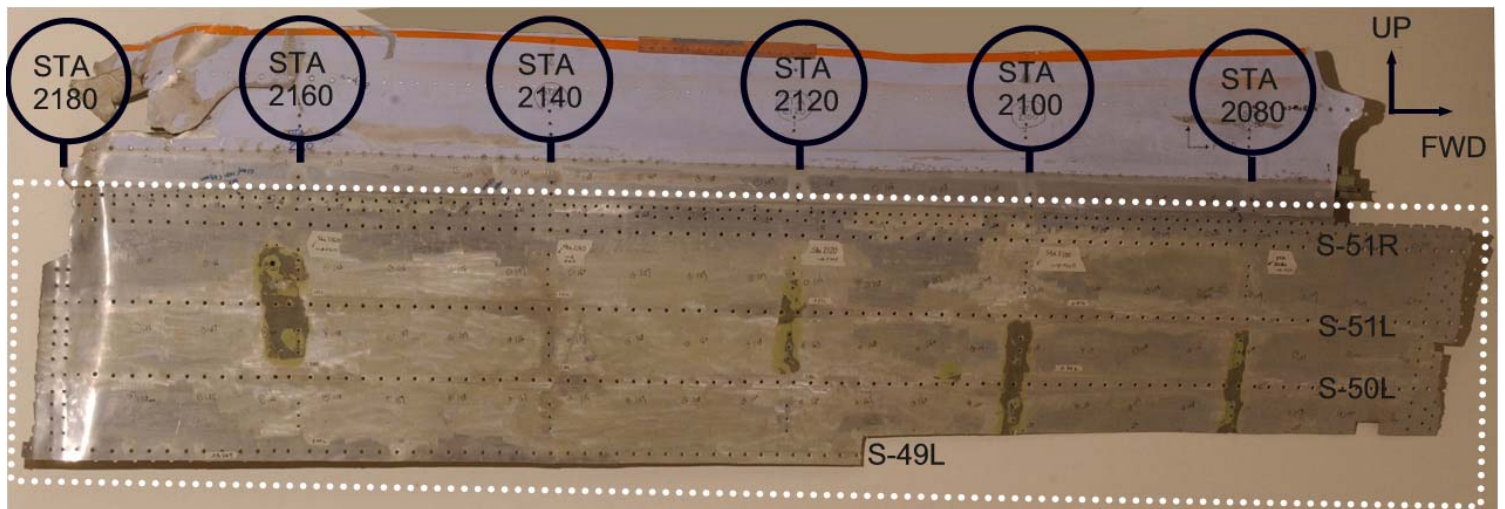
FIGURE 26. AS RECEIVED ITEM 640 C1 SKIN OUTBOARD SURFACE – The approximate location of the repair doubler is shown with dotted lines. Protective finishes were removed from the repair faying surface at the CSIST.
