# **Aviation Occurrence Report Volume II**

ASC-AOR-05-02-001

**IN-FLIGHT BREAKUP OVER THE TAIWAN STRAIT**

**CHINA AIRLINES FLIGHT CI611**

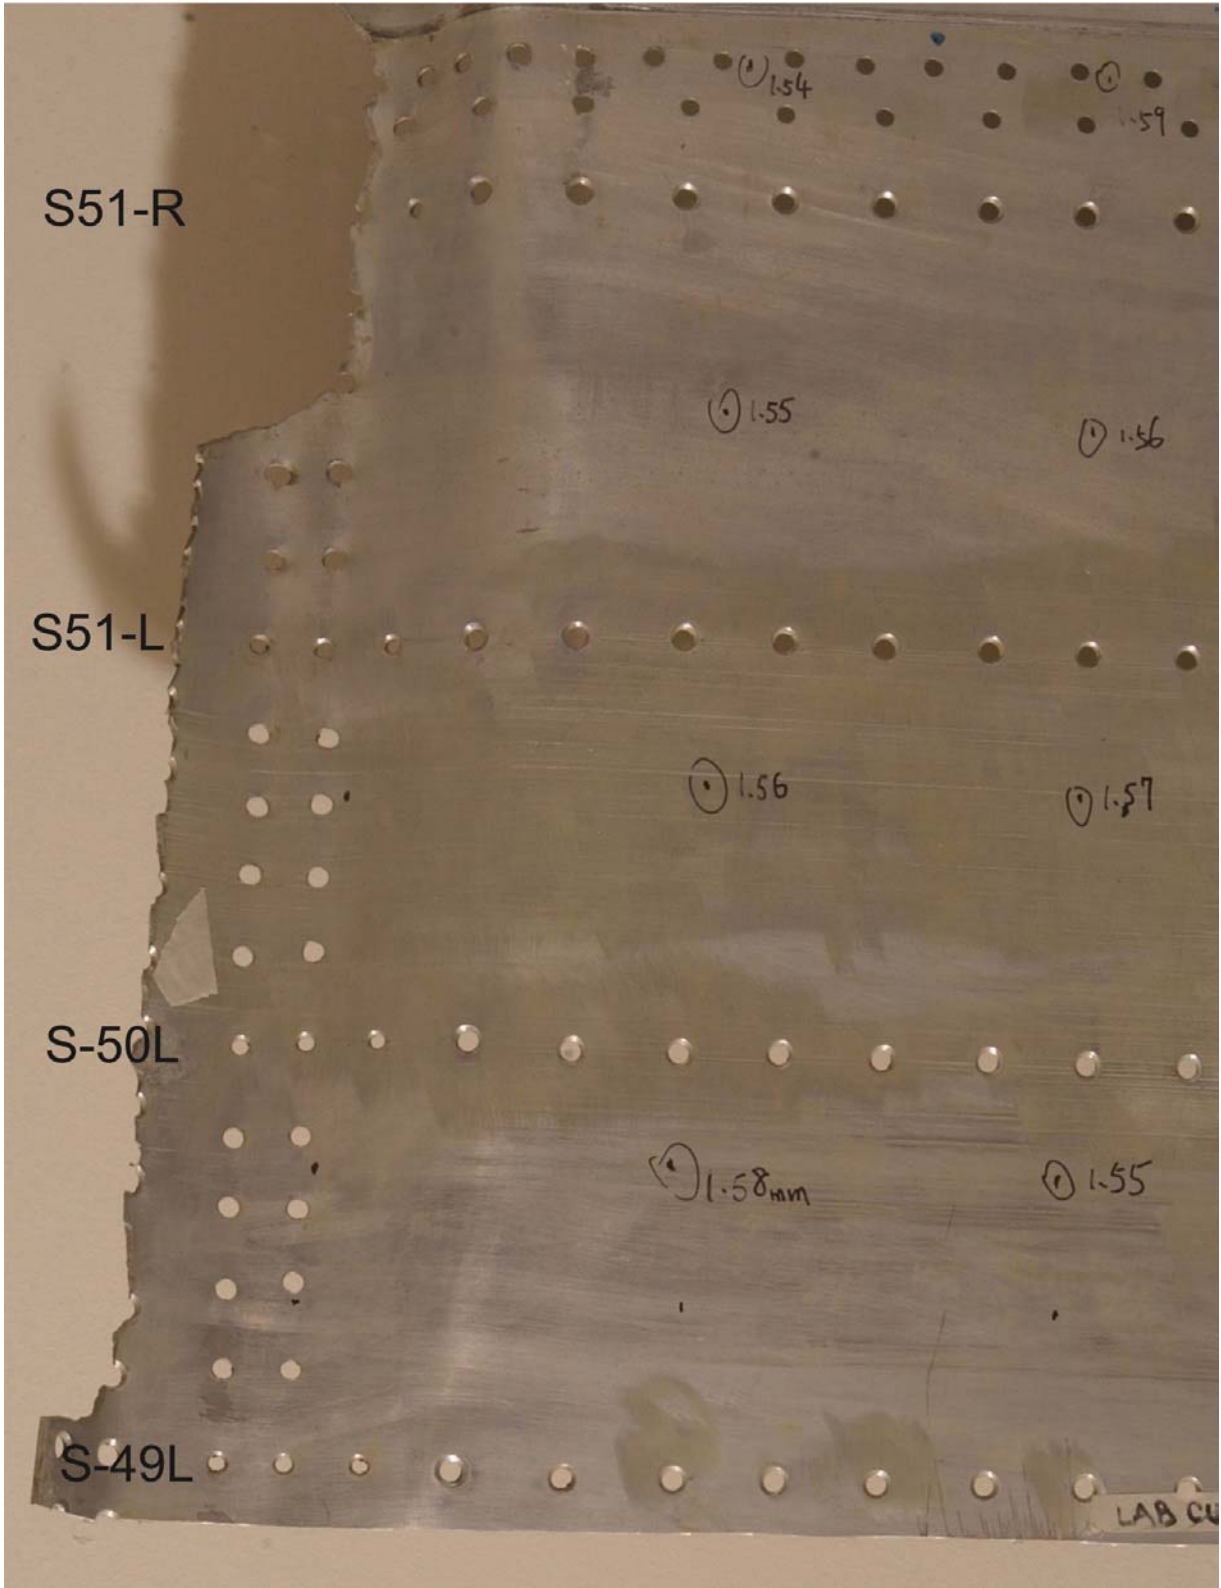
FIGURE 28 – EXTENT OF DAMAGE CONSISTENT WITH A TAIL STRIKE – Scratches may be noted at S-50L and S-51L. Numerical information on skin are results of thickness measurements at the CSIST. Scratch severity increases as you move forward on the panel as shown in the following photographs.

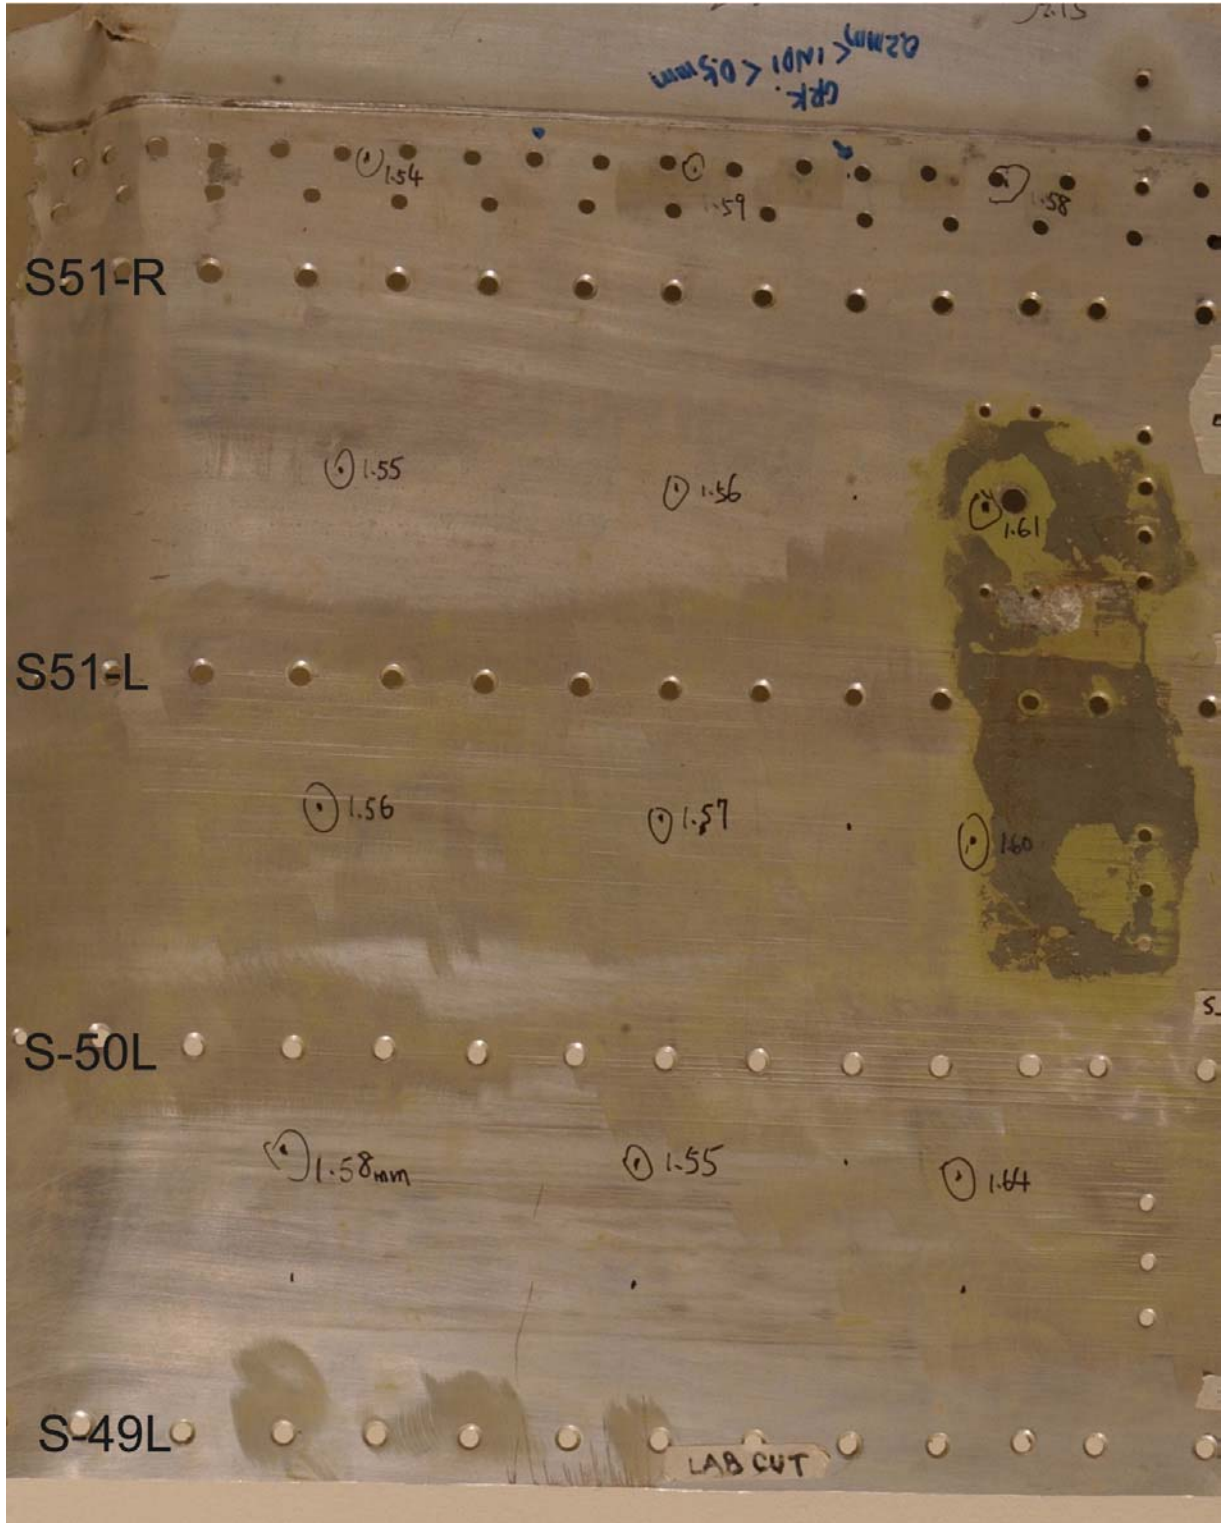
FIGURE 29. EXTENT OF DAMAGE CONSISTENT WITH A TAIL STRIKE – Scratches may be noted at S-50L and S-51L. Scratches may also be noted at the shear tie between S-49L and S-50L.

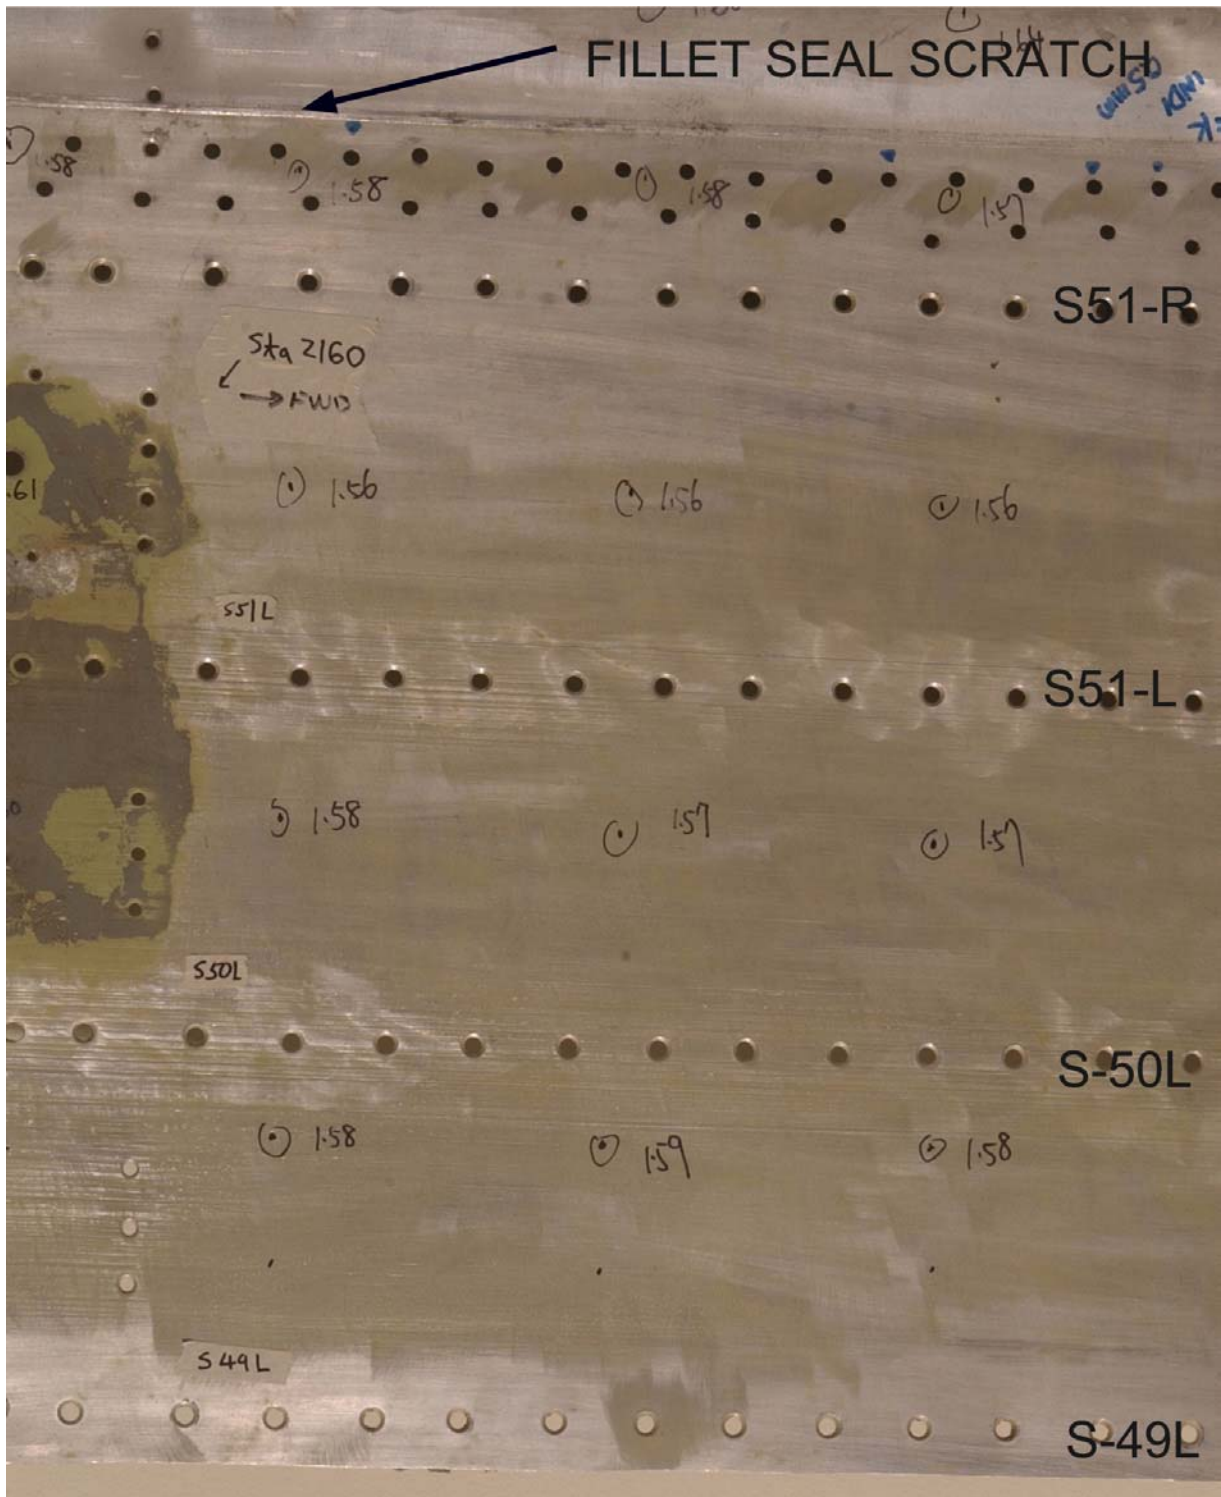
FIGURE 30. EXTENT OF DAMAGE CONSISTENT WITH A TAIL STRIKE - Note that minimal damage occurs on the right hand side of the repair area. Scratching in the doubler fillet seal area may also be seen in this photo.

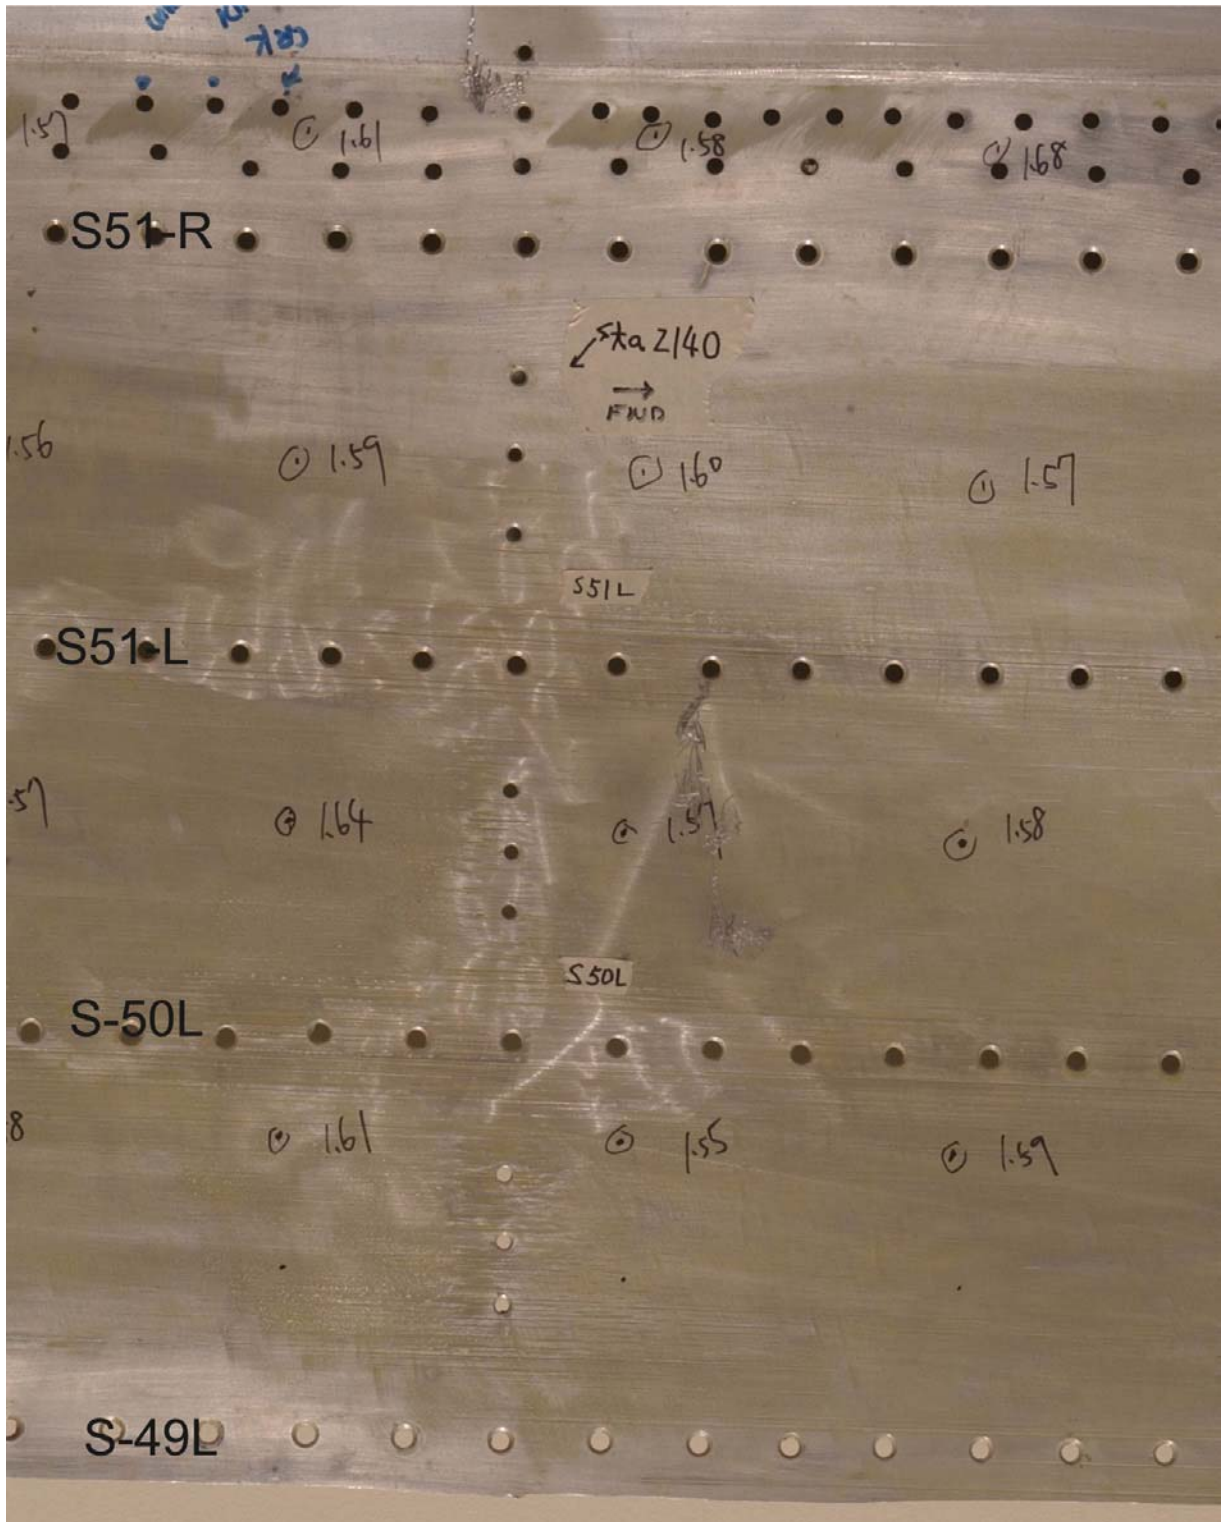
FIGURE 31. EXTENT OF DAMAGE CONSISTENT WITH A TAIL STRIKE

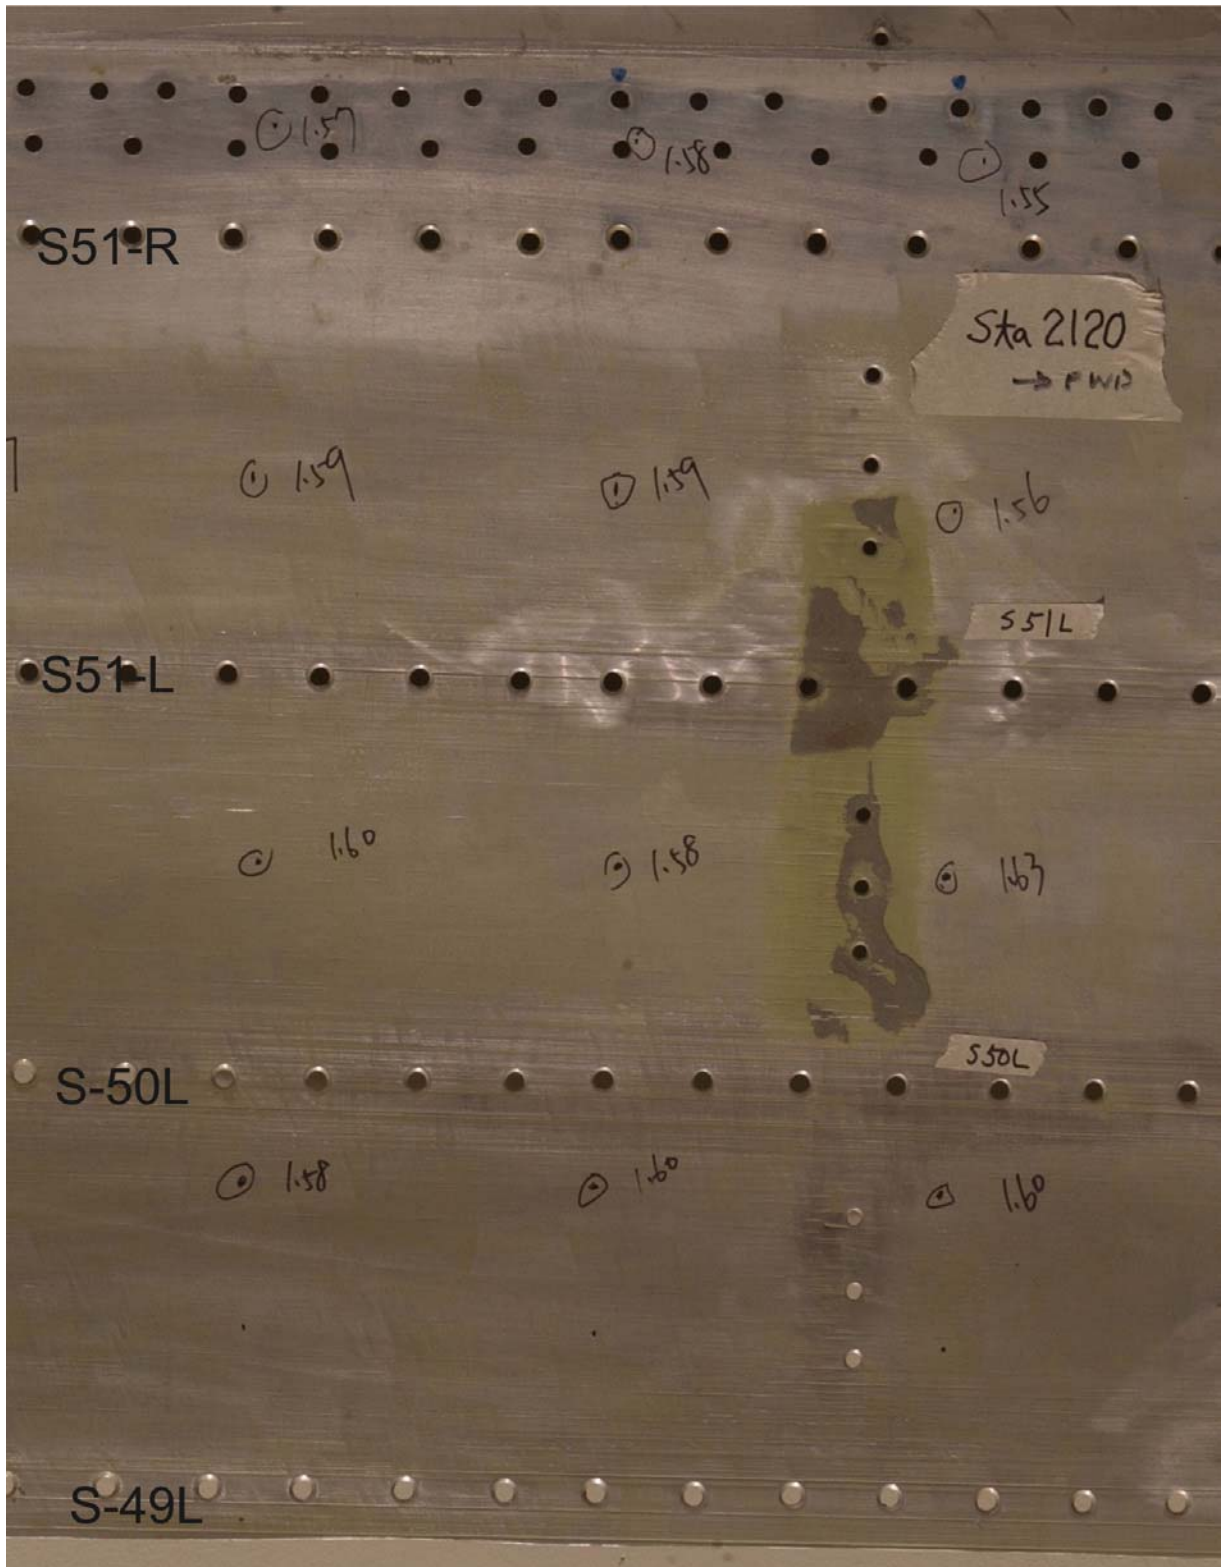
FIGURE 32. EXTENT OF DAMAGE CONSISTENT WITH A TAIL STRIKE – Deep scratches can be noted at S-49L, S-50L, AND S-51L.

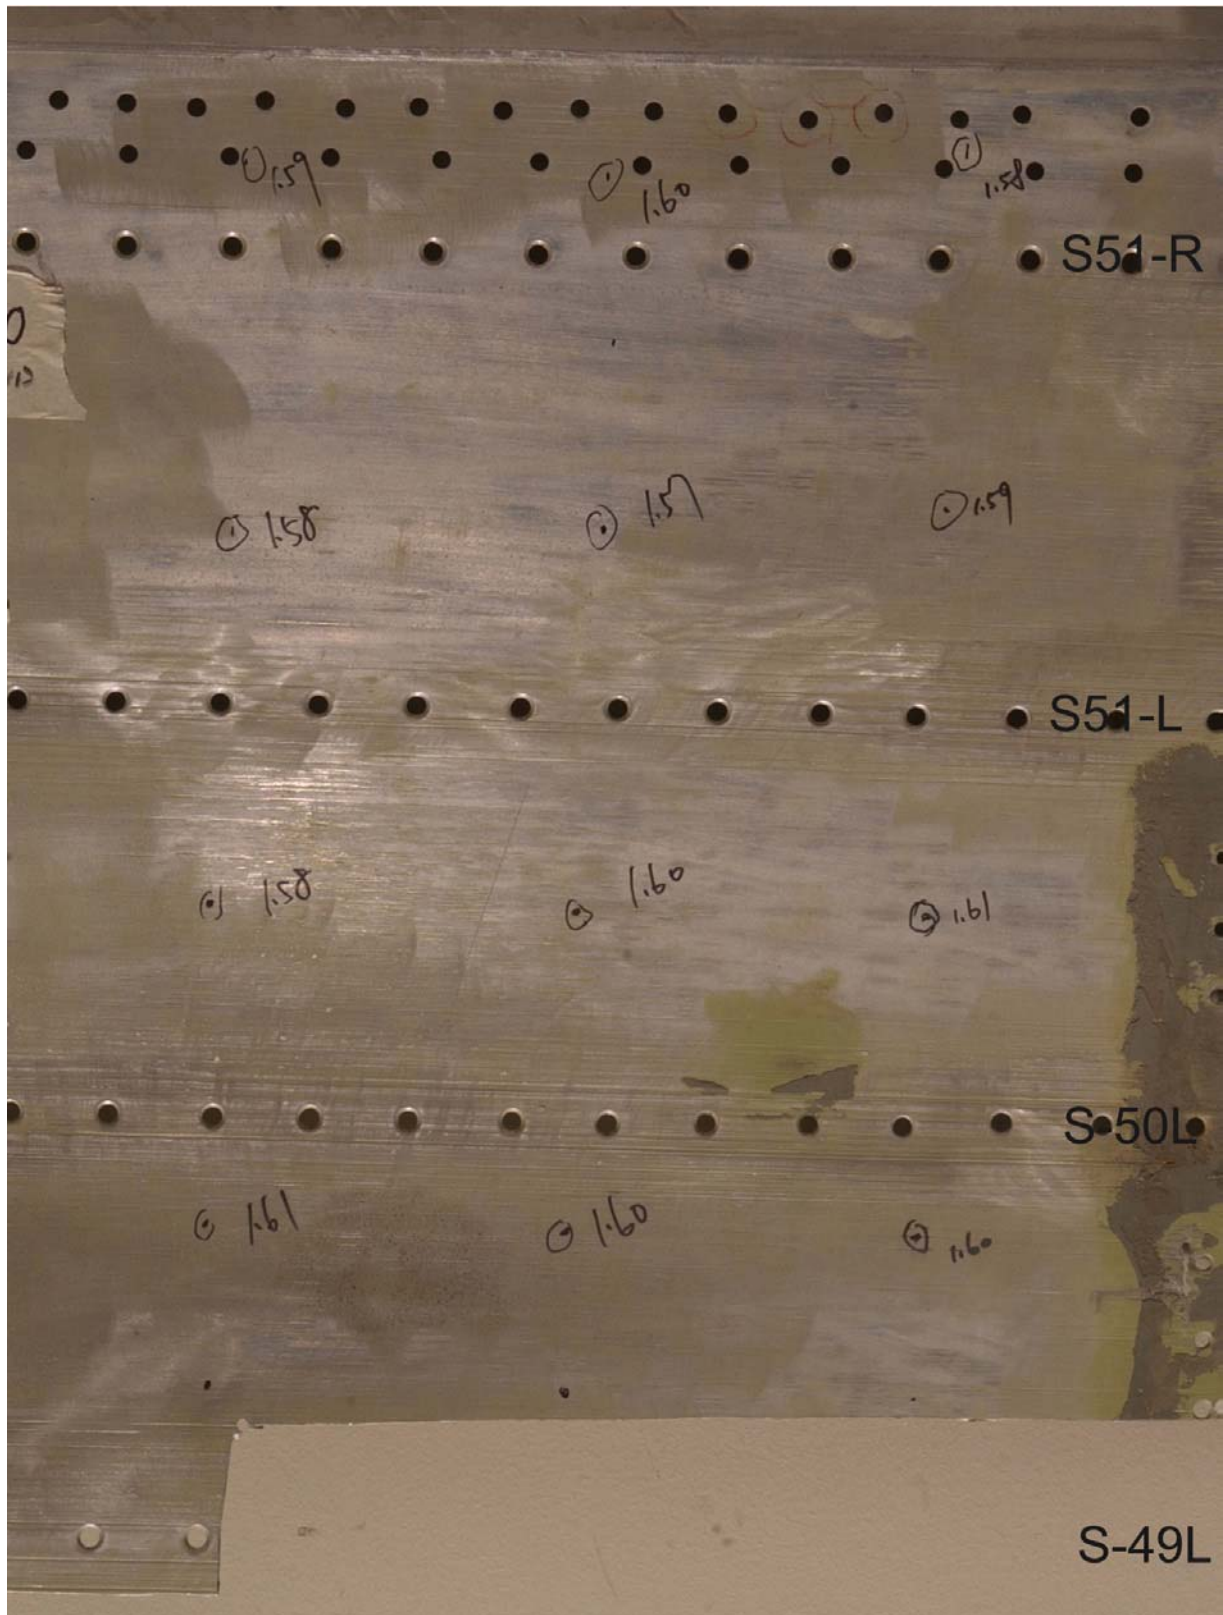
FIGURE 33. EXTENT OF DAMAGE CONSISTENT WITH A TAIL STRIKE

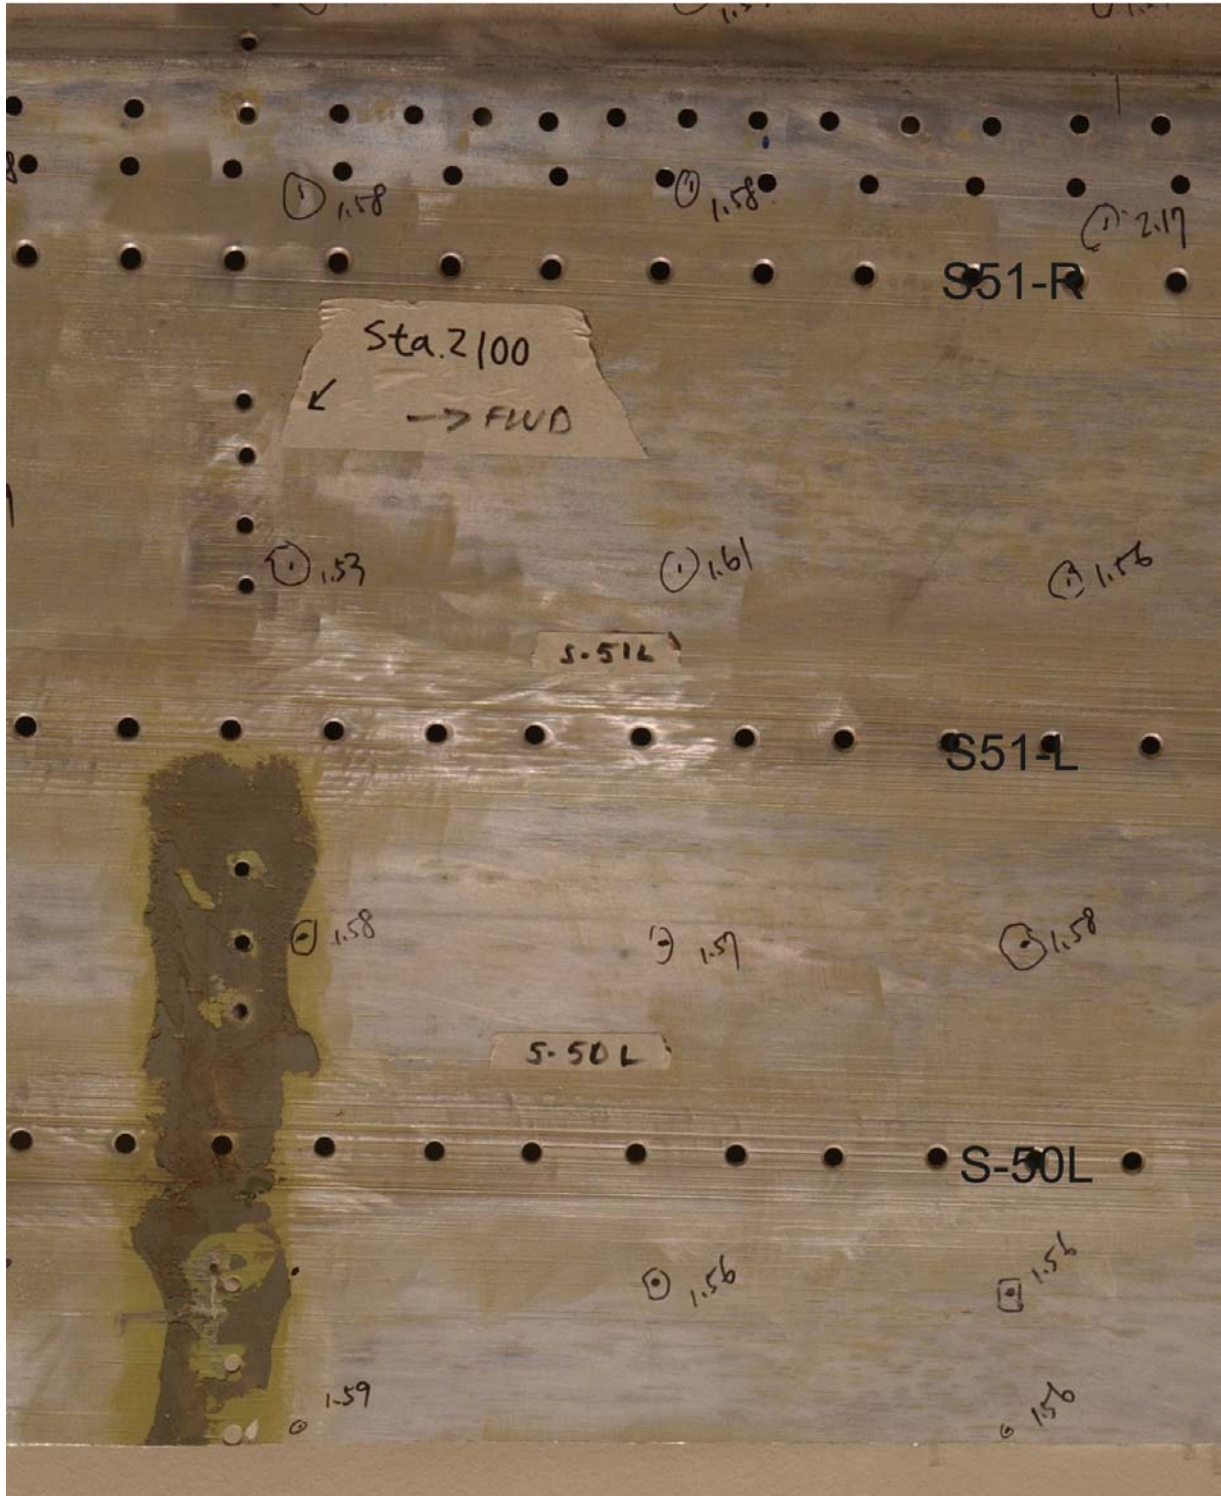
FIGURE 34. EXTENT OF DAMAGE CONSISTENT WITH A TAIL STRIKE

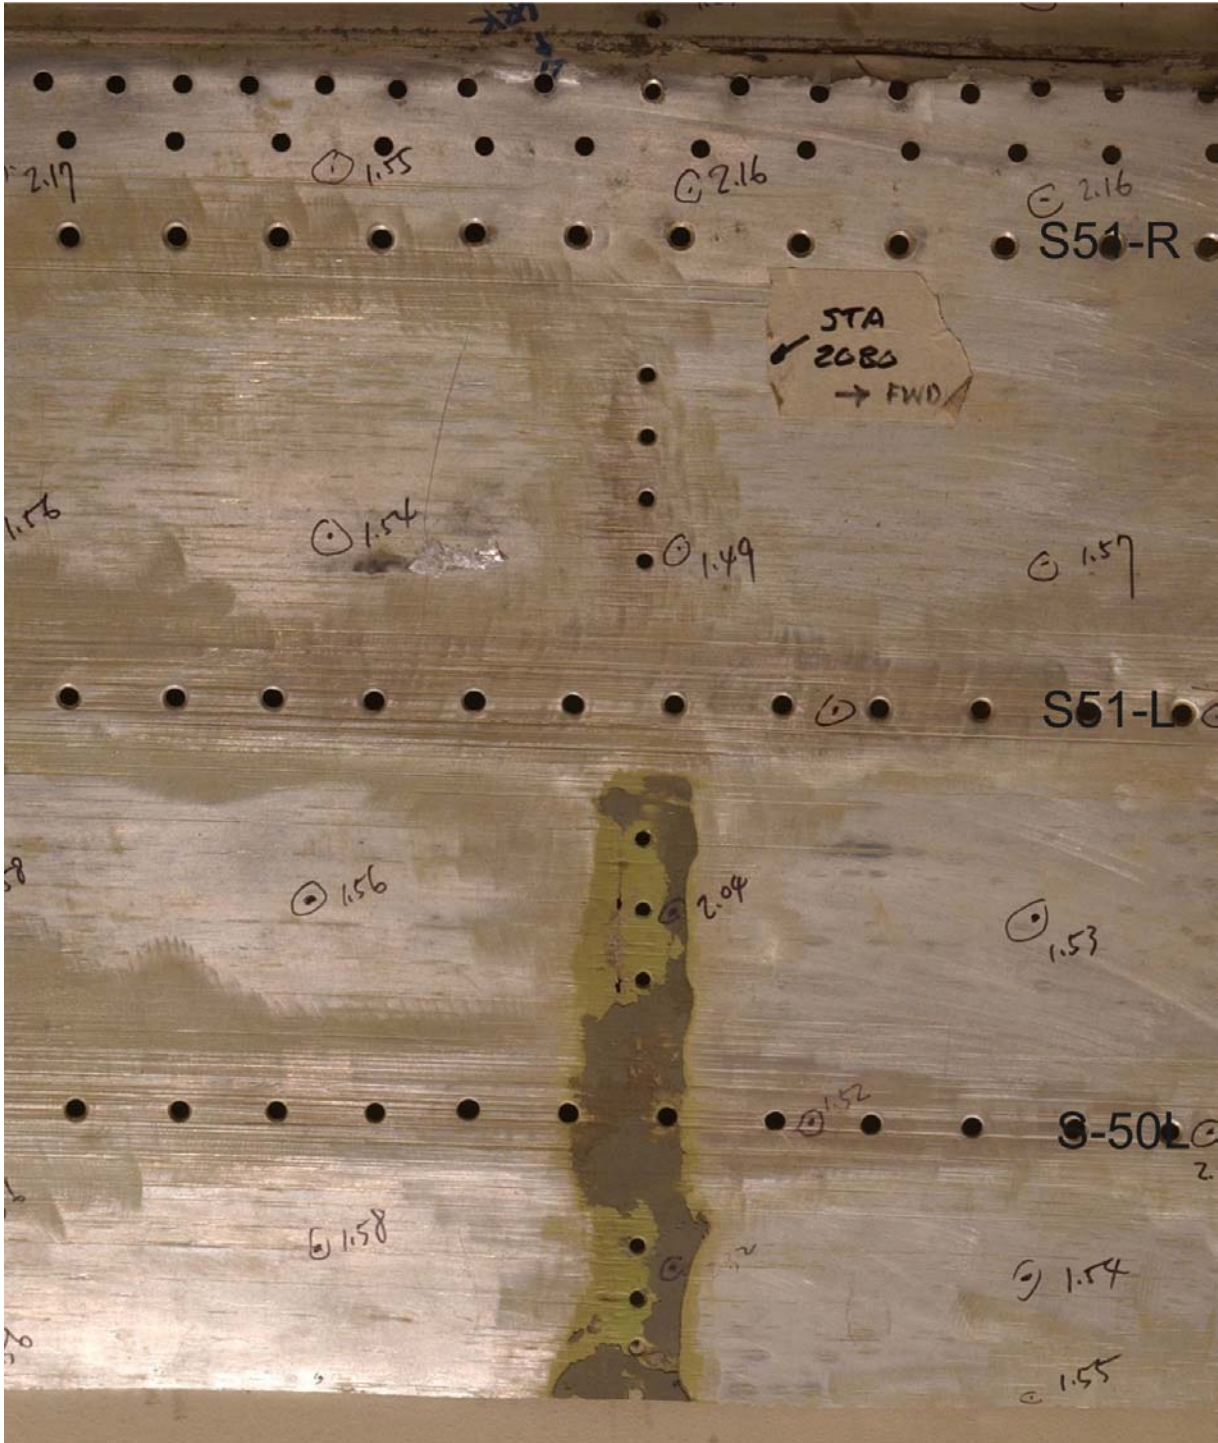
FIGURE 35. EXTENT OF DAMAGE CONSISTENT WITH A TAIL STRIKE – Note the severity of damage in this photo.

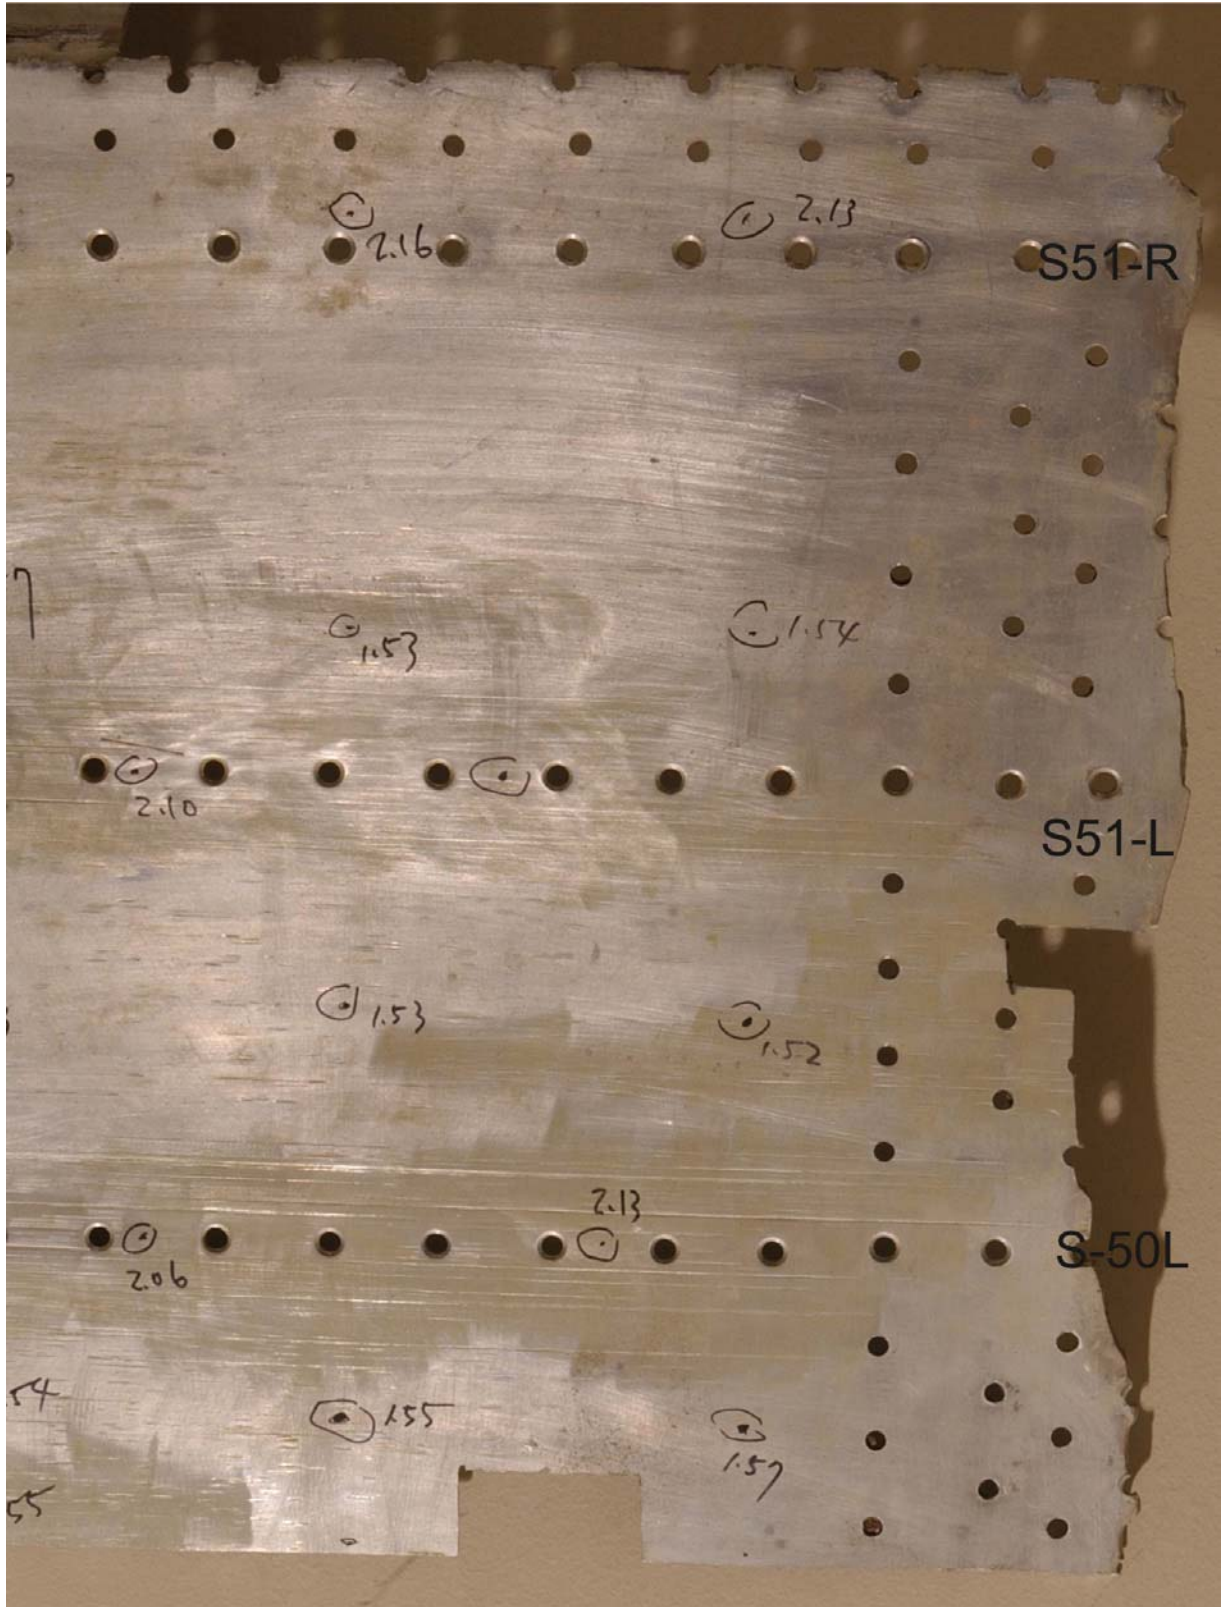
FIGURE 36. EXTENT OF DAMAGE CONSISTENT WITH A TAIL STRIKE

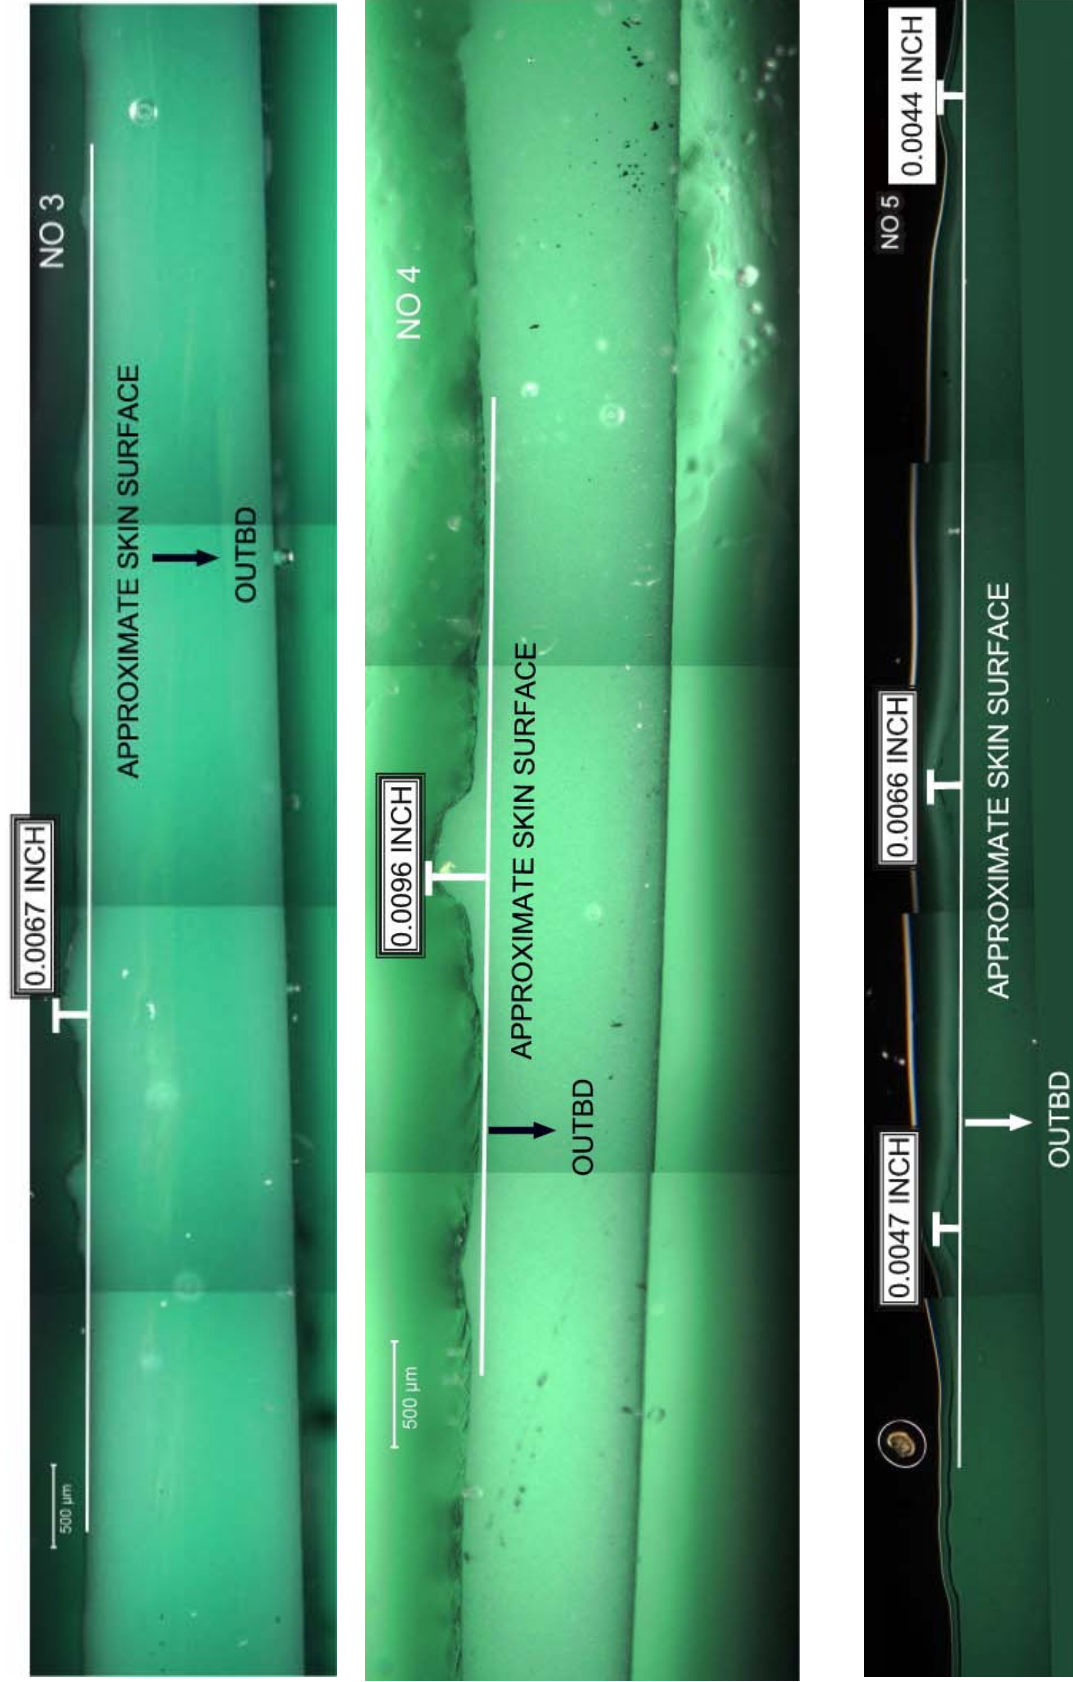
FIGURE 40. SCRATCH PROFILE COMPOSITE PHOTOGRAPHS – Shown above are replicas from locations 3,4, and 5. Location 4 presented the deepest scratch found using this technique.

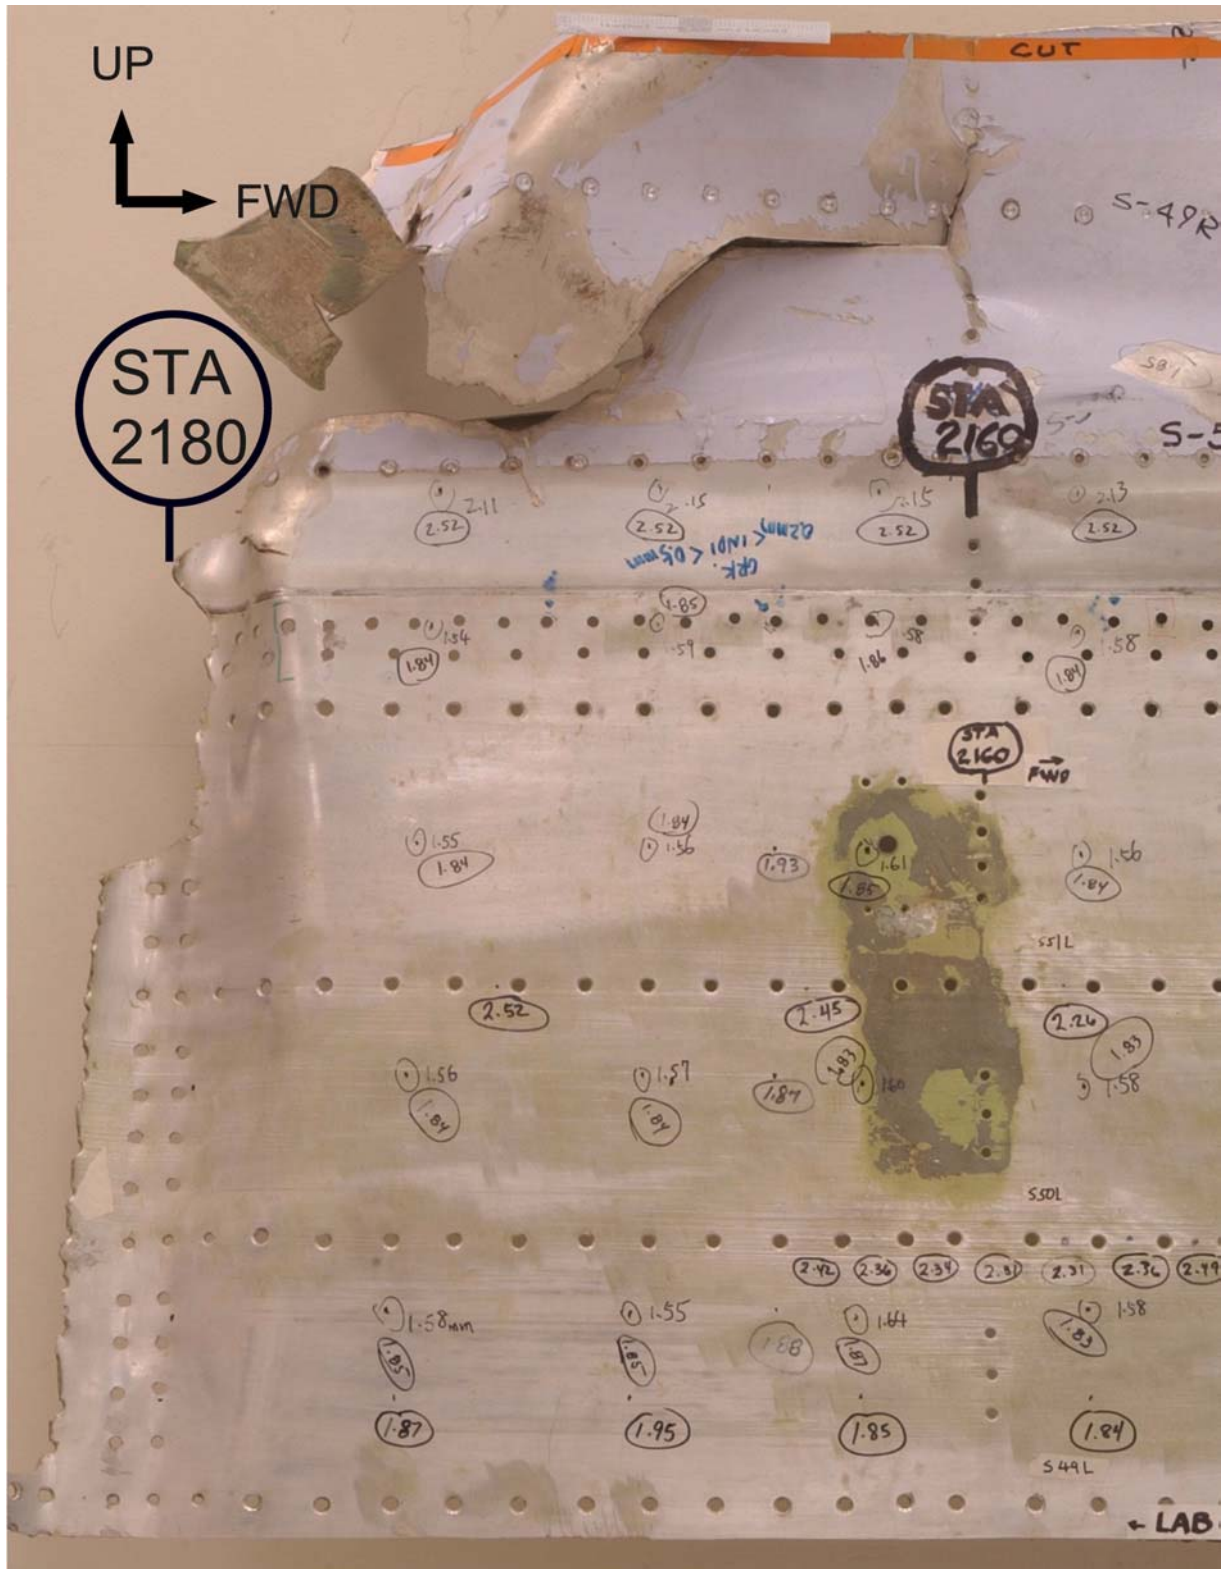
Figure 41. SKIN THICKNESS MEASUREMENTS - All measurements are in millimeters. Circled values were performed at Boeing.

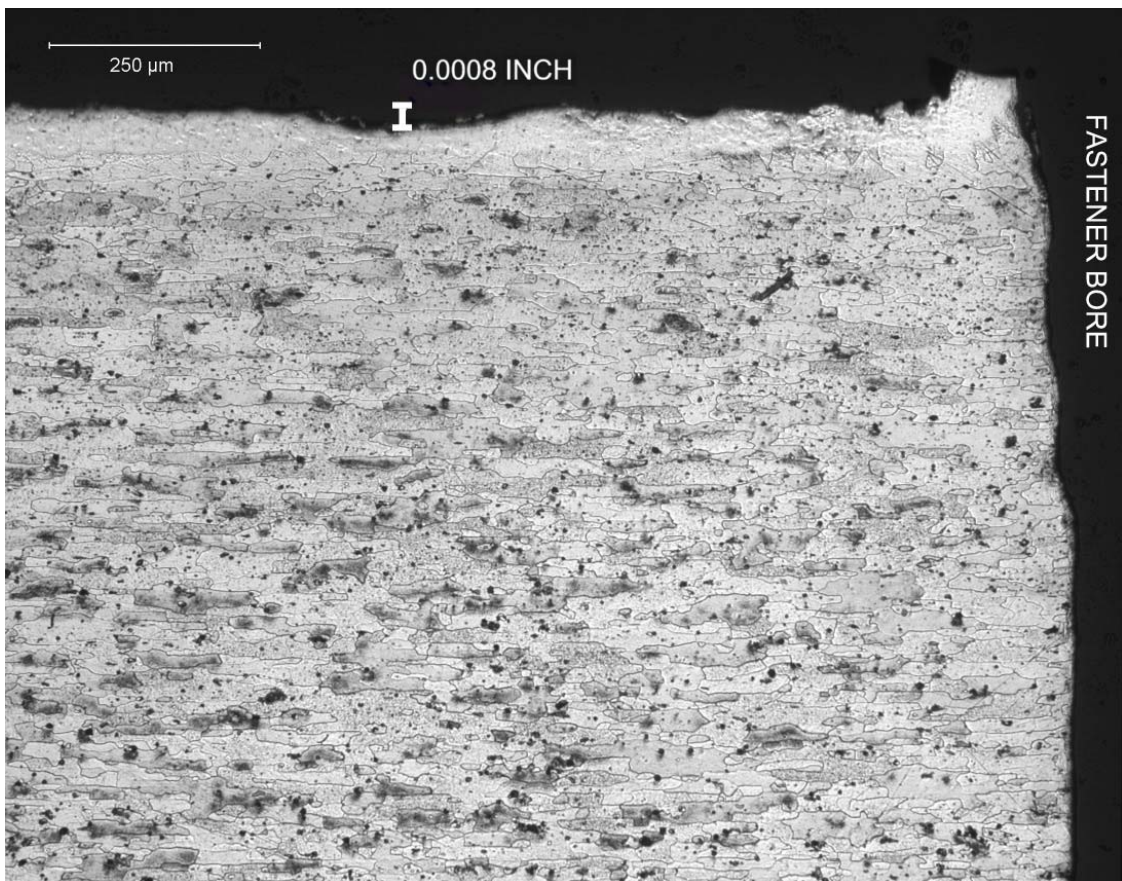
Figure 59. OUTER FASTENER ROW SCRATCH FEATURES AT PLANE A-A – Skin damage at this location was much less severe than on the left hand side of repair doubler. Skin cladding was not compromised by surface damage in this view.

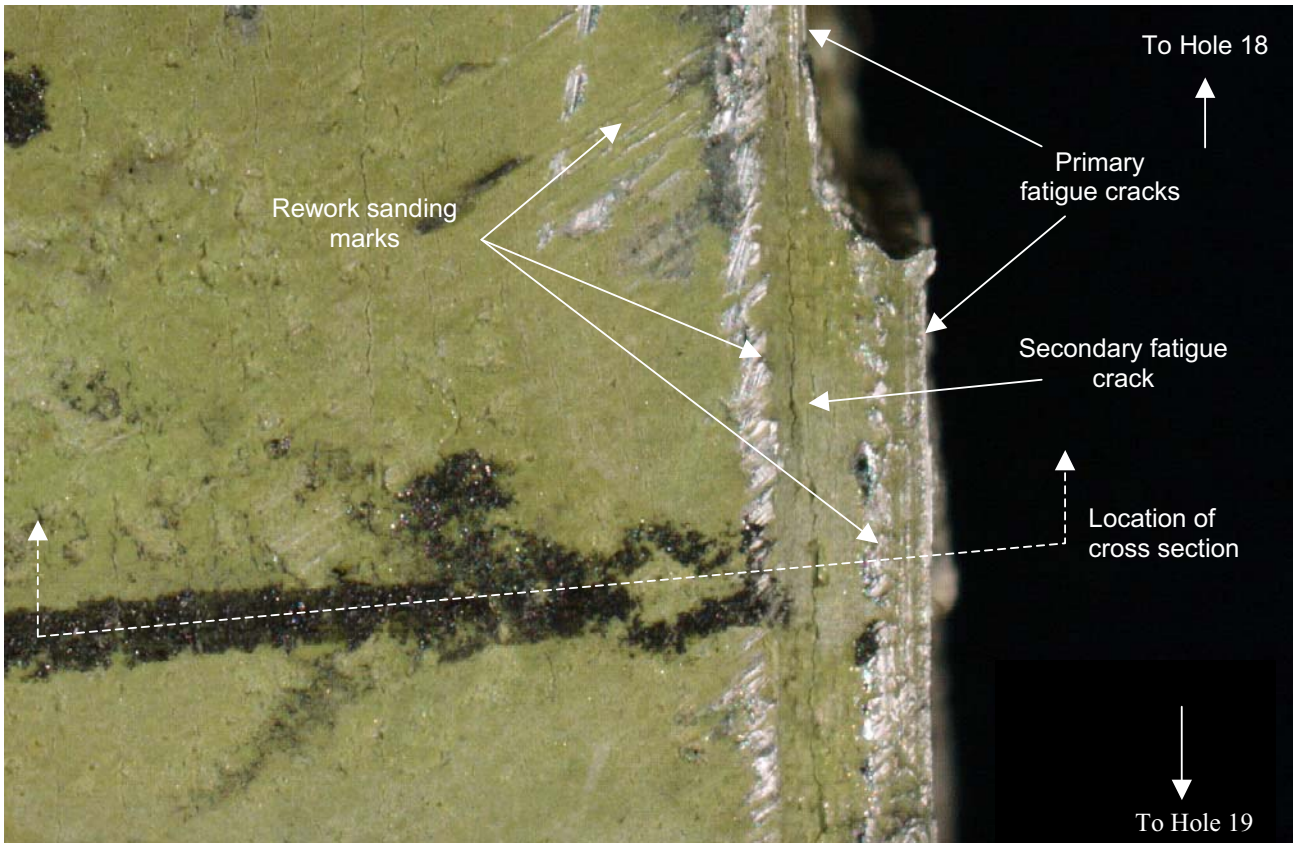
Figure 61. Location of cross section taken to characterize the scratch depth and geometry in the main fatigue region between holes 18 and 19.
