# **Aviation Occurrence Report Volume II**

ASC-AOR-05-02-001

**IN-FLIGHT BREAKUP OVER THE TAIWAN STRAIT**

**CHINA AIRLINES FLIGHT CI611**

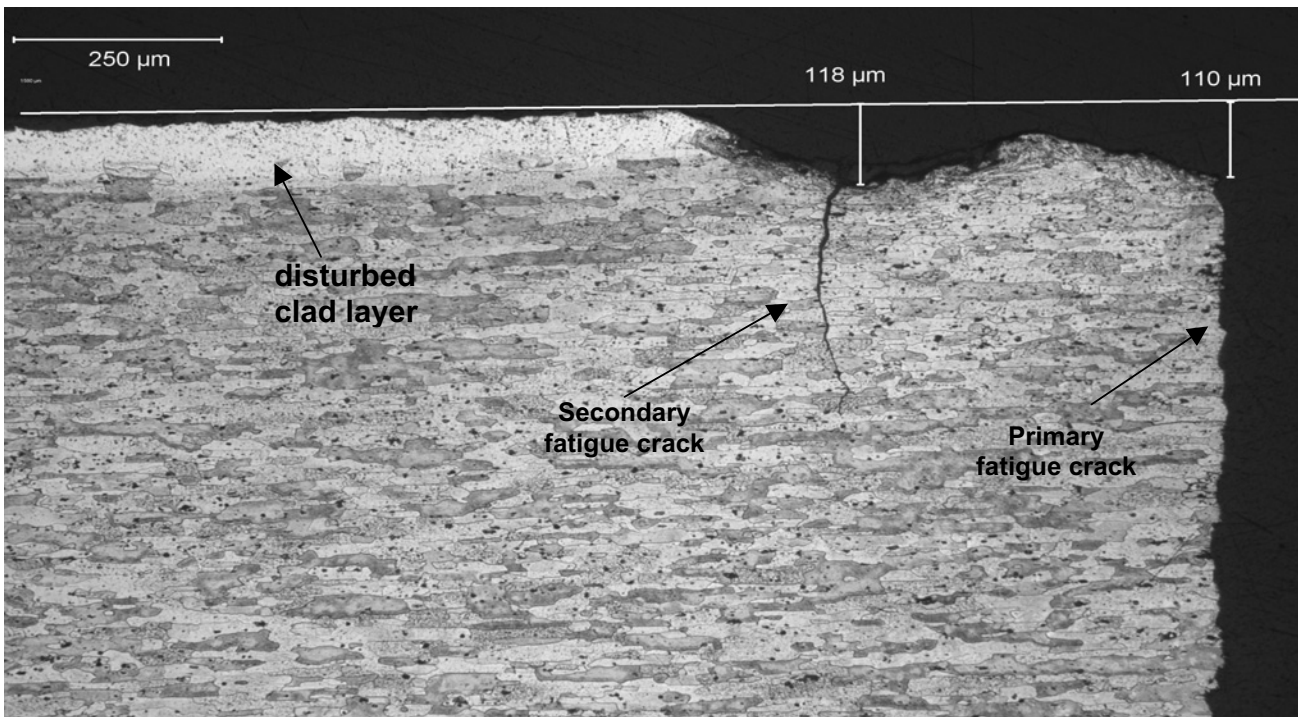
Figure 62. Metallographic specimen through the area indicated in Figure 61 above. The line shown was projected back to an area of undisturbed clad material to determine the depth of the scratches at the primary and secondary fatigue cracks present in this area.

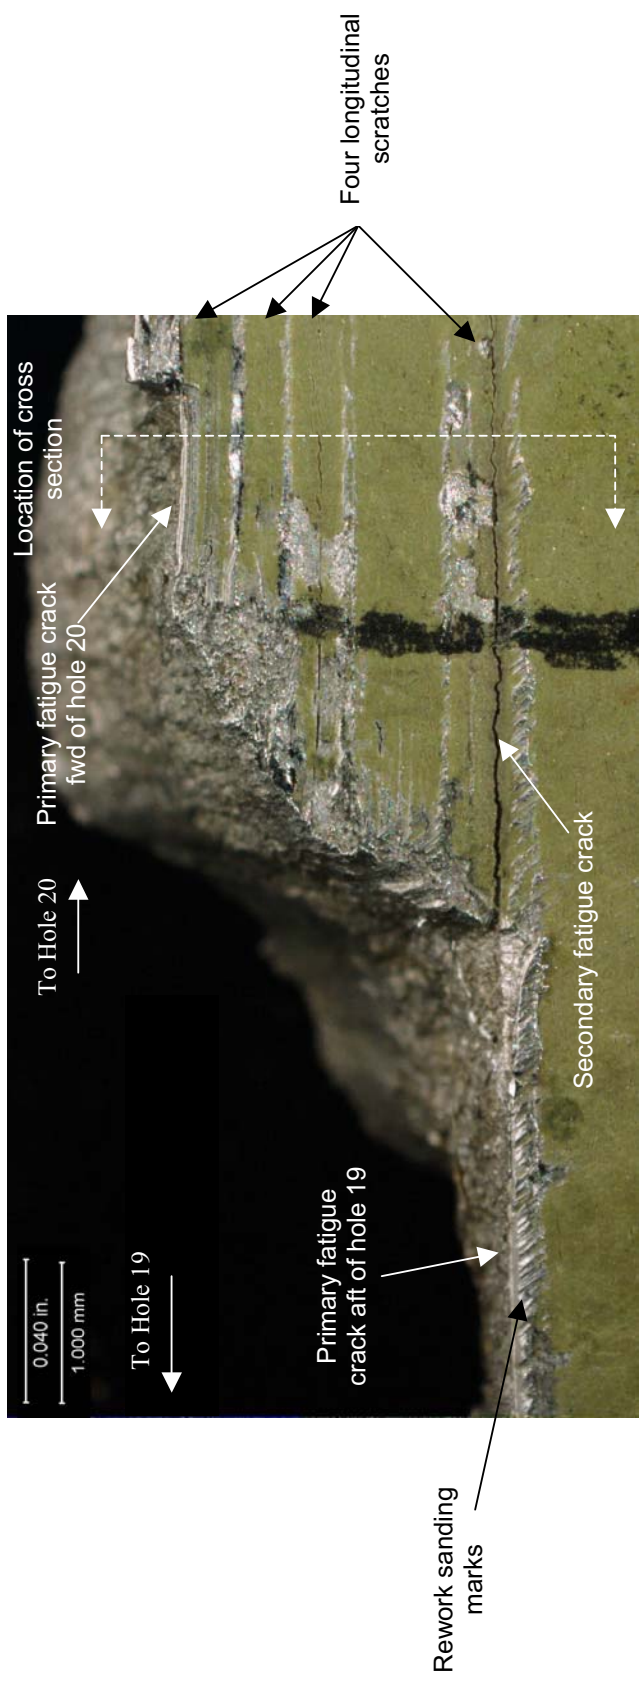
Figure 63. Location of cross section taken to characterize the scratch depth and in the main fatigue region between holes 19 and 20.

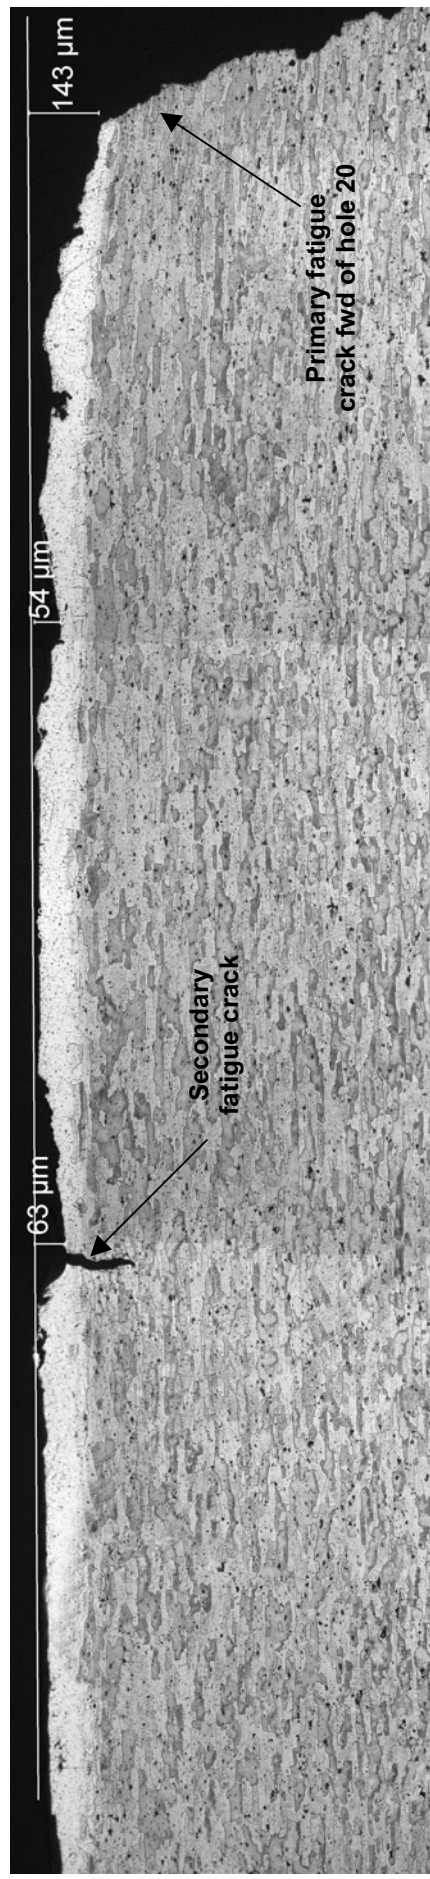
Figure 64. Metallographic montage through the area indicated in Figure 63 above. The line shown was projected back to an area of undisturbed clad material to determine the depth of the scratches at the primary and secondary fatigue cracks present in this area.

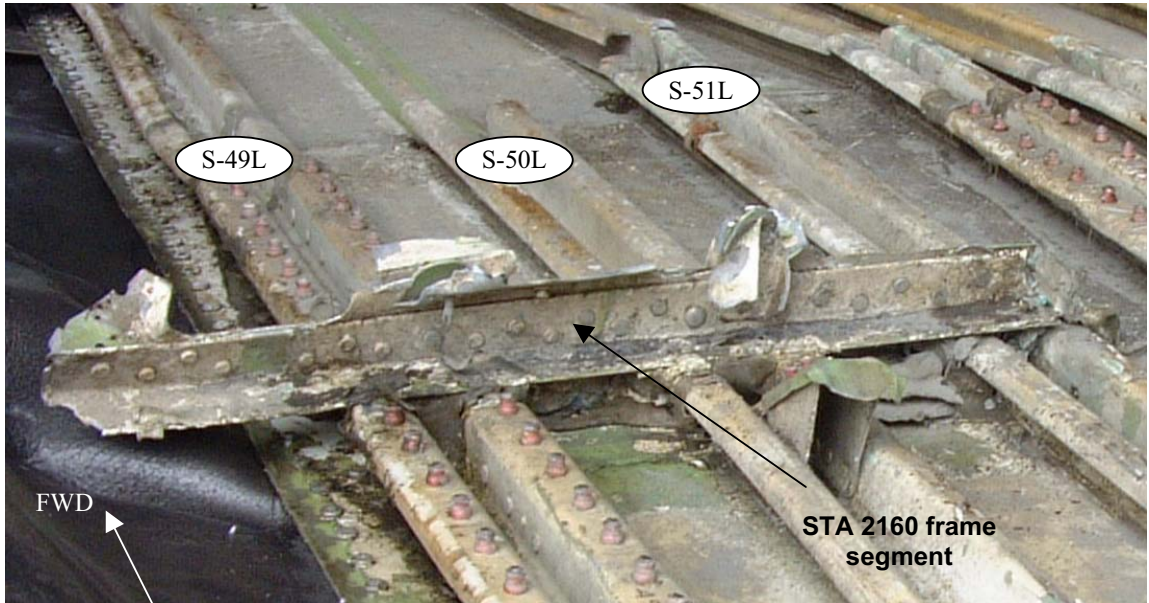
Figure 70.  
Condition of the STA 2160 frame segment prior to disassembly from the Item 640C1 skin panel at the CSIST.

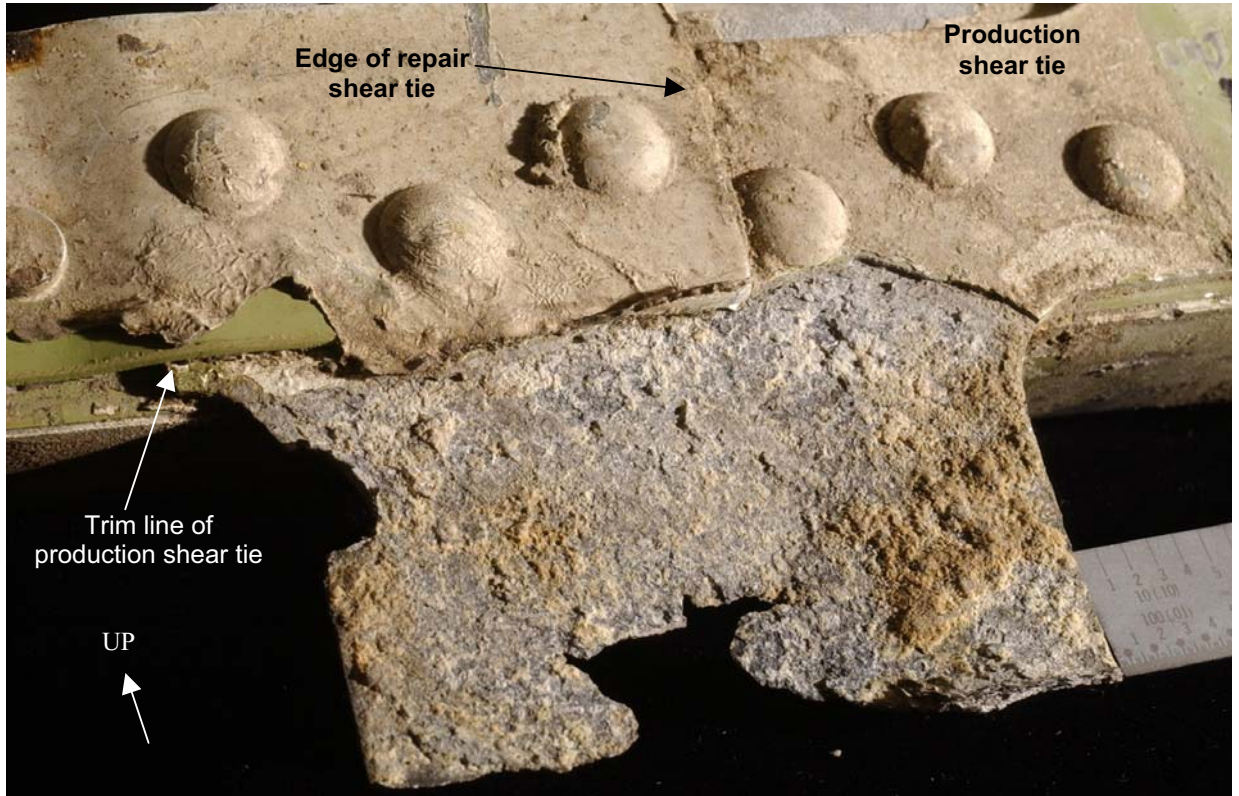
Figure 73.  
Exfoliation corrosion present at shear tie between S-50L and S-49L of STA 2160 frame segment.

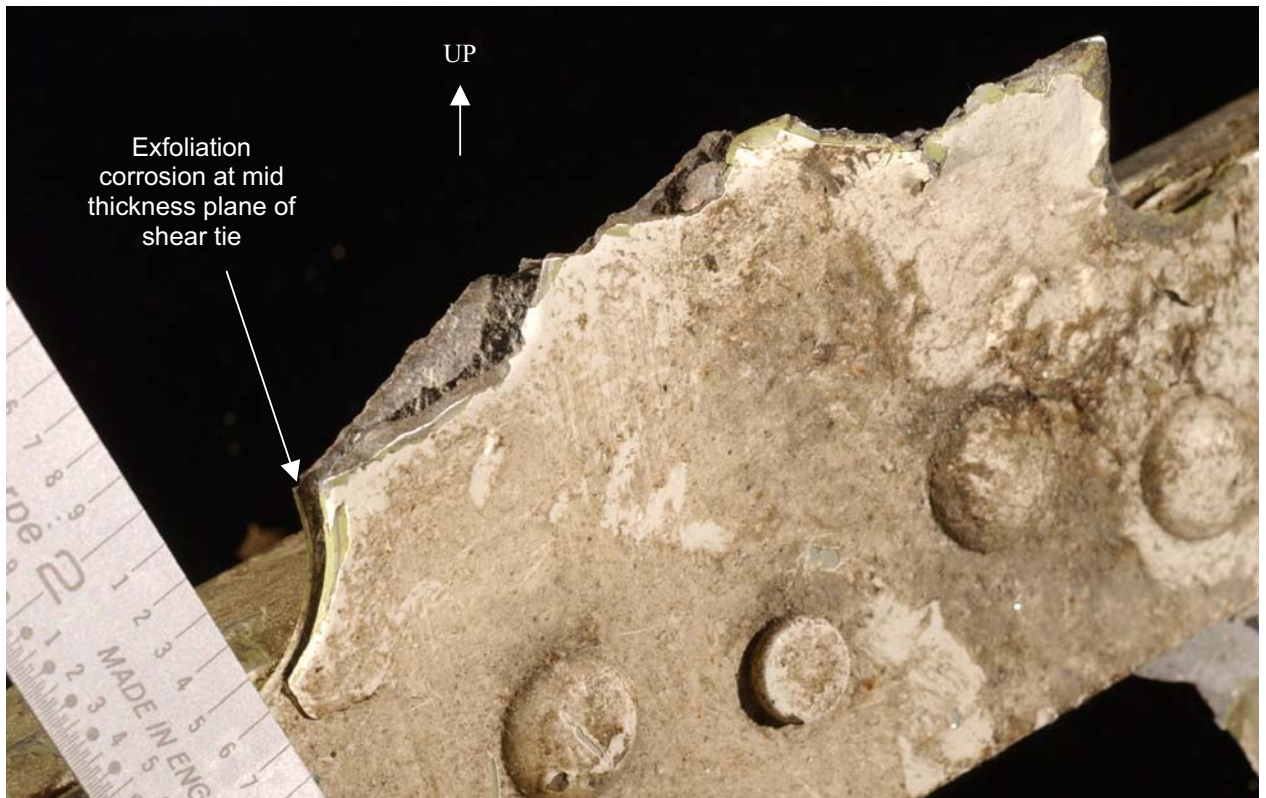
Figure 74.  
Exfoliation corrosion present at shear tie between S-49L and S-48L of STA 2160 frame segment.

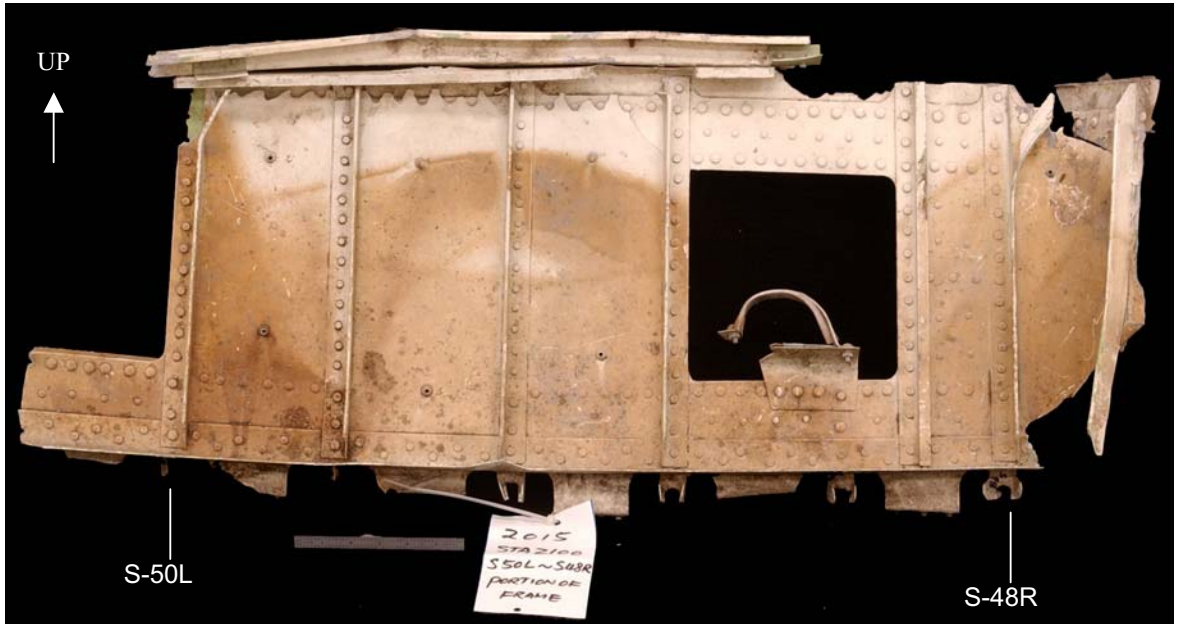
Figure 75. As received condition of the STA 2100 frame segment submitted for examination. The aft surface is shown in this view.

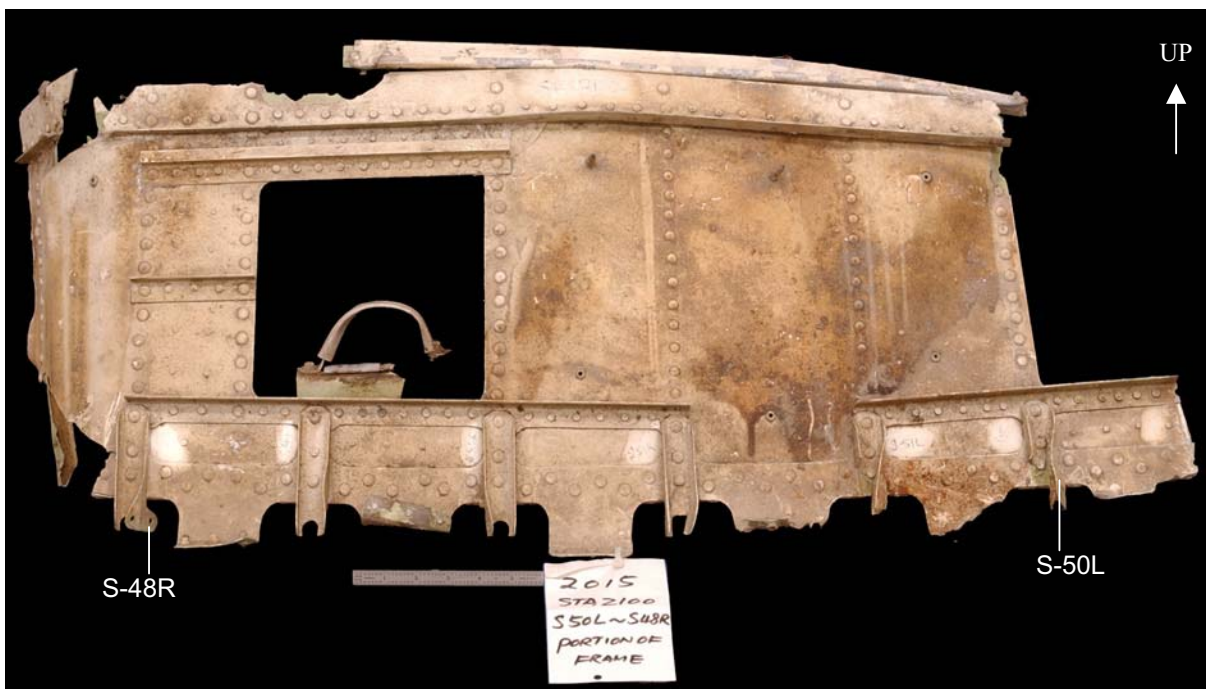
Figure 76. As received condition of the STA 2100 frame segment submitted for examination. The forward surface is shown in this view.

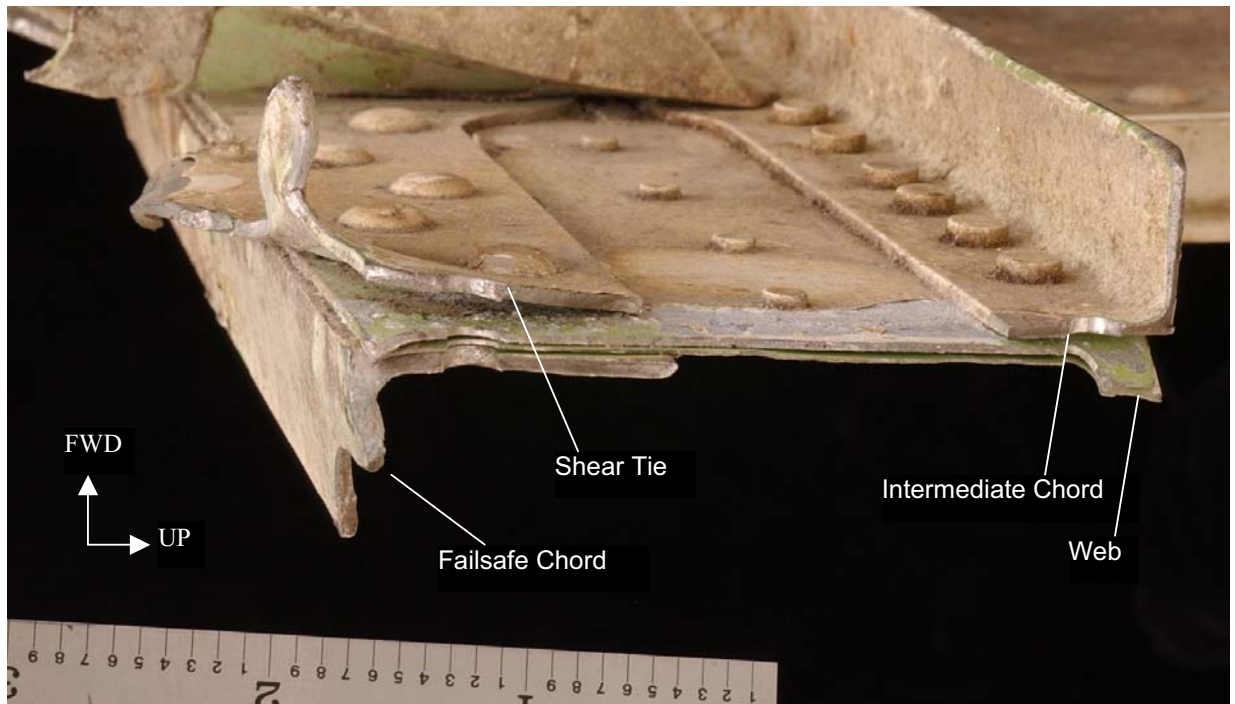
Figure 77.  
Fracture at S-49L of the STA 2100 frame segment showing deformation in shear tie and web.

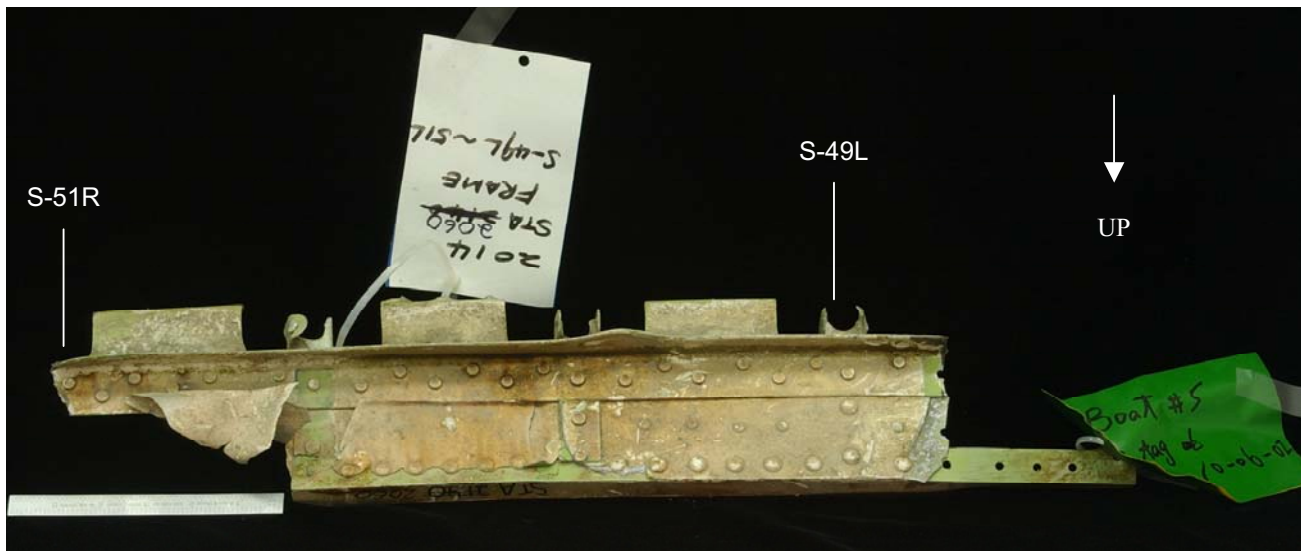
Figure 80. As received condition of the STA 2060 frame segment. The aft surface is shown in this view.

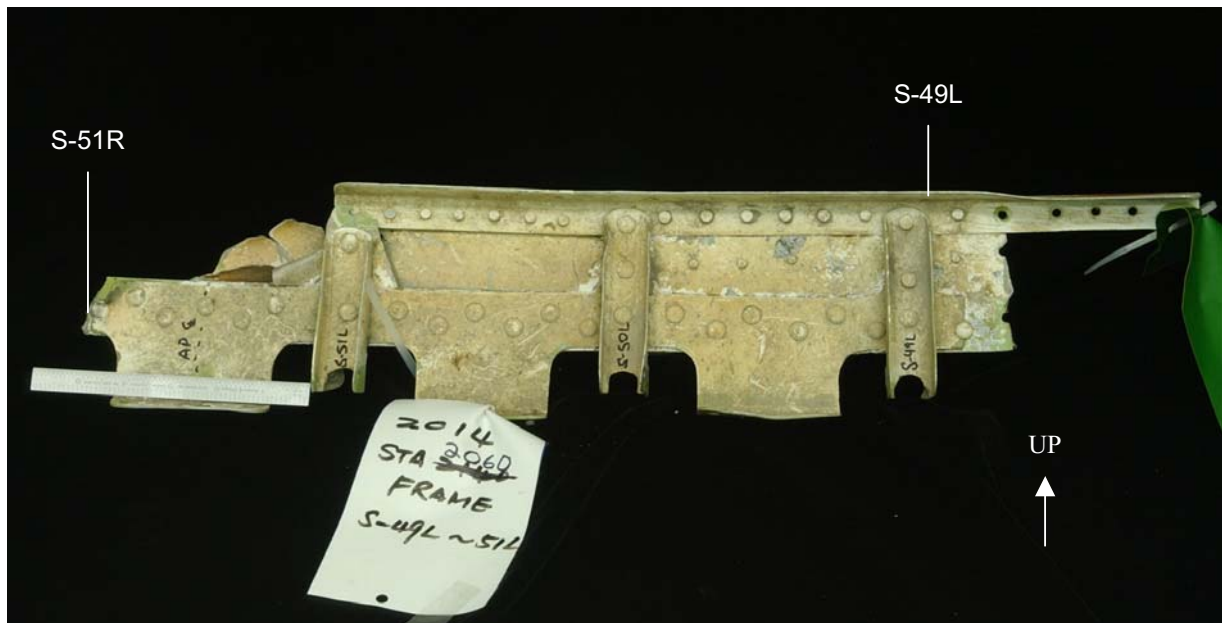
Figure 81.  
As received condition of the STA 2060 frame segment. The forward surface is shown in this view.

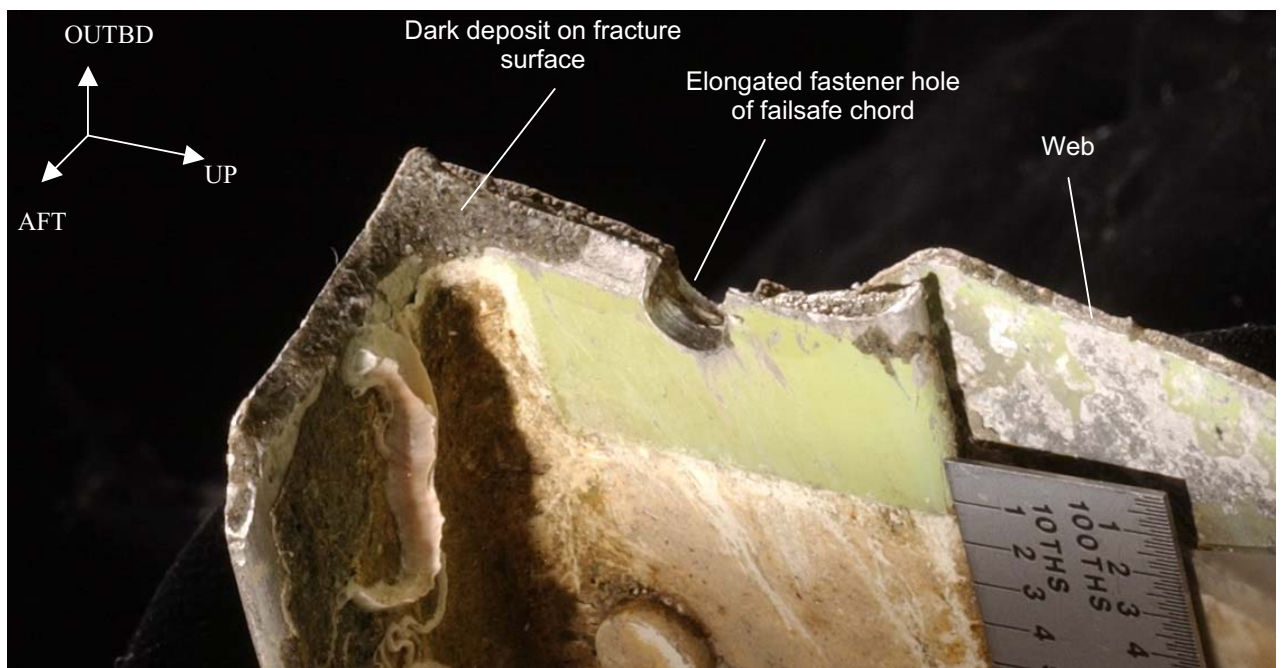
Figure 82.  
Fracture surface of failsafe chord and web common to S-49L of the STA 2060 frame segment.

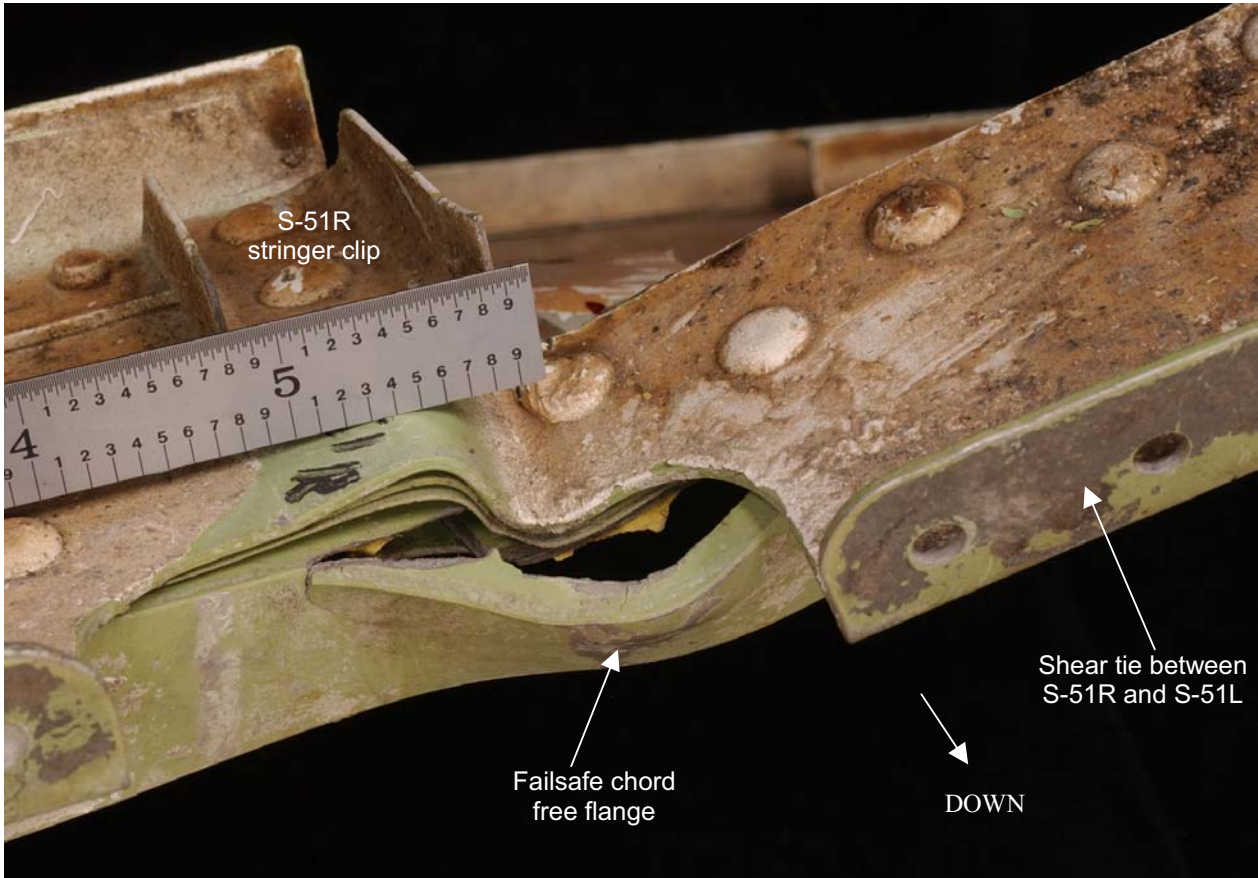
Figure 86. Fracture in failsafe chord free flange radius at S-51R of the STA 2040 frame segment.

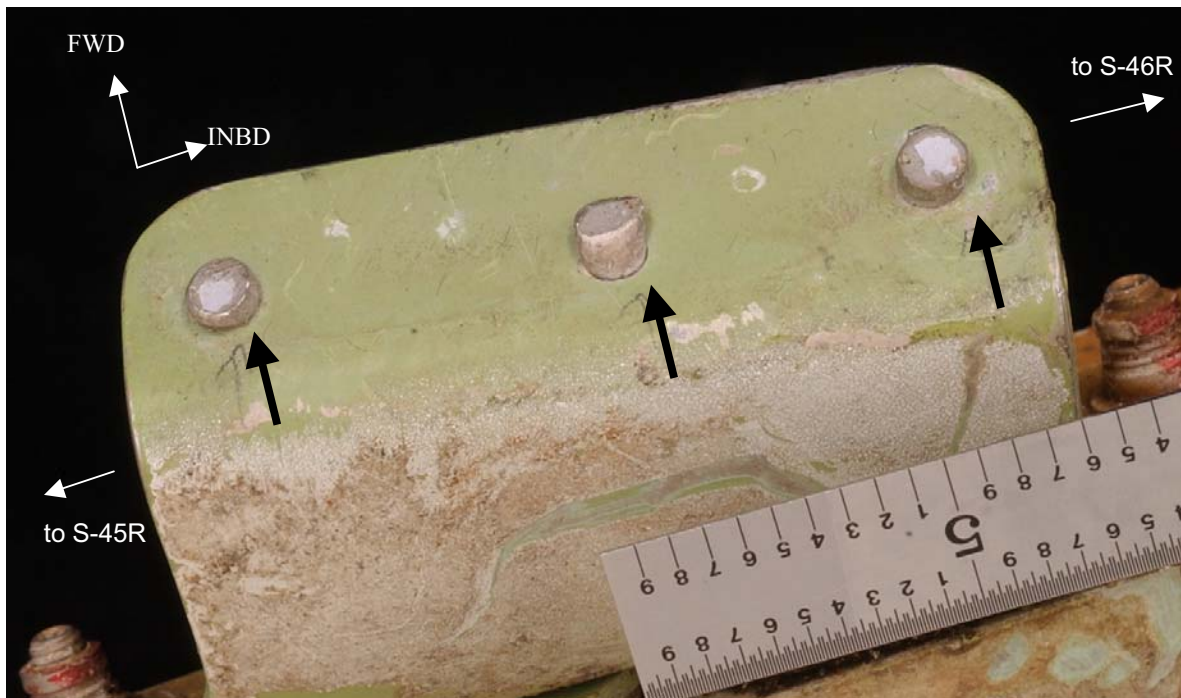
Figure 87. Skin flange rivet fractures at shear tie between S-45R and S-46R of the STA 2040 frame. Black arrows indicate the direction of loading.

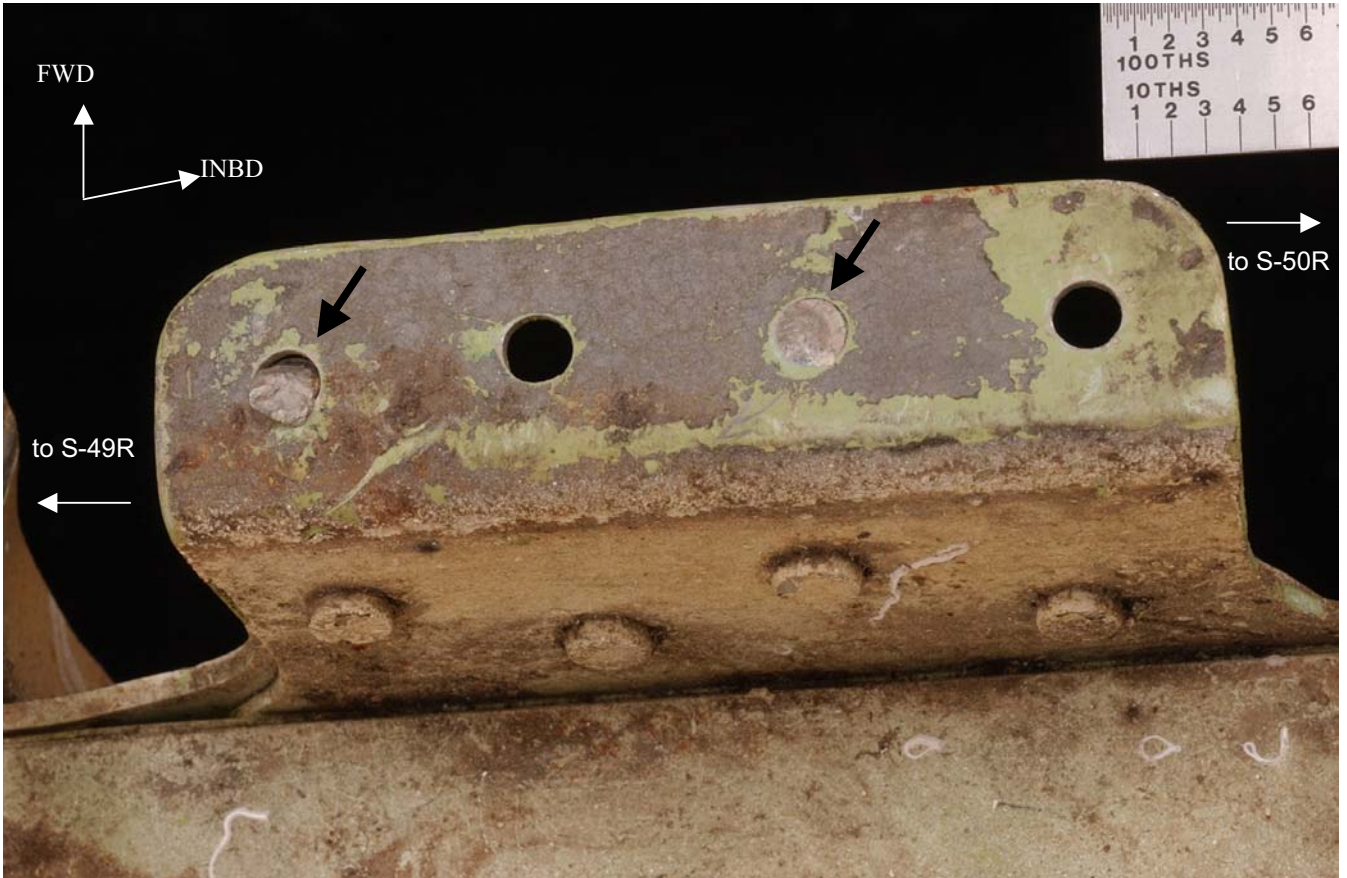
Figure 88. Skin flange rivet fractures at shear tie between S-49R and S-50R of the STA 2040 frame segment. Black arrows indicate the direction of loading.

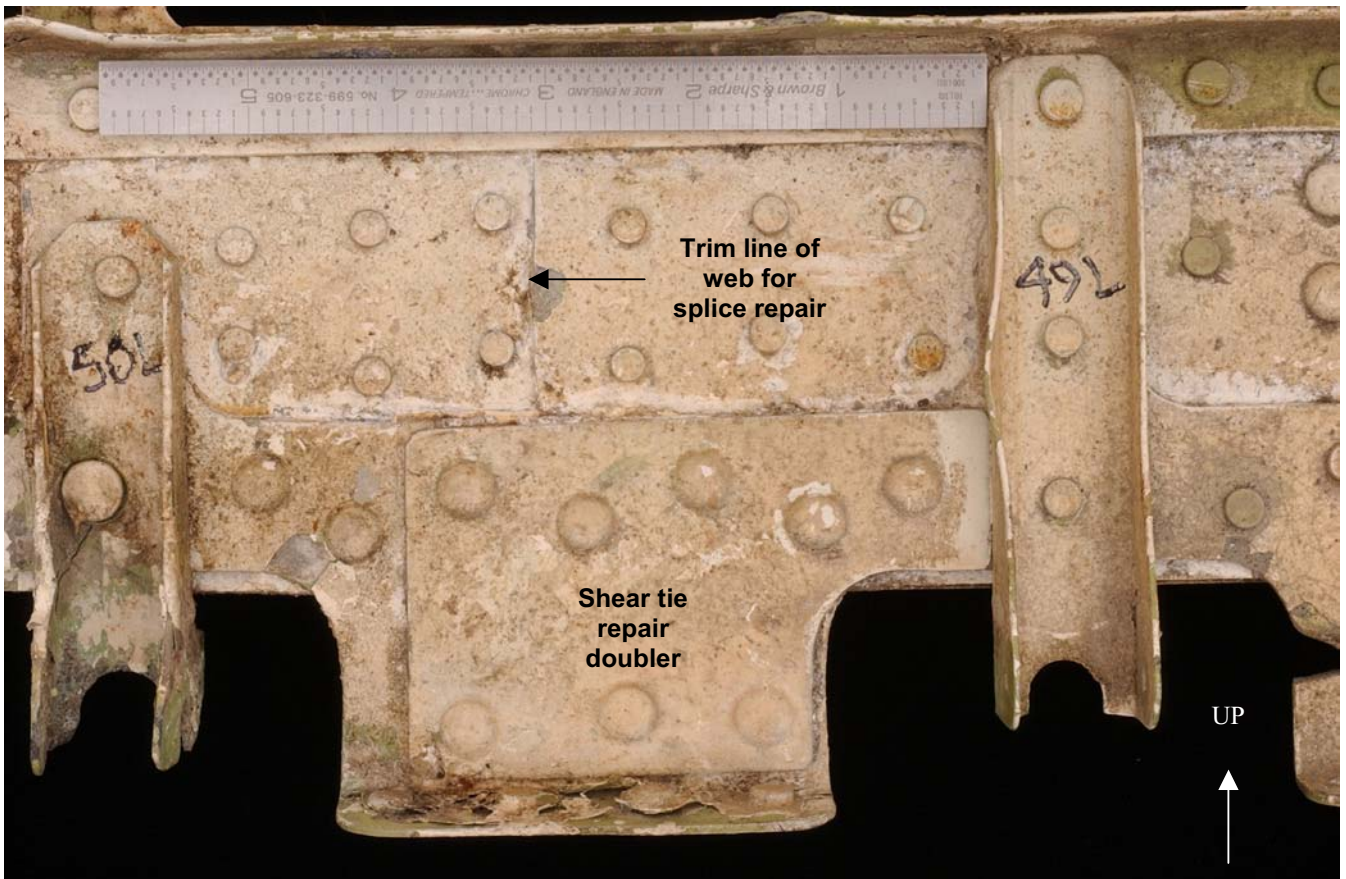
Figure 91.  
STA 1940 frame segment showing the shear tie repair doubler and web splice repair  
at the location between S-50L and S-49L.

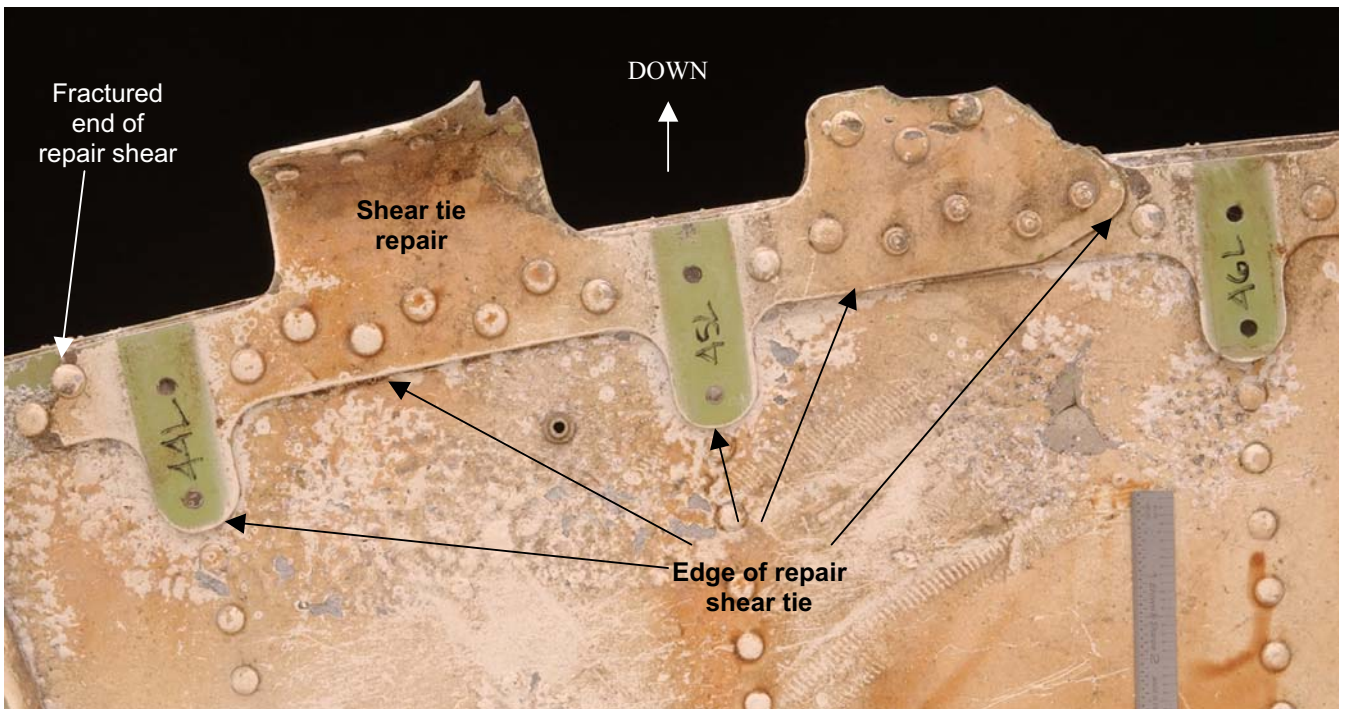
Figure 92.  
 STA 1940 frame segment showing the shear tie repair between S-46L and S-44L.

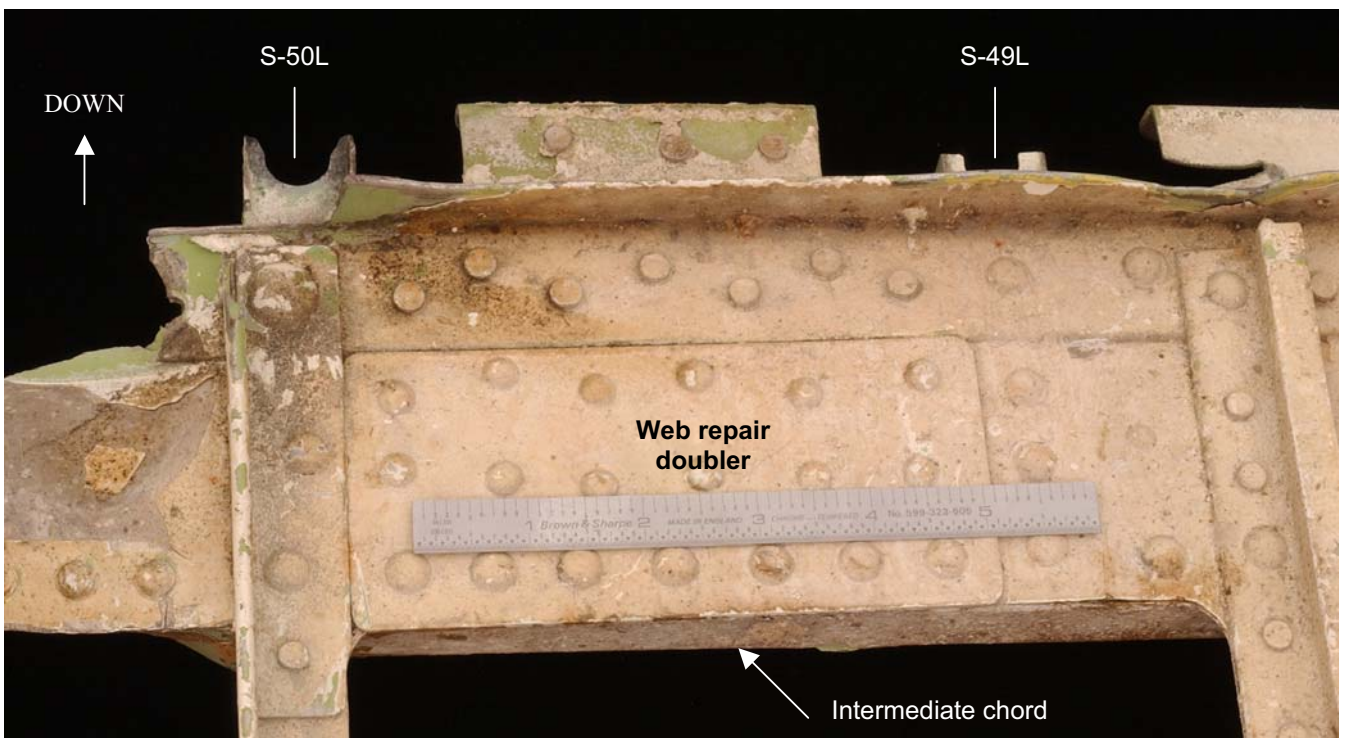
Figure 93.  
 STA 1940 frame segment showing the web repair doubler on the aft side between S-50L and S-49L.

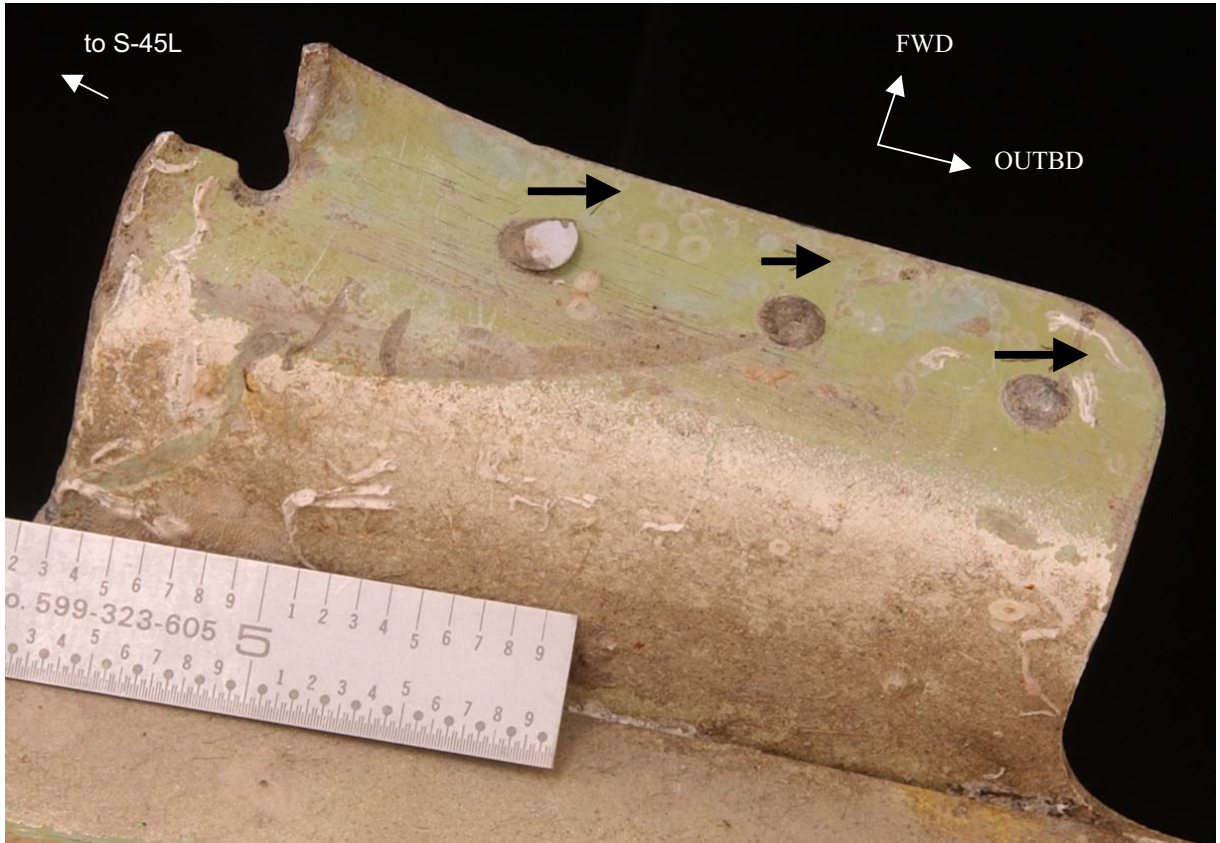
Figure 94. Shear tie between S-45L and S-44L of STA 1940 frame segment.  
Black arrows indicate the direction of loading.

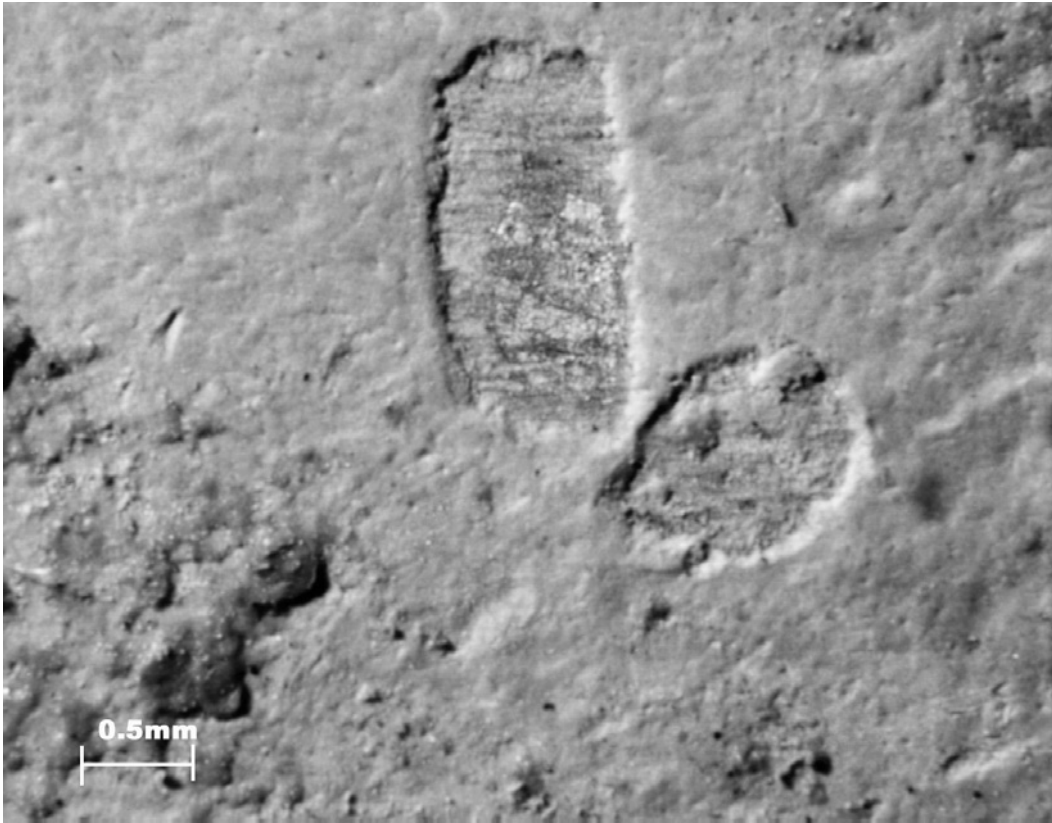
Figure 9 Surface area adjacent to hole +16
