**Aviation Safety Council  
Taiwan**

**Far Eastern Air Transport Flight EF306,  
Boeing 757-200 / Thai Airways  
International Public Company Ltd  
Flight TG659, Boeing 777-300**

**A TCAS Event in Narrow Collision  
Avoidance at an Altitude of 34,000 Ft.  
and 99 NM South of Jeju Island, Korea**

**Final Report**

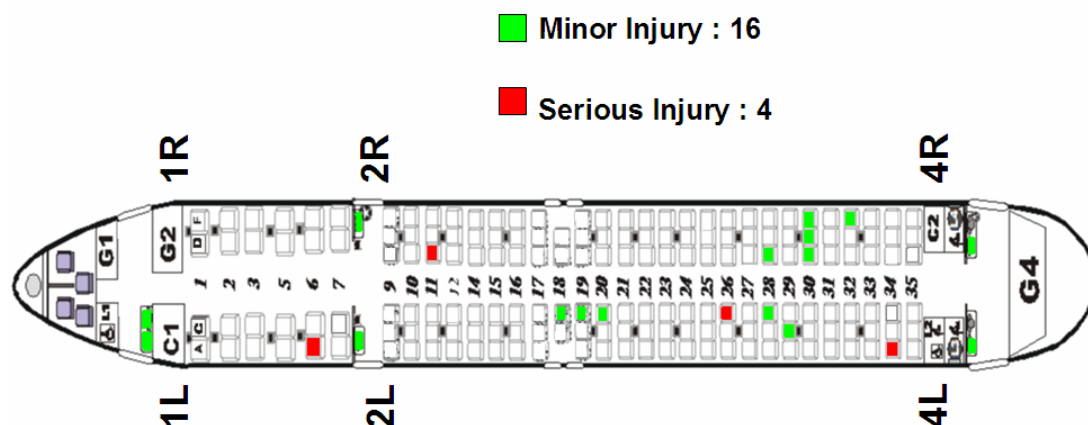
There were 4 serious injuries among the 129 passengers and 8 crewmembers aboard. The injury condition is summarized in Table 1.2-1. Figure 1.2-1 showed the aircraft seats and the injury distribution.

Figure 1.2-1 Injury distribution

1. The passenger seated in 6A suffered from fracture of ribs and clavicle and left hemothorax and was sent to the National Taiwan University hospital after returned from South Korea.
2. The passenger seated in 11D suffered from complicated fracture of left humerus with radial nerve injury, sprains of the right ankle region and fracture of a big toe and was sent to the Mackay Memorial Hospital after returned from South Korea.
3. The passenger seated in 26C suffered from a head injury, intra-cranial hemorrhage (ICH) and subarachnoid hemorrhage (SAH) and was sent to the National Taiwan University hospital, after returned from South Korea.
4. The passenger seated in 34A suffered from fractures of left ribs and hemothorax and was sent to the Mackay Memorial Hospital after returned from South Korea.

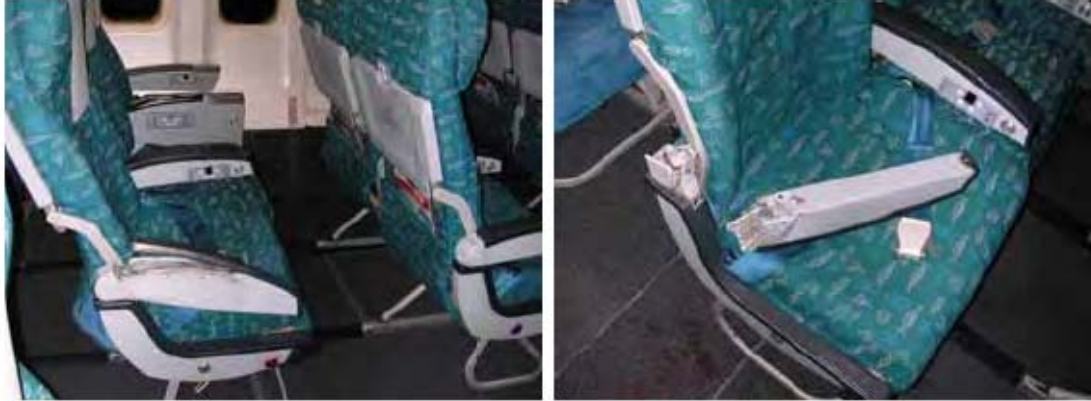
- Arm-rests of passenger seats (18D, 19C, 29C) were broken.
- Ceiling panels above passenger seat 27A and 33A were out of position and a puncture on ceiling panel above seat 27A was observed.

Figure 1.12-1 The broken arm-rests of passenger seats.

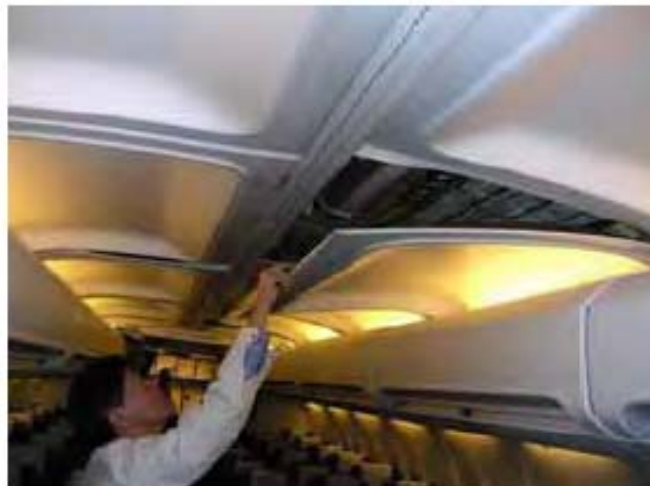
Figure 1.12-2 Out of position ceiling panels.

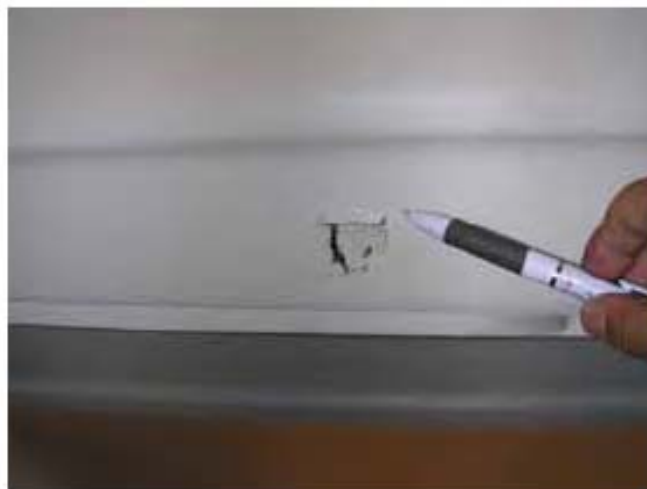
Figure 1.12-3 A puncture on a ceiling panel.

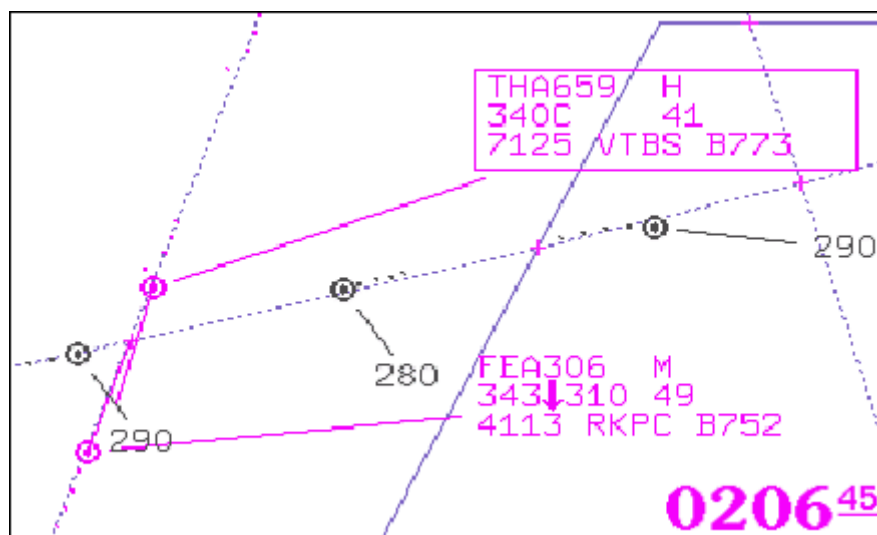
Figure 2.3-1 Radar display at 02:06:45

At this section, the ACC time in Attachment 1 is used for analysis. During the period of 4 minutes after instructing EF306 to descend to 31,000 feet, while concentrating on radar identification of UNS514T which was flying along A586, SSRC missed the converging situation of EF306 and TG659 for a while. Soon after, he recognized that the two aircraft were approaching at a distance of about 13NM as shown in the radar display<sup>26</sup> of Figure 2.3-1. He stated that at the time, “I thought it was a little urgent.” after recognizing that EF306 was passing 34,300 feet and TG659 was cruising at 34,000 feet from the opposite direction.

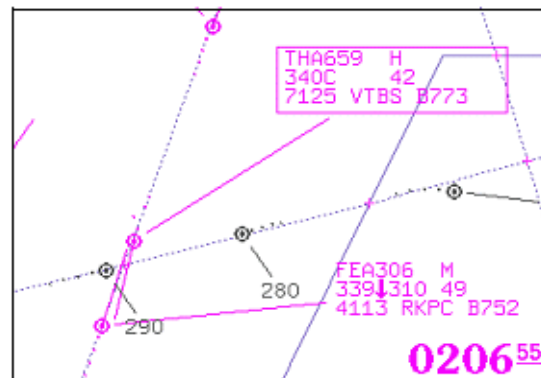
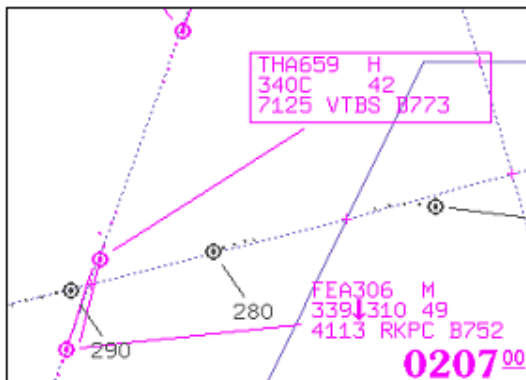
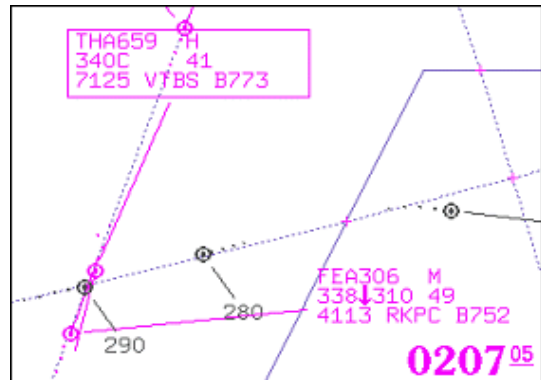
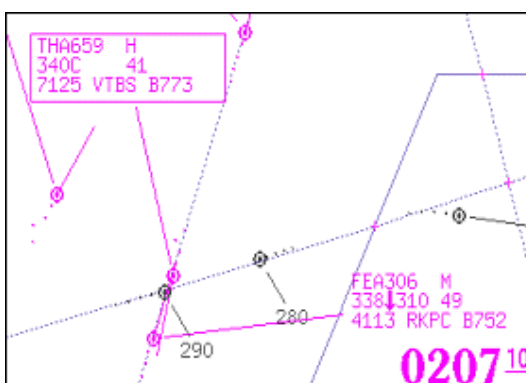
In response to this control instruction, EF306 did not read back the instruction and stopped descent momentarily as shown in Figure 2.3-3, 4, 5 and 6 because EF306 misunderstood the instruction to stop at 34,000 feet. EF306 flight crew stated that they did not perceive the latter half of the instruction to descend immediately, and TG659 turned to the right after reading back the instruction.

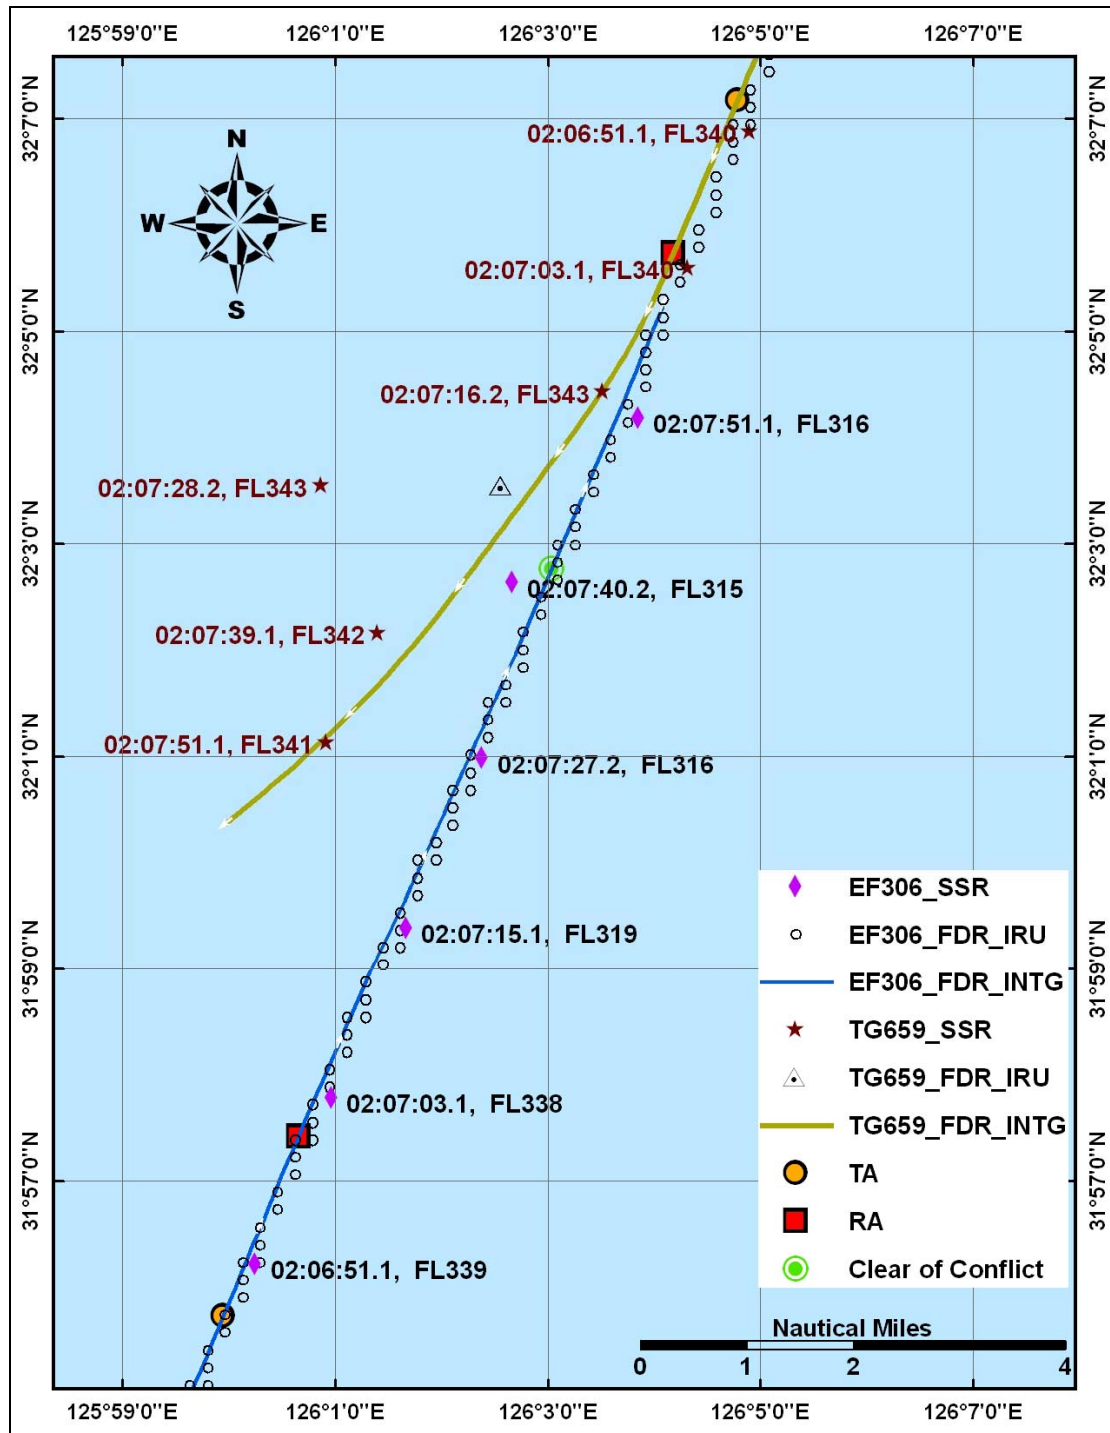
Figure 2.4-1 Superposition of the radar tracks and flight paths

In summary, TG659 followed the TCAS RA command to climb. However, the EF306 descended by using both of visual contact and TCAS RA command.

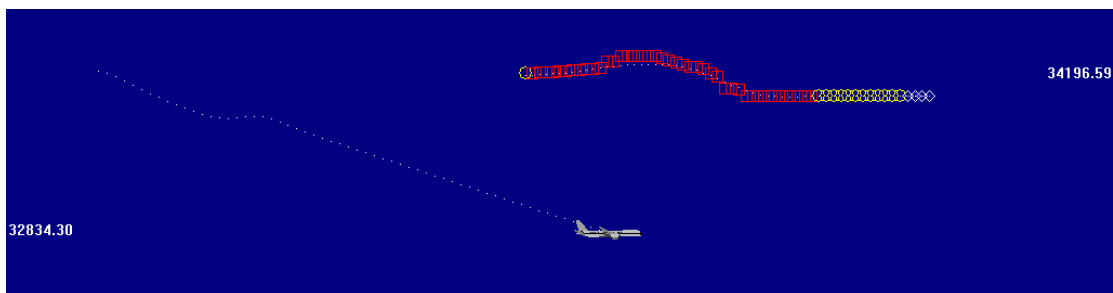
Figure 2.6-4 Side view of Scenario 3 on TSIM

- The Traffic Advisory occurred at time 02:06:48.
- The Descend RA “Descend, Descend” occurred at time 02:07:00
- The Reduce Descend RA “Adjust Vertical Speed, Adjust” occurred at time 02:07:22.
- The RA Removed “Clear of Conflict” occurred at time 02:07:40
- The closest relative range was 0.320 nm at that time 02:07:35 and the altitude separation was approximately 1,000 ft. Referred to Figure 2.6-4.
