Taiwan Transportation Safety Board

Major Transportation Occurrence Draft Final Report

Mandarin Airlines Co., Ltd Flight AE7931

**The aircraft cabin experienced brief loss of pressure
during descending**

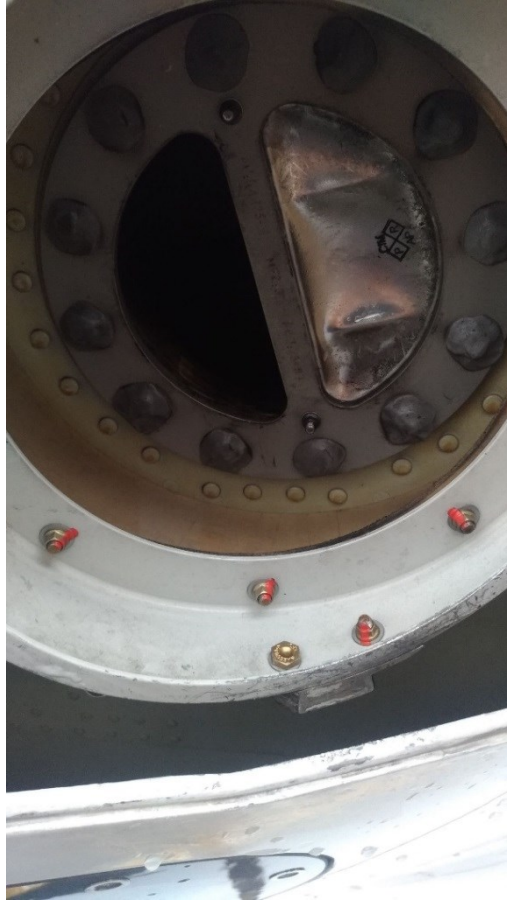
Figure 1.6-1 Failure Position of the Ground Connection Check Value

Kaohsiung Airport before the occurrence. According to the ground inspection conducted after the occurrence at Hualien Airport, the valve spring applying pressure to the blade of the ground connection check valve was broken, resulting in the valve not being able to be secured in fully closed position. The check valve connected the pressurized cabin from inside to outside. When the aircraft was parked on ground, the ground air-conditioning unit can be connected to the aircraft through the check valve, providing the cockpit and cabin with conditioned air. When the valve functioned normally, conditioned air is supplied one-way from outside to inside the cabin. When the ground air-conditioning tube was removed, the spring applied pressure to the blade, so the valve was automatically spring-forced back to the closed position. When the cabin started to be pressurized, the valve can also be secured in the fully closed position because of the difference of pressure inside and outside the cabin.

According to the post-occurrence inspection, the spring applying pressure to the blade of the valve was broken, resulting in the valve not being able to be secured in fully closed position. When the valve was not fully closed, the pressurized cabin was connected to the atmosphere outside the cabin, and the air leaked out of the pressurized cabin from the check valve. When the engine air supply decreased, the cabin altitude rose and the cabin pressure cannot be maintained as a result.

- *The replacement of the air conditioning ground check valve for the occurrence aircraft (B-16851) was completed after the occurrence. The replacement of the new check valve for the other four ATR72 aircrafts (B-16852-B-16856) were implemented on May 14 and May 15, 2019. ATR72 aircrafts (B-16857, B-16858) delivered this year were manufactured with the new check valve (standard modification).*
- *According to the TPS21-22-001 recommendation, the Flight Crew Department revised the Pre-flight, Transit and Daily Checklist on May 3, 2019, with an additional note: if the ground air-conditioning unit is connected to a departing aircraft, the flight crew should confirm that the air conditioning ground check valve is secured at fully closed position after the unit is removed.*

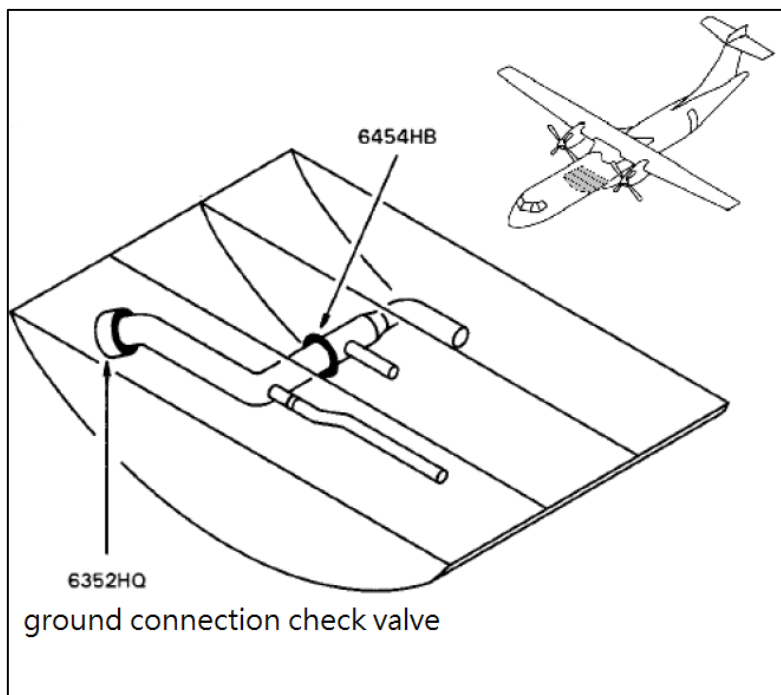
Figure 1.6-2 Installation Position of the Ground Connection Check Valve

The ground connection check valve is located on the right side of the belly of the fuselage, as shown in Figure 1.6-2, equipment number 6352HQ. Its exterior is shown in Figure 1.6-3. When the aircraft is parked on the ground, conditioned air can be supplied to the cockpit and cabin through the check valve from the air-conditioning unit.

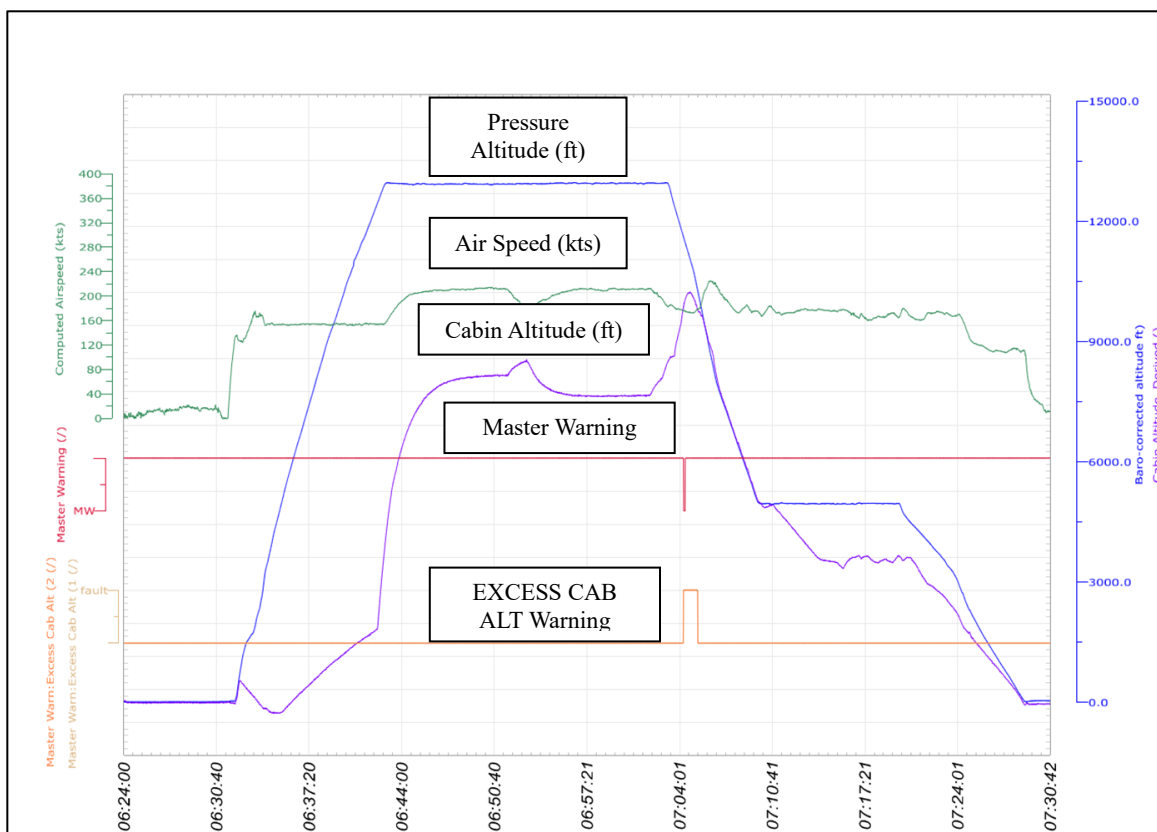
Figure 1.11-1 Flight Data Plot of the Occurrence Aircraft

5. At 15:04:45 Taipei Local Time, the pressure altitude of the aircraft was 11,090ft and the cabin altitude peaked at 10,241ft.
6. At 15:05:19 Taipei Local Time, the pressure altitude of the aircraft was 10,284ft. The EXCESS CAB ALT warning was cancelled when the cabin altitude became 9,833ft.
7. The aircraft landed at Hualien Airport at 15:28:50 Taipei Local Time.
8. At 15:34 Taipei Local Time, FDR stopped recording.

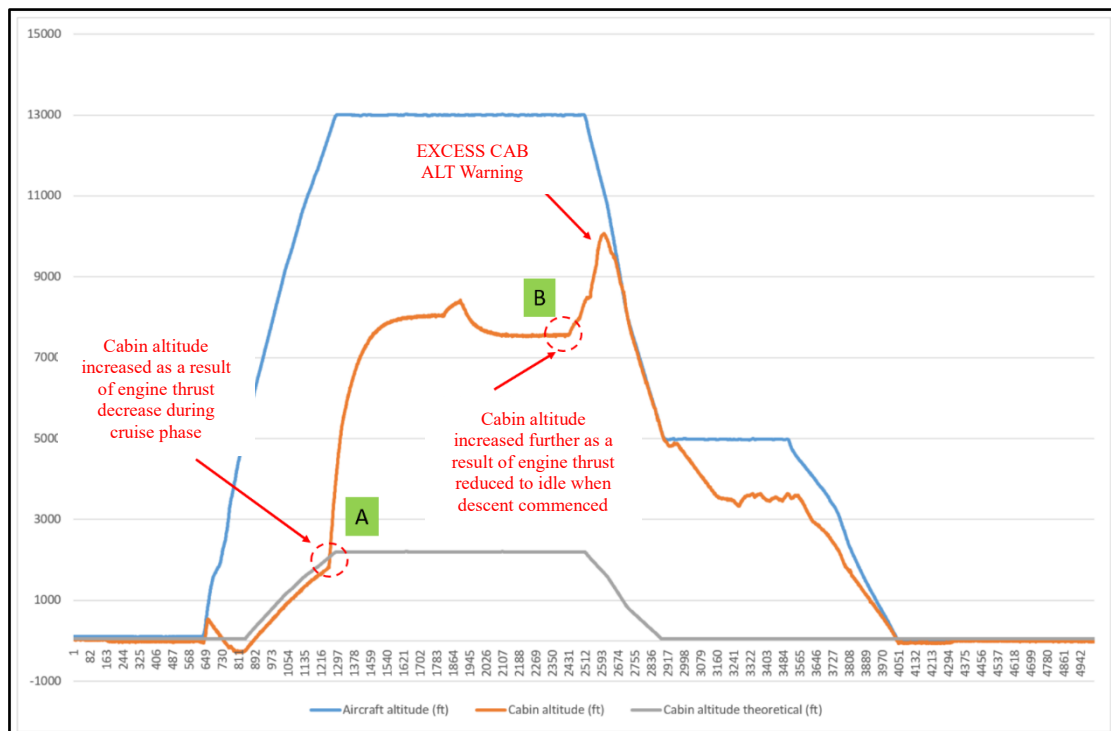
Figure 2.2-1 Cabin Altitude and Relevant Information Plot

When the ground connection check valve was not fully closed, the aircraft pressurization system would be influenced by the altitude and the engine air supply. According to the FDR data of the occurrence aircraft, the thrust of the engine during take-off and climbing provided sufficient air to maintain the cabin altitude below 2,000ft (before Point A in Figure 2.2-1). When the occurrence aircraft reached cruising altitude (13,000ft), the thrust of the engine decreased, and so did the airflow in the air-conditioning system, resulting in the rise of cabin

altitude (after Point A in Figure 2.2-1), but it was maintained at approximately 8,000ft. However, when the aircraft descended from cruising altitude (Point B in Figure 2.2-1), the thrust of the engine reduced to idle, therefore the cabin altitude rose rapidly as a result of the decrease in air supply from the air-conditioning system. After approximately 2 minutes and 30 seconds, at 15:04:17, the EXCESS CAB ALT warning was triggered.

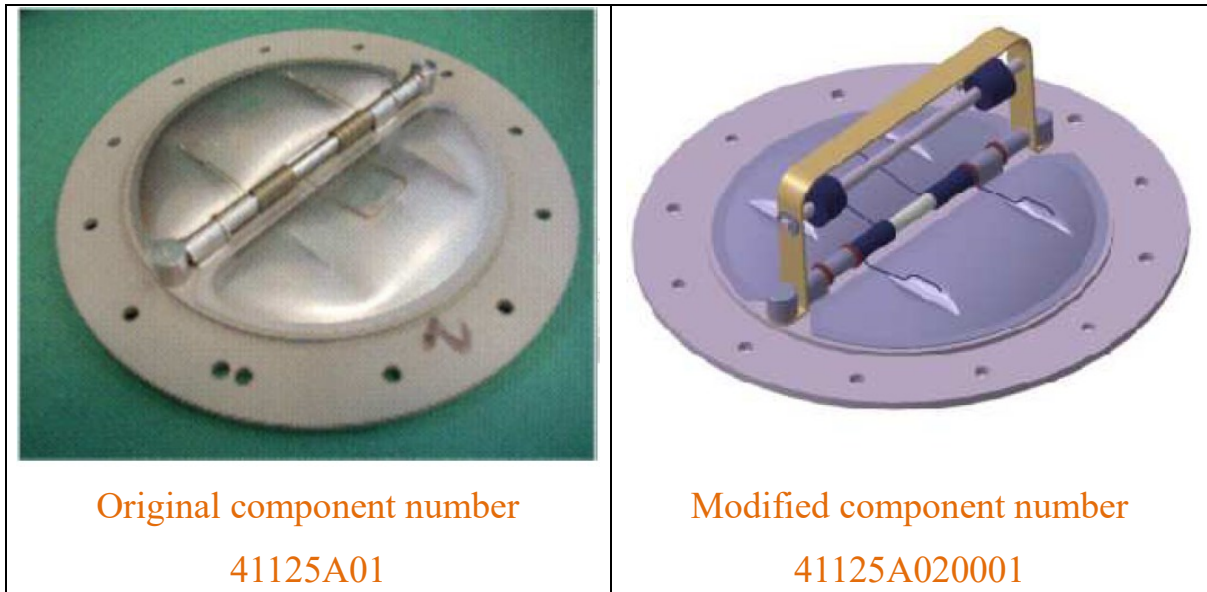
Figure 2.2-2 Original Check Valve (Left) and Modified Check Valve (Right)

- Two devices have been added to secure the valve blades in a stable position
- A middle dead point has been added to eliminate vibration
- A teflon-coated gasket between the shaft and the spring

The modified check valve is interchangeable with the original one (component number 41125A01). The exterior of the two check valves are shown in Figure 2.2-2.
