# Aviation Occurrence Report

ASC-AOR-16-01-002

**TransAsia Airways Flight GE222**

**Impacted Terrain and Collided  
with a Residential Area**

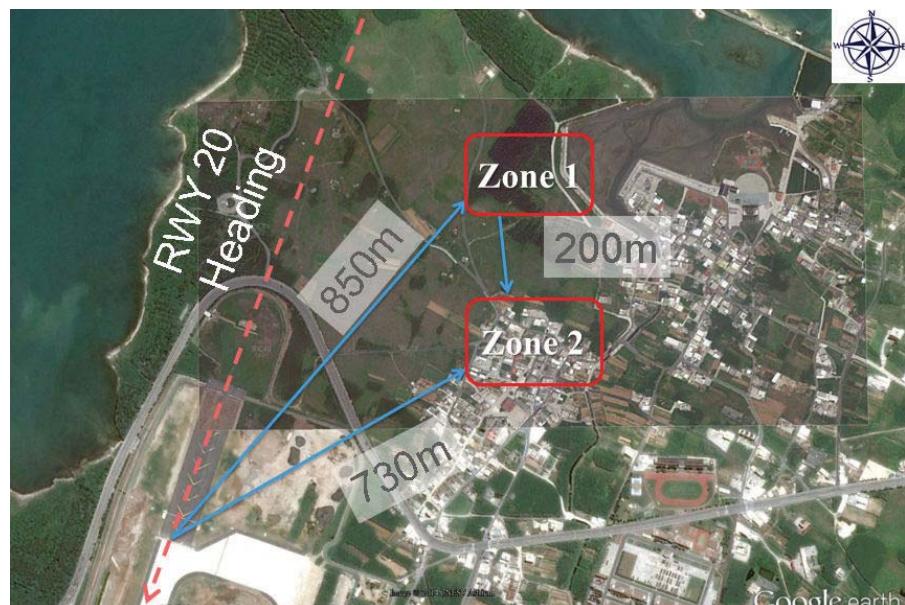
Figure 1.12-1 GE222 site survey zones superimposed on Google map

Figure 1.12-1 illustrates that the aircraft wreckage was distributed in two areas: the foliage or brushwood area (Zone 1); and the residential area (Zone 2). The aircraft impacted terrain approximately 850 meters north-east of the threshold of runway 20 at Magong Airport and then collided with a residential area on the outskirts of Xixi village approximately 200 meters to the south-east of the initial impact zone.

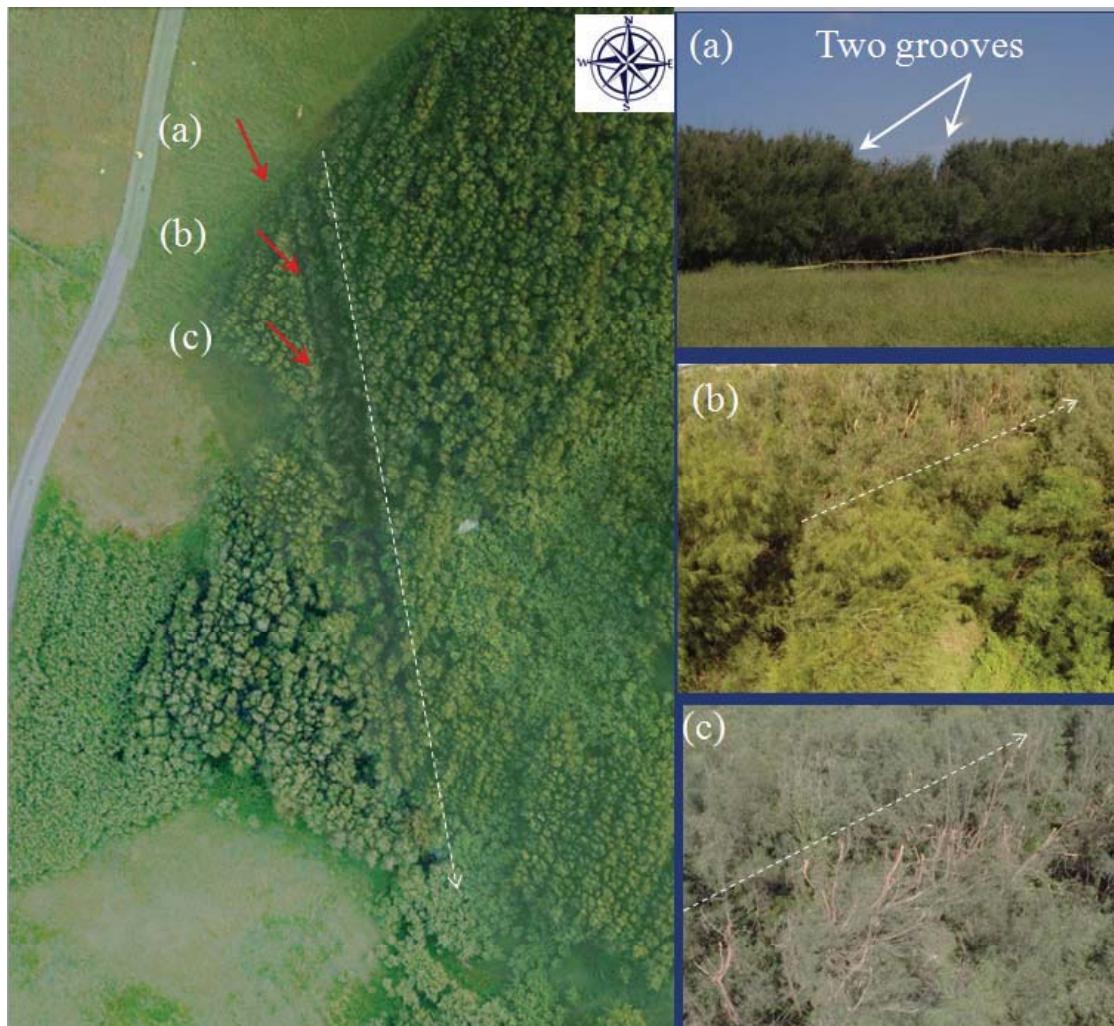
Figure 1.12-4 Initial impact point and damaged foliage in Zone 1

The damaged tree tops indicated where the aircraft first impacted the foliage. The area contained many bent trees and broken branches.

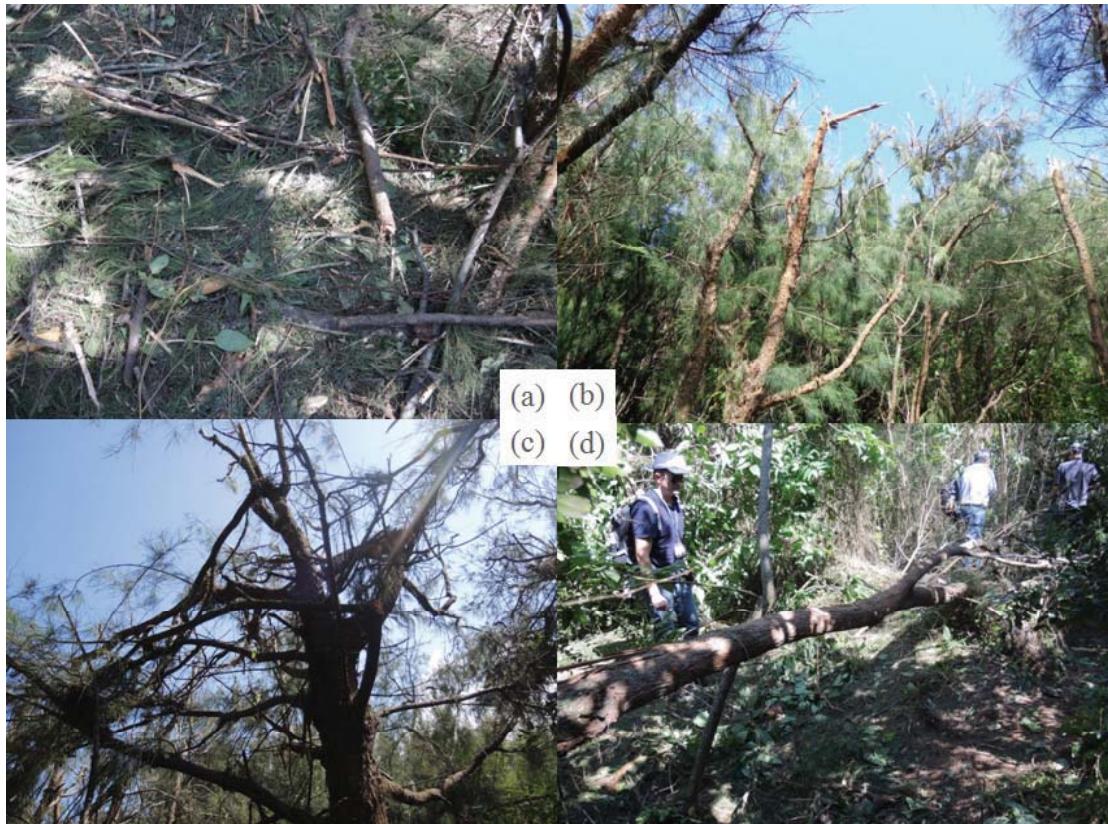
Figure 1.12-5 Damaged foliage and relevant trees

Damaged foliage and relevant tree height (H) information is depicted in Figure 1.12-5 [(a) Damaged trees on the ground, (b) Damaged tree in canopy ( $H=6.3$  meters), (c) Damaged tree in canopy ( $H=5.5$  meters), (d) Felled trees]. The largest damaged tree had a diameter of about 25 cm.

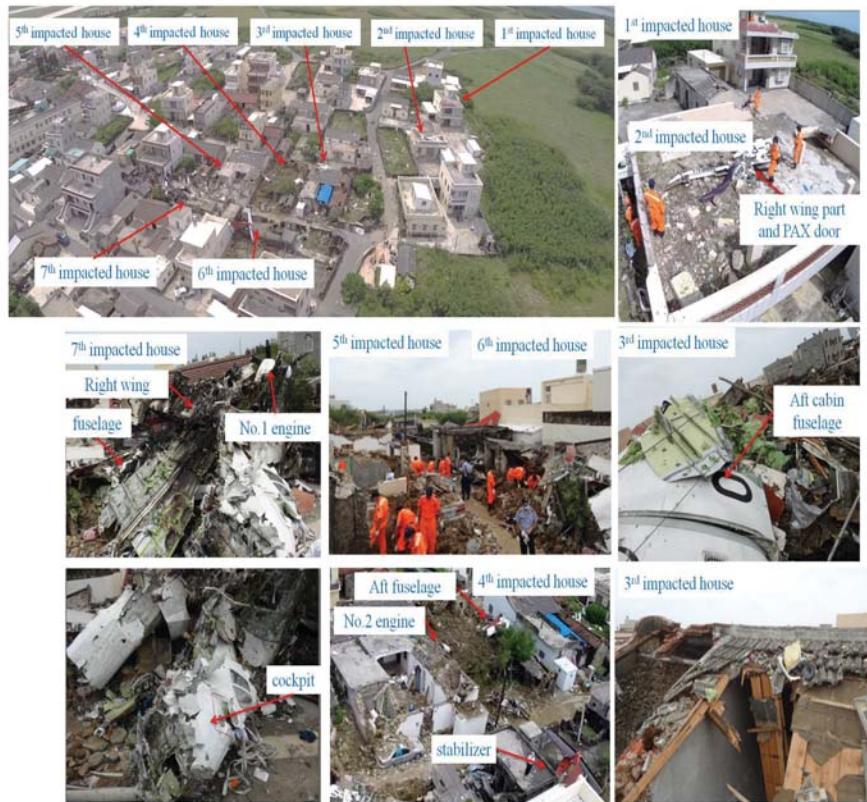
Figure 1.12-8 Aircraft main wreckage distribution and damaged buildings

Zone 2 was located in a residential area of Xixi village. The trajectory of the aircraft was from north to south. The aircraft collided with multiple buildings and broke apart into several major sections. The main wreckage site, which included the cockpit, forward fuselage, left wing, and no.1 engine came to rest in a street in the south of Zone 2. The distance between the main wreckage site and the first building collision was about 120 meters. Figure 1.12-7 depicts the aircraft wreckage distribution overlaid on a Xixi village street map. The red area indicates extensive damage to housing; the yellow area indicates houses with minor damage; and the light blue area indicates undamaged houses. In addition, smaller items of debris such as passenger seats, window frames, baggage, and fuselage skin were scattered throughout Zone 2 over an area of approximately 80 meters by 120 meters. The aircraft main wreckage distribution and damaged buildings are shown in Figure 1.12-8.

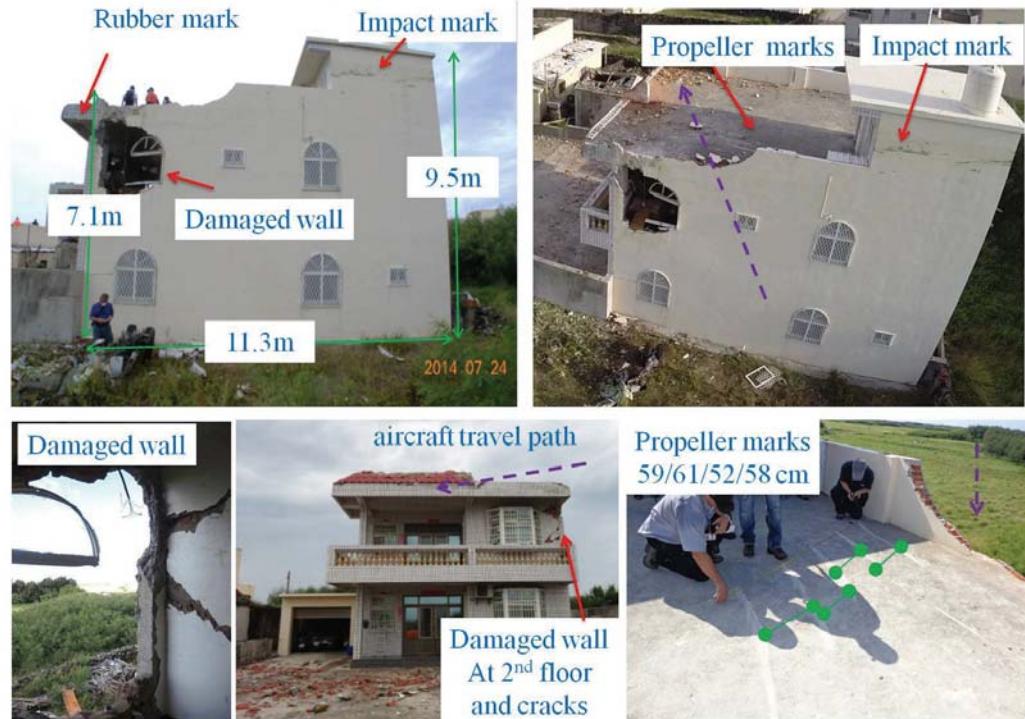
Figure 1.12-9 Initial aircraft impact, propeller, and rubber marks on building

The damage on the second floor was consistent with a main landing gear impact. The northeastern corner of the roof exhibited rubber traces from either the tires or wing deicing boots. Five parallel, almost evenly distributed, witness marks were visible on the top of the roof. Those marks were consistent with contact from the right side propellers. There was also a long prominent mark almost as wide as the wall, at the top of the northern side of the building. It continued on to the western wall. The mark was close to horizontal (approximately 10 to 15 degrees). That damage was consistent with right-wing impact. Figure 1.12-9 depicts the relevant aircraft impact marks, propeller marks, rubber marks and cracks at no. 7-1 building.

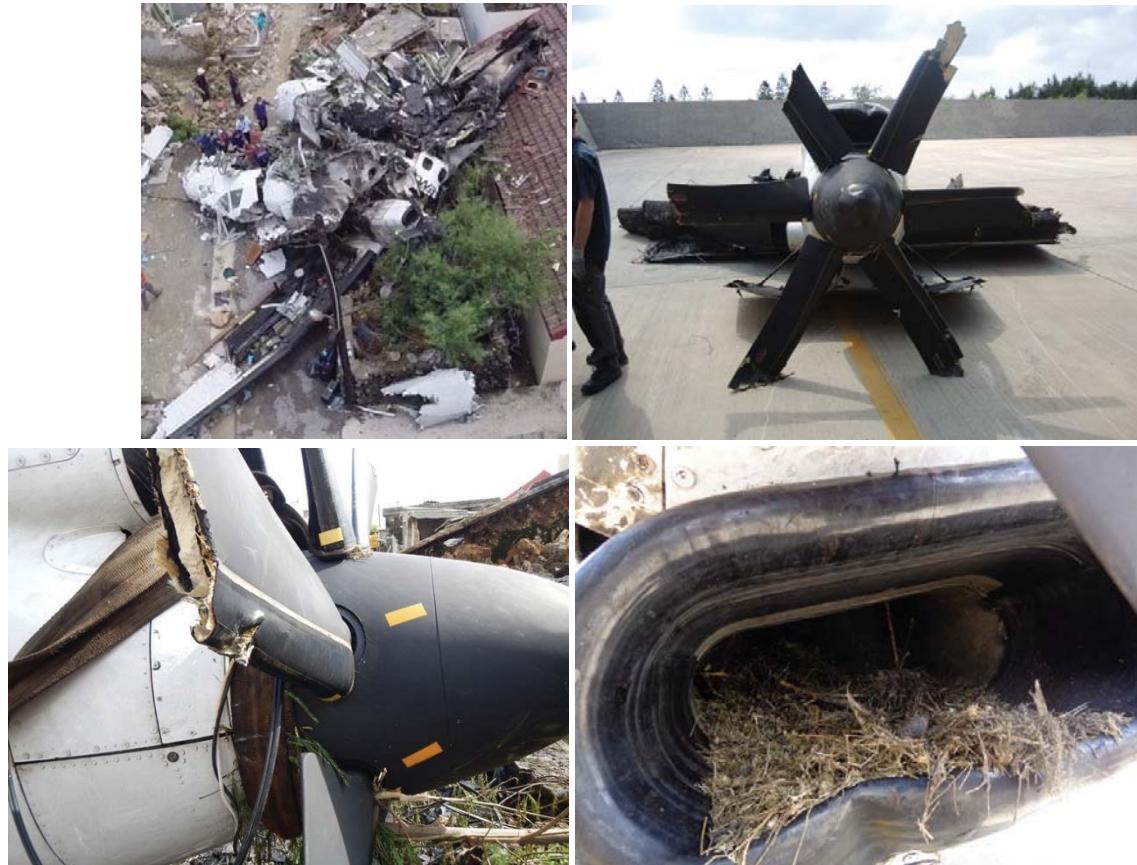
Figure 1.12-10 No.1 Engine

Both engines were recovered from the occurrence site. The no.1 engine was still attached to the left wing. The propeller pitch angle was estimated to be  $-10^\circ$ . The no.1 engine air inlet was found full of tree debris. An impact dent was located at the lower part of the intake (see Figure 1.12-10).

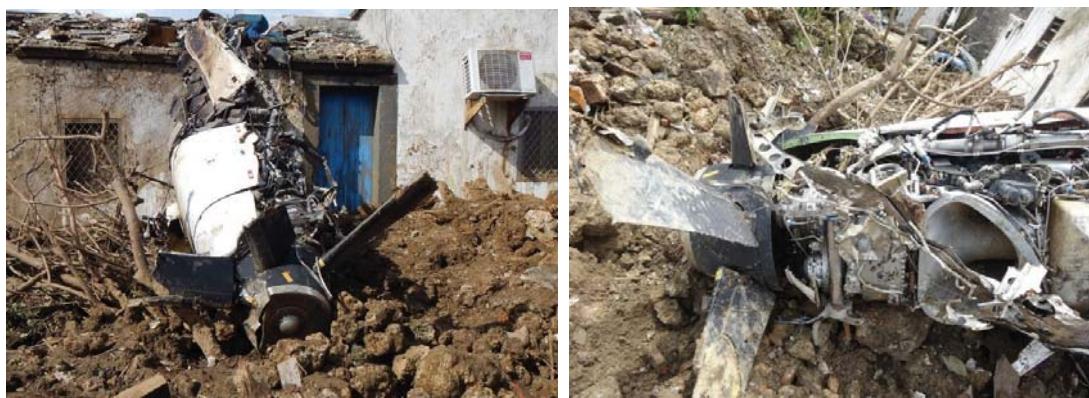
Figure 1.12-11 No.2 Engine

The no.2 engine had separated from the wing but was located in wreckage Zone 2 (see Figure 1.12-11). The propeller pitch angle was estimated to be 10°. No tree debris was found in the air inlet. The remaining propeller blades from the no.2 engine sustained more impact damage than the propellers from the no. 1 engine.
