## **Aviation Occurrence Report**

**ASC-AOR-09-09-001, Publication Date: Sep, 2009**

**A 30 in (77 cm) cracked through fuselage skin was found during transit check**

**BOEING 737-800**

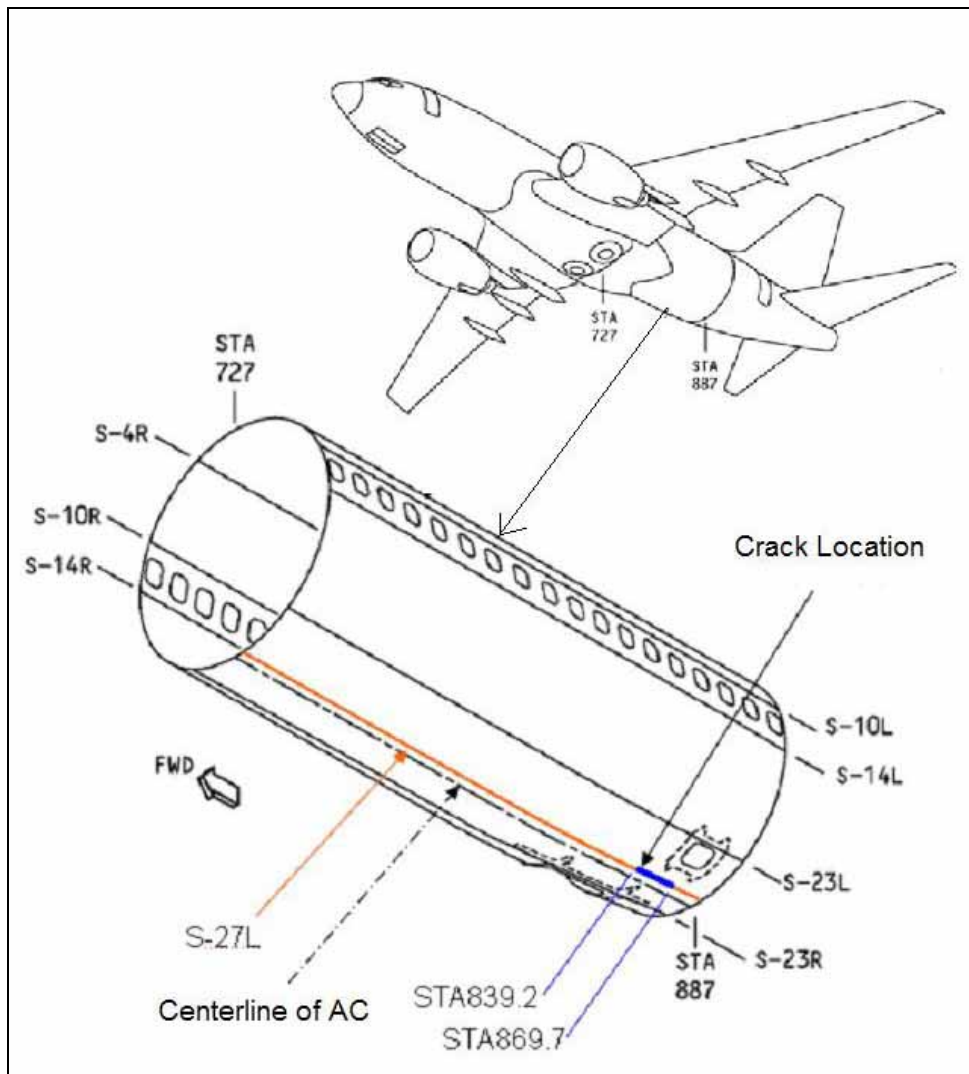
Figure 1.12-3 Location of Crack

At 1326 Japan local time, the aircraft landed in Saga. During transit check, a 30 in (77 cm) through crack located at lower belly below the after cargo door of fuselage skin was found by a mechanic. The aircraft ceased the return flight after communicated with Taipei maintenance base.

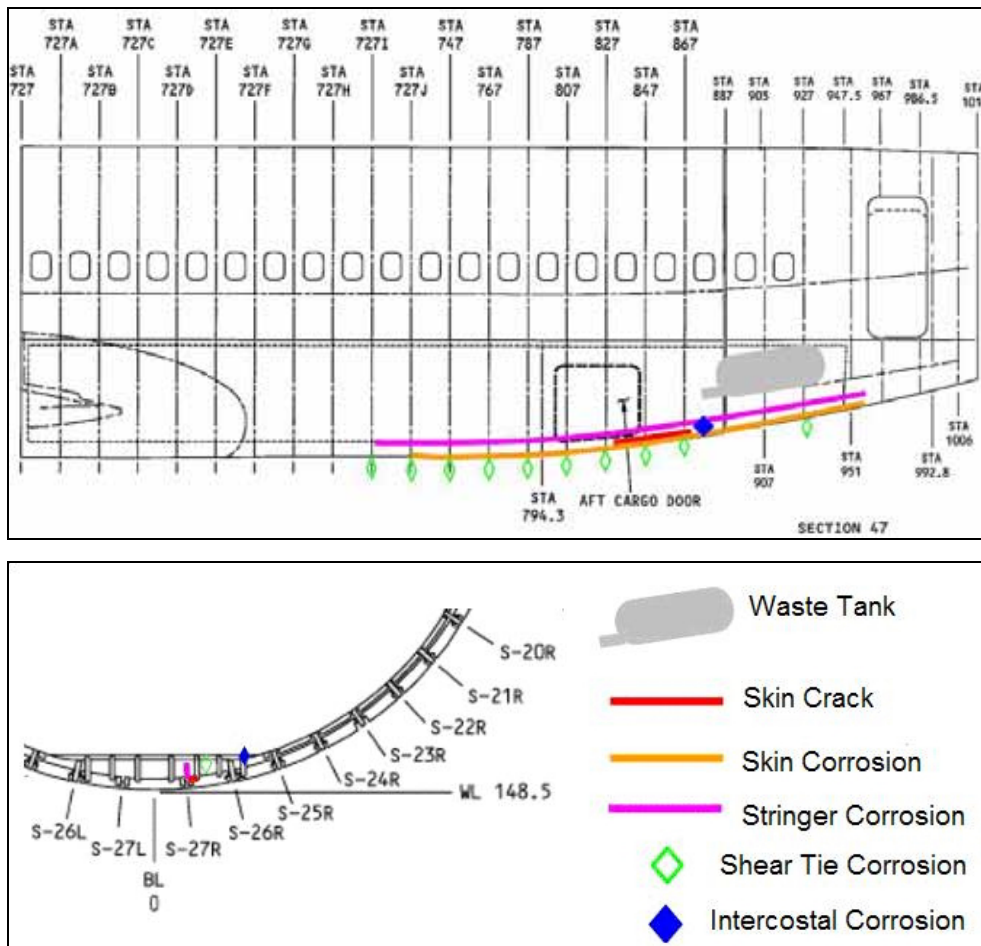
Figure 1.12-4 Location of Damages

The structure damage from corrosion was temporarily repaired per CAL EO 738-53-00-0068 at Saga airport, the temporary repair included corrosion removal of the lightly corroded skin, whilst external repair patch size 40.25 in by 20.45 in for the heavily corroded belly skin, covering the 30 in (77 cm) long crack where the most serious corrosion located, and an external repair angle over the corroded stringer S-27L before the ferry flight back to CAL's home base in Taiwan. The immediate damage investigation by ASC in Taiwan upon the ferry flight arrival, by accessing to the aft cargo compartment where the crack located, the damage to the waste water system, fuselage belly skin, stringers, intercostals, and shear ties were again verified against the damage reports delivered by the operator earlier. The 40.25 in. × 20.45 in. external repair patch was then removed to expose the heavy corrosion area where the skin crack located for investigation. ASC, in addition, took samples of the heavily corroded and cracked belly skin for specimen for further laboratory inspection. See Figure 1.12-4 for location information of these damages.

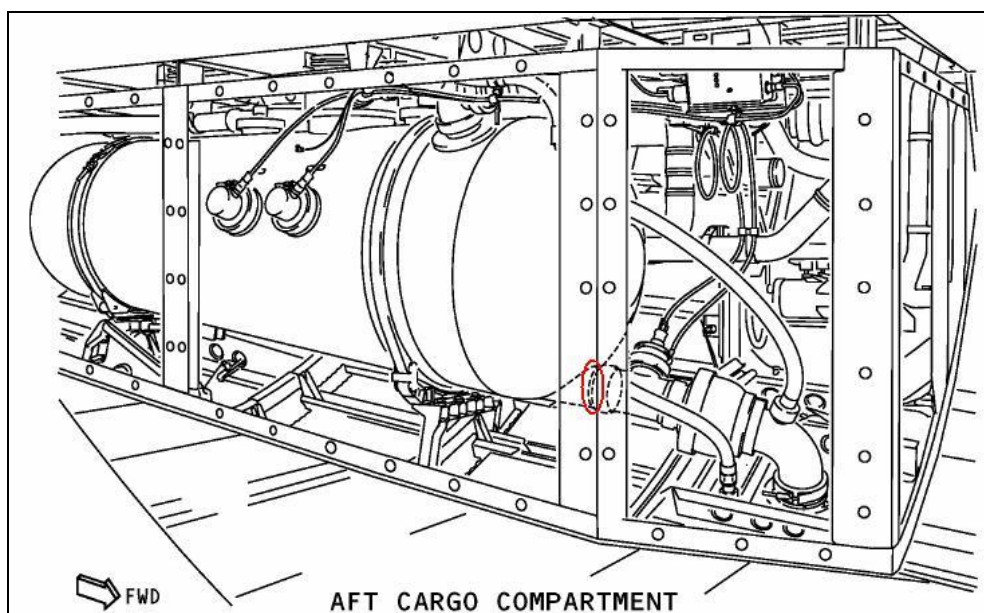
Figure 1.12-8 Location of the Damaged Waste Tank Outlet Port

Further examination of the leakage by removing the waste tank revealed that the outlet port flange from the waste tank had been broken, see red circle indicated in figure 1.12-8, the appromax 5 in long broken flange located at the lower right side of the outlet port. See figure 1.12-9.

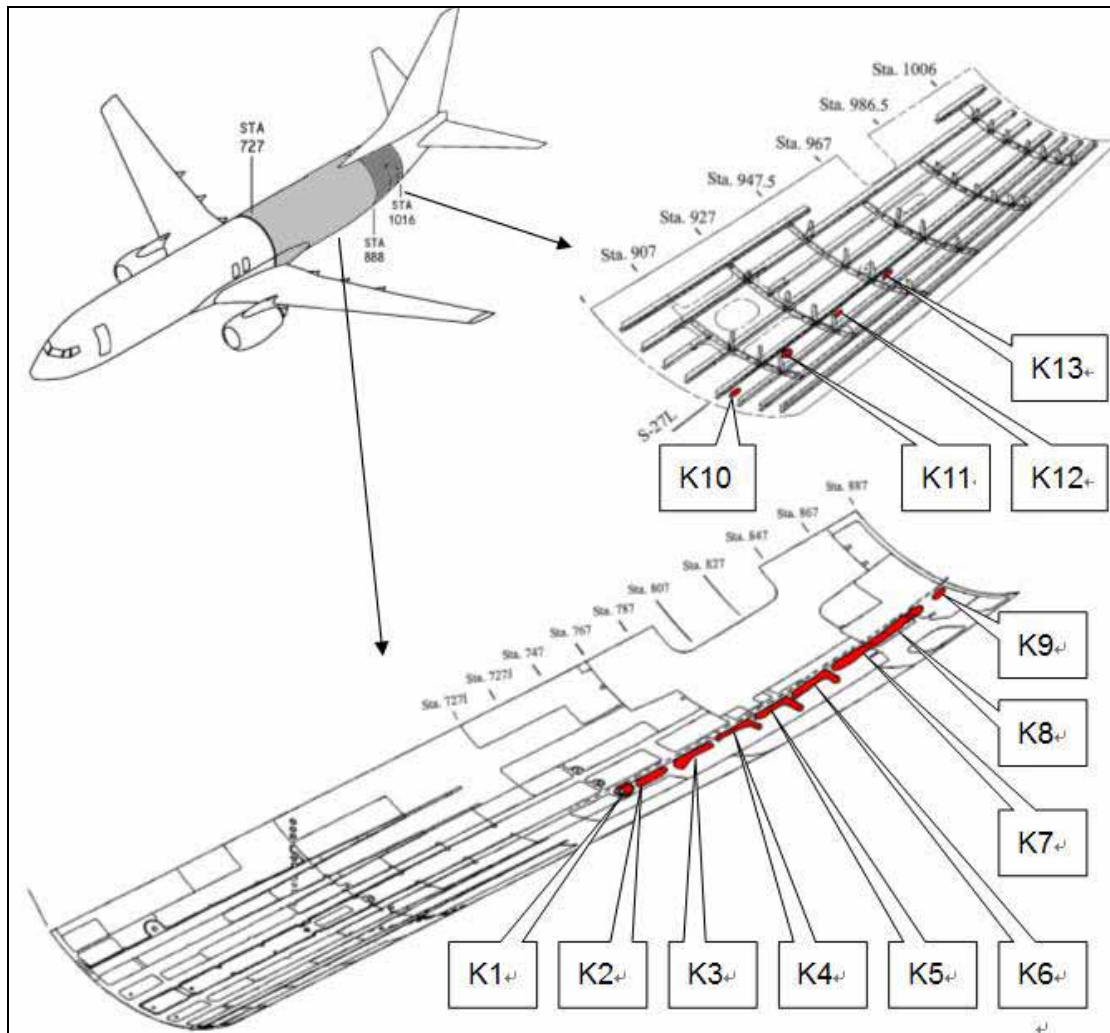
Figure 1.12-11 Relative Location of Corrosion Sites in Aft Cargo Compartment

The relative location of these corrosion sites is indicated in figure 1.12-11.

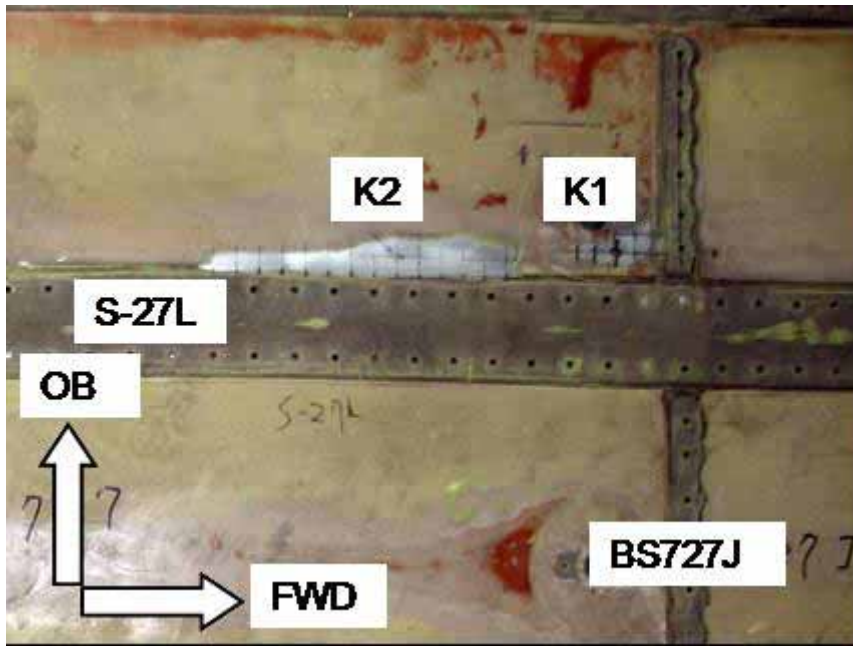
Figure 1.12-12 Corrosion of K1, K2 Sites

K1 area and K2 area: Corrosion site K1 area located surrounding the BS727J left side drain valve, adjacent to the BS727J fuselage frame. Corrosion site K2 area located next to the above mentioned corrosion as indicated in figure 1.12-12. In this figure the stringer S-27L, frame, and attached structure parts were removed, the corrosion was blent out.

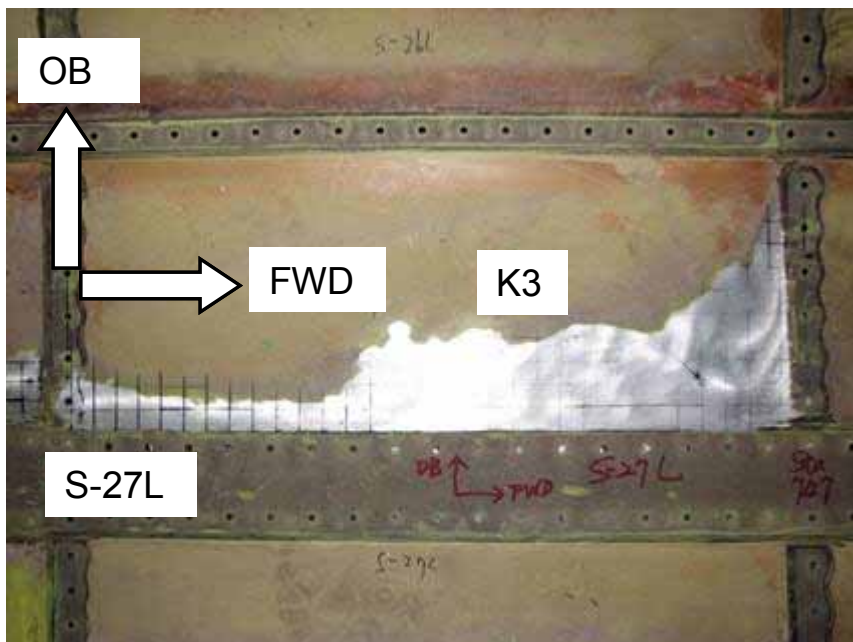
Figure 1.12-13 Corrosion Site K3

K3 area: Corrosion site K3, started at the BS747 frame shear tie, extended along S-27L to the rear, the most severe corrosion existed at where the lowest portion of all. See figure 1.12-13. In this figure the stringer S-27L, frame, and attached structure parts were removed, the corrosion was blent out.

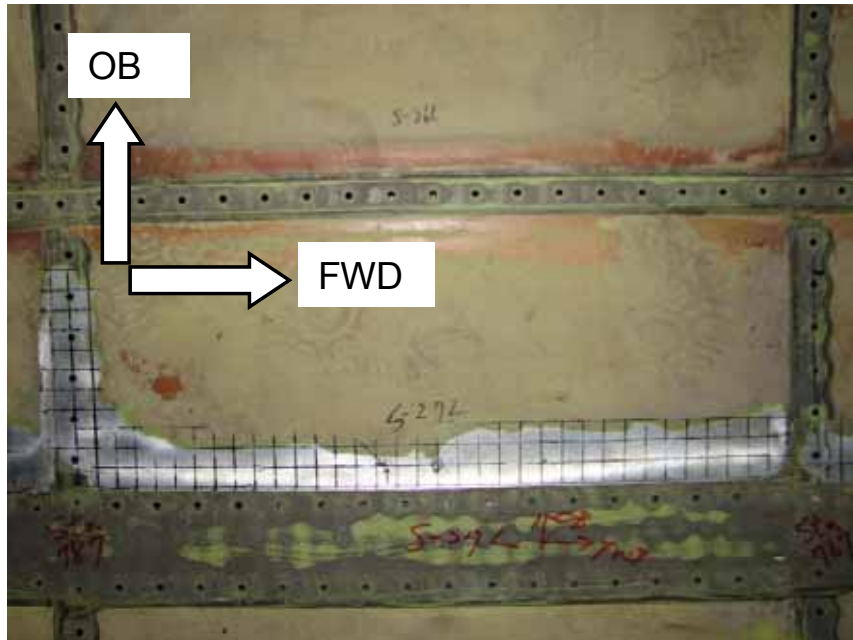
Figure 1.12-14 Corrosion Site K4

K4 area: Corrosion site K4, started at the BS767 frame shear tie, extended along S-27L to the next frame shear tie of BS787, the most severe corrosion existed at where the lowest portion of all. See figure 1.12-14. In this figure the stringer S-27L, frame, and attached structure parts were removed, the corrosion was blent out.

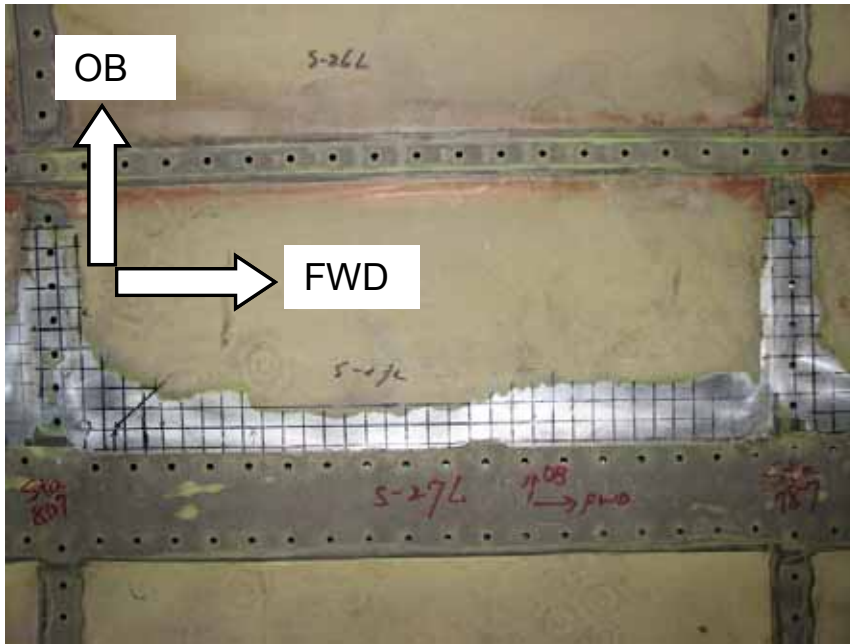
Figure 1.12-15 Corrosion Site K5

K5 area: Corrosion site K5, started at the BS787 frame shear tie, extended to the rear along S-27L and went beneath the BS807 frame shear tie, the most severe corrosion existed at where the lowest portion of this area. See figure 1.12-15. In this figure the stringer S-27L, frame, and attached structure parts were removed, the corrosion was blent out.

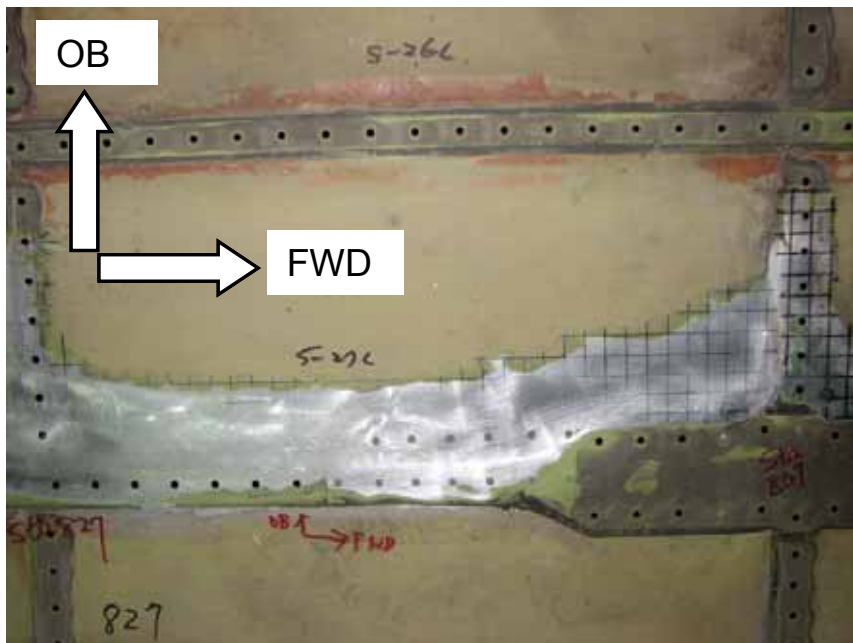
Figure 1.12-16 Corrosion Site K6

K6 area: Corrosion site K6, started at the BS807 frame shear tie, extended to the rear along S-27L and went beneath the BS827 frame shear tie, the most severe corrosion existed at where the lowest portion of this area. See figure 1.12-16. In this figure the stringer S-27L, frame, and attached structure parts were removed, the corrosion was blent out.

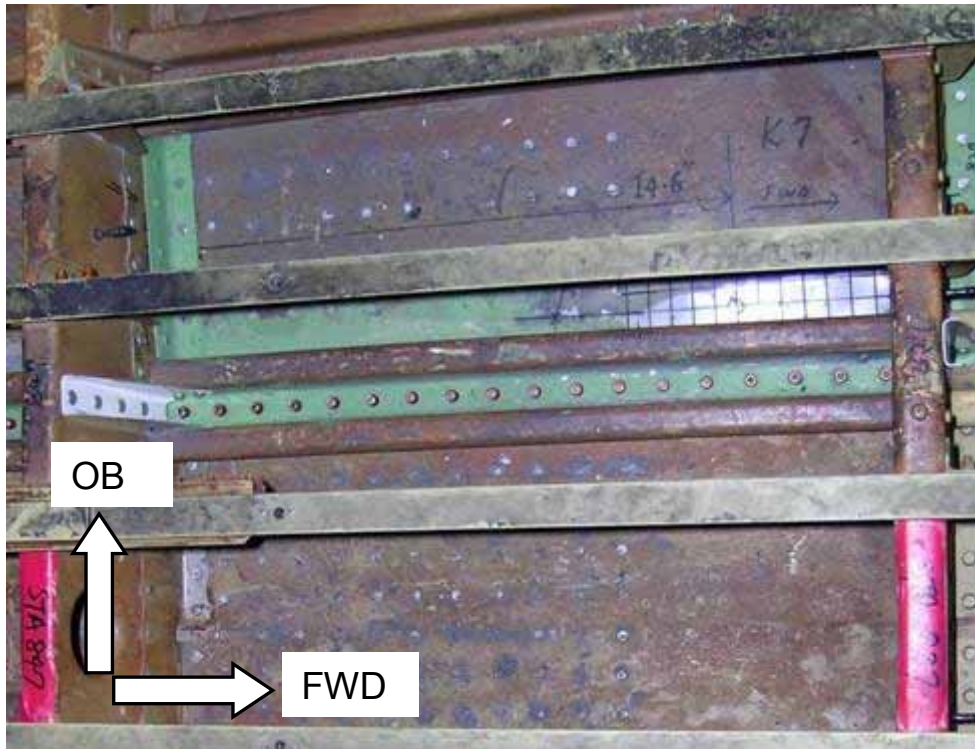
Figure 1.12-17 Corrosion Site K7

K7 area: Corrosion site K7, started at the BS827 frame shear tie, extended to the rear along S-27L and went beneath the BS847 frame shear tie, the most severe corrosion existed at where the lowest portion of this area. See figure 1.12-17. In this figure the corrosion was blent out. In addition, the through crack forward end located at BS839.2 in this corrosion area, see figure 1.12-18.

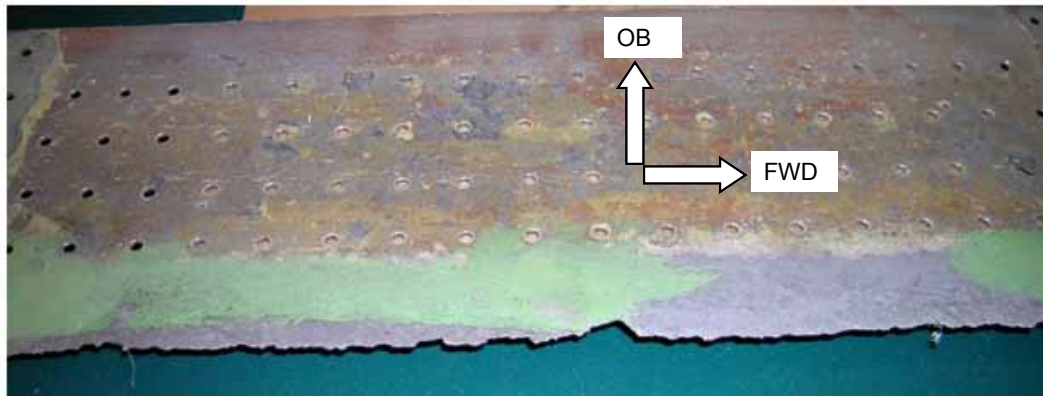
Figure 1.12-19 Corrosion Site K8

to BS872 passing the BS867 frame; the most severe corrosion existed at where the lowest portion of this area. The through crack rear end located at BS869.7 in this corrosion area, see figure 1.12-19 and 1.12-20.

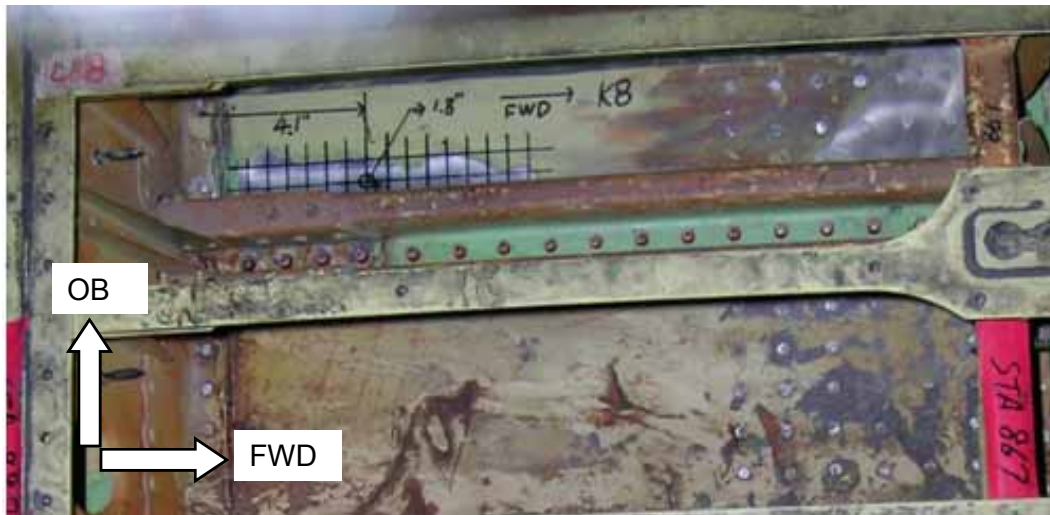
Figure 1.12-21 Corrosion Site K9

K9 area: Corrosion site K9, started at the BS877, extended to the rear along S-27L and went beneath the BS887 frame shear tie, the most severe corrosion existed at where the lowest portion of this area. See figure 1.12-21. Corrosion had been blent out in this area, in the figure also showed part of the K8 corrosion blent out whilst K9 area is located at left half of the figure, the S-27L crosses vertically inside the picture.

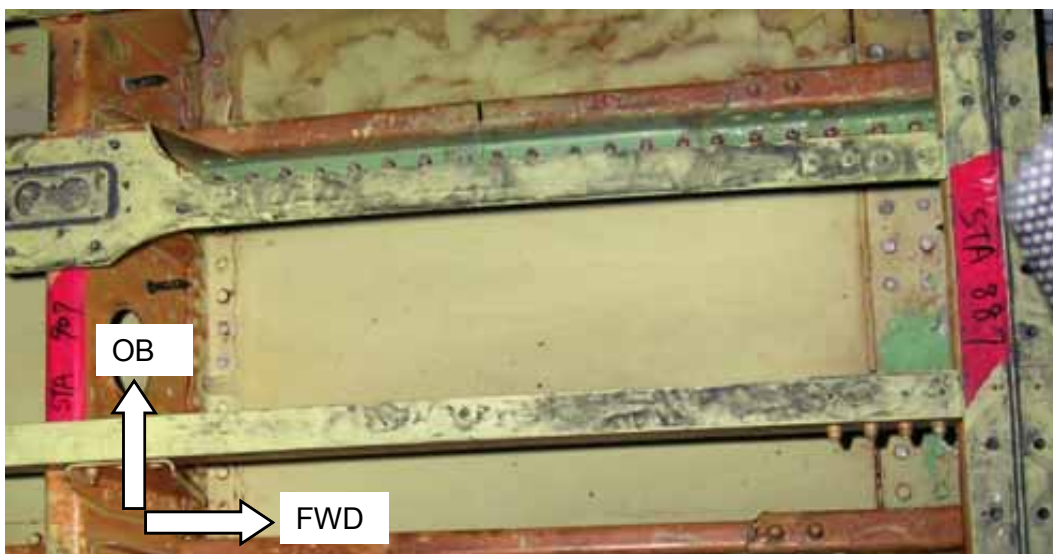
Figure 1.12-22 Corrosion Site K10

K10 area: Corrosion site located at the butt joint of the fuselage skin panels at BS887, i.e. the splicing of fuselage section 46 and section 47. Corrosion was found on the frame chord in section 47, and light surface corrosion on the fuselage skin outboard of S-27L was also found, see figure 1.12-22.

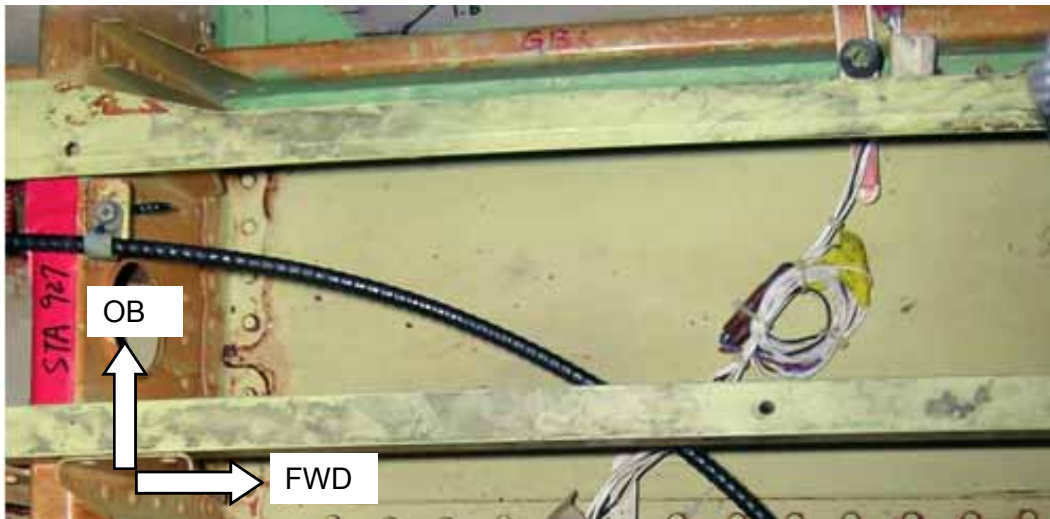
Figure 1.12-23 Corrosion Site K11

K11 area: Corrosion site located in front of BS927 outboard of S-27L, observed as light surface corrosion over skin panel, see figure 1.12-23.

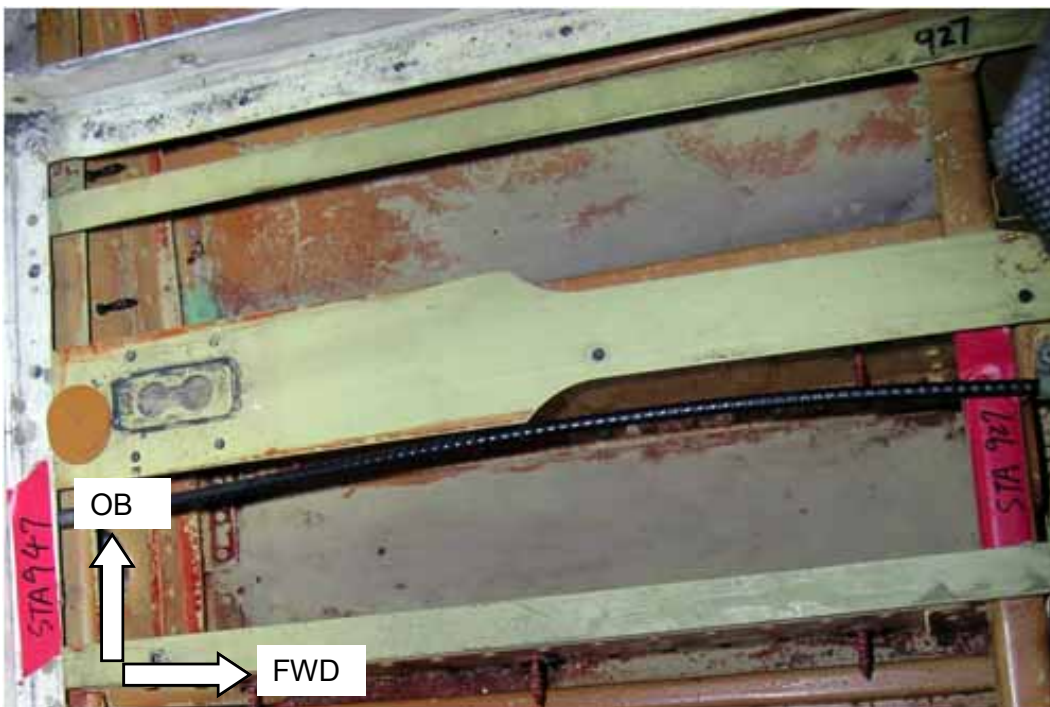
Figure 1.12-24 Corrosion Site K12

K12 area: Corrosion site located in front of BS947 outboard of S-27L, observed as light surface corrosion over skin panel, see figure 1.12-24

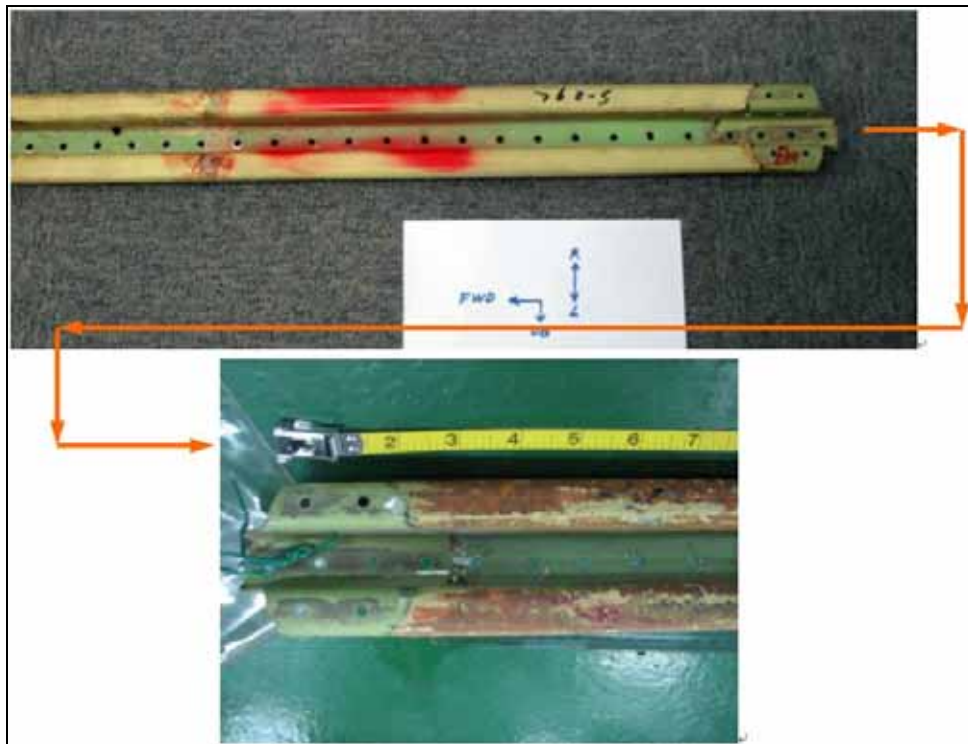
Figure 1.12-39 Corrosion Area G12

G12 area (BS867 ~ BS887): Hat section stringer, spliced jointed with another formed hat section in between BS880 ~ BS883, see figure 1.12-39.

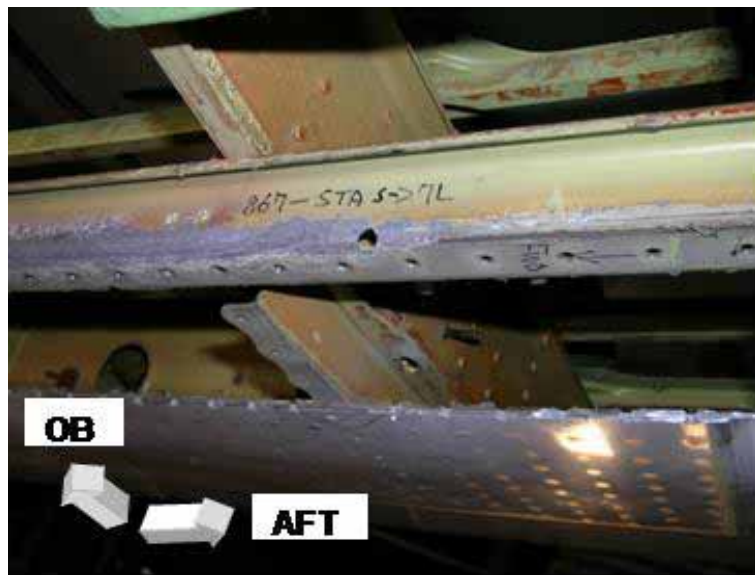
Figure 1.12-41 Material Loss on Stringer Drain Hole

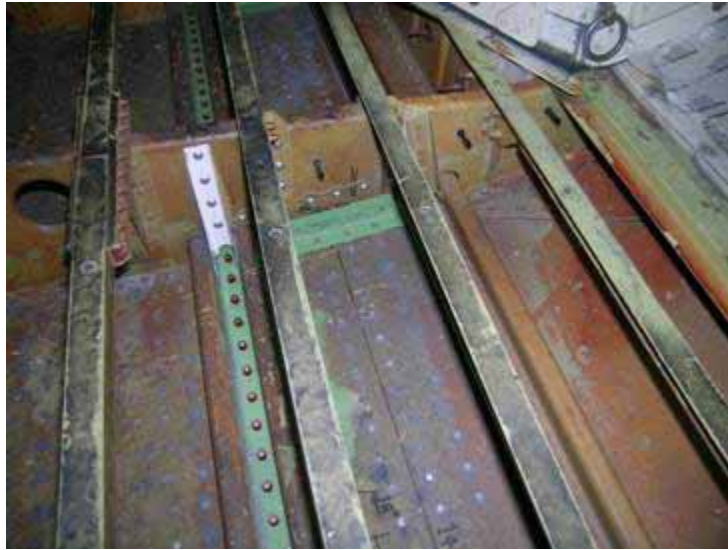
Figure 1.12-52 Shear Tie at BS847 between S-26L and S-27L

In the Chart 1.12-3, the observed corrosion of the shear ties were all located on the lower surface of their lower flange. The shear ties at BS847 and BS867 were the most heavily corroded ones. For ferry flight purpose, all 12 corroded shear ties were replaced per operator’s EO 738-53-00-0068, see figure 1.12-52 and 1.12-53.

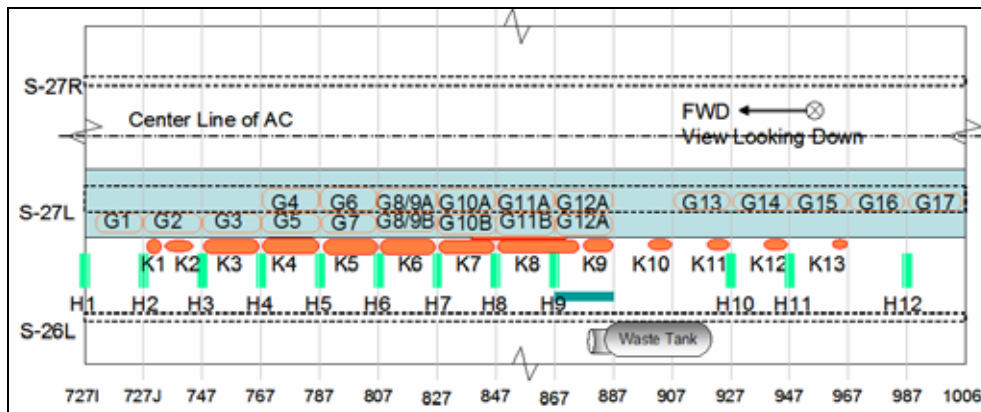
Figure 1.12-54 All Structure Corrosion Damage Sites Summary

It is concluded that from the relative position of all corrosion damage to structure parts, these corrosion sites were concentrated along the flow path of leakage fluid from the leaking waste tank outlet coupler. In addition, the shapes of corrosion areas which can be visualized by observing the corrosion blending out areas were consisted with how the fluid was trapped in the lower portions of the airplane belly structure composed of stringer S-27L, shear ties, and the milled skin panels. All structure damage sites due to corrosion are summarized as in figure 1.12-54 for visualizing this finding.

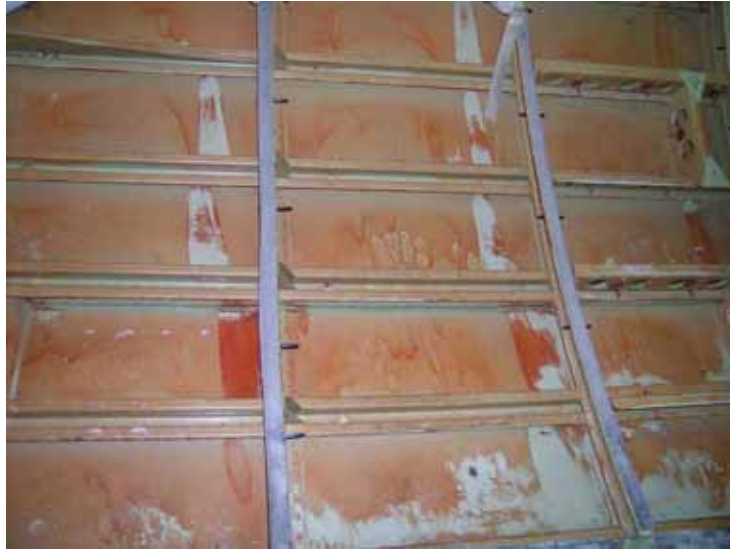
Figure 1.12-56 Side Skin Panel with CPC Washed Off

Although the CPC film was washed off by condensate water on the side fuselage skin panel in the aft cargo compartment during the site investigation of cargo compartment in operator's home maintenance depot, no corrosion was found neither, see figure 1.12-56.

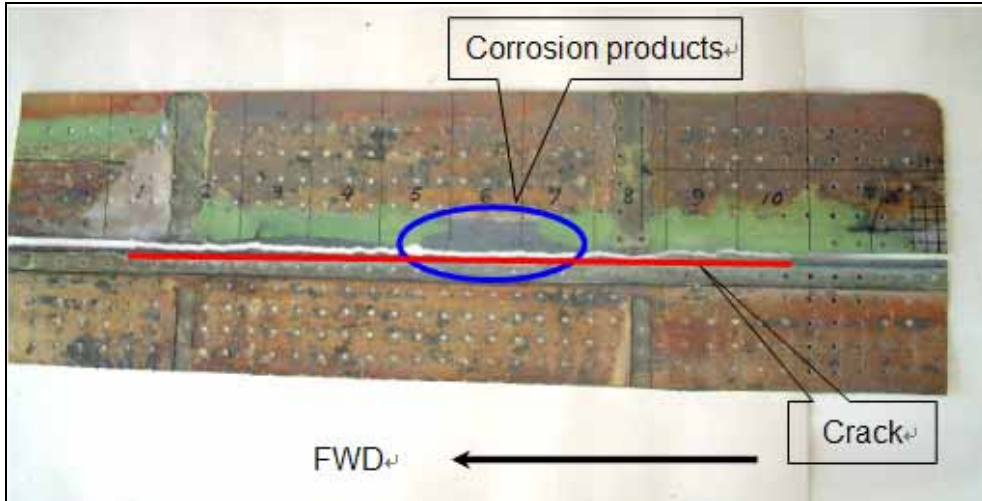
Figure 1.16-5 Interior surface of the damaged skin

The damaged overall view of the interior and exterior surface of the damaged skin (sampling) was shown in figure 1.16-5 and 1.16-6. The interior surface of the sampling (indicated by circle in Figure 1.16-5) was covered with corrosion products, and the fracture surface was rugged and rough with corrosion products. The sampling was segmented to ten sections for macro observation and photographic documentation. Figure 1.16-7 shows the macro observation of fracture surface of item 1, and figure 1.16-8 for item 9. The fracture surface obviously revealed rougher and showed the corrosion features. This is a key feature of exfoliation corrosion. See Appendix 4 for the photographs of other items.

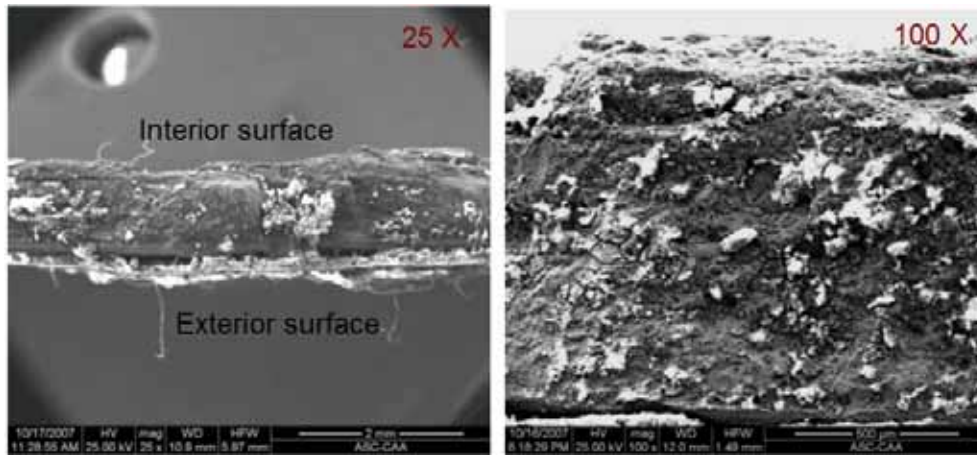
Figure 1.16-9 Fracture surface of item 1

The fracture surface of item 1 examined by Scanning Electron Microscope (SEM) was shown in figure 1.16-9. The topcoat was present up to the exterior surface of the skin, but the interior surface of the skin revealed in severe exfoliation condition. The fracture surface of item 9 was examined by Scanning Electron Microscope (SEM) shown in figure 1.16-10, the fracture surface near the interior surface of the skin revealed intergranular failure mode. Moreover, the fracture surface near the exterior surface of the skin revealed overload failure mode (dimple).

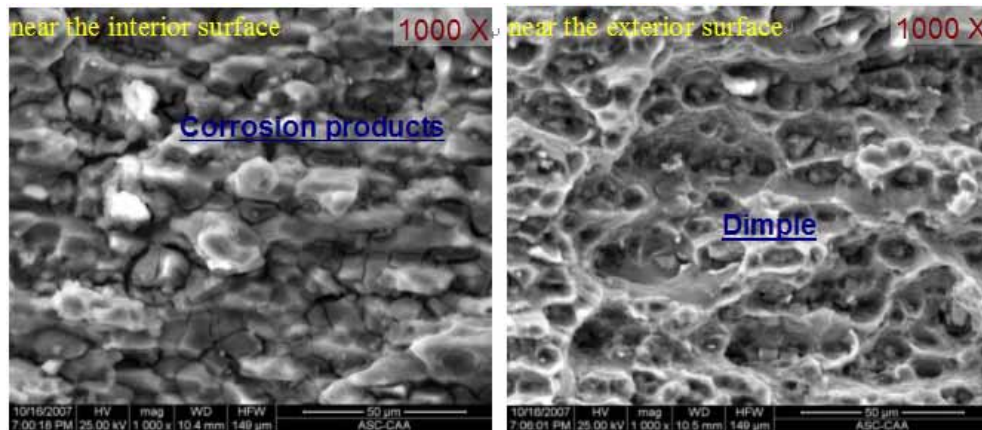
Figure 1.16-11 Fracture surface of item 5

Figure 1.16-11 showed the SEM photographs of item 5. The main failure cause of the fuselage skin is due to intergranular fracture and it possesses more area than overload.

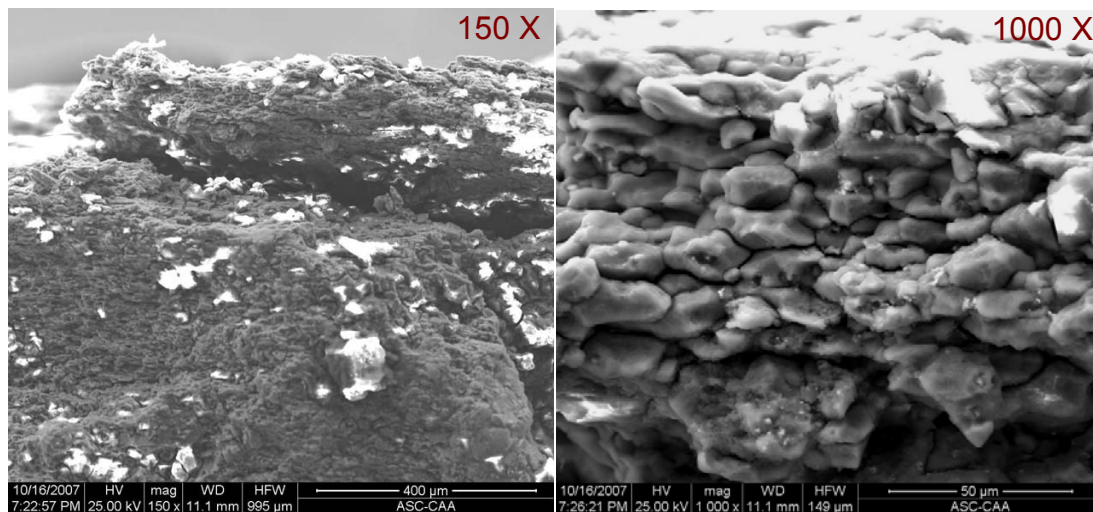
Figure 1.16-12 Fracture surface of item 5 near the interior surface

The SEM photographs of fracture surface of item 5 near the interior surface revealed the same typical intergranular failure mode. Apparently this failure mode occurred from the interior surface of the fuselage skin and continued to grow to the direction of the skin depth, until its loading surface couldn't stand the load, which resulted in overload fracture (Figure 1.16-12).

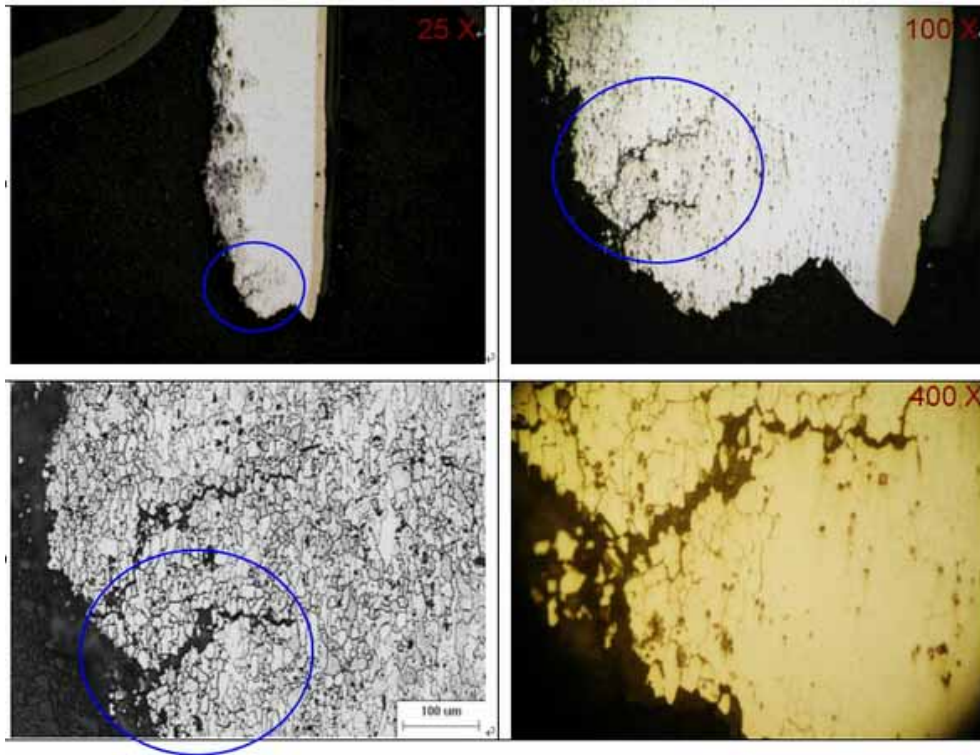
Figure 1.16-13 Metallographic photographs of item 4

figure 1.16-13. The metallographic section was examined up to 100X, it was found that the thickness of the cladding of the fuselage skin near the fracture surface became a little thin, and the nipple feature was revealed obviously.

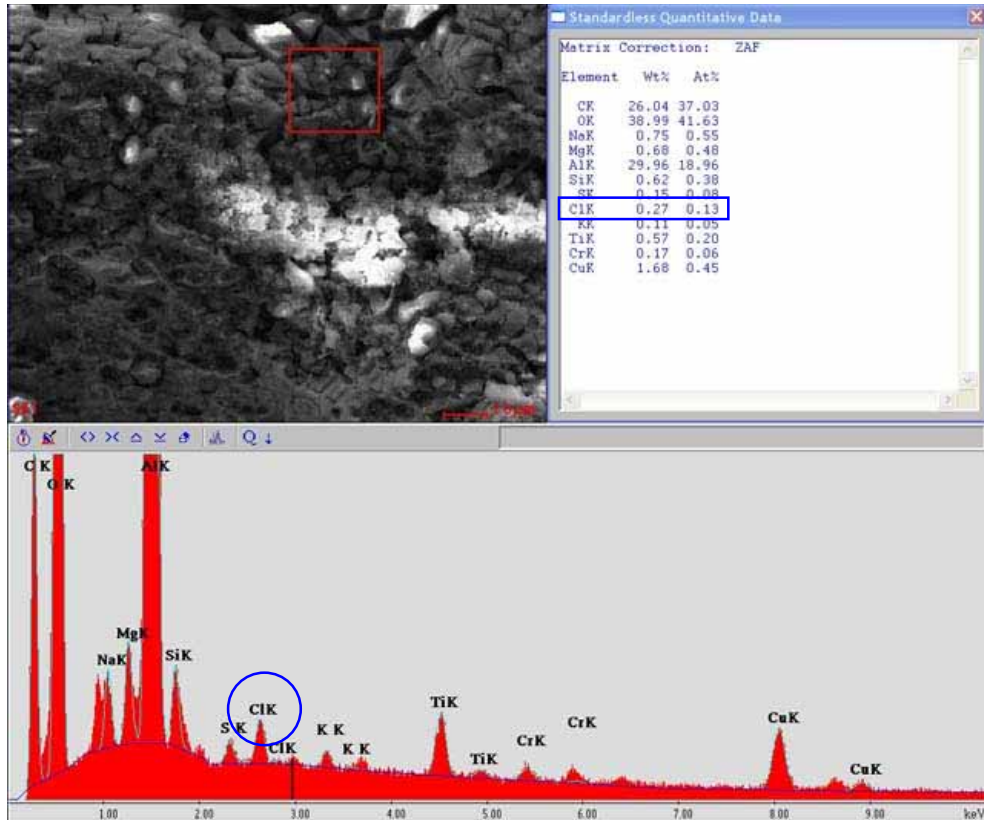
Figure 1.16-14 SEM/EDS photographs of item 9

The corrosion products were scratched by knife and were crushed to powder, which was immersed into deionize water as a testing sample. To identify the contributing factor towards corrosion, the cleaner for waste tank (10% acetic acid) and a chemical reagent acetic acid were examined by Ion Chromatography (IC) method in advance. The results showed that the chemical composition of corrosion products were acetic acid and chloride.

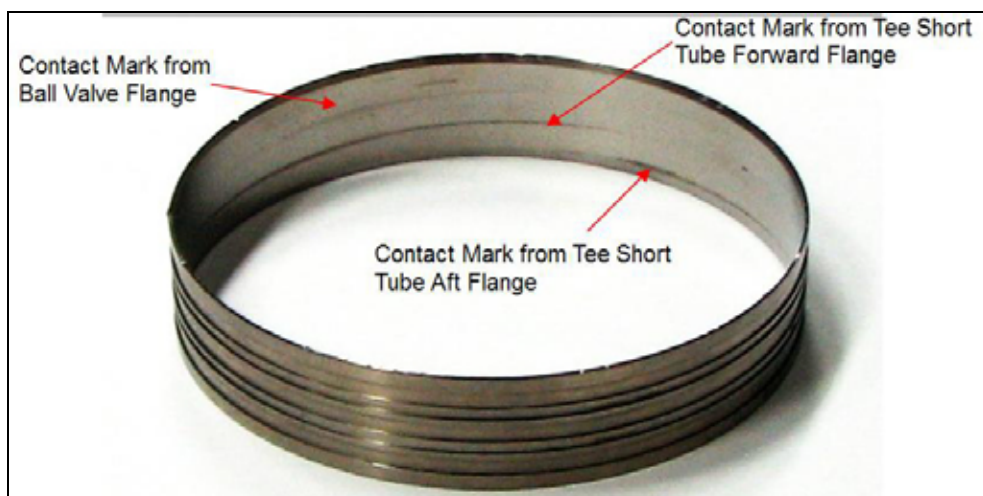
Figure 1.18-3 Trace of Contact Marks on the Inner Race of the Sleeve

In conducting the B737-800 fleet wide inspection for the gap between flanges mentioned in Section 1.6.5, the sampled sleeve from the #7 airplane, shown in Figure 1.18-3, the sleeve for coupling the short tube and ball valve, was visually examined for evidence of misalignment. On the inner race of the sleeve, two pairs of contacting marks from the short tube and from the ball valve can be observed; the pair from the short tube is clear whilst the other one from the ball valve seemed blurred. Within each pair, two traces are parallel with a 5 mm separation.

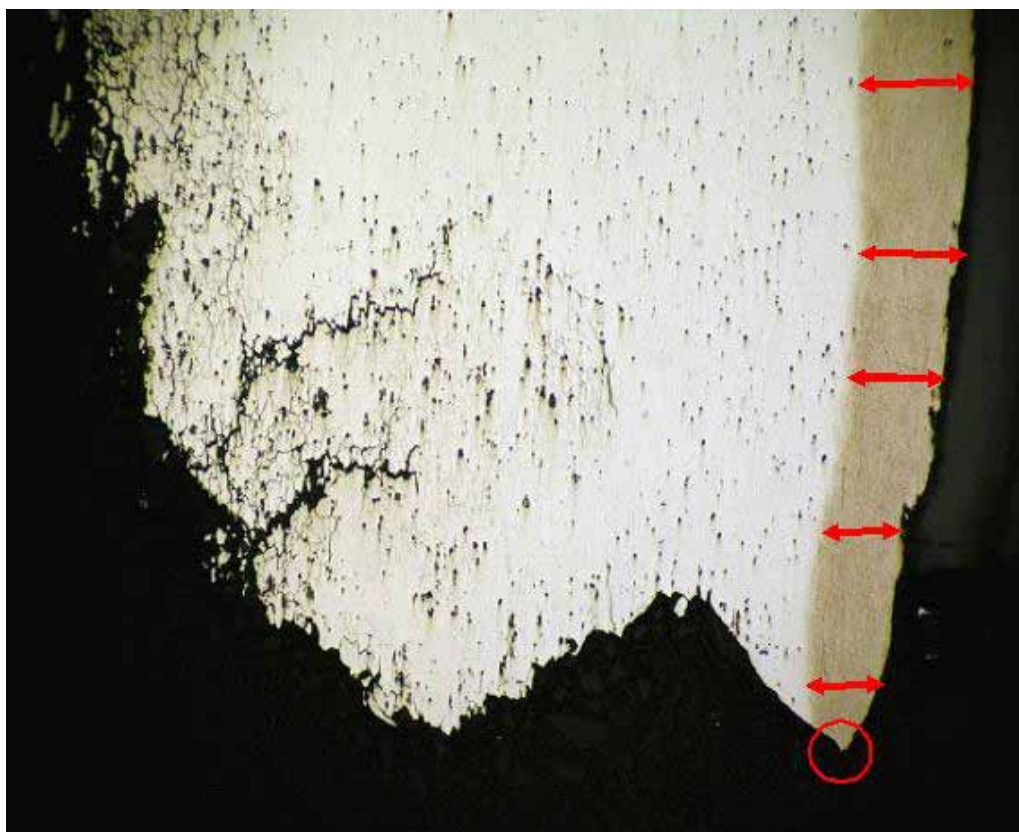
Figure 2.1-1 Metallographic photograph of item 4 (100X)

Base on above descriptions in section 1.16.1.5, the conclusions of the examinations and tests of CSIST are as follows: “The failure mechanism of the fuselage skin was caused by intergranular corrosion (exfoliation). The failure initiated from the regions of the inner surface of the fuselage skin, and subsequently propagated toward the exterior surface of the fuselage skin, the effective thickness of the fuselage skin became a little thin. The residual strength of the skin was not of sufficient to endure external load, finally the fuselage skin fractured due to the overstress.”

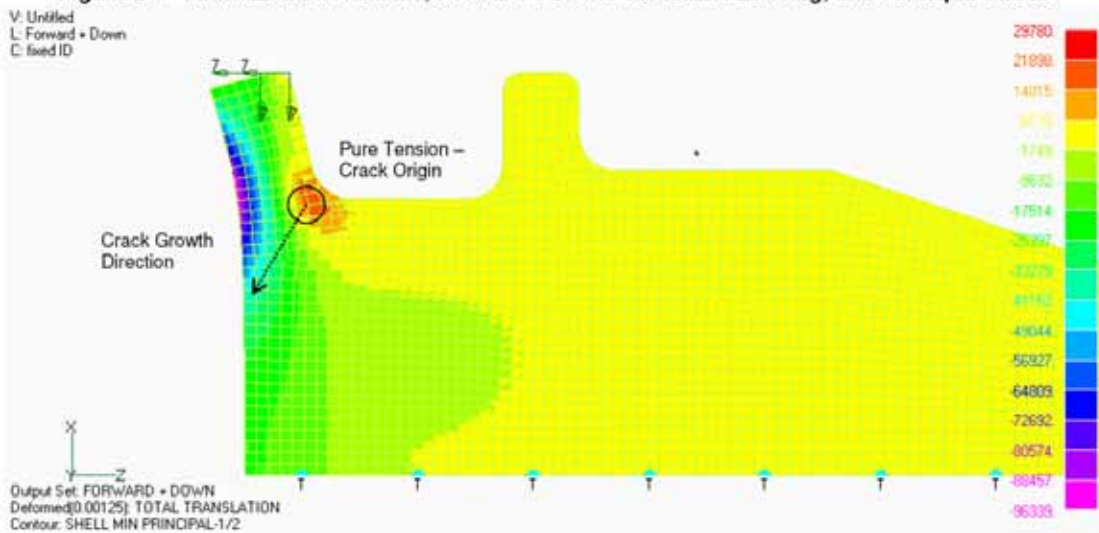
Figure 2.3-5 Mode 1 Crack Due to Combined Forward and Down Loading

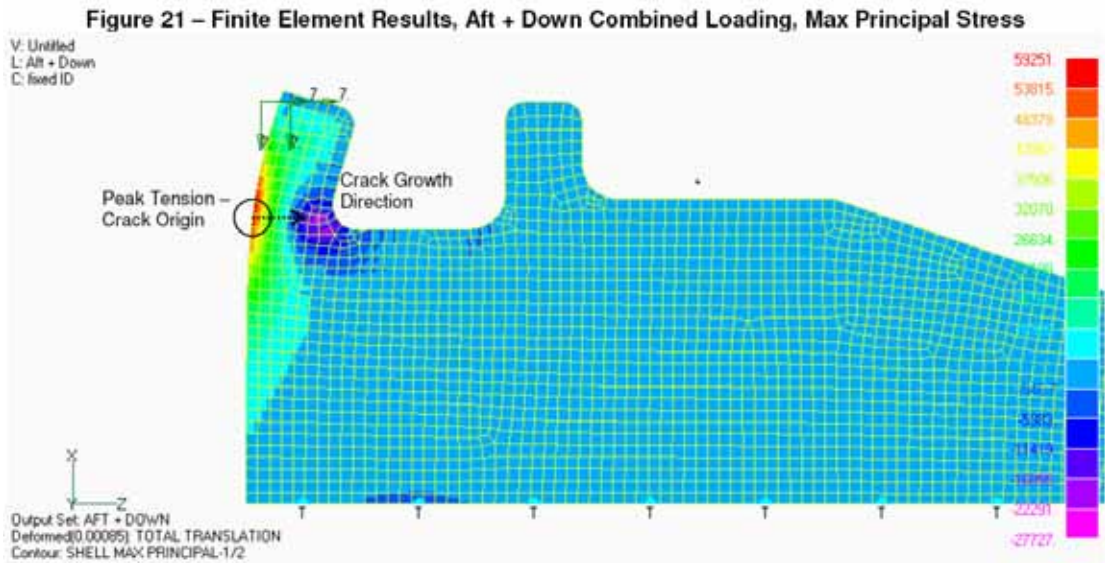
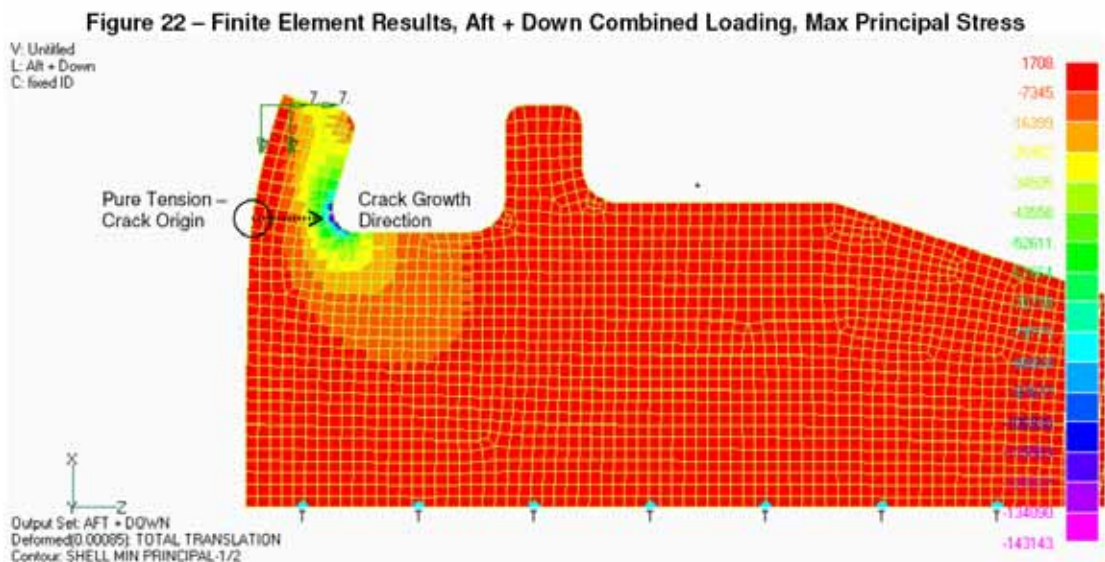
Figure 2.3-6 Mode 2 Crack Due to Combined Aft and Down Loading

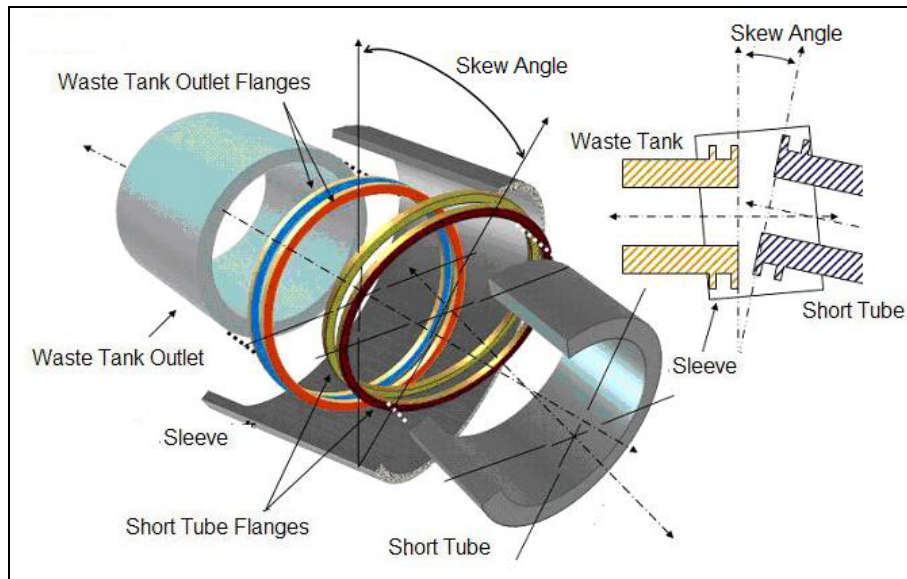
Figure 2.3-8 Unmatched and Skewed Centerlines

1. Require to improve the material of waste tank outlet flanges to sustain pre-stress resulting from the installation of coupling tubes. Before final fix the material, require to make sure to correct the unmatched and skewed centerlines problem during the installation of the waste tank outlet and the short tube to reduce pre-stress and to avoid the resultant damage to the waste tank outlet flanges. The AMM should use a practical instruction and specific tolerance to install the flanges of waste tank outlets instead of using the theoretical 0.1500 in gap dimension between the flanges of waste tank outlet and the short tub. (ASC-ASR-09-09-006)
