# Aviation Occurrence Report

ASC-AOR-10-08-002

Emergency descent due to temporary  
Interruption in the bleed air system  
Supply During Initial Descent

Cathay Pacific Airways Flight CX521  
AIRBUS A330-300, B-HLH  
September 14, 2008

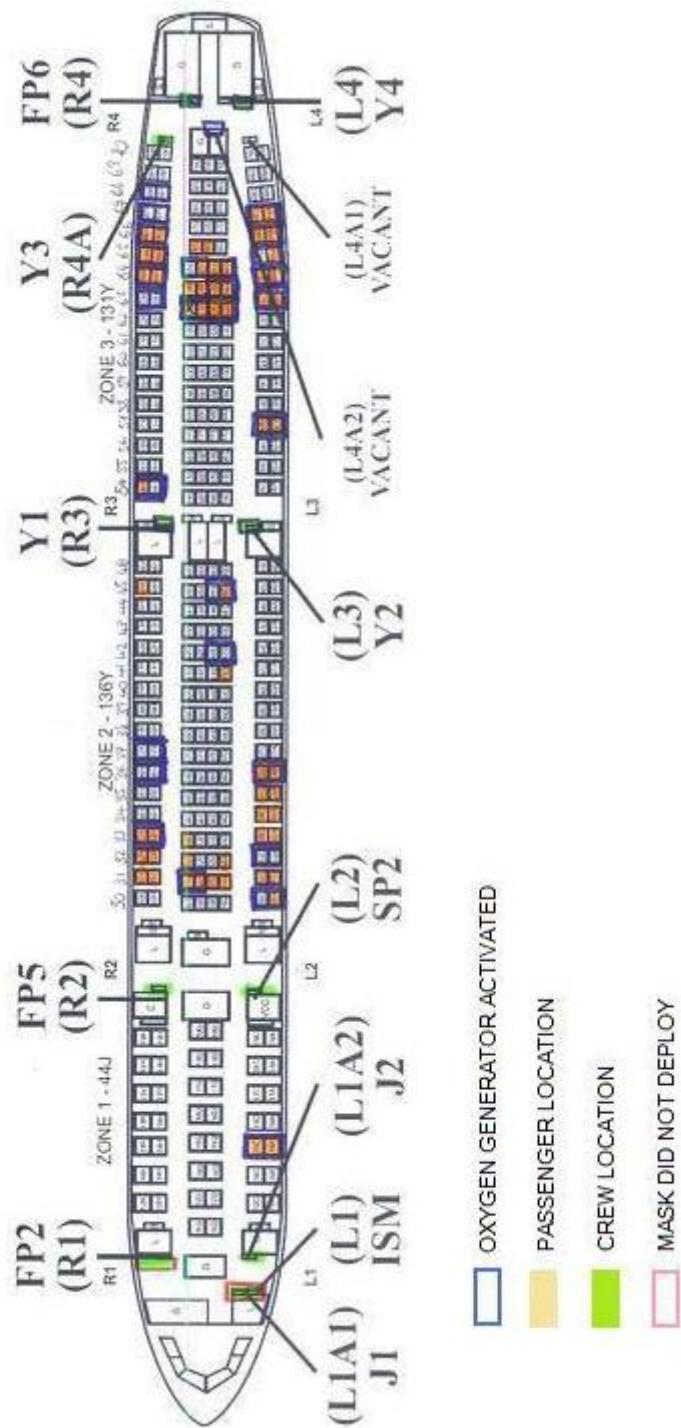
Figure 1.15-1 Cabin Configuration and Oxygen Mask Condition

During the emergency descent the cabin masks were deployed. All of the passenger masks and cabin crew masks deployed, except for those located at doors L1 and R1. A passenger oxygen mask drop test was performed IAW AMM 35-21-00, the test found that the faulty oxygen mask access panel was obstructed by an adjacent panel and prevented the mask from deploying. The oxygen container was repositioned and a subsequent test was conducted whereby all of the cabin masks deployed successfully.

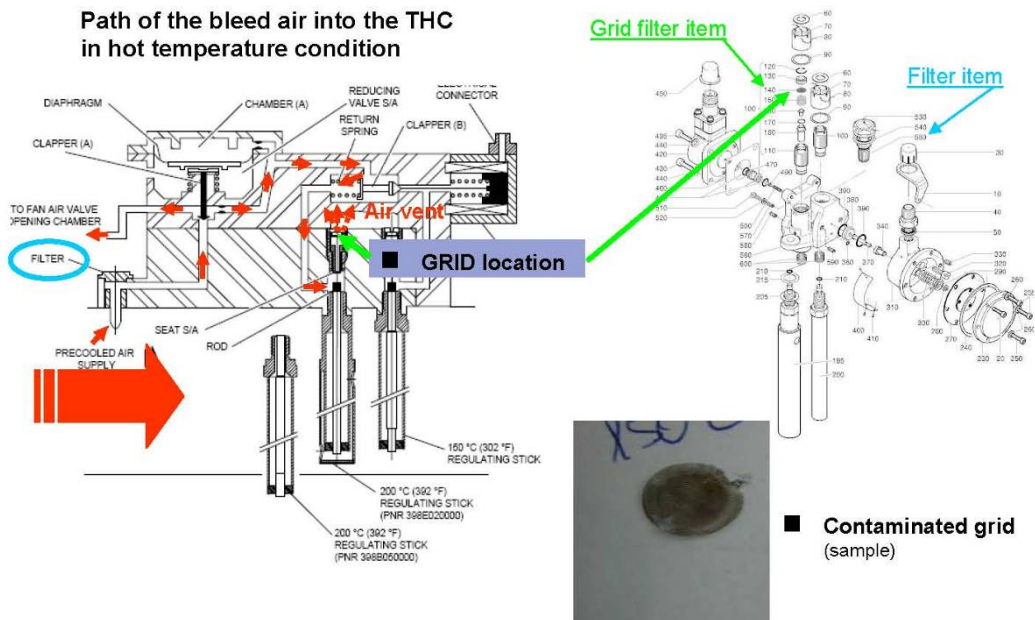
At high temperature condition the reduced pressure normally vents through the grid filter thanks to the thermal expansion of the regulation stick (see figure hereunder for air bleed path into the THC)

The contamination of the grid has affected the flow of the reduced pressure (causing a pressure loss) coming from the bleed air through the THC .

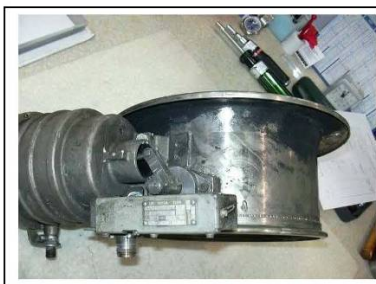
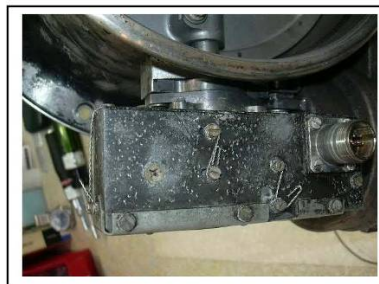
➤ \_ Visual inspection

High level of external pollution

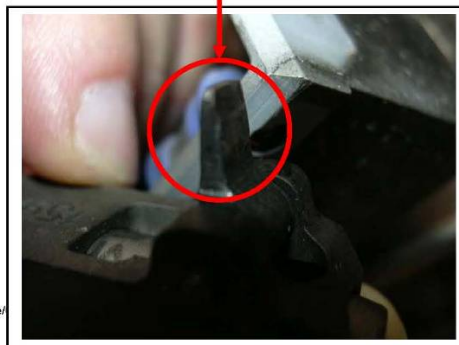
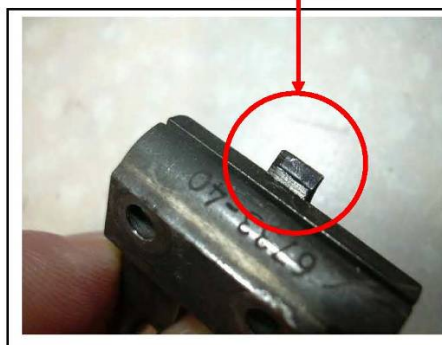
Mechanical wear

Switch lever wear

lever wear

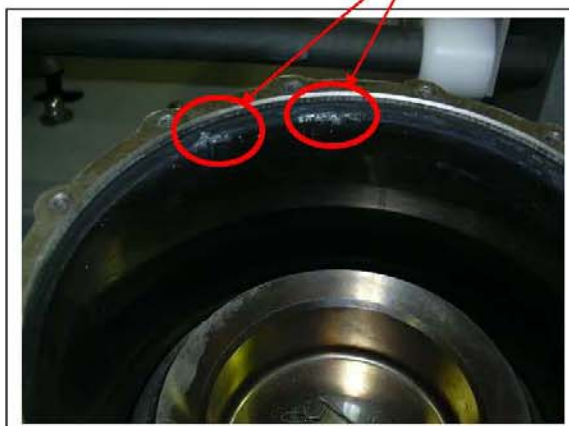
Moreover some traces of corrosion have been noted in the piston which could lead to degrade the actuator piston seal too. This corrosion could be explained by humidity environment in Asia area.
