**SMOKE CAME OUT OF THE DADO PANEL IN
REAR CABIN DURING PASSENGERS
DISEMBARKING**

**EVA AIRWAYS FLIGHT BR67
BOEING 747-400, B-16410
BANGKOK SUVARNABHUMI INTERNATIONAL
AIRPORT FEBRUARY 23, 2008**

Final Report

Report Number: ASC-AFR-09-05-002

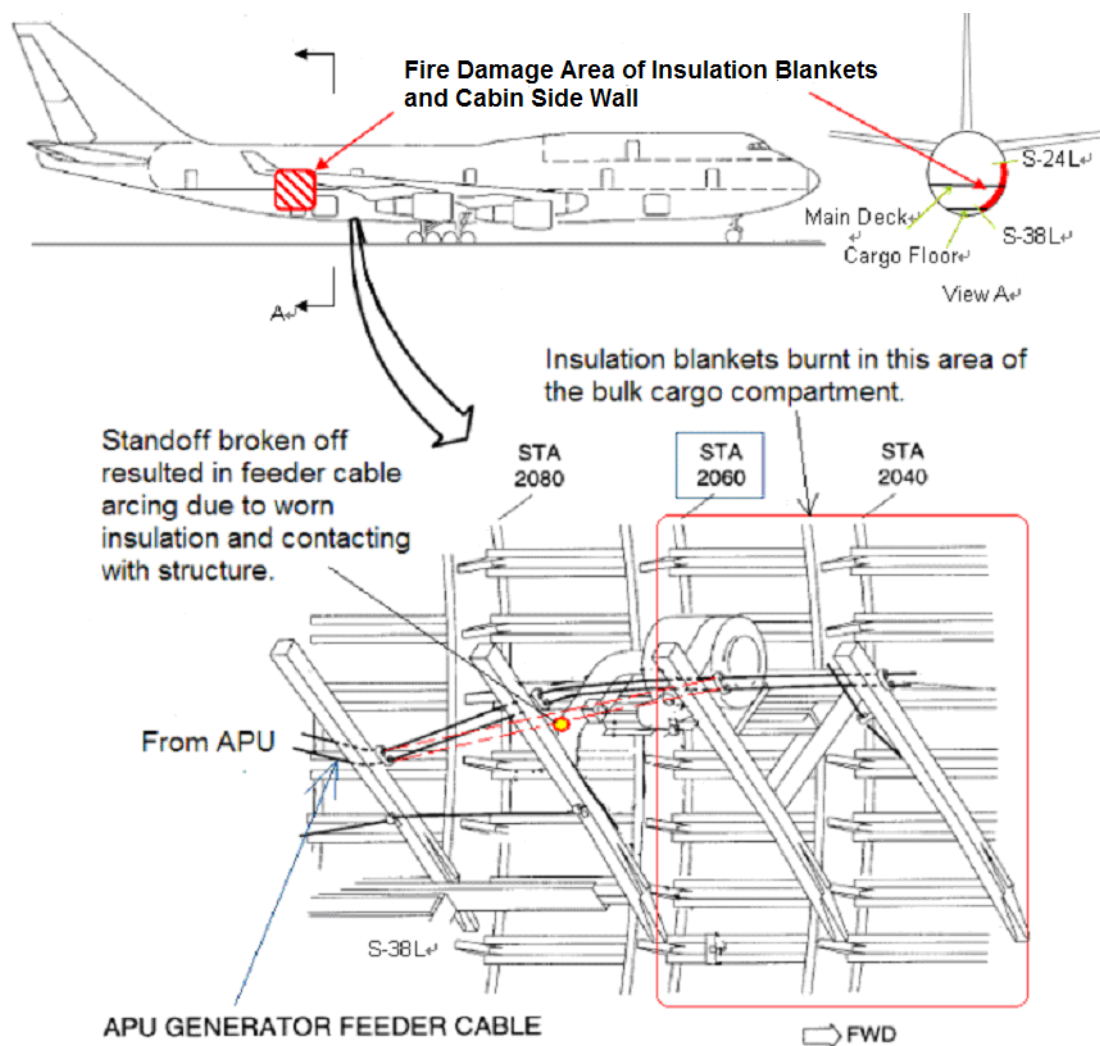
Fig. 1.12-1 Location of the Damaged Insulation and APU Power Cable

panel was partially carbonized and delaminated with heat damage (area measured 16 inches by 24 inches). One cabin side wall panel lower edge was found damaged by heat. For aircraft structure, one ventilation truss, one floor beam web for an affected area of 7 inches by 7 inches, and two stringers were found discolored with smoke; the residual strength of the structure were confirmed that had been compromised by heat with non-destruction test (NDT). The APU power cable standoff was found broken and felt off from the attachment; insulation jacket of the APU power cable charcoaled and melt locally; and the metal core of the cable was also melt; on the tip of a bolt belonging to the waste system was found melt with high temperature. All damage sites were summarized in Fig. 1.12-1 and Fig. 1.12-2.

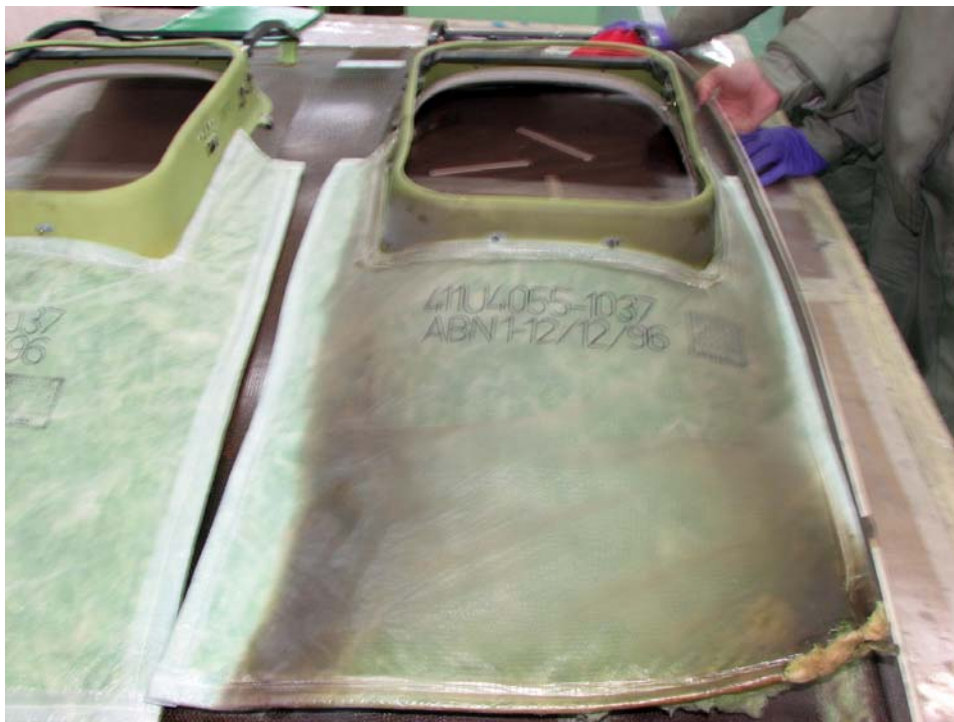
Fig. 1.12-3 Side Wall Panel Insulation Blanket

At the left side of the main deck passenger cabin E zone, between STA 2020 ~ STA 2060, seat number 64A/65A, a side wall panel lower edge seal was found damaged by heat. Near STA 2060 the insulation blanket for this side wall panel was found kinked by heat. The soot over the insulation was also found with smoke trace and discoloration from the bottom to the mid span. See Fig. 1.12-3.

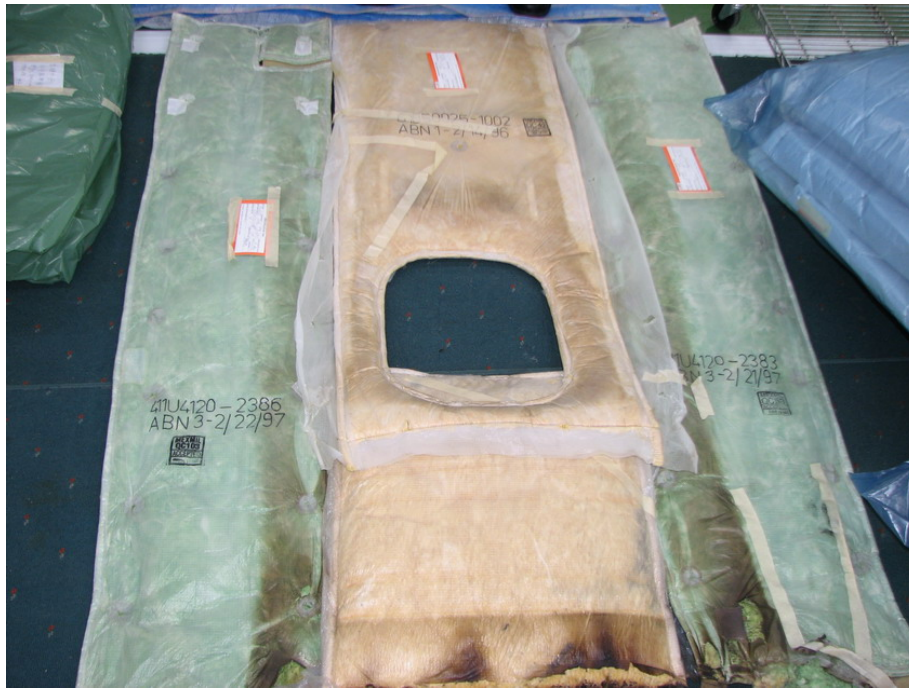
Fig. 1.12-4 Discoloration and Burnt Mark of the insulation Blanket

Cabin area left side, between STA 2040 ~ STA 2060, the insulation blanket behind the side wall panel was also found discolored by smoke; also at the bottom side, the top sheet of the insulation blanket was damaged and detached due to heat. See Fig. 1.12-4. The lower end of the insulation was also burnt and carbonized. See Fig. 1.12-5.

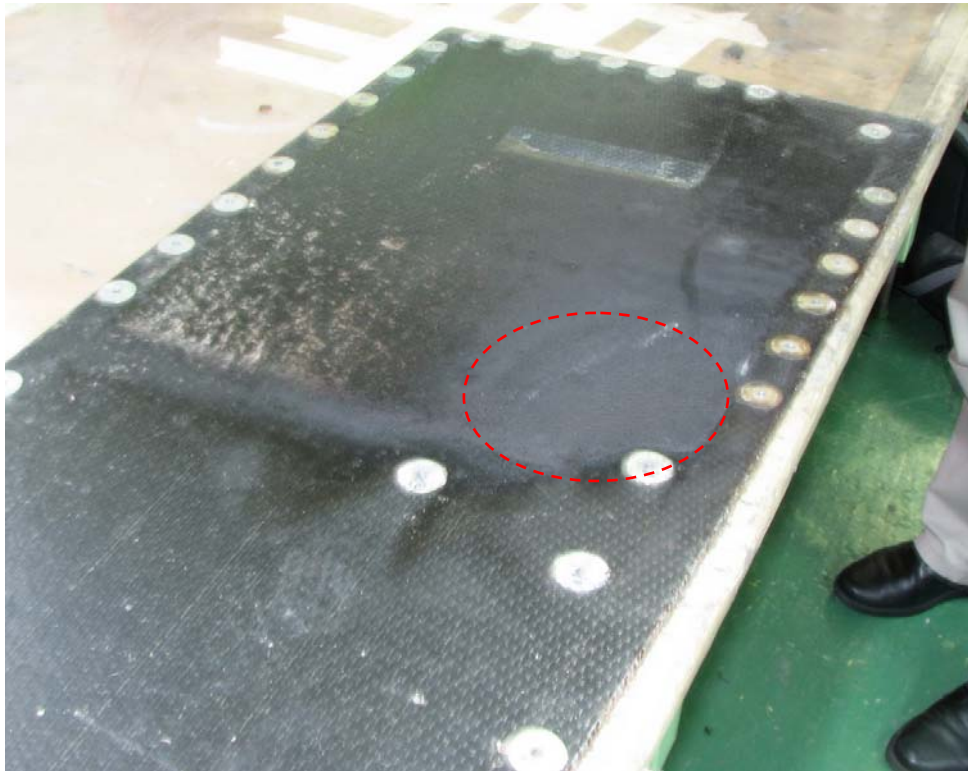
Fig. 1.12-6 Carbonized and Delamination of Floor Panel

inches. Confirmed by tapping test, a delaminated area was also found forward of the STA 2060 floor beam attachment. See Fig. 1.12-6.

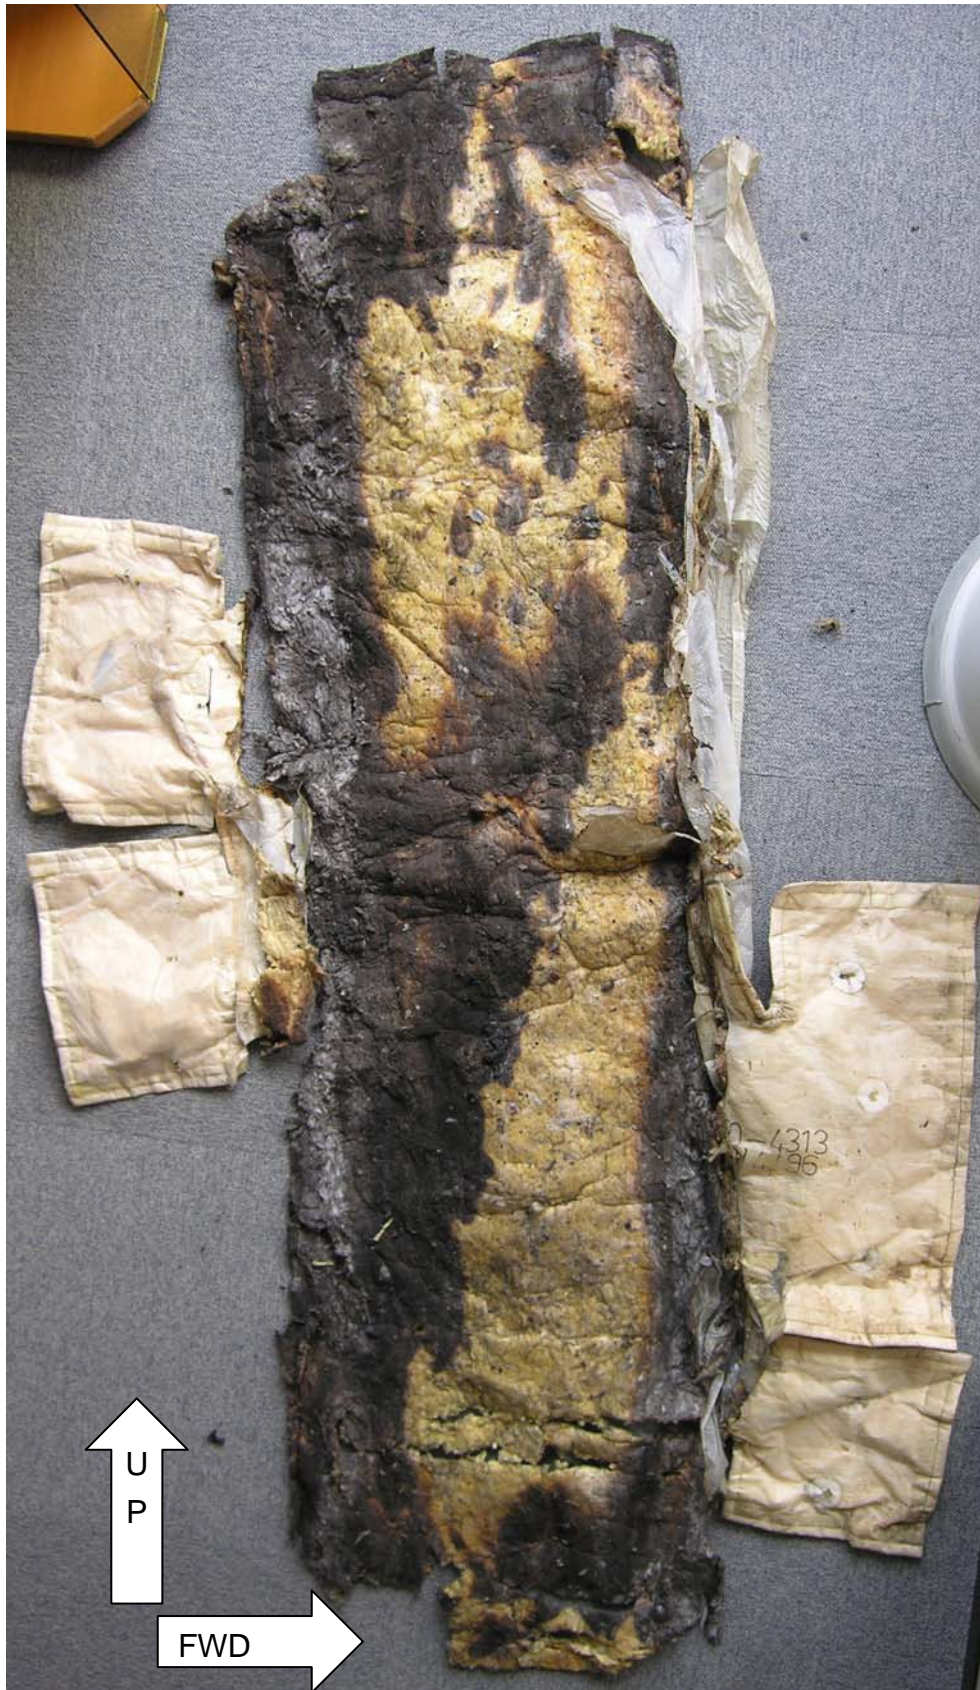
Fig. 1.12-7 STA 2020~STA 2040 Damaged Insulation Blanket IB Side

The remaining pieces of the two burnt insulation blankets between STA 2020 and STA 2060 under the main deck floor were collected by EVA for investigation. The two top side face sheets were all consumed by fire whilst the core layer was burnt into pieces with charcoal marks all over. Fire damage of the insulation blankets are shown in Fig. 1.12-7 to Fig. 1.12-10.

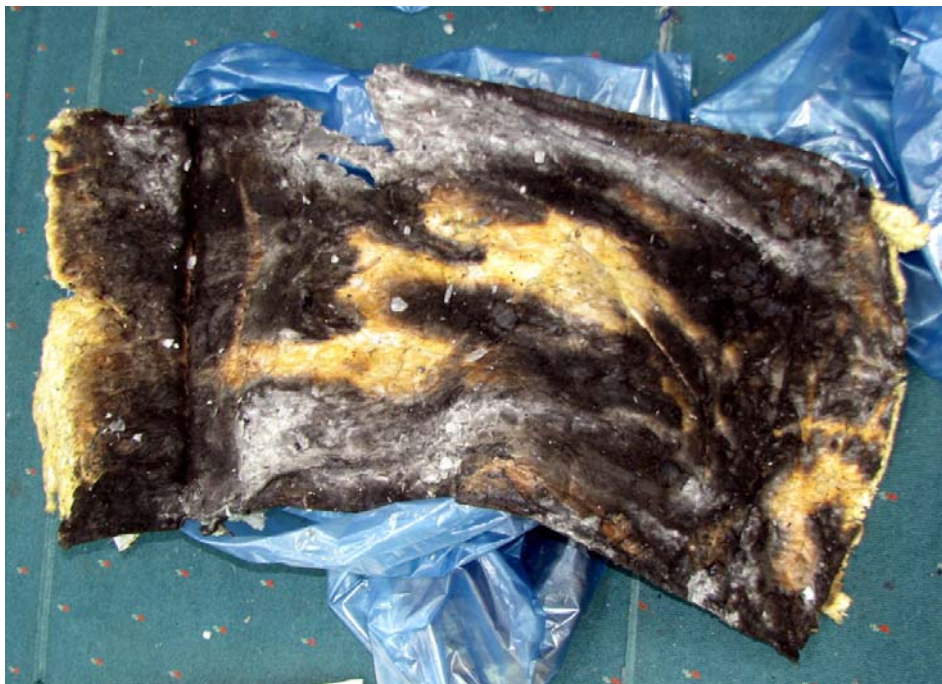
Fig. 1.12-10 Charcoaled with Grayish Deposit on Insulation Core Layer

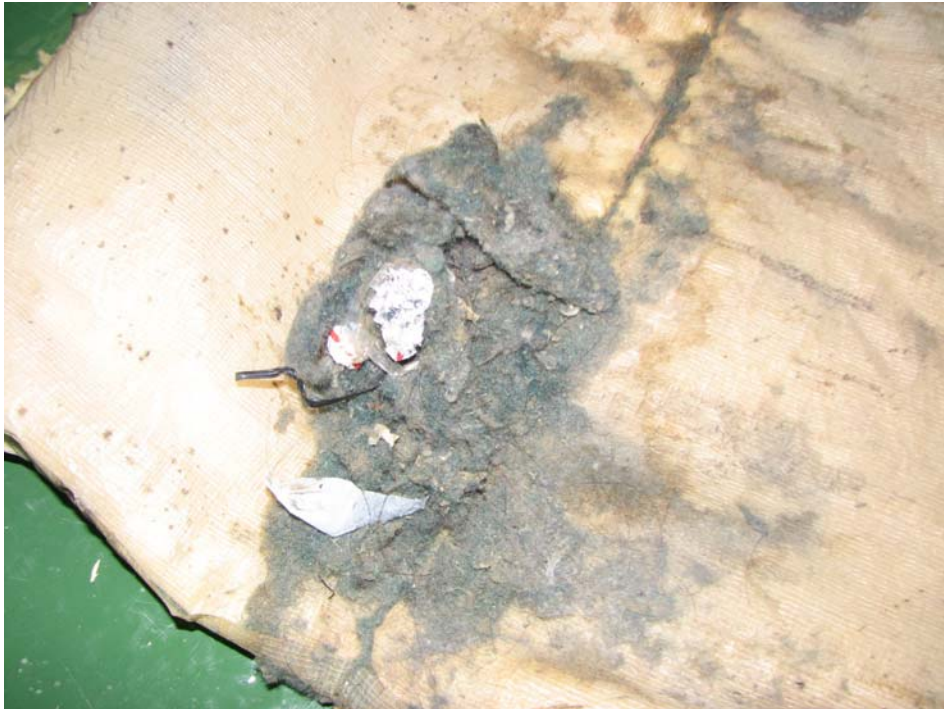
Fig. 1.12-11 Contamination, Dust and Cabin Items on the Damaged Insulation Blanket

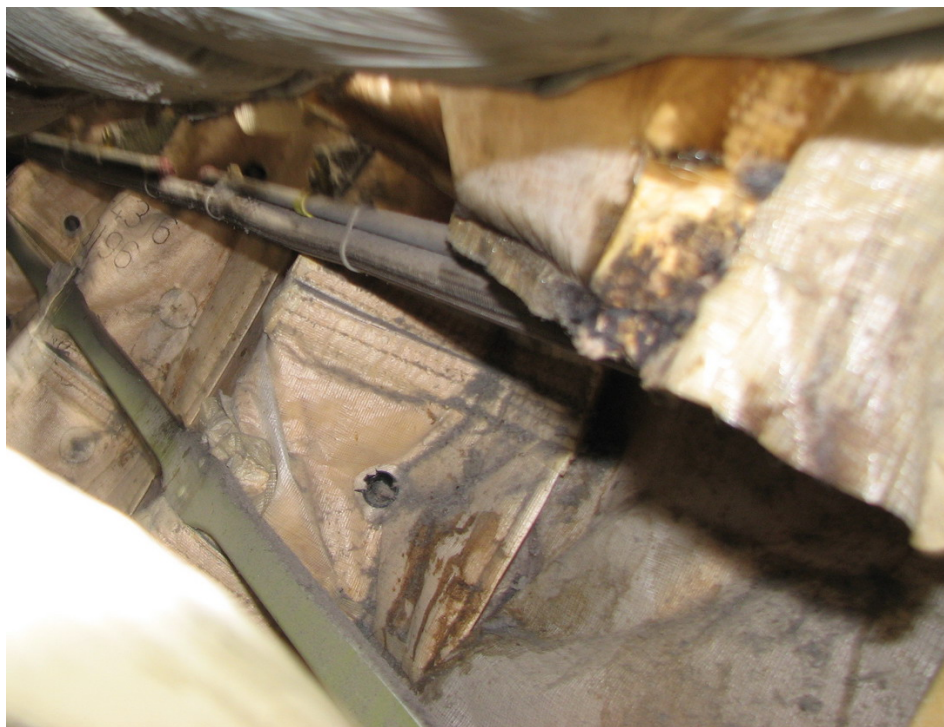
Fig. 1.12-12 Dust and Traces of Contamination on Insulation Blanket

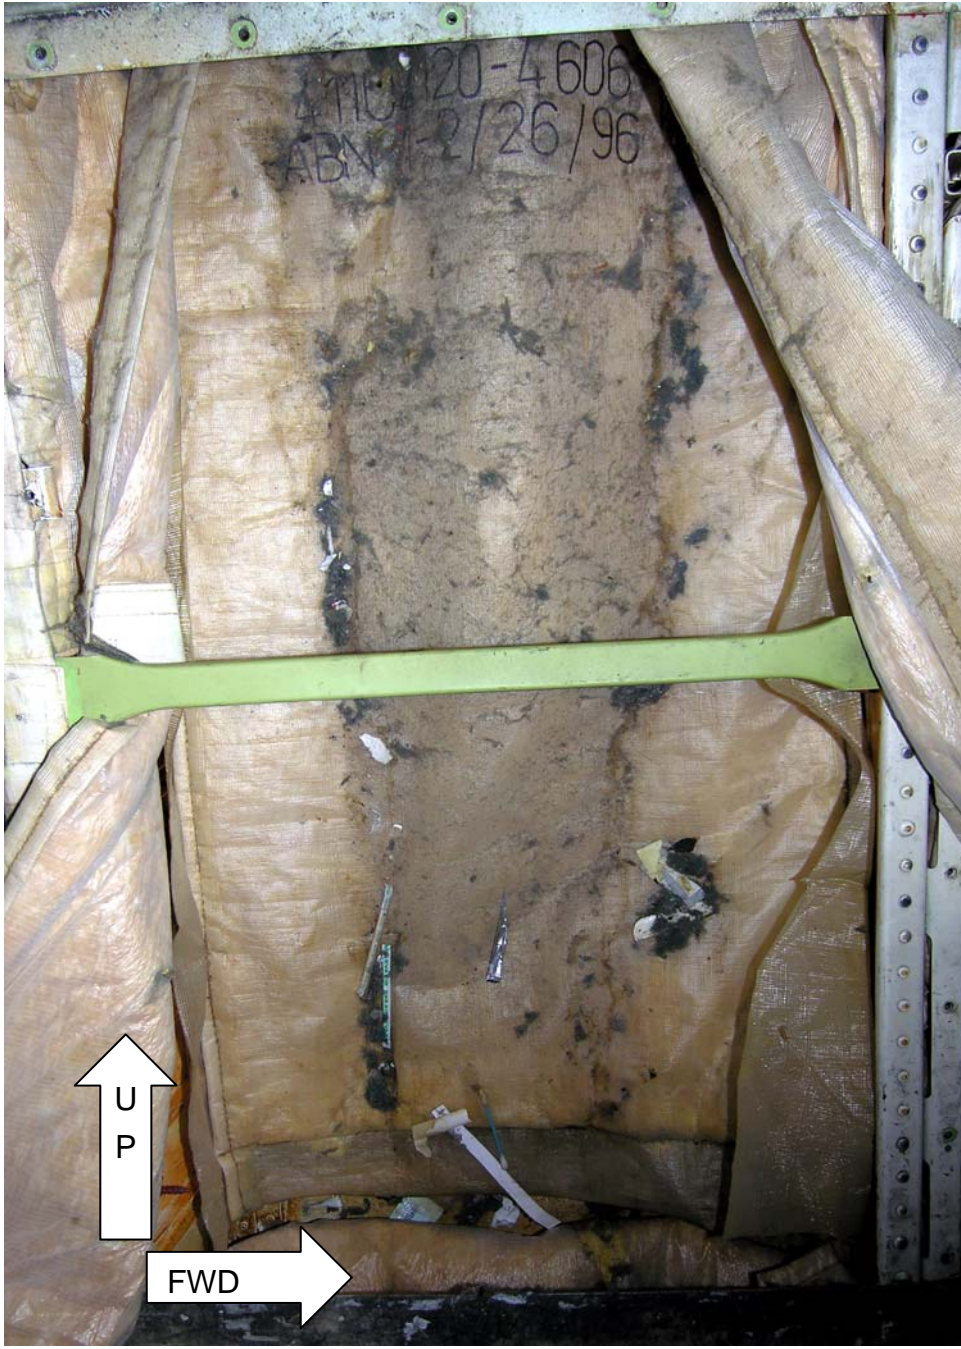
Fig. 1.12-15 STA 1940~STA 1960 below the Cargo Compartment Floor

service items found as shown in Fig. 1.12-11 to Fig. 1.12-18.

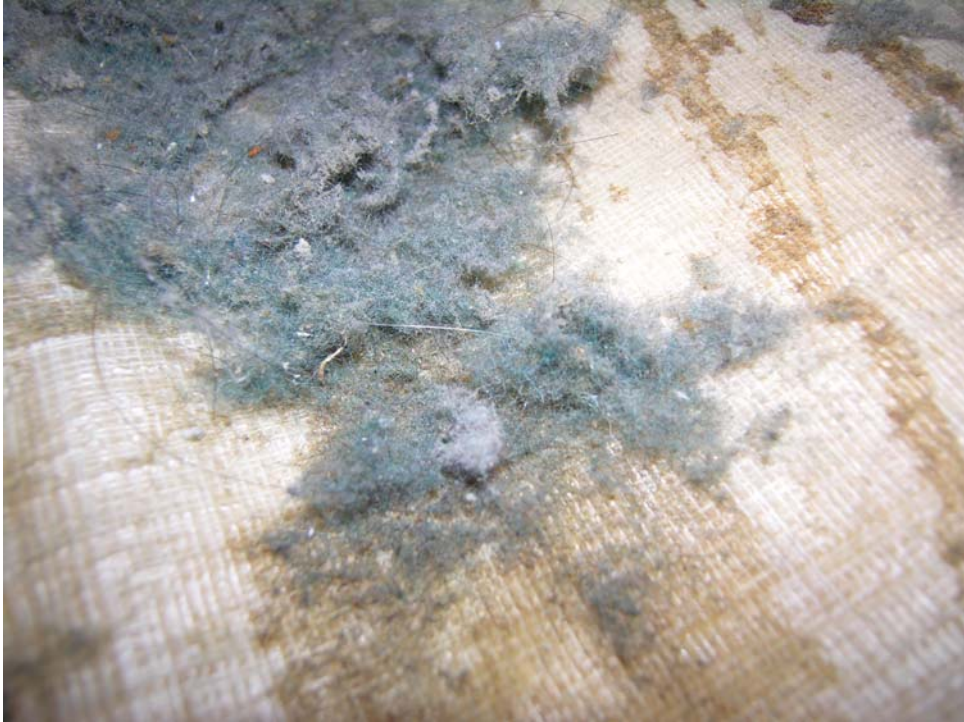
Fig. 1.12-18 Close up View of the Contamination on Insulation Blanket

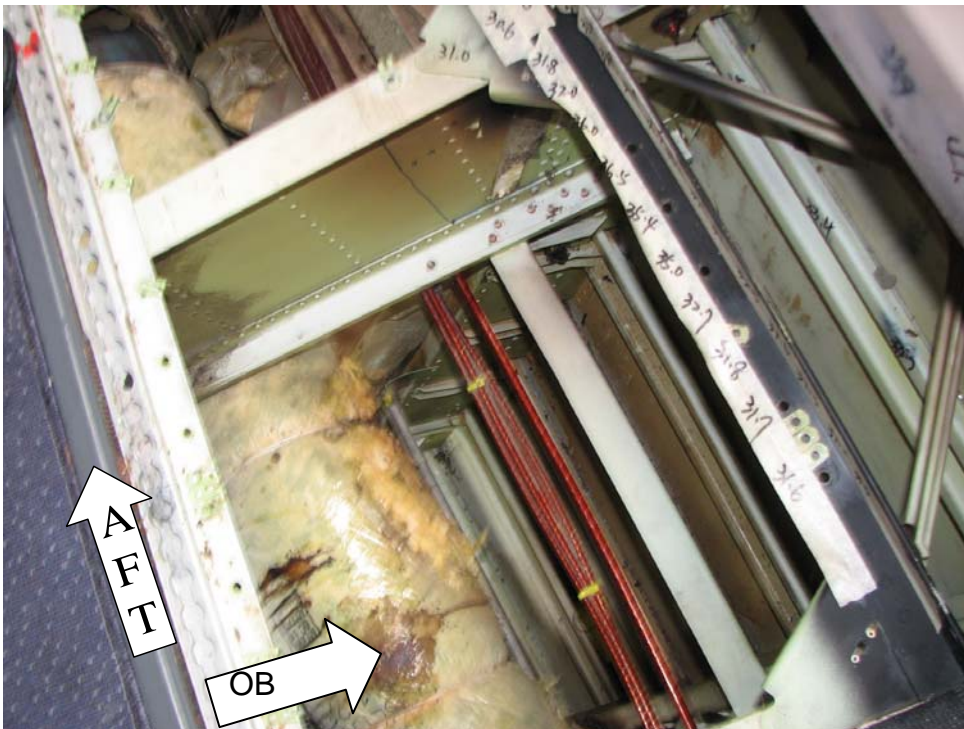
The face sheet of insulation warp of the pneumatic line for APU, between STA 2040 and STA 2060, was found melted and damaged by heat at OB side. See Fig. 1.12-19.

Fig. 1.12-19 Heat Damage of the Insulation of APU Pneumatic Line

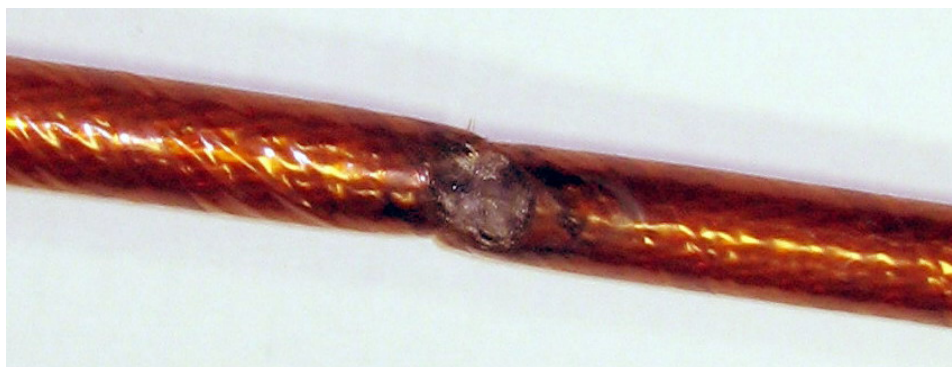
One of the three APU power cables, measured 40 inches long between STA 2040 to STA 2080, had been cut and removed in EVA maintenance depot. Within the cut off section, at the point aft of STA 2060, there was a melt and broken spot of the insulation jacket where the maintenance personnel had cut through the cable into two pieces. The melt broken spot measured 7mm in diameter; inside the pit spot the exposed metal core of cable showed signs of charcoal and melted to a 60% depth of the diameter of the metal core, see Fig. 1.12-20 and 1.12-21.

Fig. 1.12-20 APU Power Cable with Damaged Insulation Jacket

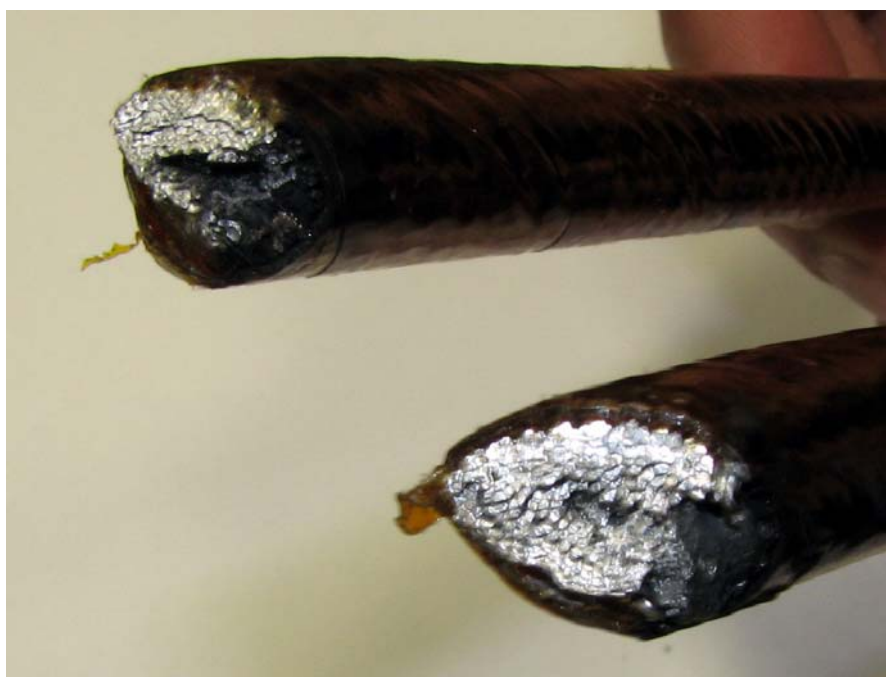
Fig. 1.12-21 Cut through View of the Damaged Spot of the Cable

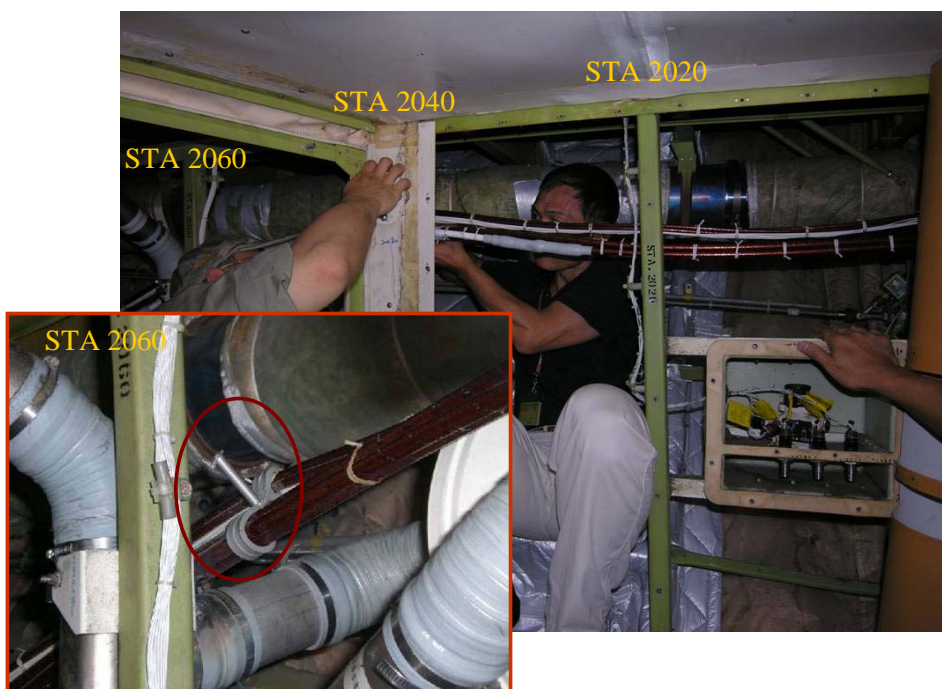
Fig. 1.12-22 The Relative Position of The Damaged Standoff to Fuselage Structure

measuring the exact location of these standoffs on the floor beam posts (from STA 2040 to STA 2080), it was found that these standoffs were located with various height against the floor level, among them the STA 2040 standoff and the STA 2060 standoff were at an elevation relatively higher than the others, as indicated in Fig. 1.12-23. The installation method of these standoffs was using two blind rivets, up and down, fixing the base of standoff onto the floor beam posts (see Fig. 1.12-24), whilst the tip of the standoff carrying the APU power cable. ASC investigator measured the load carried by the STA 2060 standoff tip with a spring scale and found it to be 20 lbs downward. Deducted the weight of the APU power cable distributed herein, the excessive load beyond is estimated to be 18 lbs.

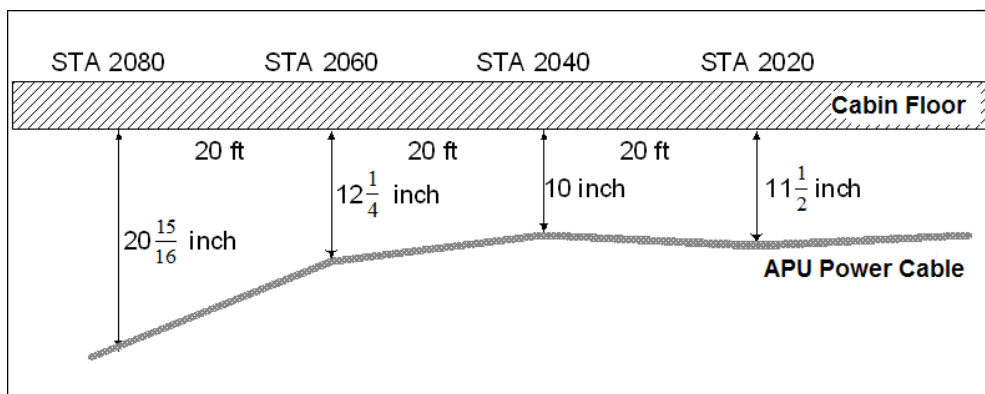
Fig. 1.12-23 Standoffs Located with Various Height to Floor Level

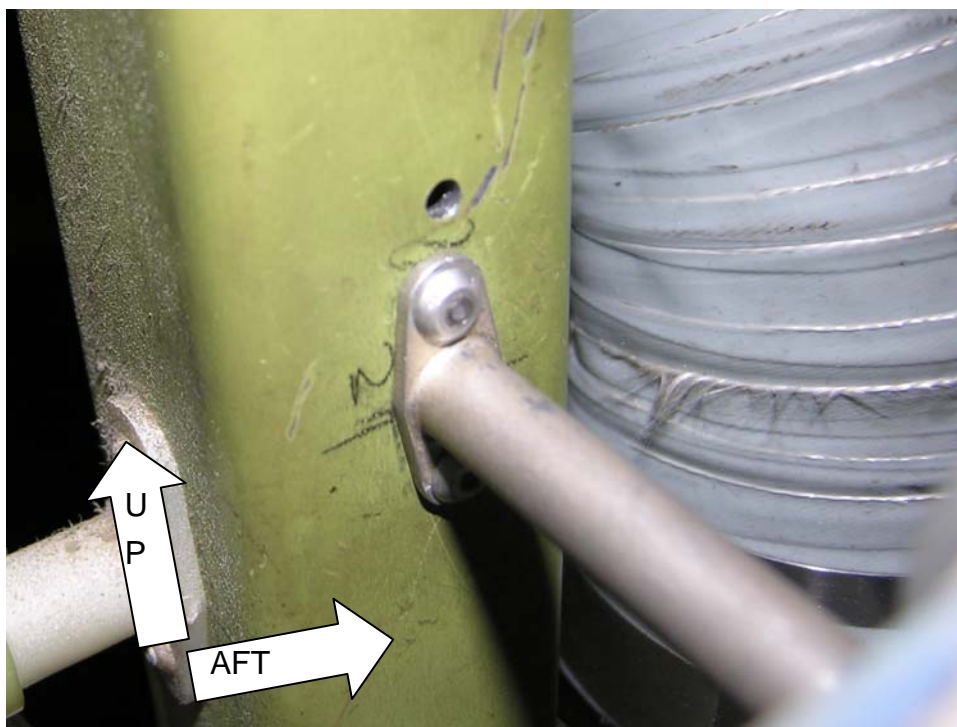
Fig. 1.12-25 New Position of the Replacement Standoff (View looking IB)

The damaged metal standoff, P/N BACN10TL3-18, at STA 2060, LBL 76.61, in fixing the APU power cable had been replaced with a new one, due to the existing fastener holes were enlarged and distorted. New fastener holes were drilled a quarter inch lower relative to the existing ones on the floor beam post, see Fig. 1.12-25.

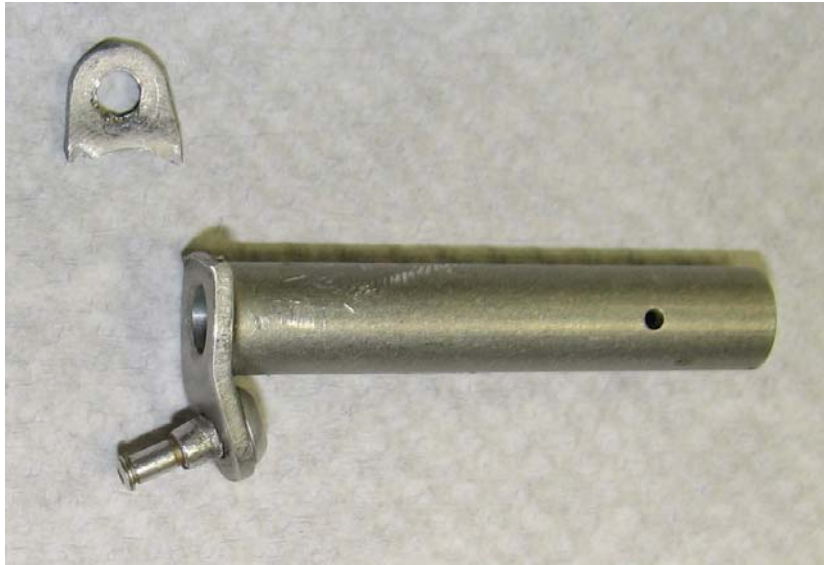
Visual check of the damaged standoff during the investigation revealed that the base of the standoff has been bent and torn broken with a downward bending force; the breaking point was at upper side of the base. The lower blind rivet is still attached on the base, see Fig. 1.12-26.

Fig. 1.12-26 The Broken Standoff

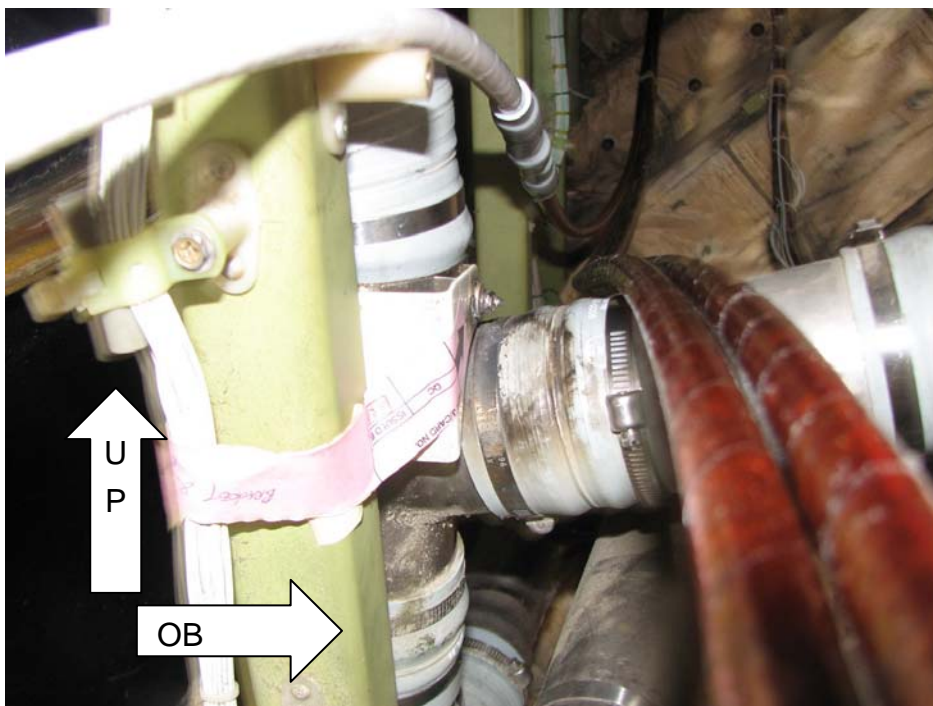
The tip of the fastener fixing the tube bracket of the waste tank vacuum pump was found melted, while on the upper surface of the tube running below the melted bolt, some grayish and black power like deposit generated by arcing was found. See Fig. 1.12-27.

Fig. 1.12-27 Fastener Tip and Deposit generated by arcing(View looking AFT)

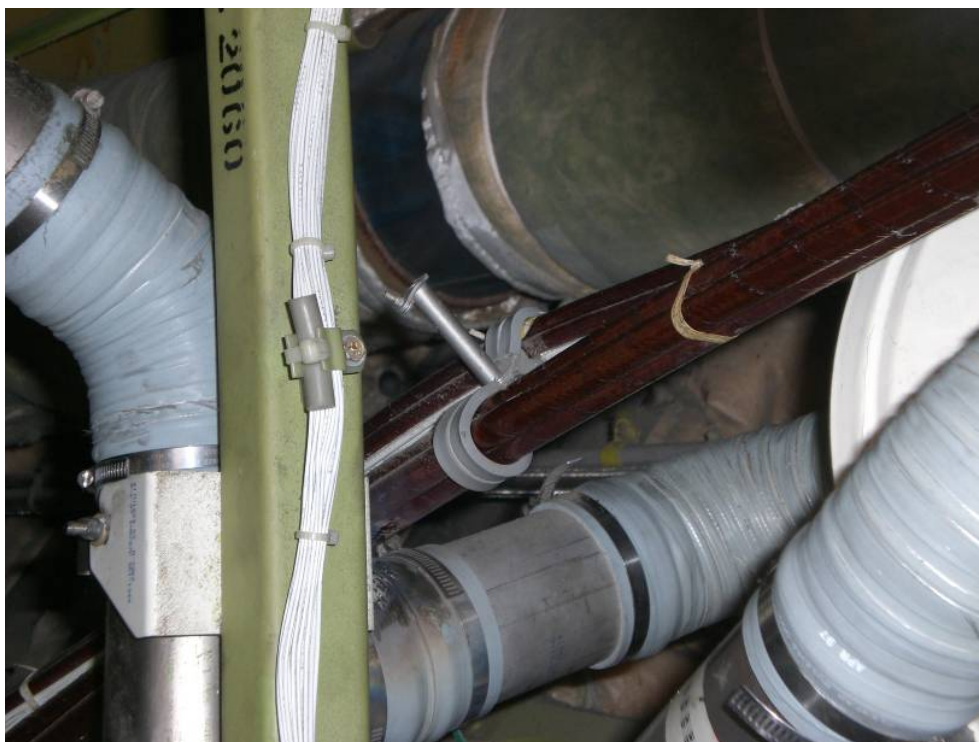
Fig. 1.12-28 Immediate Photograph of the Site (Provided by EVA)

Repeated abrasion had caused the insulation of the cable to fail and the metal wire to touch the aircraft structure, and caused the presumed arcing condition thereafter.

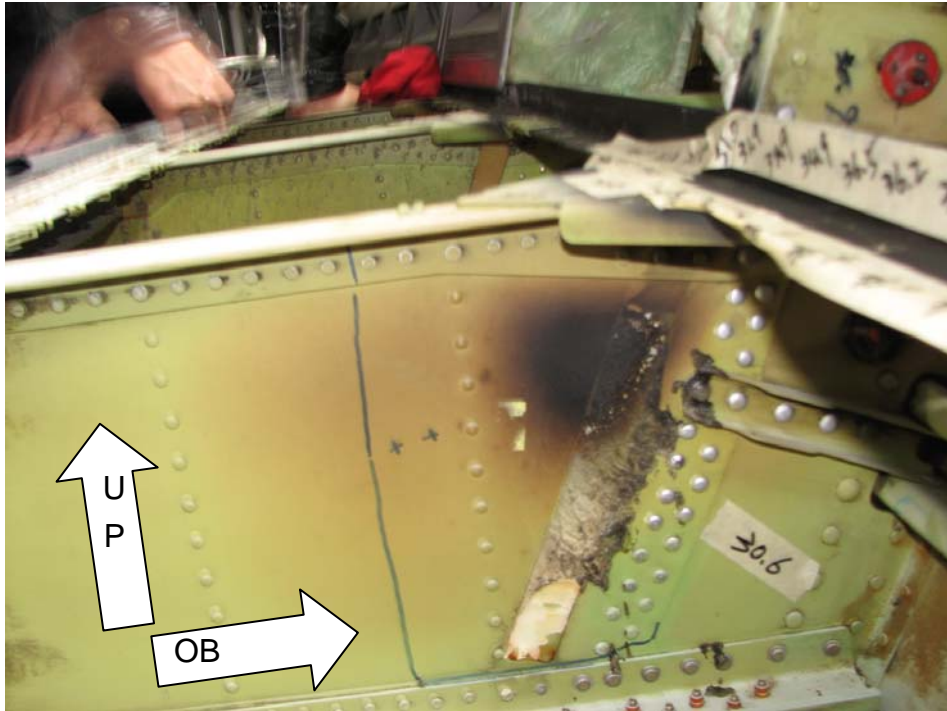
Fig. 1.12-29 STA 2060 Forward Side of Floor Beam
(View looking DOWN & AFT, L/H of A/C)

After removal of the fire engorged insulation blankets in the bulk cargo compartment, the floor panel, and the side wall panel in the main deck cabin, it was found that the most left side web and upper chord of the STA 2060 floor beam were discolored with smoke and heat, the discoloration area measured 12.5 inches wide laterally and whole beam width vertically. Another finding was some charcoal remaining fragment of the insulation blanket sticking on the forward surface of the floor beam web and tail end of the S-27L stringer clip, see Fig. 1.12-29 and Fig. 1-12-30.

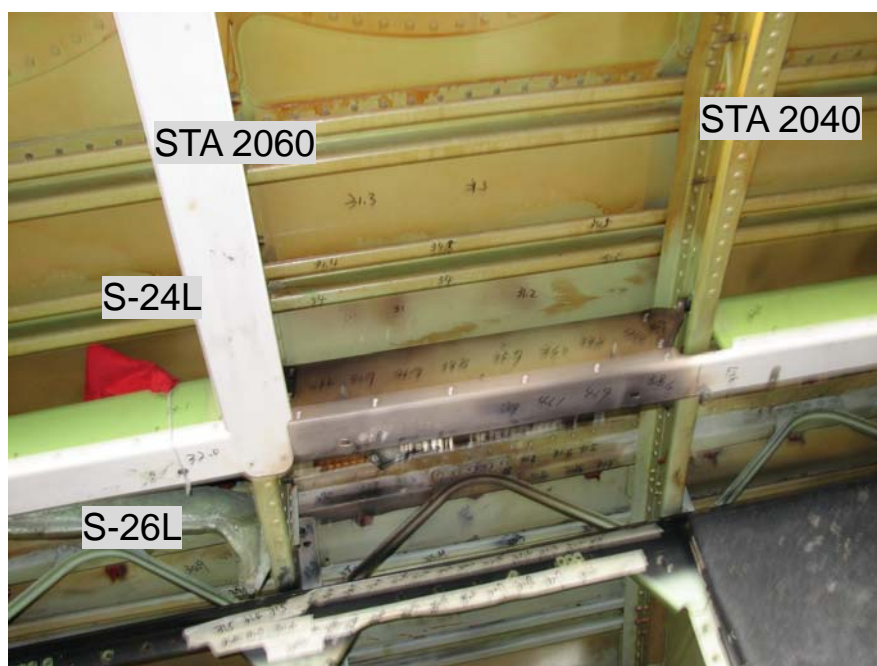
Fig. 1.12-31 STA 2040~STA 2060 Cabin Left Side Structure

Soot and discoloration from heat was found on the STA 2040 and STA 2060 frames between S-24L and S-27L. Stringers namely S-24L, S-25L, S-26L, and S-27L were discolored between STA 2040 and STA 2060. Stringer clips for S-25L and S-27L at STA 2060 were discolored. All heat damage related findings are shown in Fig. 1.12-31.

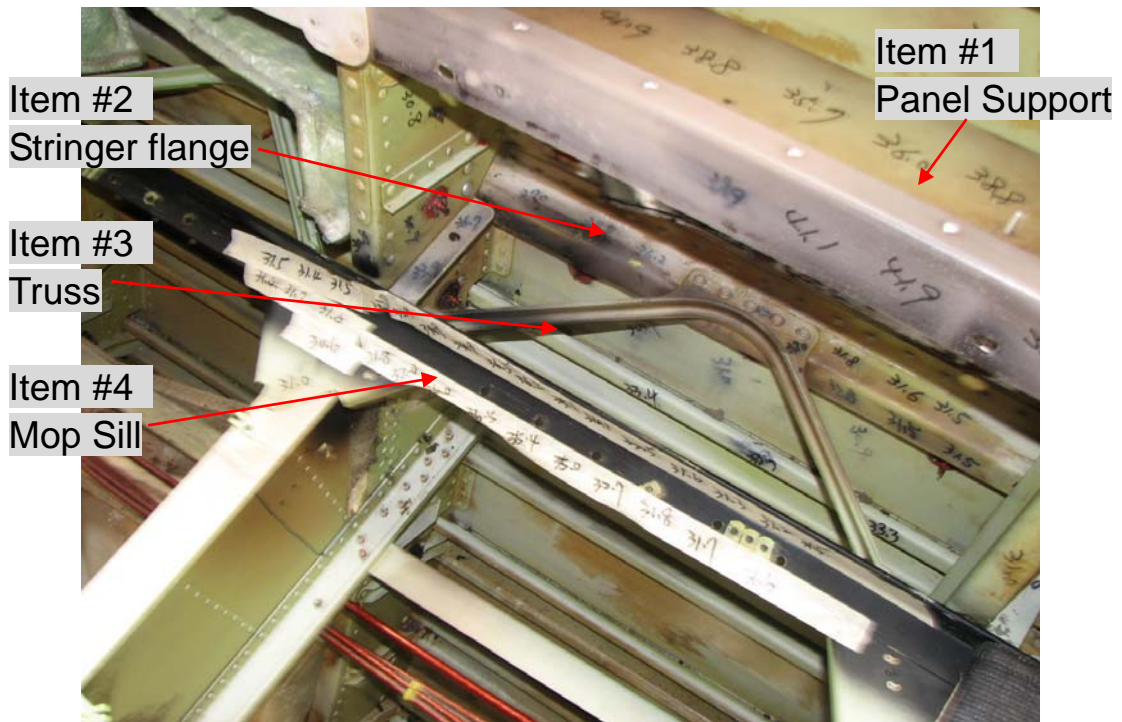
Fig. 1.12-32 STA 2040~STA 2060 Fuselage Left Side Structure

Mop sill (P/N: 65B06029-1) was found discolored between STA 2040 and STA 2060, as shown in Fig. 1.12-32, Item #4.

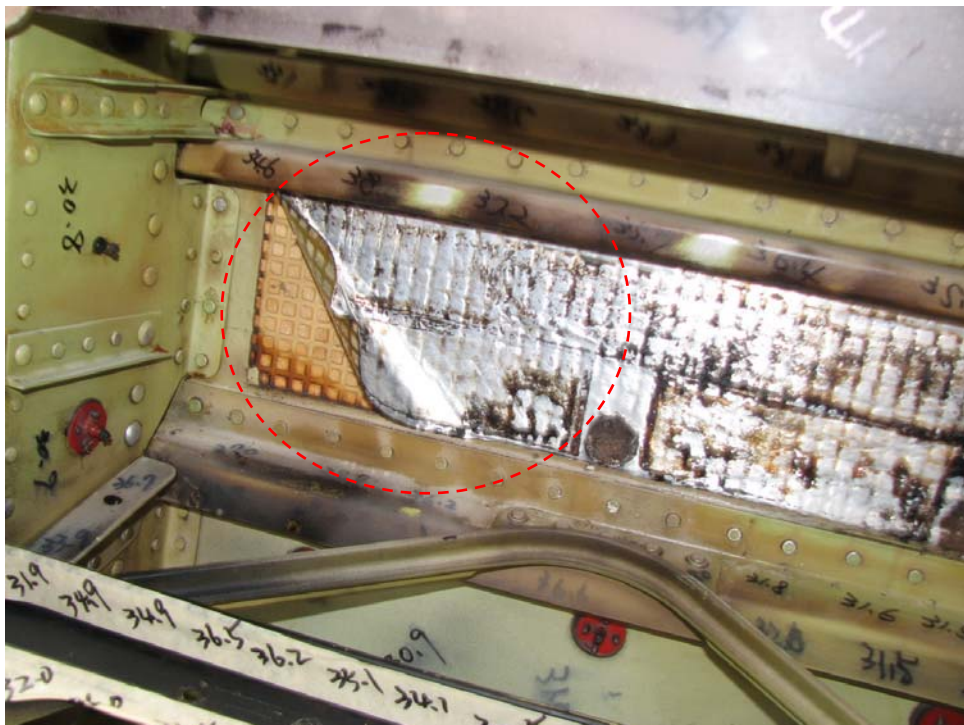
Fig. 1.12-33 Noise Barrier at STA 2040

Noise barrier applied between STA 2040 and STA 2060, S-25L and S-26I, was found covered with soot and detached at lower aft corner. See Fig. 1.12-33.

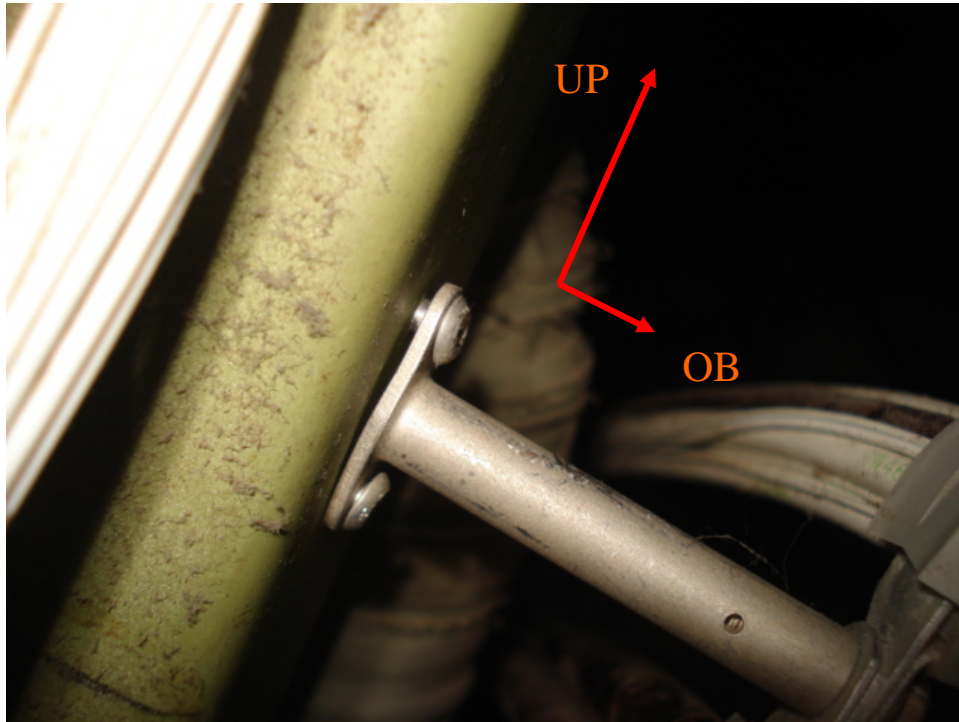
A fleet wide inspection for all the B747-400s of EVA was conducted immediately after the occurrence. One similar case of compromised standoff was found on another sister ship, register number B-16411, with identical APU power cable standoff installed at STA 2060, which the base of the aluminum standoff was found bent downward slightly with a pulled loose blind rivet at the upper side, and the lower blind rivet head clinched. See Fig. 1.12-34.

Fig. 1.12-34 Similar Case Found in Fleet Wide Inspection

1. Assessment of the fleet wide condition of the APU power cable installation at BS2060 standoff, including inspection, measurement, and correction of the pre-existing excessive loading if found.
2. In an effort to take account of Boeing's experience and service letter 747-SL-25-170-B, enhancing the evaluation of contamination in the cargo compartment to revise maintenance plan of cabin and cargo compartment accordingly.
3. Review and evaluate job card number 1A62IN and related job cards in accordance with AMM to add inspective and corrective procedures such that maintenance personnel can be complied with.
4. It was not a complete dispatch release to fly from Bangkok to London, Bangkok and Taoyuan. Eva should enhance the outside station maintenance

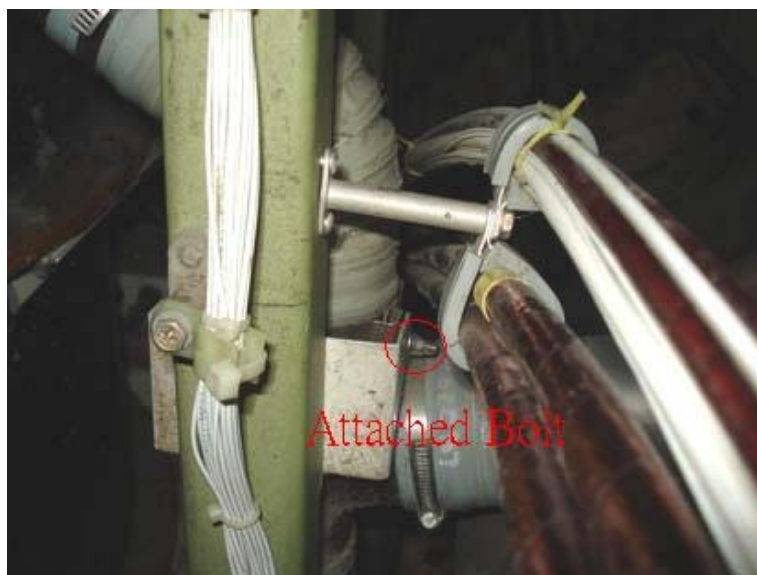
Fig. 1.14-1 Attached Bolt of Waste Tank Tube Fixture

After the smoke put out, EVA maintenance representative started the APU and tried to supply power again. No. 1 APU generator power breaker was tripped and short circuit was found around aft cargo compartment. After inspection, a fell out standoff was found which was resulted from loosed rivets and the broken standoff fixture. One of the three phase electrical wires of No. 1 APU generator rubbed against the attached bolt (refer to Fig. 1.14-1, this figure was taken from another aircraft at the same location, but the upper rivet was loosed) of waste tank tube which resulted in the damage of insulation covering of wire. The damaged insulation covering caused the exposure of metal wire (refer to Fig. 1.14-2).

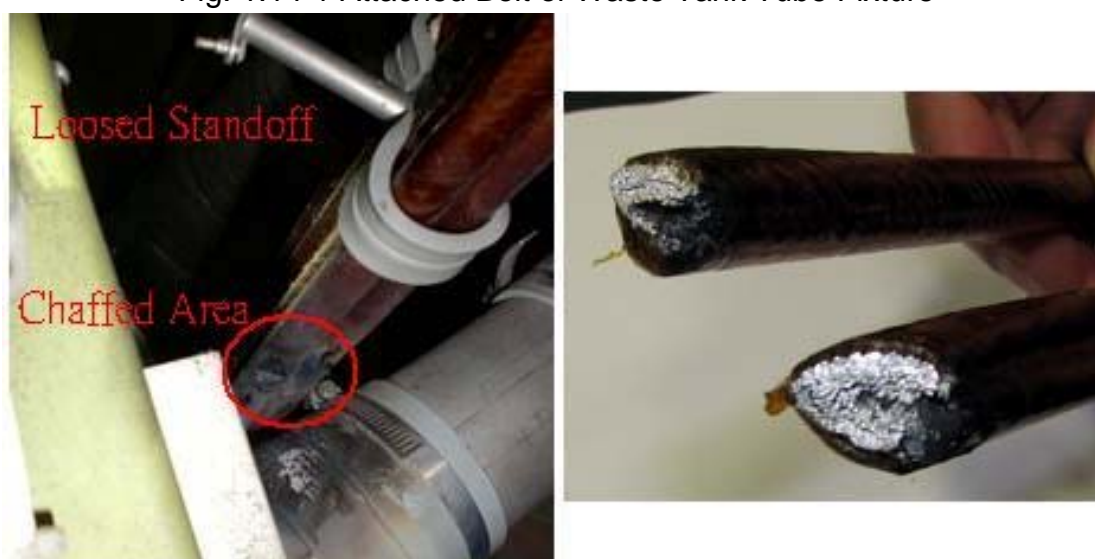
Fig. 1.14-2 Damaged Cable wire

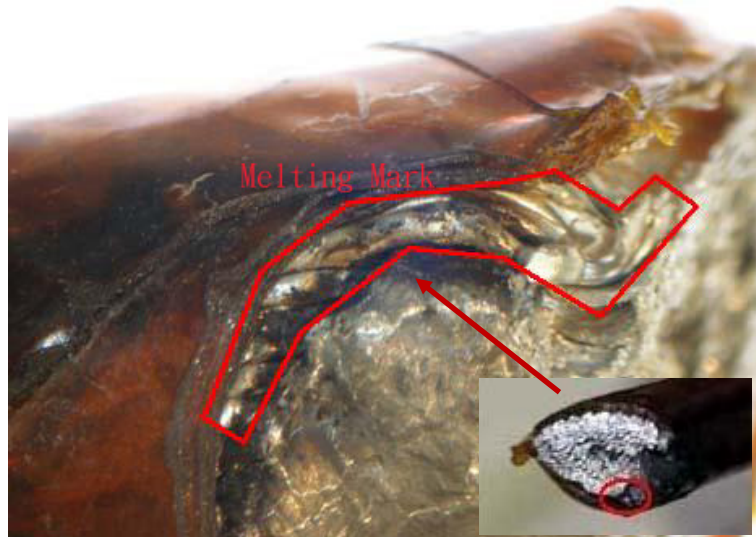
The contact of exposed cable and bolt resulted in short circuit and the melting of cable condensed into a cascade of melting marks due to the heat (refer to Fig. 1.14-3 and Fig. 1.14-4).

Fig. 1.14-3 Melting Mark of Metal Wire Due to Heat-1

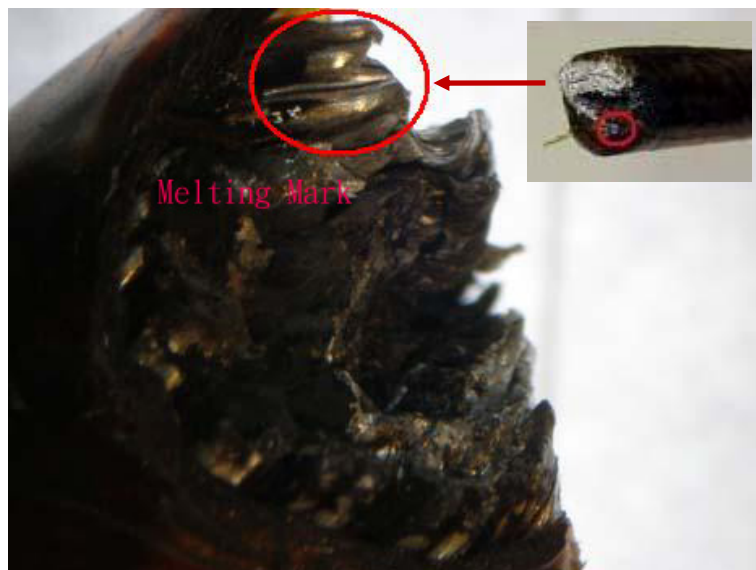
Fig. 1.14-4 Melting Mark of Metal Wire Due to Heat-2

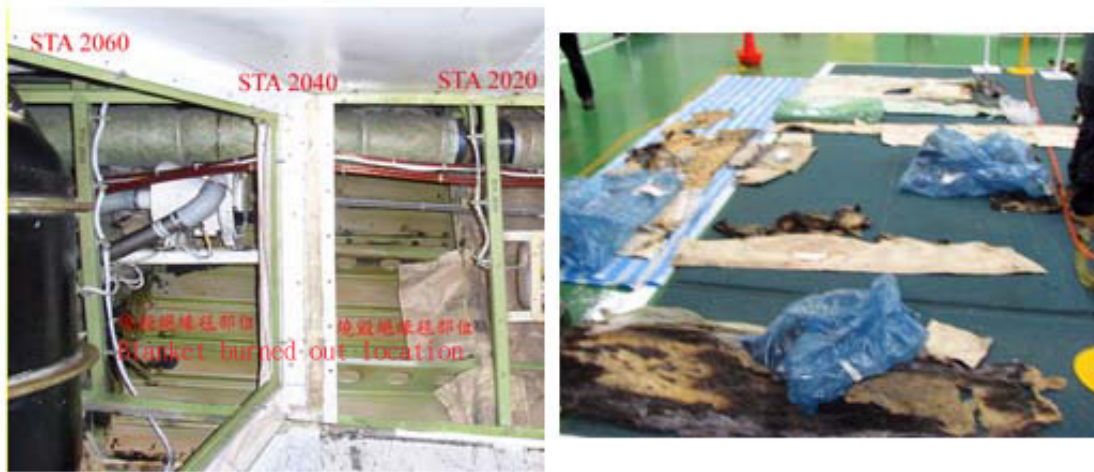
Fig. 1.14-6 Locations and Status of Damaged Insulation Blankets

The damaged and replaced insulation blankets were in cabin and aft cargo compartment covered from station 2020 to station 2060 (refer to Fig. 1.14-6 left Part). The yellow insulation blankets located beneath the wire with damaged insulation covering and short circuit had more serious burnout than other places (refer to Fig. 1.14-6 right Part) while those green insulation blankets installed in cabin were only discolored.
